Development of Improved Guidelines and Designs for Thin Whitetopping: Construction and Initial Environmental Response of Full-Scale BCOA Sections

# Development of Improved Guidelines and Designs for Thin Whitetopping: Design, Instrumentation, Construction and Initial Environmental Response of Full-Scale BCOA Sections

Partnered Pavement Research Center (PPRC) Strategic Plan Element (SPE) 4.58B:  
Evaluate Early Age and Premature Cracking for PavEM and LCCA (whitetopping);  
Project Task 2878

1. REPORT NUMBER UCPRC-RR-2017-02	2. GOVERNMENT ASSOCIATION NUMBER	3. RECIPIENT'S CATALOG NUMBER
4. TITLE AND SUBTITLE Development of Improved Guidelines and Designs for Thin Whitetopping: Construction and Initial Environmental Response of Full-Scale BCOA Sections		5. REPORT PUBLICATION DATE July 2018

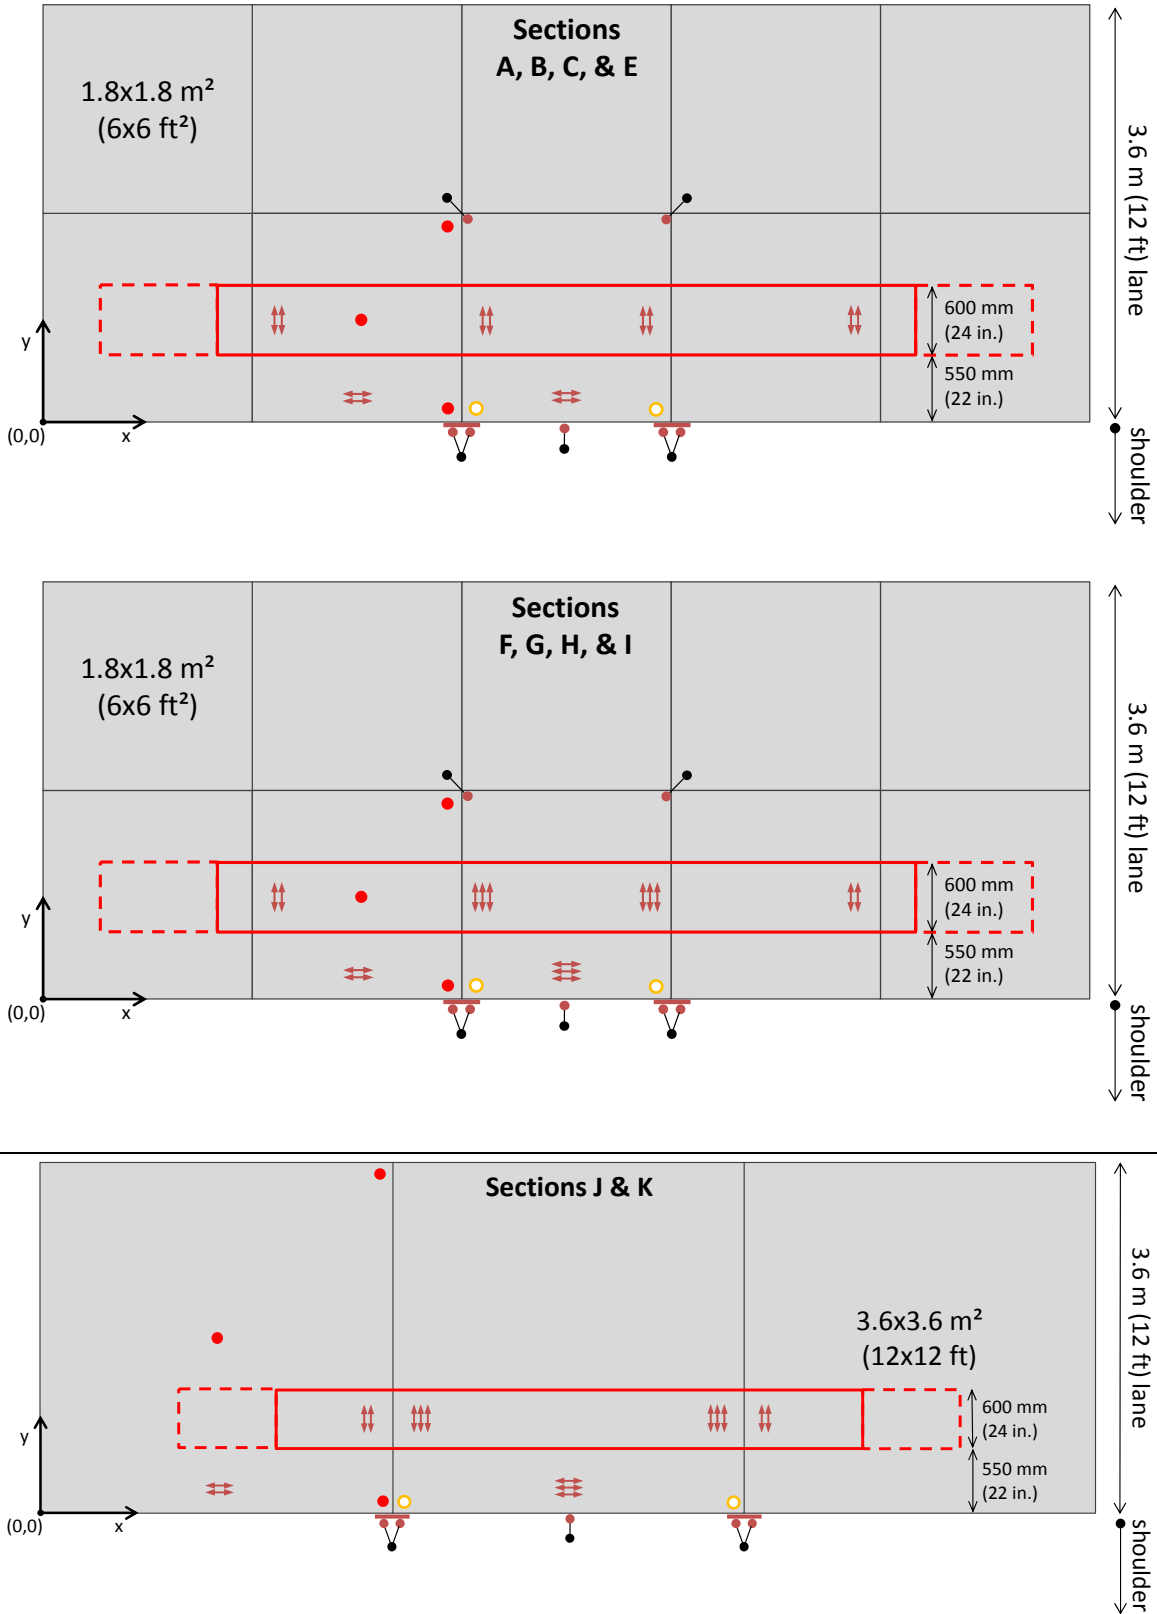
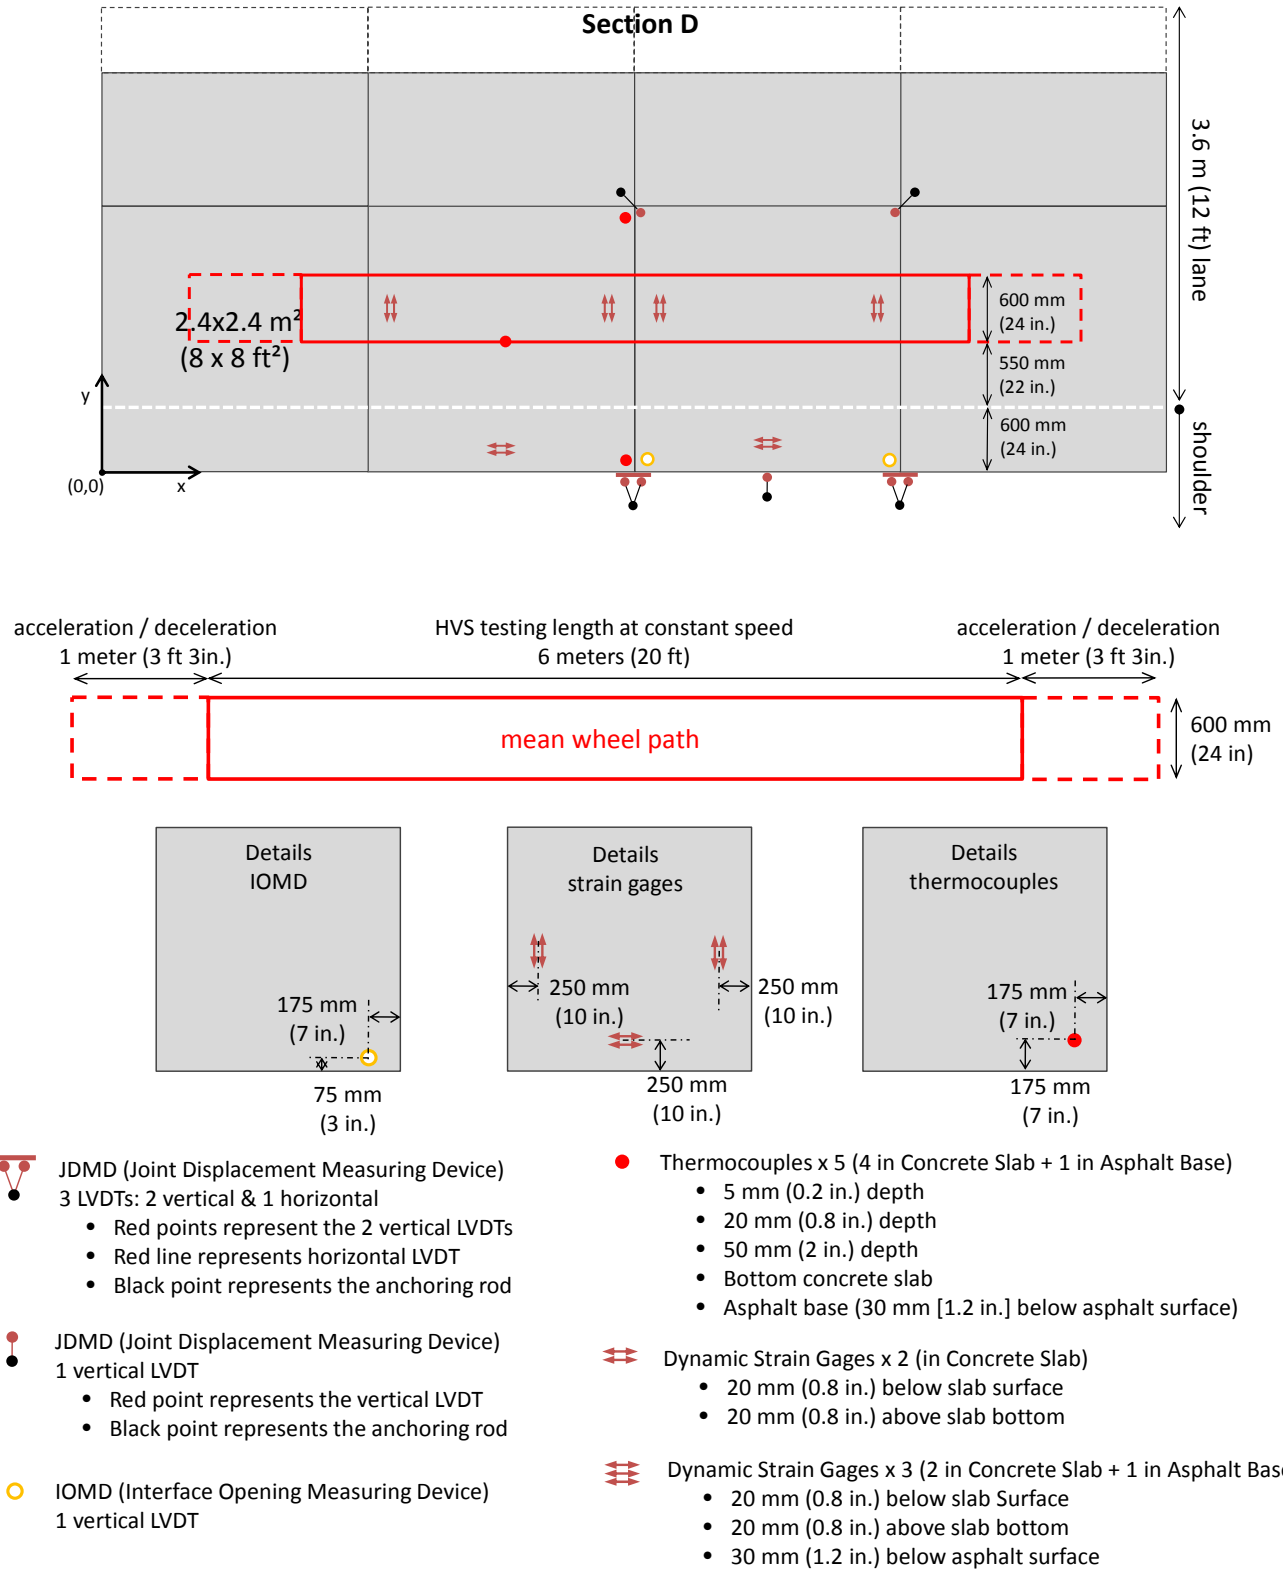
Figure 3.1: Instrumentation of the HVS sections.

**Figure 3.1 (cont.): Instrumentation of the HVS sections.**

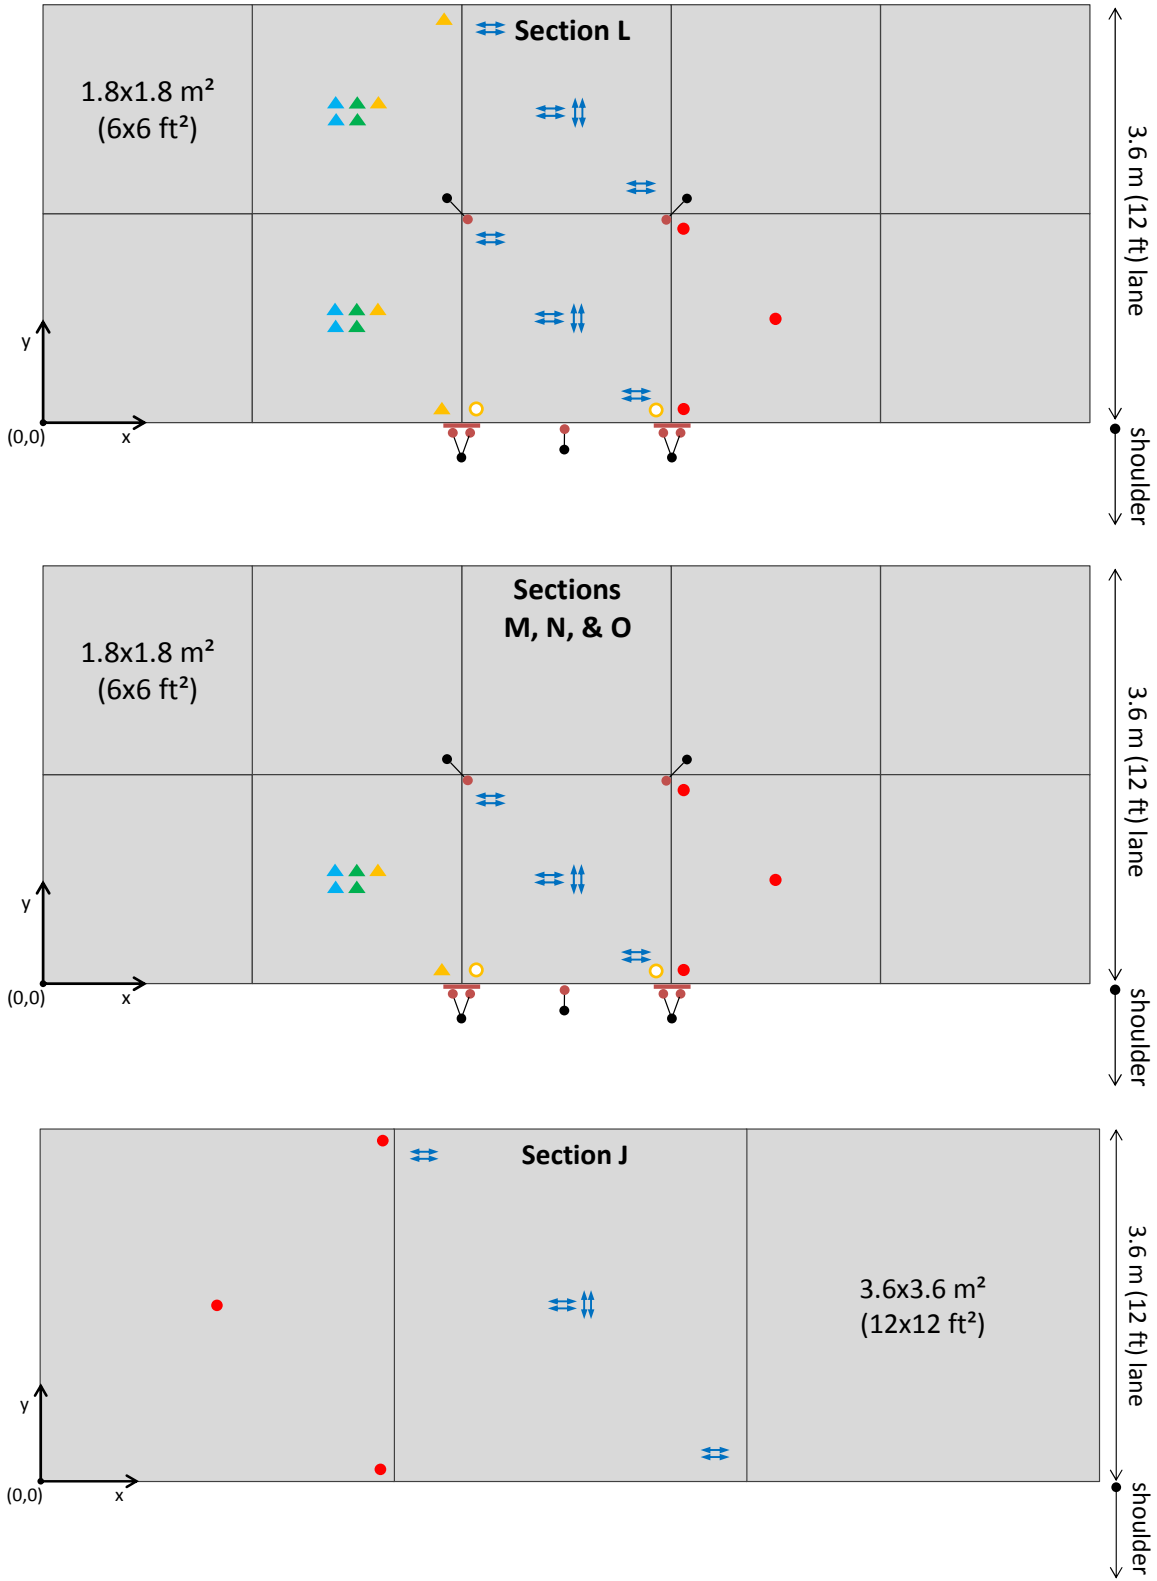
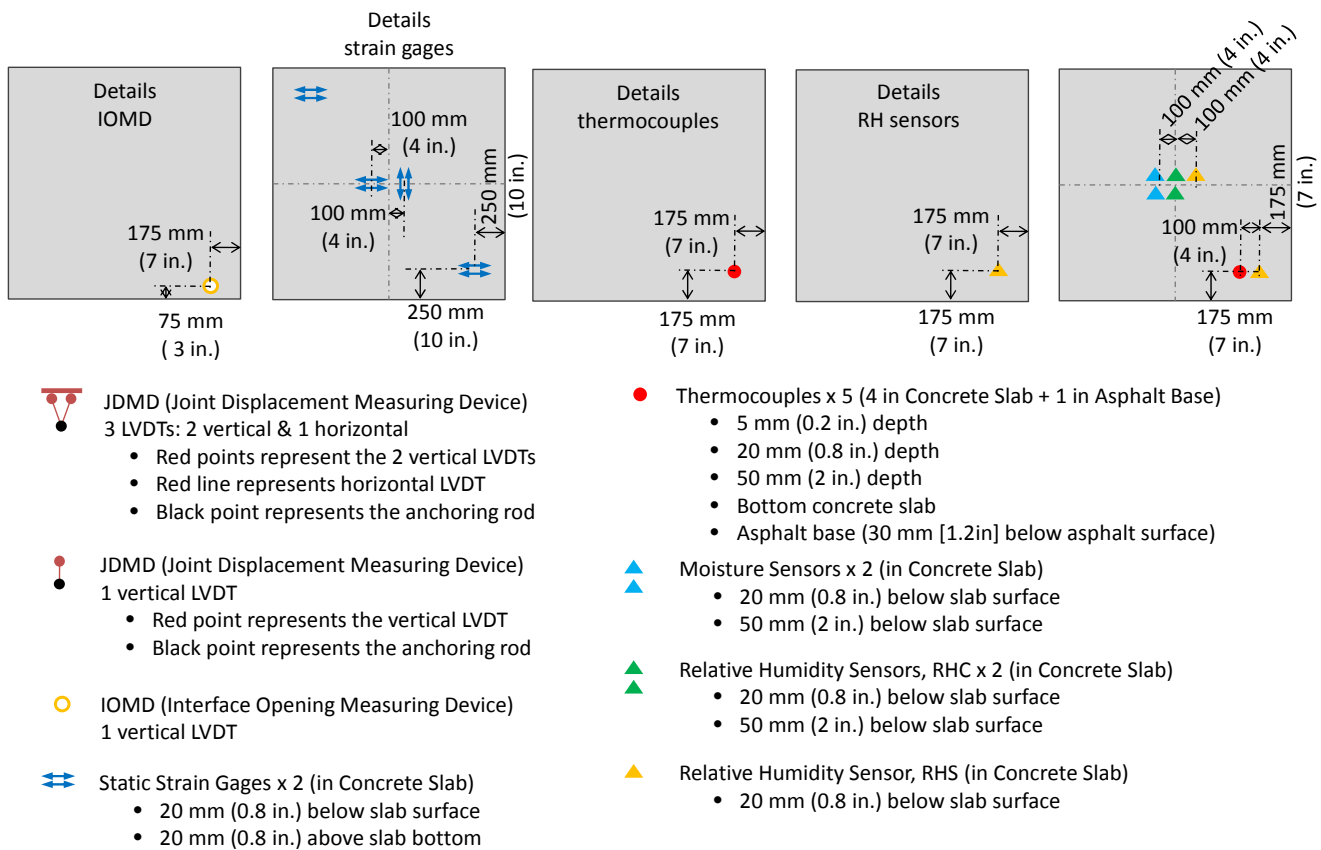
The ENV sections were also instrumented with thermocouples to monitor concrete and asphalt temperature. The location and depth of these sensors matched those in the HVS sections. Specifically, they were installed in one slab of each section: at the slab center, at one of the slab's interior corners, and at one of the slab's exterior (shoulder) corners. As with the HVS sections, the thermocouples were installed at five depths: 5 mm (0.2 in.), 20 mm (0.8 in.), 50 mm (2.0 in.), at the slab bottom, and at the asphalt base (30 mm [1.2 in.] below the asphalt surface). It should be noted that other sensors that monitor environmental response (VWSG, relative humidity sensors, and moisture sensors) also include temperature sensors.

Figure 3.5: Instrumentation of the environmental sections.

**Figure 3.5 (cont.): Instrumentation of the environmental sections.**

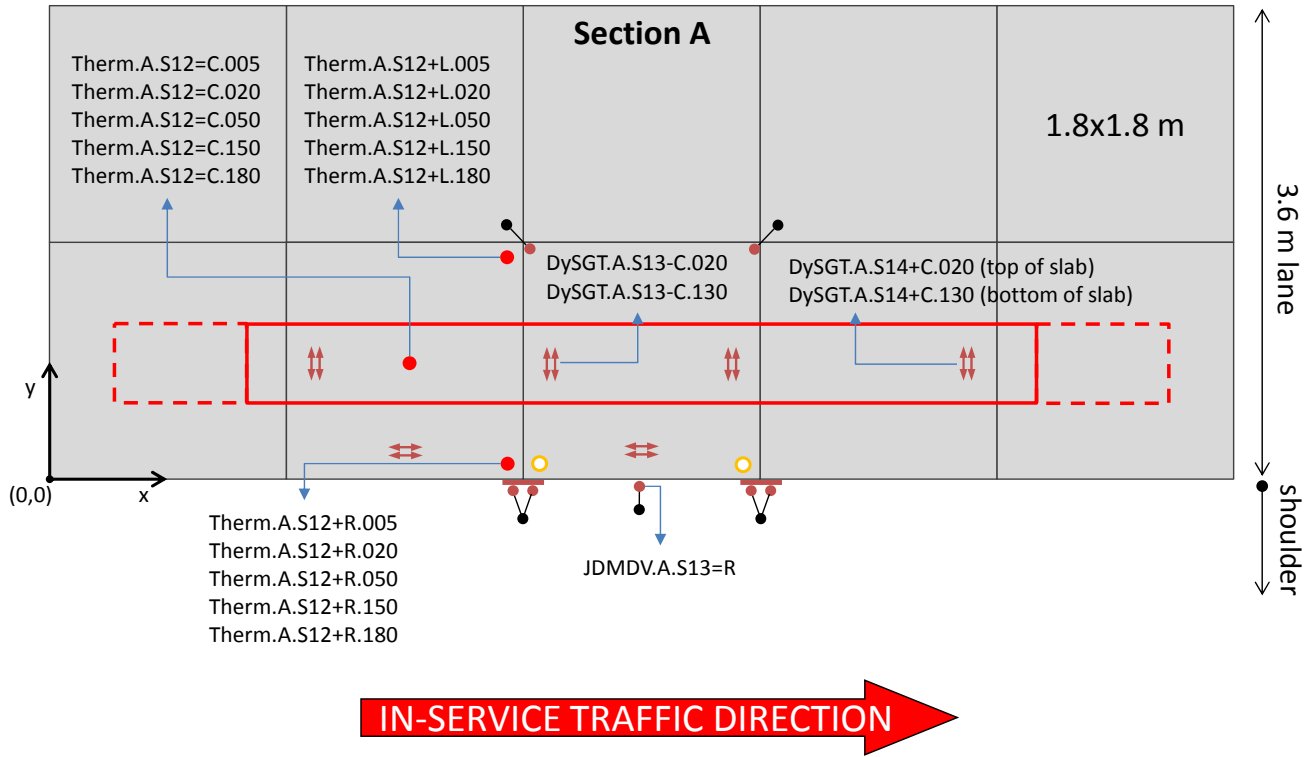
- b. The sensor’s location within the slab is indicated with a symbol and a letter, as indicated below. Its location within a joint is indicated with either an “L” for left or an “R” for right. A minus sign (-), an equal sign (=), or a plus sign (+) refers to the approaching, middle, or leave part of a slab, respectively.

**Figure 3.6: Example sensor codes (Sections A and K).**

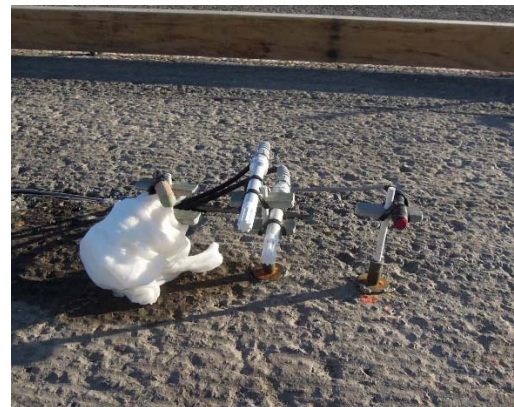
Moisture conditioning of RH and moisture content sensors

From left to right: two moisture content sensors (the bottom one is under the wet paper towel), two RHC sensors, and one RHS sensor

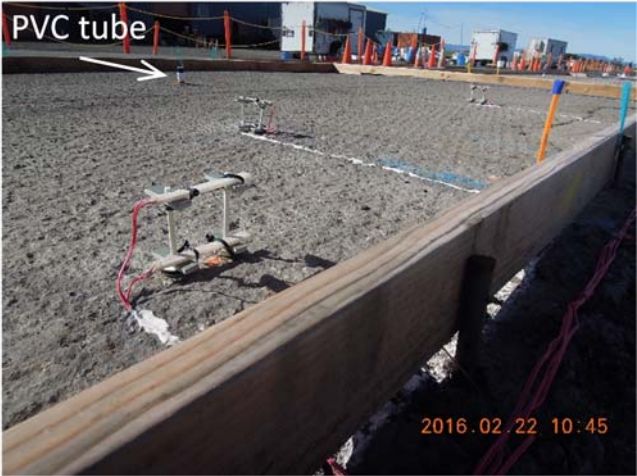
The dynamic and static strain gages were both installed by using fiberglass frames to set them in place, but without the tube-screw system used earlier, even though this meant that the distance between the upper strain gage and the top of the slab might vary from the 20 mm (0.8 in.) target value (because the actual slab thickness might differ from the theoretical one) (Figure 3.10). On the other hand, this allowed the lower strain gage to be located at the correct distance (20 mm [0.8 in.]) from the bottom of the slab and ensured that the distance between both strain gages would match the theoretical distance.

**Dynamic strain gages**

**Figure 3.10: Installation of strain gages.**

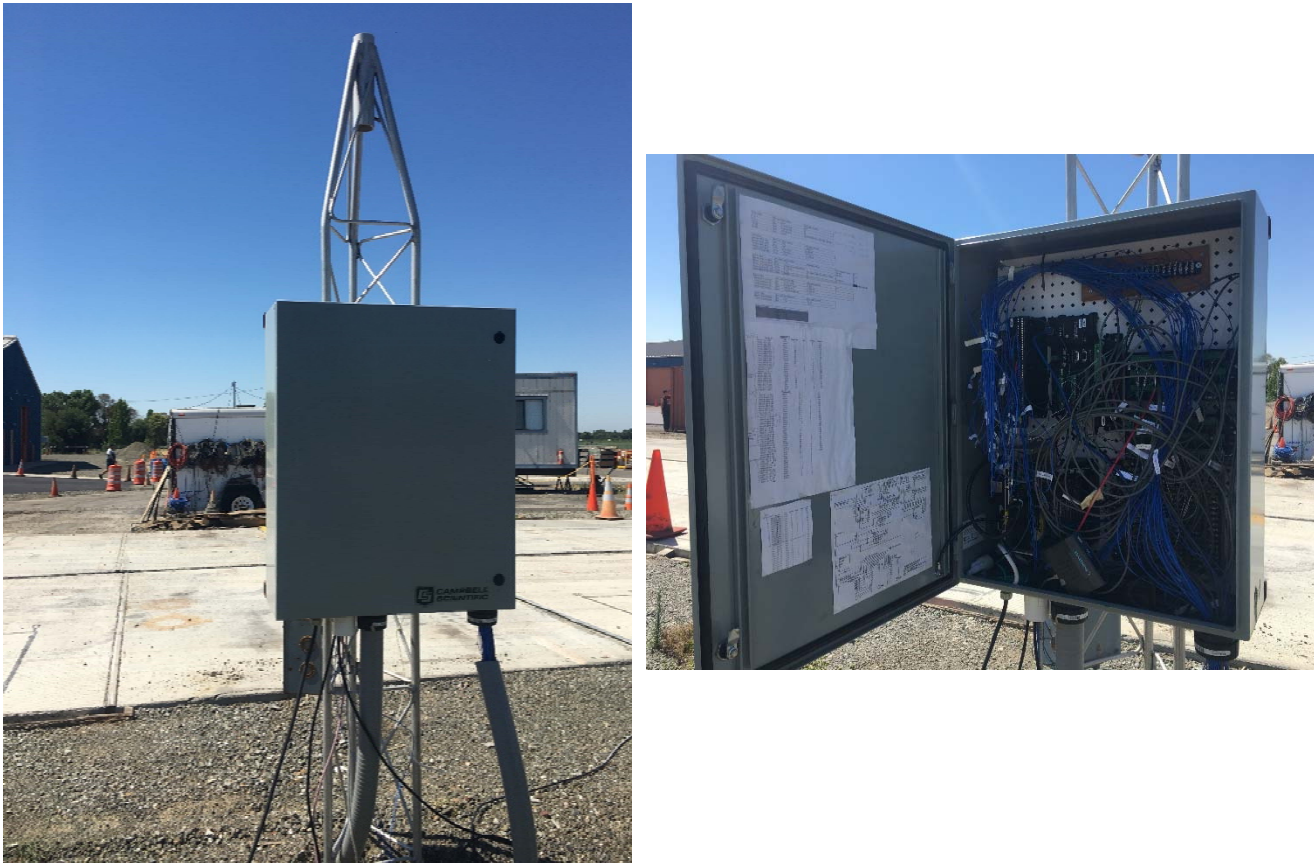
directly connected Sensirion SHT75 humidity sensors and from the Campbell Scientific CS215 sensors. In addition, each DAS can record the voltage signal from DC-operated LVDTs.

**Figure 3.16: Pictures of one of the Campbell Scientific data acquisition systems.**

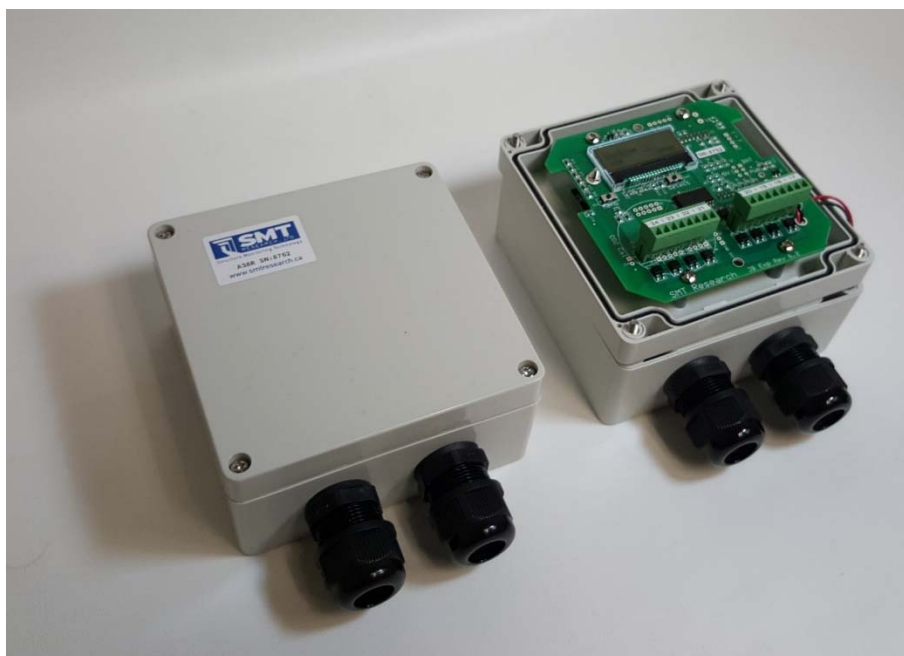
connected. The remaining two channels were used to connect the temperature signals with one channel for each depth. The temperature data were needed for correcting the moisture content readings.

**Figure 3.17: Photos of the A3 NEMA data logger from SMT Research.**

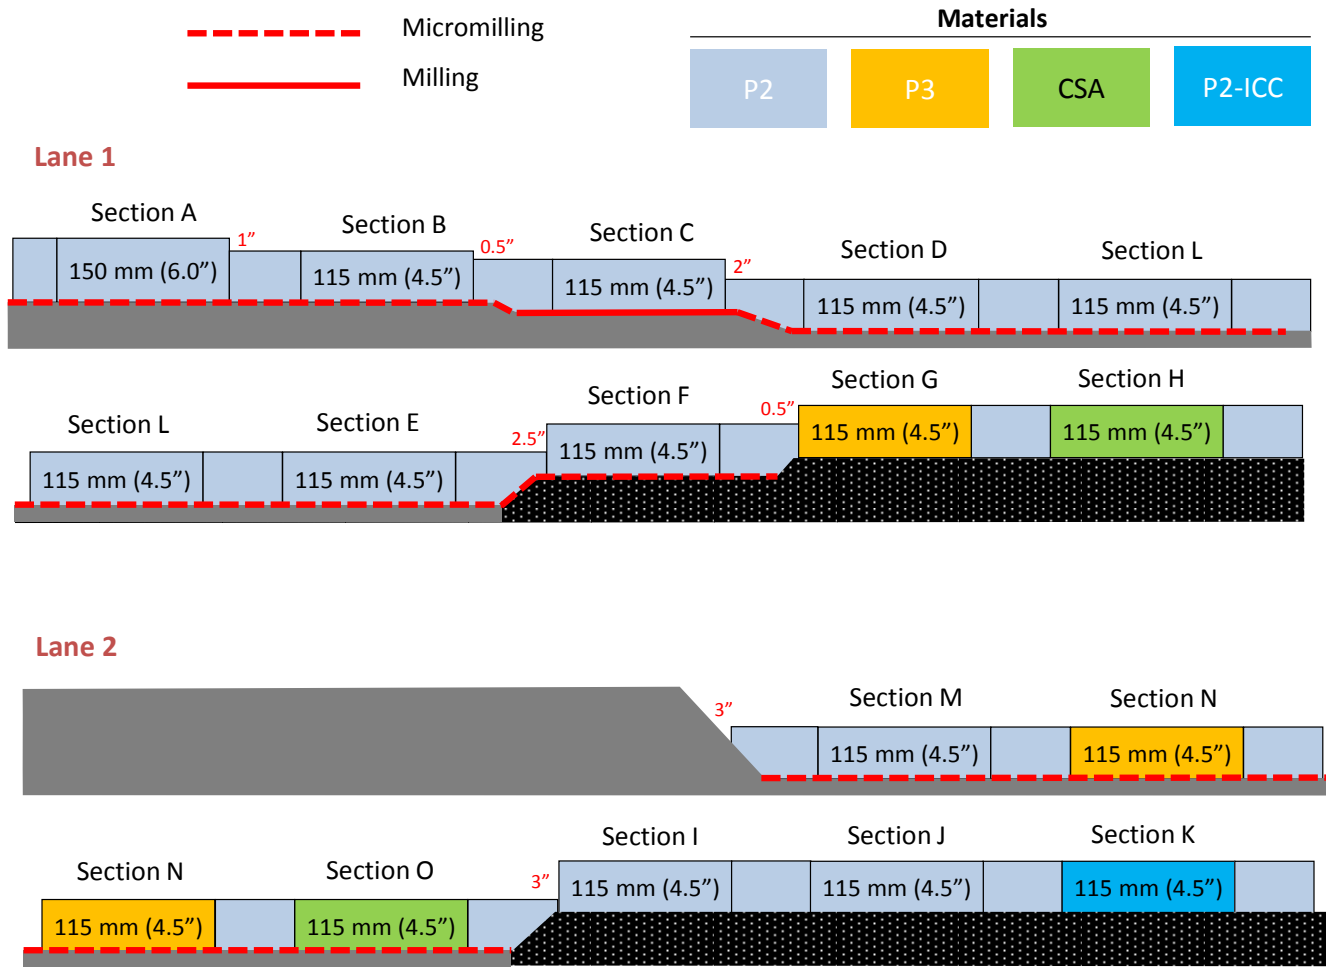
**Figure 4.4: Longitudinal profile of the two lanes.**  
 (Note: figure not to scale.)

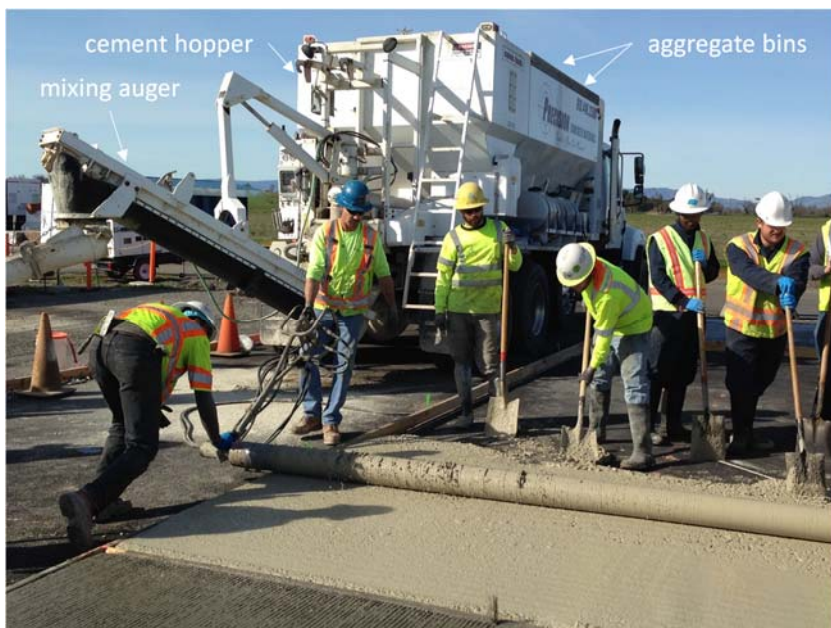
**Figure 4.7: Volumetric mixer.**

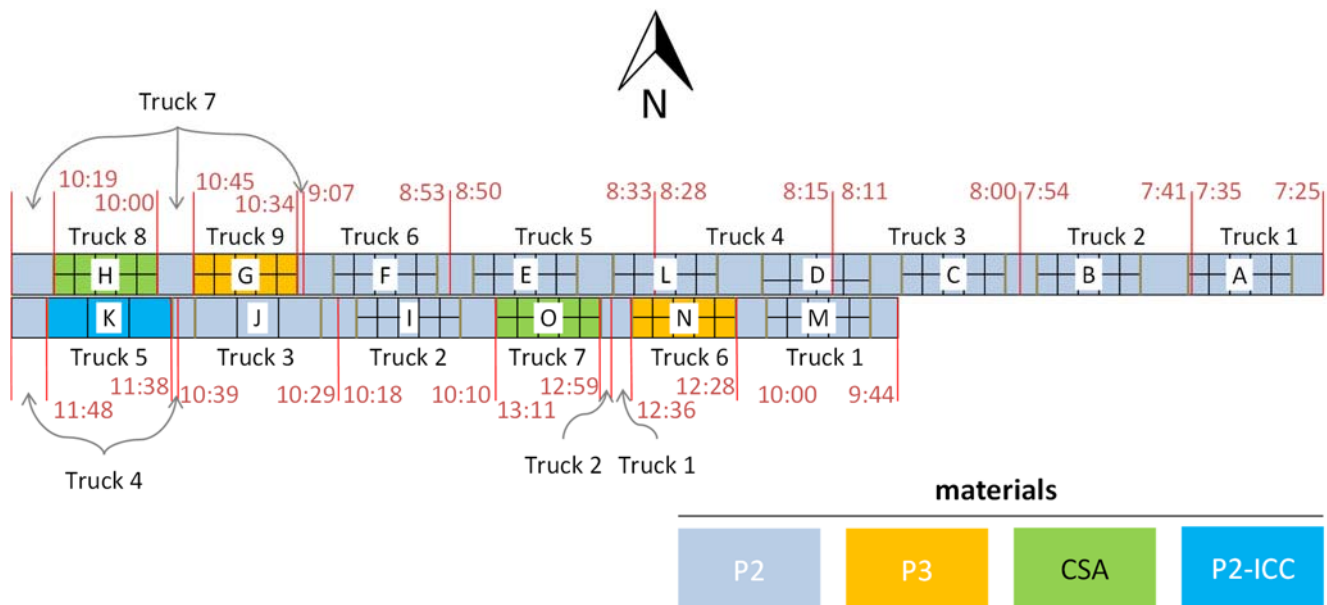
Apart from the two CSA sections (Section H in Lane 1 and Section O in Lane 2), eight ready-mix trucks were required for the Lane 1 overlay construction and six were required for Lane 2. This includes paving the sections themselves, the intermediate areas between sections, and the ramps to access both lanes. The trucks were assigned consecutive numbers, according to the order in which they were used. For reporting and quality control purposes, the CSA volumetric mixing of each section was also assigned a truck number. Correspondence between truck number and overlay area is shown in Figure 4.8. It should be noted that the intermediate areas between sections were all paved with the P2 mix (10-hour OT, Type II/V cement). These intermediate slabs were required to provide a place for the feet of the Heavy Vehicles Simulators during accelerated loading testing.

**Figure 4.8: Overlay area paved with each truck.**  
 (Note: The start and end placement time for each truck is shown in red.)

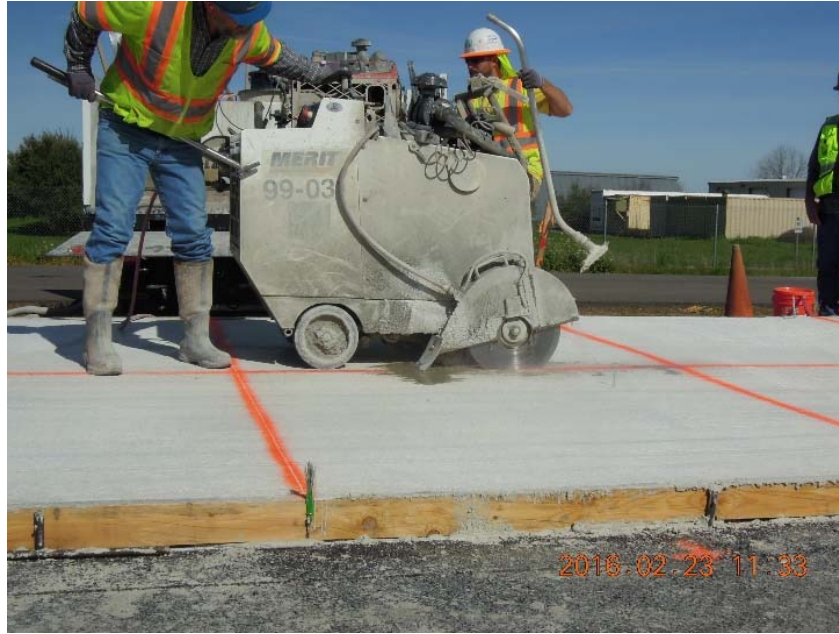
Joins were cut to a depth of one-third of slab thickness, which resulted in 50 mm (2 in.) saw cut for Section A and a 38 mm (1.5 in.) saw cut for the rest of the sections (Figure 4.13). Full-depth cuts were conducted at the beginning and end of each section where transverse paving forms had not been previously placed. The objective of this full-depth cutting was to ensure that the performance of each section did not interfere with the performance of the adjacent sections. In addition, the feet of the HVS were expected to significantly damage the intermediate slabs between sections and that damage might affect an adjacent section’s slabs without a full-depth cut to prevent it.

**Figure 4.13: Saw-cutting operation.**

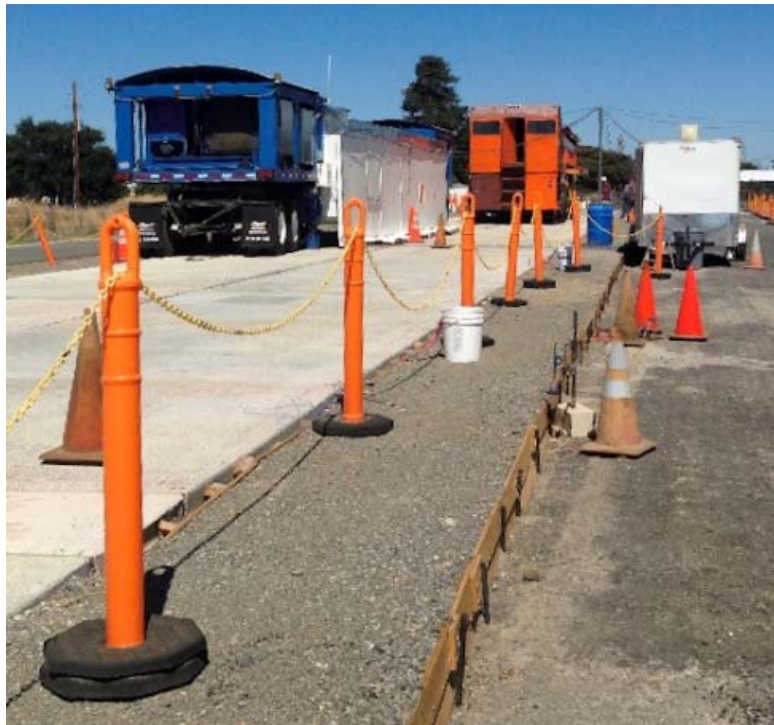
Caltrans Class 2 aggregate base material was used for construction of the shoulders since a minimal amount of traffic is expected on them. Construction took place in late April to early May of 2016. The finished shoulders are shown in Figure 4.23. The feet of the HVS resting partly on the shoulder are shown in Figure 4.24. It should be noted that a metal plate had to be placed under the feet of the HVS because the granular shoulder had insufficient bearing capacity to support weight of the HVS.

**Figure 4.23: Granular shoulders of the test track.**

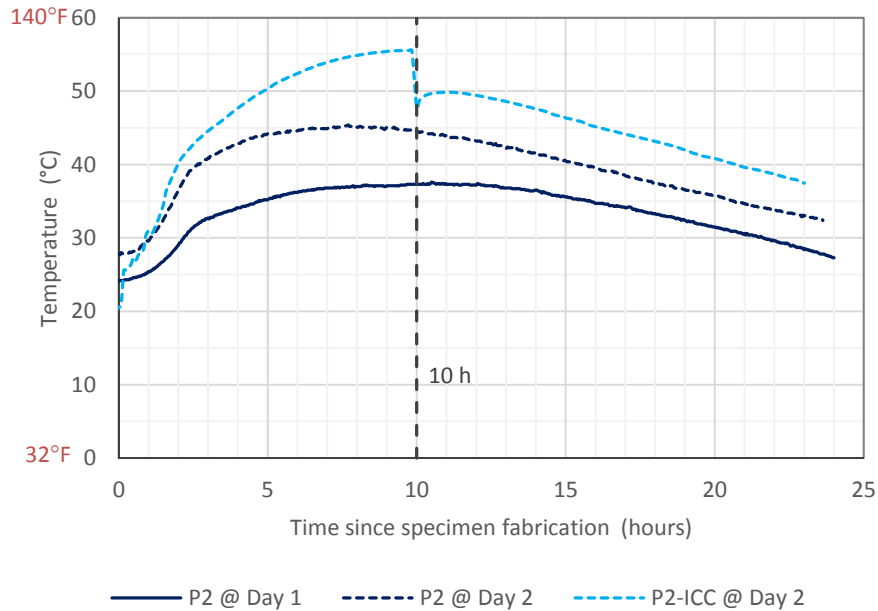
**Figure 5.2: Comparison of P2 versus P2-ICC mixes—Internal temperature of beams in the curing boxes (ASTM C31).**

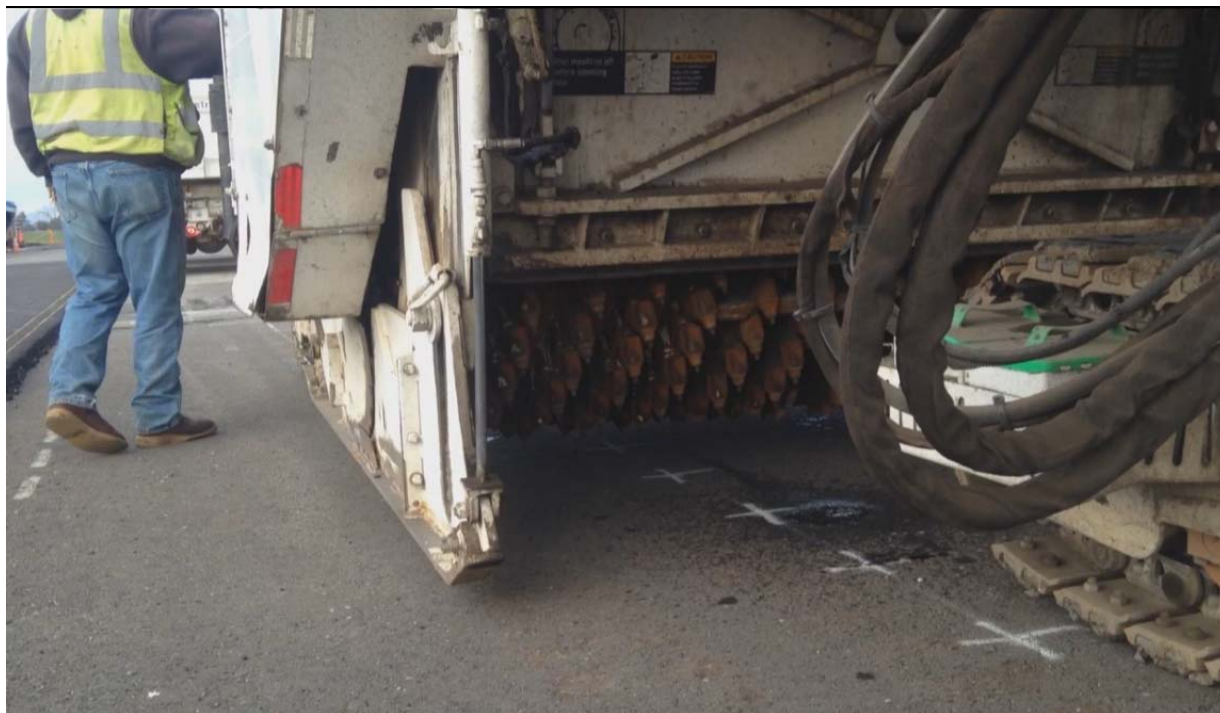
**Figure A.9: Milling machine with micromilling teeth spacing.**

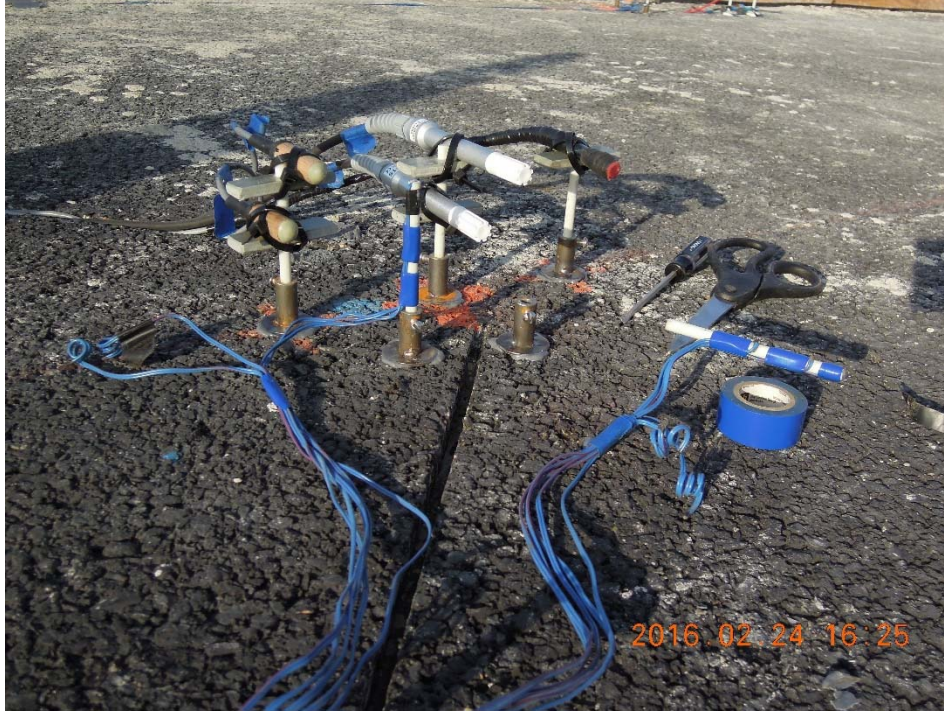
**Figure A.29:** From left to right: two moisture content sensors, thermocouples attached to a fiberglass rod, two RHC relative humidity sensors, and one RHS relative humidity sensor.

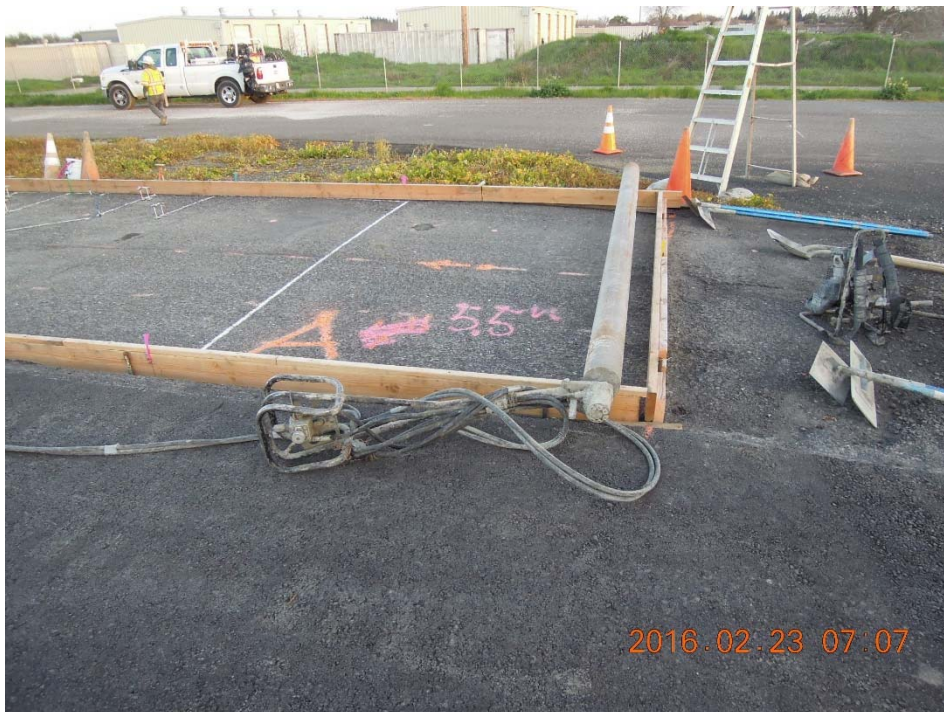
**Figure A.30:** Roller screed on Section A prior to arrival of concrete.

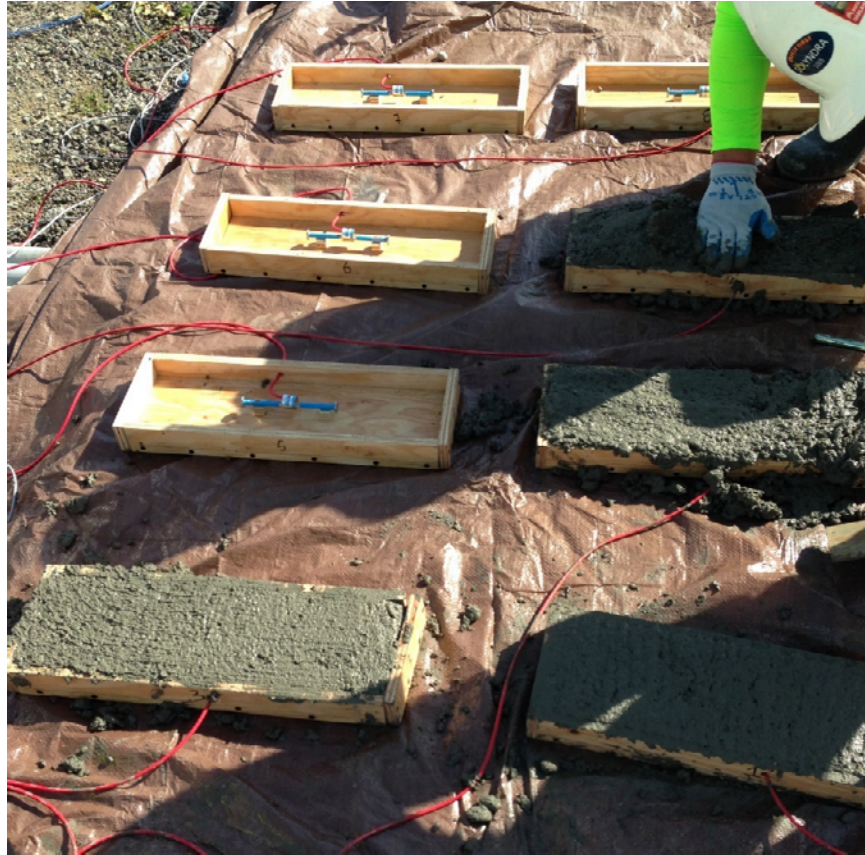
**Figure A.89: Unrestrained shrinkage beams.**

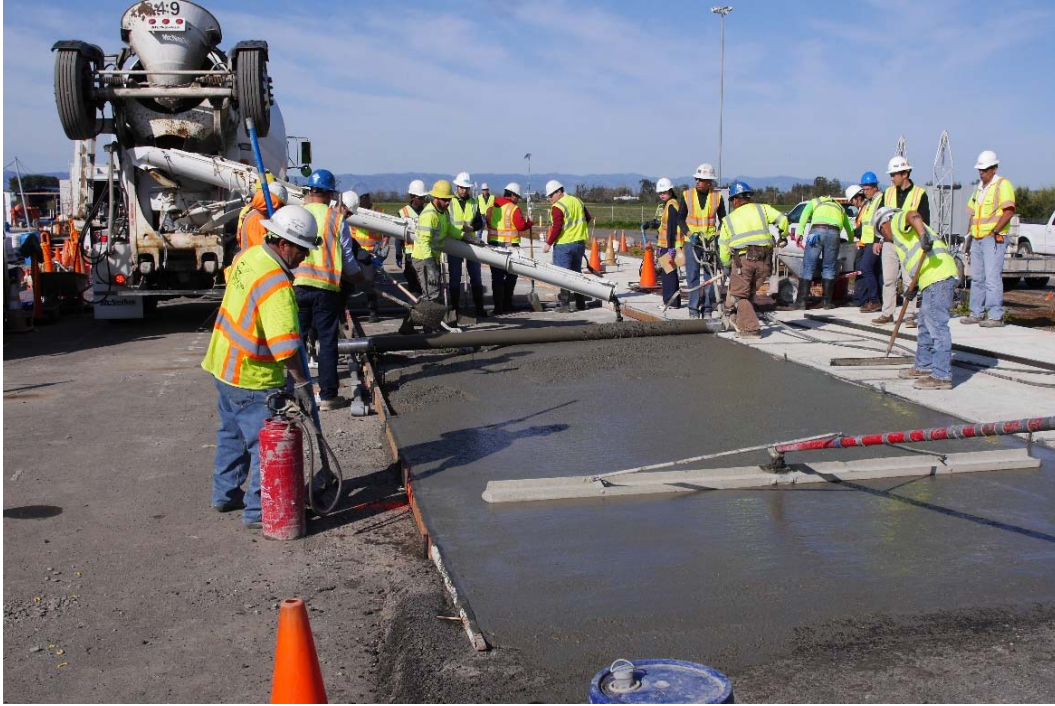
**Figure A.97: Concrete pouring (discharge chute), consolidation (roller screed), and finishing (bull float).**

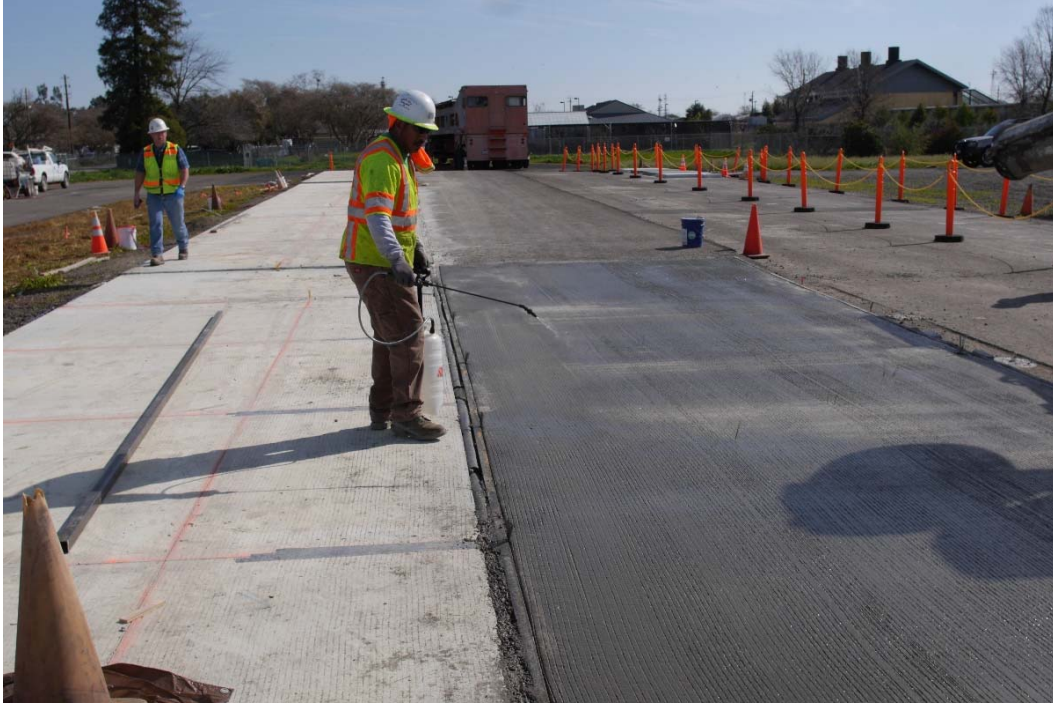
**Figure A.99: Manual application of shrinkage-reducing admixture.**

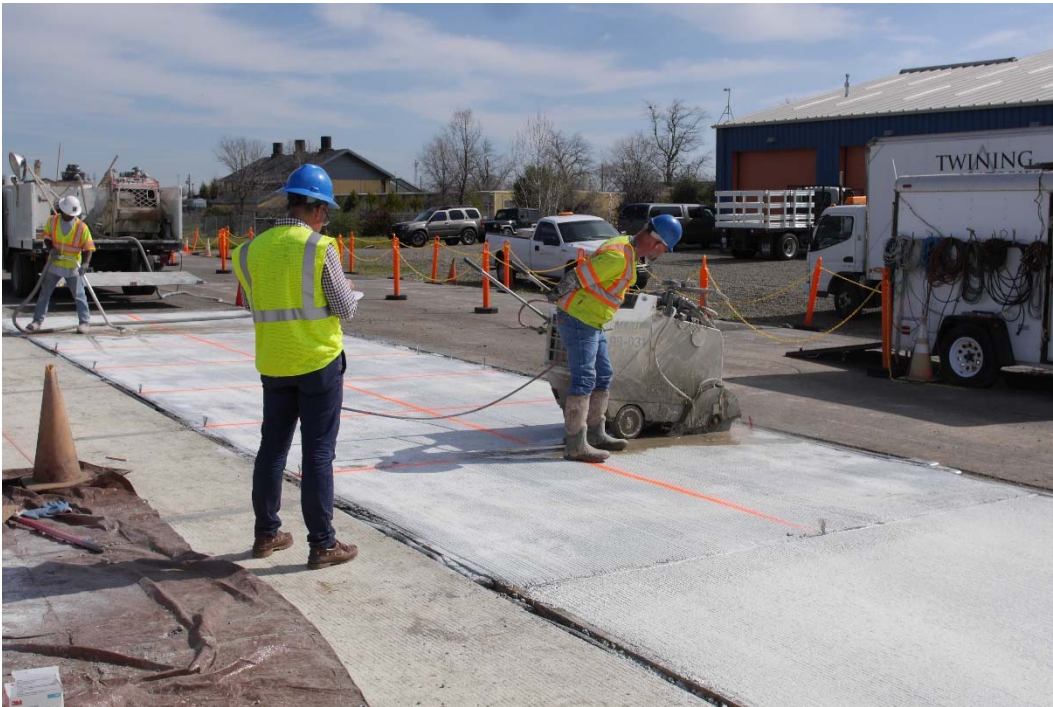
**Figure A.100: Saw-cutting of transverse joints.**
