Mt. Vettore Fault Zone Rupture: LIDAR- and UAS-Based Structure-From-Motion  
Computational Imaging

## MT. VETTORE FAULT ZONE RUPTURE: LIDAR- AND UAS-BASED STRUCTURE-FROM-MOTION COMPUTATIONAL IMAGING

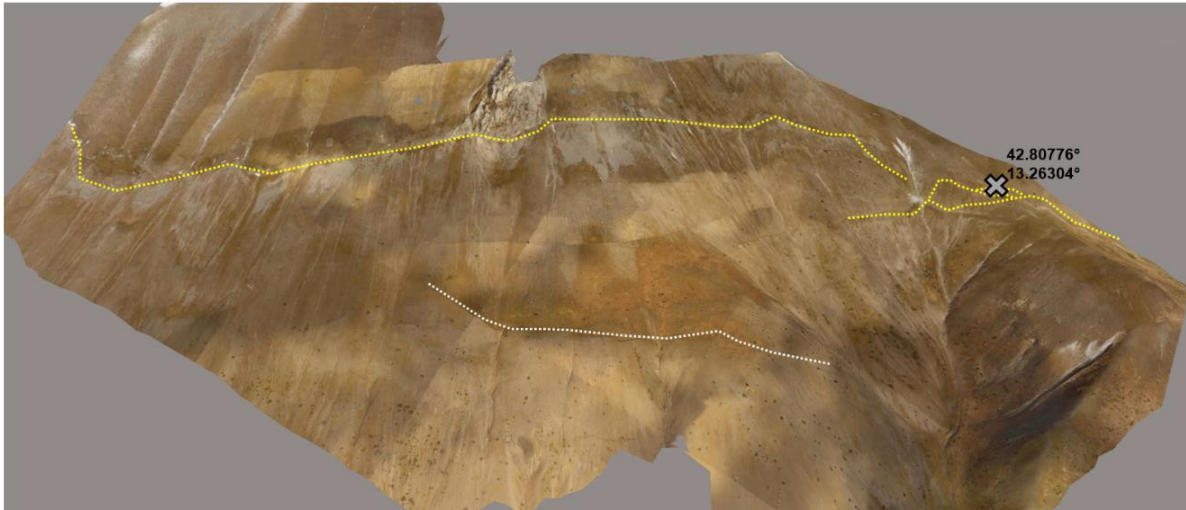
**Figure 4.** UAS/TLS-based orthomosaic model of the SW face of the Mt. Vettore Massif after the 30 October earthquake with 3D digital terrain model from merged SfM and LiDAR data. Approximate main fault trace(s) indicated in yellow, a second 1 km long visible trace of the “Western Trace” shown in white. Looking from the west. The left of the image is to the north. The slope moves from top to bottom of the image.

Point cloud data from the UAS are processed through a computationally intensive multi-stage process. First, a flight plan is established to overfly the fault and collect downward looking photographs using a Phantom 4 UAS quad-copter. These images were collected with a minimum of 80% overlap and 80% side-lap coverage to ensure that there are common features in adjacent images. Using cloud computing software from 'Dronedeploy,' and workstation-based software 'ContextCapture' from Bentley Software and 'Photoscan' from Agisoft, all of the downward-looking images were aligned using hard features that were common to multiple photographs. Images were first aligned crudely, and then a sequence of higher level alignments improved the model and established a tight relationship between adjacent images. The structure-from-motion method computes angular separations between objects visible in overlapping images. The scale and location of the objects are determined by knowing the location of each photograph from the photo metadata GPS-location. That is, the GPS-tagged photographs from the drone provided the scale for the model.

Aligned drone imagery was used to process a dense point cloud and a 3-D mesh triangular irregular network surface. The same aligned imagery was used to construct a precise orthomosaic of the scanned area. Once the UAS model was constructed, the point cloud from the UAS data can be merged with the point cloud from the Lidar scanner. UAS and LiDAR datasets are merged using the software ISITE-Studio (Maptek company). The advantage of merging data is that the Lidar data-set is presumably more precise regarding pixel location, whereas the UAS data have a more accurate color representation for each pixel because of the direct relationship between the point cloud and the orthomosaic image.

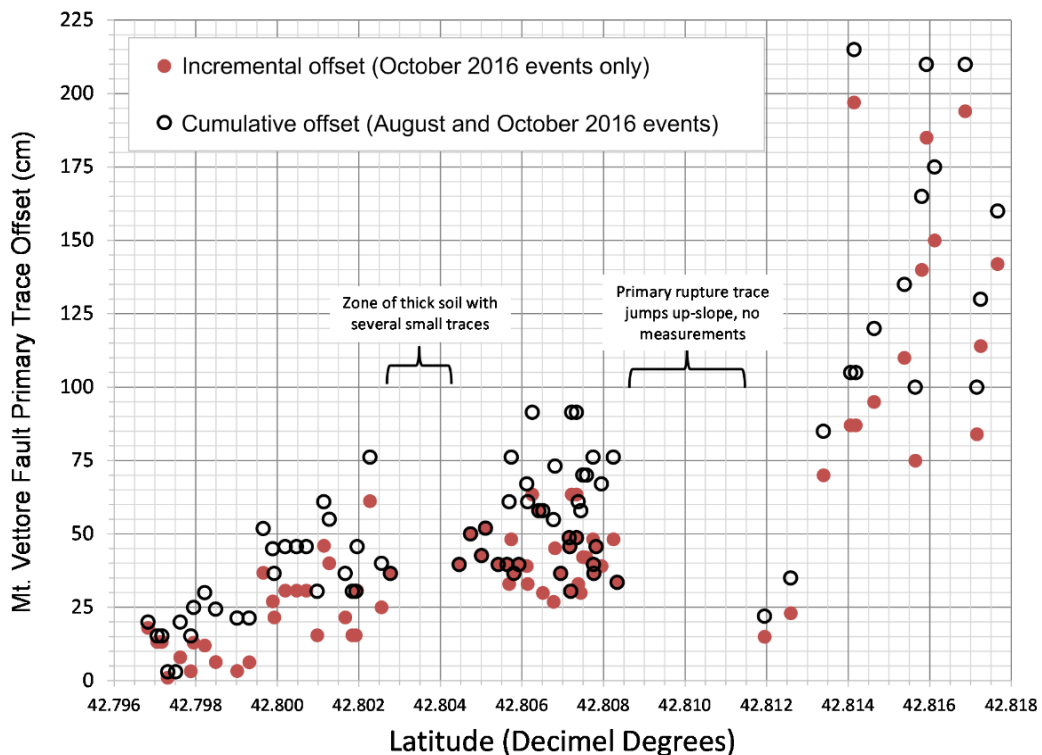
**Figure 5.** Distribution of differential and cumulative fault offsets for the southern half of the Mt. Vettore fault. All data in this Figure from hand measurements.

The data of vertical slip on the Mt. Vettore fault includes total cumulative slip, with the total displacement measured in the December reconnaissance. Additionally, the data include the September-to-December survey differential, which is calculated as the total cumulative slip from all three events (December reconnaissance measurements) minus the combined effects of 26 October and the 30 October event (remaining amount attributed to the August 24 event). These totals and differentials were measured along the southern portion of the Mt. Vettore fault rupture along the (Figure 5). An example of the multi-epoch fault displacements can be seen in Figure 6 (42.81724°N, 13.25449°E). The upper white band represents the slip from the August 24 event with an average displacement of 16 cm. The total offset for the three events is approximately 130 cm, leaving 114 attributable to the October events and any accumulated co-seismic slip.

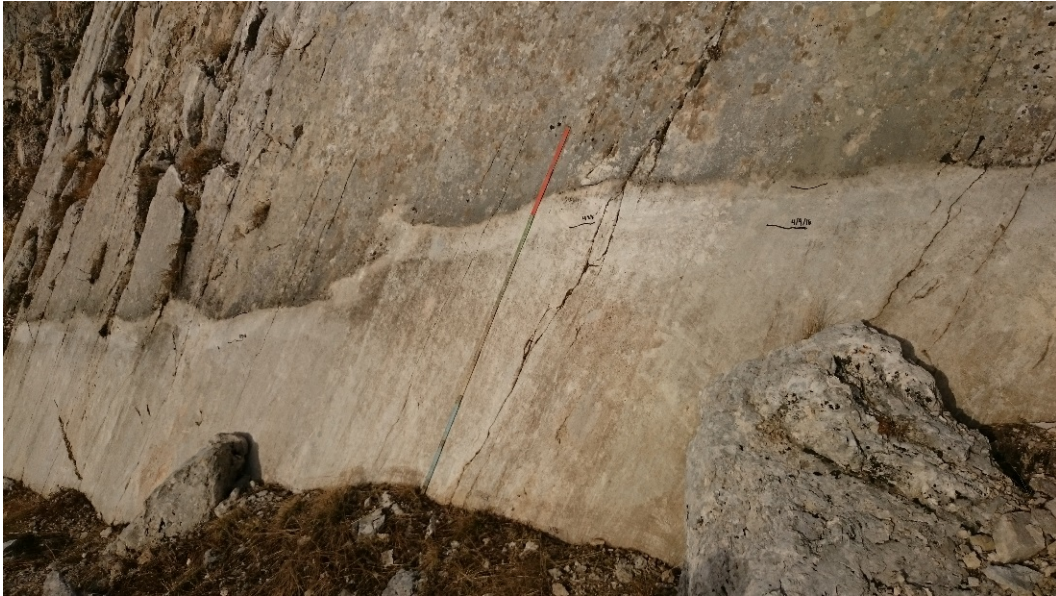
**Figure 6.** Example of fault slip measurements showing multi-epoch offsets from August 2016 (upper white band, 16 cm) and October 2016 (130 cm) events. Lat = 42.81724, Long = 13.25449.
