UCLA Electronic Theses and Dissertations

Compositional Analysis of Lacquer Alterations in Post-Angkorian Buddha Statues and a Novel 3D Approach to Their Conservation

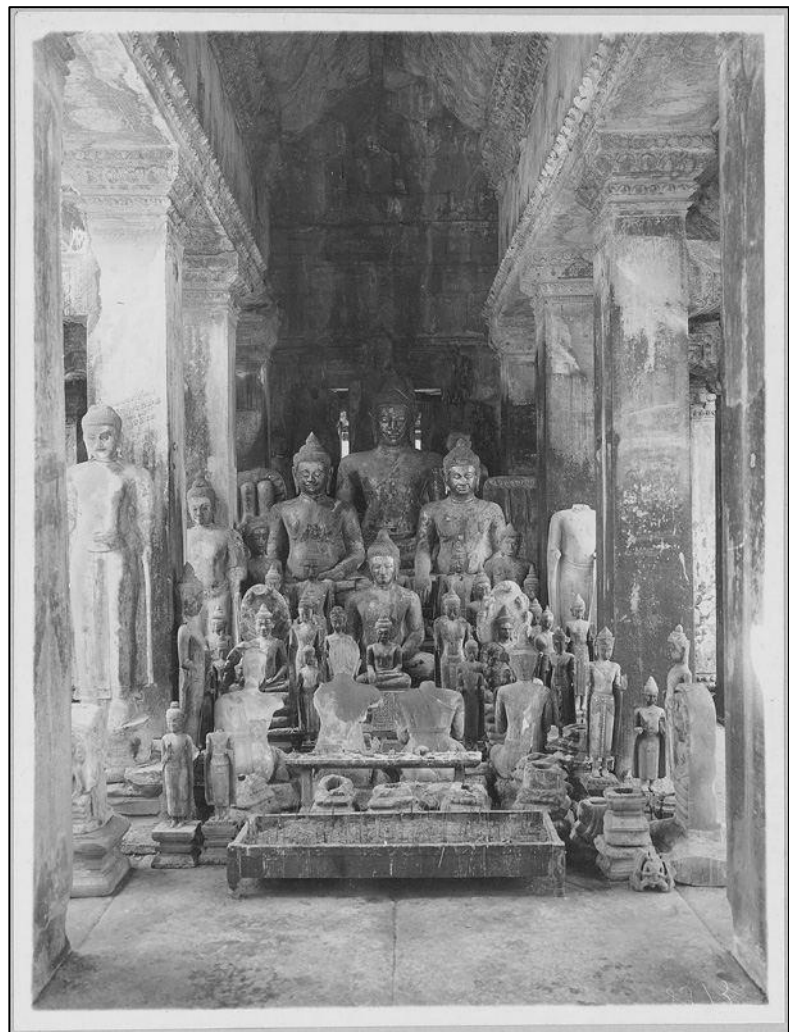
Figure 12: Historic photo of Preah Pean Buddha statues in situ, c. 1930. Image from l'École Française d'Extrême-Orient CAM05055.

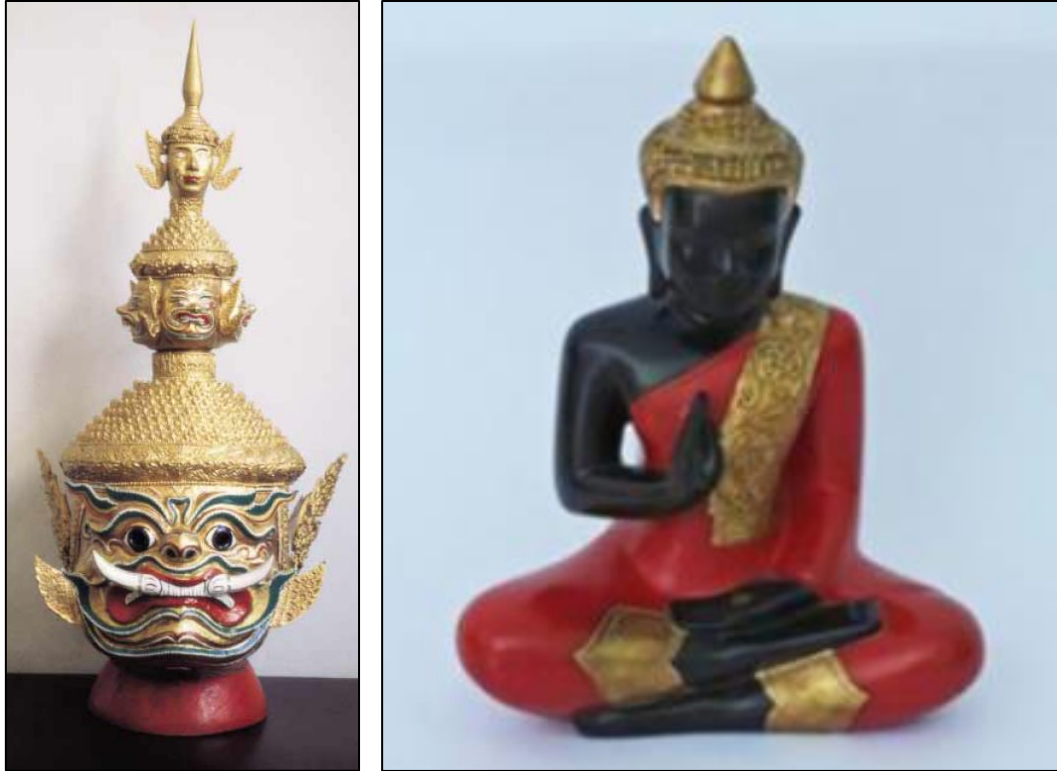
Figure 13: (Left) Mask by An Sitha. (Right) Buddha figurine by Stocker Studios.

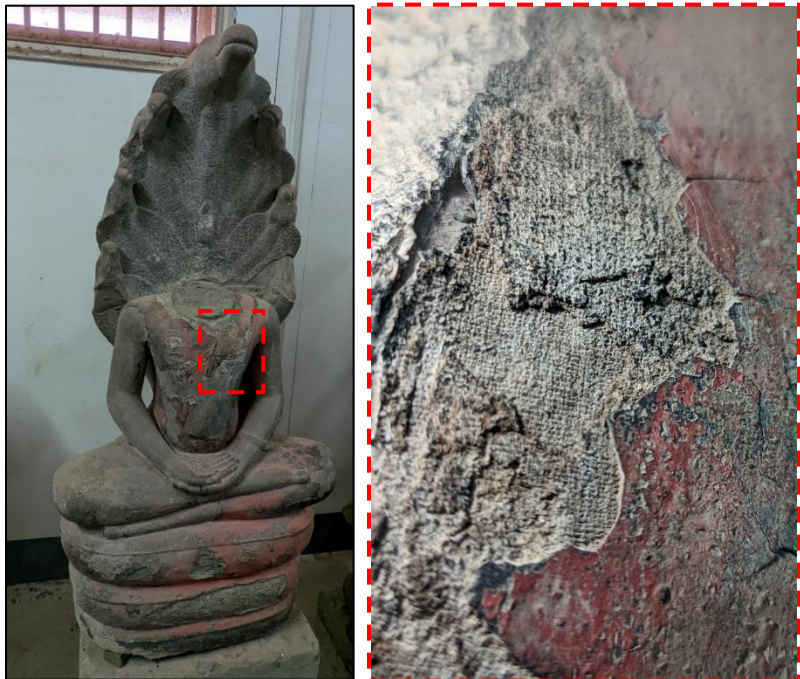
Figure 14:(Left) Buddha statue with evidence of textile alterations. (Right) Enlarged chest area with clear textile layers beneath lacquer losses.

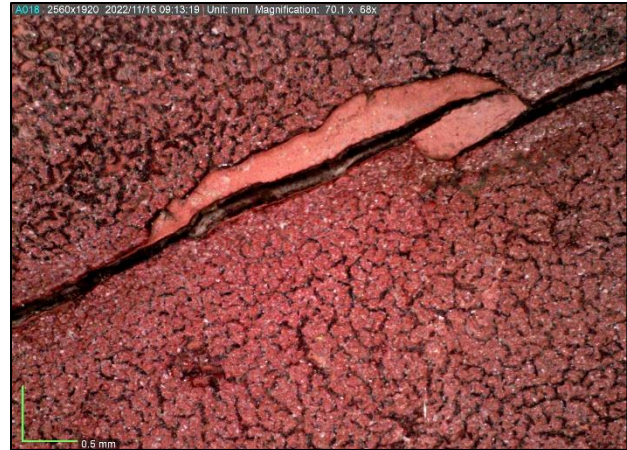
Figure 21: Photomicrograph of multiple red layers visible along a crack.

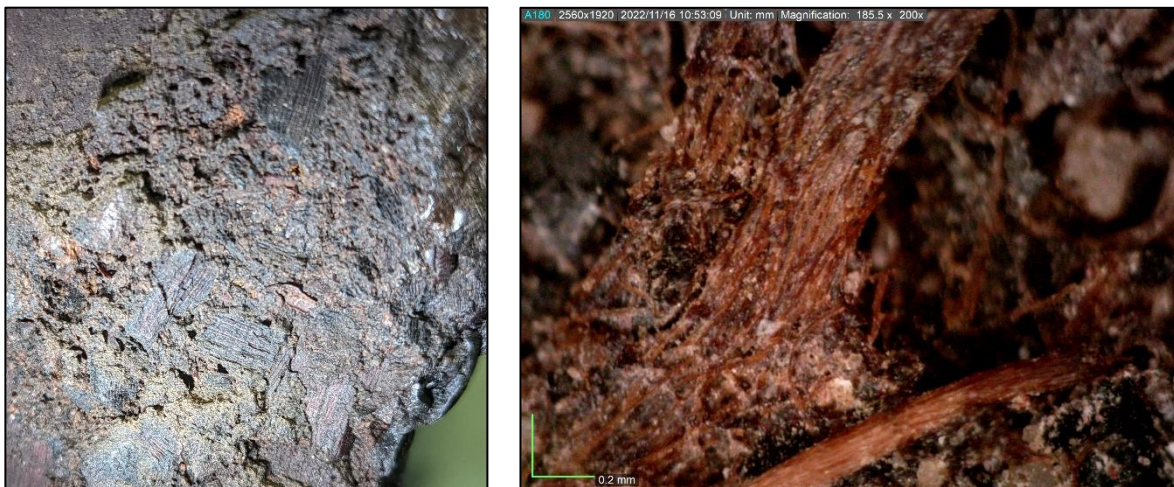
Figure 24: Detail image (left) and photomicrograph (right) of fibrous plant filler on N1323

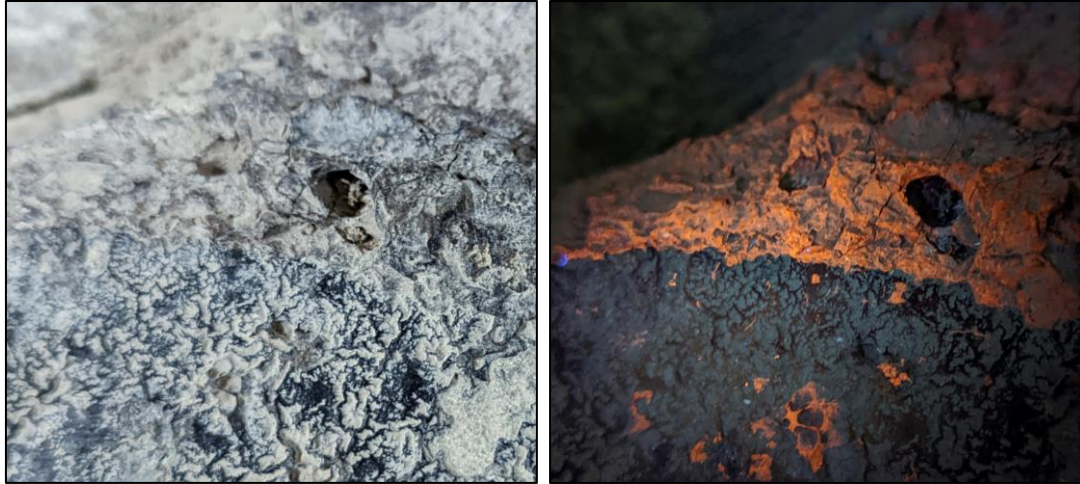
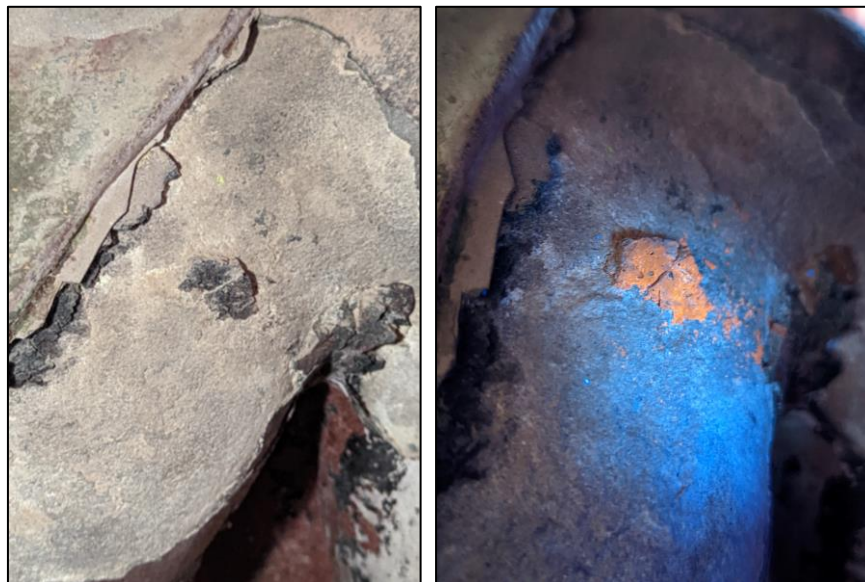
Figure 27: Fluorescences of non-lacquer material on (from top to bottom) N509, N1420, and 2259.

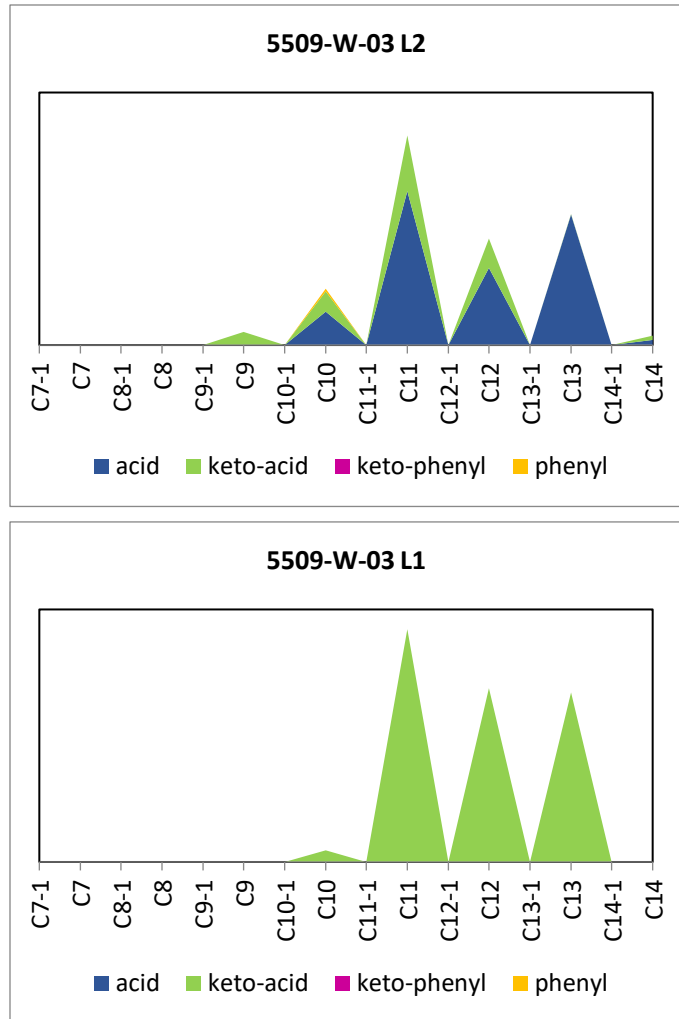
Figure 39: *Thitsi Gestalt* graphs showing the aging difference between the bulked applique material (top) and decorative lacquer (bottom).

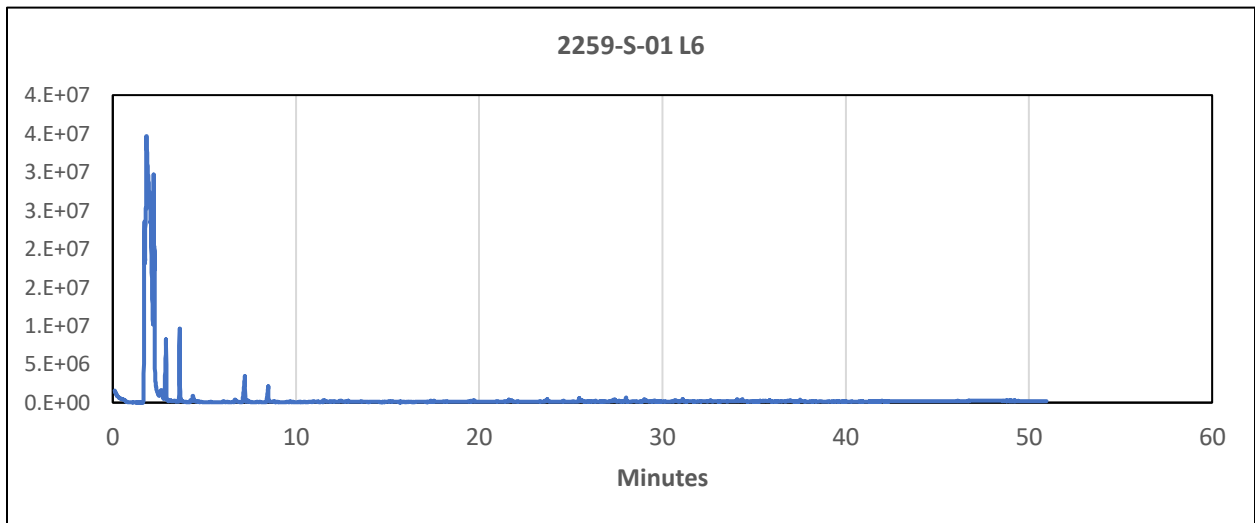
Figure 41: Py-GC/MS Chromatograms of pine resin and camphor mixture layers (top) followed by two pure pine resin layers (center and bottom).

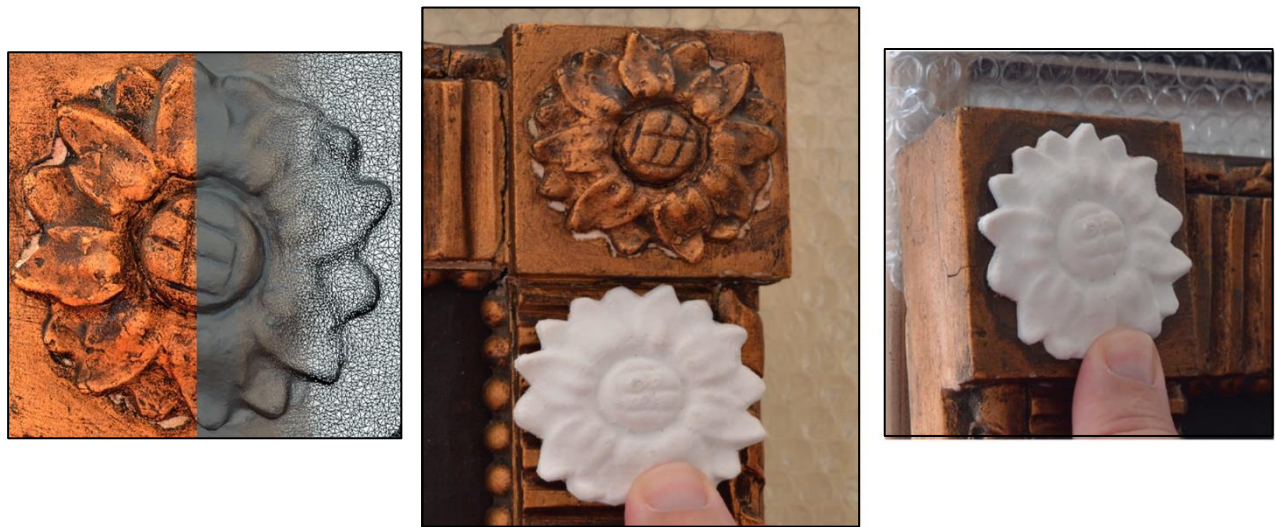
Figure 46: Reconstructed frame element from 3D scanning and modeling (left) followed by printing and adhering (right). Images from Henriques, 2020.

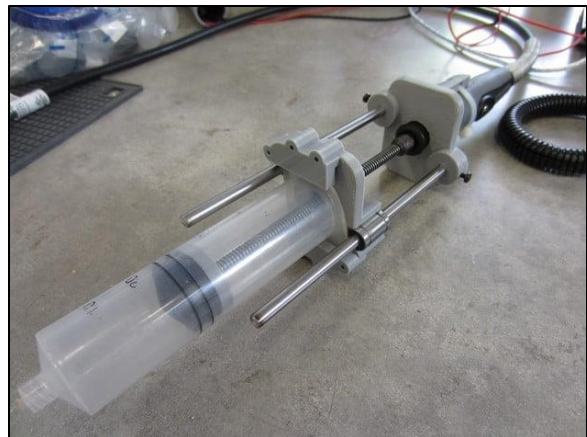
Figure 52: Screw-rod (top) and belt-driven (bottom) plungers. Images from Thingiverse.com.

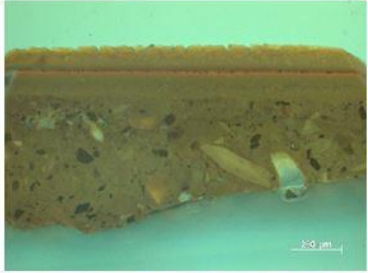
4-5: [R1, missing], B1, R2, B2, B3/Substrate ?
2259-S-01

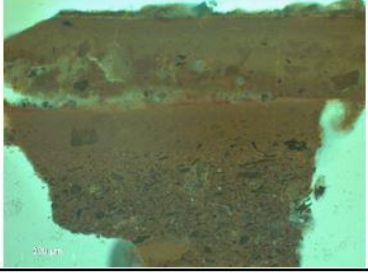
7-10: [Potential green layer], G1, S1, B1, B2, [G2 and S2], R1, B3, B4

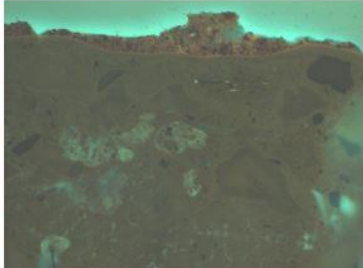
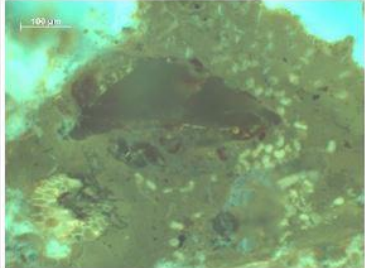
4: [Missing G1] R1, B1, B2
N1323-W-03

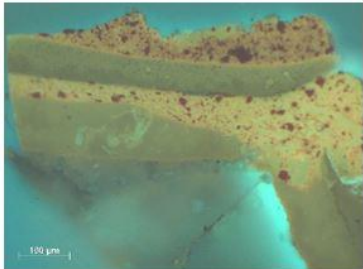
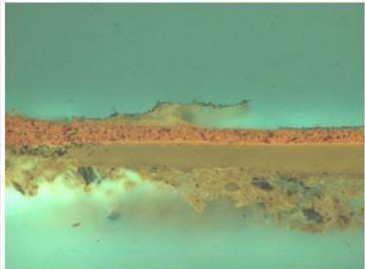
13: [R1 missing], B1, [G1 missing], R2, B2, G2, R3, B3, G3, S1/B4, R4, B5, B6
N1323-W-04

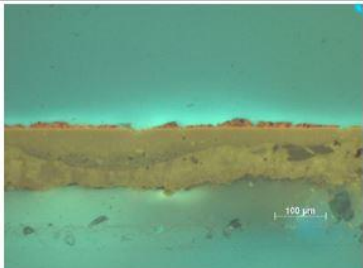
3: R1, B1, B2
N1323-W-05 A

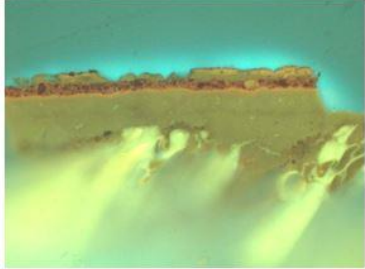
6: [G1 missing], R1, B1, R2, B2, B3
N1420-W-02

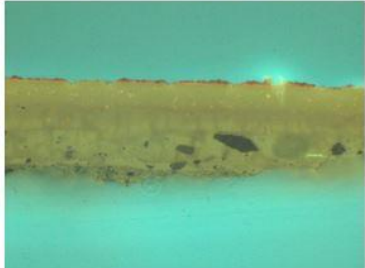
5: R1, B1, B2, B3, B4
N1420-W-03
