Investigation of suspected gulls in the Jurassic limestone strata of the Cotswold Hills, Gloucestershire, England using electrical resistivity tomography

2016-09-01

Author links open overlay panel [A.J.M. Barron^a](#) [S. Uhlemann^{ab}](#) [G.G. Pook^c](#) [L. Oxby^a](#)

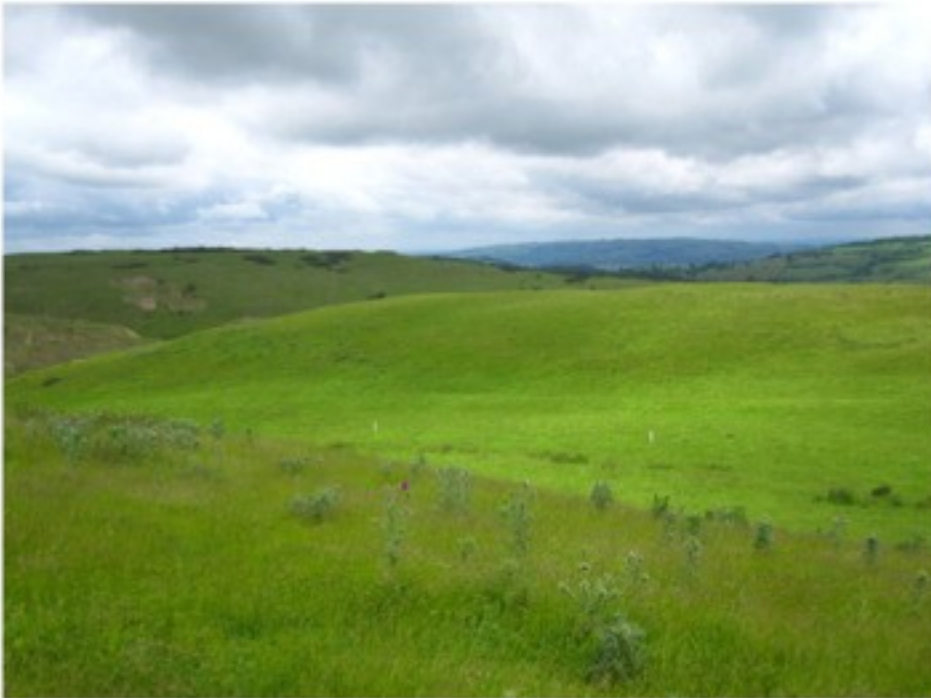
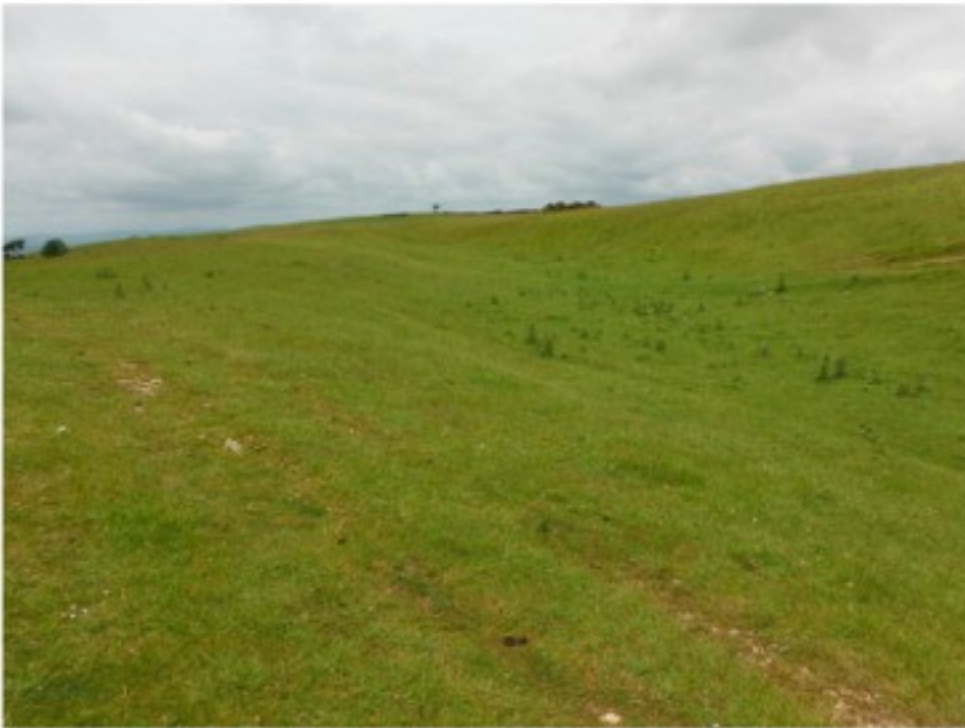
Fig. 3. Surface gulls on Cleeve Hill: 3a Postlip Warren [SO 9984 2604]. Photographer G G Pook (P902222). 3b Cleeve Hill, view to north-west [SO 9908 2506]. Photographer A J M Barron (P902218).

and-fault structures now. Notably, the slopes on the Whitby Mudstone outcrop below are commonly affected by extensive landsliding. Upslope where the cap-rock thickens (more than 20 m), in many cases surface gulls are seen crossing the slopes ([Figs. 3a, 3b](#)).

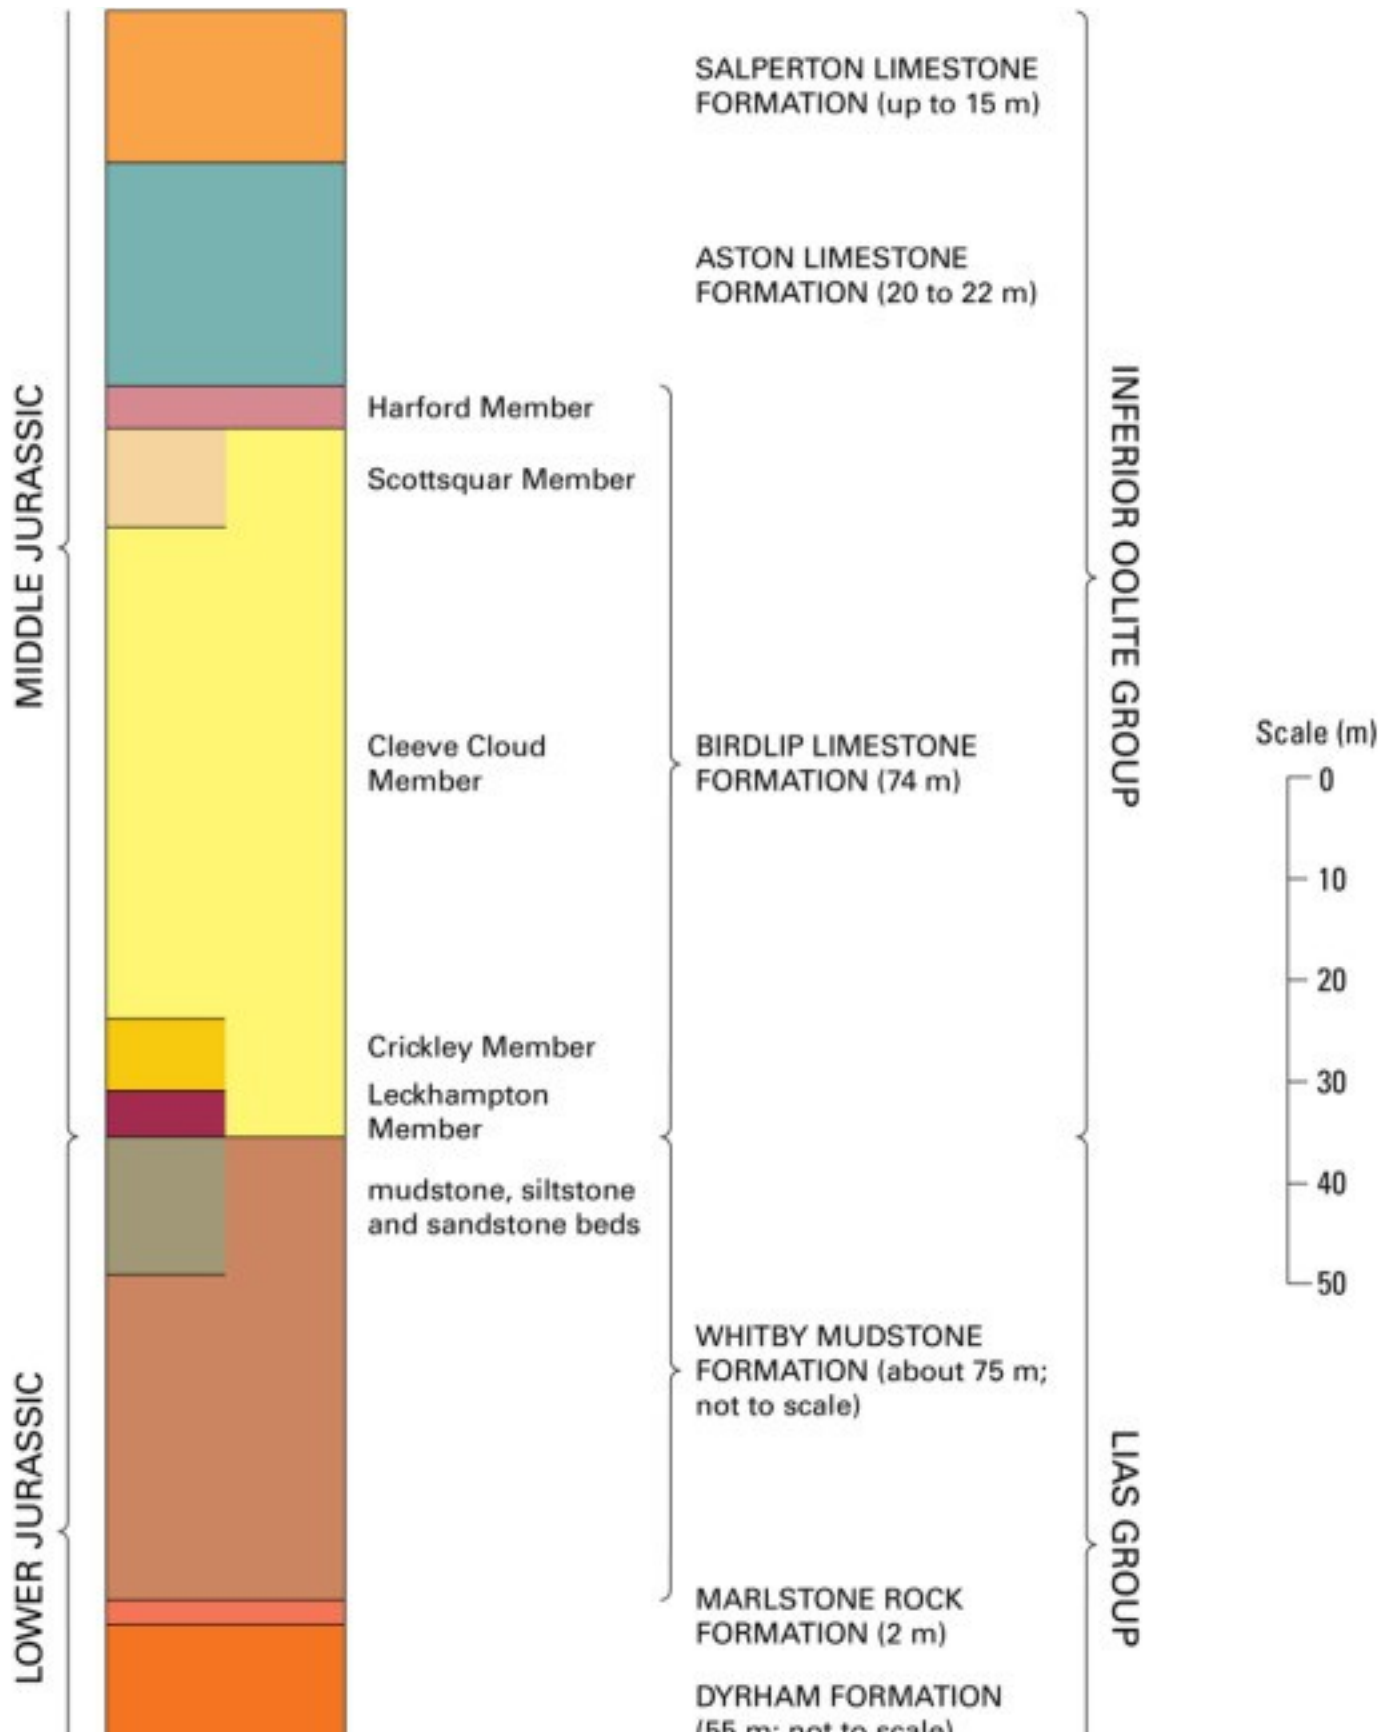
Fig. 5. Generalised vertical section of [bedrock](#) at Cleeve Hill and Postlip Warren. The Salperton Limestone which comprises about 15 m of limestone has limited [outcrops](#) on the Cleeve Hill plateau ([Fig. 2](#)). The Aston Limestone Formation comprises up to 22 m of shelly, sandy, ooidal limestones. Its four subdivisions widely recognisable on Cleeve Hill were not mapped on Postlip Warren where up to 20 m of strata are present.

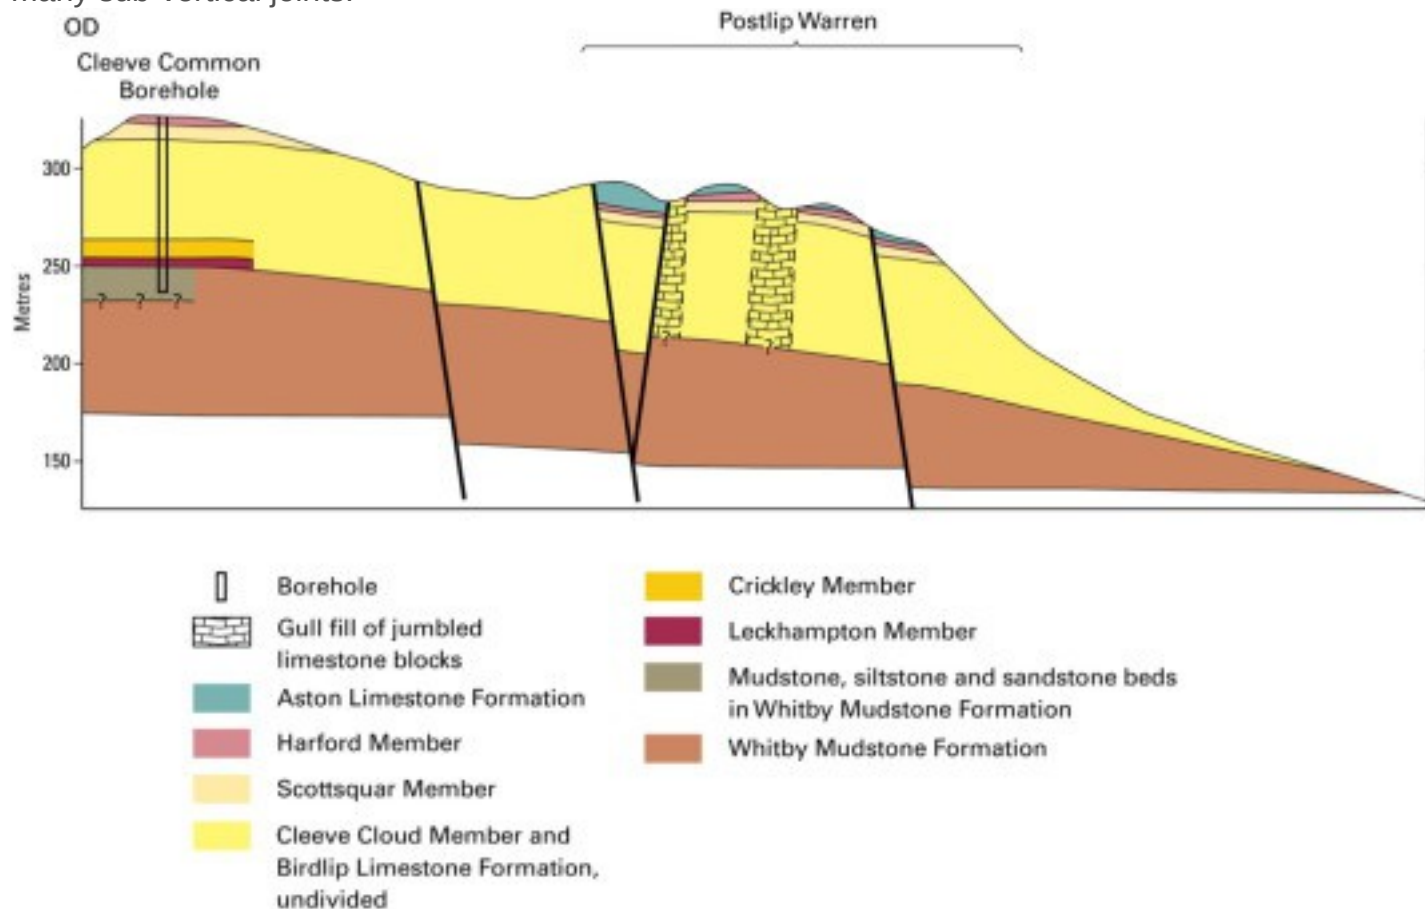
Fig. 6. Cross-section of Postlip Warren including Cleeve Common [borehole](#). For line of section see [Fig. 2](#). Vertical exaggeration x4.

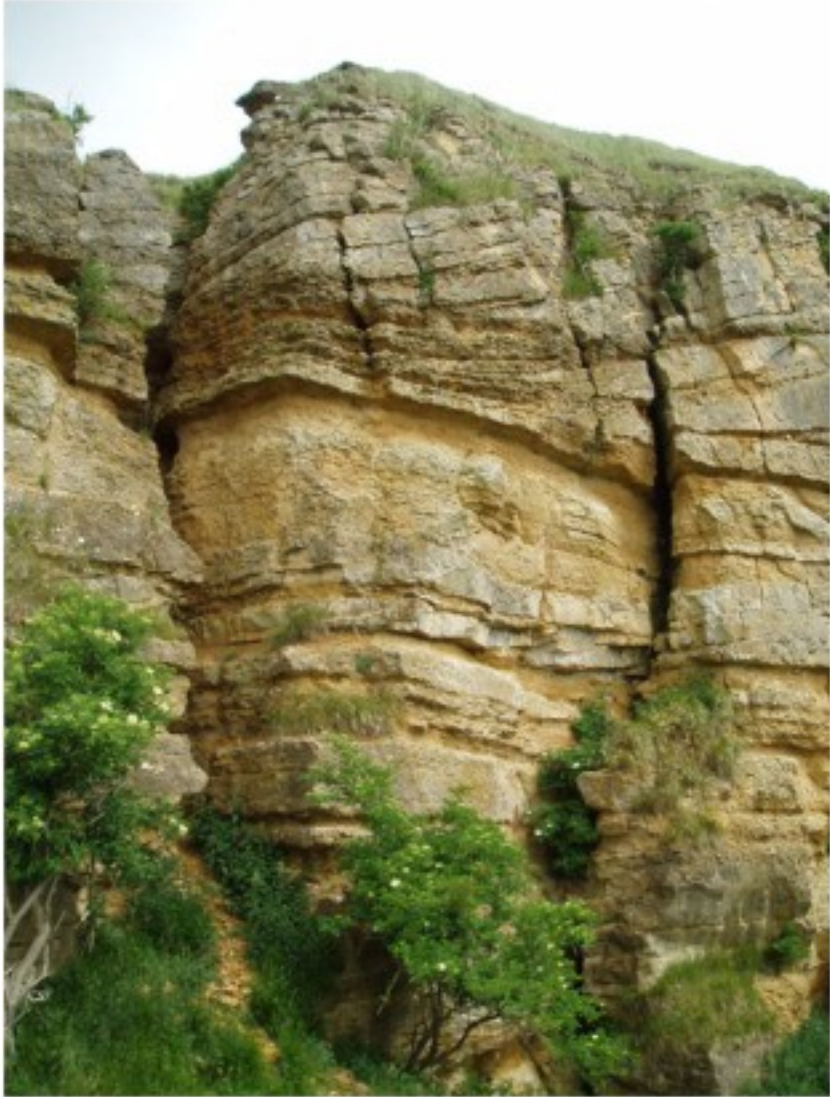
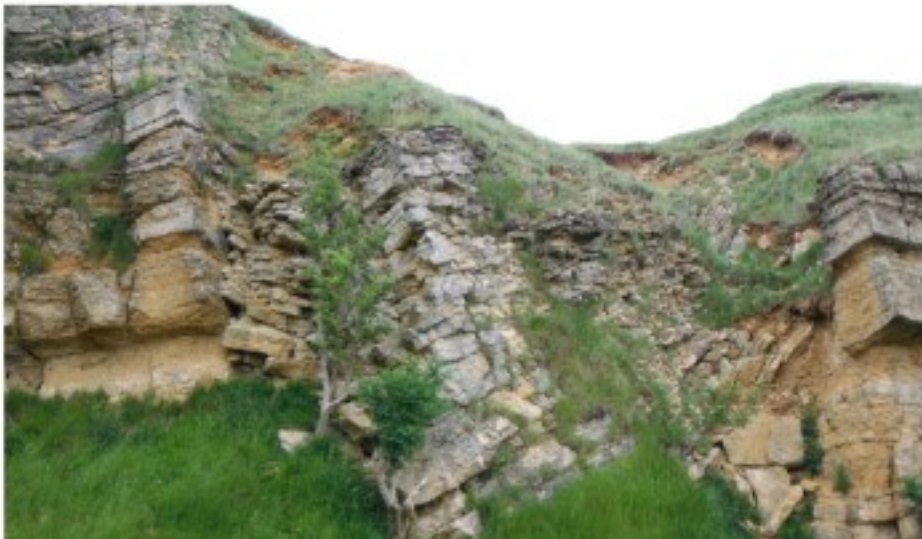
Fig. 7. The Cleeve Cloud Member exposed at Cleeve Cloud: 7a Open joints in a face about 18 m high [SO 9842 2555]. Photographer AR Farrant (P902219). 7b. Exposed gull fill [SO 9842 2560]. Photographer A J M Barron (P902214). 7c Eroded-out gull structure on Cleeve Cloud [SO 9842 2543]. Photographer P R N Hobbs (P902216). The Whitby Mudstone Formation comprises predominantly grey silty shaly mudstone. The BGS Cleeve Common Borehole ([Fig. 6](#)) proved 13.0 m of grey silty mudstone, silt and fine-grained sandstone beds below the Inferior Oolite.

The main quarry face on Cleeve Cloud [SO 984 256] exposes a 300 m-long continuous section of at least 25 m of strata of the Birdlip Limestone Formation ([Fig. 7a](#)) cut by two or three minor faults, and displaying many open sub-vertical joints, some of which are wide enough (up to about 1.5 m) to enter – ‘gull caves’ ([Self and Boycott, 2007](#) (for 2006)). Although there are signs of dissolution on most joint faces, the gull caves are thought to have widened mechanically as they exhibit rough, broken walls with symmetrically opposing wall morphologies (‘fit features’ of [Self, 1986](#)). They tend to be vertically parallel-sided, the roof formed by trapped fallen debris or bridged by slabs in higher beds, either where there is [bedding-plane](#) slippage or the rift steps sideways, as visible in the quarry face ([Fig. 7a](#)), and the caves end where choked with boulders or rock and earth debris, or grade into impassable passages. The gull caves here show a strong [preferred orientation](#) of 120–140°, indicating lateral opening (dilation) to the south-west with, in some cases, a small component of [vertical movement](#). Other joint orientations are seen of about 070 to 080°, showing some widening, and intersections of these two sets permits divergent movement forming ‘gull tears’ ([Self, 2008](#)). These two orientations coincide closely with the vertical joint-sets J_2 and J_1 respectively, measured in the Cotswolds by [Hancock \(1969\)](#).

In addition to the caves, at one location on the quarry face of Cleeve Cloud there is a zone 10 to 15 m wide where a large, relatively coherent block of bedded limestone appears to have sunk (‘foundered’) and rotated at least 30° ([Fig. 7b](#)), although part of this inclination may be due to [cross-bedding](#). It is flanked by more disrupted masses of limestone and jumbled blocks, pockets of stony clay and earth and some minor air-filled voids. The entire mass lies between two sharp, near vertical sub-parallel joints and extends between them back into the hill. The formation and continuing development of this structure would have created a surface gull on the plateau above, which is now partially obscured. In the face, the rocks outside the zone are intact and the individual beds can be matched across indicating little vertical displacement (less than 1 m down to the south) between the walls. Comparing the main foundered mass with the walls suggests it is displaced down at least 5 m. It is inferred that this zone of displaced material extends down to the base of the Birdlip Limestone (about another 12 m), filling the space made by lateral opening, although the presence within it of large cavities cannot be discounted, and giving a cap-rock thickness here of about 25 m. The amount

of lateral opening is estimated as 2 to 4 m. This structure is regarded here as exemplifying most of the features of the gulls and surface gulls on Cleeve Hill. Nearby, a vertical notch between two intact blocks of Birdlip Limestone ([Fig. 7c](#)) is interpreted to be a gull about 2 m wide from which the fill has been eroded away. In all these instances of gulls that are too wide to be bridged, as well as the pre-existing foundered strata, other geological material would have accumulated in the resulting surface hollows. This would include limestone rubble and soil falling from the walls (colluvium) plus the gradual weathering of limestone debris and in situ development of topsoil. If recent proposals by ([Farrant et al., 2015](#)) are accepted, that gull formation along the Cotswold escarpment dates from the Middle Pleistocene and that the current summit surface of the Cotswolds is, or is close to, an exhumed pre-late Cretaceous erosion surface, this would preclude the inclusion of material derived from younger Jurassic bedrock that was removed from the Cleeve Hill area in the [early Cretaceous](#). In addition, given the topographic position on a hill top, the potential for later (Quaternary) input of further material would have been limited, apart from some hillwash and wind-blown fine sediment. Furthermore, any continued opening of the gull and/or foundering of the fill would tend to maintain the existence of the surface gull ([Fig. 3b](#)), albeit with additional infill that may differ materially from the walls.

From this interpretation, and by comparison with observations of nearby exposed phenomena ([Fig. 7b](#)), we infer that the surface gulls on Postlip Warren are underlain by graben-like structures with vertical or possibly overhanging walls, and extend at least to the base of the Birdlip Limestone succession, at a depth of about 80 m. They occupy almost the full width of the bottom of the hollows they underlie, and are filled with a semi-chaotic jumble of Birdlip Limestone material including some air-filled voids. Although their geometry indicates that their bounding surfaces may not coincide in 3D with normal tectonic faults along a similar alignment, any pre-existing fault plane or zone is likely to have been exploited and incorporated in the fill of disrupted bedrock material.

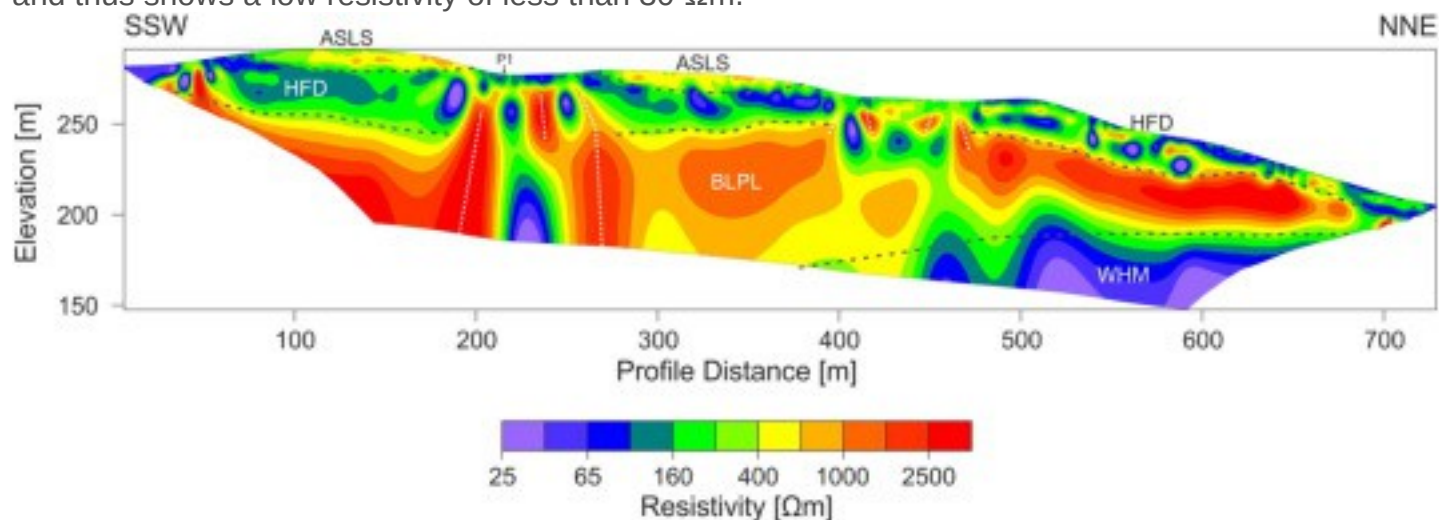
Fig. 8. Interpreted ERT section of profile L1. Dark dashed lines indicate stratigraphical boundaries, white dashed lines indicate discontinuities. ASLS – Aston [Limestone](#), HFD – Harford Member, BLPL – Birdlip Limestone, WHM – Whitby [Mudstone](#).

The [geophysical survey](#) of L1 ([Fig. 8](#)) provides information about the deeper geology at the site, imaging the main formations and units. The resistivity models of L2 to L4, and P1 can be used to follow the structural features characterising the gull ([Fig. 9](#)). In these profiles cold colours indicate low resistivities ($< 100 \Omega\text{m}$), corresponding to material with higher clay content and less [consolidation](#), such as [colluvium](#) and the sand and [mudstone](#) beds of the Harford Member. Warm colours, such as yellow and red, show the high resistivities ($> 500 \Omega\text{m}$) of the competent and weathered [limestone](#). The lithological boundaries indicated in [Fig. 8](#) relate very well with the mapped [bedrock](#) geology as shown in [Fig. 4](#), and are thus in agreement with the local stratigraphy. The deeper limestone members of the Birdlip Limestone Formation show a rather homogeneous structure with resistivities ranging between 1000 and 3500 Ωm . The capping Aston Limestone, however, shows a much more heterogeneous structure with smaller resistivity values (between 200 and 1000 Ωm), thus highlighting the weathering of this formation. This heterogeneity has also been imaged in the adjacent profiles L2 to L4 in [Fig. 9](#). Due to the higher resolution of these profiles, the non-uniform structure of the Aston Limestone is even more pronounced. The lithological difference of the Harford Member and its overlying and underlying limestones provides a clear resistivity contrast in the geophysical profiles, with resistivities well below 300 Ωm . The boundary between the Aston Limestone and Harford Member becomes less apparent with a profile distance of more than 475 m along L1, where high and low resistive features alternate, and a minor fault crosses the section. Towards the northern end of L1 it was also possible to image the upper boundary of the Whitby Mudstone Formation underlying the Birdlip Limestone. This mudstone is characterized by high clay content and thus shows a low resistivity of less than 30 Ωm .

We have interpreted sub-vertically aligned structures by tracing lines through the zones of highest resistivity in Lines L1 to L4 ([Fig. 8](#), [Fig. 9](#)), most of which are inferred to correspond with vertical discontinuities (see [Section 7](#)). These structures are more dominant and deeper-seated in the southern gull (at a profile distance of about 225 m along L1), which also has the largest surface expression, and interestingly the fractures on the southern (200 m) and northern (260 m) sides appear to dip steeply to the south and north respectively. Using profiles L2 to L4, the geometry of these features can be followed through the gull. Bounding discontinuities have been highlighted by black planes in the fence diagram shown in [Fig. 10](#). The discontinuity that bounds the gull in the south is located at about 85 to 90 m, and changes its dip from southerly in L2 to northerly in L4. Its resistivity signature shown in L1 (190–200 m) indicates that it is a deep-seated structure. The most prominent and deepest feature is located at about 110 m along L2, at the topographically lowest point in the gull. From L2 to L3 (which are separated by 60 m) its signature hardly changes, but it becomes less prominent in L4, which may correspond to a change in the nature of the gull fill at depth – possibly its water content. Together with the intermediate features at 230 m in L1 and 130 m in L3 and L4 these are inferred to be a median zone of chaotic material, rather than bounding planes.

The inverted resistivity model arising from the synthetic data shows very similar features to what is imaged in [Fig. 8](#), [Fig. 9](#). The two vertical features cause a heavily distorted resistivity model, with areas of under- and overestimation of the true resistivity. Both, however, are successfully imaged as near vertical, although not as sharply as, and with less resistivity contrast than in, the forward model. Also, these features extend not as deep as in the model. To both sides of the features, areas of low resistivity arise, which are also caused by the disturbance of the current flow by the vertical insulators. These low resistive features can also be seen in lines L1 to L4, decreasing the low resistivity of the Harford Member. Additionally, the resistivity model in [Fig. 10](#) shows a low resistive area between the two fractures, which is similar to features that can be found in the field data (e.g. L1 at a profile distance of 215 m).

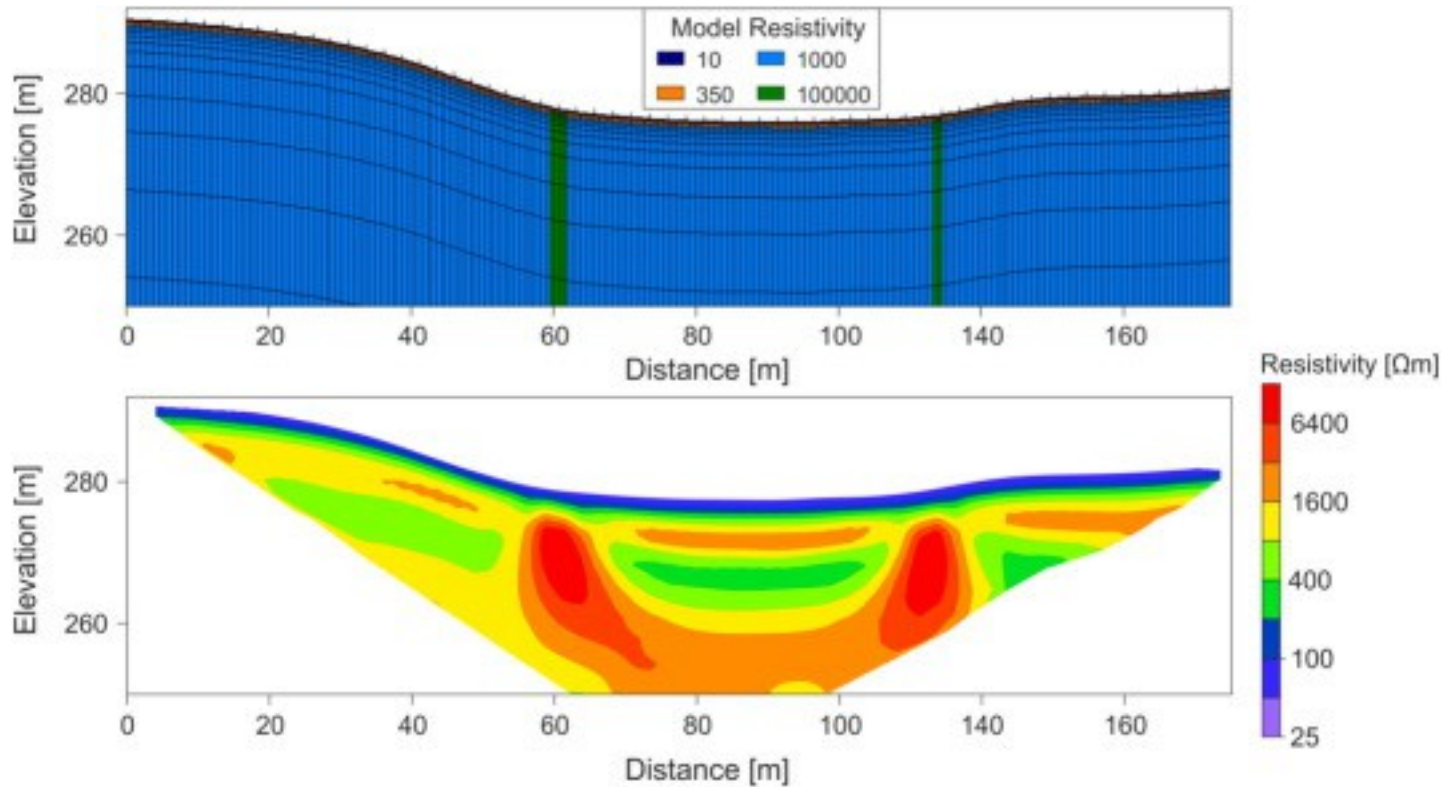
Fig. 11. Resistivity forward model (top) used to create a synthetic data set. Green structures represent deep-seated discontinuities. (bottom) Resistivity model obtained by inverting synthetic data. High resistive structures at a distance of 60 m and 125 m correspond to the modelled discontinuities.

Due to the limitations of the inversion process of ERT, i.e. smoothing of the resistivity models, fractures are not easily imaged nor interpreted. For resistivity measurements an open fracture is equivalent to an isolator, thus current will not pass this region and the data will contain only minimal information about its presence. To understand the effects such fractures will cause in the ERT models, numerical [forward modelling](#) was employed to create synthetic data which were then inverted using the same constraints as for the field data. The resistivity forward model and the inverted resistivity model arising from the synthetic data are shown in [Fig. 11](#). The model resembles a simplified geological section, with a very thin layer of overburden ($\rho = 10 \Omega\text{m}$, 0.5 m thick) covering weathered [limestone](#) ($\rho = 350 \Omega\text{m}$, 1.5 m thick), which is overlying competent limestone [bedrock](#) ($\rho = 1 \text{ k}\Omega\text{m}$). In the model the local topography of L3 has been employed. The trough in the middle of the model indicates the gull, which is bounded by two vertical features. These are assumed to be mostly air-filled fractures and therefore a large resistivity of $\rho = 100 \text{ k}\Omega\text{m}$ has been assigned to them. Although not shown in [Fig. 11](#), the model extends down to about 70 m. The [electrode](#) arrangement used to create the synthetic data is similar to the field arrangement used at L3, i.e., electrode spacing of 2.5 m, dipole lengths (a) of 2.5, 5, 7.5, 10, and 12.5 m, and dipole separations (n) of 1 to 8. The amount of employed electrodes was 64 – slightly smaller than in the field acquisition.
