Evaluation of Wet Weather Accident Causation Criteria

**California PATH Research Report
UCB-ITS-PRR-2010-24**

Final Report for Task Order 6602

Prepared for:
The California Department of Transportation

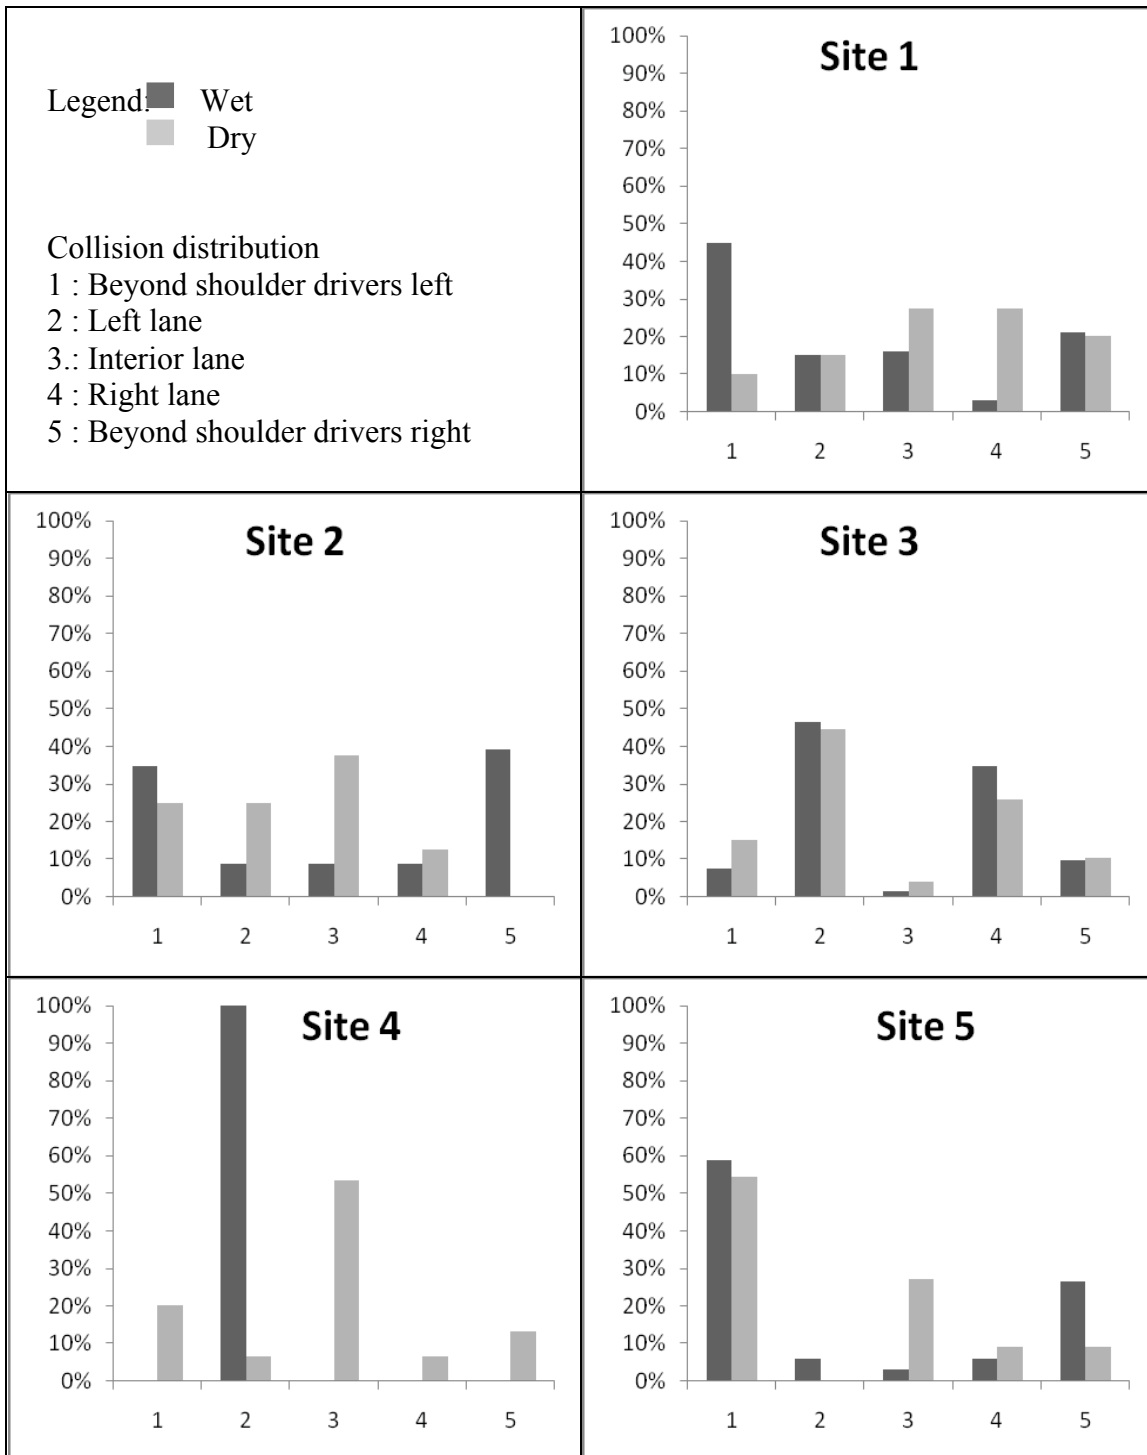
Figure 5 shows the collision distribution between 1994 and 2006 at each of the true positive sites under dry and wet pavement conditions. Sites 1, 2, 4, 5 and 6 showed a noticeable shift in collision distribution, while no change in collision distribution was observed at other sites. To identify site conditions that might have contributed to the shift

FIGURE 5
Collision Distributions With Respect to Pavement Type

in collision distribution and high collision rates, the research team visited each of the sites. The findings from the site visits are presented in conjunction with further analysis in the following sections.

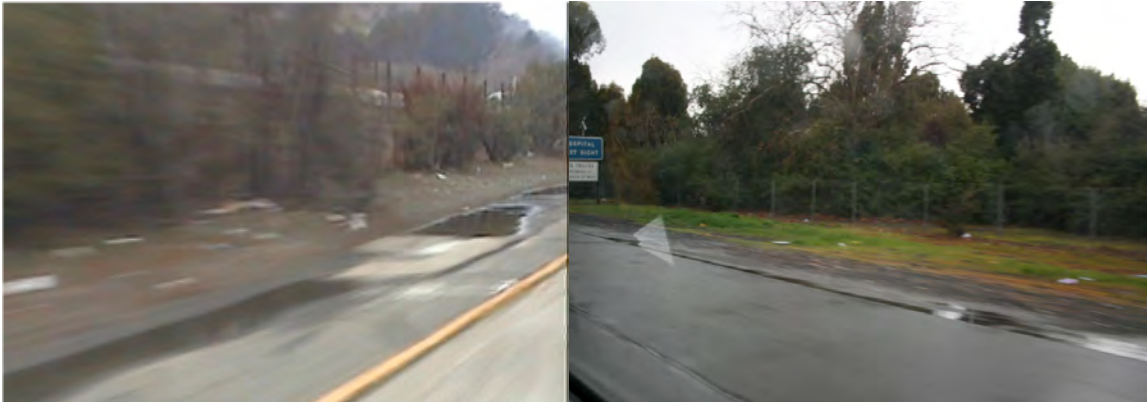
PHOTOGRAPH 1
Water Accumulation on Drivers' Left Shoulder
and Heavy Vegetation at Study Site 1

Photograph 1 was taken at Site 1 shortly after moderate rain, and as shown in the picture, accumulation of water beyond the shoulder on the drivers' left was observed. In addition, the presence of heavy vegetation along the road was also observed. This vegetation could potentially clog the drainage ditch during the rainy season and cause water to accumulate at the shoulder. We also observed "water spray," that can reduce sight distance at study sites (see Photograph 2).

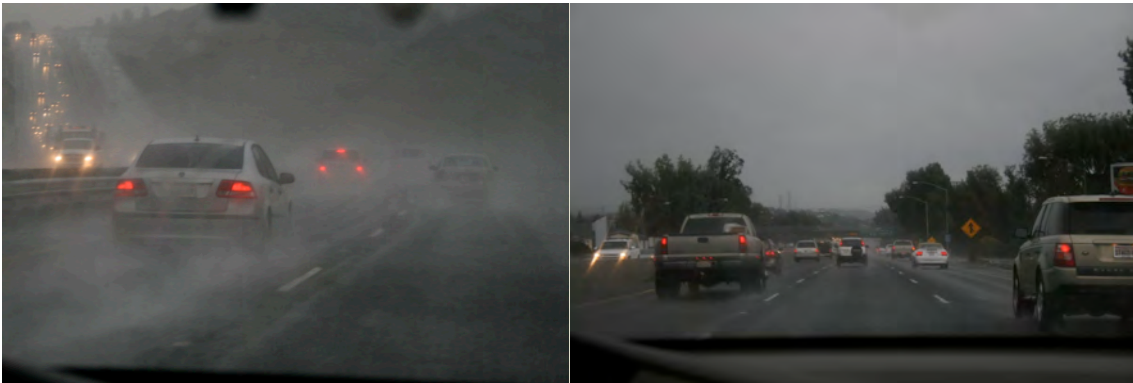
PHOTOGRAPH 2
Water Spray at Study Site 19 and a Non-High Collision
Concentration Location

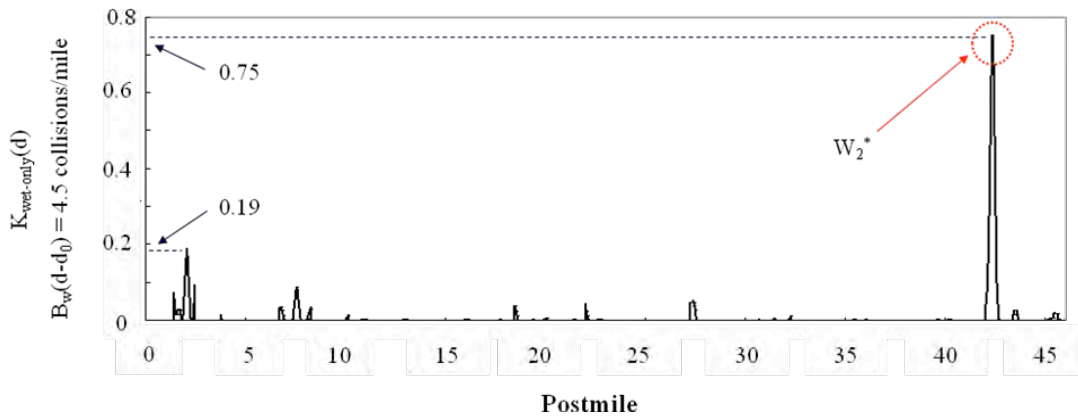
Figure 11 is the result of filtering out the redundant peaks in Figures 9 and 10. As a result, the peaks in Figure 11 identify the locations displaying high collision rates only under wet pavement conditions. As a result of this procedure, the unique HCCLs related to wet pavement conditions can be identified.

FIGURE 11
Wet-Only Continuous Risk Profile

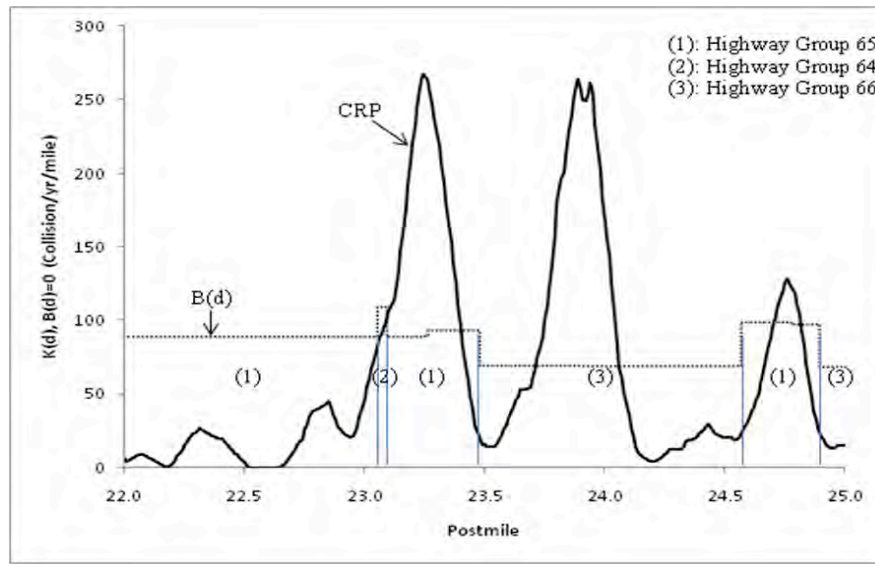
FIGURE 12

For reasonable comparison, the value of $B(d)$ is set as the number of collisions required for significance at 99.5% using the Sliding Window Approach, converted to the number of collisions per unit distance. The value of $B(d)$ is constant within the same type of facility, but changes discretely when the facility classification changes.

$K(d)$ at $B(d)=0$ and $B(d)$ at Significance at 99.5%, I 880 Northbound, 2005
