Tidal marsh restoration at Triangle marsh, Marin County

## TIDAL MARSH RESTORATION AT TRIANGLE MARSH, MARIN COUNTY

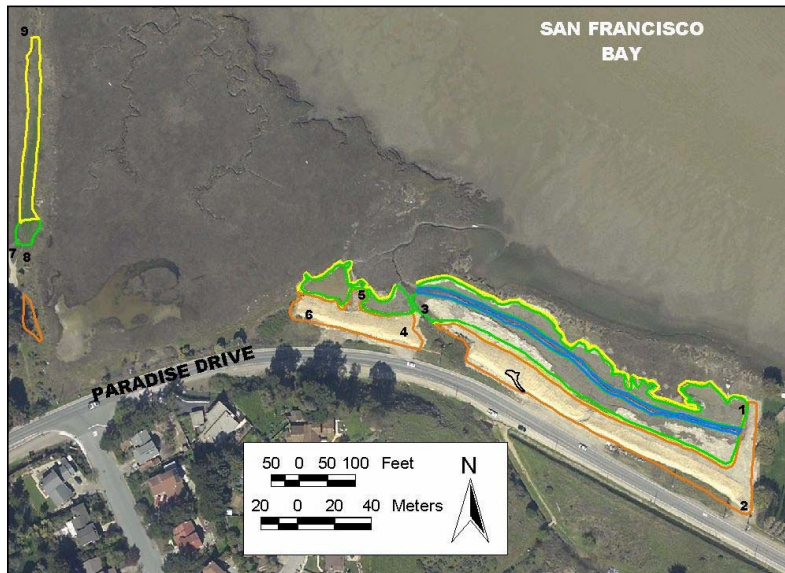
Figure 2. Aerial map of Triangle Marsh.

The topographic features were delineated using GPS after grading and contouring of the site (February 3, 2005). Future tidal-marsh areas (green outline), wetland-upland transition areas (yellow outline), and upland areas planted with native vegetation (orange outline) are shown. A channel was excavated at the eastern section (blue) to allow tidal inundation. Public viewing and access is shown in black. Numbers represent points where ground photos were taken (January 9, 2004 and January 13, 2005).

Caltrans provided funding and assistance to the Marin Audubon Society (MAS) with monitoring work for the restoration of 0.48 ha (1.19 a) of tidal marsh habitat (figure 2). The restoration occurred within three areas of the site: the eastern and middle portions of the site along Paradise Drive and the levee along the western property boundary. Upland areas were excavated to tidal-marsh elevation while existing tidal marsh and transitional high marsh atop manmade land (fill) were left undisturbed. An upland berm was constructed along the boundary between the marsh and Paradise Drive to provide a physical barrier between the public and the middle site. In the larger, eastern restoration area, this berm has more gradual slopes on its northern (restored marsh) side to provide wetland-upland transitional refuge habitat. The existing western berm was lowered to provide additional transitional refuge habitat. An estimated 8,158 cubic meters (m<sup>3</sup>) (10,670 cubic yards (cy) of soil was excavated, 1,869 m<sup>3</sup> (2,445 cy) were used on site for berm construction, and 6,289 m<sup>3</sup> (8,225 cy) were removed for off-site disposal.

Caltrans biologists will take photographic records of the same locations annually during the five-year monitoring period to monitor the progress of the restoration work (figure 2). Figures 3, 4, and 5 are representative of the photographic records taken at the site.

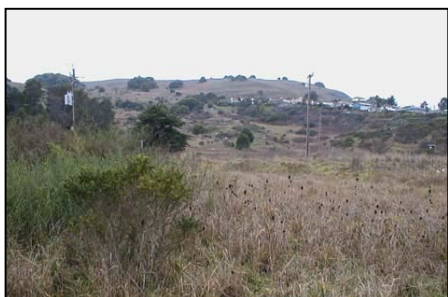
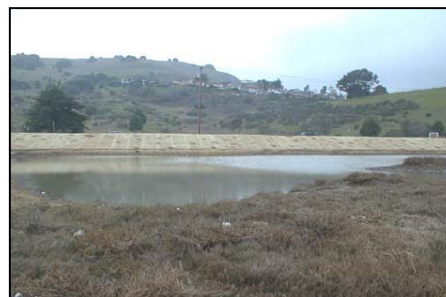
Point 1

Because the January 13, 2005, survey occurred shortly after the grading and contouring of the site was completed, not many plants were observed growing in the eastern section (figure 3). The upland berm of the eastern section was sparsely planted with California sagebrush (*Artemisia californica*), marsh gumplant, coyote brush (*Baccharis pilularis*), toyon (*Heteromeles arbutifolia*), and coast live oak (*Quercus agrifolia*). Pickleweed, marsh gumplant, and California cordgrass (*Spartina foliosa*) were growing at the margins of the eastern section adjacent to the tidal marsh.

Figure 3. Eastern restoration section.

Photos taken before restoration work (January 9, 2004) are shown on the left. Photos taken after grading and contouring of the site (January 13, 2005) are shown on the right.

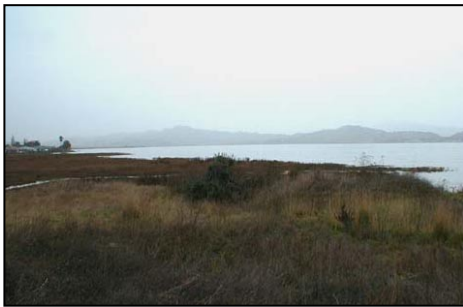
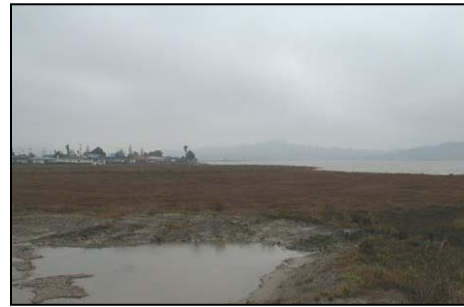
Point 4

The middle section, like the eastern section, did not have many plants growing in the area as of the January 13, 2005, survey because this section was recently graded and contoured (figure 4). The upper berm of the middle section was also sparsely planted with toyon, coyote brush, marsh gumplant, California sagebrush, and bee plant. Caltrans biologists observed killedeer and deer tracks in the middle section.

Figure 4. Middle restoration section.

Photos taken before restoration work (January 9, 2004) are shown on the left. Photos taken after grading and contouring of the site (January 13, 2005) are shown on the right.

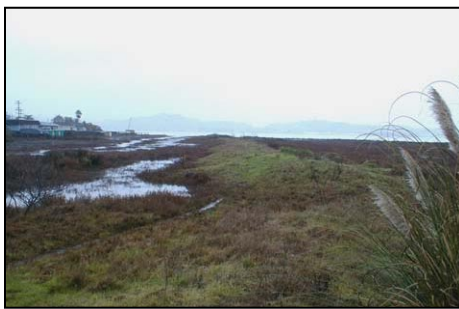
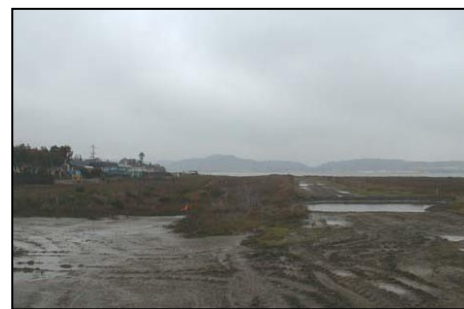
Point 7

The western section was also recently graded and contoured down to marsh elevations (figure 5). Pickleweed and marsh gumplant were growing at the margins of the western section adjacent to the tidal marsh on the January 13, 2005, survey. As natural recruitment of the area is expected to occur, the western section was not planted.

Figure 5. Western restoration section.

Photos taken before restoration work (January 9, 2004) are shown on the left. Photos taken after grading and contouring of the site (January 13, 2005) are shown on the right.
