# **Reflective Cracking Study: Initial Construction, Phase 1 HVS Testing, and Overlay Construction**

Partnered Pavement Research Program (PPRC) Contract Strategic Plan Element 4.10:  
Development of Improved Rehabilitation Designs for Reflective Cracking

This first-level report describes the design and construction of a Heavy Vehicle Simulator (HVS) test track that will be used to validate Caltrans overlay strategies for the rehabilitation of cracked asphalt concrete. The report also summarizes the first phase of HVS testing, carried out on six separate sections to crack the pavement, as well as design and construction of the overlays for the reflective cracking HVS experiments. The construction, preliminary field and laboratory data, and accelerated pavement tests reveal several issues regarding the performance of the asphalt concrete pavement cross section tested under the Heavy Vehicle Simulator.

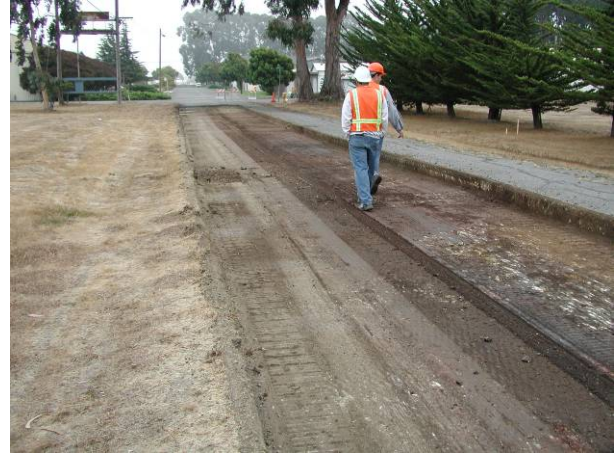
The existing aggregate base and asphalt concrete layer were milled to a depth of 250 mm (10 in), which removed all material to the surface of the subgrade (Figures 2.5 and 2.6). The ends of the pavement (25 m [82 ft] in length) were tapered to a thickness of 100 mm (4 in) to remove the existing asphalt concrete, leaving the existing aggregate base and subgrade in place.

Figure 2.5: Milling of existing roadway

Figure 2.6: Exposed subgrade

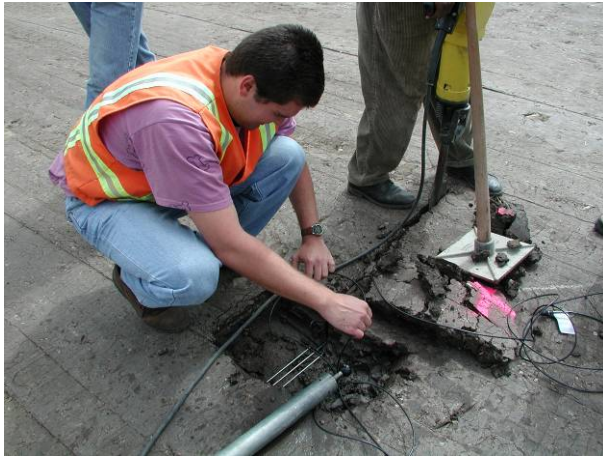
Six TDRs were placed horizontally at a depth of 50 mm (2 in) below the subgrade surface while one TDR was positioned vertically at a depth of 200 mm (8 in) below the subgrade surface. The TDRs were compacted in-place using a hand tamper and the wires taken to the edge of the shoulder, and then buried in the subgrade layer to protect them from damage by the aggregate trucks and the larger aggregate particles of the compacted base material.

**Figure 2.8: Installation of Time Domain Reflectometer**
