# A brief overview of climatization strategies of historic houses in the Netherlands: From “one size fits all” to “a process of deliberation”

*Bart Ankersmit and Marc Stappers*

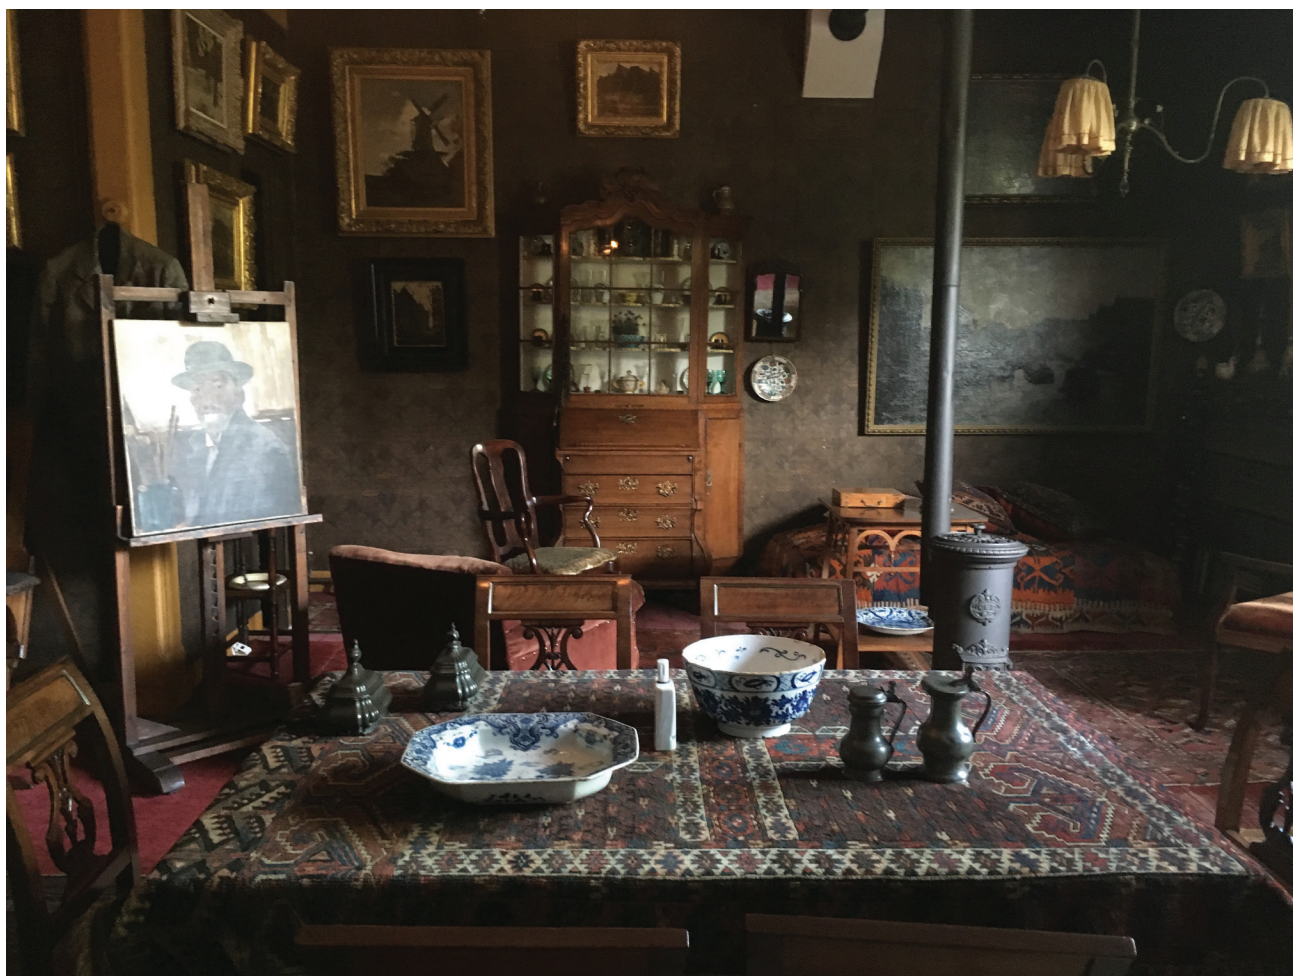
**IMAGE 20.** The interior of the Witsenchamber with a datalogger on the table and the furnace for a small amount of heat on the right. BART ANKERSMIT

The apartment can be visited by appointment (Image 20). The apartment has very limited climate control: a little heating but no moisture control. In 2020, the small organization of volunteers who check the condition of the collection regularly and give tours to visitors noticed signs of mold on the book collection. It was decided not to
