Redwood Creek Restoration at the Banducci Site: Geomorphic Changes on Lower Redwood Creek from 2003 to 2022

LDARCH 227: River Restoration

December 18, 2022

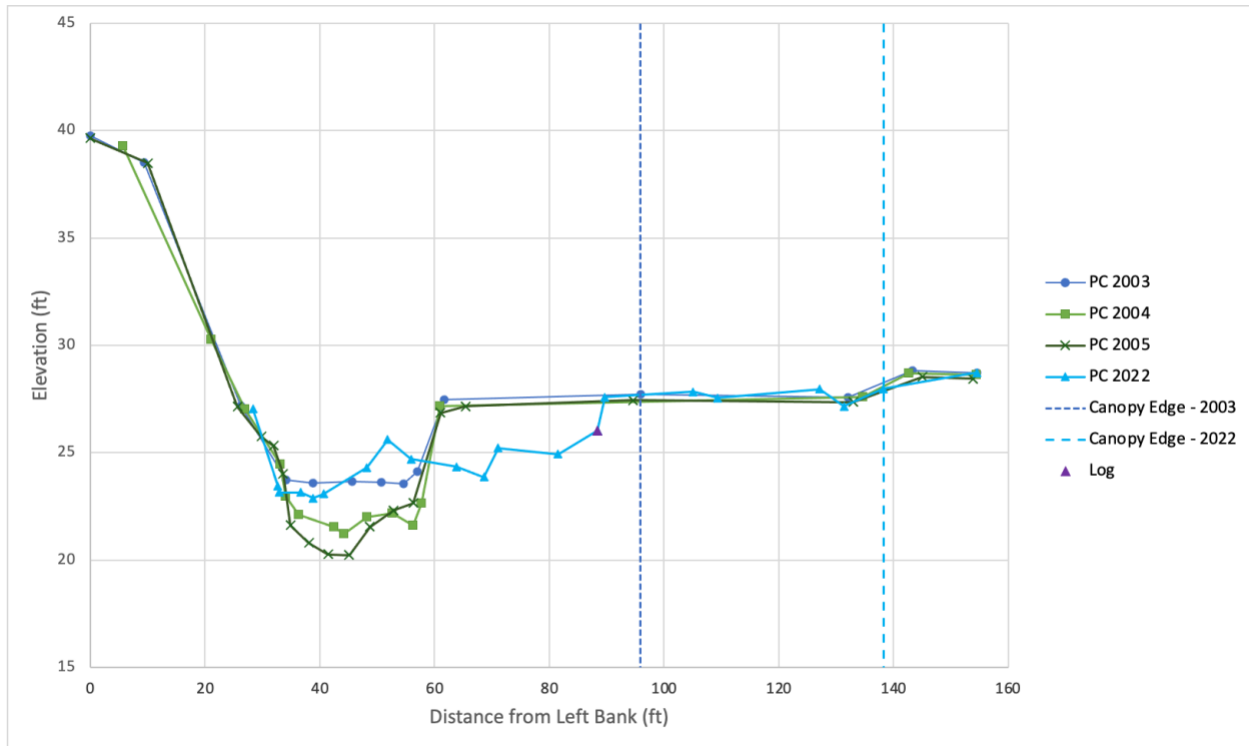
**Figure 3.** Cross section PC 3, shown facing downstream, illustrates channel conditions just upstream of the complex three-weir structure in 2003, 2004, 2005, and 2022. This shows the width of the right bank riparian canopy has expanded 42 ft since 2003. The location of a log in the 2022 survey is marked with a purple triangle. The log was from a naturally fallen tree and seemed to be contributing to some bank stability.

Cross section 3, displayed in Figure 3, is upstream from a three-weir log jam complex constructed in 2003 (Figure 2). The post-project survey from 2003 to 2005 for XS 3 showed channel downcutting, where the thalweg dropped approximately 3.5 ft over three years. However, the XS PC 3 2022 survey showed sediment accumulation raising the channel bed elevation almost to the same elevation as in 2003. The channel in 2022 was highly complex, with what looks to be a narrower main channel and additional side channels. Added channel complexity of the right bank is likely a product of high flows accumulating behind the log jam upstream and eventual overflow onto the floodplain on the right bank terrace thereby scouring the right bank (Appendix Photo 4). In the field, we observed a very deep pool that had formed under and downstream of the three-weir log jam, created from flow forced under the weir, that scoured the channel bed, and over weir, creating a plunge pool downstream (Appendix Photo 7).

Lastly, the canopy within this cross section expanded approximately 42 ft on the right floodplain (Appendix Photo 6). This canopy expansion could have been the result of increased floodplain connectivity and water inundation, allowing for greater water availability for shallow-root riparian vegetation and a higher nutrient pool due to the more frequent flooding.

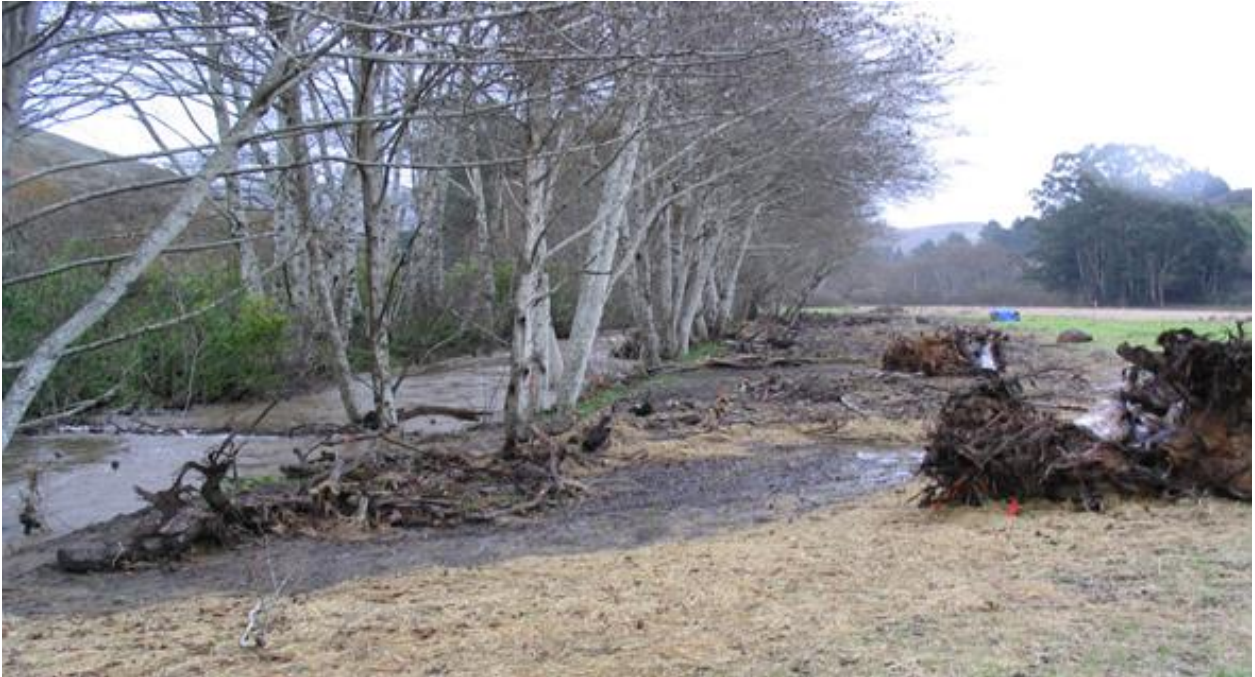
**Photo 1:** *View downstream of XS 7 on December 30, 2003. Source: Photos for UCB Pre\_Post\_Action April 2004*

the floodplain. Before the 2003 construction, the riparian canopy consisted of a single line of trees lining the river's banks (Appendix Photo 1, Figure 3). Today, riparian vegetation on the right bank consists of a dense stand of alders and understory vegetation which have occupied the floodplain areas graded as part of project actions (Appendix Photo 2, Figure 4).

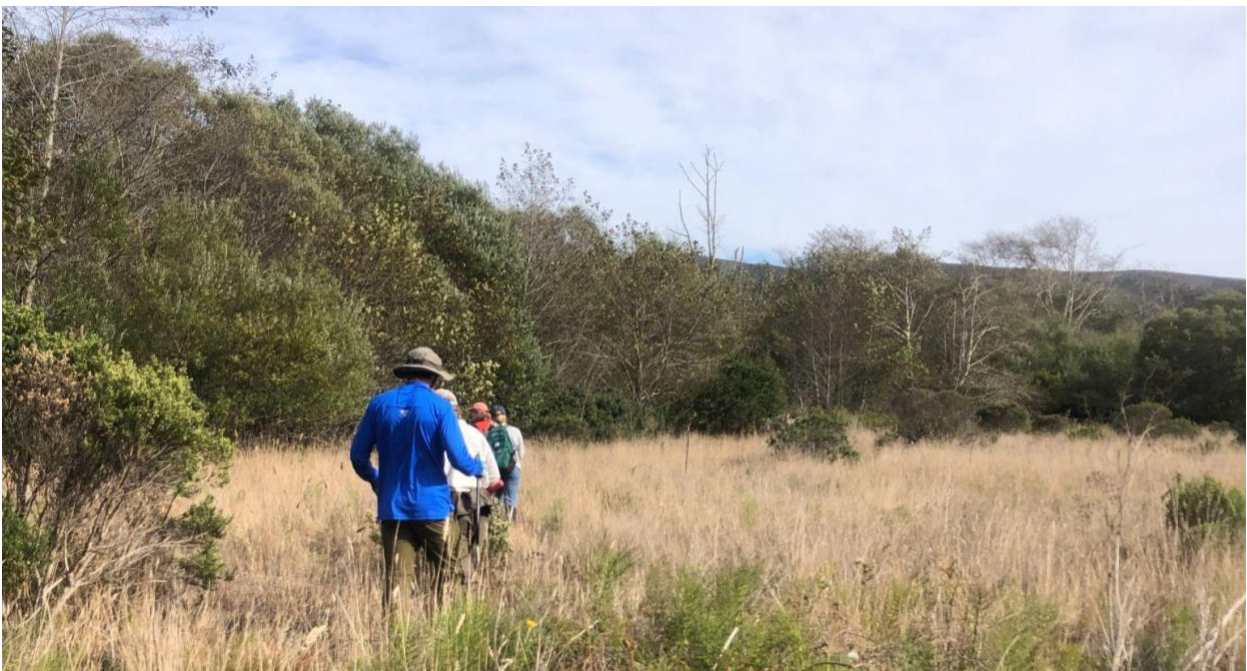
**Photo 2:** *View downstream of XS 7 on the right bank outside of the riparian canopy on October 22, 2022.*

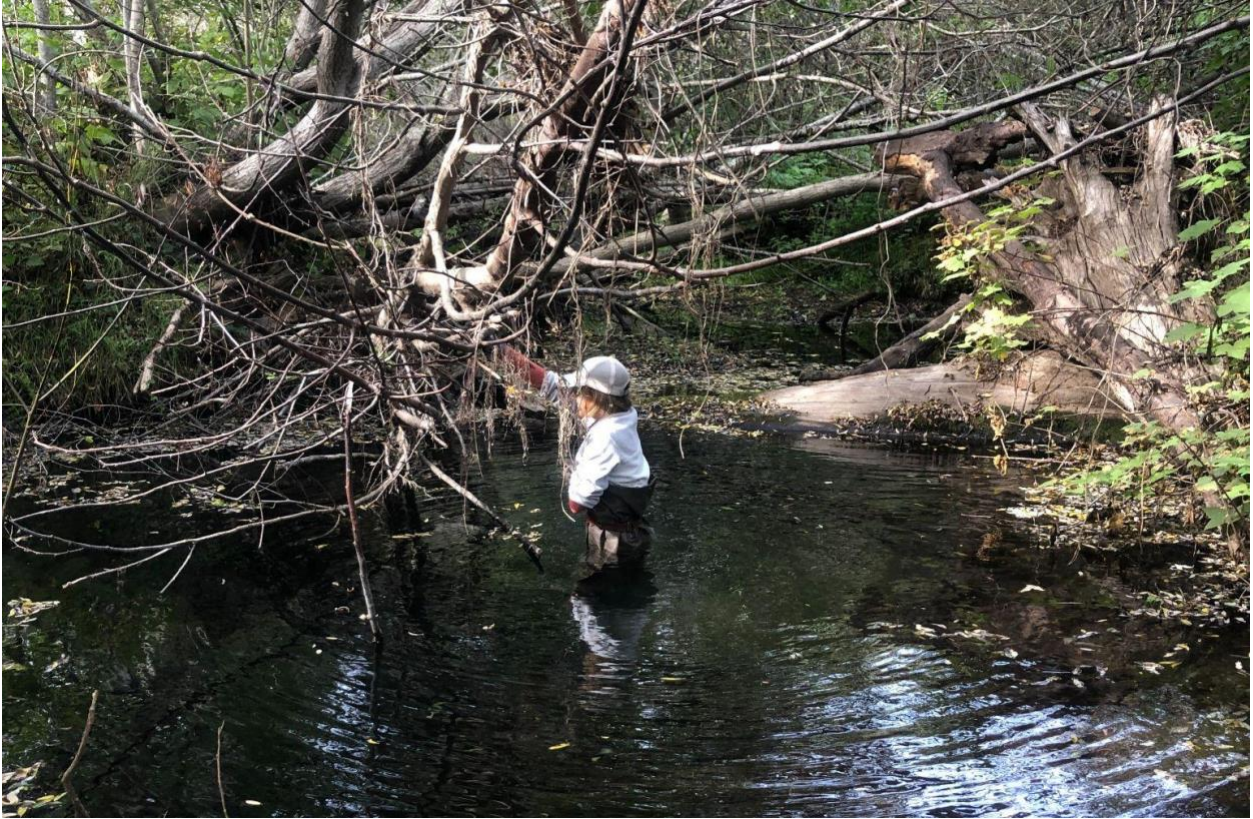
**Photo 3:** *Deep scour pool observed directly upstream of XS 5 on October 22, 2022.*

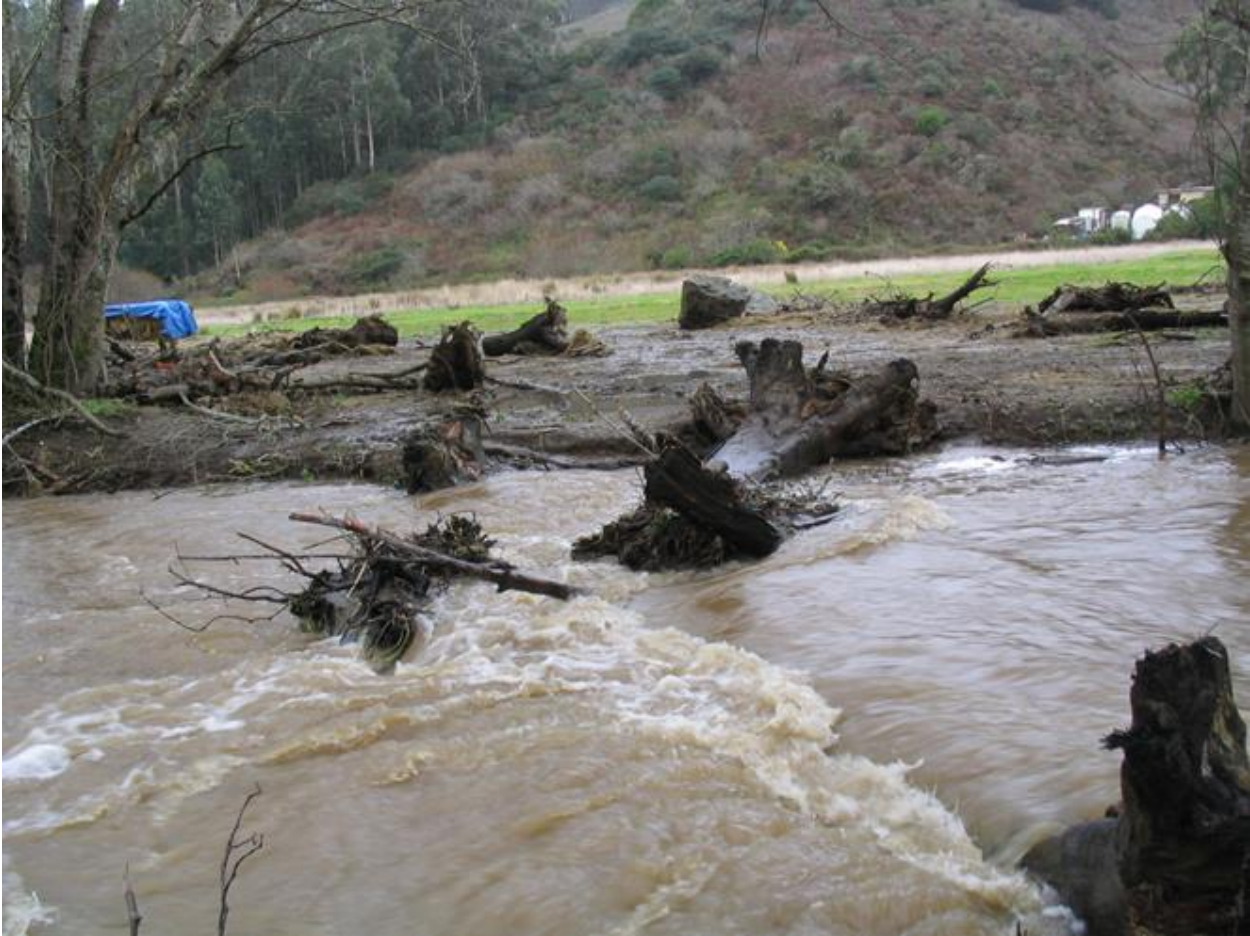
**Photo 4:** View of the right bank of XS 3 during a bankfull event in January 2004. Source: Photos for UCB Pre\_Post\_Action April 2004

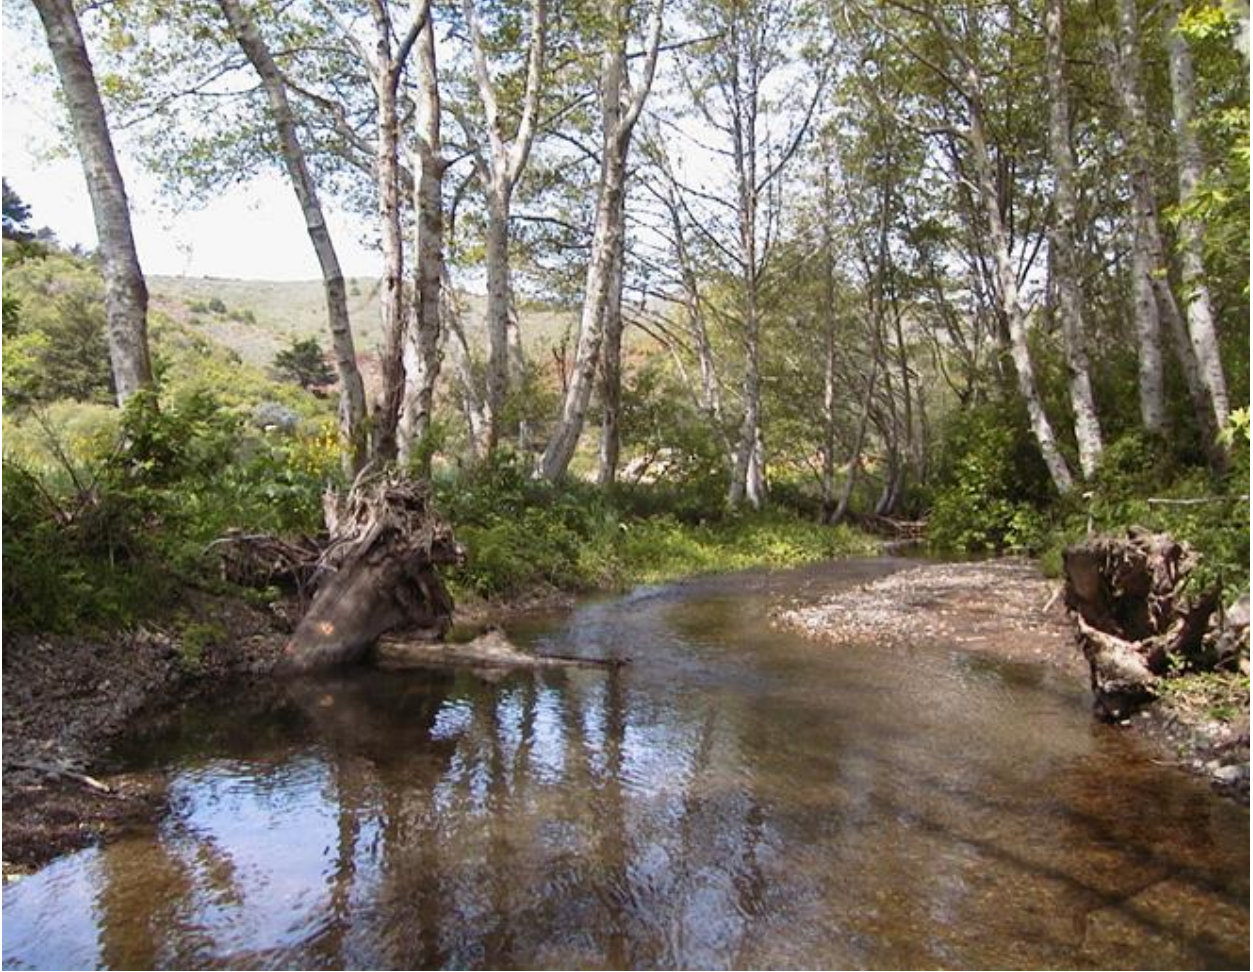
**Photo 5:** View log structure upstream of XS 7 in April 2004. Source: Photos for UCB Pre\_Post\_Action April 2004

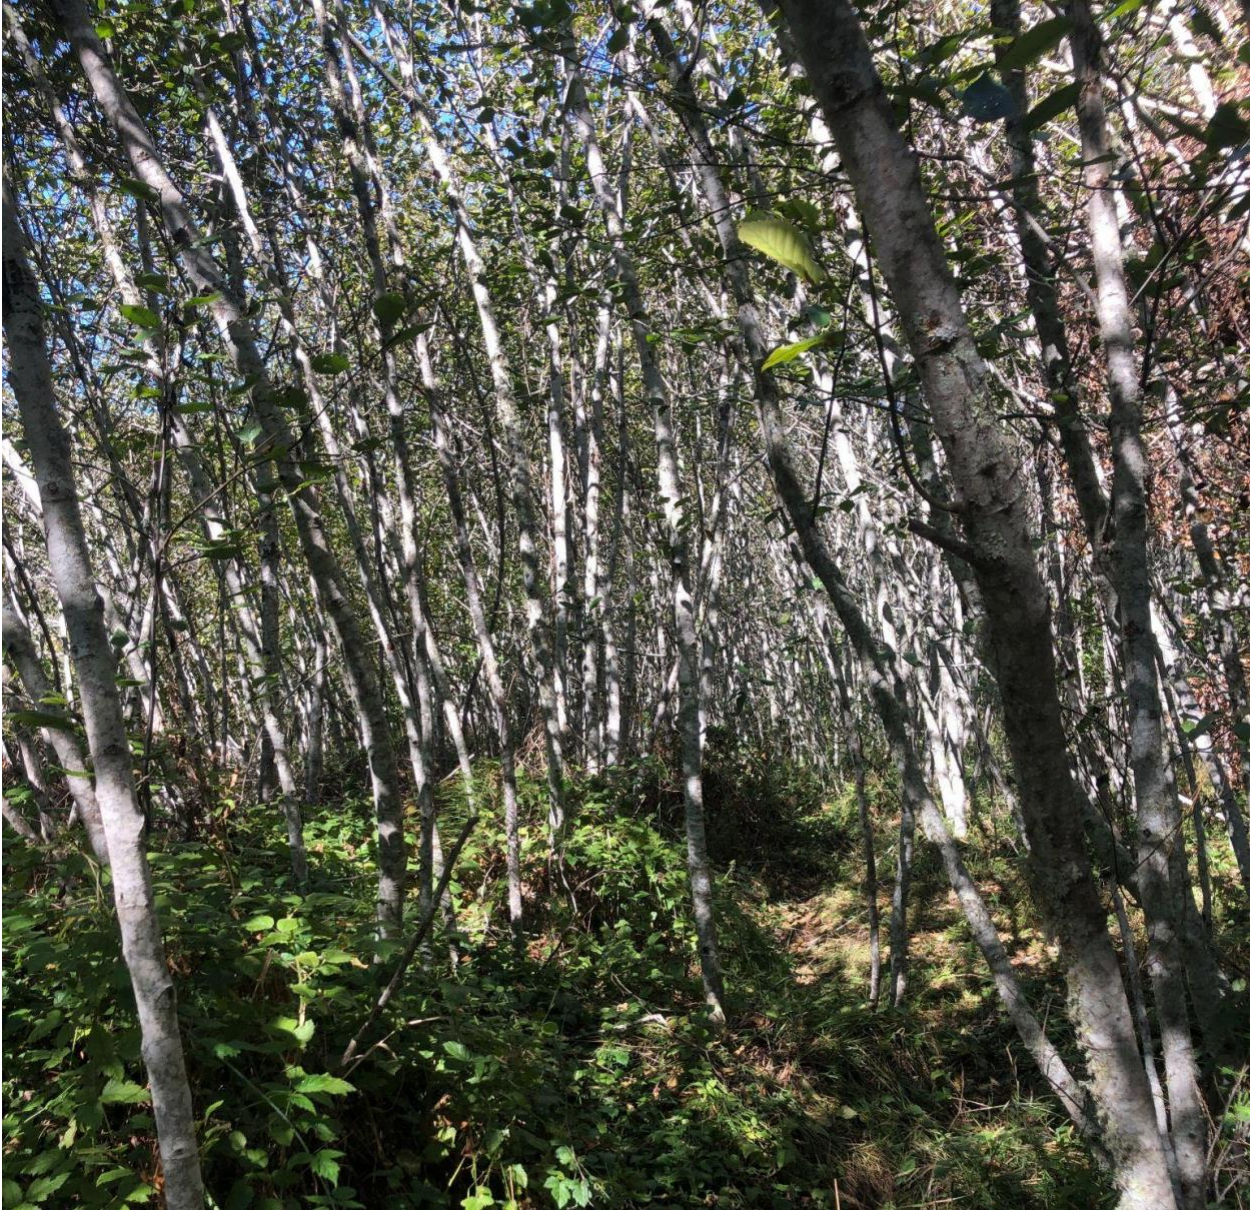
**Photo 6:** *View of dense canopy from right bank towards creek on XS 3 on October 23, 2022.*

Issues around the lines of sight could have also contributed to errors. As mentioned, the dense riparian vegetation obstructed a clear line of sight (Appendix Photo 6). Maneuvering the measuring tape around trees and other obstacles likely added distance to our stations. Without

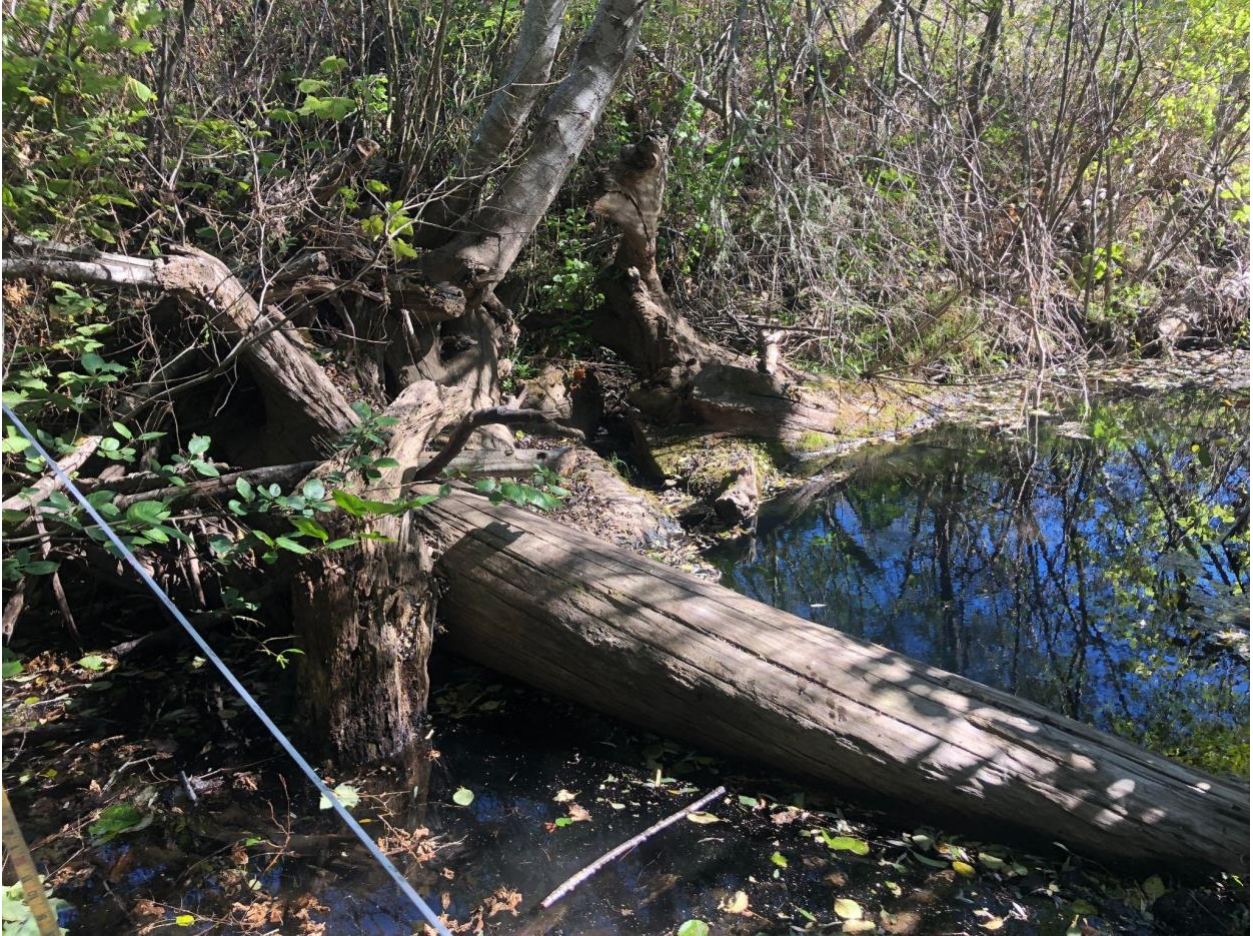
**Photo 7:** View from right bank of three-weir log jam upstream of XS 3 on October 23, 2022.
