Assessing Current Site Conditions and Vulnerabilities to Sea-Level Rise and Saltwater Intrusion: Lower Carneros Creek, Elkhorn Slough

Final Draft

Prepared by Emma Lasky and Olivia Won

LDARCH 227 - Restoration of Rivers and Streams

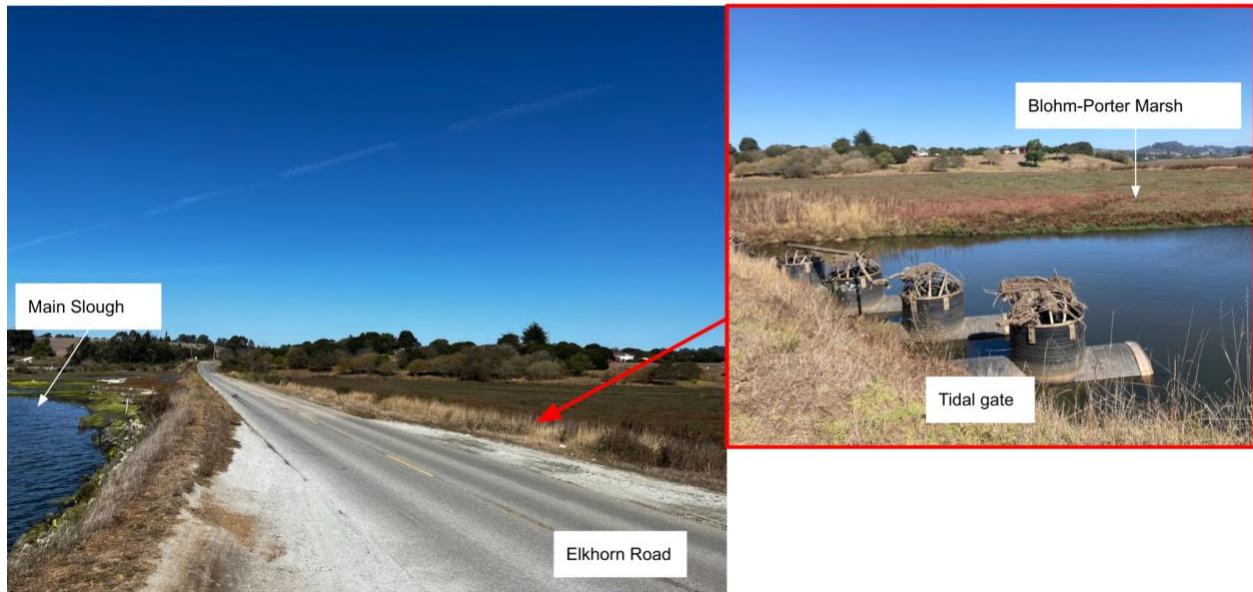
Figure 6. Tidal gate at Elkhorn Road separating the Blohm-Porter Marsh Complex from the main Elkhorn Slough channel. The Blohm-Porter Marsh Complex is at a noticeably lower elevation than the land on the other side of the road by the slough channel.

Despite concerted efforts to keep saltwater flows out of Blohm-Porter Marsh and LCC, the tidal gates have routinely failed since their initial construction (A. Woolfolk, personal communication, November 2023). The tidal gate was destroyed in the major 1989 Loma Prieta earthquake, which allowed for the natural flow of tides until the tidal gate was reconstructed in 1995 (Figure 6; Peichel et al., 2007). Tidal gate breaching due to mechanical failures has continued over the last 20 years (D. Dunkell, personal communication, October 2023). For this reason, the Blohm-Porter Marsh complex remains brackish and is dominated by halophytic

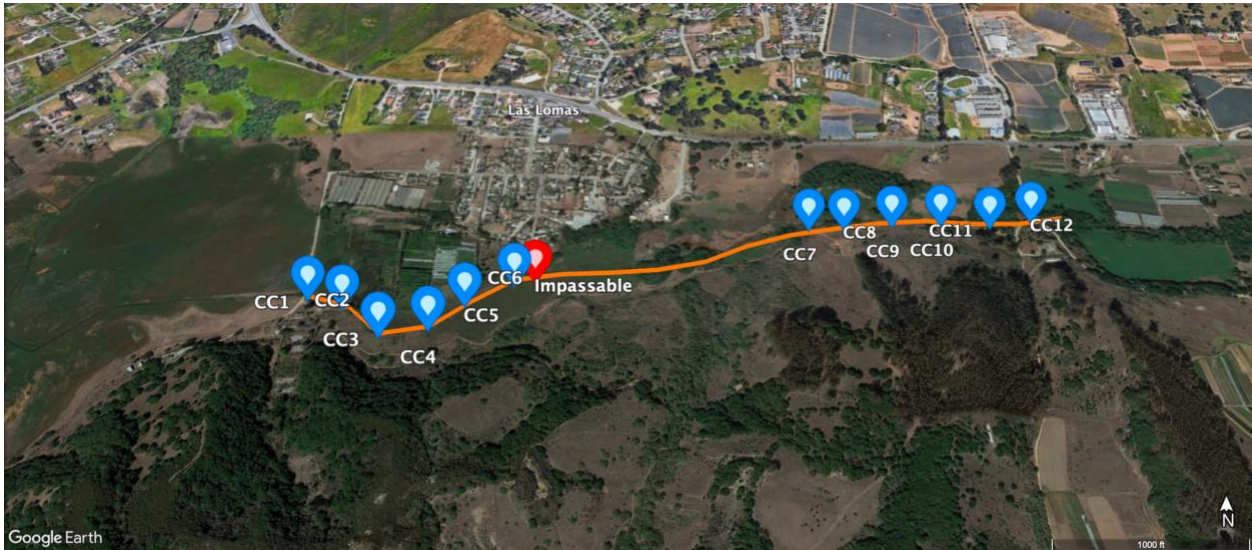
Figure 8. Sampling locations along Lower Carneros Creek. There were 12 sampling sites in total and are marked as “CCX” with “CC” signifying Carneros Creek and “X” signifying the sampling number and these sites are marked in blue. The red mark indicates the beginning of the impassable stretch of the creek; this continued until CC7.

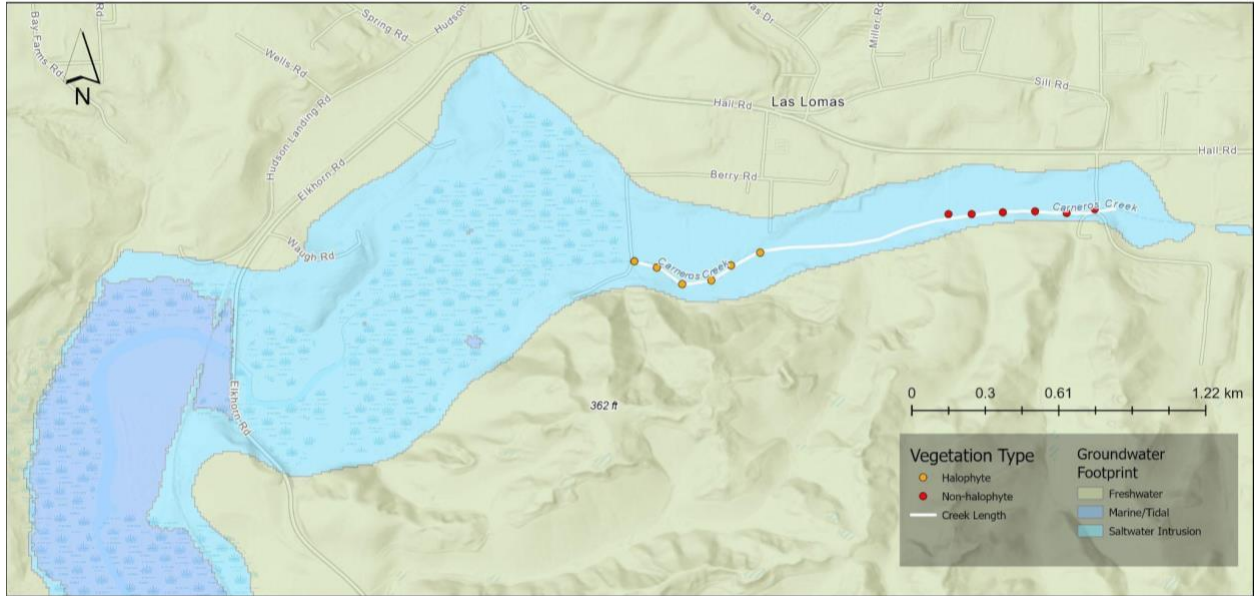
Figure 10. Points of survey sites along Carneros Creek from Blohm Road to the Eastern ranch road with or without halophytic species overlaid onto the groundwater footprint during a .25m sea-level rise scenario with a Kh of 0.1.

a 0.25m sea-level rise scenario. Once identified, we visualized the locations of wells and color-coded sites with halophytes present (Figure 9). With the selected wells, we produced a scatterplot in RStudio (version 2021.09.2; RStudio Team) to visualize the quantity of chloride observed in well sampling (Supplemental Figure 1). Chloride is commonly used as a proxy for saltwater and therefore can be used to identify evidence of saltwater intrusion (Dugan et al., 2017).

Riparian vegetation composition varied across the LCC extent. The downstream sites (1-6) were characterized by the consistent presence of halophytic species, such as *Salicornia pacifica* and *Atriplex prostrata* which are also dominant in adjacent Blohm-Porter Marsh (Figure 2, Figure 6). Site 7 had the vegetative composition that characterizes a freshwater marsh and was dominated by *Schoenoplectus spp.* Upstream sites (8-12) were characterized by freshwater riparian species such *Salix spp.*, *Rubus ursinus*, and *Persicaria sp.* Detailed descriptions of species and percent cover for each site are included in the supplemental material of this report (Appendix: *Sites*). There was no identifiable trend of varying species diversity or native versus non-native species presence along the downstream- upstream gradient for LCC (Table 1; Figure 12). Most notably, halophytic species were present across sites 1-6 (Figure 10; Figure 12).

compositions along LCC show that this system was historically tidally influenced and retains tidal wetland vegetation compositions (Figure 10; Table 1).

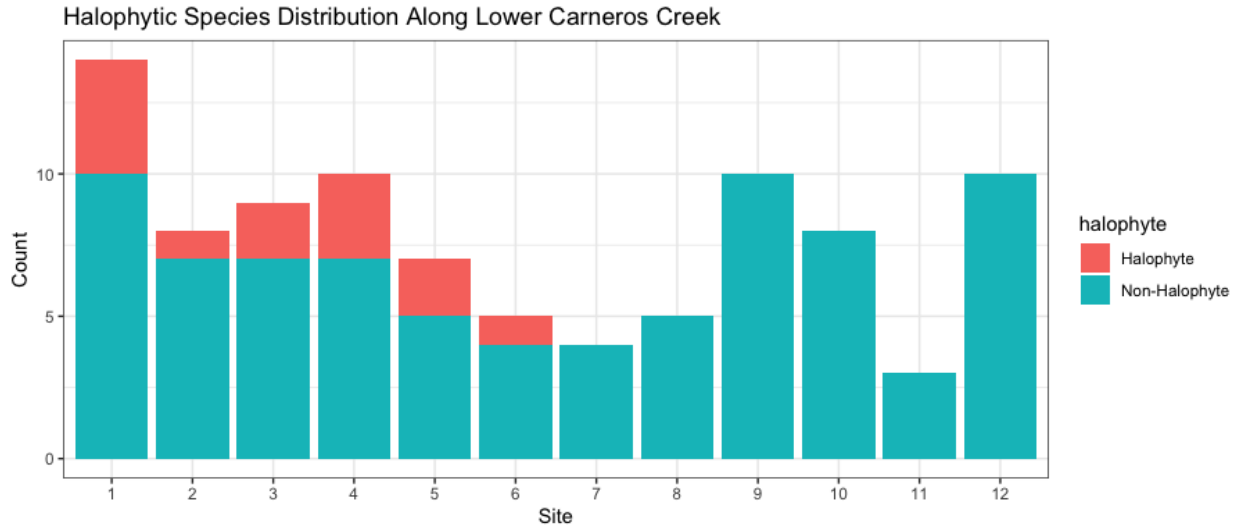
Figure 12. Halophytic Species vs Non-Halophytic Species across LCC sampling sites

These results demonstrate that, even with existing tidal controls, saltwater will intrude underground into the Blohm-Porter Marsh complex and Lower Carneros Creek (Figure 12). These hydrological changes will alter the vegetation composition in the riparian zone, including the extent of our sampling area. As our vegetation data demonstrates, halophytic species are already present in the riparian areas. We can infer that as groundwater rises, the middle and upper segments of Lower Carneros Creek will be inundated for longer portions of the year and potentially exposed to salinized groundwater. These changing physical conditions will likely result in plant composition shifts. Freshwater riparian species like *Salix spp.* have low saltwater tolerances and will likely be imperiled as soil salinity increases. These conditions will support species that can withstand inundation for long periods of time as well as salinized soil conditions (RI Coastal Resources Management Council, 2007).
