REPORT ON THE ENGINEERING TEST OF THE LBL 30 SECOND NEUTRAL BEAM SOURCE FOR THE MFTF-B PROJECT

REPORT ON THE ENGINEERING TEST
OF THE LBL 30 SECOND NEUTRAL BEAM SOURCE
FOR THE MFTF-B PROJECT

M.C. Vella, P.A. Pincosy, C.A. Hauck,
and R.V. Pyle

August 1984

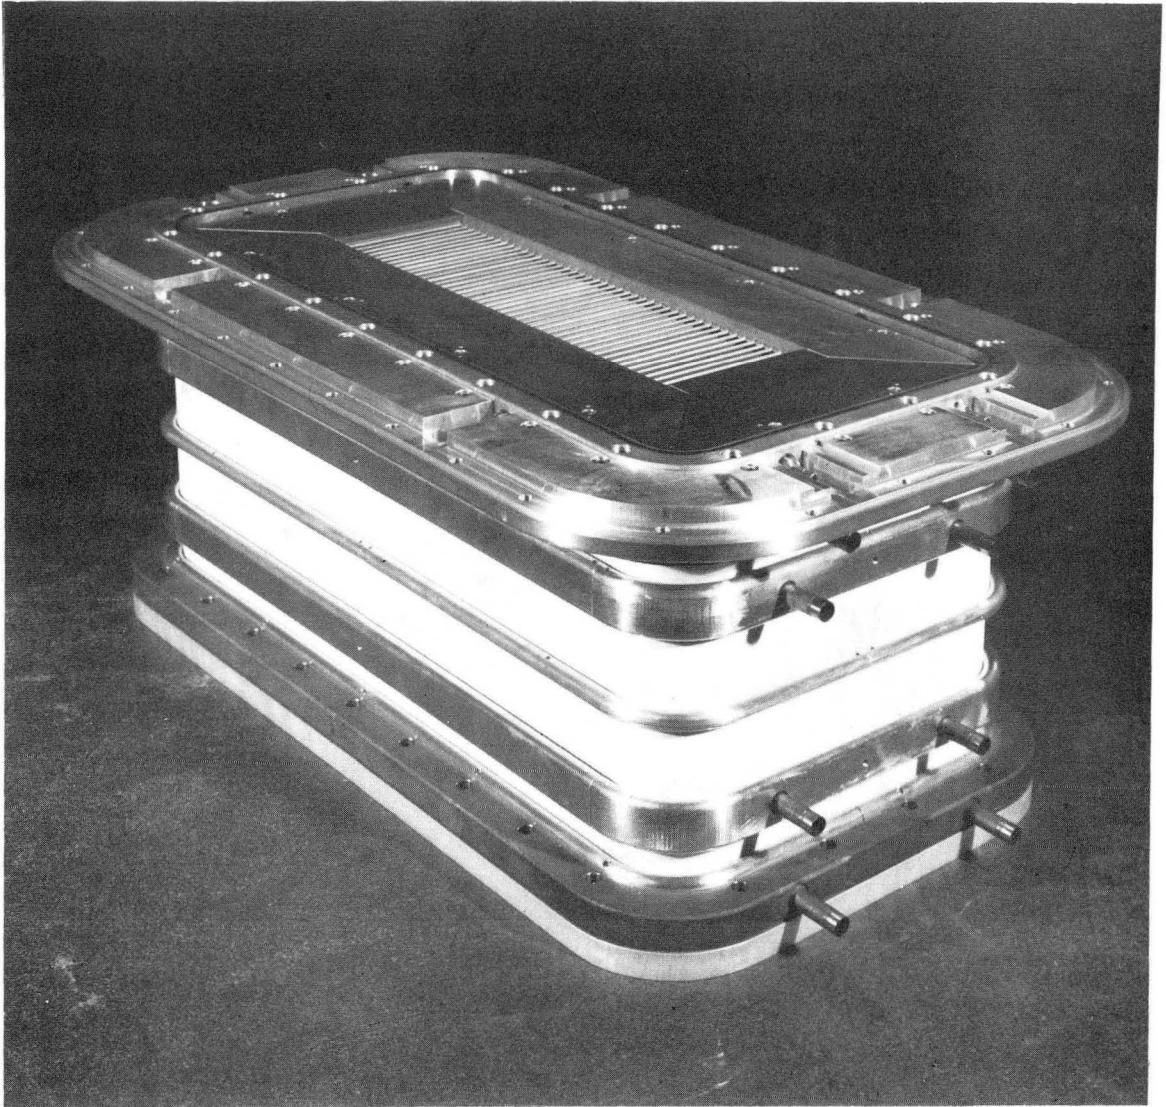
CBB 810-10869

Figure 3. The Long Pulse Accelerator (LPA) is shown.

The LPA is a radiation hardened structure, designed for 150 kV operation in a reactor environment. The insulator stack is brazed ceramic and stainless steel, and the accelerator grids are water cooled molybdenum tubes. Design and construction of the LPA has been documented previously.^{2,3} A picture of the LPA is shown in Figure 3. The first test of the LPA⁴ was in 1982. A field-free plasma source was used initially, and, later, the LPS was used for testing up to two seconds. Pulse length was power supply and target limited at that time. The LPS plasma source is an arc in a magnetic bucket geometry,

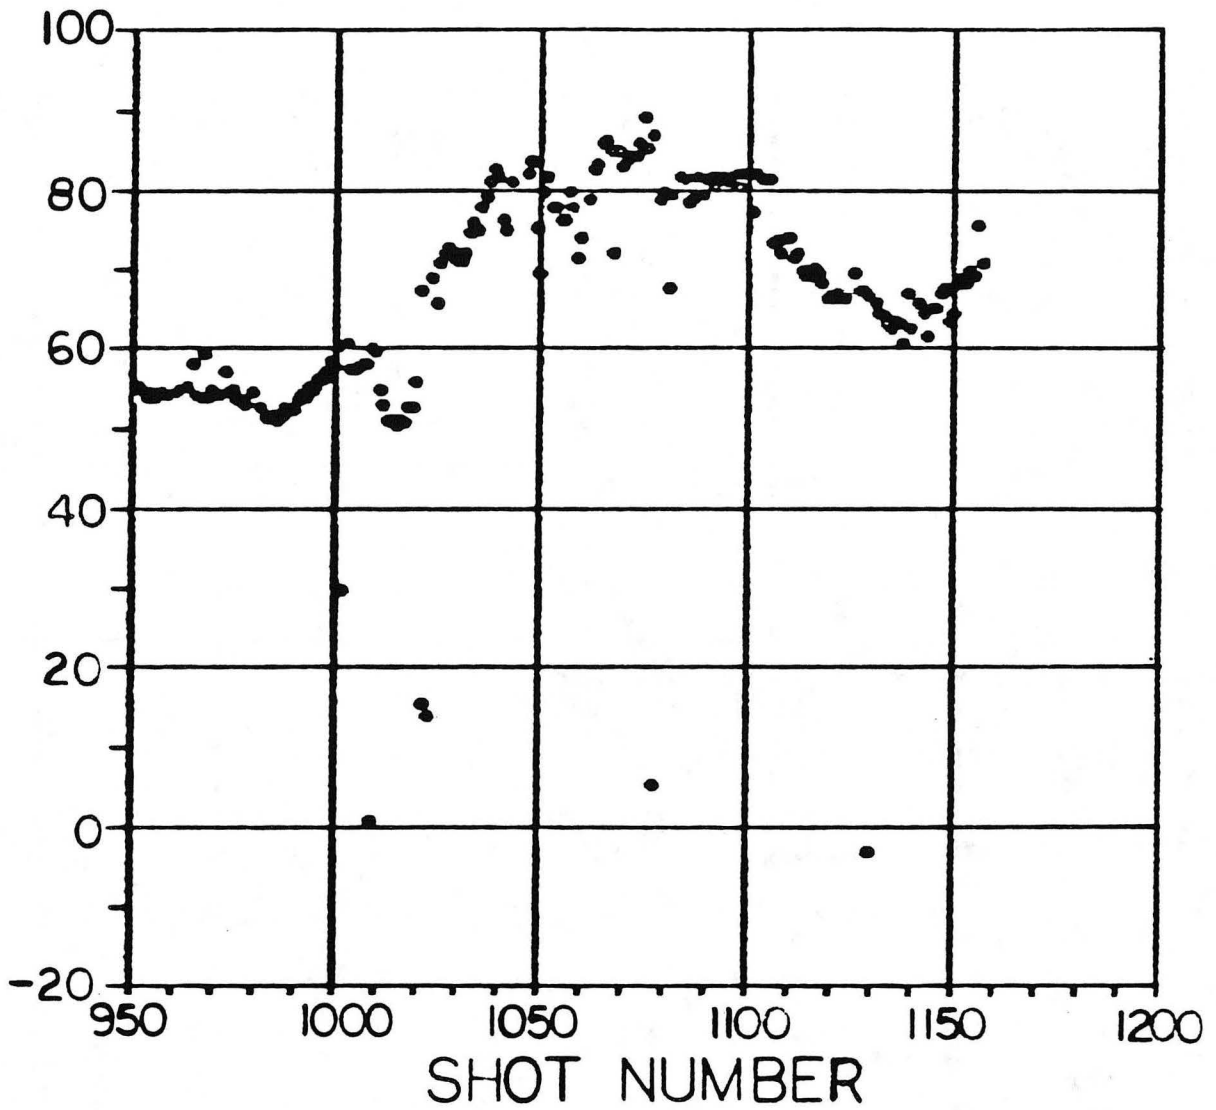
XBL 847-3102

Figure 6. The conditioning history of the Long Pulse Source (LPS) is illustrated. Arc voltage is plotted vs shot number.

Initial arc conditioning was carried out in one shift on November 14. Arc voltage and arc power for each shot of the day are shown in Figures 6 and 7. To avoid source damage, conditioning is done with the arc spot detector set to just allow operation. The basic strategy is to run at the lowest possible voltage, in order to avoid spotting. Arc voltage and power are raised as arc spot detector faults decrease. In this case, initial operation was with the back plate magnets removed, which gives field-free anode area and allows operation as low as 40 - 50V. The first shots were also restricted to 10 msec pulses and 15 kW, while the arc spot detector was setup.¹ The pulse length was later stretched to 0.5 sec. When arc power reached 80 kW at 80 V, the pulse was stretched to 4 seconds. The backplate magnets were then installed, and the source conditioned from 15 kW, 60 V to 70 kW, 70 V with 0.5 sec shots. Finally, the pulse was stretched to 2 seconds.

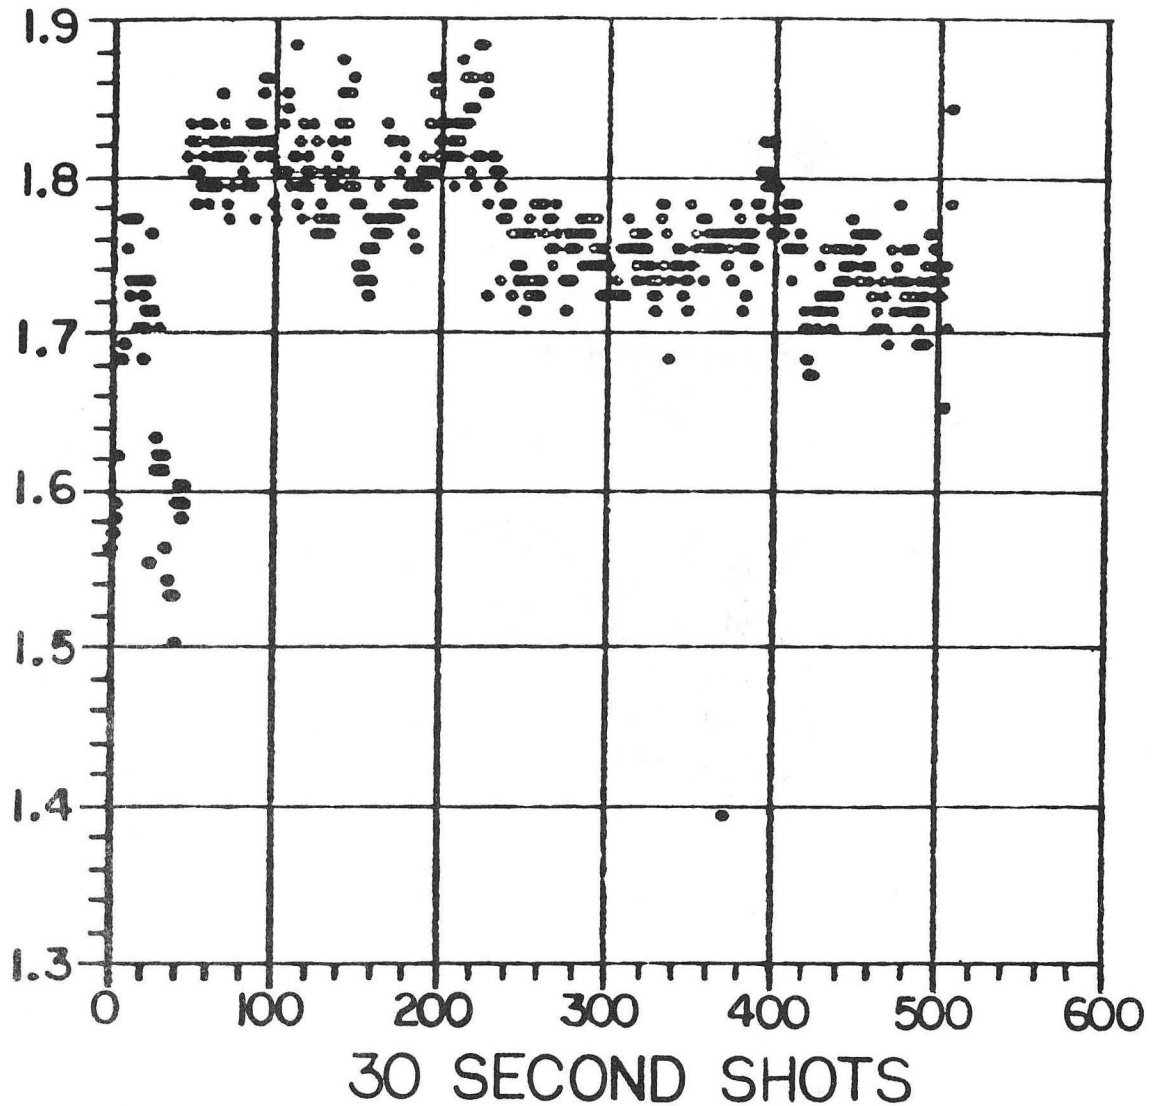
XBL 847-3106

Figure 10. The 30 second shot history of the Long Pulse Accelerator (LPA) is illustrated. Accelerator perveance (μ pervs) is sequentially plotted for each shot counted in the Test.

In Figure 9, accel current is shown for the same shot sequence; the range is approximately 35 - 43 A. Perveance is shown in Figure 10; the Test range was 1.4 - 1.9 μ pervs. On all 30 second shots, arc feedback regulation^{6,7} was used to maintain a constant accel current. The feedback system compared an input signal with a precision reference voltage, and phase controlled the arc power supply to maintain a constant input. During the Test, the input used was the saturated ion current read by a newly developed, 1/4" O.D. water cooled plasma probe, biased -22 V with respect to cathode. With arc regulation, the variation in accel current over a 30 second shot was determined by arc and filament power supply ripple, approximately $\pm 2\%$. Without regulation, beam operation up to 10 seconds required careful adjustment of the filament current; the stepper was used for filament adjustment. Due to changing arc efficiency, variation in the unregulated arc level gave a gave an accel current which had a maximum/minimum difference of 10%.

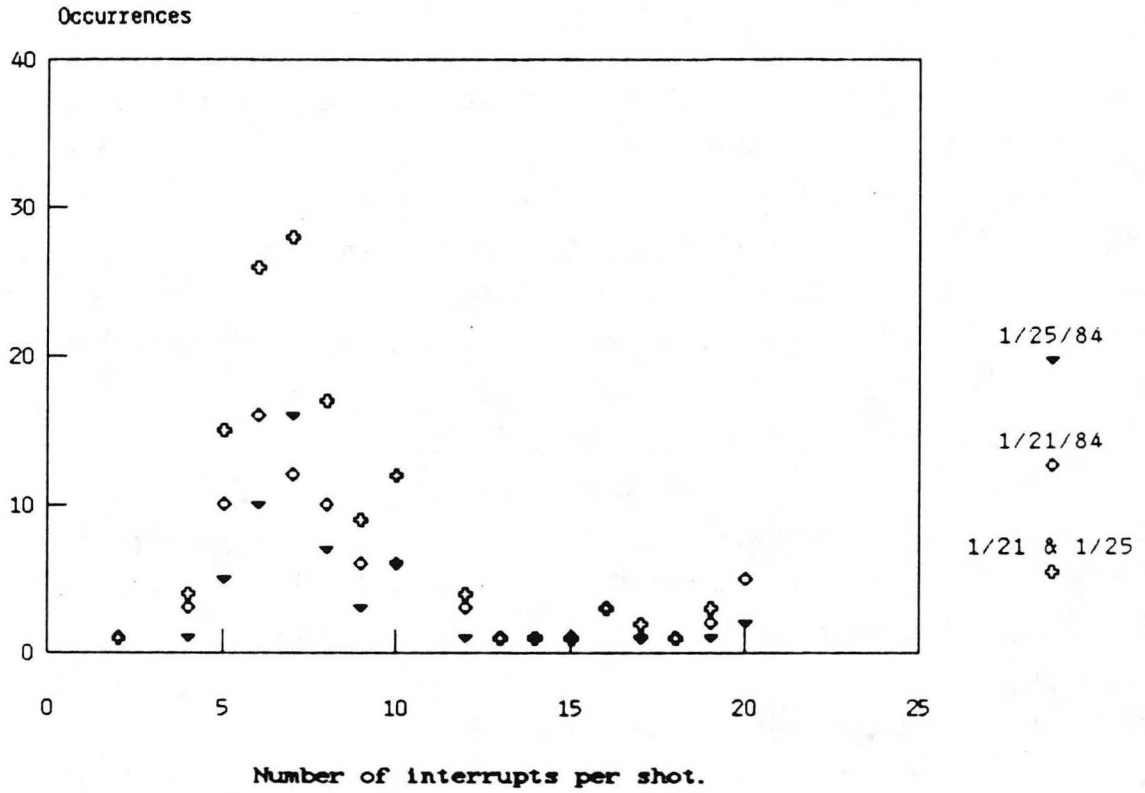
XBL 847-3107

Figure 12. The number of times that a particular number of faults occurred on a 30 second shot is plotted for the best days of operation, January 21 and 25.

The average number of interrupts per shot for January 21 and 25 is plotted in Figure 12. During the Test, interrupts decreased with conditioning from 40 to 5 per shot. Although the conditioning history is obscured by beamline downtime, the downward trend in interrupts on days of prolonged operation shows reconditioning, and suggests further improvement.

Accel reliability for January 21 and 25 is illustrated in Figure 12, where the occurrence of a given number of interrupts is plotted. The peak of the distribution is at 6 or 7 interrupts per shot. The nonstatistical features on the tail suggest another variable in addition to accelerator conditioning. During testing, a tendency for bursts of interrupts associated with target leaks was apparent, and would account for these features. At the end of the Test, the accelerator appeared to still be conditioning.

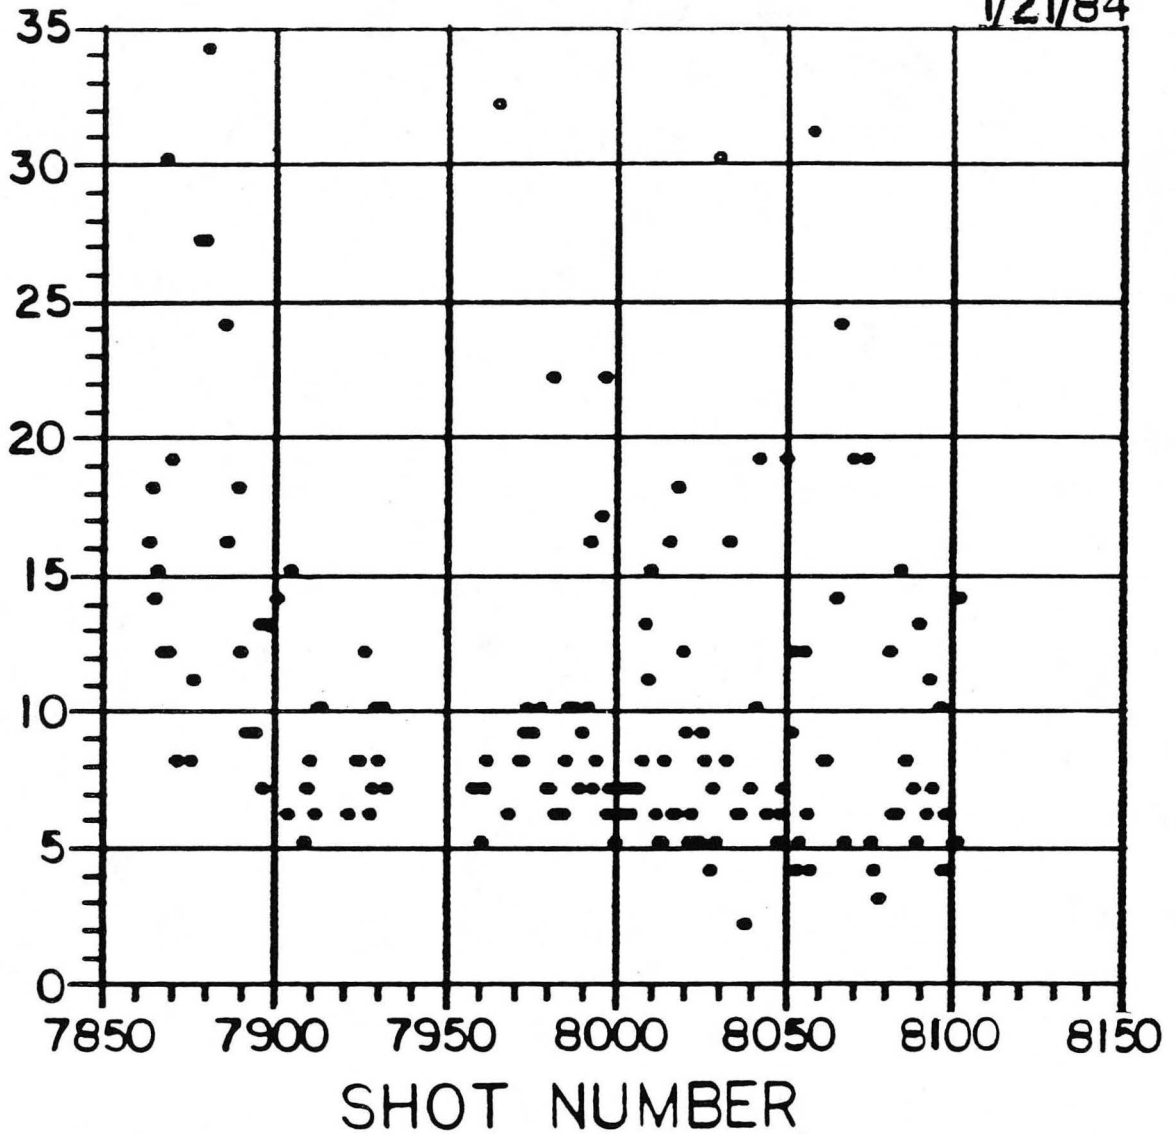
XBL 847-3108

Figure 13. The interrupt history for January 21 is shown; the number of interrupts on each 30 second shot is plotted vs shot number.

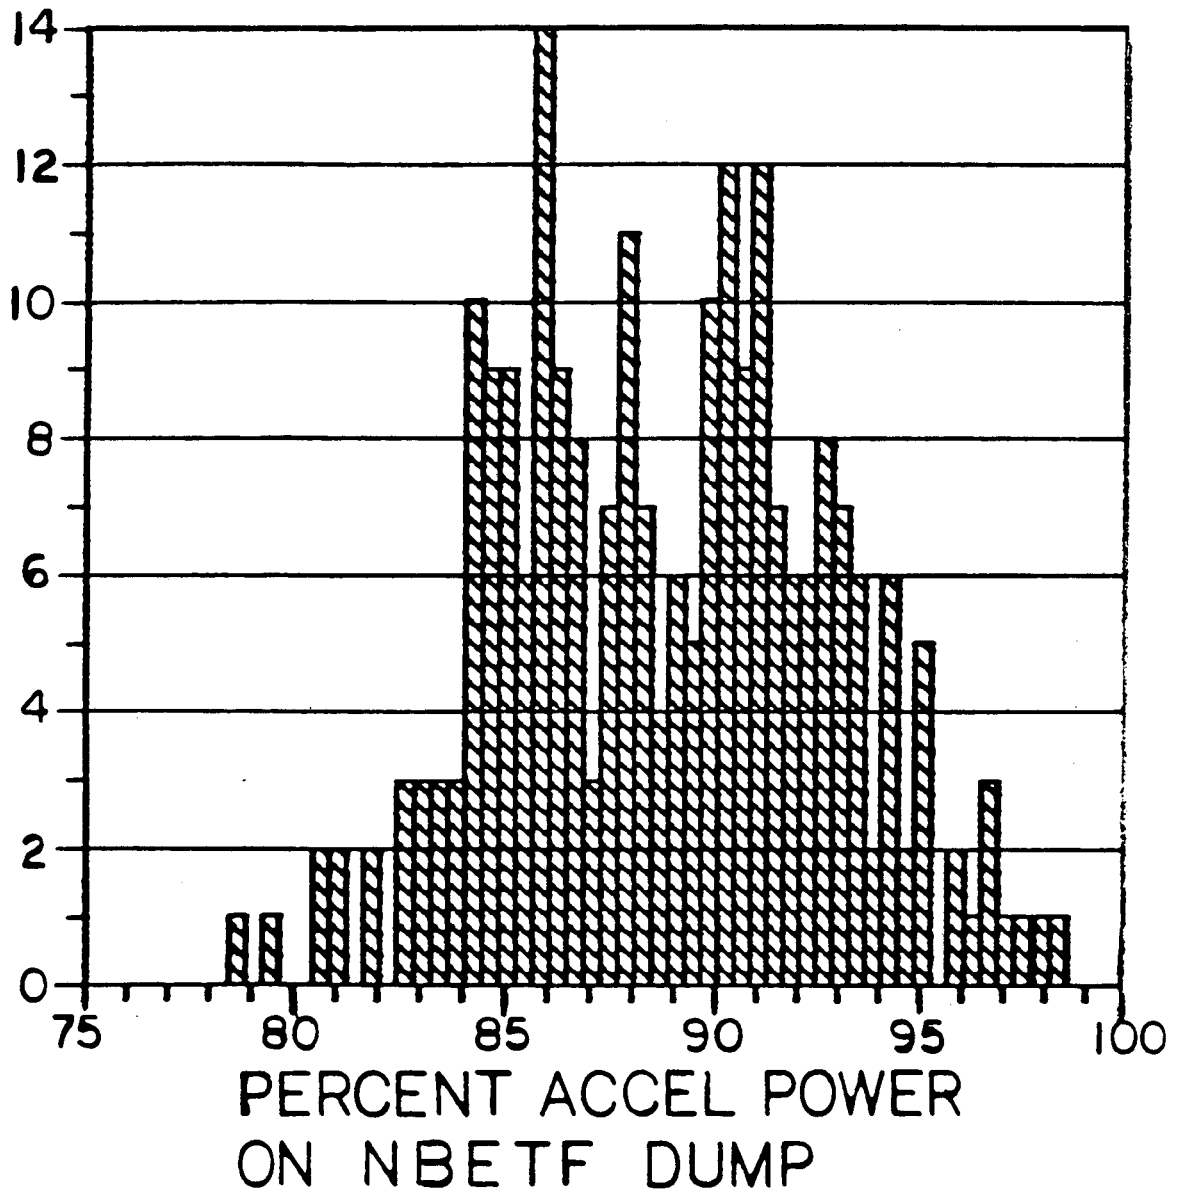
XBL 847-3114

Figure 25. A histogram is shown of the power fraction measured on the active beam target. The number of 30 second shots is plotted vs the percentage of power on the target.

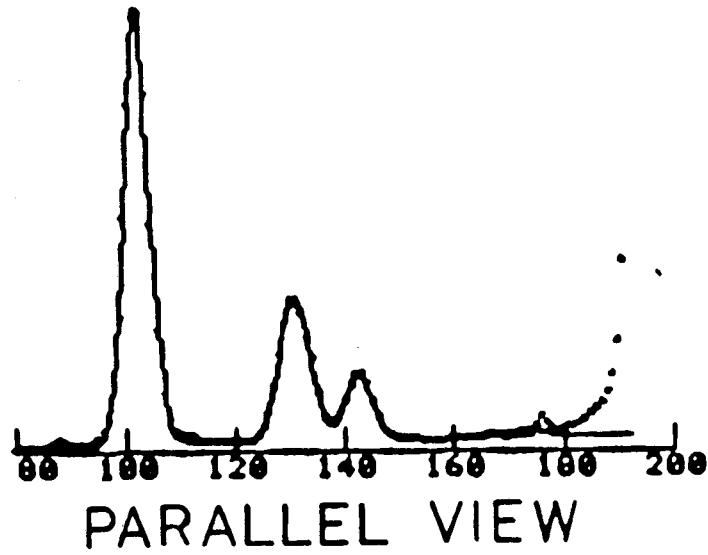
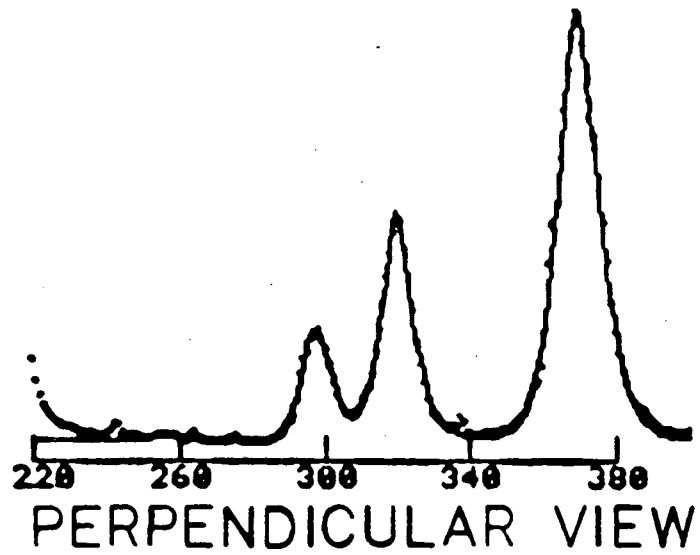
XBL 847-3117

Figure 28. Typical OMA data from a 30 second shot are shown.
