Water Temperature Suitability for Steelhead Trout (*Oncorhynchus mykiss*) in Codornices Creek

**Water Temperature Suitability for Steelhead Trout**  
**(*Oncorhynchus mykiss*) in Codornices Creek**  
**[Final Draft]**

Sasha Figel and Rene Gonzalez

LDARCH 227

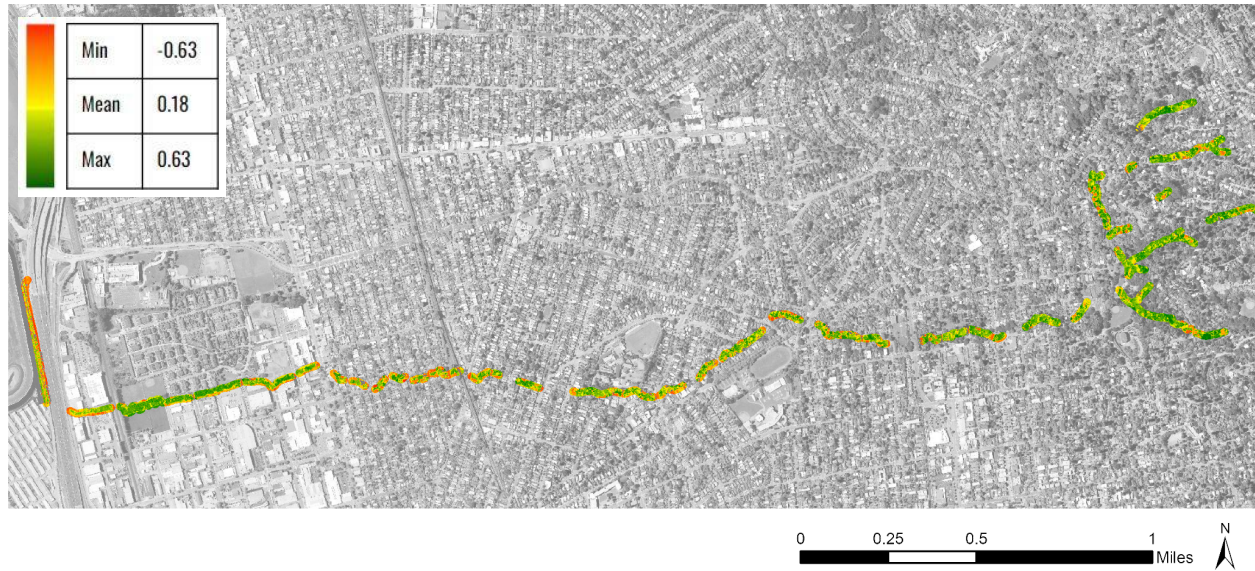
Figure 3: NDVI of daylight streams on Codornices Creek

We performed the spatial analysis by applying NDVI to the NAIP image within the 30-meter buffer around daylight portions of Codornices Creek (Figure 3). This index is used to quantify vegetation greenness and is useful in understanding vegetation density and assessing changes in plant health.<sup>5</sup> An NDVI map is made by calculating the difference between the infrared and red bands as a ratio. The result of this ratio generates a value between -1 and 1. Low values represent sparse and less healthy vegetation while high values represent lush and healthy vegetation (Figure 4). Specifically, values between 0.2 and 0.5 indicate moderately healthy and dense while anything over 0.5 is very healthy and dense.<sup>6</sup>

The spatial analysis using NDVI yielded results in-line with previous stream restoration efforts and the creek's geography. As a whole, the 30 meter buffer around Codornices Creek gave us a maximum of 0.63, a minimum of -0.63, and a mean of 0.18 indicating a moderately healthy and dense canopy (Figure 3). Maximum and minimum density vegetation values did not vary significantly between our four stream reaches (Stream 1 through Stream 4). What is notable is that the mean from Stream 1 (Figure 11), located downstream, reflects previous restoration efforts from 4th Street to 8th Street and the mean from Stream 2 and 3 reflect disturbance and constraints on canopy health and density from urbanization (Figure 12 and 13). The mean in Stream 4 (Figure 14), located upstream, increased to levels seen in the downstream reach. Woody vegetation health and density is greatest in lower and upper reaches of Codornices Creek.

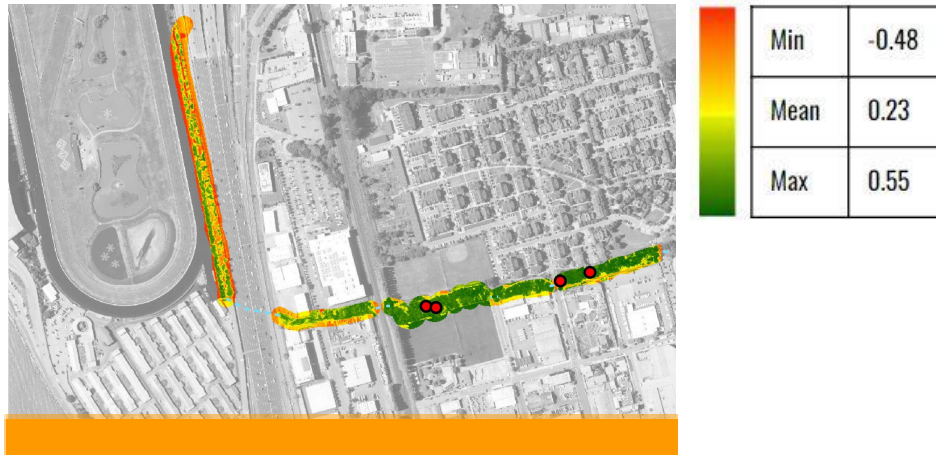
Figure 11: NDVI of stream section 1 (lower reach)

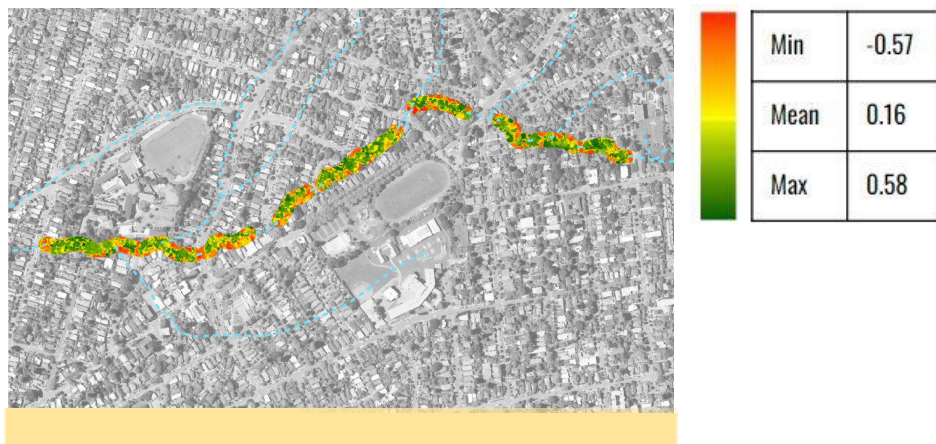
Figure 13: NDVI of stream section 3 (mid-top reach)
