Reflective Cracking Study: Summary Report

Partnered Pavement Research Program (PPRC) Contract Strategic Plan Element 4.10:  
Development of Improved Rehabilitation Designs for Reflective Cracking

California Department of Transportation  
Division of Research and Innovation  
Office of Roadway Research

University of California  
Pavement Research Center  
UC Davis, UC Berkeley

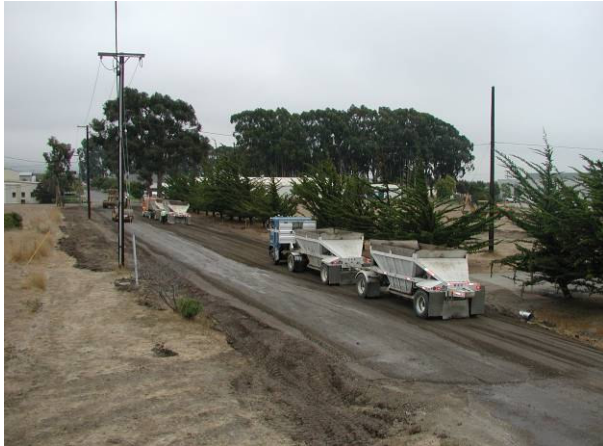
**Figure 3.1: Location of HVS test track at Richmond Field Station. (1)**

The test track for this study was located at the University of California, Berkeley, Richmond Field Station (Figures 3.1 and 3.2).

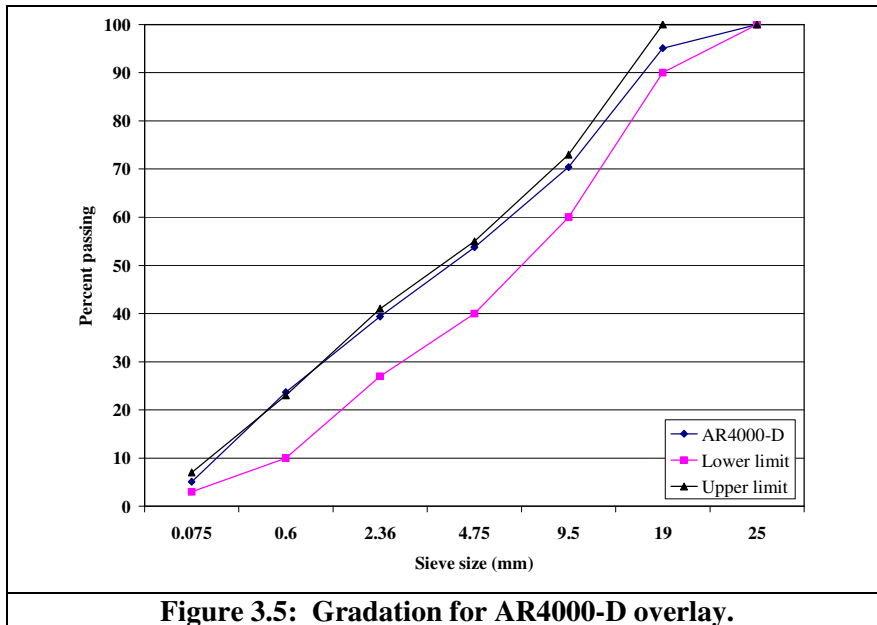
Figure 3.5: Gradation for AR4000-D overlay.

The aggregate gradations for the dense- and gap-graded mixes generally met Caltrans specifications for 19.0 mm (0.75 in.) maximum size coarse and gap gradations respectively. Gradations are illustrated in Figure 3.5 (AR4000-D) and Figure 3.6 (modified binders).

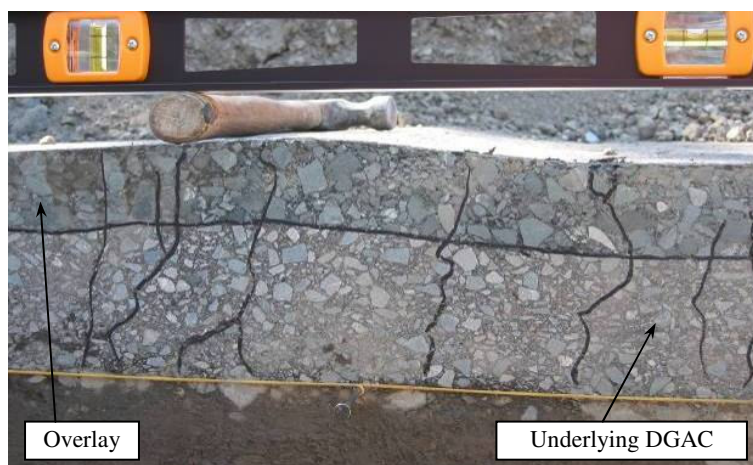
- Cracks were observed on some of the test pit profiles (Figure 4.10). In the underlying DGAC layer, cracks were generally clearly visible. However, in the modified binder overlays, heat generated from the saw cut operation appeared to seal any cracks and no conclusions could be drawn as to the depth that cracks had reflected into the overlays. Most cracks (that could be traced) appeared to have initiated close to the bottom of the underlying DGAC. Some crack initiation was also observed at poorly bonded joints between lifts and overlays in the AR4000-D section. No additional information was gathered from an assessment of cores. No cracking was observed in the base.

**Figure 4.10: Test pit profile showing highlighted cracks (RAC-G section).**

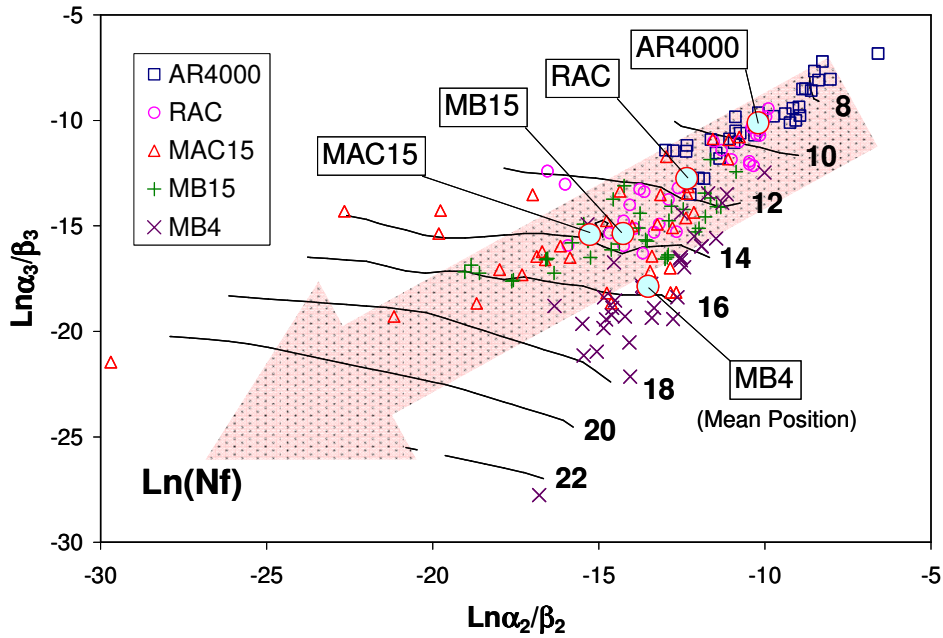
Figure 6.2: Identification of fatigue performance from  $\ln\alpha_3/\beta_3$  and  $\ln\alpha_2/\beta_2$  parameters.

One possible disadvantage of using  $\ln\alpha_3/\beta_3$  and  $\ln\alpha_2/\beta_2$  as the parameters to identify fatigue and shear performance is that independent testing variables such as temperature, stress/strain, and air-void content are embedded in the parameters, which can limit assessment of the influence of individual variables on material performance. The two parameters thus become functions of the independent testing variables, thereby potentially losing the connection between independent test variables and material performance.

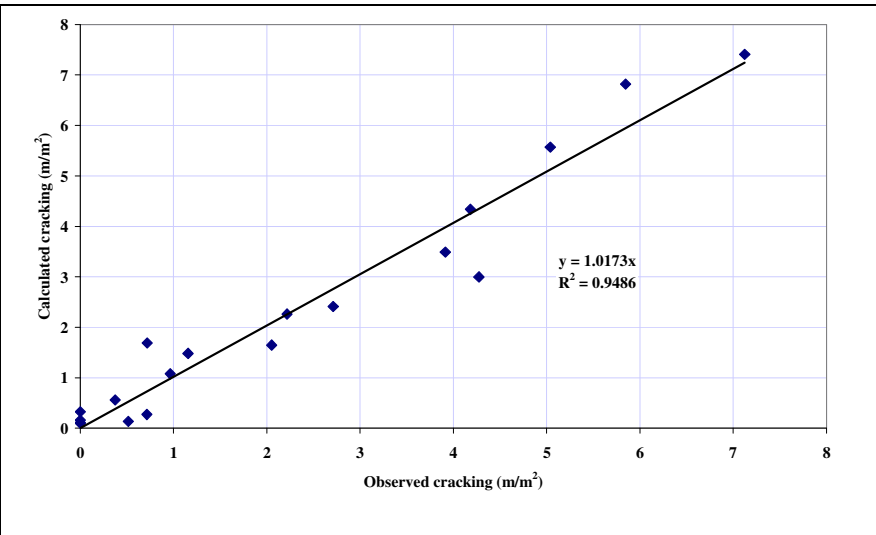
**Figure 6.6: Predicted vs observed reflective cracking, using modified parameters (Eqs. 6.1/6.2).**

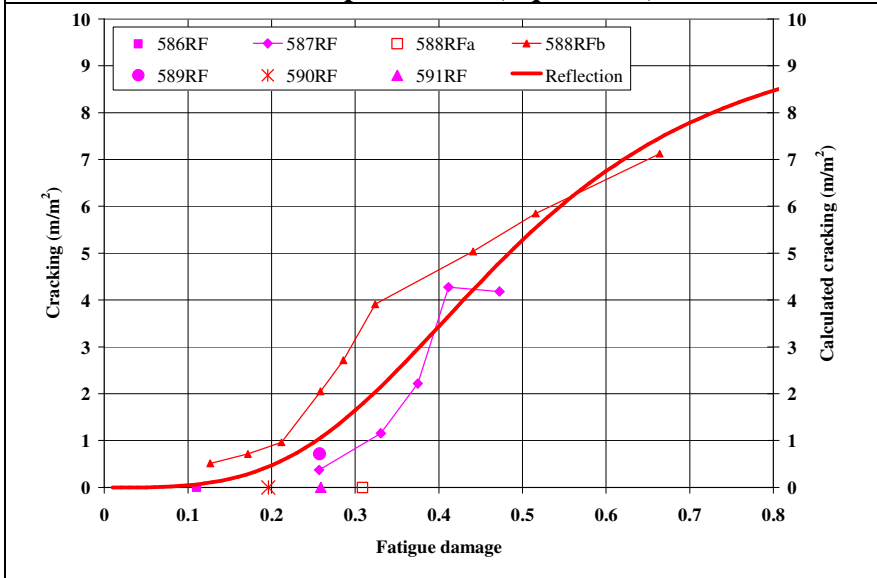
**Figure 6.7: Observed reflective cracking vs fatigue damage using modified parameters (Eqs. 6.3/6.4).**

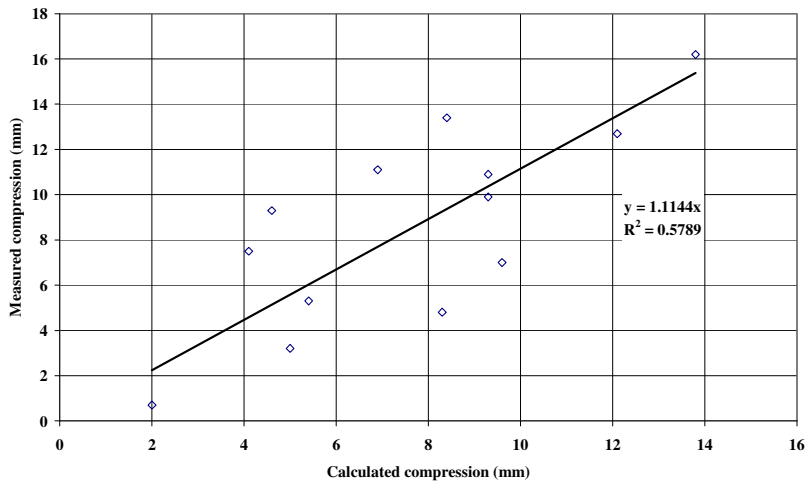
An approximate value for the permanent compression of the asphalt concrete layer(s) can be obtained by subtracting the permanent deformation of the top MDD module from the average down rut, although it should be recalled that the first value is from one to three test points and the latter is the average over the whole 6.0-m (19.7-ft) long test section (except where the section was split into two subsections). In addition the MDDs were not exactly at the asphalt concrete/base interface. The calculated permanent deformation of the individual asphalt concrete layers and the measured thickness of the layers are shown in Figure 6.11.

**Figure 6.11: Calculated final compression of AC from profile and MDD versus measured value.**

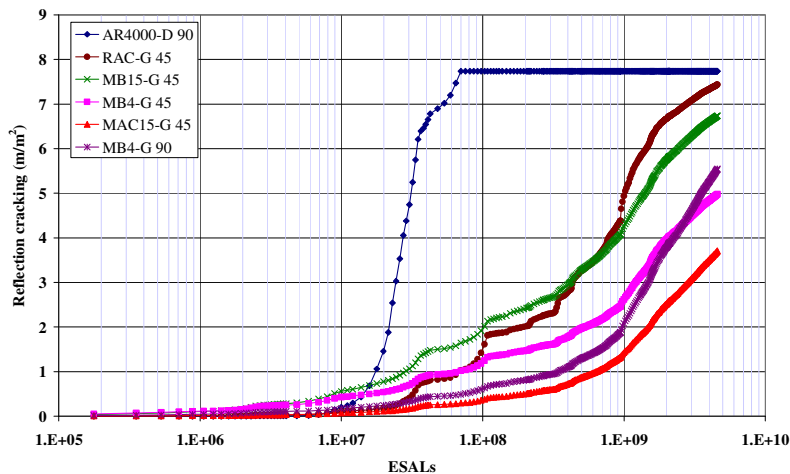
The simulated reflective cracking is shown as a function of the number of loads (in ESALs) in Figure 6.12. The ranking depends to some extent on the number of load applications. The ranking would not change significantly if it was based on the reflective cracking predicted from fatigue damage of the overlay.

**Figure 6.12: Simulated damage for identical testing conditions.**
