MONOGRAPH 62
COTSEN INSTITUTE OF ARCHAEOLOGY
UNIVERSITY OF CALIFORNIA, LOS ANGELES

EXCAVATIONS AT
CERRO AZUL, PERU
THE ARCHITECTURE AND POTTERY
JOYCE MARCUS

Excavations at Cerro Azul, Peru

THE ARCHITECTURE AND POTTERY

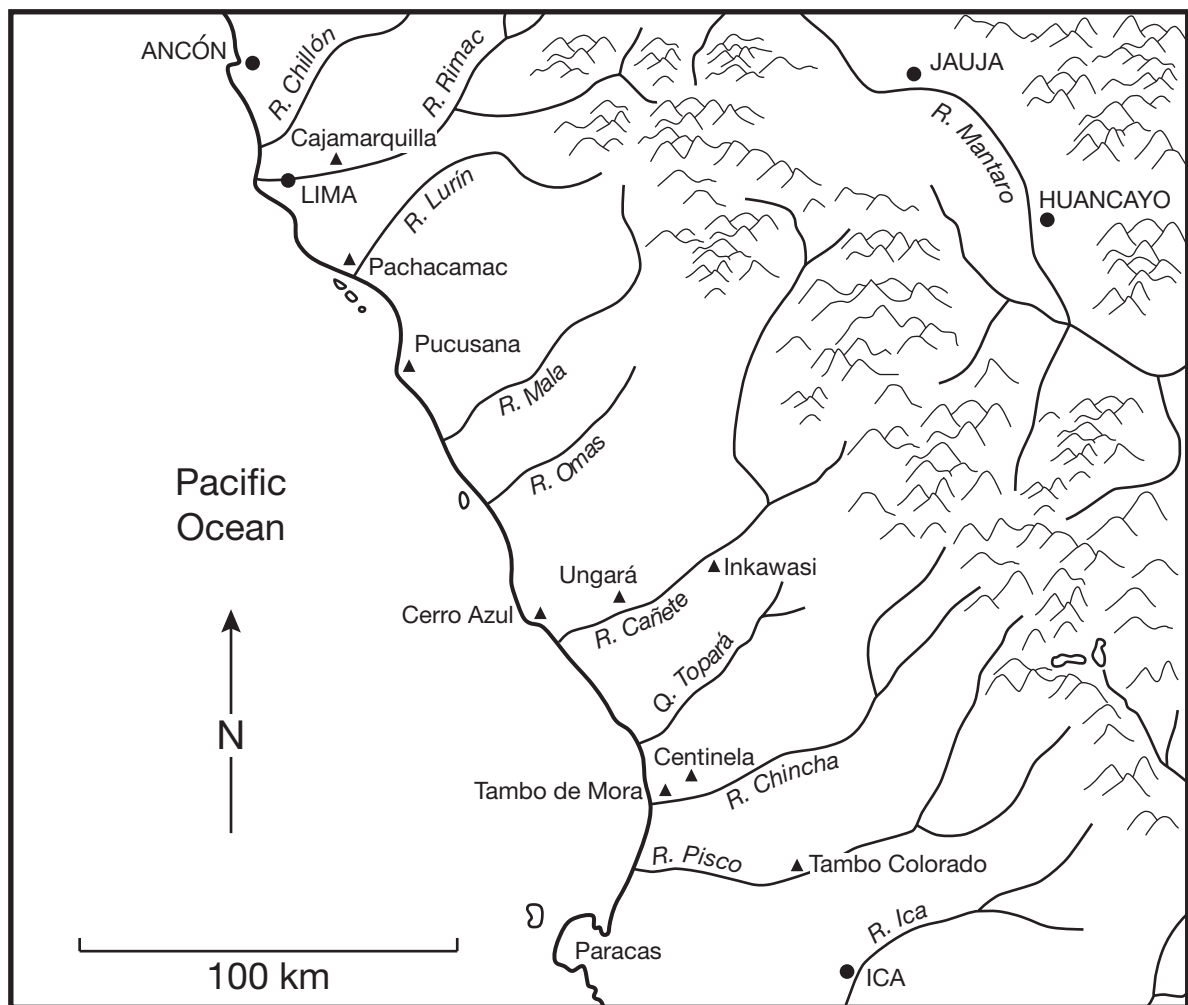
Figure 1.1. The south central coast of Peru, between Ancón and the Paracas Peninsula. The circles are cities; the triangles are archaeological sites. The valleys of the Ríos Cañete, Chíncha, and Pisco and the Quebrada Topará shared stylistic similarities during the Late Intermediate period.

Cerro Azul lies some 130 km south of Lima, at 13° 01' south latitude and 76° 29' west longitude, in the lower valley of the Río Cañete (Figure 1.1). Rostworowski's ethnohistoric research had showed that during the Late Intermediate period (A.D. 1100–1470) this region had been divided between two complementary *señoríos* or polities: the Kingdom of Huarco (Quechua, *Warku*) and the Kingdom of Lunahuaná (Quechua, *Runarwanak*) (Rostworowski 1978–1980). The Huarco polity controlled the *yunga* or coast proper, while the Lunahuaná polity controlled the *chaupi yunga* or piedmont.

When the Inka arrived in the Cañete region in A.D. 1470, they came down the quebrada of the Río Cañete and subdued Lunahuaná first. There they built a major Late Horizon center, Inkawasi (Figure 1.1; Cieza de León [1553] 1943, Ch. 73; Villar Córdova 1935:268–269; Villar Córdova 1982; Hyslop 1985). Cerro Azul valiantly refused to submit to the Inka, causing the imperial army to remain upstream for some time while it worked out a strategy for conquest. The stalemate was broken when the Inka ruler pretended that he had a desire for peace in the polity. To celebrate the “peace,” the people of Huarco got into their balsas and went out to hold a ceremony at sea. While

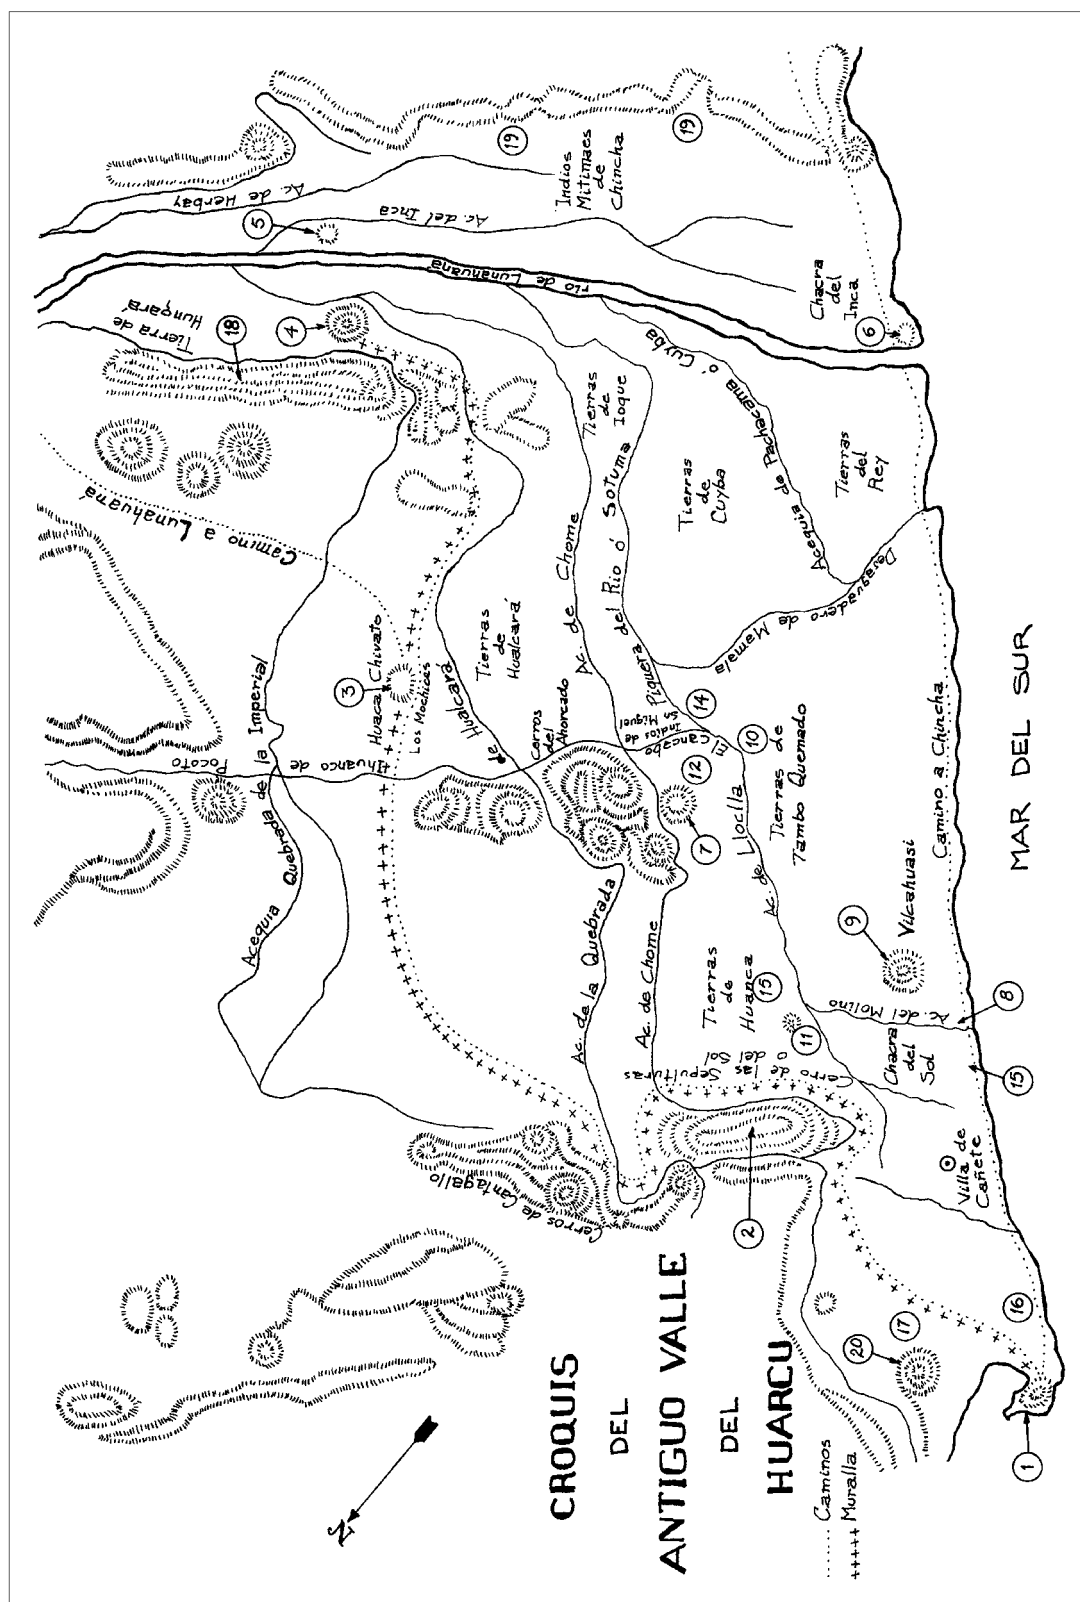
Figure 1.2. Larrabure y Unánue's sketch map of the Kingdom of Huarco, showing major irrigation canals, roads, and the great muralla or fortification wall. The author used numbered circles to indicate landmarks such as Cerro Azul (1), Cancharí (7), Los Huacones (9), the Fortress of Ungará (4), the Fortress of Huaca Chivato (3), and Cerro del Oro (2); not all landmarks are discussed in this chapter (redrawn from Larrabure y Unánue [1935:270] by K. Clahassey).

Acequia de la Quebrada de Hualcará is the name assigned by Larrabure y Unánue to the northernmost branch of the canal. However, according to documents in the Archivo General de Indias in Seville, the canal’s more ancient name was Chumbe (AGI Escribanía de Cámara 498B, fol. 792 and 797v [A.D. 1575]). In Colonial times, this same branch was renamed María Angola; it is said to have run for 24 km and featured 34 water takeoff points (ONERN 1970).

The more southerly Acequia de Chiome (or Chome), renamed San Miguel during Colonial times, ran for 35 km. This branch of the canal

While Cancharí and Ungará are extremely important ruins, the largest archaeological site within the great *muralla* of Huarco was Los Huacones, the locality Larrabure y Unánue called "Vilcahuasi" (marked "9" in Figure 1.2). Williams and Merino (1974) considered Los Huacones the most important architectural complex in the Cañete Valley and estimated its size as 80 hectares (Figure 1.6).

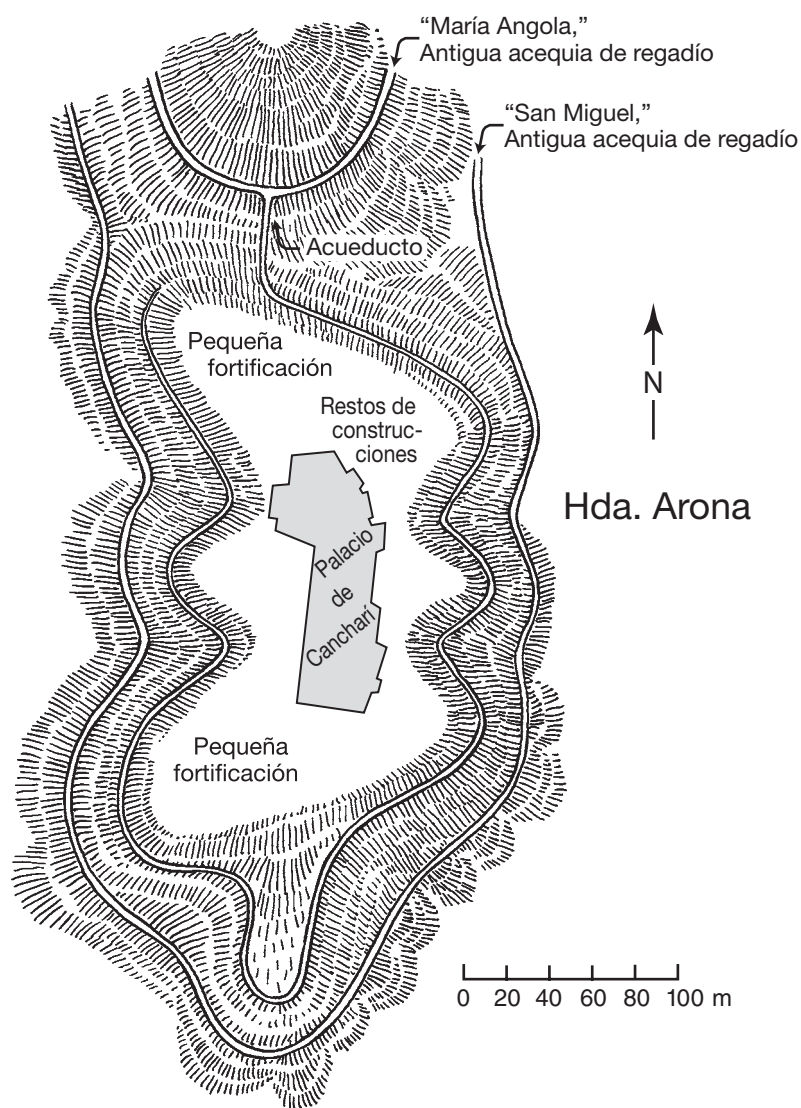
Figure 1.3. Sketch map of the ruins of Cancharí, featuring the palace of the ruler of Huarco. Note the way that two irrigation canals (María Angola and San Miguel) encircle the hill (redrawn from Harth-Terré [1933] by John Klausmeyer).

Figure 1.3 shows Harth-Terré’s sketch of the palace on its defensible hilltop; Figure 1.4 gives Harth-Terré’s plan and interpretation of the palace, based on walls that were visible during his visit to the site.

One of the most interesting features seen in Figure 1.3 is the extent to which the hilltop was supplied with water. On the lower slopes, the canal known as “San Miguel” looped around the entire hilltop before continuing on to the valley’s irrigated fields. Nearer to the summit, an aqueduct originating from the canal known as “María Angola” carried potable water to the palace complex (Larrabure y Unánue [1893] 1935:307). This aqueduct would have provided water to the ruler and his warriors even if Cancharí were under siege. Villar Córdova (1935:262) describes these canals as “true works of hydraulic engineering,” and Harth-Terré says that both canals served to protect the site because they were difficult to cross, analogous to the moats that protected feudal European castles.

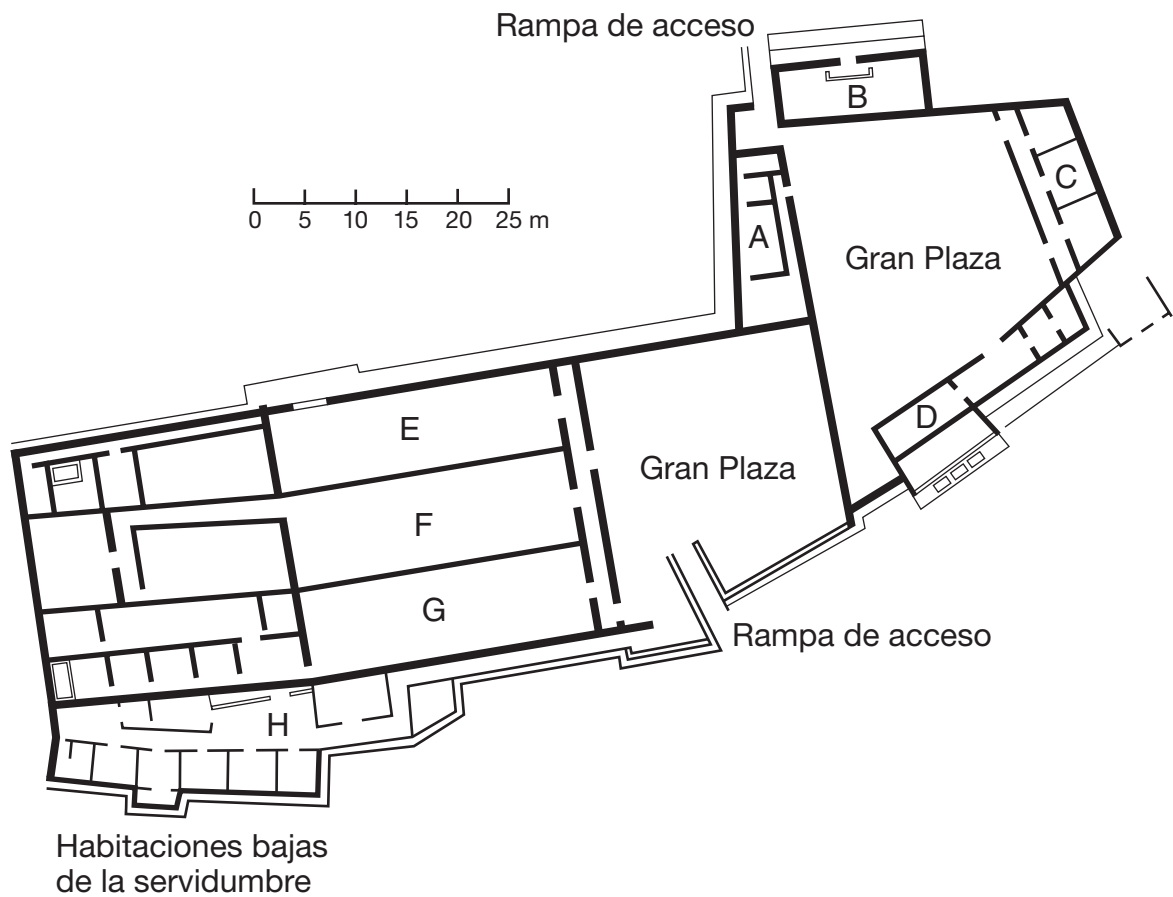
Figure 1.4. Plan of the palace of the ruler of Huarco atop the hill of Cancharí in the Cañete Valley (redrawn from Harth-Terré 1933). For orientation, see Figure 1.3.

As for the palace plan shown in Figure 1.4, one should bear in mind that we are dealing with Harth-Terré’s interpretation of an unexcavated building. His plan shows two access ramps. One leads to the trapezoidal plaza flanked by room complexes A–D, the other to a centrally located and more rectangular plaza. Beyond this plaza lies a complex of elongated rooms (E–G) and an area Harth-Terré interprets as “servants’ quarters.”

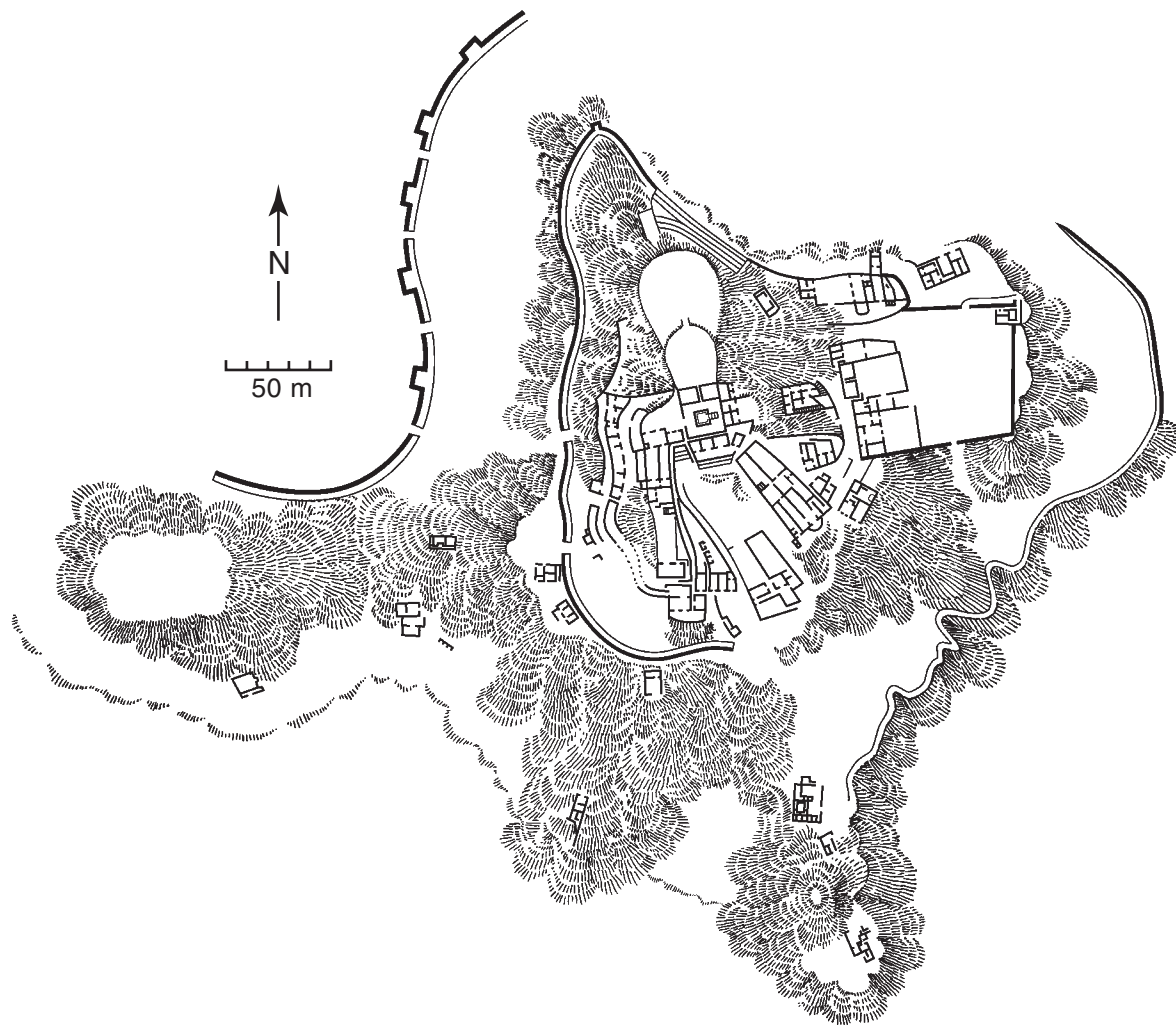
Figure 1.5. The Fortress of Ungará, which guarded the takeoff of the most important irrigation canals of the Kingdom of Huarco (redrawn from Harth-Terré 1933).

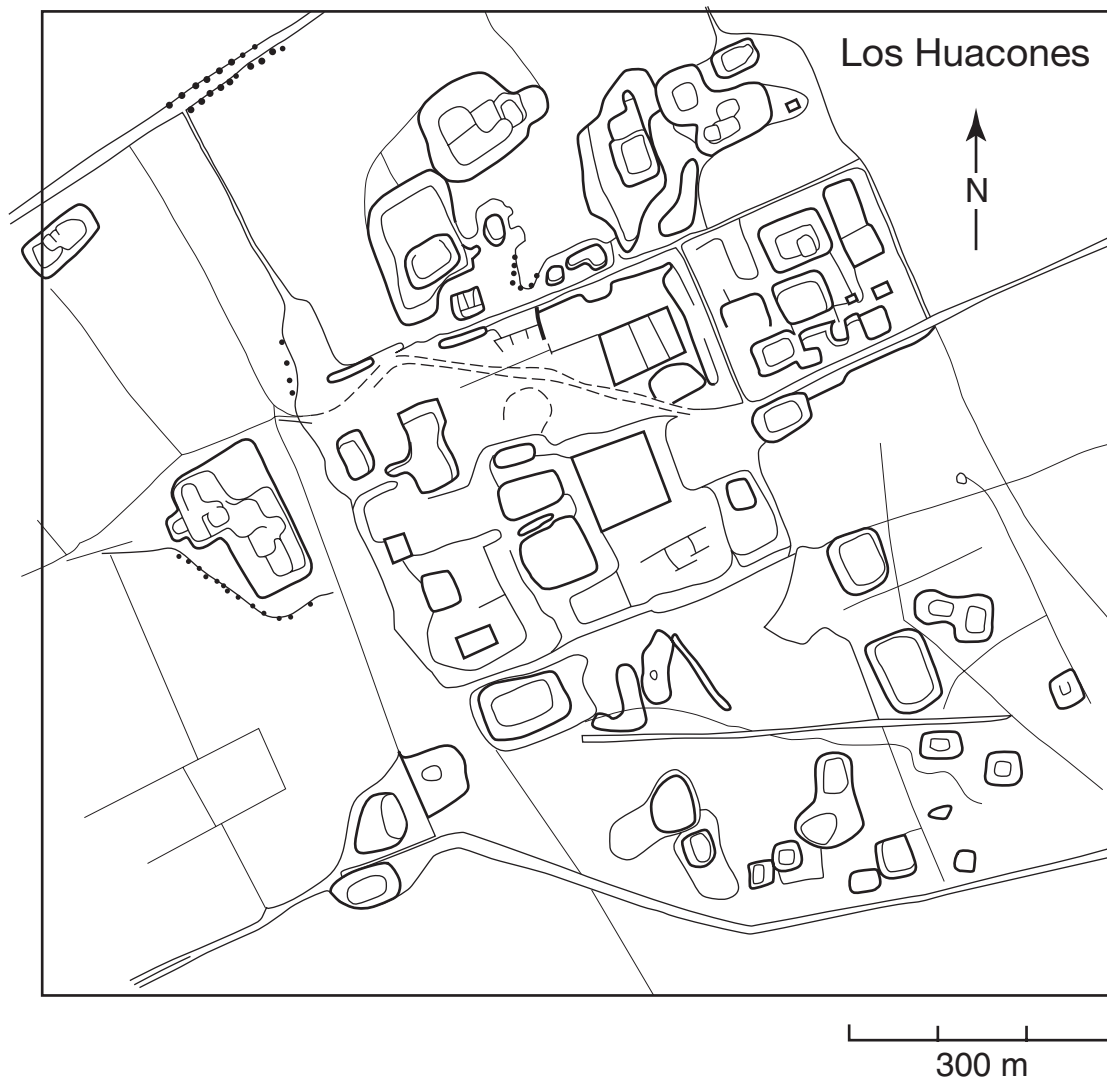
Figure 1.6. Sketch map of the site of Los Huacones in the Cañete Valley (redrawn from Williams and Merino 1974).

According to Williams and Merino, Los Huacones can be divided into 11 sectors, featuring more than two dozen pyramids. Near the site center is a set of pyramids that delimit several patios; close to this central complex are major structures. Farther from the center of the site are more dispersed and isolated pyramidal mounds.

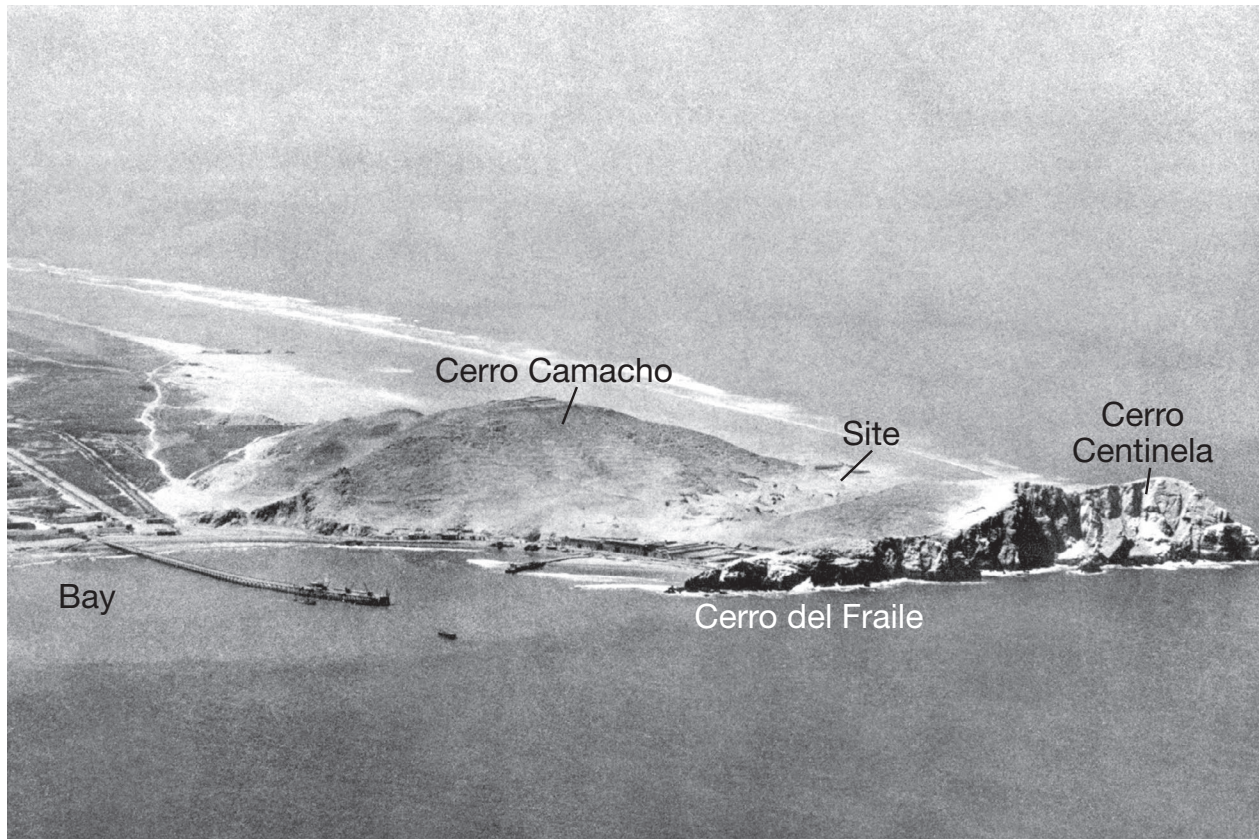
Figure 1.7. Cerro Azul seen from the north, showing the relationship of the bay, Cerro Camacho, Cerro del Fraile, Cerro Centinela, and the Late Intermediate archaeological site. Enhanced version of aerial photo from Johnson (1930:Fig. 103).

along the coastline. Cerro Azul was one of the sites he selected for aerial photography (Johnson 1930). I present labeled and computer-enhanced versions of three of his photographs in Figures 1.7–1.9.

Figure 1.7 shows how the Late Intermediate site at Cerro Azul lay in a protected saddle between Cerro Camacho (an inland mountain) and the twin sea cliffs of Cerro del Fraile and Cerro Centinela. Figure 1.8 shows the port of Cerro Azul as it looked during the 1920s, emphasizing the proximity of Late Intermediate Structure E to the bay. In the chapters that follow, I will examine Late Intermediate Cerro Azul in more detail.

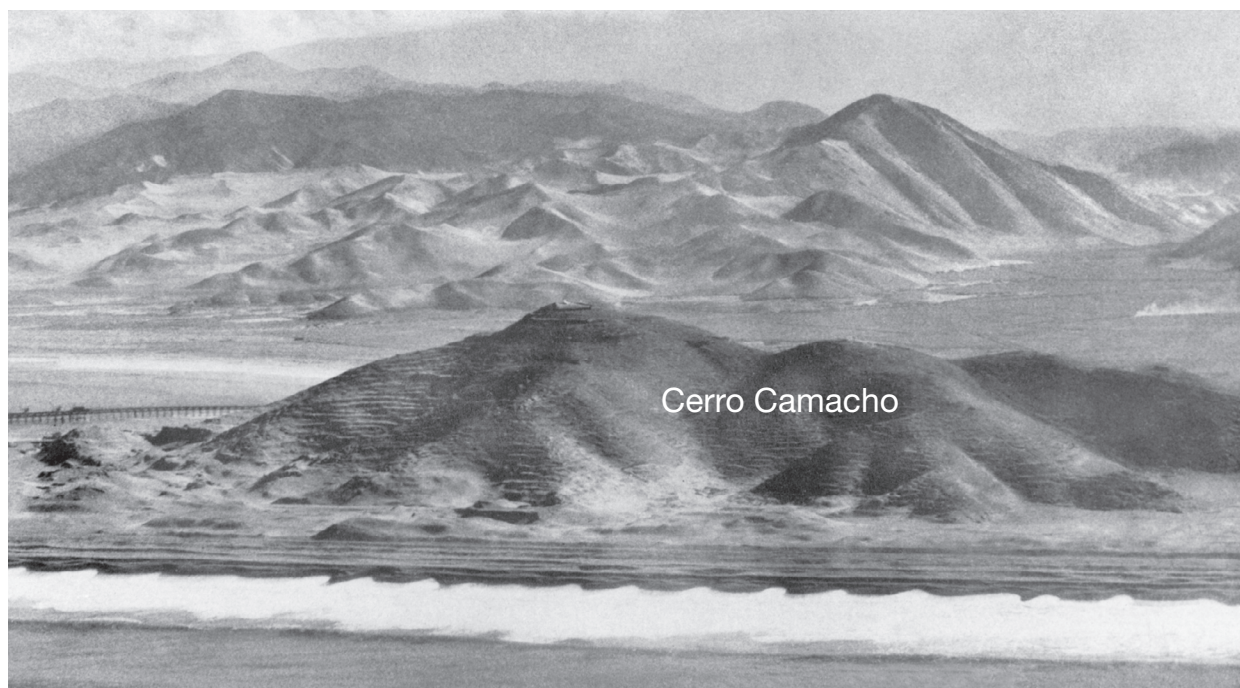
Figure 1.8. Photo of Cerro Camacho from the southwest, with Cerro Azul bay indicated by the pier on the left. The coastal ranges of the Andes can be seen in the background. Enhanced version of aerial photo from Johnson (1930:Fig. 104).

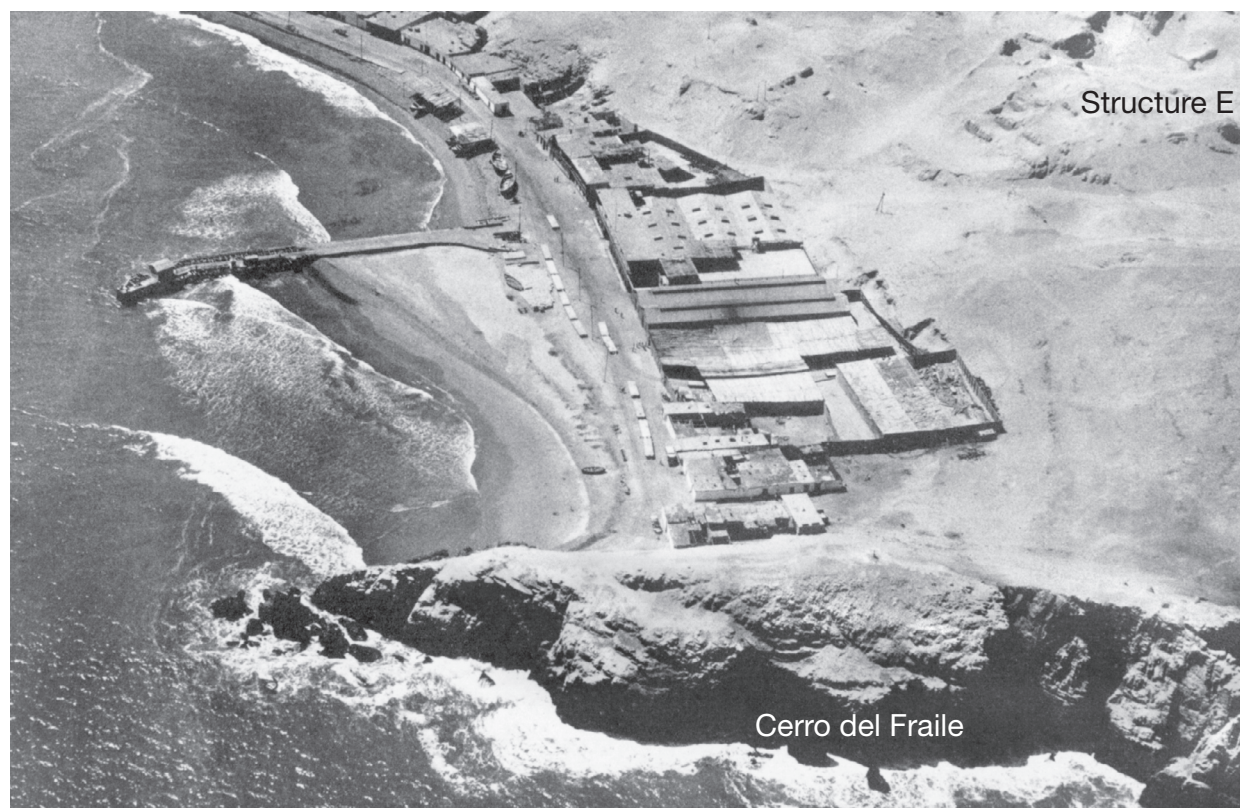
Figure 1.9. The community of Cerro Azul as it looked in the 1920s. Cerro del Fraile can be seen in the foreground, just west of the bay. Kroeber's Structure E appears in the upper right corner. Enhanced version of aerial photo from Johnson (1930:Fig. 105).

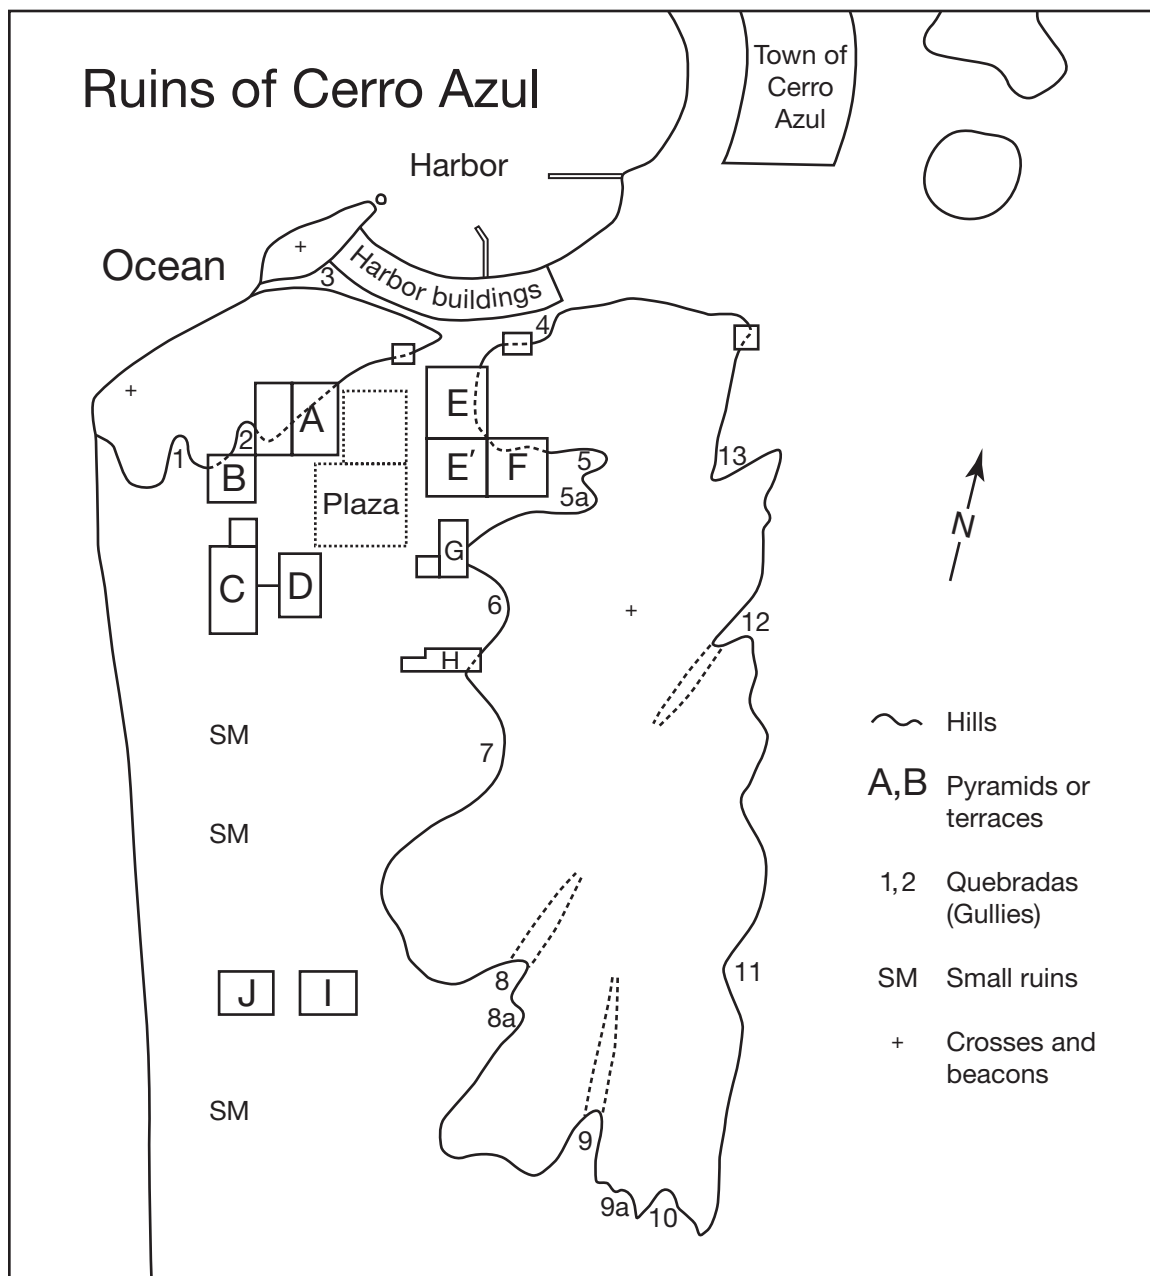
Figure 2.1. Kroeber's sketch map of Cerro Azul, showing major structures (A–J), “small ruins” (SM), and quebradas (1–13) (redrawn from Kroeber 1937:Pl. LXXXI).

From April to May of 1925, legendary anthropologist Alfred L. Kroeber excavated at Cerro Azul. His first task was to produce a sketch map (Kroeber 1937:Pl. LXXXI), our redrafted version of which is given in Figure 2.1. Kroeber assigned capital letters A through J to the ten large *tapia* compounds. Not having time to excavate any of them, he assumed that they were giant terraces built to support pyramids, and recorded them as such. He did not number the smaller *tapia* structures, but he called them “small ruins” and put some of them on his map with the symbol “SM.” Kroeber marked a naval beacon on Cerro Centinela and a cross atop Cerro del Fraile with plus signs (+).

Kroeber noted that his major buildings A, B, C, and D lay on high points to the west of an open area, while his E/E', F, G, and H lay to the east. On the assumption that these major buildings might be pyramids for temples, he considered the open area “a central level plaza” (Figure 2.1). Now that we have an actual contour map of the site (Figure 2.2), it seems more likely that the open area was simply a natural depression, unsuitable for the placement of buildings. In fact, given the amount of dust, sand, and disintegrated *tapia* that has partially filled the depression over time, it is even possible that during the Late Intermediate period it was a marshy depression, even a source of water. Marshy depressions or groundwater seeps can still be found to the northeast of Cerro Camacho.

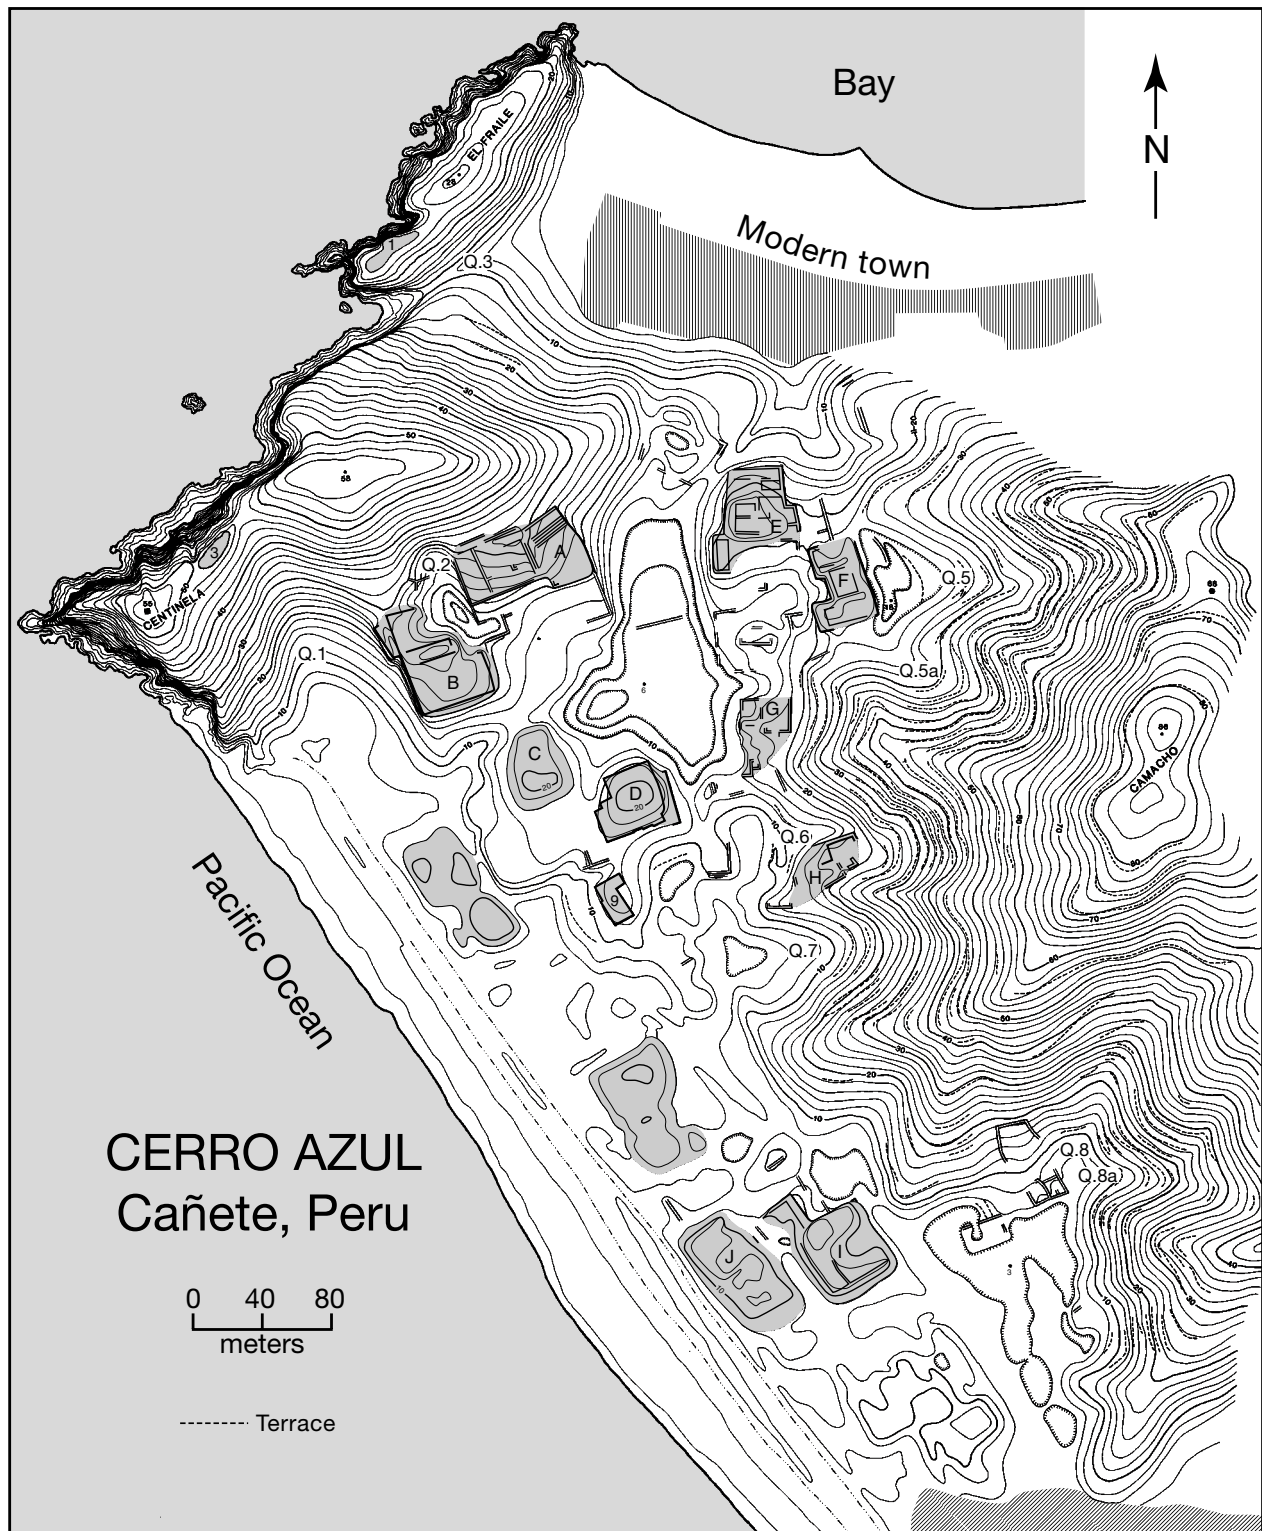
Figure 2.2. Contour map of the ruins of Cerro Azul, showing Structures A-J of Kroeber; Structures 1, 3, and 9 of the University of Michigan project; and Quebradas 5-8a of Cerro Camacho. Elevations in meters above sea level (cartography by Charles M. Hastings; drafted by Kay Clahassey).

One key to our work was to have an accurate contour map of the site. The map shown in Figure 2.2 was produced by Charles M. Hastings using an alidade, two workmen with ranging poles graduated in centimeters, and stereo pairs of overhead aerial photographs. Hastings mapped all major visible walls and quebrada terraces. We retained Kroeber’s number designations for Quebradas 1–8a, and numbered the terraces within each quebrada from the top down. We preserved Kroeber’s capital letters for the ten major *tapia* compounds, and decided that any of his “small ruins” we chose to excavate would be given numbers. Eventually this numbering system was extended to the small rooms and stone masonry cists we excavated in the quebradas as well.

modest tapia-walled building just to the south of Structure D. This building, designated Structure 9 (Figure 2.2), turned out to be a fish storage facility (see Chapter 8). We suspect that the two small ruins in Figure 2.8 will turn out to look very different if and when they are excavated.

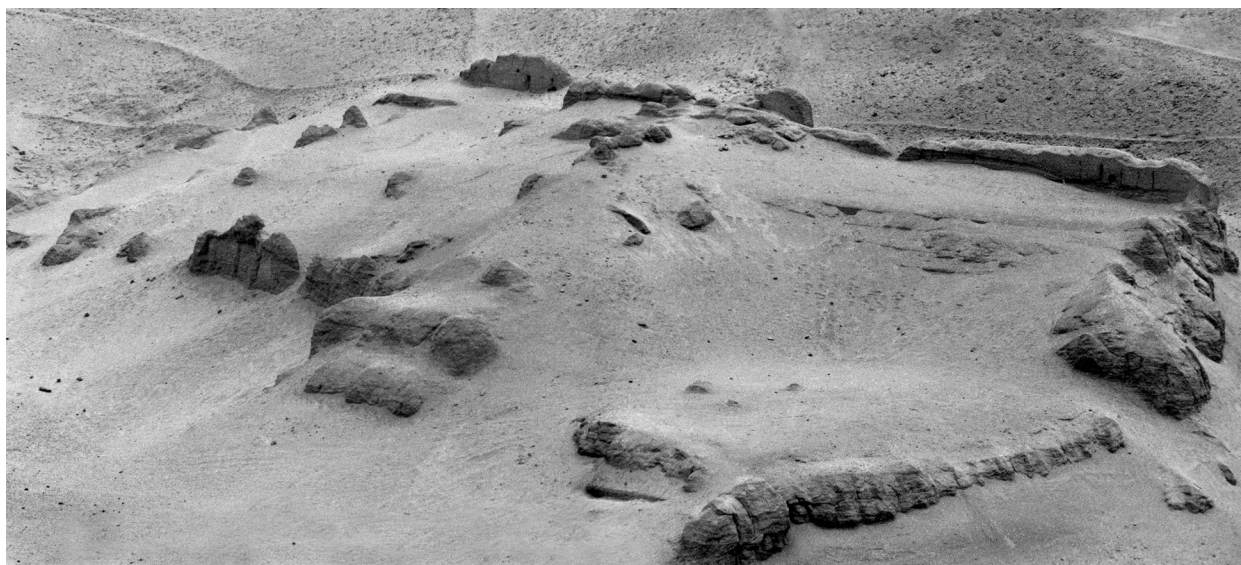
Figure 2.3. Structure A, arguably the most impressive of all the elite residential compounds at Cerro Azul, seen from the southeast.

Structure A (Figure 2.3) appeared to be the largest of the *tapia* compounds and occupied the highest promontory. It seemed to consist not only of room complexes but of the large walled spaces

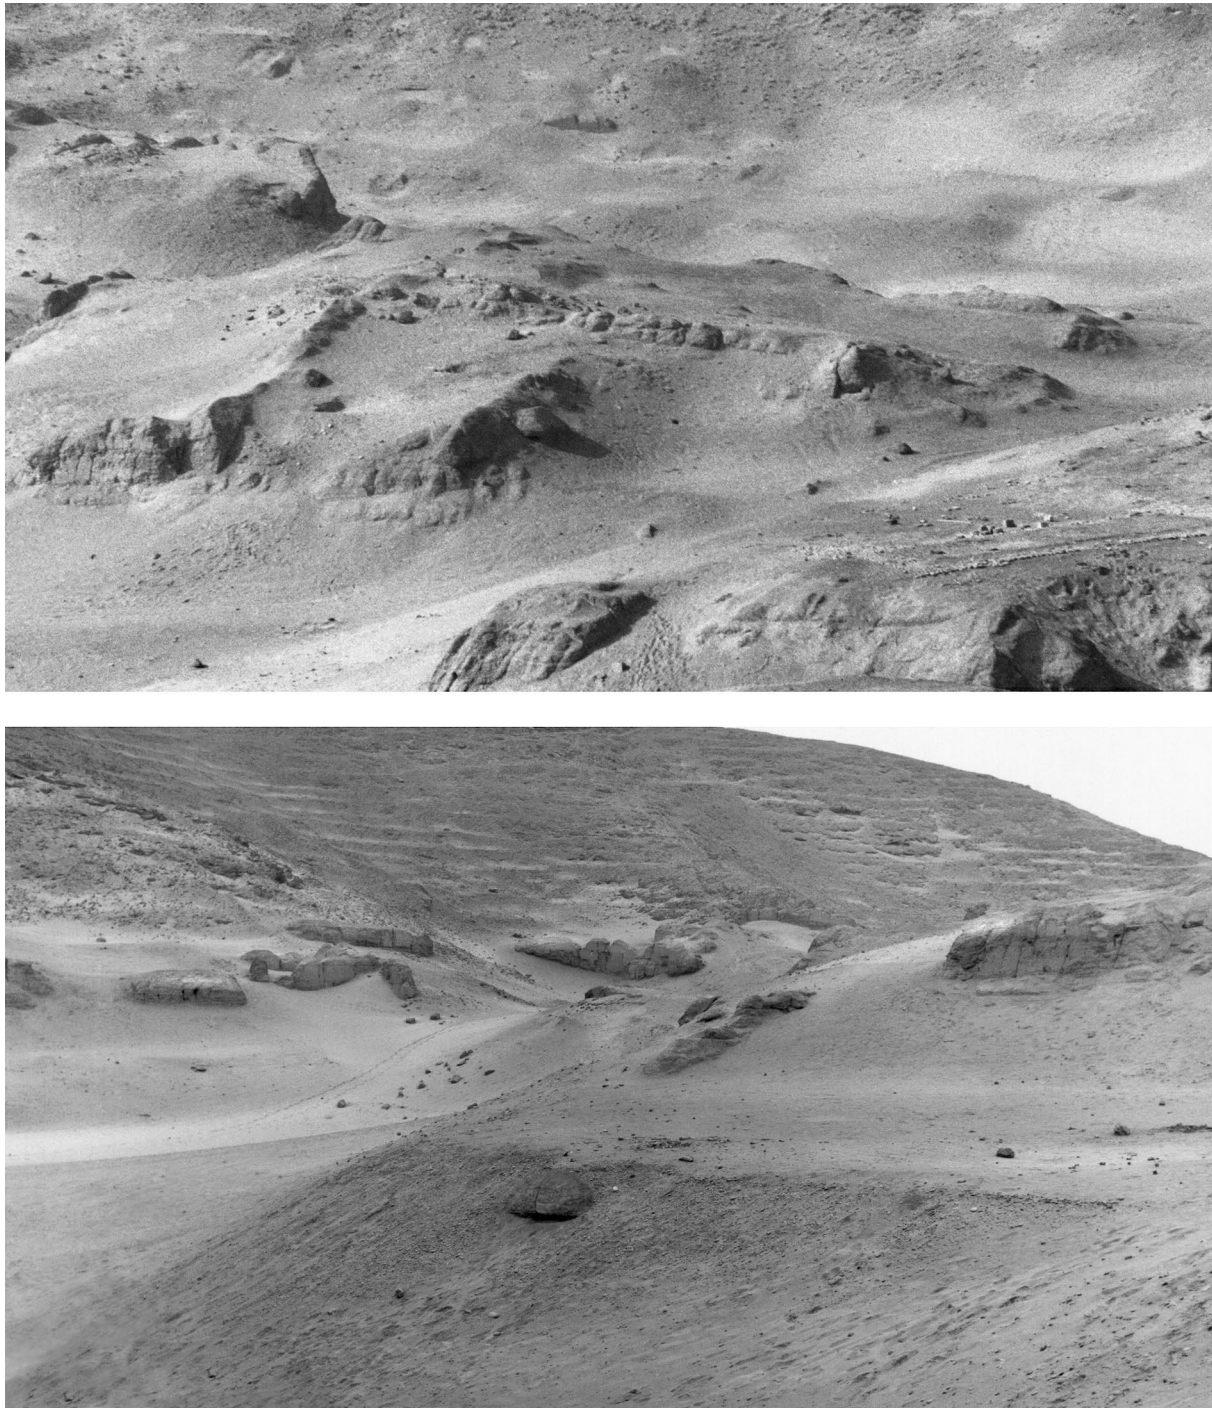
Figure 2.4. Two views of Structure D at Cerro Azul. (*Top*): A telephoto shot of Structure D, looking east from the Cerro Azul lighthouse. (*Bottom*): The north flank of Structure D, showing an artificially created, flat work area outside the walls of the elite compound.

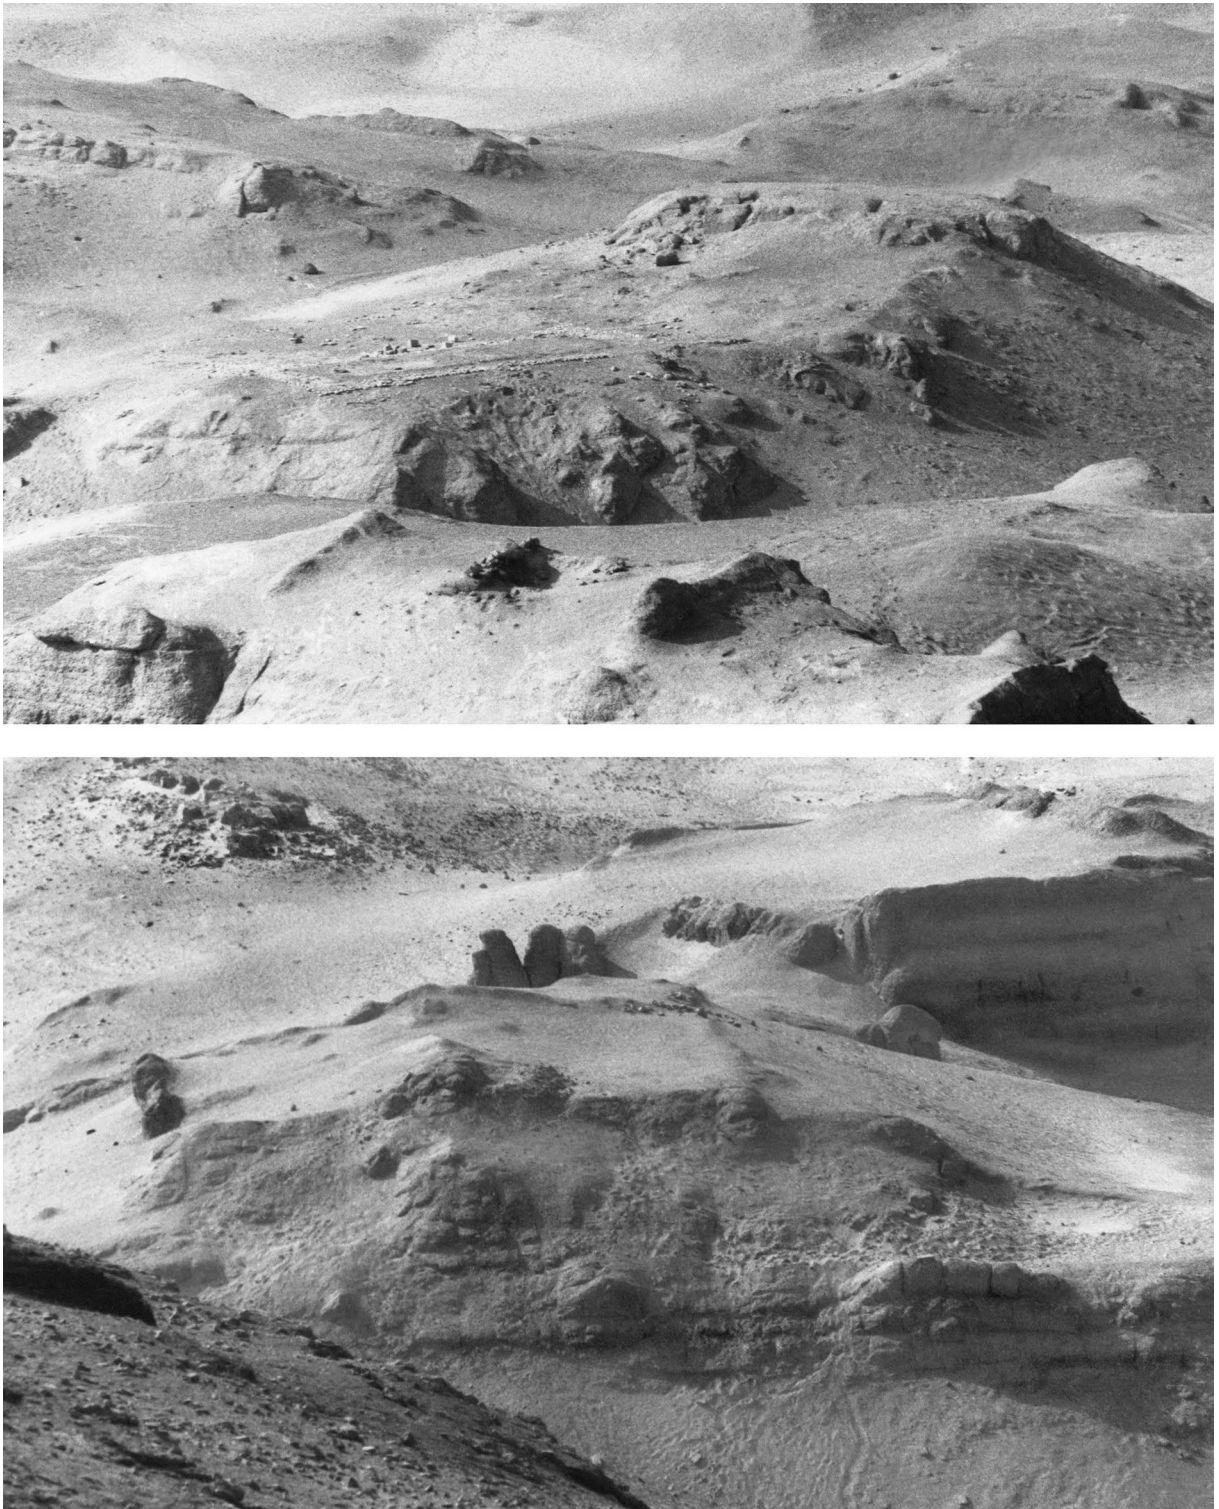
Figure 2.5. Two elite compounds at Cerro Azul, looking east from the lighthouse. (*Top*): Structure C (note traces of a recent building on the flat area at center). (*Bottom*): Structure E with its massive tapia buttresses.

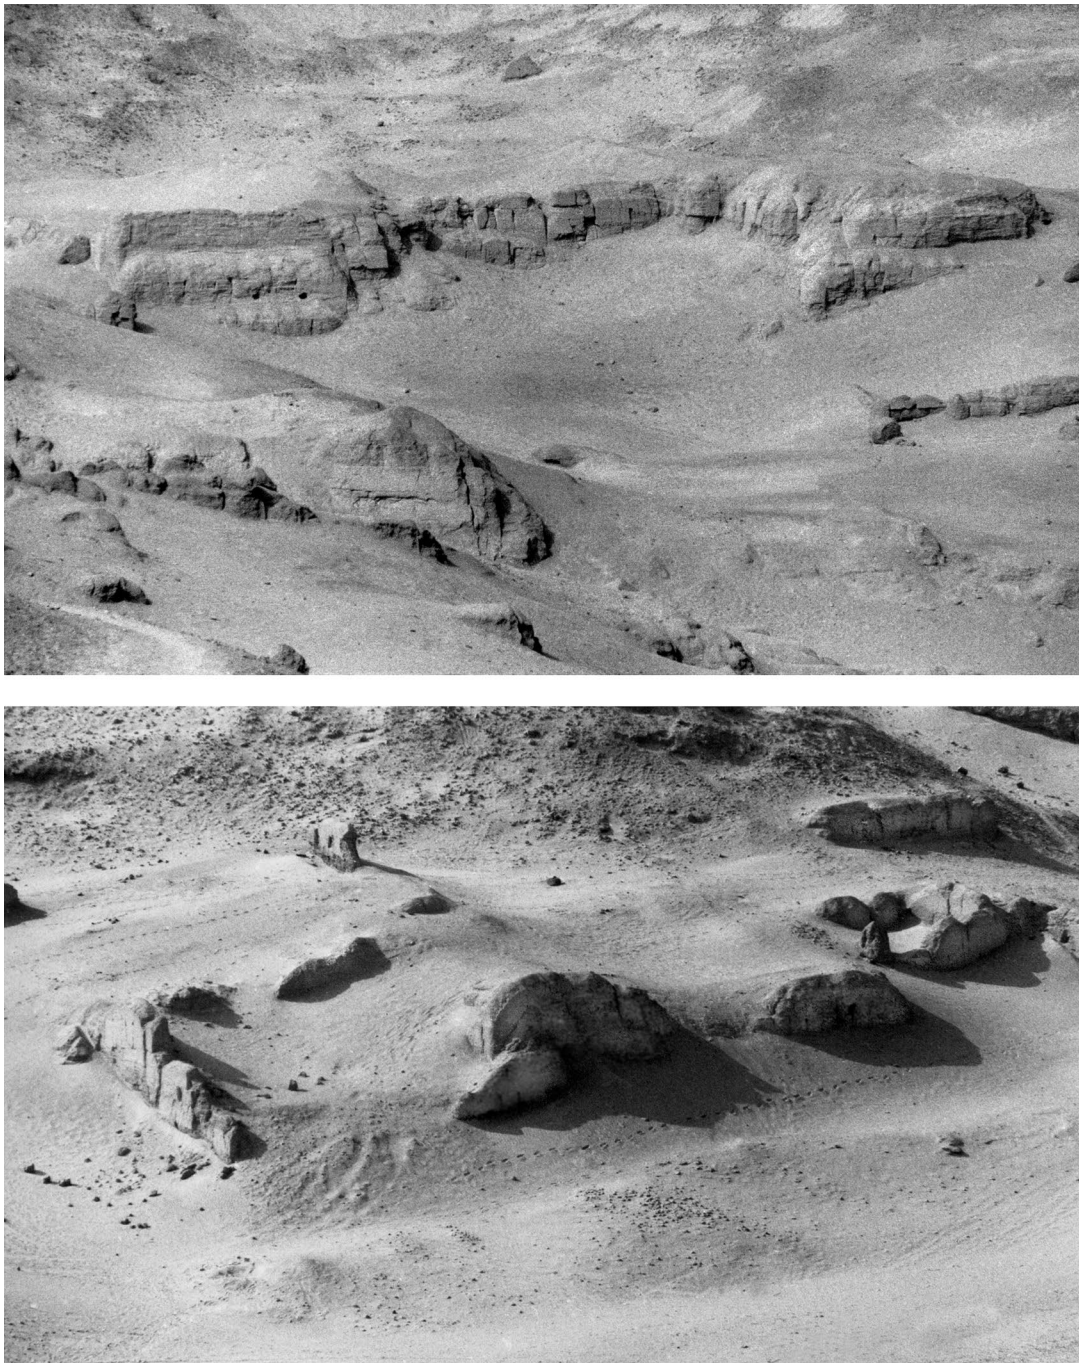
Figure 2.6. Two elite compounds at Cerro Azul, looking east from the lighthouse. (*Top*): Structure F, with Quebrada 5 in the background. (*Bottom*): Structure G.

No two compounds had the same layout. Structure F gave the impression of having the greatest degree of bilateral symmetry (Figure 2.6, top). We knew, of course, that our impression could change once the overburden of disintegrated tapia and sand had been removed.

Structure G (Figure 2.6, bottom) was a medium-sized compound built on a rocky spur be-
