MONOGRAPH 62
COTSEN INSTITUTE OF ARCHAEOLOGY
UNIVERSITY OF CALIFORNIA, LOS ANGELES

EXCAVATIONS AT
CERRO AZUL, PERU
THE ARCHITECTURE AND POTTERY
JOYCE MARCUS

Excavations at Cerro Azul, Peru

THE ARCHITECTURE AND POTTERY

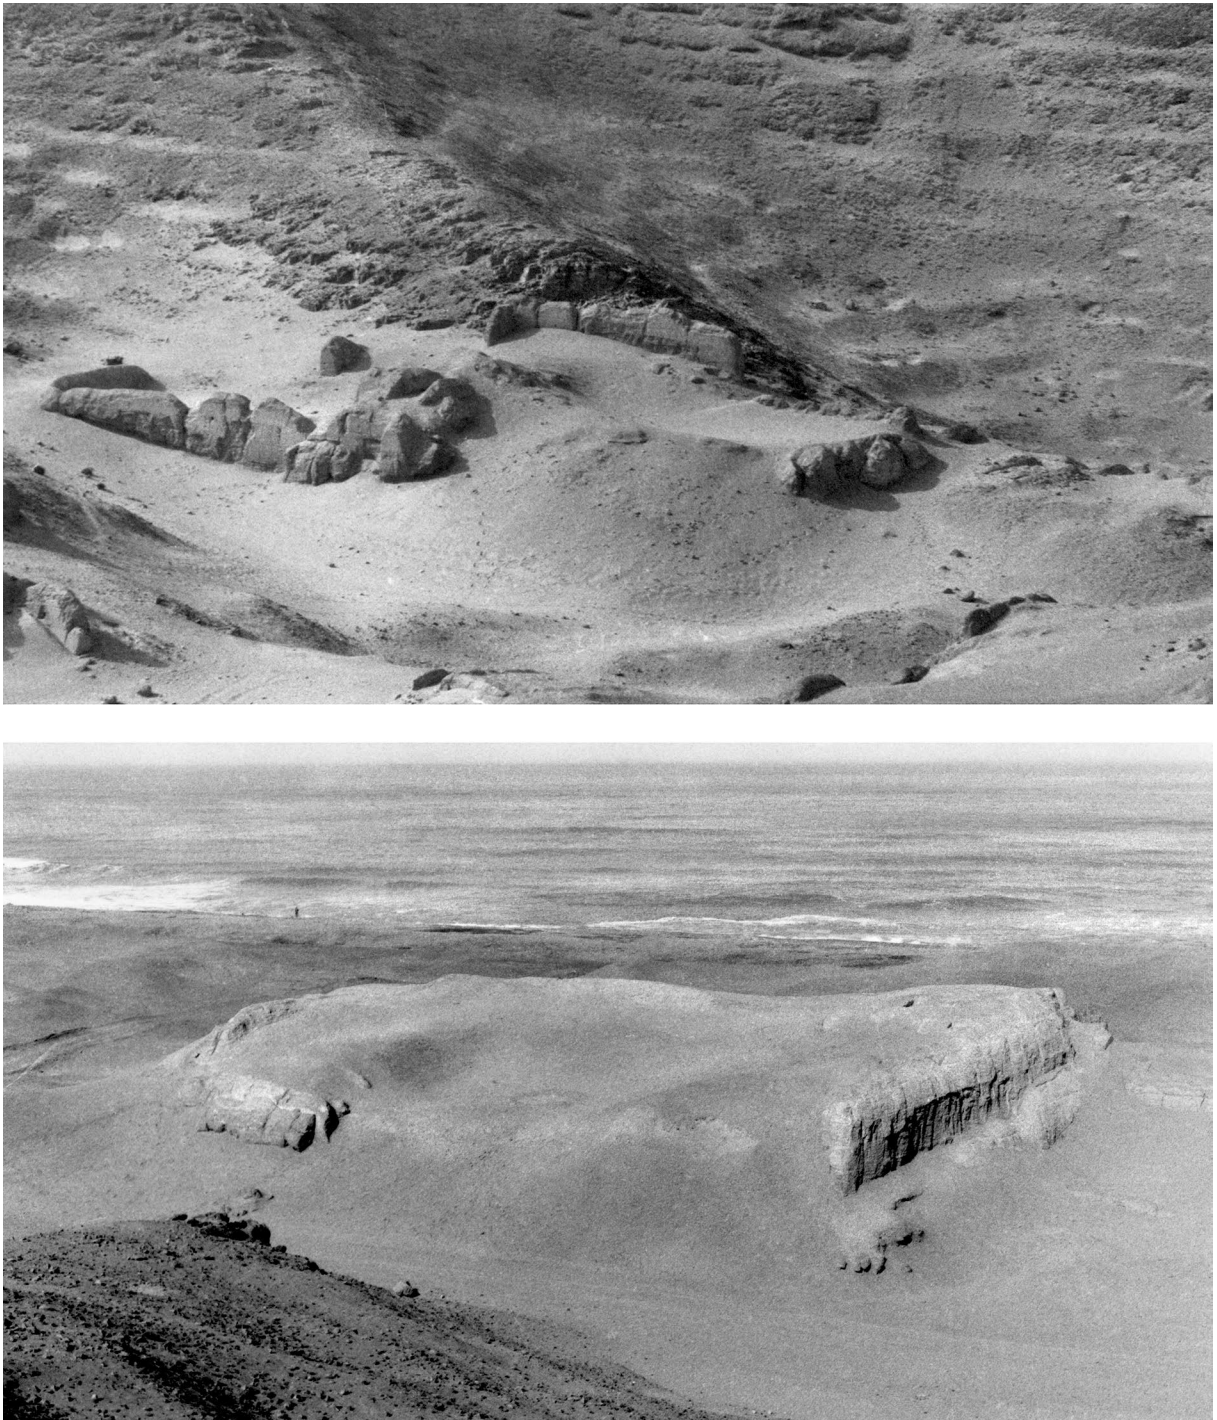
Figure 2.7. Two elite compounds at Cerro Azul. (*Top*): A telephoto shot of Structure H, looking east from the lighthouse. This compound rests against the rocky ridge which separates Quebrada 6 (*at left*) from Quebrada 7 (*at right*). (*Bottom*): Structure I, looking west from a spur of Cerro Camacho.

tween Quebradas 5a and 6 of Cerro Camacho. Structure H (Figure 2.7, top) occupied a similar setting on a rocky spur between Quebradas 6 and 7. The locations of Structures G and H made it clear that the builders had sought exposed bedrock for the heavy tapia foundations of the compounds.

Finally we come to Structures I and J, the closest to the ocean. As can be seen in the bottom photo of Figure 2.7, these structures had been subjected to the destructive effects of *garúa* (salt fog), and few of their walls were visible.

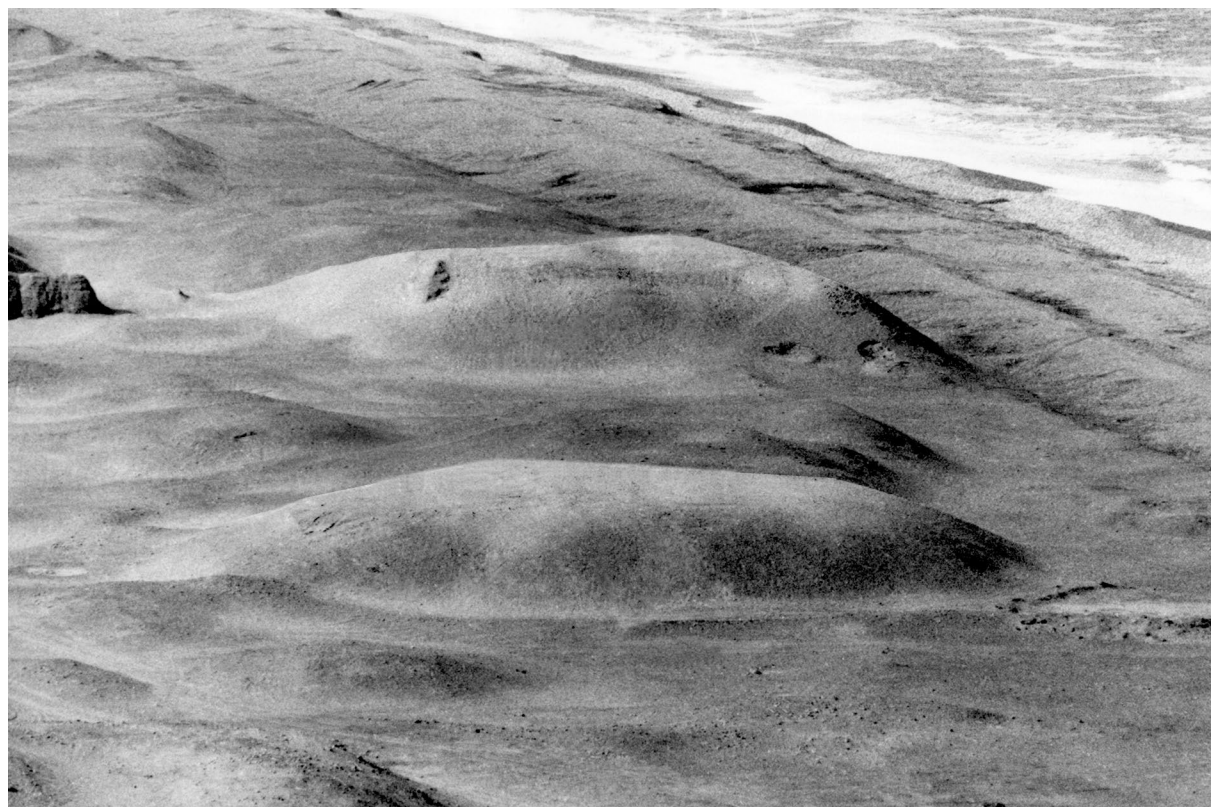
Figure 2.8. Two of Kroeber’s “small ruins,” located between Structure C and the ocean.

Figure 2.8 shows two of the mounds Kroeber referred to as “small ruins.” While areas of tapia wall were exposed in places on these two buildings, many of the small ruins close to the ocean showed evidence of having been built largely of rounded beach cobbles. Trying to excavate such buildings can be an archaeologist’s worst nightmare, especially if they have been exposed to wave action over the centuries.

modest tapia-walled building just to the south of Structure D. This building, designated Structure 9 (Figure 2.2), turned out to be a fish storage facility (see Chapter 8). We suspect that the two small ruins in Figure 2.8 will turn out to look very different if and when they are excavated.

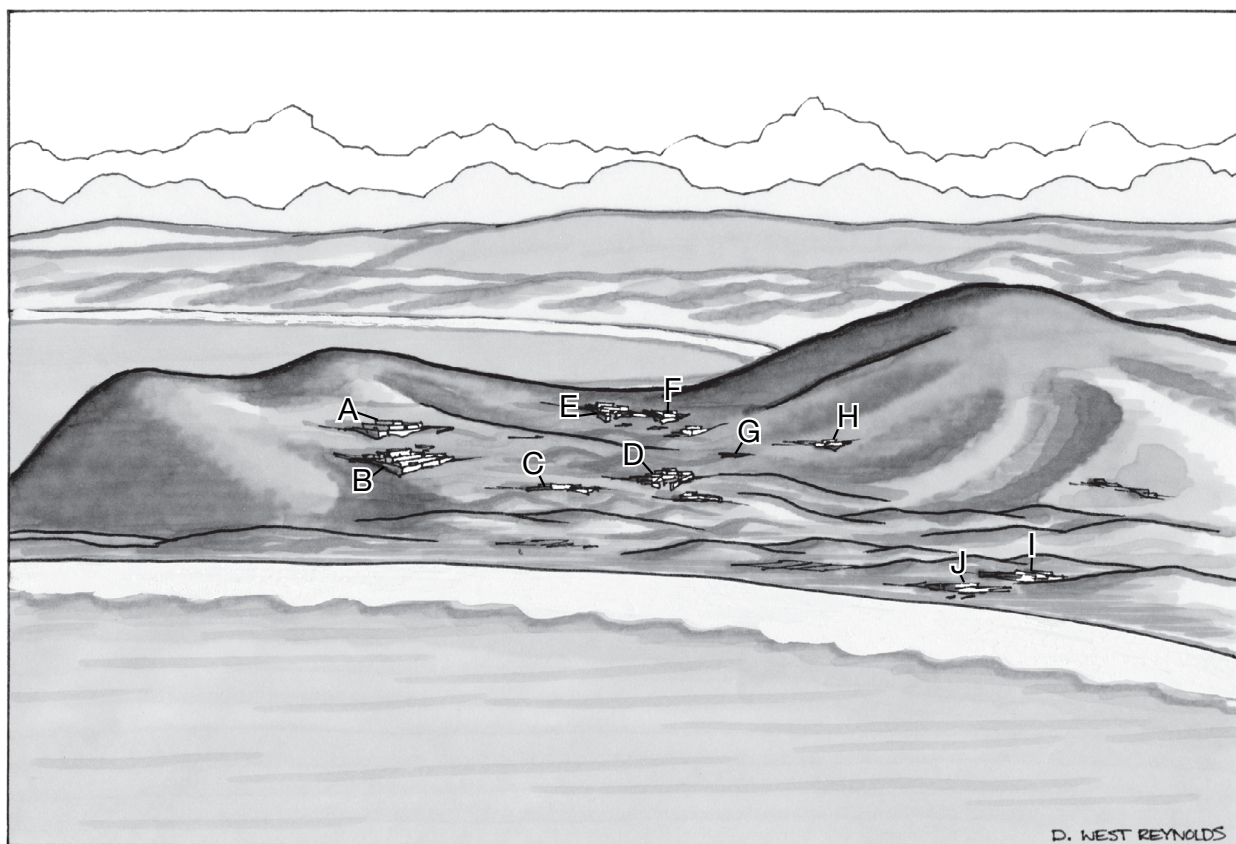
Figure 2.9. Artist's conception of Cerro Azul as it might have looked from the sea during the Late Intermediate period.

Figure 2.9 is an artist's conception of Cerro Azul as it might have looked from the sea during the Late Intermediate period. All ten of the major tapia compounds are indicated.

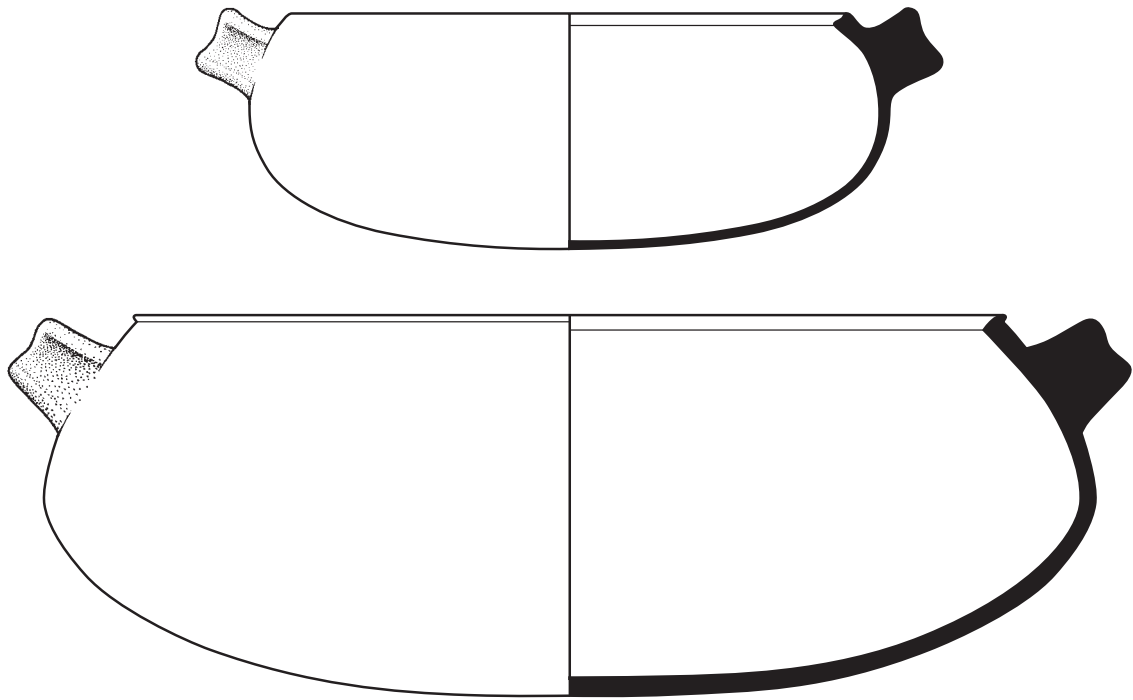
Figure 3.1. One of the most common vessel shapes in Camacho Reddish Brown was a cooking pot with a slightly restricted orifice and two horizontally set strap handles. Many of these pots were fire-blackened on the exterior.

A few of the most common vessel shapes are shown in Figures 3.1–3.11, and many more examples are illustrated later in the volume. Among the most common shapes is a *cooking pot with a slightly restricted orifice and two strap handles* which would have allowed it to be lifted on and off the fire (Figure 3.1).

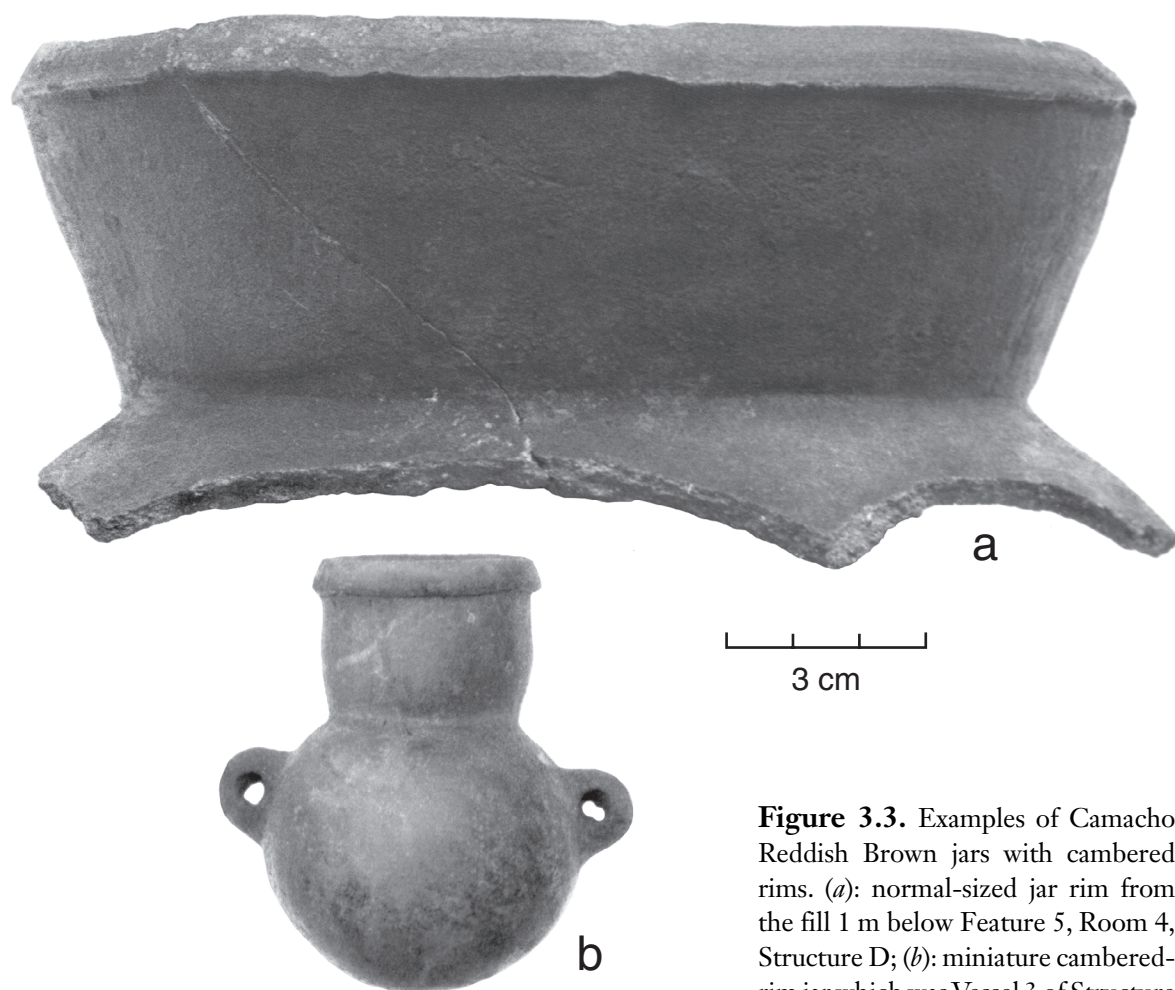
Figure 3.3. Examples of Camacho Reddish Brown jars with cambered rims. (a): normal-sized jar rim from the fill 1 m below Feature 5, Room 4, Structure D; (b): miniature cambered-rim jar which was Vessel 3 of Structure 5, a burial cist in Quebrada 5a.

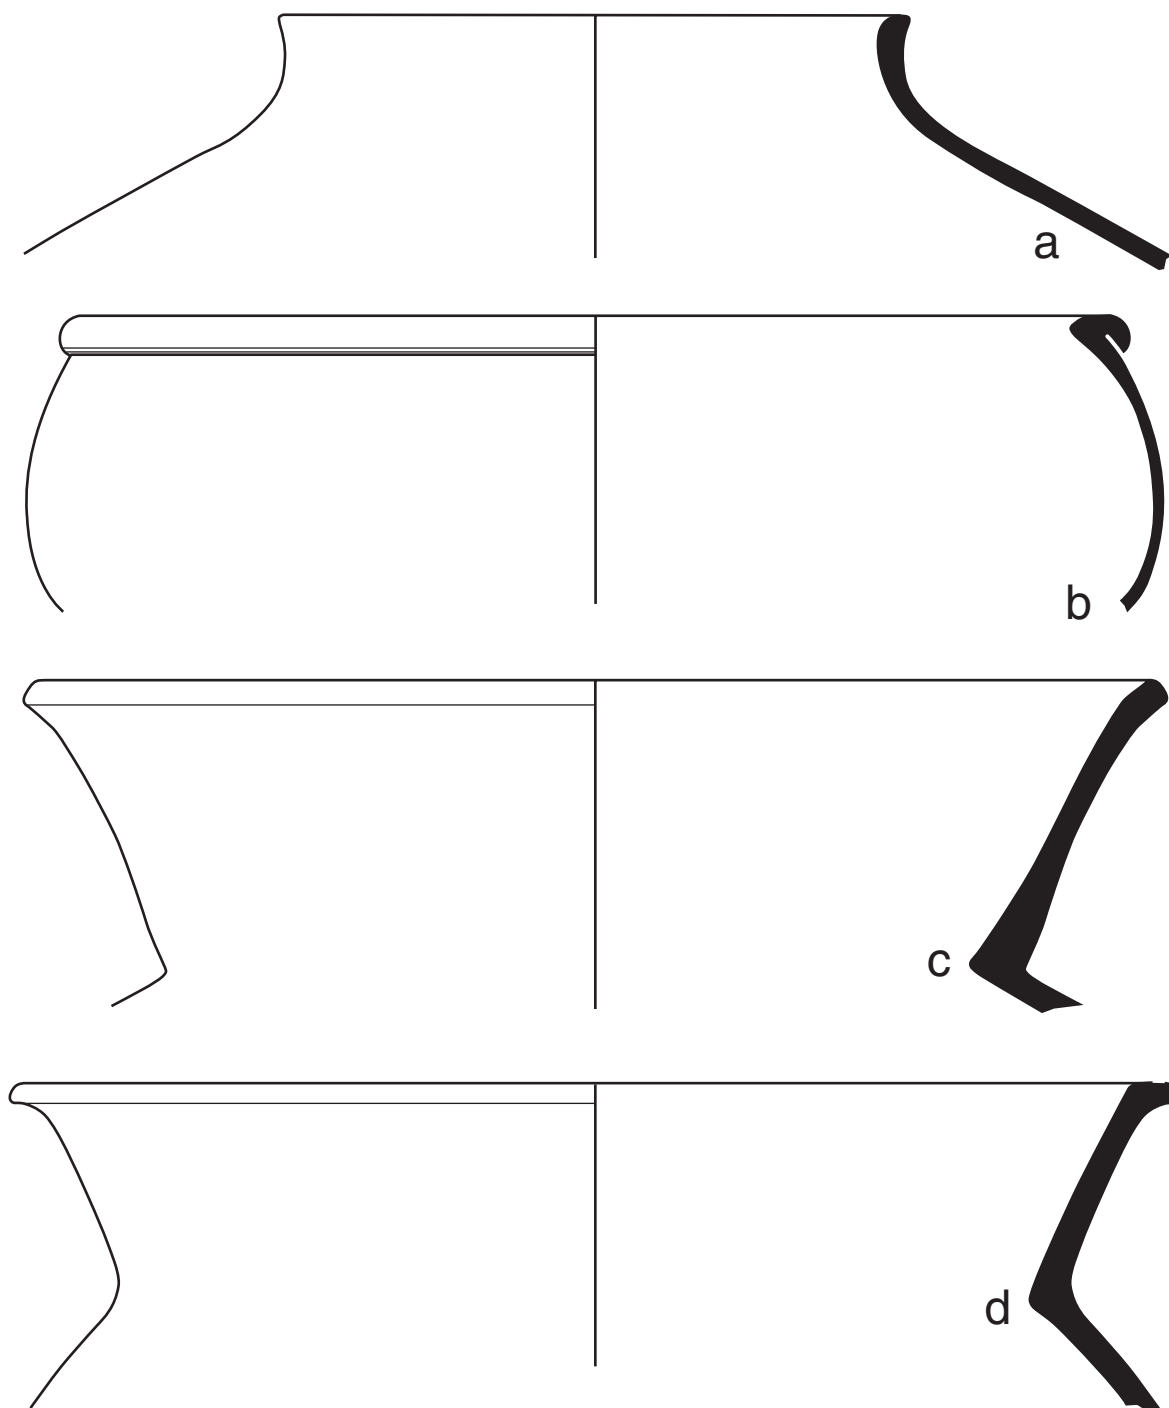
Figure 3.4. Among the rim profiles seen on Camacho Reddish Brown jars were plain (*a*), rolled (*b*), beveled (*c*), and everted (*d*).

alternative rim forms are shown in Figure 3.4; these include *plain rims*, *rolled rims*, *beveled rims*, and *everted rims*.

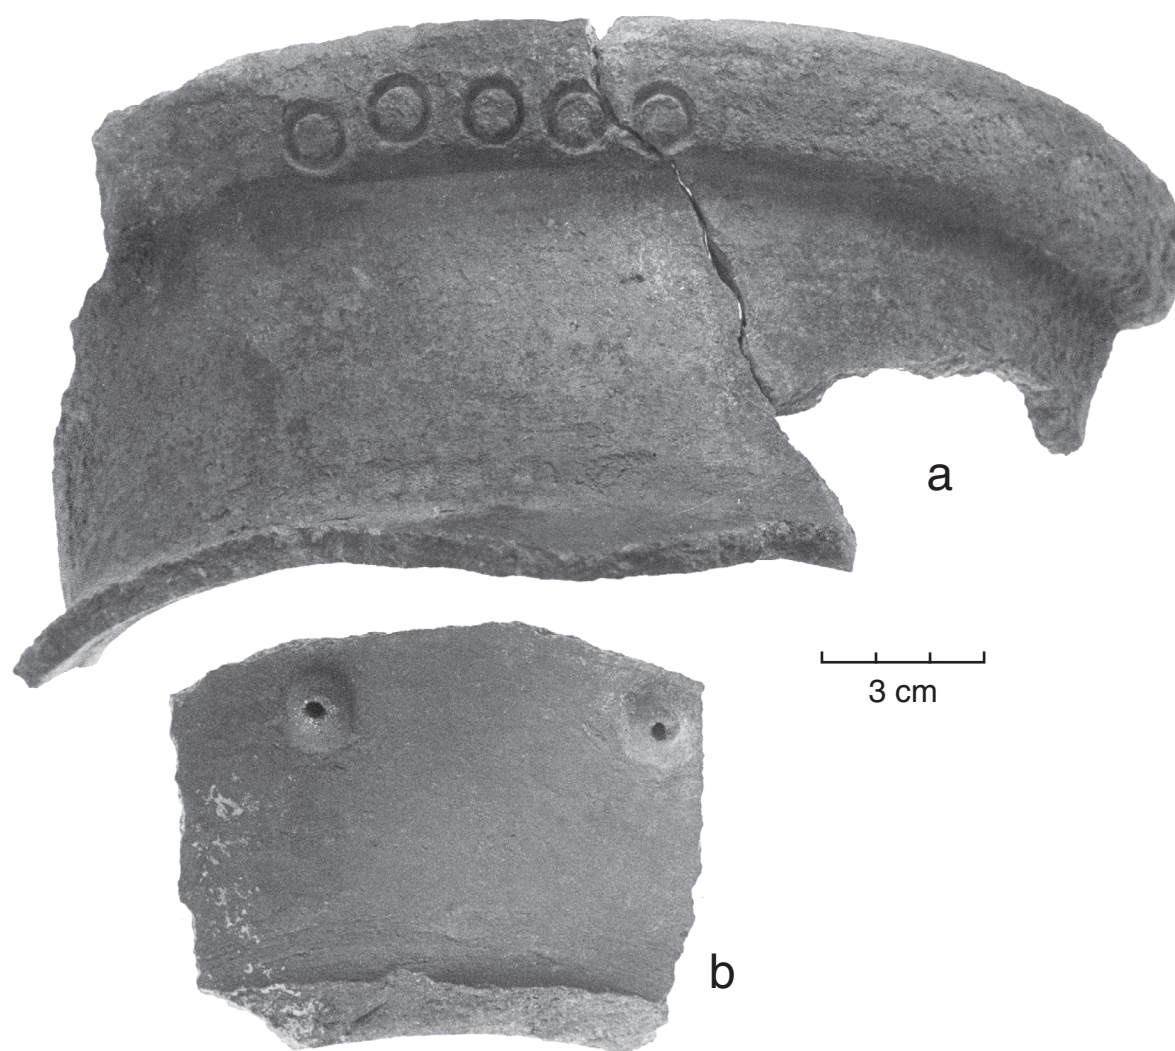
Figure 3.5. Examples of Camacho Reddish Brown jars with plastic decoration. (a): jar with bolstered rim, decorated with cane-end impressions; found in the North Central Canchón, Structure D; (b): jar neck with modeled and punctate nipples, found in Feature 4, Structure D.

While the vast majority of Camacho Reddish Brown vessels are undecorated, there are exceptions. Jars can be decorated with *cane-end impressions* or *punctate nipples* (Figure 3.5). Perhaps the most elaborate plastic decoration on jars of this type is an occasional *modeled human face* (Figure 3.6b). Such faces were usually reserved for burial offerings, and sometimes appear to represent dead people with puffy “coffee-bean” eyes.

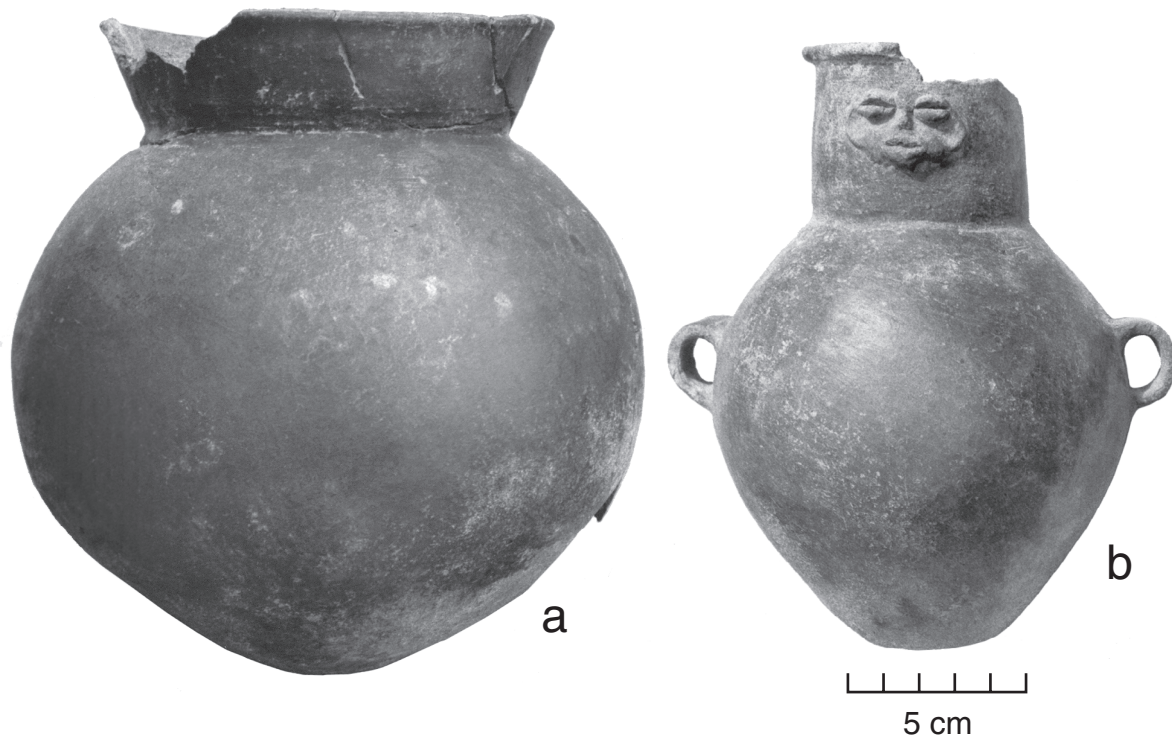
Figure 3.6. Examples of Camacho Reddish Brown jars. (a): globular jar with plain rim; this is Vessel 1 found with Individual 2 of Burial 7 in Quebrada 5a. (b): jar with strap handles and a tall neck with a modeled human face; this is Vessel 1 of Burial 1, Quebrada 5a.

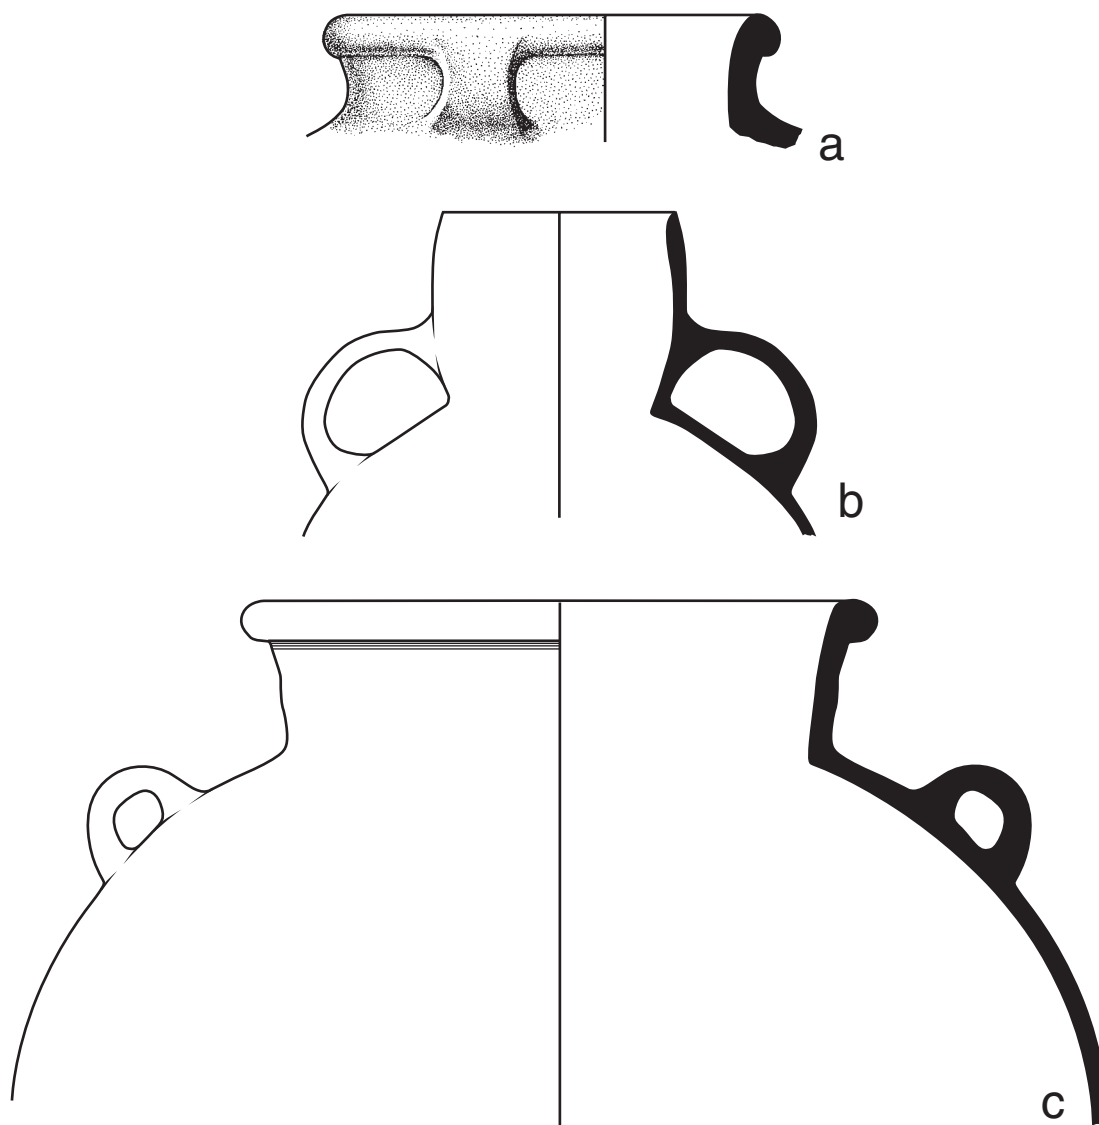
Figure 3.7. The handles on Camacho Reddish Brown jars could be attached to the rim (*a*), the shoulder (*b*), or the upper body (*c*). Handles could vary from loop type (*c*) to strap type (*a*, *b*). The rim profile shown in (*a*) and (*c*) is the bolstered type.

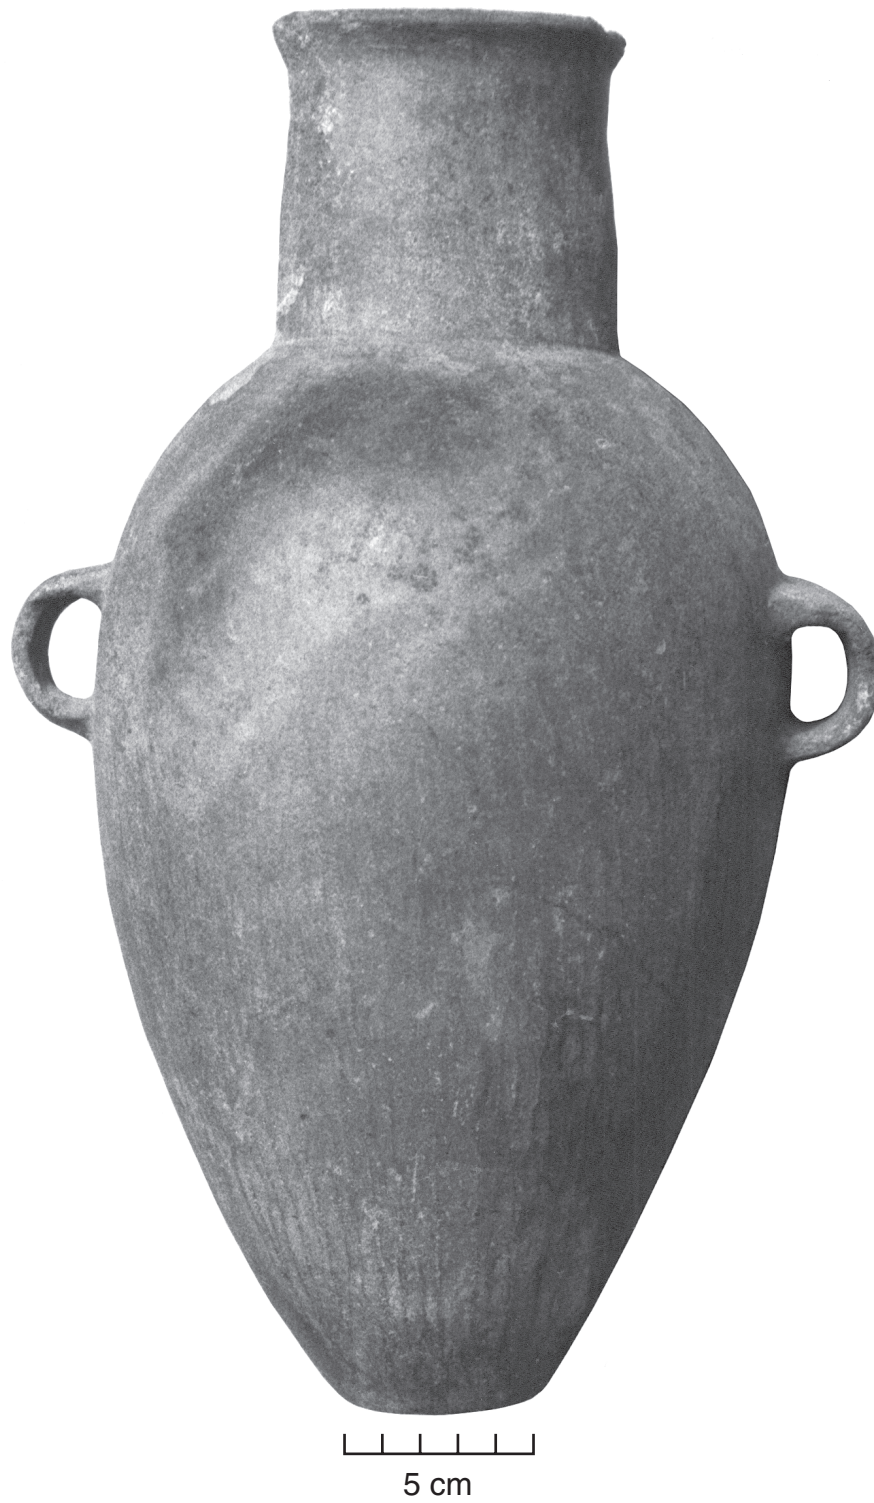
Figure 3.8. Camacho Reddish Brown amphora from stratigraphic Zone A of Terrace 9, Quebrada 5a.

While many Camacho Reddish Brown jars are globular, the *amphora* vessel shape was also used (Figure 3.8). It is particularly common in burial cists, probably serving as a water jar.

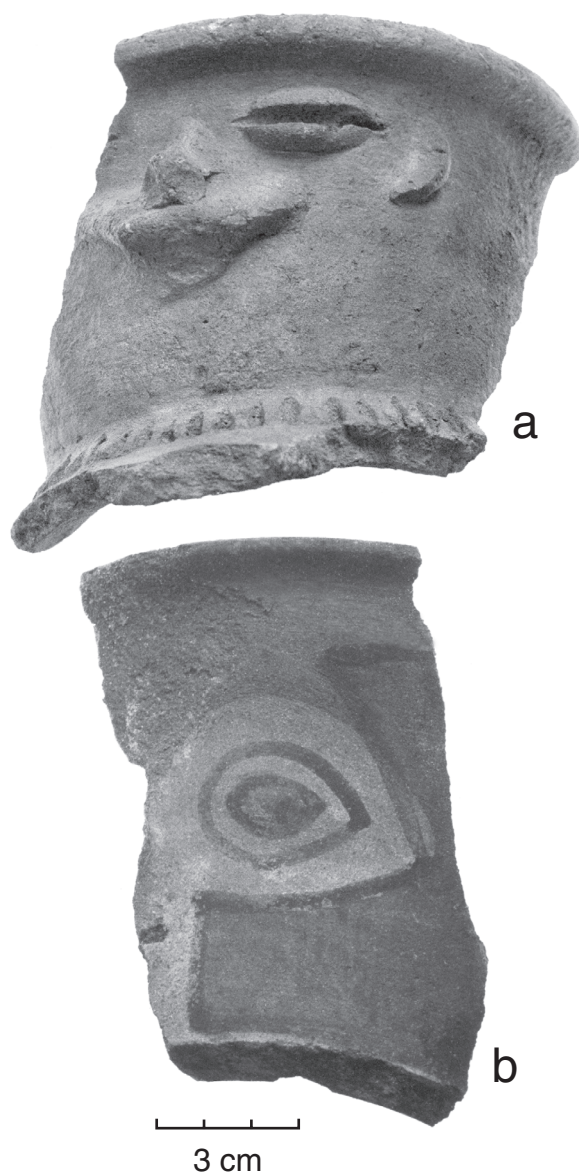
Figure 3.9. Examples of Camacho Reddish Brown jar rims decorated with human faces. (*a*): neck with modeled face featuring coffee-bean eyes, found in the *kincha* layer above the floor of Room 3, Structure D; (*b*): neck with face painted in white/black/red, found while sweeping the surface of Structure 9 before excavation, in the area above the south entrance.

While most human faces on Camacho Reddish Brown jars are modeled (Figure 3.9a), there are occasional examples of *faces painted on jar necks in white, black, and red* (Figure 3.9b). Such

painted faces are far more common in Pingüino Buff, which provide a much better surface for painting. Another point illustrated by Figure 3.9 is that while most modeled faces look dead, most painted faces seem open-eyed and alive.

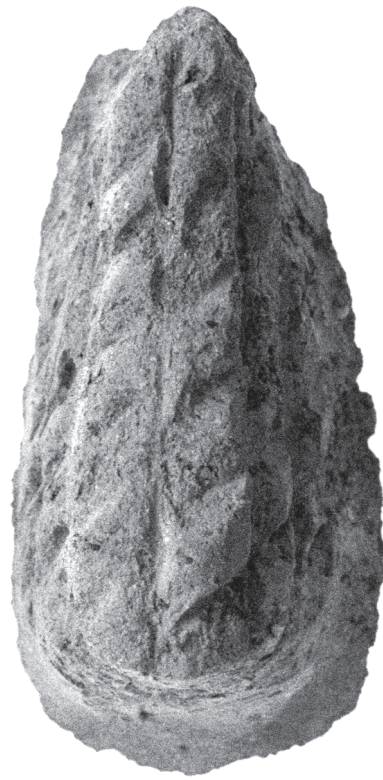
Figure 3.10. Lug in the shape of a maize cob, broken off a large Camacho Reddish Brown jar; found in the North Central Canchón, Structure D.

Camacho Reddish Brown vessels is a *lug modeled in the shape of a maize cob* (Figure 3.10). For reasons that will become clear during our discussion of the kitchen/brewery in Structure D (Chapter 7), we believe that these lugs are a reference to *chicha*, or maize beer, and may suggest the original contents of the jar.

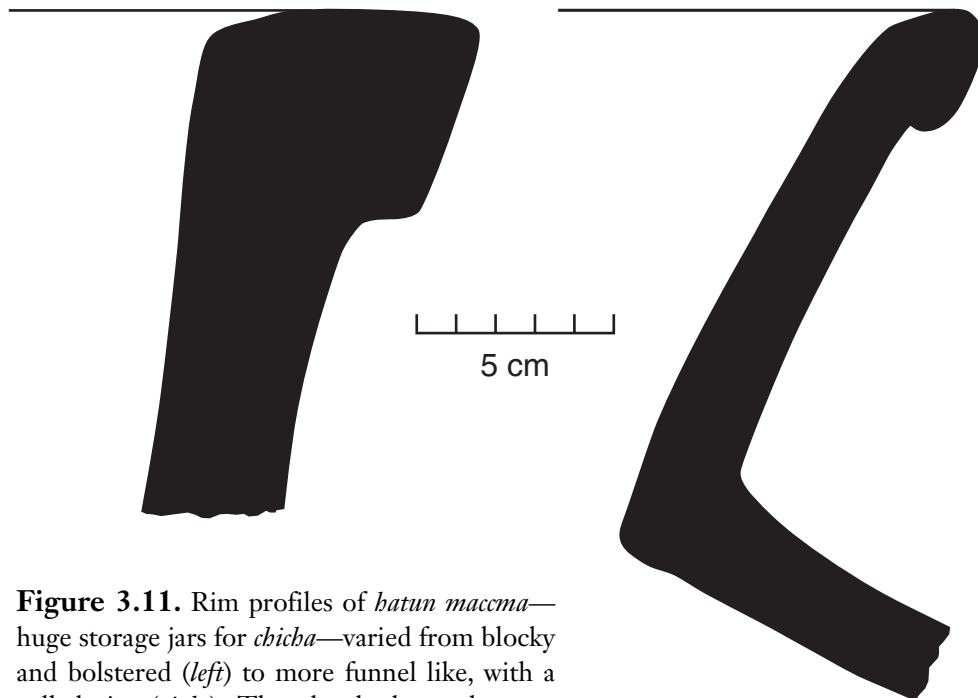
Figure 3.11. Rim profiles of *batun maccma*—huge storage jars for *chicha*—varied from blocky and bolstered (*left*) to more funnel like, with a rolled rim (*right*). The clay body used was a coarser version of Camacho Reddish Brown.

2008). They are so heavy that we suspect that they were formed and fired in situ out of an even coarser variety of Camacho Reddish Brown. Figure 3.11 shows two rims from such *batun maccma*, whose paste is 25% temper. This ware has an average grain size index of 2.9, the highest index of any vessel at Cerro Azul.

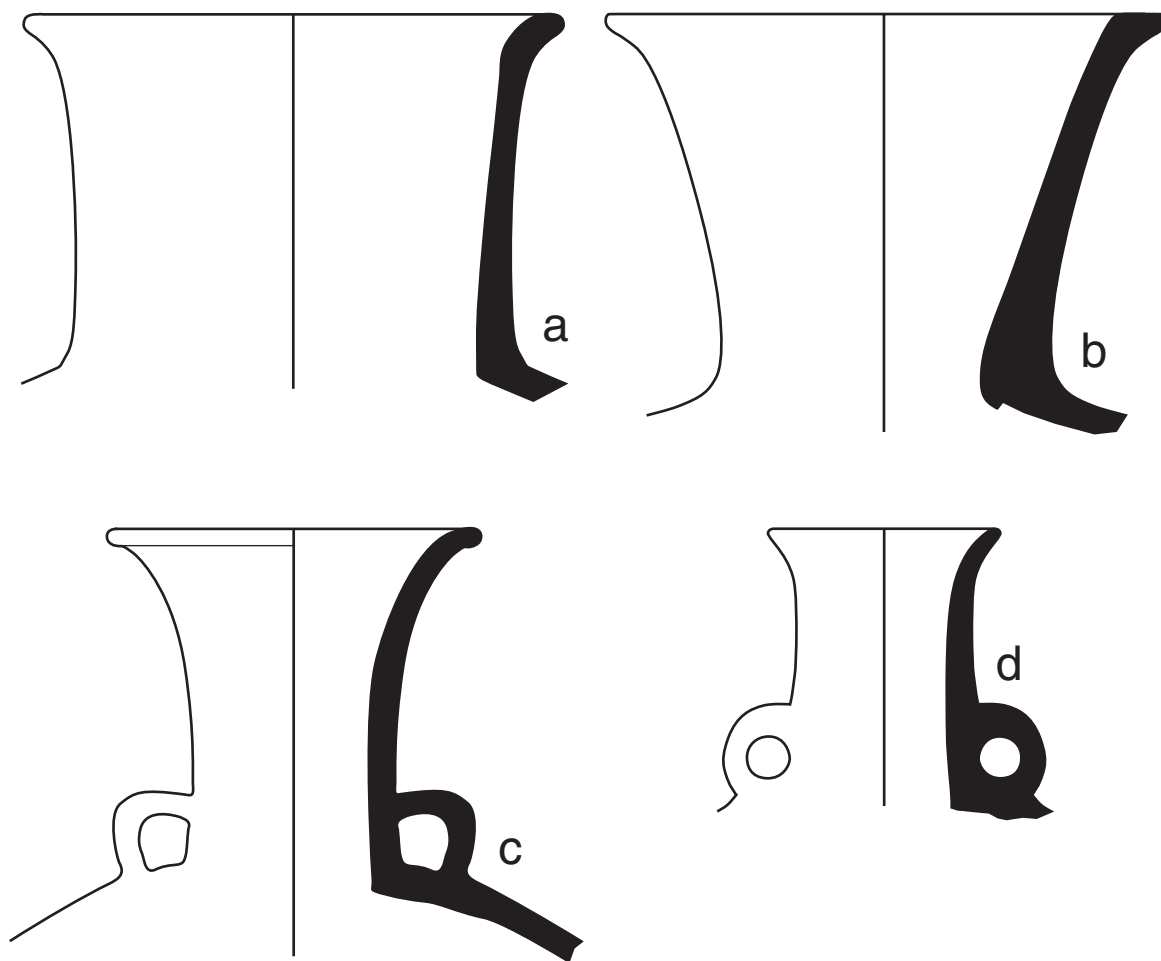
Figure 3.12. The necks of Camacho Black jars and amphorae varied from vertical (*a*) to funnel shaped (*b*) and could have strap handles (*c*) or loop handles (*d*) linking them to the shoulder.

Among the most common vessel shapes in this ware are *jars and amphorae* (Figure 3.12). In the case of small rim sherds, it was not always possible to tell whether the vessel had had the more globular body of a jar or the more conical body of an amphora. Necks vary from *vertical* (Figure 3.12a) to *funnel shaped* (Figure 3.12b), and the vessels can have *strap handles* or *loop handles* on the shoulder or body (Figure 3.12c, d). Many standard variety amphorae included with burials have a *human face modeled on the neck* (Figure 3.13). In Figure 3.13 one can see the pitting of the vessel surface caused by the penetration of salt crystals over time.

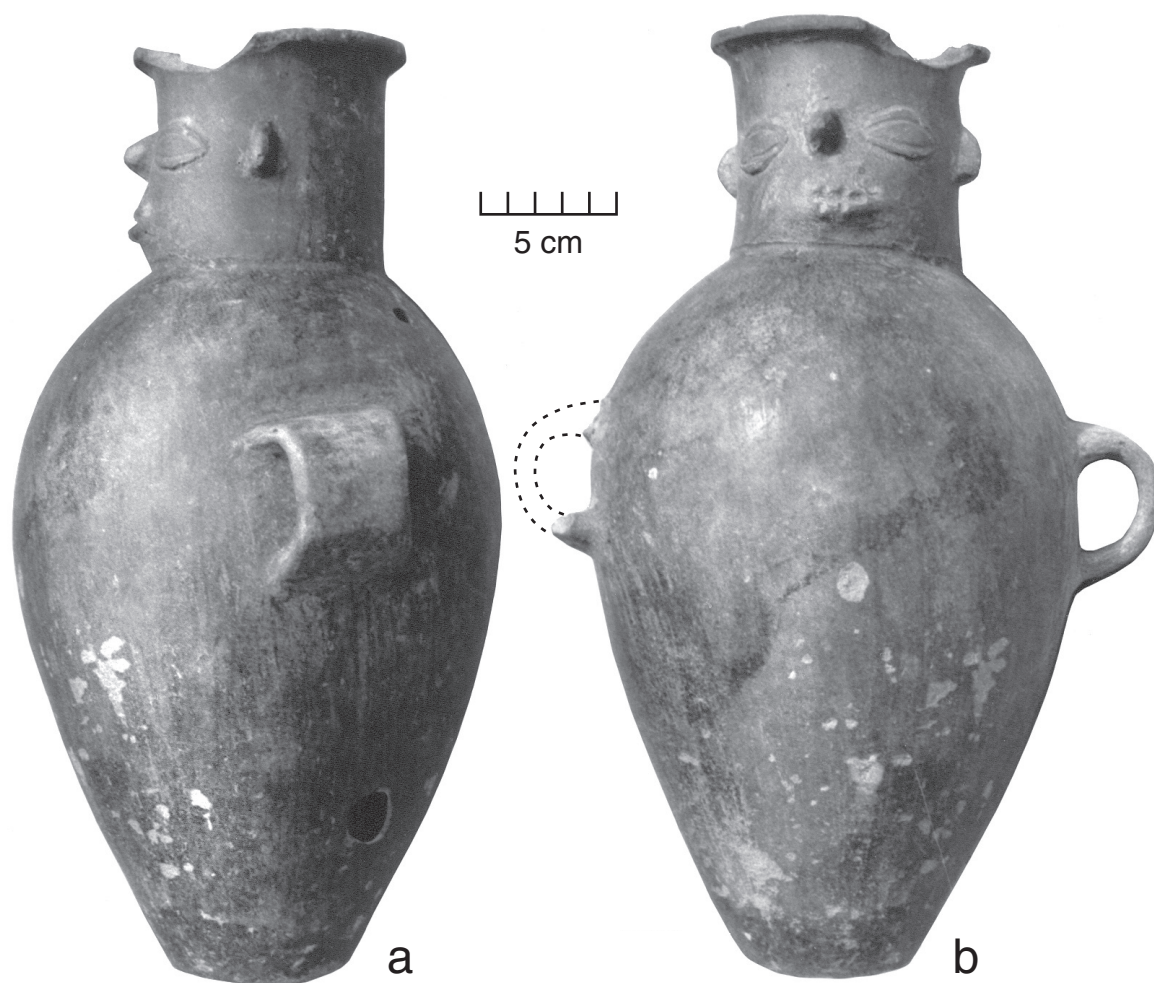
Figure 3.13. Front and side views of a standard variety Camacho Black amphora with a human face modeled on the neck. This amphora was Vessel 2 of Burial 8.

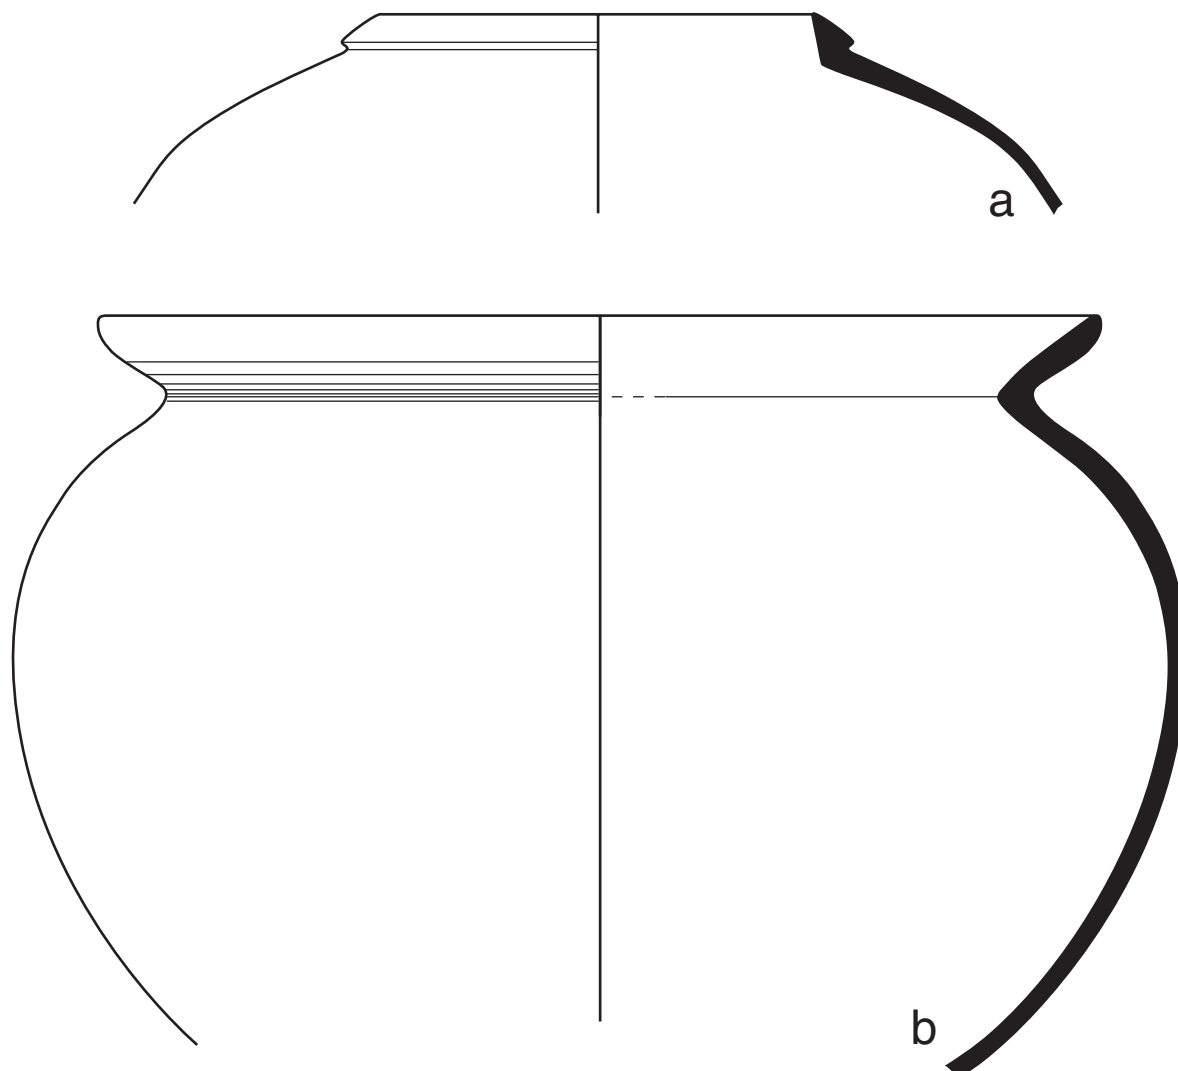
Figure 3.14. The mouths of Camacho Black globular jars varied from small and restricted (*a*) to wide (*b*). Rims could be tightly rolled (*a*), cambered, or plain (*b*).

Figure 3.14 shows additional globular jars (standard variety) with *rolled to plain rims* on *wide or restricted mouths*.

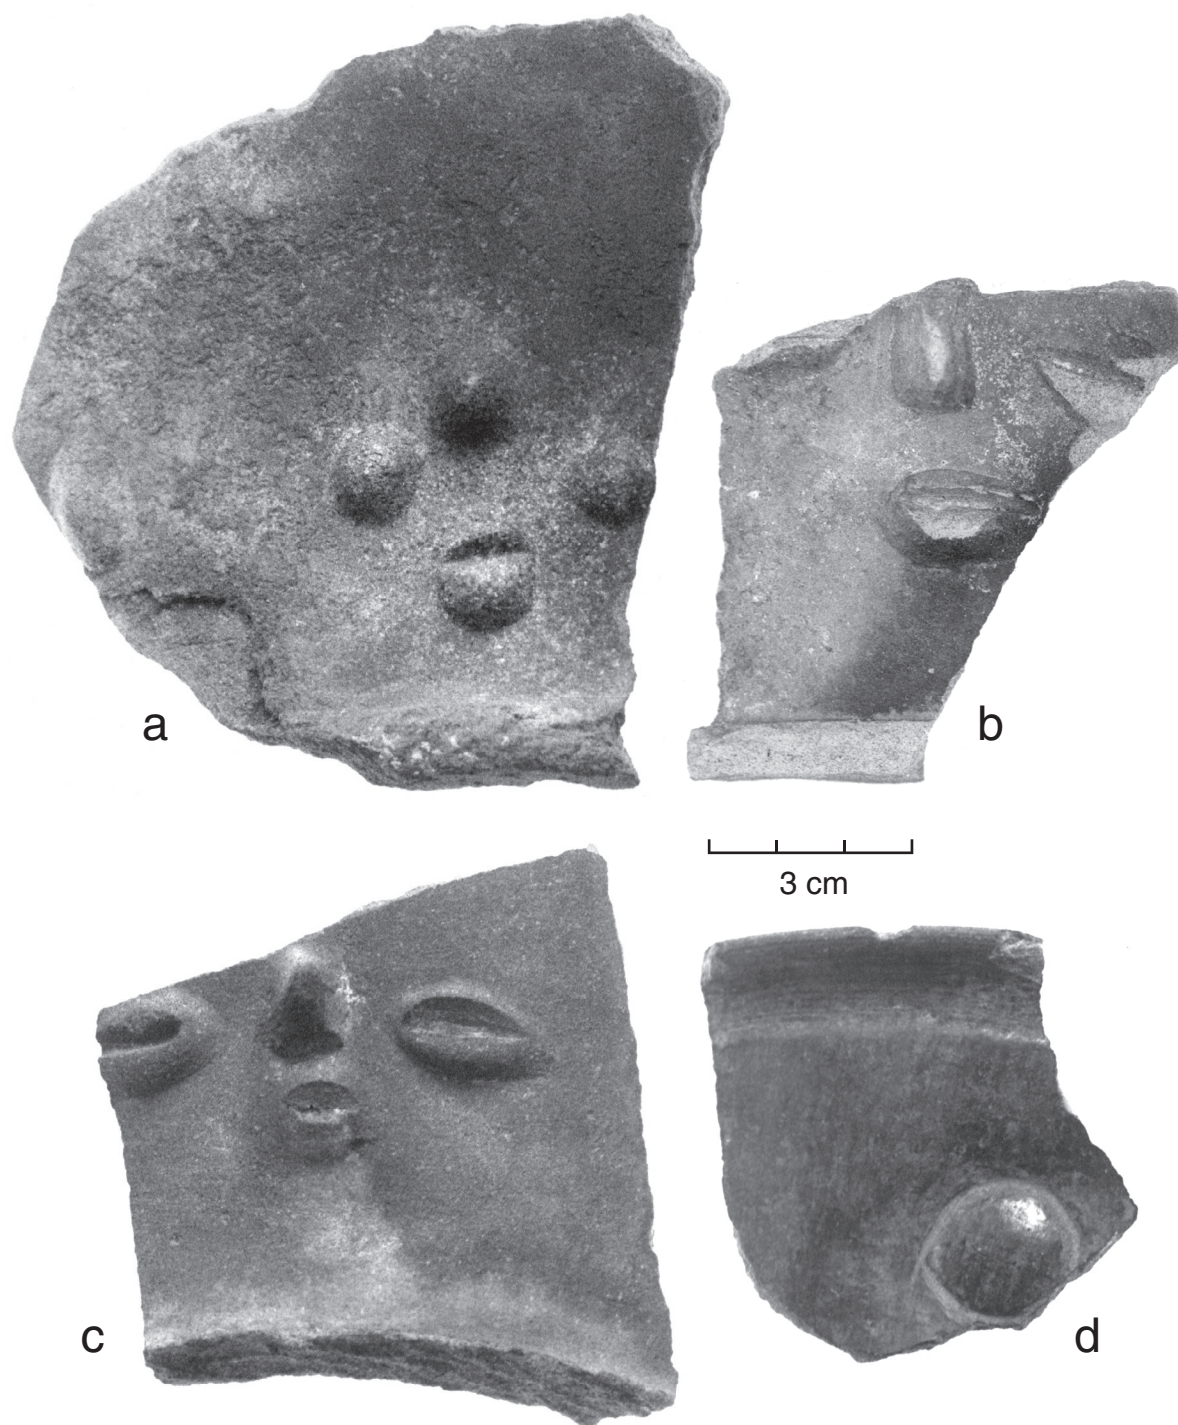
Figure 3.15. Fragments of modeled human faces from Camacho Black vessels. (*a, c*): from Feature 4, Structure D; (*b*): from Northeast Canchón, Structure D; (*d*): showing a modeled and incised “eye,” from Feature 6, Structure D.

Human faces modeled on amphora necks come in many varieties, as seen in Figure 3.15. They can have *coffee-bean eyes* (Figure 3.15c), *modeled and incised eyes* (Figure 3.15d), or simple *pinched nipples* as eyes (Figure 3.15a).

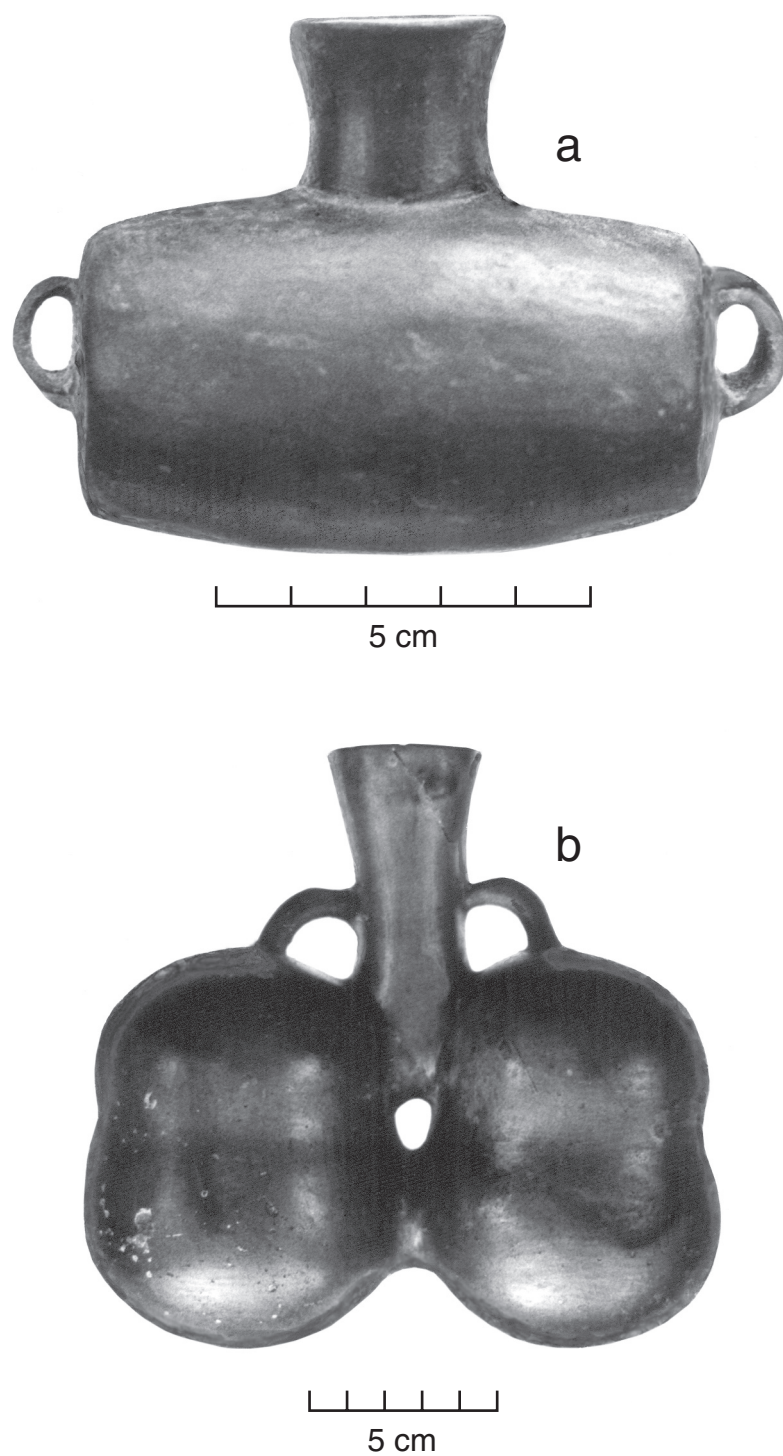
Figure 3.16. Examples of the highly burnished variety of Camacho Black. (a): miniature drum-shaped vessel found with Burial 1; (b): double vessel found with Burial 4. The highly burnished variety was more common among burial offerings than in general midden debris.

In Figure 3.16 we show two examples of the highly burnished variety of Camacho Black. Both are small to miniature vessels included with burials. They do not by any means exhaust the variety of small burial offerings in Camacho Black, which will be discussed in detail in a future volume on the burials found in the quebradas of Cerro Camacho. Figure 3.16 makes clear how shiny and graphite-like the surface of these double-burnished vessels can be.
