MONOGRAPH 62
COTSEN INSTITUTE OF ARCHAEOLOGY
UNIVERSITY OF CALIFORNIA, LOS ANGELES

EXCAVATIONS AT
CERRO AZUL, PERU
THE ARCHITECTURE AND POTTERY
JOYCE MARCUS

Excavations at Cerro Azul, Peru

THE ARCHITECTURE AND POTTERY

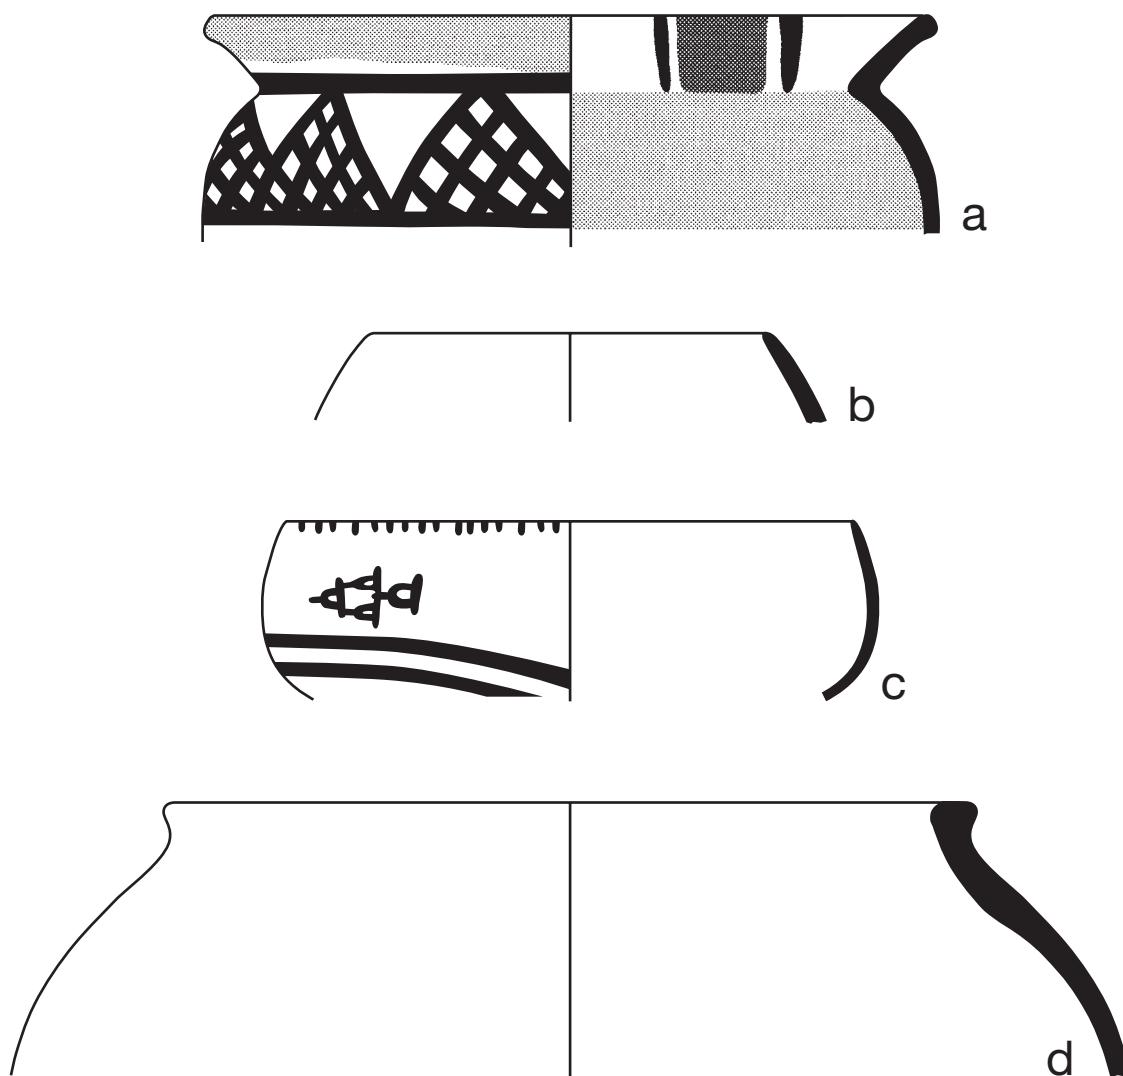
Figure 3.17. Among the vessel shapes in which Pingüino Buff occurred were globular jars with wide mouths (*a*), globular jars with restricted mouths (*d*), hemispherical bowls (*c*), and bowls with a restricted orifice or incurved rim (*b*). Painted designs were added in black and white or black/white/red.

Some of the most common vessel shapes in Pingüino Buff are *globular jars with wide mouths* which can be either small (Figure 3.17a) or large (Figure 3.18b). There are also *globular jars with restricted mouths* (Figure 3.17d) and *large globular jars with funnel necks* (Figure 3.18a). The larger jars, which were probably used for the storage of water, *chicha*, and other liquids, can have paired strap handles, set either vertically or horizontally. The small globular jars with wide mouths more likely held porridge-style meals for one to two people. They are frequently painted on all visible surfaces (Figure 3.17a).

Bowls in Pingüino Buff can be *hemispherical* (Figure 3.17c) or have a *restricted orifice* (Figure 3.17b). These vessels were probably used for individual servings of food.

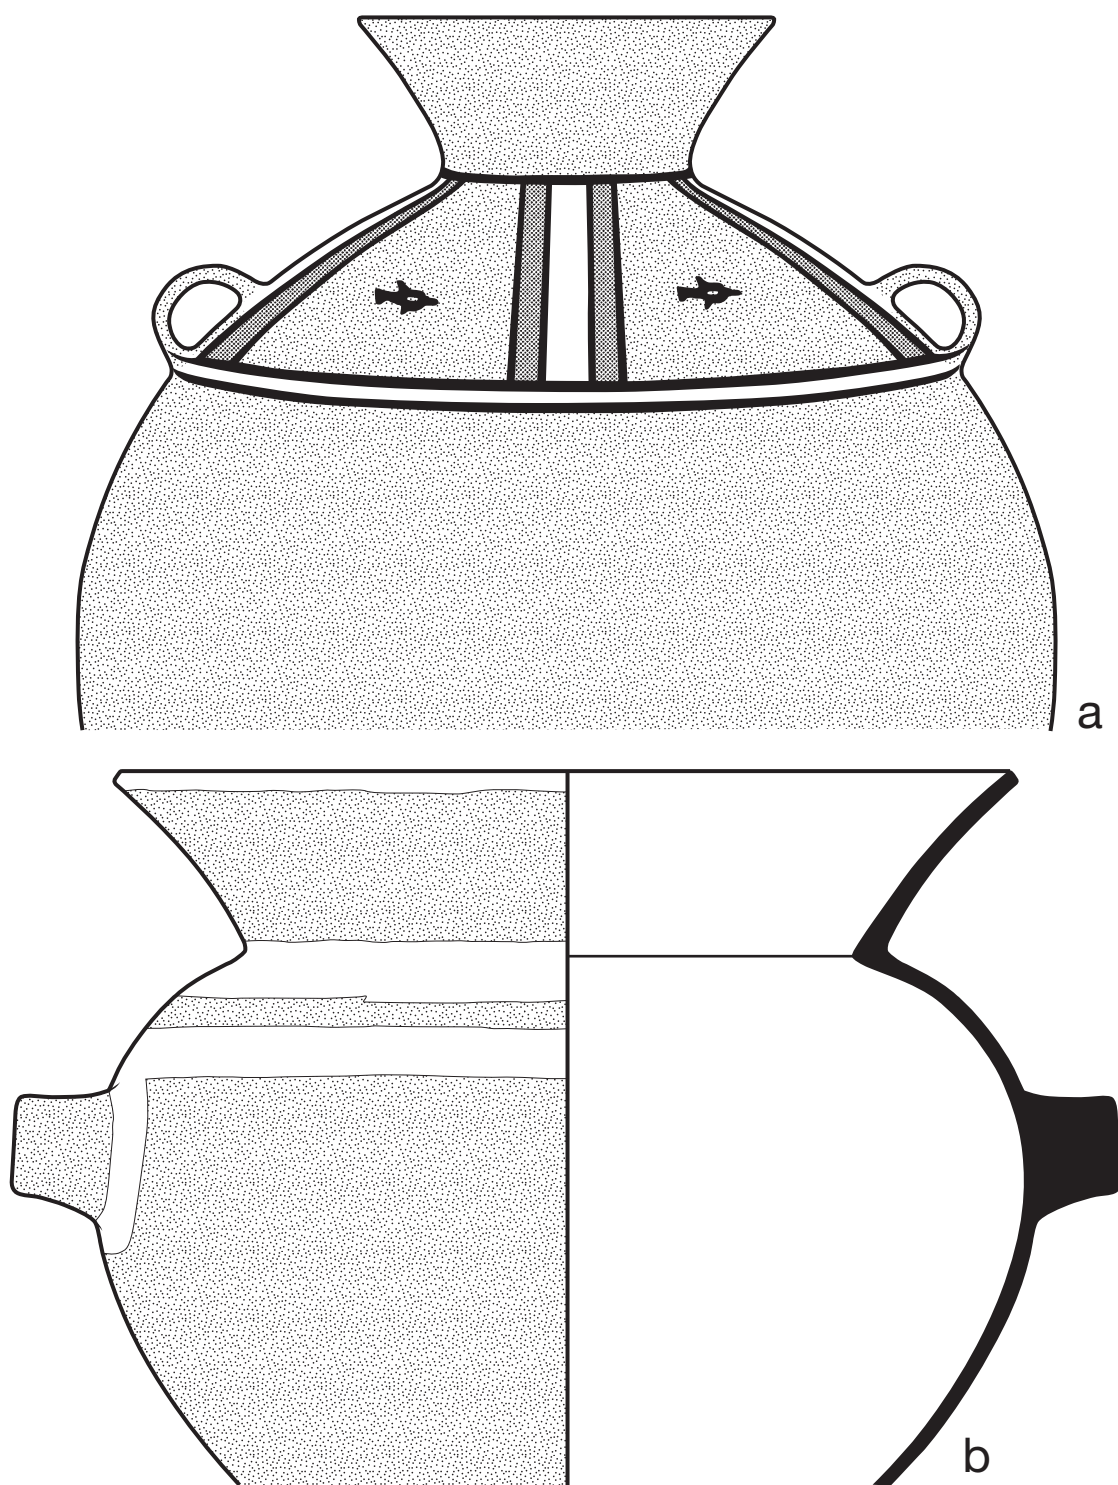
Figure 3.18. The strap handles on Pingüino Buff jars could be set vertically (*a*) or horizontally (*b*) on the vessel. The difference may reflect whether the vessel was to be lifted by ropes through the handles or directly by the hands. The vessel shown in *a* is the atypical orange variety of Pingüino Buff.

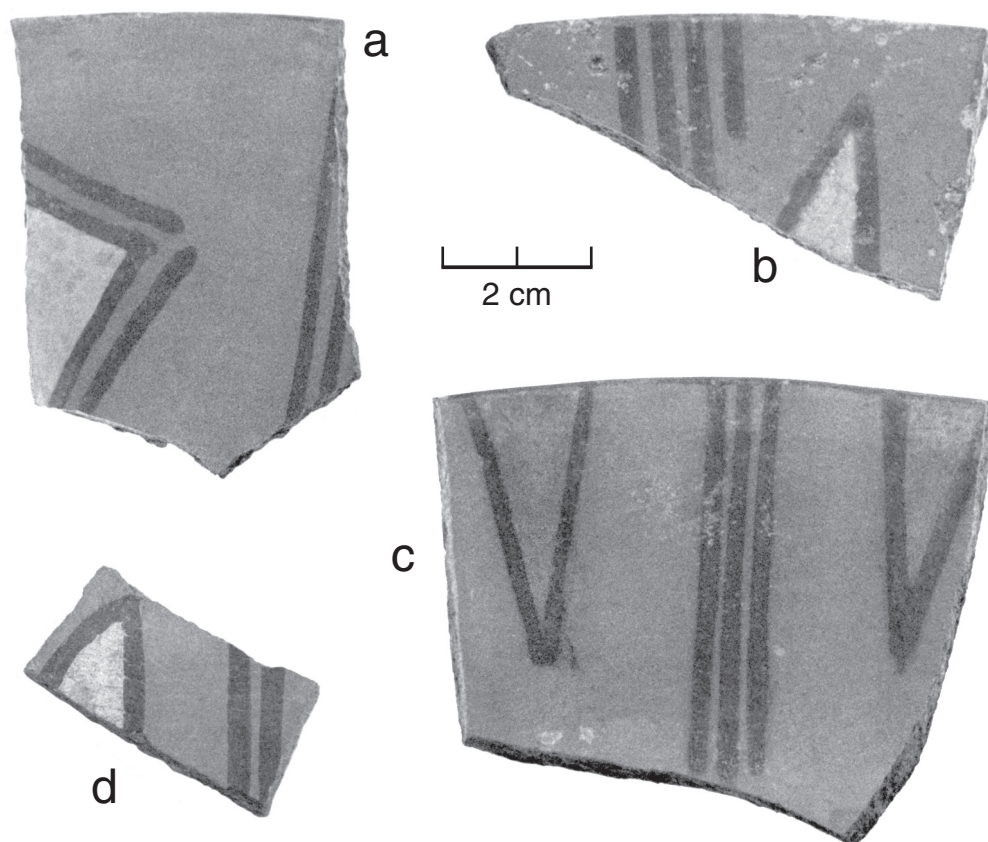
Figure 3.19. Pingüino Buff bowl sherds, painted in a style that may antedate most of the occupation of Structure D. Sherds *a–c* were redeposited in Structure 4, a burial cist found on Terrace 9 of Quebrada 5a, and probably originated in the midden into which the cist was excavated. (*a, b*): bowls given a red wash and painted in black and yellow; (*c*): bowl given a red wash and painted in black and iridescent purple; (*d*) sherd found in the fill above the floor in Room 1, Structure D.

on Pingüino Buff. Figure 3.19 shows sherds of Pingüino Buff bowls whose interior walls are painted neatly with diamonds, narrow triangles, and parallel black lines. Most were given a red wash, after which the design was outlined in black; finally, the diamonds or triangles were filled with yellow paint (Figure 3.19a, b, d) or iridescent purple paint (Figure 3.19c). Three of the sherds came from deep stratigraphic levels in Quebrada 5a of Cerro Camacho, while the fourth was redeposited in room fill in Structure D. The bowl form, the motifs, and the neatness of the painting are reminiscent of pottery at earlier sites such as Cerro del Oro (Kroeber 1937).

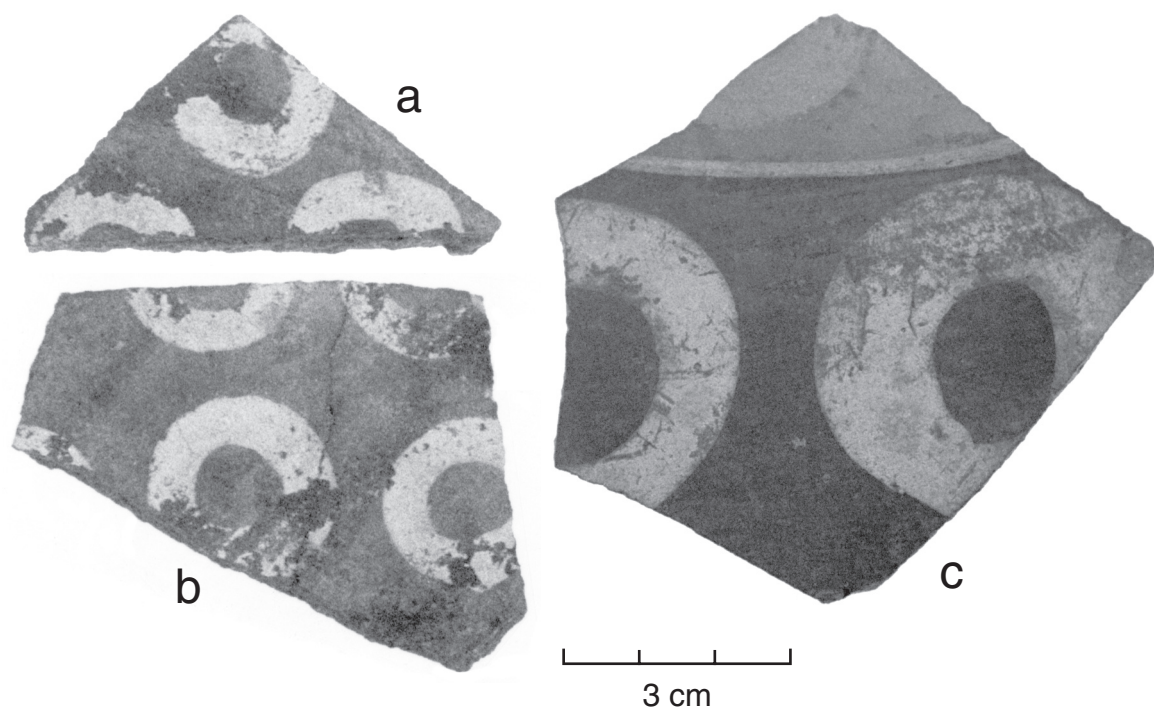
Figure 3.20. Pingüino Buff jar sherds featuring the “Life Saver” motif. It is suspected that this motif goes back further in time than the bulk of the occupation of Structure D. (a, b): sherds with “Life Savers” painted in cream on black, found between Floors 1 and 2 of Room 6, Structure D; (c): sherd with “Life Savers” painted in yellow on red (*top*) and cream on purple (*bottom*), redeposited in Structure 5, a burial cist on Terrace 9 of Quebrada 5a. This sherd probably originated in the midden into which the cist was excavated.

Figure 3.20 shows Pingüino Buff jar body sherds bearing what I have called the “Life Saver” motif. In that figure, sherds *a* and *b* are from a Pingüino Buff jar that has a black-painted zone, over which cream-colored Life Savers have been painted. Sherd *c* is from a jar whose exterior surface has been divided into two zones, one painted red, the other painted purple. The Life Savers painted over the red zone are yellow; those painted over the purple zone are cream-colored. This is a rare motif at Cerro Azul, occurring mainly in the deep levels of the quebradas on Cerro Camacho, but occasionally found redeposited in the fill of later buildings. As in the case of the motifs in Figure 3.19, I suspect that the Life Saver motif was a survival from earlier times.

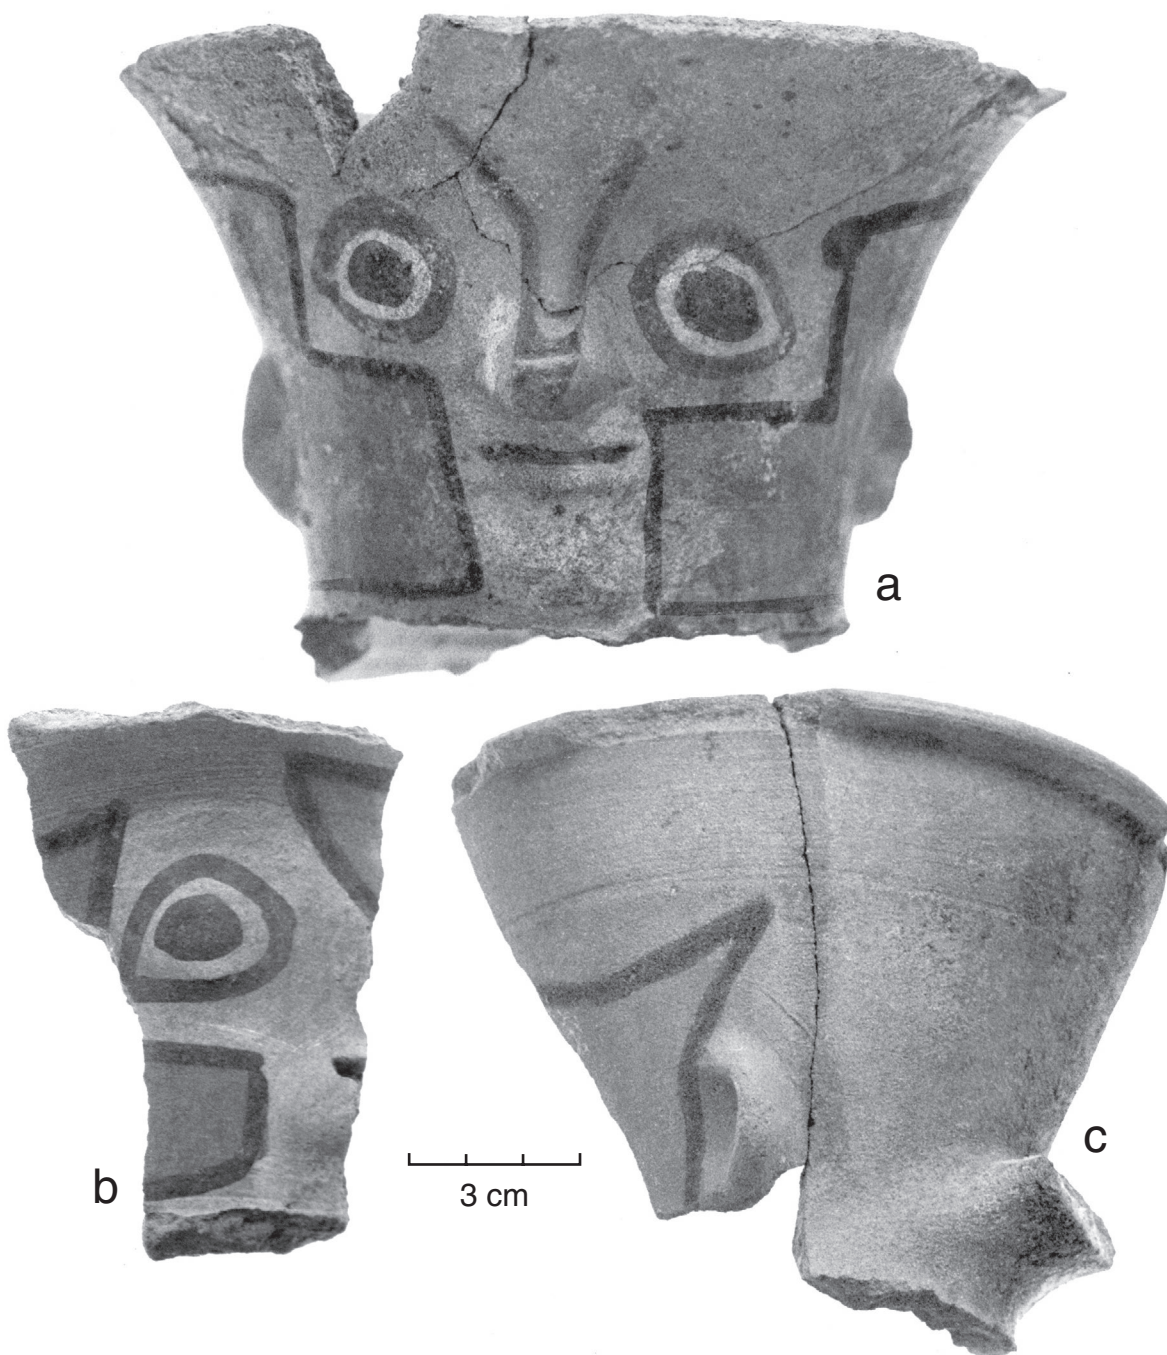
Figure 3.21. Examples of Pingüino Buff jars with painted and modeled human faces on the neck. (a): from the South Corridor, Structure D; (b): from the floor of Room 3, Structure D; (c): from the floor of the North Central Cancón, Structure D.

Far more common at Cerro Azul are human faces modeled and painted on Pingüino Buff jar necks (Figure 3.21). In contrast to the dead-looking faces on Camacho Black jars and amphorae, these Pingüino Buff faces look very much alive, with large, open eyes painted in black and white. These specimens also have a distinctive and standardized form of red facial paint, with the bridge of the nose painted, and L-shaped red areas extending from cheek to ear. The same type of facial painting can be found on some figurines at Cerro Azul (Marcus 1987a:Fig. 21a). We do not know whether this style of facial painting was related to sociopolitical status, ethnic identity, or something else. Some of the figurines with this kind of facial paint have female bodies.

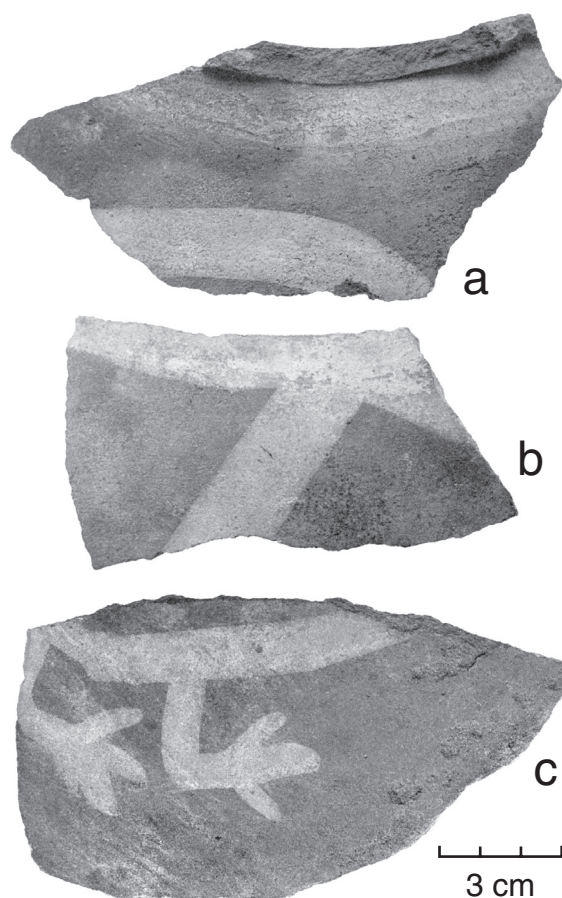
Figure 3.22. Sherds from Pingüino Buff jars with white-on-natural-buff painting. (*a, b*): sherds left by the looters of Structure 6, Terrace 9, Quebrada 5a; (*c*): sherd from the North Central Cancón, Structure D.

Figure 3.23. Three conjoining Pingüino Buff sherds from a jar painted with white-on-black disks over natural buff. Found in the fill above the low wall dividing Rooms 9 and 10, Structure D.

3.22). Motifs range from geometric (Figure 3.22a, b) to zoomorphic (Figure 3.22c). In other cases, simple geometric motifs are painted in white over a black wash, which causes the white design to stand out more prominently (Figure 3.23).

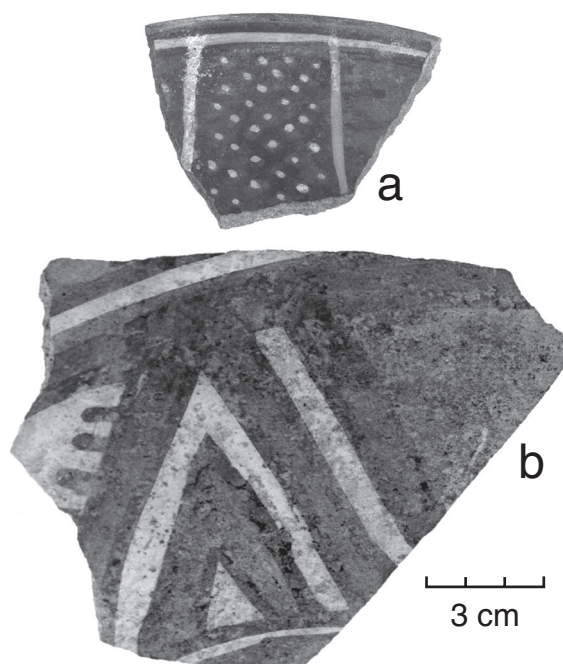
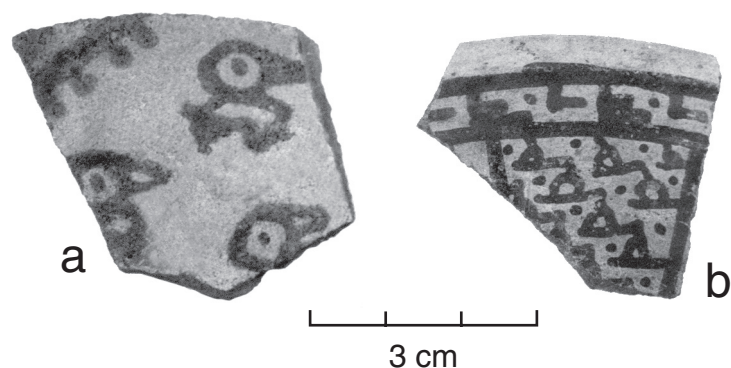
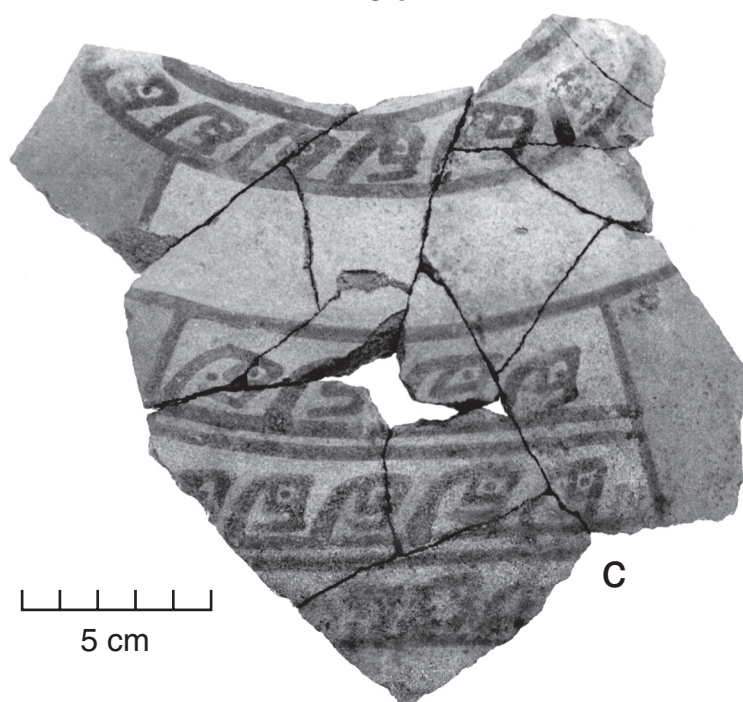
Figure 3.25. Pingüino Buff sherds with bird motifs painted in black on white. (*a*): found with a pile of maize cobs in the South Corridor of Structure D, features realistic birds; (*b*): from Room 6 of Structure 9, this sherd has a horizontal row of stylized birds above a “school of fish” motif; (*c*): conjoining sherds from a jar found in the *kincha* layer above the Room 3 floor, Structure D, have horizontal rows of stylized bird heads with long necks and curving beaks.

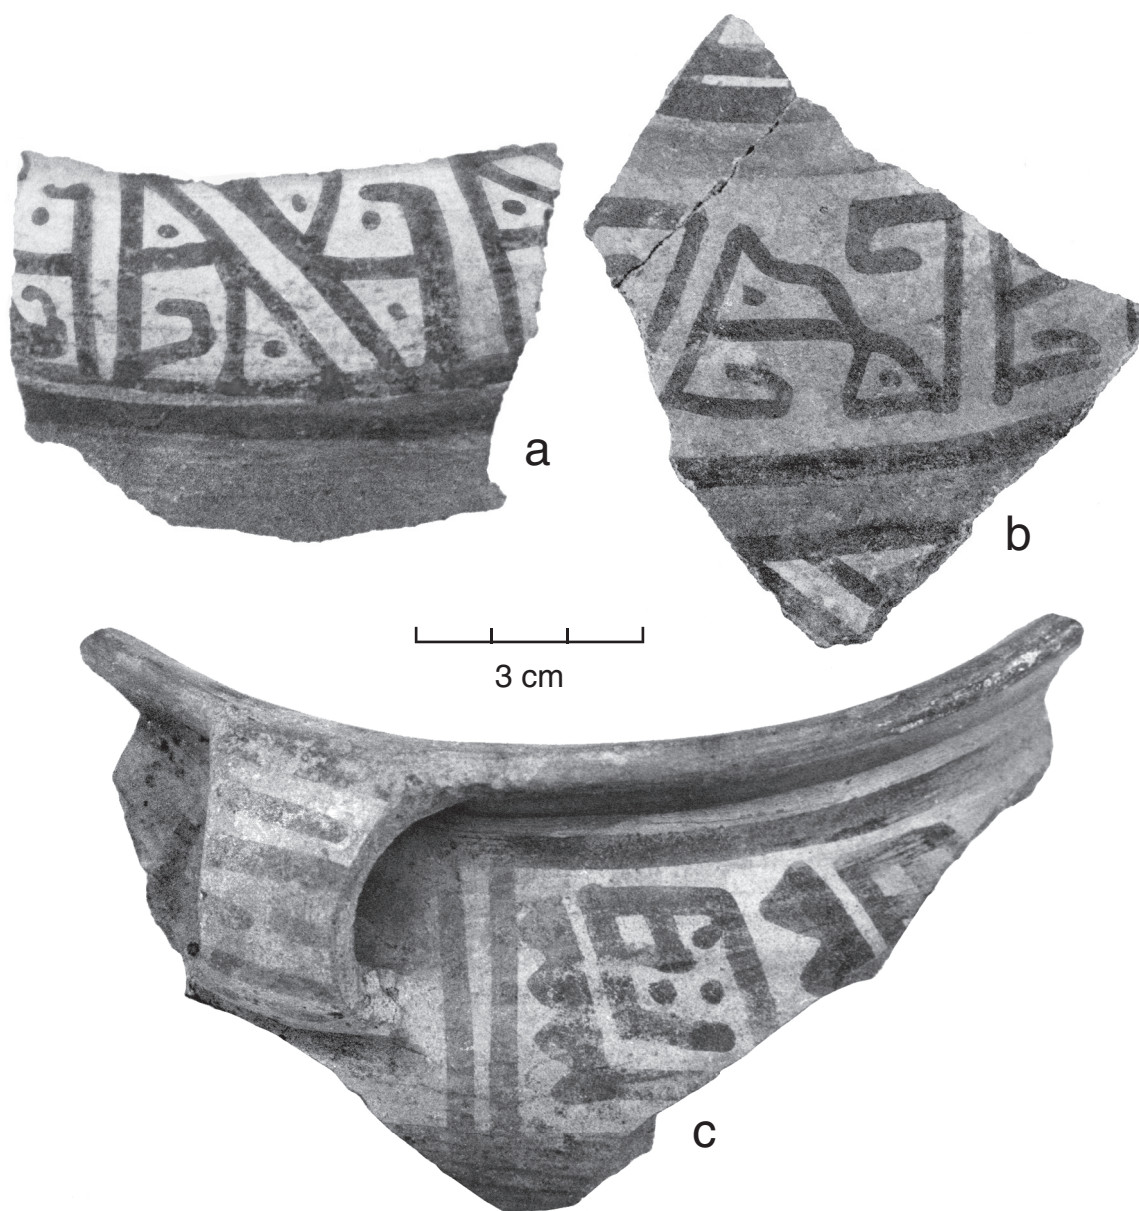
Figure 3.26. Pingüino Buff sherds with step-fret or other geometric motifs painted in black on white. Sherd *a* is from the fill above the North Platform of the Southwest Canchón, Structure D; *b* is from Room 3, Structure D; *c* is from Feature 4 of Structure D.

Figures 3.24–3.27 provide the reader with a sample of motifs painted on Pingüino Buff jars in black and white or black/white/red. Geometric motifs include nested black/white/red chevrons (Figure 3.24b), zones of dots set off by white lines (Figure 3.24a), checkerboards (Figure 3.27b), combinations of crosses, discs, and dots (Figure 3.27a), and the crosshatched “mountains” already shown in Figure 3.17a. Zoomorphic motifs may be naturalistic (Figure 3.25a) or stylized (Figure 3.25b, c). In the case of some motifs, it is not clear whether the painter was trying to produce stylized animals or simply abstract motifs (Figure 3.26).

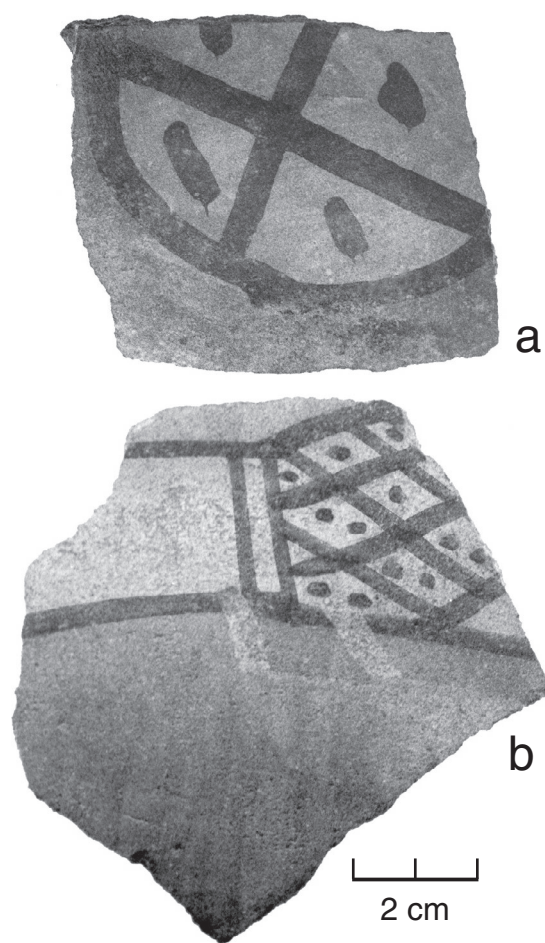
Figure 3.27. Pingüino Buff sherds with geometric motifs painted in black on white. (*a*): from the South Corridor, Structure D; (*b*): from Collca 1, Structure D.

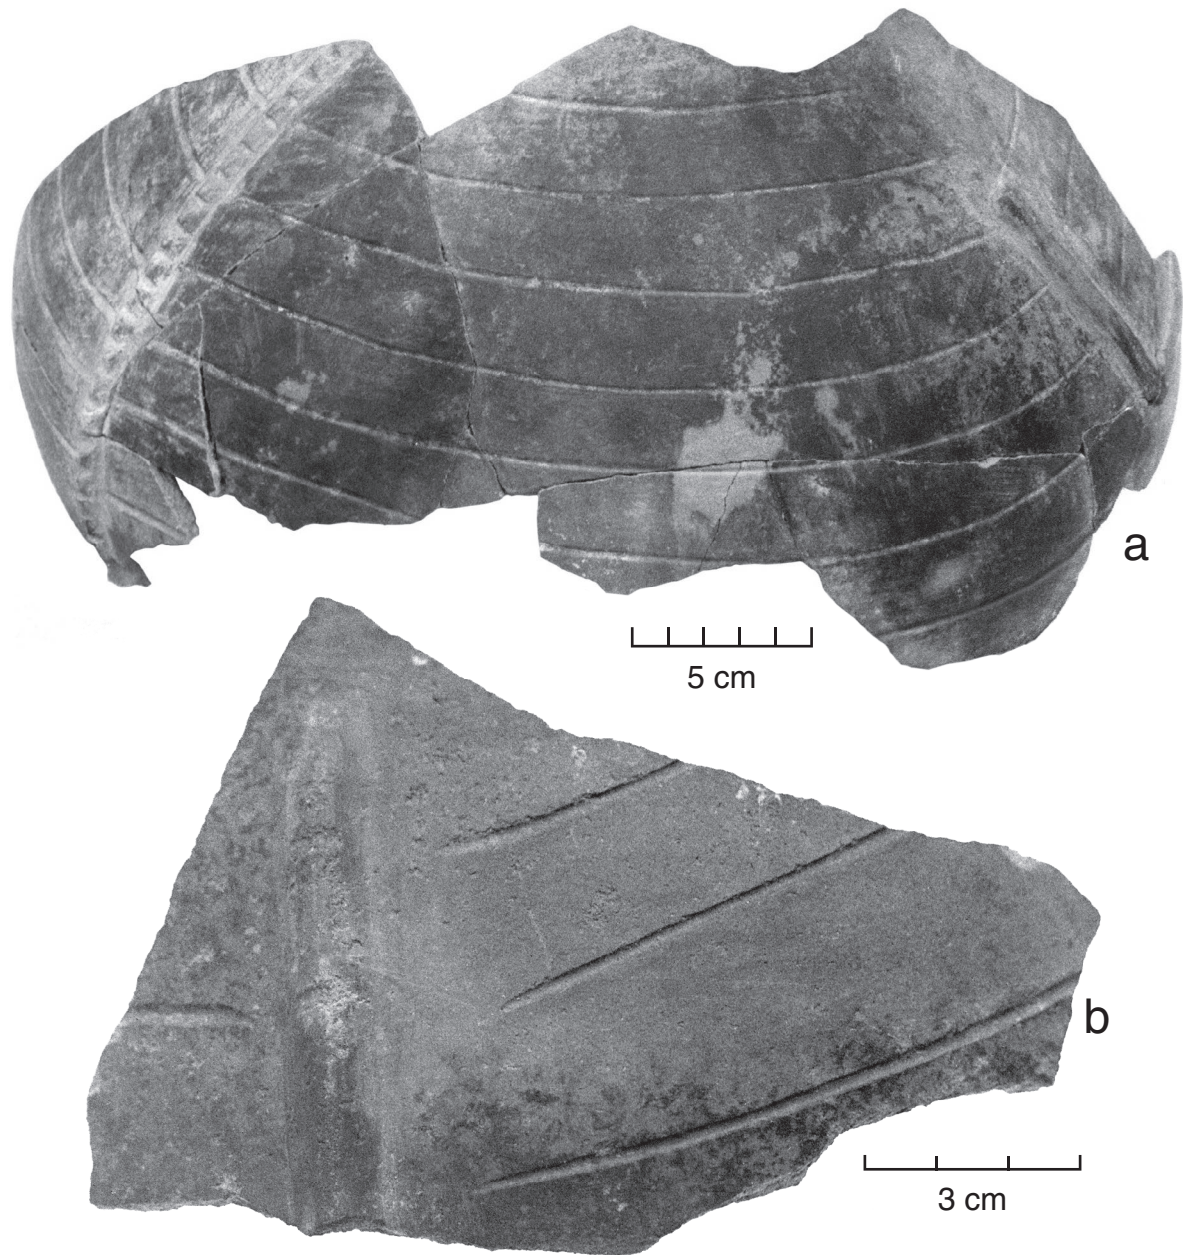
Figure 3.28. Pingüino Buff vessels depicting “fat skeletons.” (a): partially restorable jar from inside Feature 9 of the North Central Canchón, Structure D. A modeled vertebral column appears at far left; a modeled spindly arm appears at far right. In between are horizontal incisions representing ribs. (b): sherd found while sweeping above Rooms 3–5, Structure 9, prior to excavation.

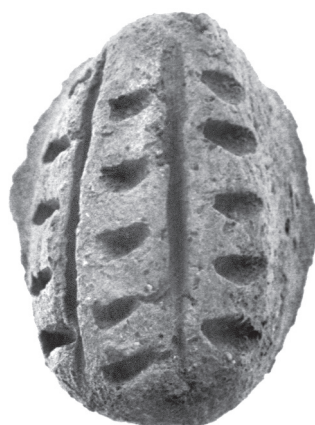
Figure 3.29. Pingüino Buff jar lug in the shape of a maize cob from Room 7, Structure 9.

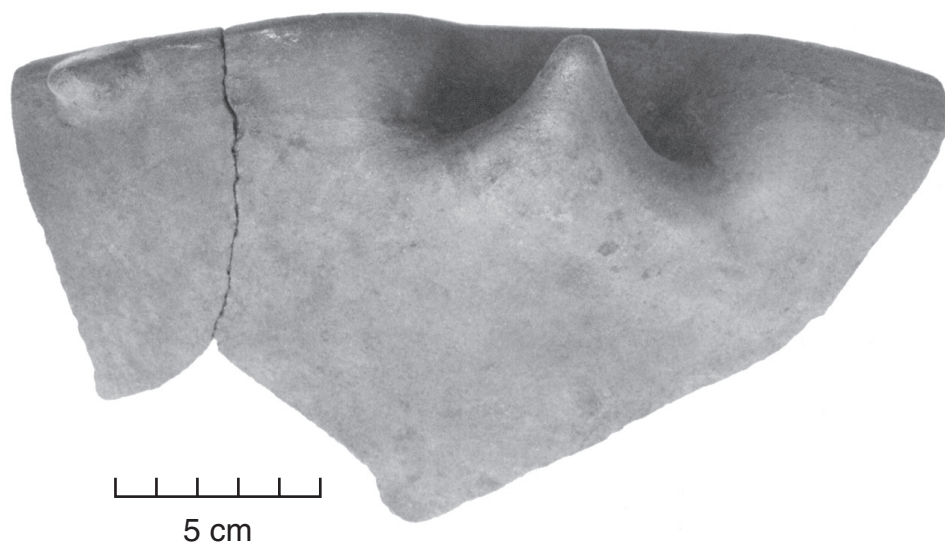
Figure 3.30. Conjoining sherds from a Pingüino Buff bowl which features a “turtle tail” and stubby “turtle foot”; found in Room 3, Structure D.

A few effigy bowls in Pingüino Buff seem to represent *the inverted carapace of a turtle*. These bowls feature small protuberances that resemble the tails and feet of a turtle (Figure 3.30).

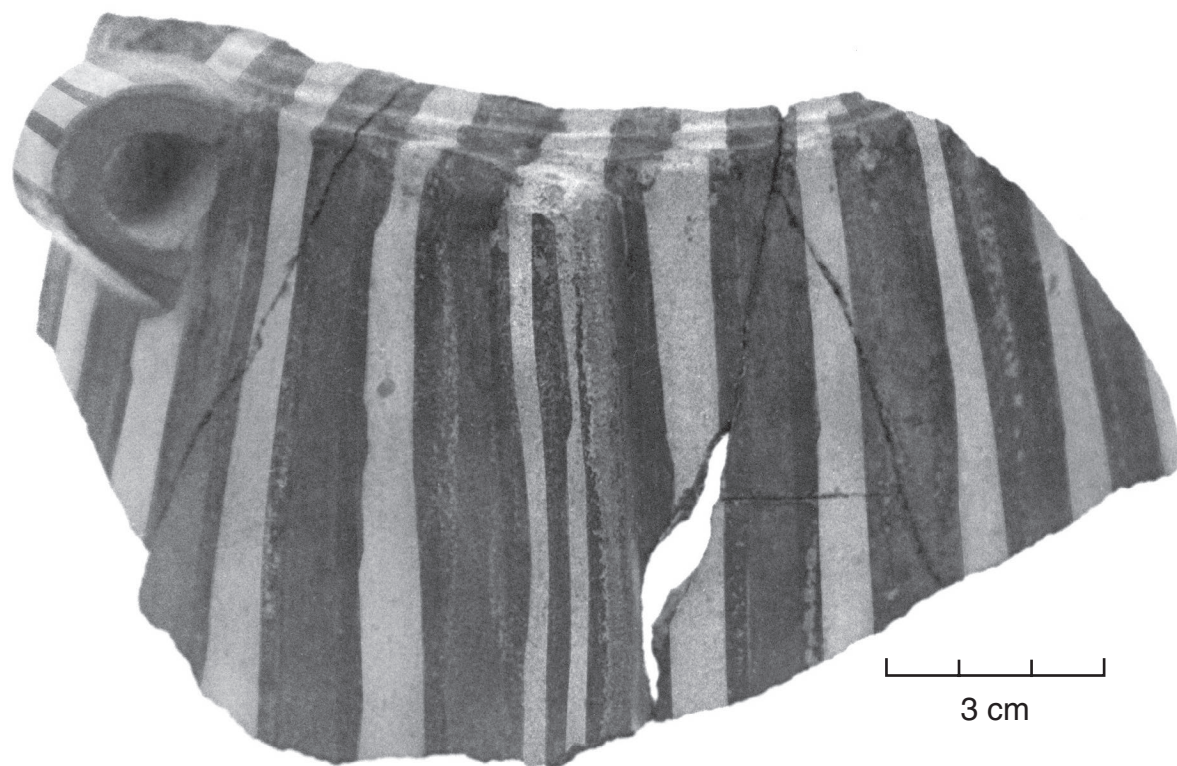
Figure 3.31. Conjoining sherds from a vessel made with the atypical orange variety of Pingüino Buff, found in Room 5 of Structure 9. This vessel appears to have been painted in imitation of the typical Late Intermediate brown-and-white-striped burial wrappings. On such wrappings, *algodón pardo* alternates with *algodón blanco*.

Figures 3.31 and 3.32 illustrate a few of the vessels from Cerro Azul that are atypical either in paste or decoration. The vessel in Figure 3.31 is made with the atypical orange variety of Pingüino Buff. It is painted in a style common to burial wrappings of the Late Intermediate period: alternating brown and white stripes. In the case of the burial wrappings, the effect is created without dye, simply by alternating the yarn of two local types of cotton, *algodón pardo* (brown) and *algodón blanco* (white).

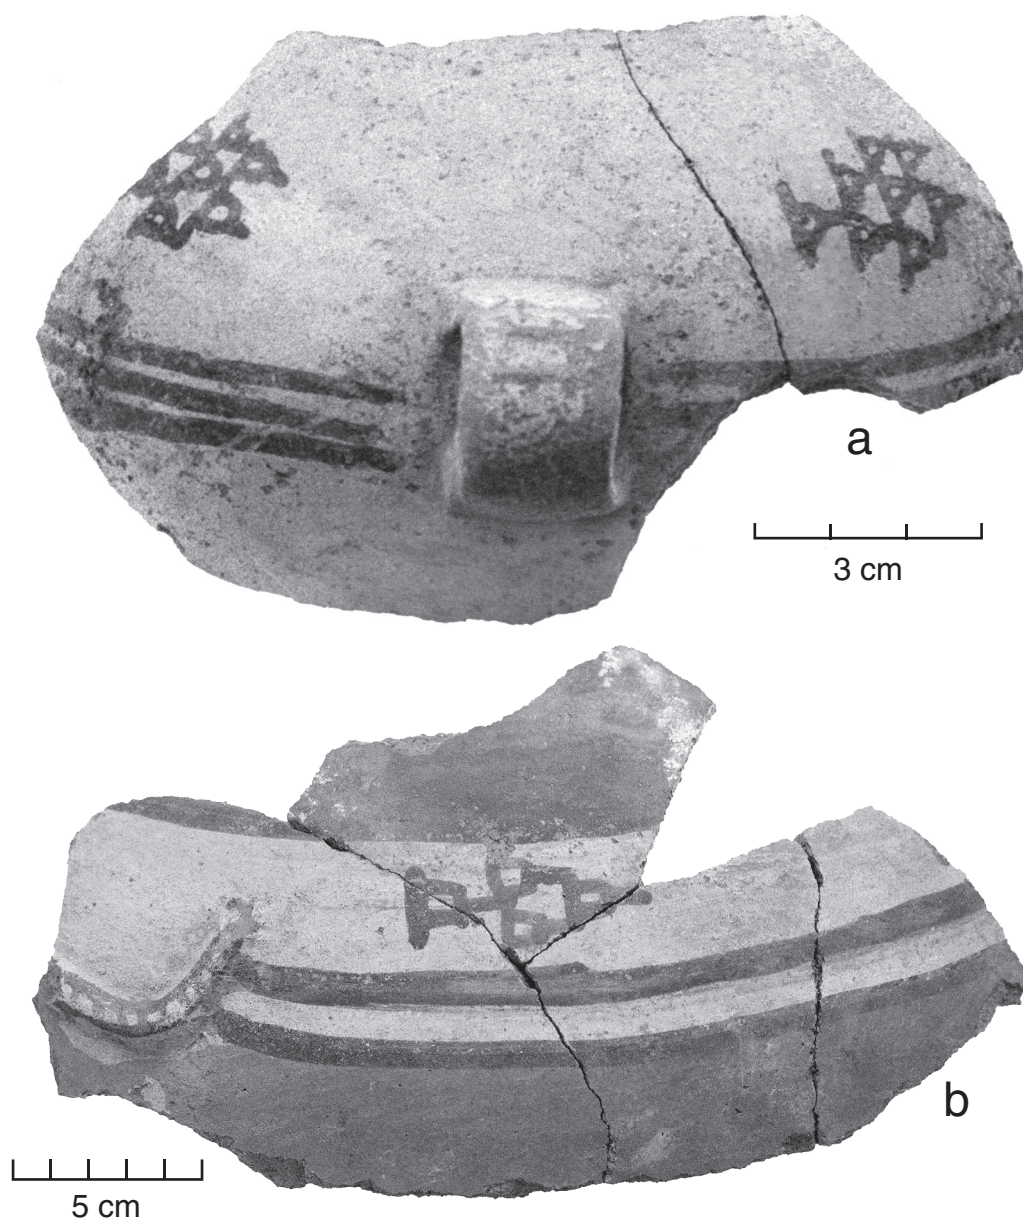
Figure 3.32. Vessels painted in Pingüino Buff style, but with atypical paste. Both feature the “school of fish” motif. (*a*): found in Room 5 of Structure 9, this is painted in black over a cream slip and has paste similar, but not identical, to that used for Trambollo Burnished Brown; (*b*): from an ash-filled hollow in the floor of the Northeast Cancón, Structure D; this is made on Camacho Reddish Brown paste, but painted in black/white/red as if it were Pingüino Buff.

The two jars shown in Figure 3.32 are painted in typical Pingüino Buff style but are made from pastes not typical of that type. Figure 3.32a is made on a paste similar to that of Trambollo Burnished Brown, while Figure 3.32b is made on Camacho Reddish Brown paste but is painted as if it were a Pingüino Buff vessel. Both jars in

Figure 3.32 feature the “school of fish” motif, which is often found on Pingüino Buff.

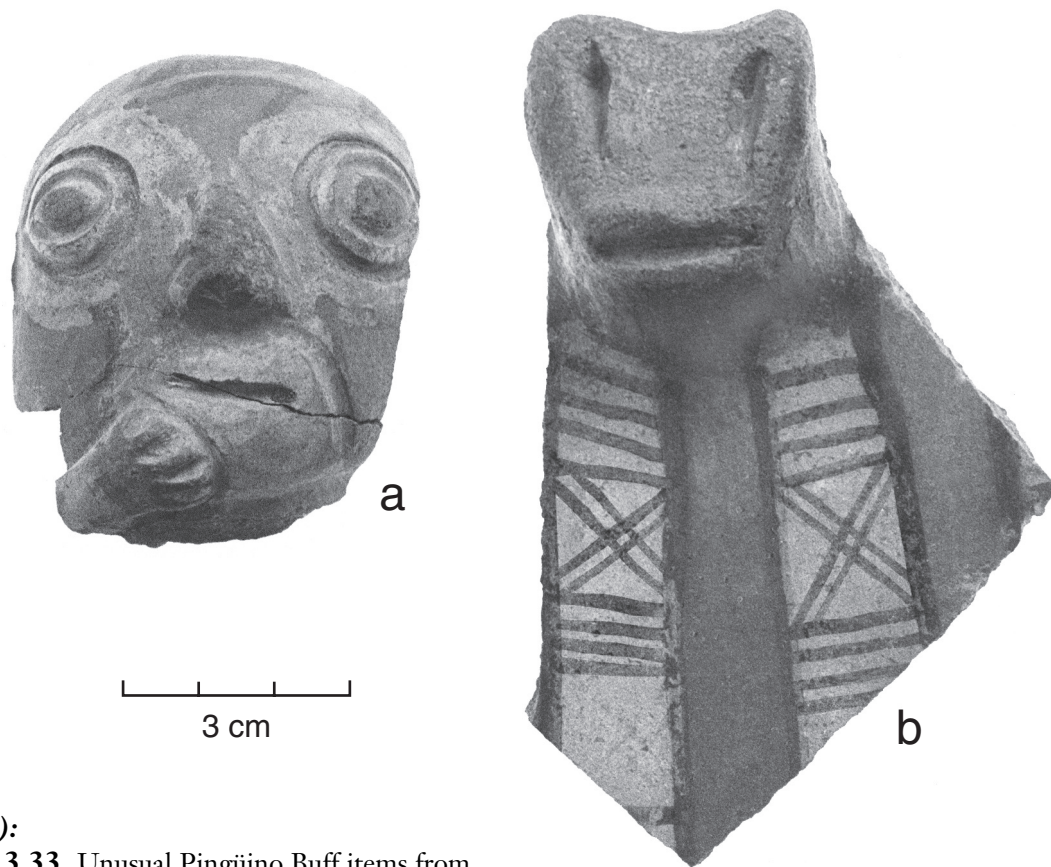
Figure 3.33. Unusual Pingüino Buff items from Feature 4, a Late Horizon *kincha* hut built atop Structure D. (a): three dimensionally modeled head from an effigy vessel of some kind, painted black/white/red; (b): sherd from a local imitation of an Inka *aryballos*, with a modeled lug and areas painted in black/white/red.

Finally, we come to a series of vessels whose shape or decoration I consider to fall relatively late in the occupation of Cerro Azul. The two specimens shown in Figure 3.33 came from Feature 4, a Late Horizon *kincha* hut built in a

patio of Structure D after the Late Intermediate occupation of that building had ended (Chapter 5). Figure 3.33b is a sherd from a Pingüino Buff imitation of an Inka *aryballos*, complete with a three-dimensionally modeled lug. Figure 3.33a is a three-dimensionally modeled human head from an effigy vessel of some kind. Neither vessel in Figure 3.33 is typical of the Late Intermediate.

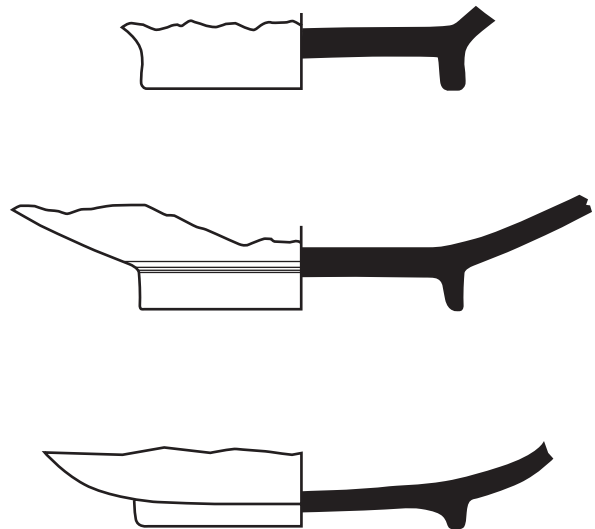
Figure 3.34. Ring bases on Pingüino Buff vessels seem to have been a relatively late attribute, only occurring toward the end of the Late Intermediate and continuing into the Late Horizon.

Globular jars with tightly rolled rims in the highly burnished variety of Camacho Black are also more typical of the Late Horizon. Another relatively late attribute of Cerro Azul pottery is the *low annular base* (or “ring base”). Such bases occur at the very end of the Late Intermediate period and continue into the Late Horizon and early Colonial period (Figure 3.34).

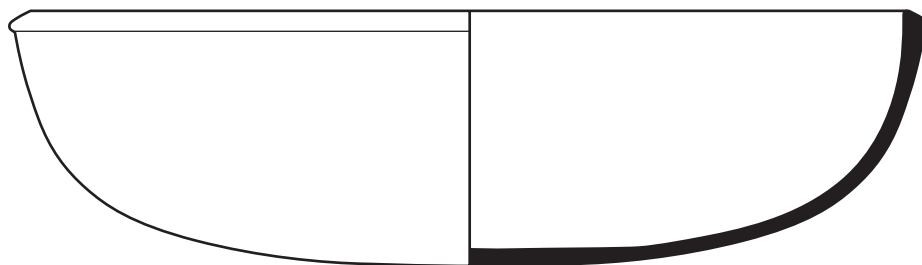
Figure 3.35. The most common vessel form in Trambollo Burnished Brown was a hemispherical bowl closely resembling a *mate*, or gourd bowl.

Figures 3.35 and 3.36 present the most common vessel shape in which Trambollo Burnished Brown appears: a hemispherical bowl that is about the right size for an individual serving. Except for its slightly cambered rim, there is little to distinguish it from a gourd vessel of the same size.

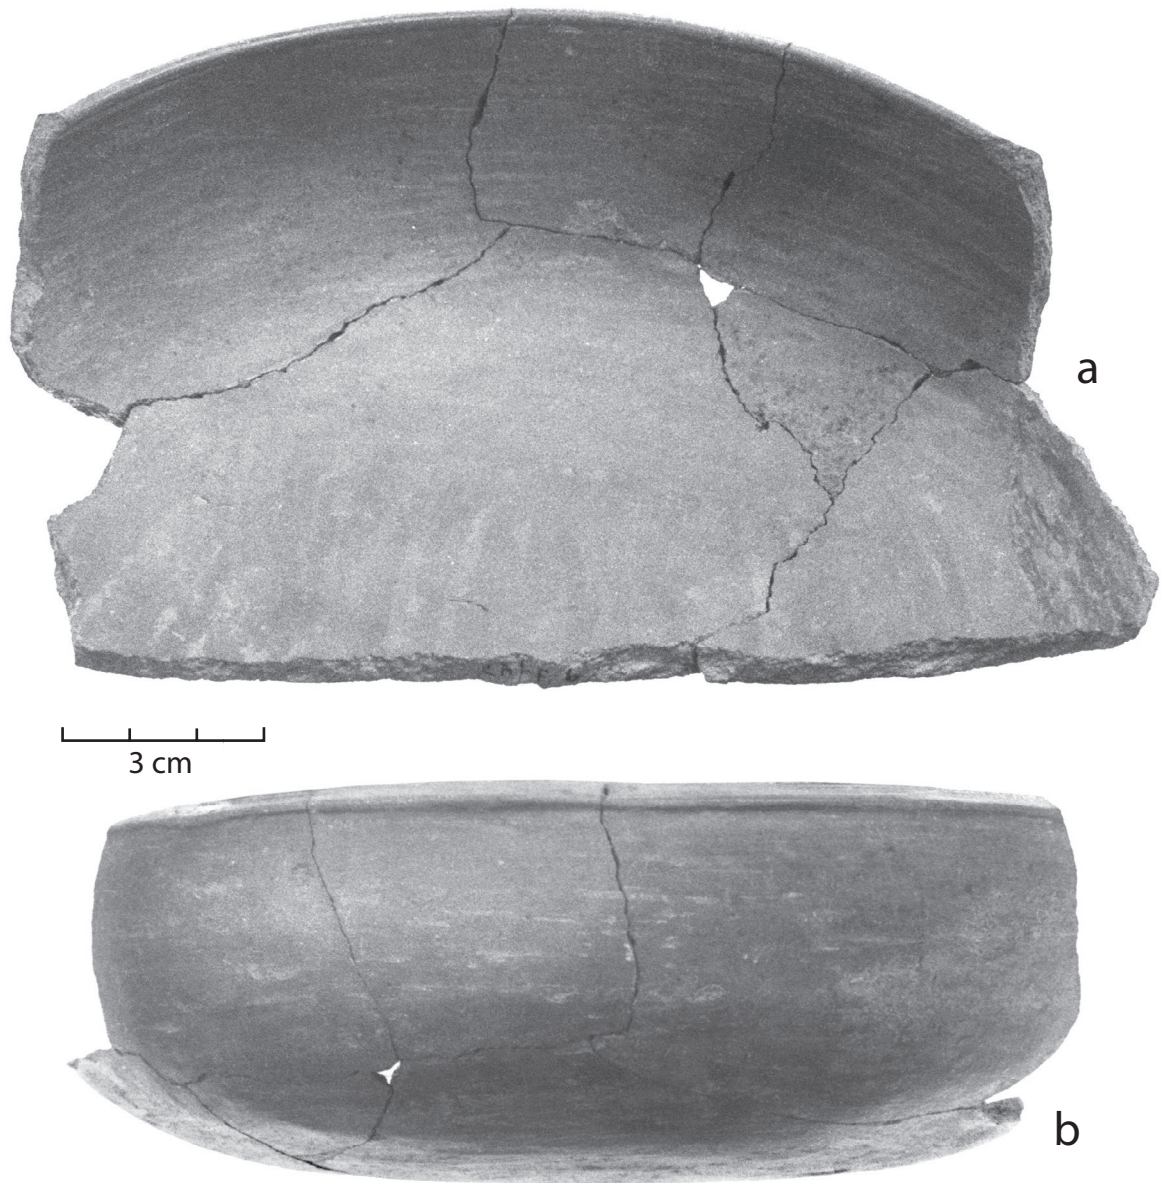
Figure 3.36. Two views of a typical Trambollo Burnished Brown hemispherical bowl from Feature 6 of Structure D.

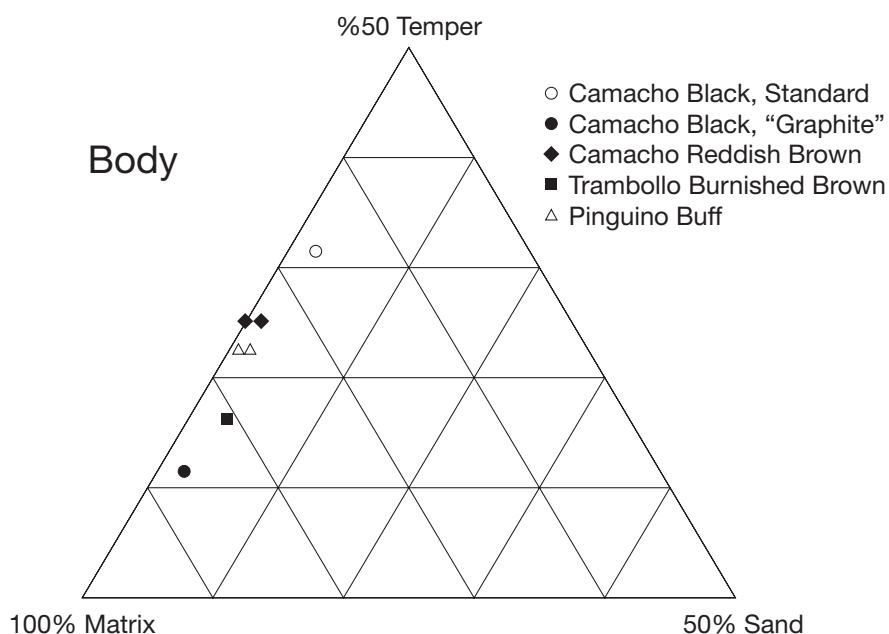
Figure A.2. Ternary graph comparing types/varieties of Cerro Azul pottery with regard to matrix (clay), sand (natural inclusions of sand size), and temper (added by humans) in the body. The main variable is temper, since the kind, amount, and size of temper particles reflect conscious decision making on the part of the potter (see text).

Before proceeding to the individual thin sections, let us examine Figures A.1–A.3, which present the basic data for all seven Cerro Azul pottery types/varieties in terms of their percentages of ingredients and aplastic grain sizes. Overall, it can be said that the basic clay for all seven varieties of ceramics is relatively clean—less than 10% silt and less than 5% sand (Figures A.1 and A.3). The standard variety of Camacho Black has the greatest amount of temper (about 30%), while the highly burnished (“graphite”) variety of that same type has the least (about 10%). Trambollo Burnished Brown has the second smallest amount of temper (16%), while the remaining four varieties tend to have 22%–25% temper (Figure A.2).

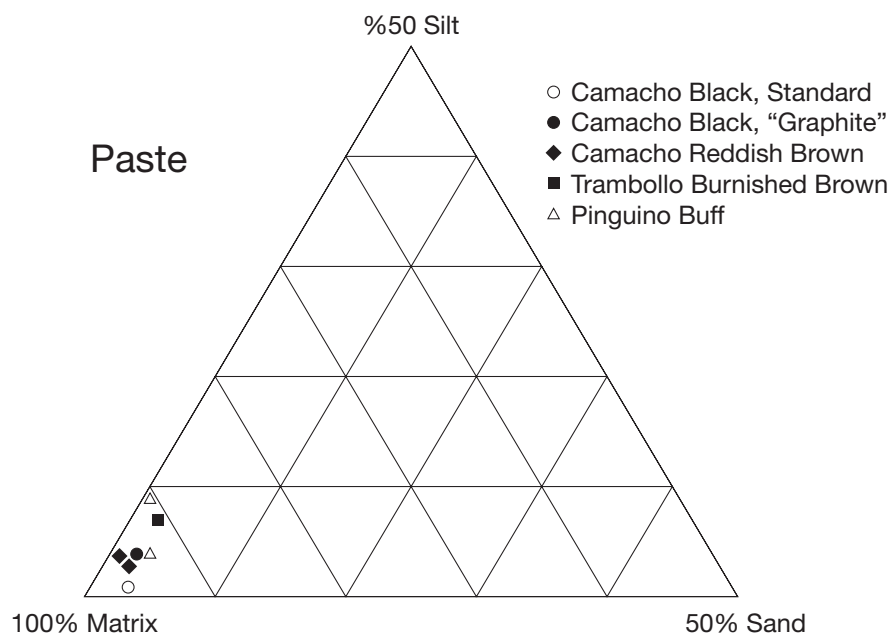
Figure A.3. Ternary graph comparing types/varieties of Cerro Azul pottery with regard to matrix, silt, and sand in the paste (the natural clayey sediment from which the vessels were made). Excluded from this graph is the temper added by humans. While all thin sections show paste values of greater than 90% matrix, less than 10% silt, and less than 5% sand, the atypical orange variety of Pinguino Buff has the siltiest paste (8%). When one combines this difference in paste with its orange color and the fact that the temper is granodiorite/dacite rather than latite, there are grounds for viewing this atypical variety as of non-local derivation (see text).

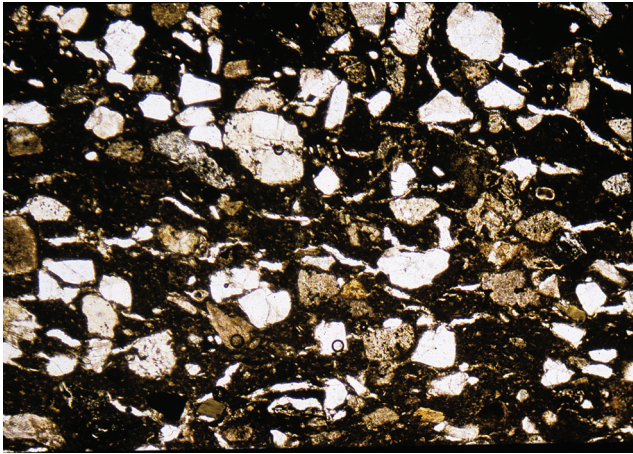
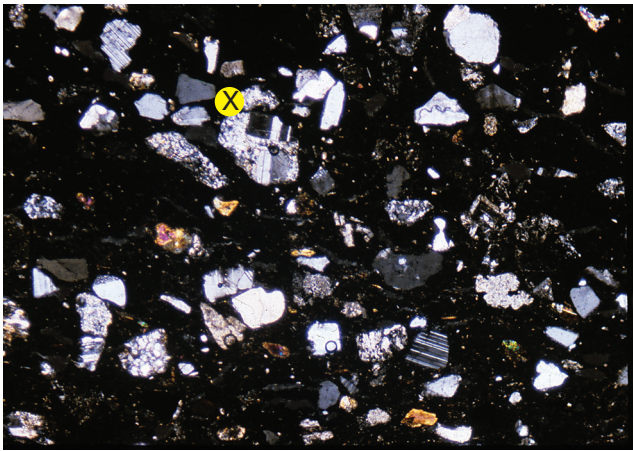
Figure A.4. Two views of a thin section of Camacho Black, standard variety. (*Top*): Under plane polarized light. (*Bottom*): Under cross-polarized light. This pottery type features latite temper. The large particle marked with an “x” (*bottom*) contains multiple plagioclase crystals in a fine-grained groundmass and measures 0.475 mm. Note that its structure appears clearer under cross-polarized light.
