MONOGRAPH 62
COTSEN INSTITUTE OF ARCHAEOLOGY
UNIVERSITY OF CALIFORNIA, LOS ANGELES

EXCAVATIONS AT
CERRO AZUL, PERU
THE ARCHITECTURE AND POTTERY
JOYCE MARCUS

Excavations at Cerro Azul, Peru

THE ARCHITECTURE AND POTTERY

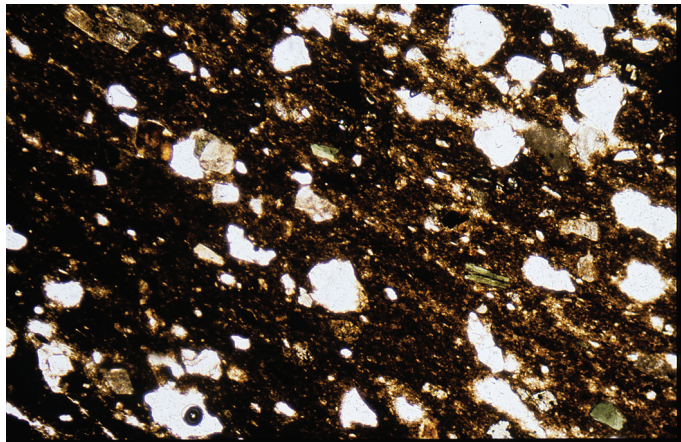
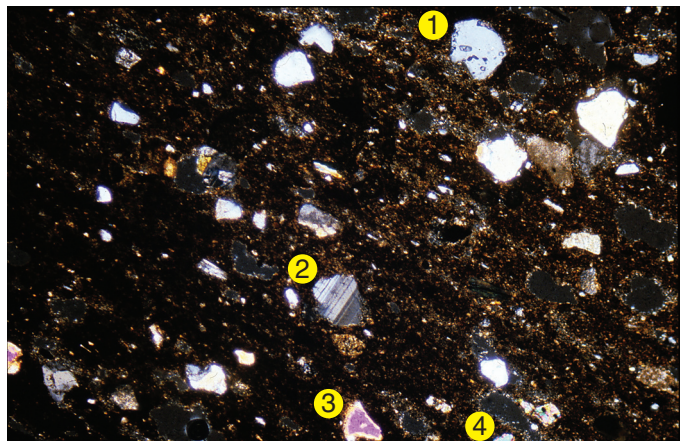
Figure A.6. Two views of a thin section of a standard Camacho Reddish Brown cooking vessel. (*Top*): Under plane polarized light. (*Bottom*): Under cross-polarized light. This pottery type features latite temper. Under cross-polarized light (*bottom*) can be seen (1) four plagioclase phenocrysts in a dark, nearly opaque groundmass measuring 0.675 mm; (2) greenish colored amphibole; and (3) a rock fragment containing both plagioclase and alkali feldspar in a dark groundmass.

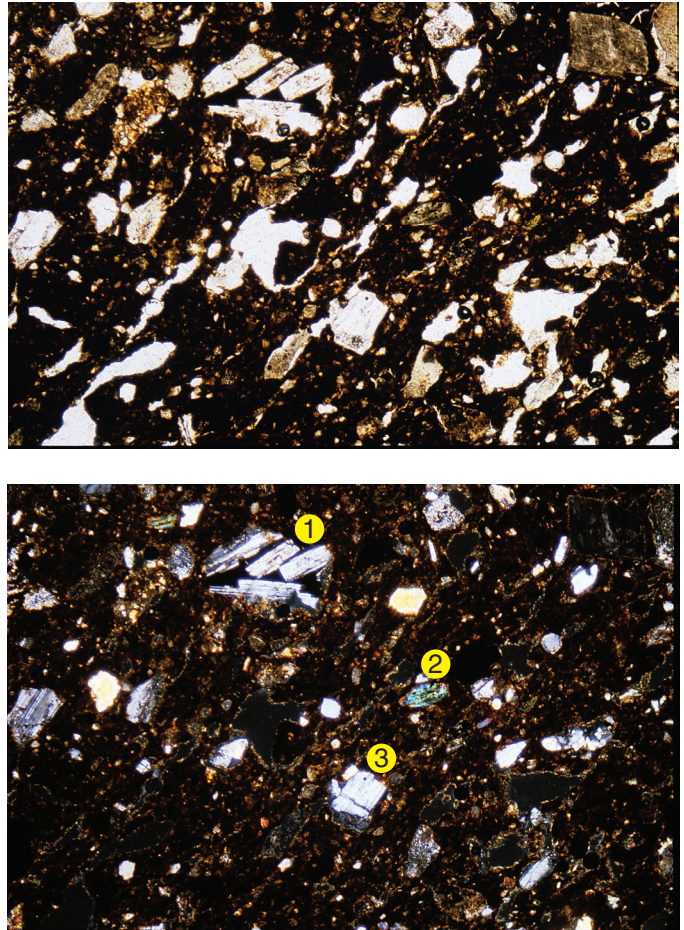
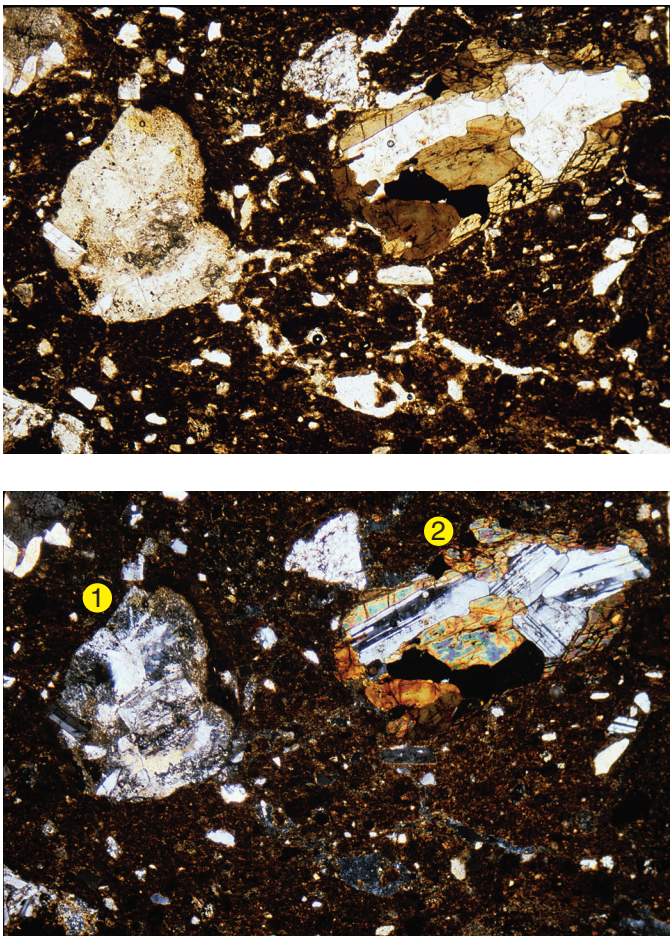
Figure A.7. Two views of a thin section of the coarser version of Camacho Reddish Brown used for *batun maccma*, or massive storage jars. (*Top*): Under plane polarized light. (*Bottom*): Under cross-polarized light. The very large vessel analyzed here appears to have contained coarse tempers of multiple origins. The two numbered temper particles (*bottom*) are (1) a 1.125-mm piece of rhyolite, a cryptocrystalline rock with quartz and sanidine phenocrysts; and (2) a 1.725-mm piece of diorite containing twinned plagioclase and both brown amphibole and black opaques.

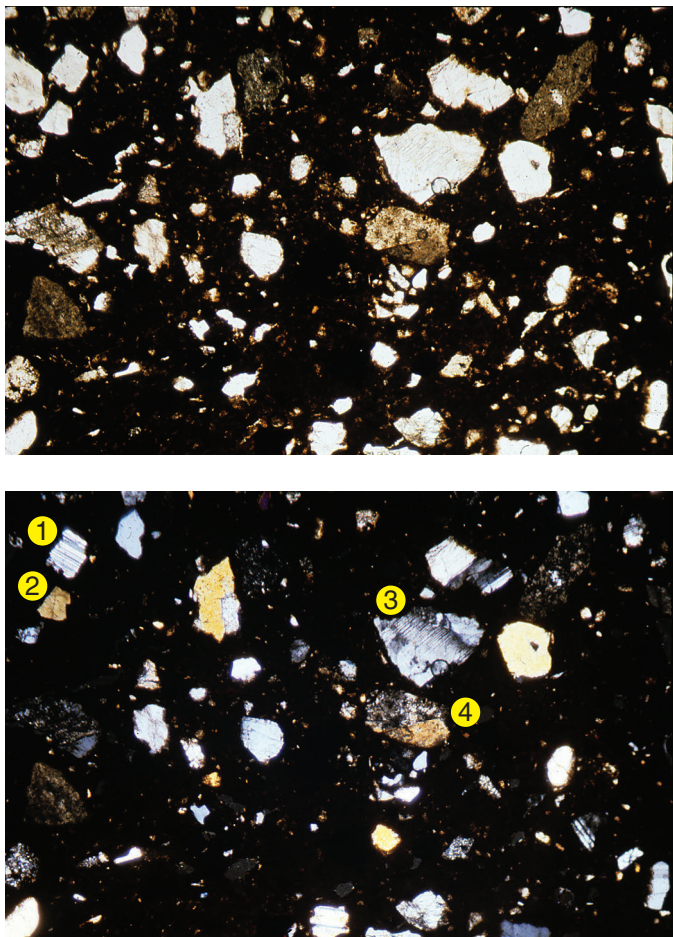
Figure A.8. Two views of a thin section of a standard Pingüino Buff painted vessel. (*Top*): Under plane polarized light. (*Bottom*): Under cross-polarized light. This pottery type features latite temper. Four particles of interest have been numbered in the cross-polarized photo (*bottom*). They are (1) twinned plagioclase; (2) sanidine, a twinned alkali feldspar, whose other half is visible under plane polarized light; (3) a grain of plagioclase and alkali feldspar measuring 0.6 mm; and (4) a fragment of cryptocrystalline groundmass.

Pingüino Buff, Standard Variety (Figure A.8)

Pingüino Buff, the distinctive black-and-white or polychrome painted ware at Cerro Azul, has latite

temper. This temper makes up 22% of the body and has a size index of 1.67. The largest grain in the photomicrographs, marked “3,” measures 0.6 mm and is composed of plagioclase and alkali feldspar. Other grains marked in the photos are twinned plagioclase (“1”), sanidine (“2”), and a fragment of cryptocrystalline groundmass (“4”).

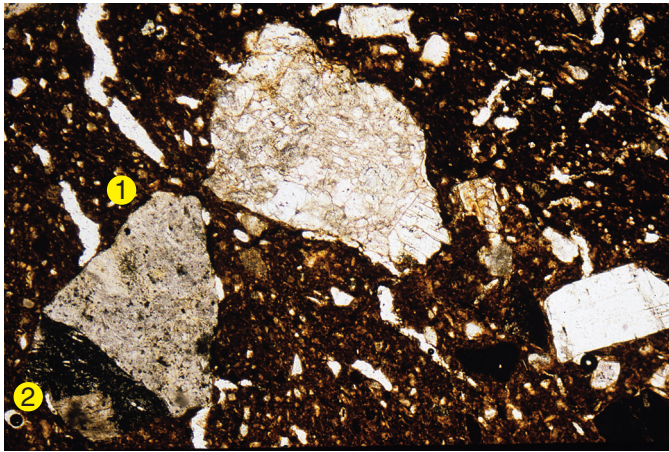
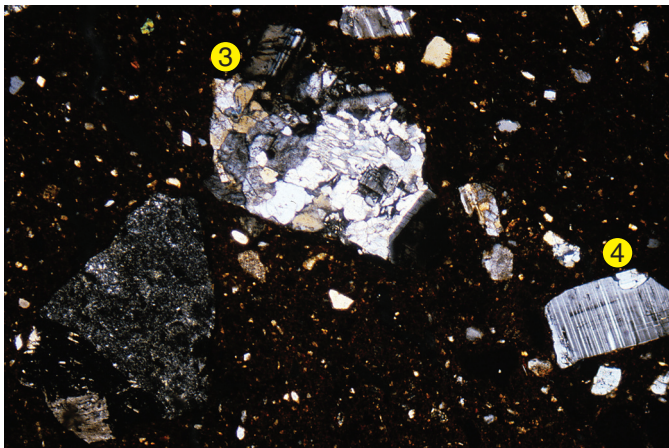
Figure A.9. Two views of a thin section of the atypical orange variety of Pingüino Buff. (*Top*): Under plane polarized light. (*Bottom*): Under cross-polarized light. This variety, which may be nonlocal, features dacitoid-granitoid temper rather than latite. The particle marked "1" (*top*) is a 1.325-mm piece of what appears to be dacite, incorporating a plagioclase phenocryst (2) in a dark groundmass which has both cryptocrystalline and glassy areas. Under cross-polarized light (*bottom*) we see (3) a 1.5-mm grain of granodiorite and (4) a piece of polycrystalline plagioclase.

It is interesting to compare standard Pingüino Buff to its atypical orange variety. Standard Pingüino Buff, presumably made locally with latite-derived temper, has an average temper grain size index of only 1.67. The atypical orange variety, possibly made elsewhere with granodiorite-and-dacite-derived temper, has a much larger temper grain size (index, 2.44). Thus, several variables—Munsell color, overall appearance, temper size, and mineralogical origin—suggest that the atypical orange variety is indeed nonlocal.

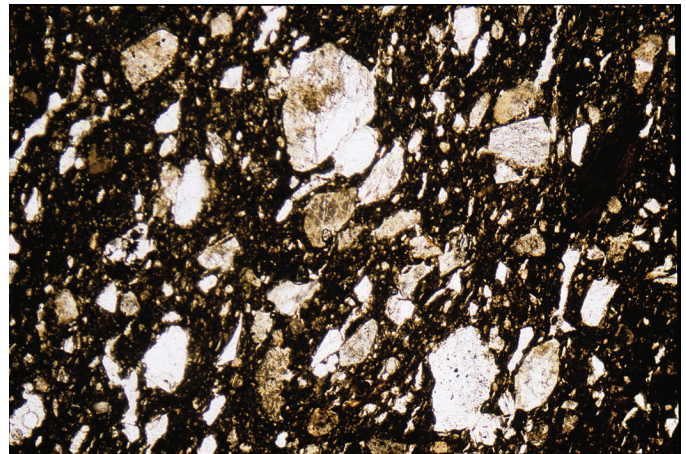
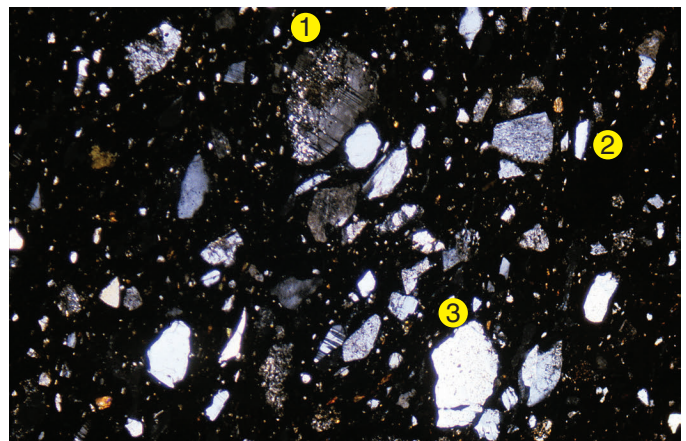
Figure A.10. Two views of a thin section of Trambollo Burnished Brown. (*Top*): Under plane polarized light. (*Bottom*): Under cross-polarized light. This pottery type features latite temper. The particle numbered "1" is a grain of altered plagioclase with sericite measuring 0.675 mm. In the cross-polarized photo (*bottom*), we see (2) a piece of biotite measuring 0.70 mm, which appears nearly opaque; and (3) a large clear grain of quartz measuring 0.575 mm.

Trambollo Burnished Brown (Figure A.10)

This ware, used mainly for hemispherical bowls resembling gourd vessels, has latite temper. Its temper is fine (index, 1.50) and makes up only 18% of the body. In the photomicrographs, the largest grain (marked “1”) is a loose phenocryst of altered plagioclase with sericite. Other grains marked include a clear grain of quartz (“3”) and a piece of biotite (mica) which appears nearly opaque in the thin section (“2”).

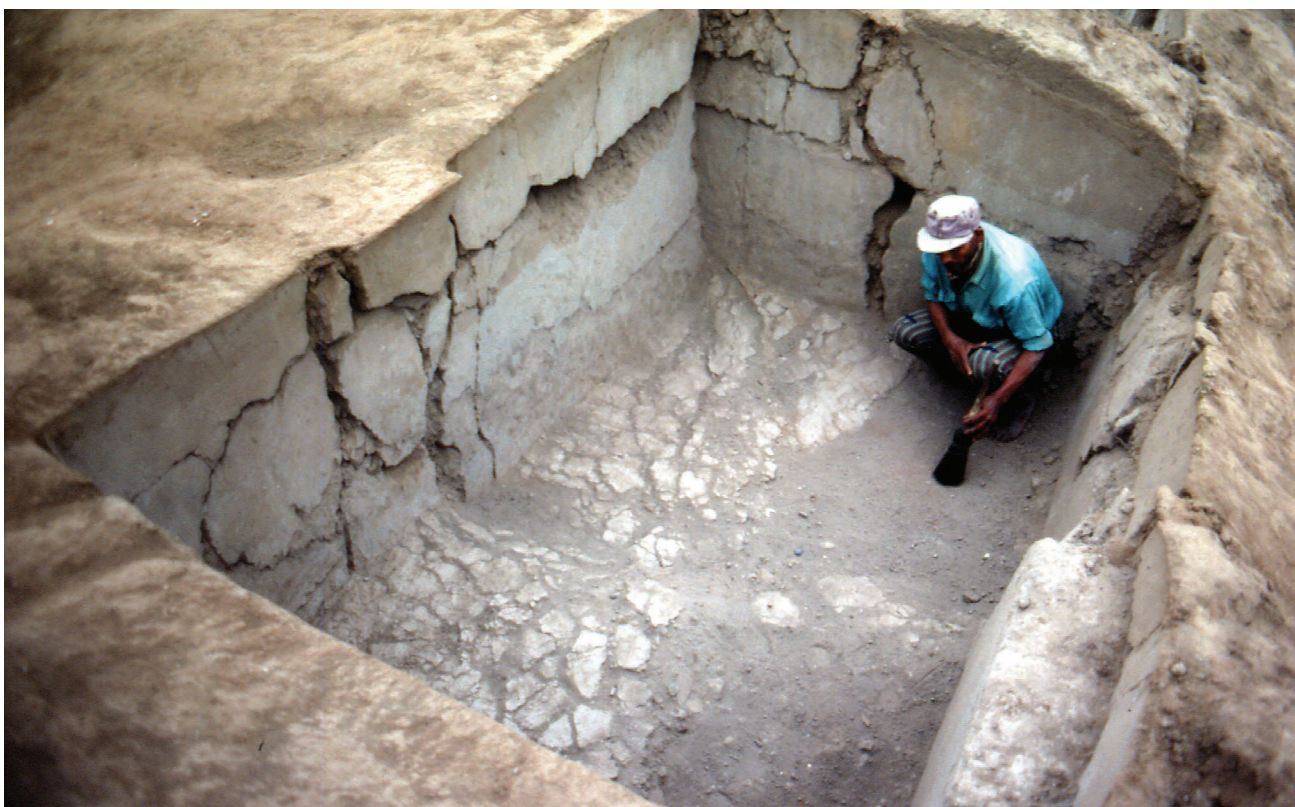
Plate VI. Room 7 of Structure D, a storage room that suffered earthquake damage (Chapter 7)

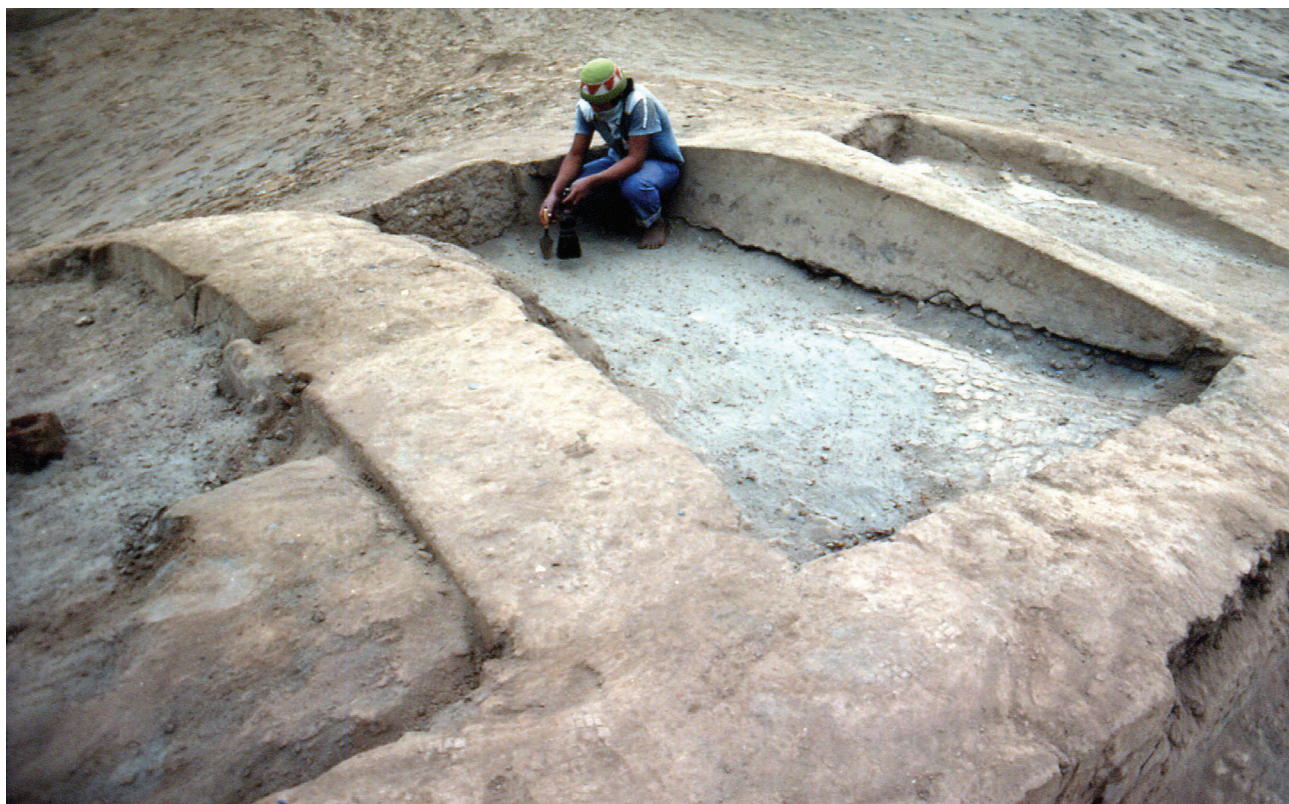
Plate XI. Rooms 2, 3, and 4 of Structure 9, showing the effects of long-term wind erosion on the tapia walls (Chapter 8)

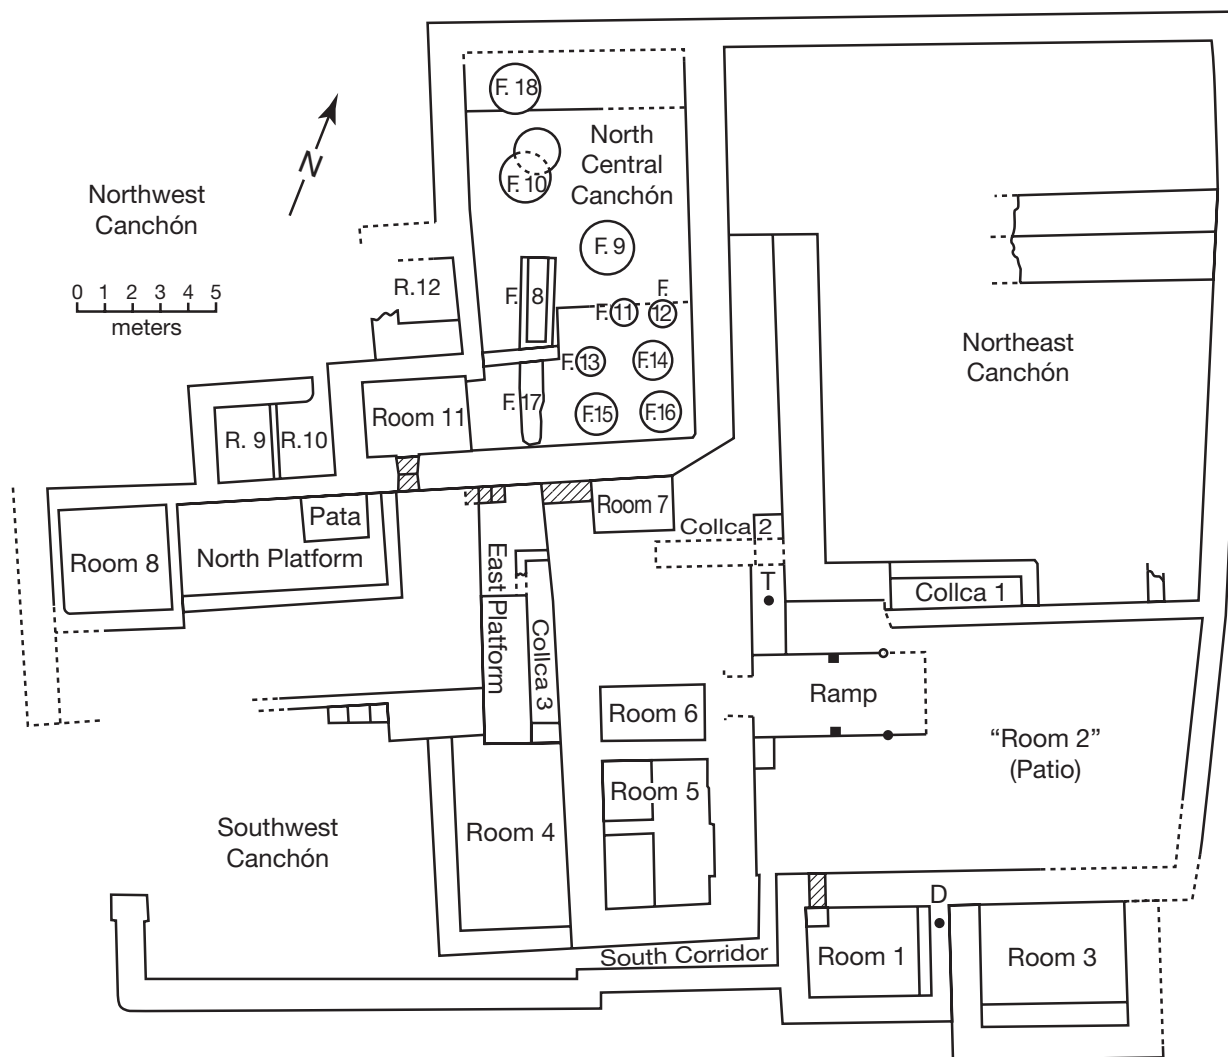
Figure 4.1. Ground plan of Structure D at Cerro Azul. R. = Room. F. = Feature. T = Alidade station. D = Datum point established on the building's highest spot. Blocked doorways and corridors are shown as hachured. The dashed-line area near Collca 2 is a looter's trench; other dashed-line areas indicate wind erosion.

After preparing a preliminary plan that showed every wall visible after sweeping, we established two permanent datum points. One, marked T on Figure 4.1, lay on a flat surface near the center of the building, where the tripod for our alidade could be set up. Our cartographer, Dr. Charles M. Hastings, had determined that this point could be seen from the other compounds for the purposes of triangulation and mapping. The alidade station turned out to be approximately 20.3 m above sea level.

The second datum point, marked D on Figure 4.1, was the actual high point of the building. While not sufficiently level to support a tripod, it served as the arbitrary "zero point" from which all depths of floors and features in Structure D could be taken. We drove a permanent stake made from steel reinforcing rod into point D. All depths below datum given in this volume refer to the top of this stake.

By the time the excavation was completed, we were in a position to interpret Structure D as the residence of an elite family and its support staff (Figure 4.1). We found clear living quarters with built-in sleeping benches; multiple collcas or storage cells; several canchones, or walled but unroofed work areas; a large *chicha* brewery and/or kitchen; places where weaving had been carried out; rooms

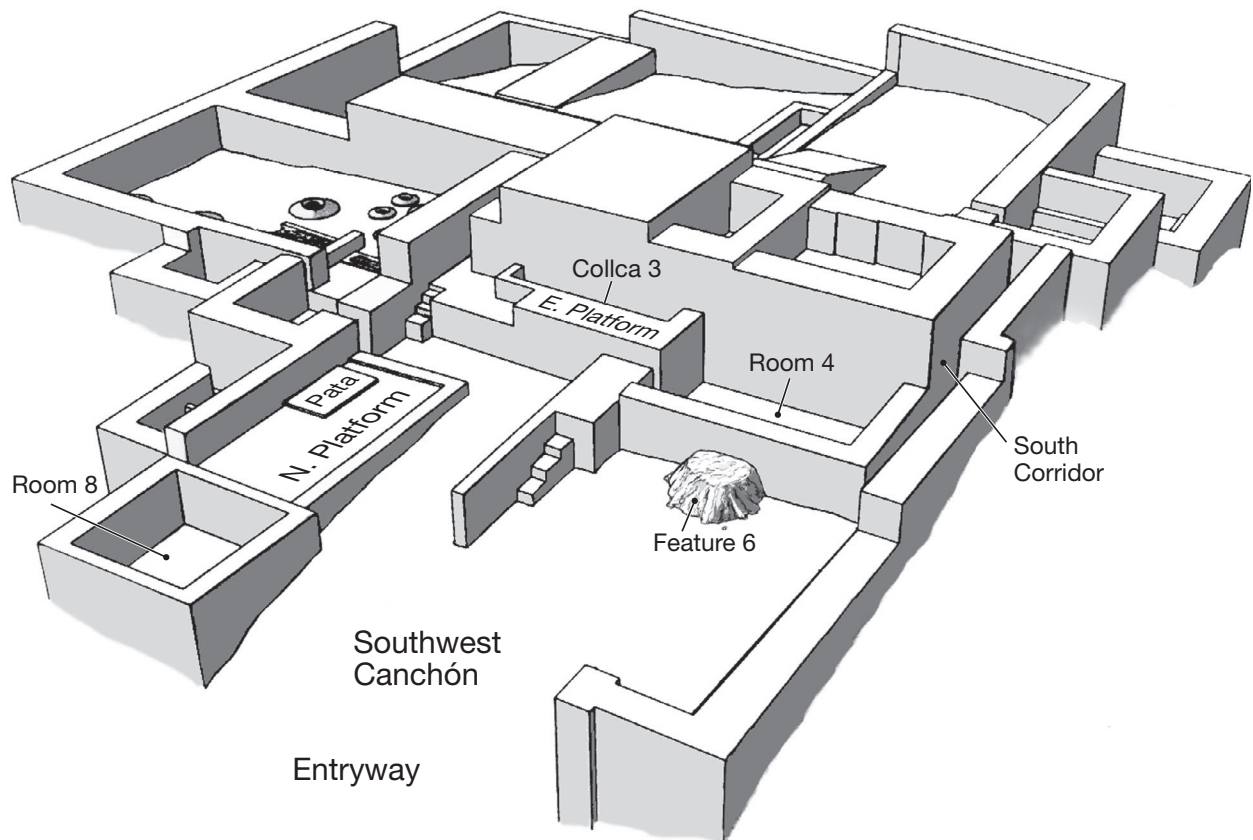
Figure 4.3. Artist's conception of the southwest quadrant of Structure D.

Figure 4.3 shows an artist's conception of the southwest quadrant of Structure D. Visitors to the compound would have passed through a wide entryway into the Southwest Canchón, a large walled enclosure that underwent modifications during the occupation of the building. This canchón might originally have covered an area of some 16 × 17 m but was eventually reduced in size by the creation of Room 4 and several platforms. Its floor was irregular, averaging 3.78 to 4.78 m below datum near the center and sloping down to 5.68 m below datum near the entrance.

There would originally have been two ways to reach the East Platform. One approach was from a stubby wall with an inset three-step stairway, leading east from the middle of the Southwest Canchón (Figure 4.3). We suspect that this stairway, whose middle step was 3.38 m below datum, would have been used by laborers

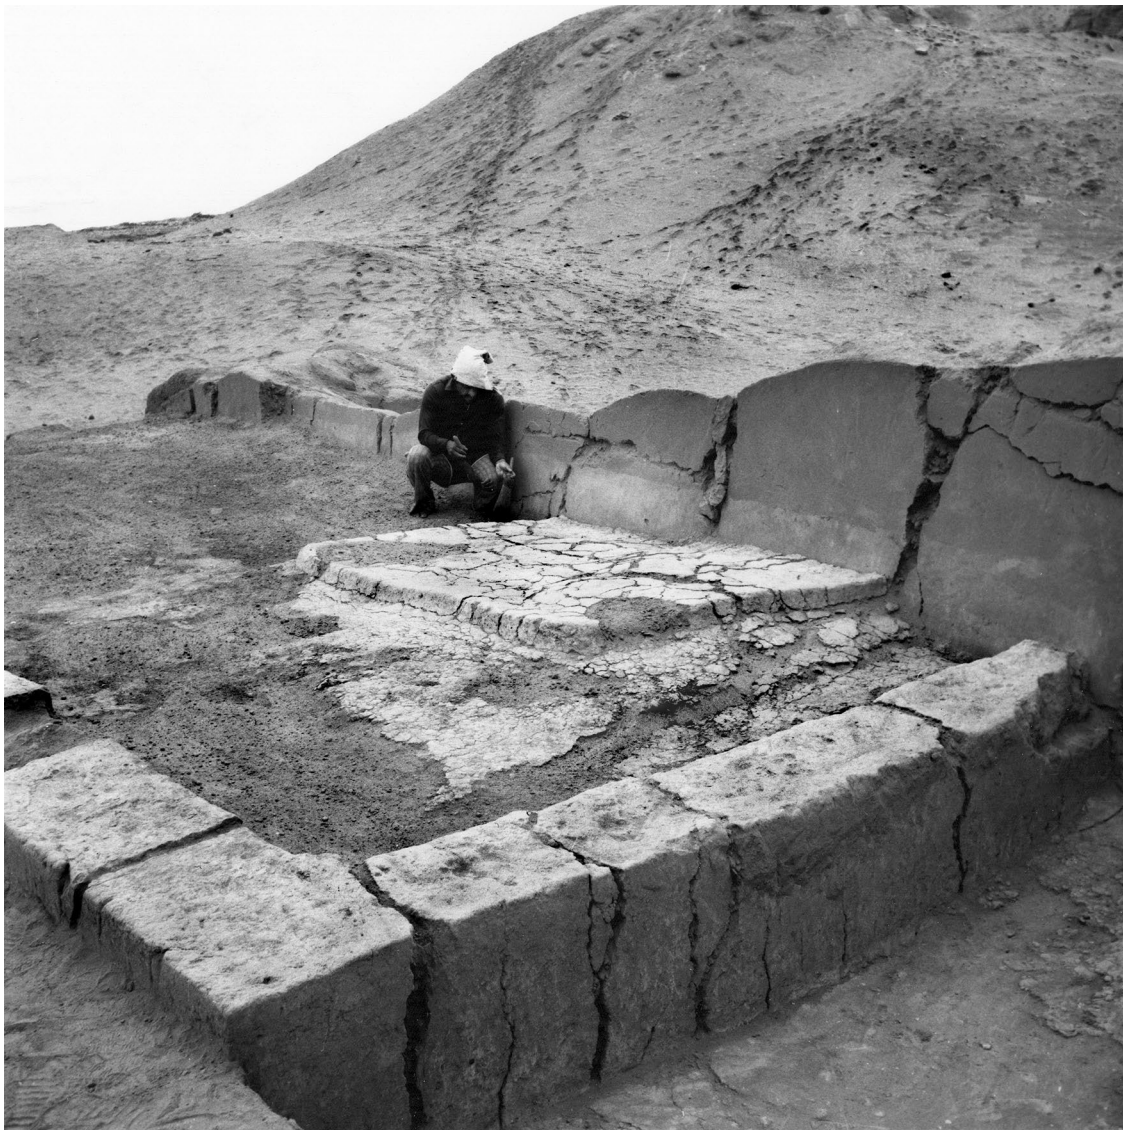
Figure 4.4. The North Platform of the Southwest Canchón, Structure D, seen from the southeast. Pedro Manuel Zavala is sweeping the *llamkana pata*, or raised work platform.

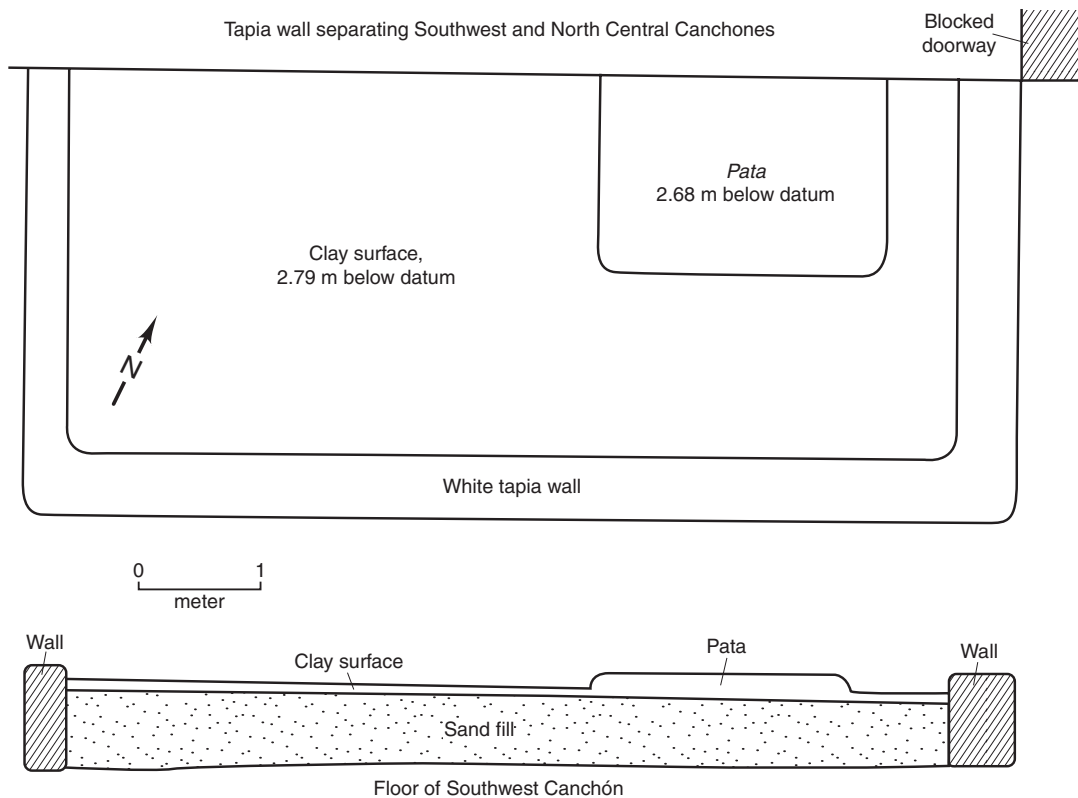
Figure 4.5. Plan and cross section of the North Platform in the Southwest Canchón, Structure D. This platform's most important feature is a *llamkana pata*, or raised work platform.

Atop the North Platform was a smaller raised area that we interpret as a *llamkana pata/puñunu pata* (in Ayacucho Quechua), a working and/or sleeping platform. The *pata* measured 2.38×1.66 m, and its surface lay 2.68 m below datum (Figures 4.5, 4.7). Like the platform below it, the

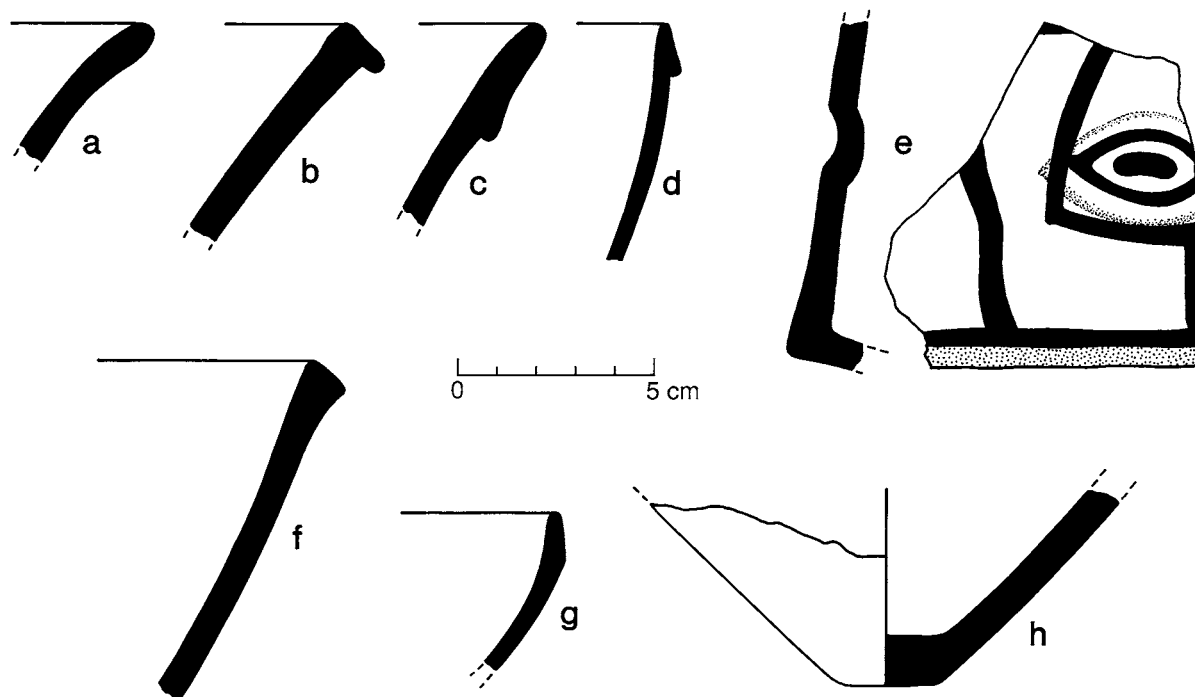
Figure 4.6. Ceramics from the surface of the North Platform in the Southwest Canchón, Structure D, near the *llamkana pata* (raised work platform). Sherds *a–d* are Camacho Reddish Brown jar rims. (*a*): plain rim; (*b*): everted rim; (*c, d*): cambered rims. Sherds *e–h* are Pingüino Buff. (*e*): jar neck with modeled face painted black on natural; the pupil of the eye has been pushed out from the interior; (*f*): jar rim; (*g*): rim of hemispherical bowl, slipped white on interior and exterior, painted black on white on exterior; (*h*): conical base of jar or amphora.

Camacho Reddish Brown (Figure 4.6a–d)

Pingüino Buff (Figure 4.6e–h)

- Jar rims, plain, unpainted: 2
- Jar neck showing face with paint, modeled and painted in black: 1
- Painted jar, black on white: 1 sherd (showing pupil from eye on jar neck?)

Conical base of jar or amphora: 1
Hemispherical bowl rim, slipped white on the interior and exterior, painted black on white on the exterior: 1

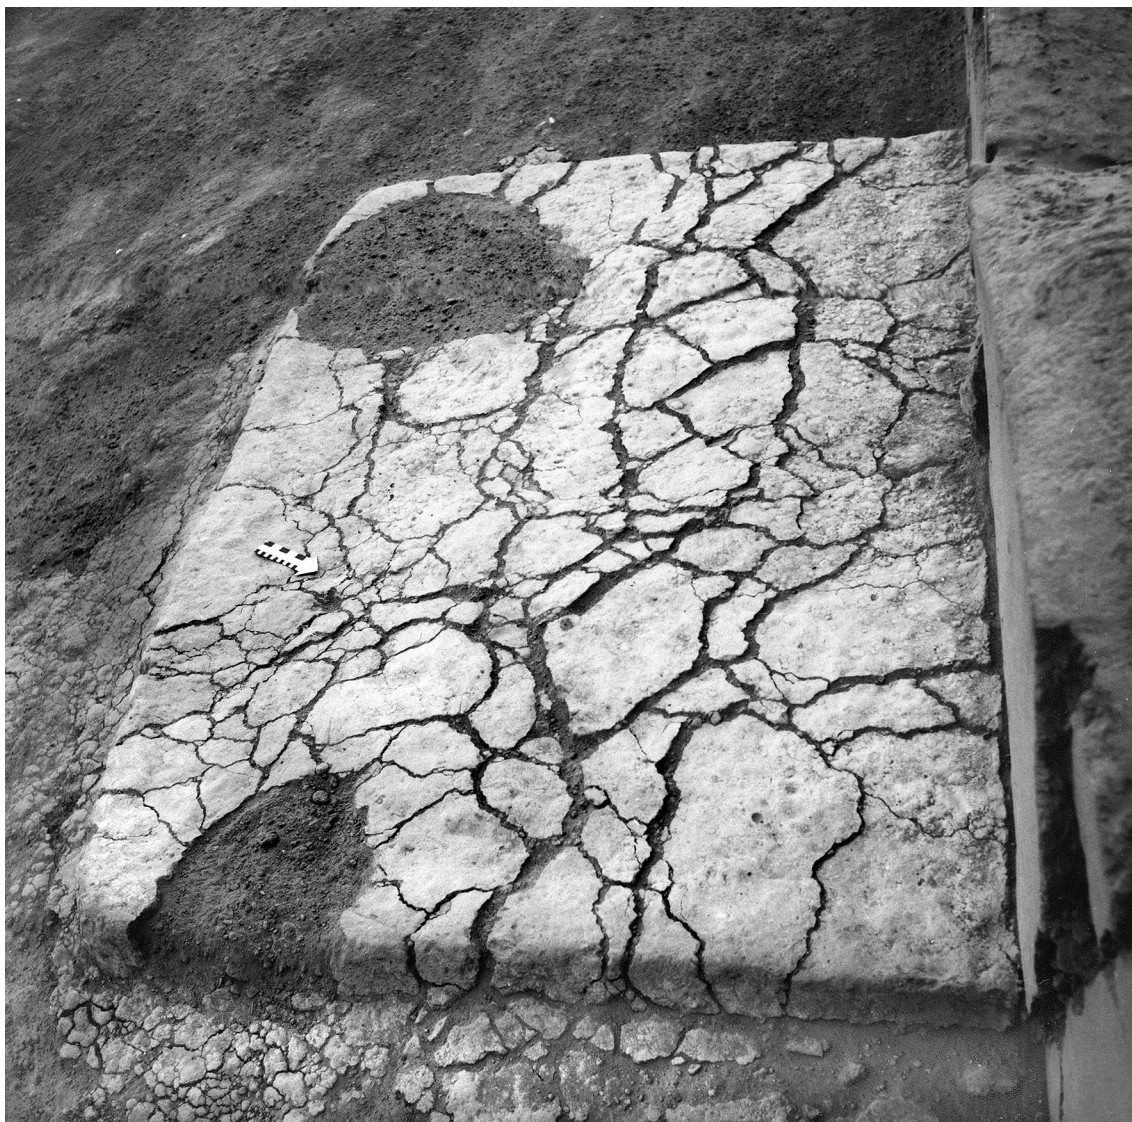
Figure 4.7. The *llamkana pata* atop the North Platform of the Southwest Canchón, Structure D. Measuring 2.38×1.66 m, this *pata* may have been assigned to the person overseeing activities in the Southwest Canchón. The two dark circles represent damage caused by much later intrusive posts (arrow points north).

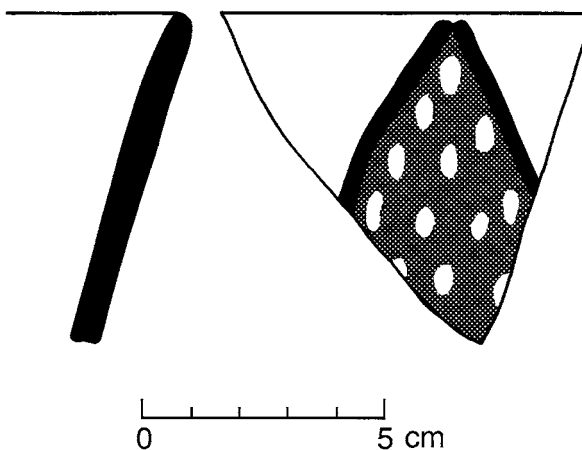
Figure 4.8. Pingüino Buff jar rim sherd, found on the *llamkana pata* (raised work platform) atop the North Platform of the Southwest Canchón, Structure D. The sherd is painted cream, black, and brownish red over its burnished buff exterior; the interior was left unslipped and unpainted. The cream is 10 YR 8/4; the brownish red is 10 R 4/4.

Pingiino Buff (Figure 4.8)

This rim sherd is painted cream (10 YR 8/4), black, and brownish red (10 R 4/4) over burnished buff on the exterior; left unslipped and unpainted on the interior.

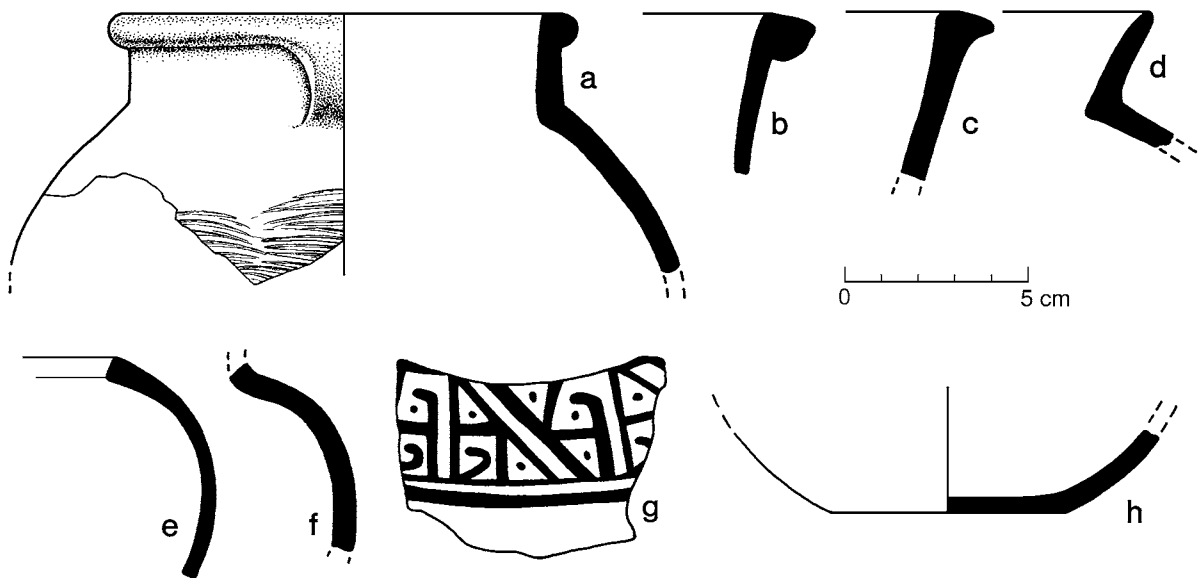
Figure 4.9. Camacho Reddish Brown vessels from the fill above the North Platform of the Southwest Canchón, Structure D. (a): small jar with bolstered rim and strap handle, fire-blackened; the shoulder shows brushing, while the rim is smoothed; (b): bolstered jar rim; (c): everted jar rim; (d): plain jar rim; (e): cooking pot with restricted orifice; (f, g): profile and plan view of atypical jar shoulder, given a band of black-and-white painting usually reserved for Pingüino Buff; (h): jar base which could have come from the vessel shown in f and g.

Camacho Reddish Brown (Figure 4.9)

- Jar with plain rim: 1 (fire-blackened on the exterior)
- Jar with bolstered rim: 1
- Jar with everted rim: 1 rim sherd
- Small jar with bolstered rim, strap handle, and brushed body: 1 rim (fire-blackened on the exterior)
- Cooking pot with restricted orifice: 1 rim
- Jar shoulder with panel of black-and-white decoration: 1
- Basal sherds, possibly from the vessel shown as Figure 4.9f, g: 2

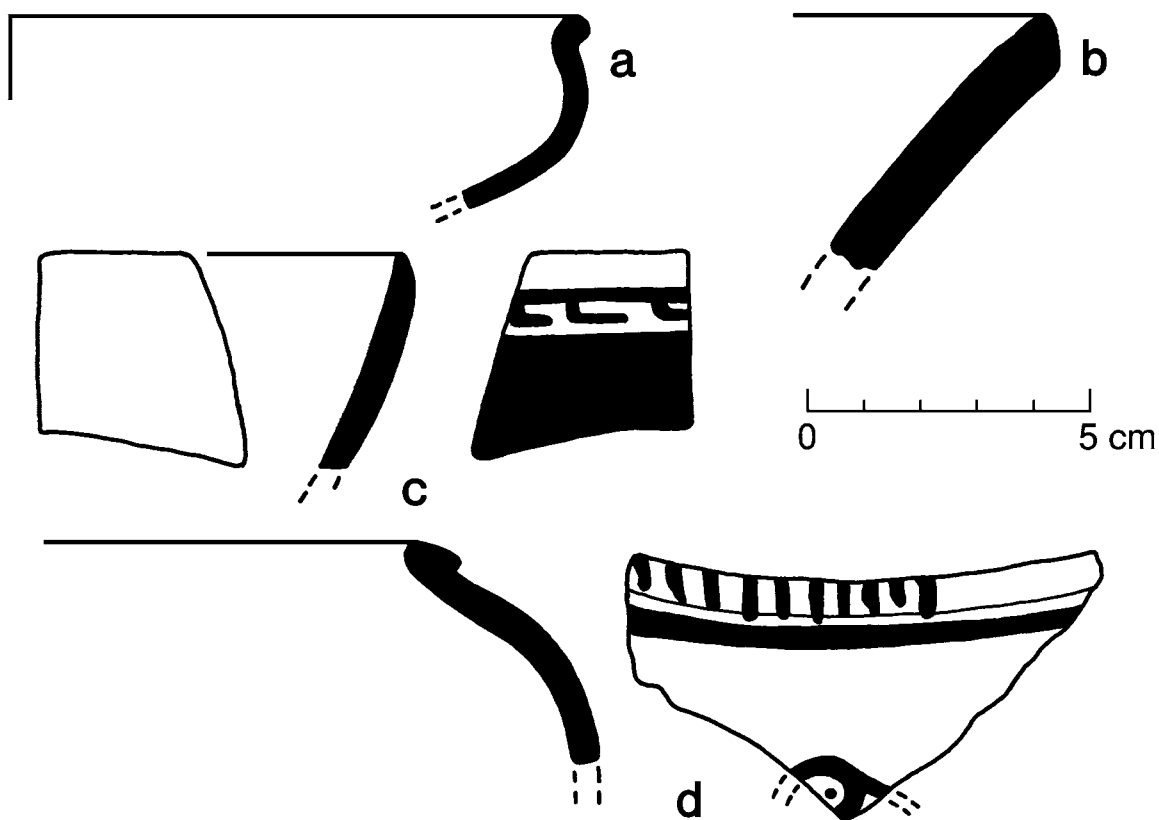
Figure 4.10. Ceramics from the fill above the North Platform of the Southwest Canchón, Structure D. (a): Camacho Black (highly burnished variety) small composite silhouette bowl with rolled rim; (b): Pingüino Buff jar with flaring, slightly beveled rim; (c): Pingüino Buff hemispherical bowl, slipped brilliant white on interior and exterior, then painted black on white on the exterior; (d): Pingüino Buff jar with restricted orifice and rolled rim, painted black and white on the exterior.

Camacho Black (Highly Burnished Variety) (Figure 4.10a)

Pingüino Buff (Figures 4.10b–d, 4.11)

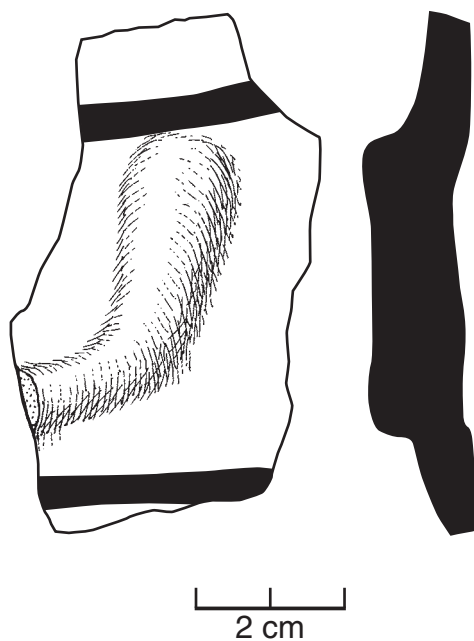
Figure 4.11. Sherd from the neck of a Pingüino Buff jar, showing a modeled human arm in an area painted black and white over natural buff. Found in the fill of the Southwest Canchón, Structure D.

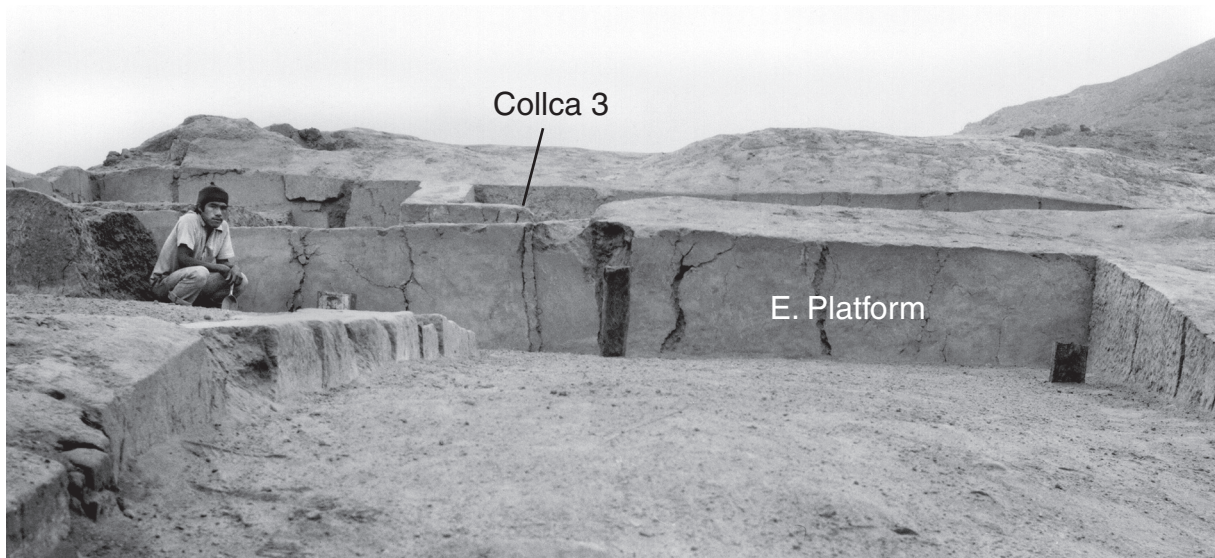
Figure 4.12. The East Platform of the Southwest Canchón, Structure D, seen from the west. The L-shaped wall that created Collca 3 can also be seen. Edgar Zavala squats on the North Platform. (The two wooden posts are from an intrusive *kincha* house built over the ruins of Structure D.)

The East Platform of the Southwest Canchón measured 9.8×2.5 m and included Collca 3, a storage cell that had been created by the addition of an L-shaped wall (Figures 4.12, 4.13). The original surface of the East Platform was 1.95 m below datum.

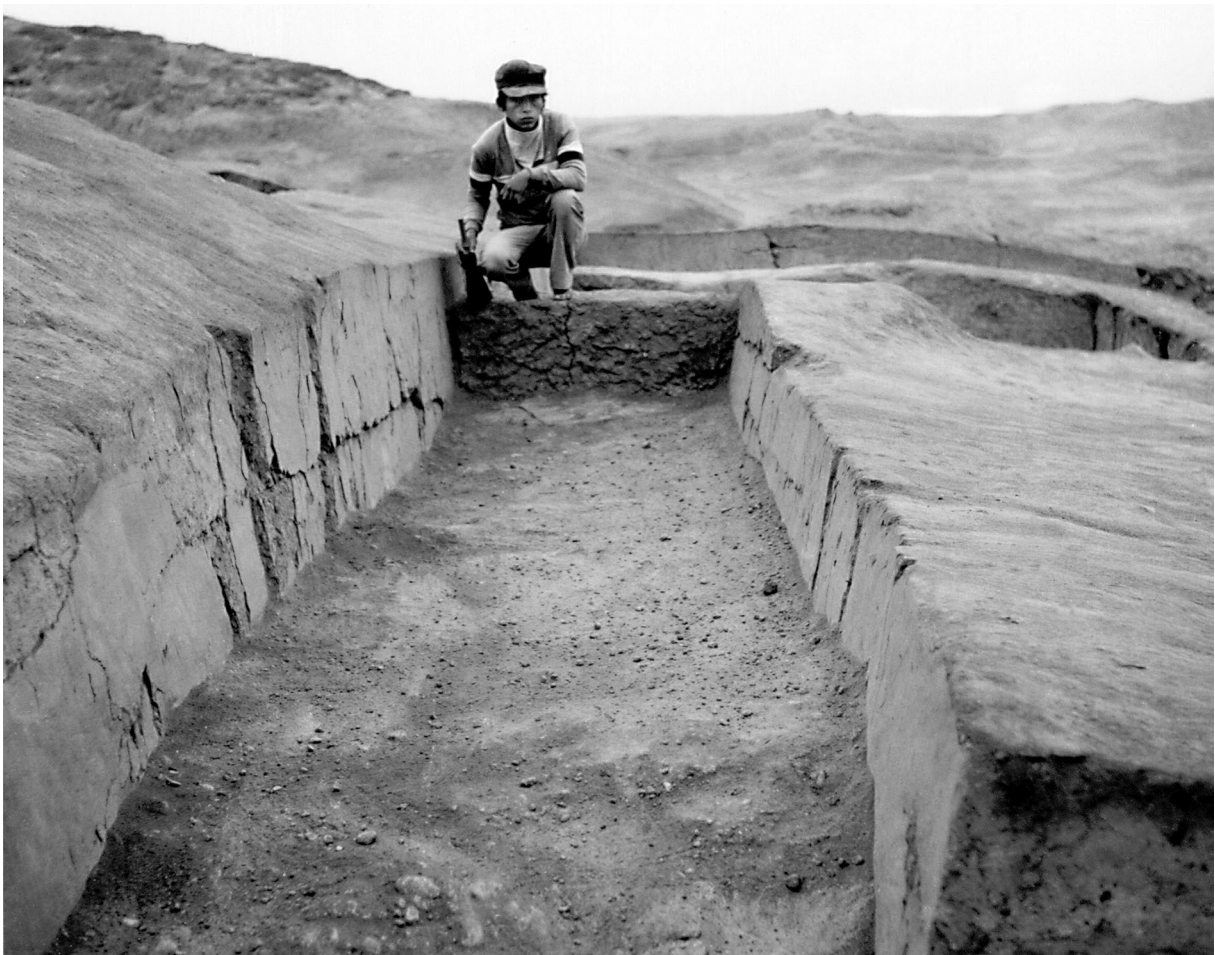
Figure 4.13. Collca 3 of Structure D seen from the north, with Cirilo Cruz serving as scale.

Collca 3, the storage cell on the East Platform, measured roughly 6.01×1.1 m, depending on how one took the measurement. The collca's floor was 1.65 m below datum. Two sherds were found in Collca 3, as follows:

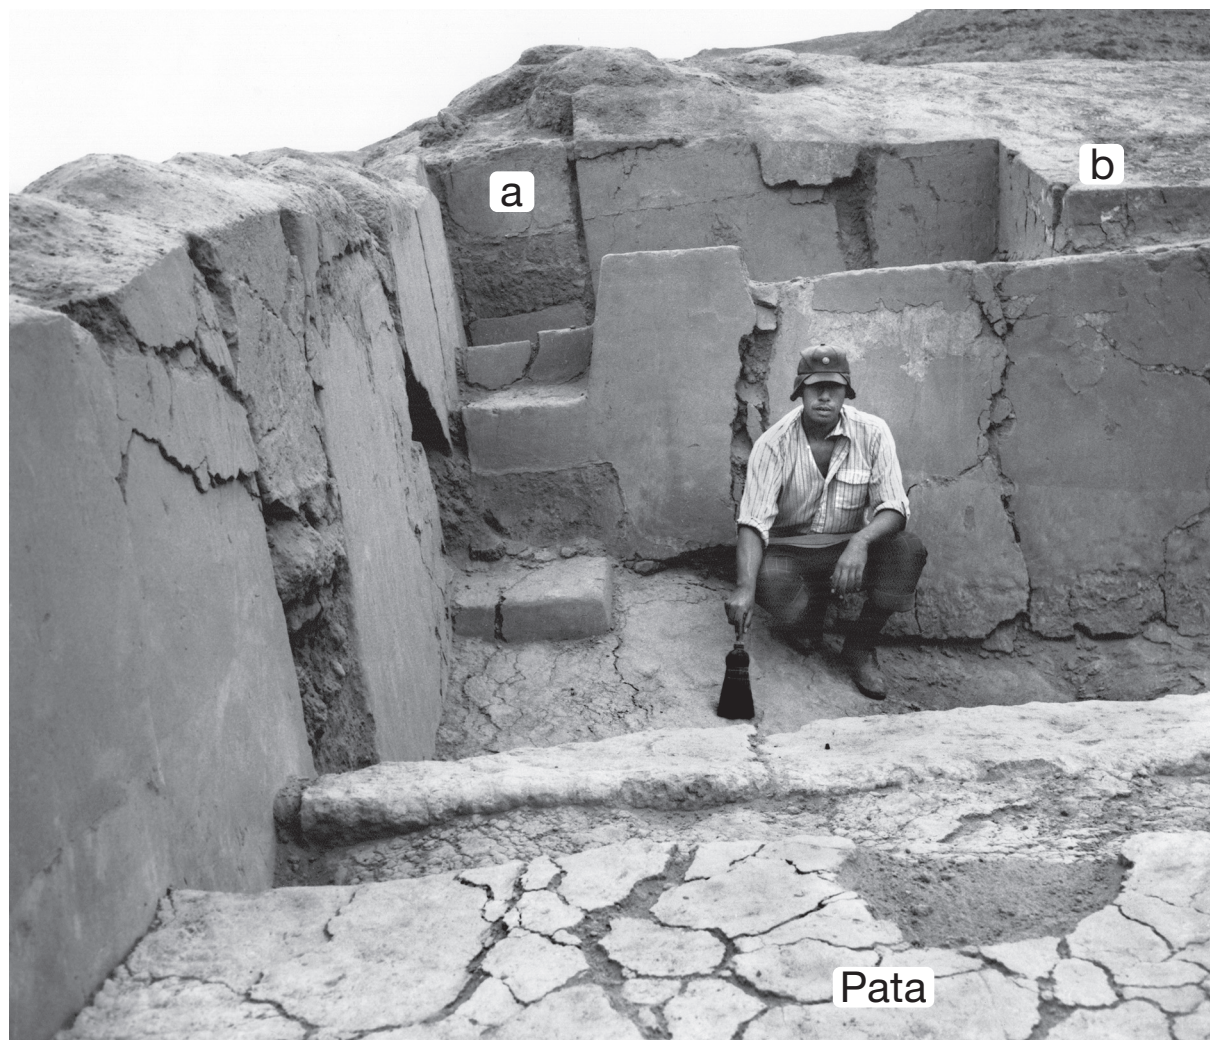
Figure 4.14. Looking east from the *llamkana pata* atop the North Platform of the Southwest Canchón, Structure D. Victor de la Cruz kneels on the floor of the Southwest Canchón. To the left, one can see the broken remains of a small stairway that ascended to the East Platform of the canchón. At *a* is a blocked corridor that formerly led to Room 7. At *b* we see Collca 3, still unexcavated at this stage of the work.

carrying products from llama caravans directly to the collca. The other approach was by way of a small stairway at the extreme north end of the East Platform (Figure 4.14). Given the location of this stairway, we suspect that it would have been used by the administrator on the North Platform whenever he wanted to enter the interior of the building. At a later stage of the building's history, this small stairway and the narrow

passageway just to the east of it were blocked with tapia (Figures 4.14, 4.15). The narrow passageway had formerly led to Room 7 (Figure 4.1).

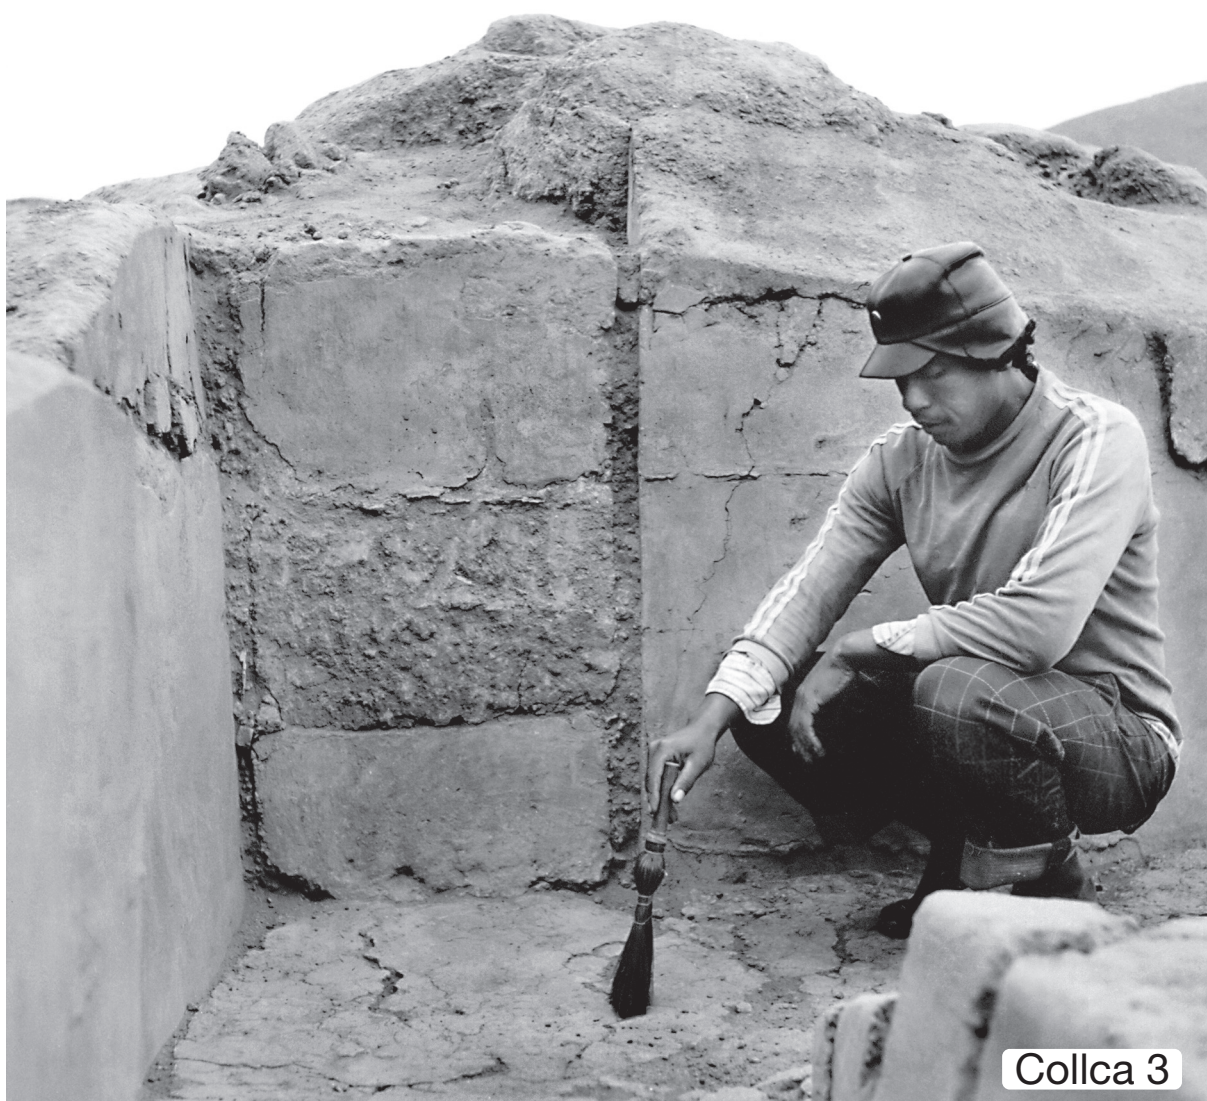
Figure 4.15. Victor de la Cruz kneels on the surface of the East Platform of the Southwest Canchón, Structure D. Just to the left of his whisk broom is the blocked entrance to a corridor which once led toward Room 7. (This is one of many places where the traffic flow was altered during the occupation of Structure D.) In the lower right foreground, one can see the corner of Collca 3.

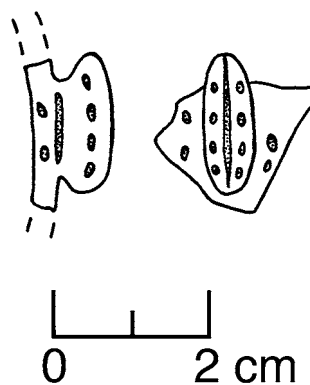
Figure 4.16. Punctate lug from a Trambollo Burnished Brown vessel, found in Collca 3, Structure D.

Trambollo Burnished Brown (Figure 4.16)
