MONOGRAPH 62
COTSEN INSTITUTE OF ARCHAEOLOGY
UNIVERSITY OF CALIFORNIA, LOS ANGELES

EXCAVATIONS AT
CERRO AZUL, PERU
THE ARCHITECTURE AND POTTERY
JOYCE MARCUS

Excavations at Cerro Azul, Peru

THE ARCHITECTURE AND POTTERY

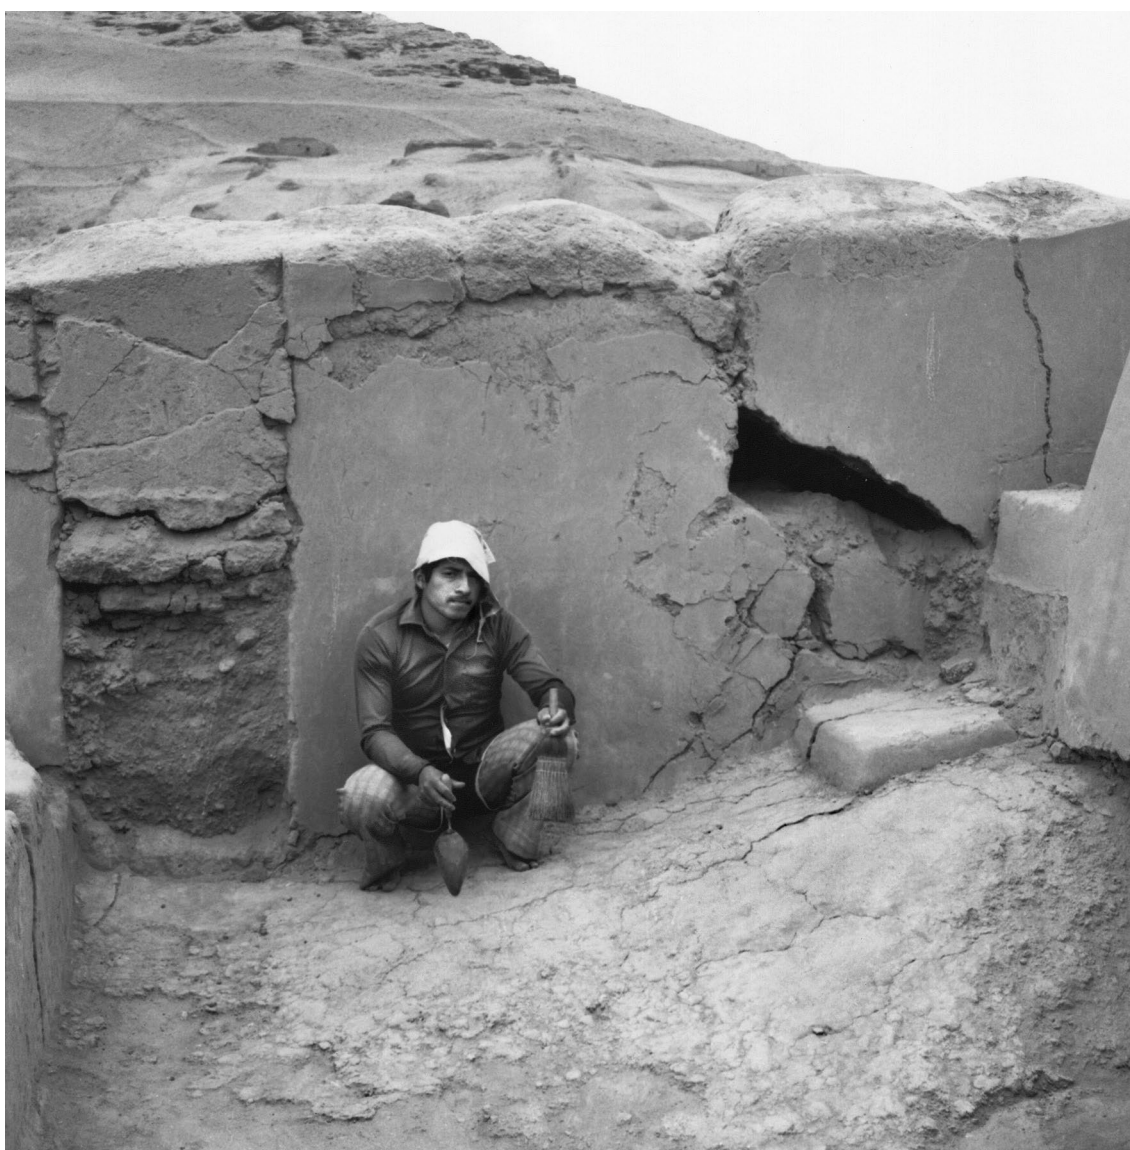
Figure 4.17. Pedro Manuel Zavala squats near the northeast corner of the Southwest Canción, Structure D. Beside him is a blocked doorway that once led from the Southwest Canción to Room 11 (see Figure 7.28 for the other side of this doorway). At the far right in the photo, we see the stairway (now broken) that led up to the East Platform of the Southwest Canción. Extensive earthquake damage can be seen on the wall nearby.

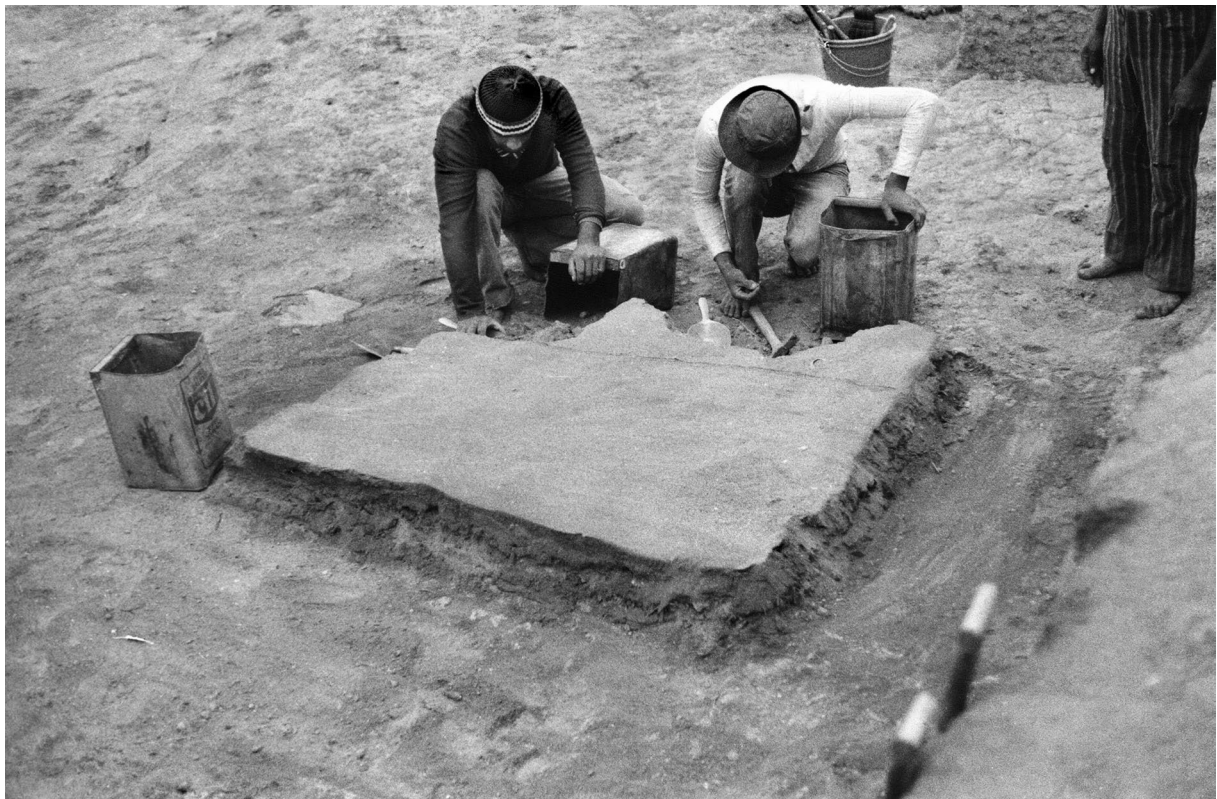
Figure 4.18. Southwest Canchón, Structure D. The final squares of the Feature 6 midden are being removed for fine screening.

We suspected that from time to time, the floor of the Southwest Canchón had been swept and its debris piled against a wall until such time as it could be removed from the building. (Given what we discovered in later seasons, the ultimate resting place for all trash from the compounds seems to have been the terraces in the quebradas of Cerro Camacho.) Luckily for us, the final load of debris swept from the floor of the canchón was never carried to the quebradas; it remained piled against the L-shaped wall built to create Room 4. This large heap of debris—essentially a midden 50 cm deep and 2 m in diameter—was designated Feature 6 (see Figures 4.3, 4.18).

We consider our discovery of Feature 6 a fortunate one, since it gave us considerable insight into the range of debris-producing activities carried out in the final months of occupation in the Southwest Canchón. We isolated Feature 6 on a pedestal (Figure 4.18) and assigned two of our most careful excavators to it. They were each given two sieves,

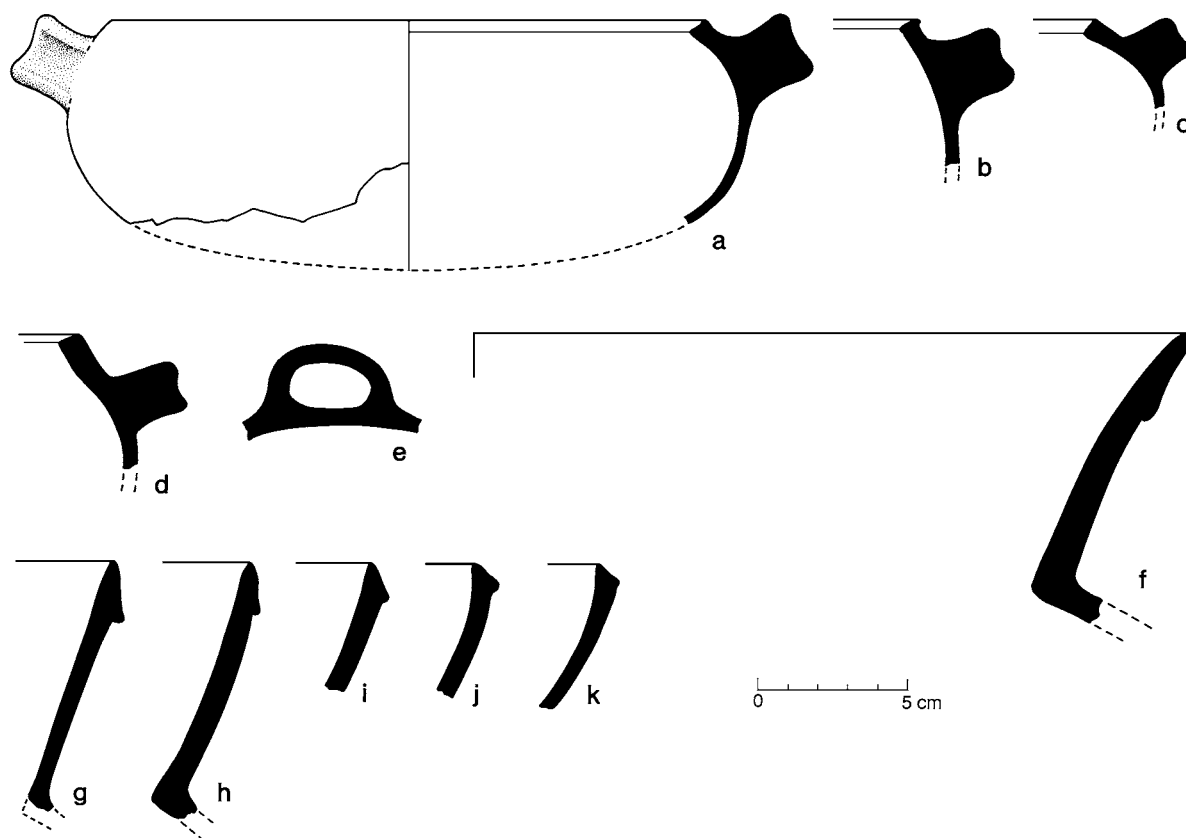
Figure 4.19. Camacho Reddish Brown vessels from Feature 6, Structure D. (a–d): Cooking pots with restricted orifice and horizontally set strap handles; fire-blackened; (e): top view of typical strap handle; (f–k): cambered rims from jars; fire-blackened.

Cambered rims from jars: 27 (Figure 4.19f–k)

Cooking pots with restricted orifice, horizontally set strap handles: 7 rims (Figure 4.19a–d)

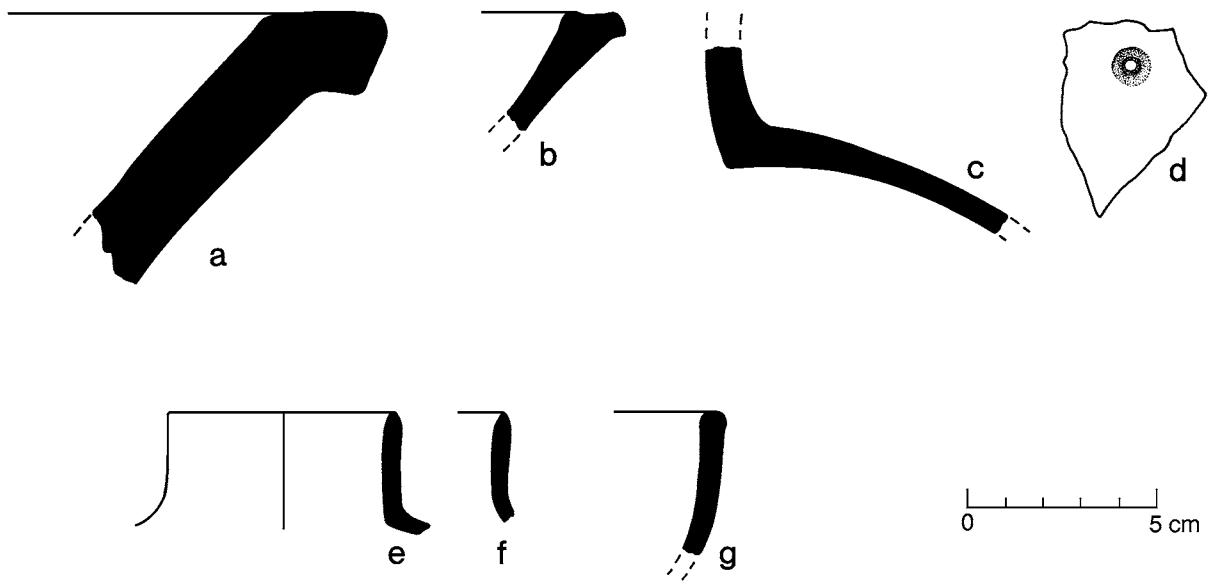
Figure 4.20. Camacho Reddish Brown vessels from Feature 6, Structure D. (a): rim of giant *tinajón* or *batun macma* like those in the North Central Canchón; (b): everted rim from jar; (c): jar shoulder; (d): jar sherd showing hole drilled for suspension; (e, f): vertical necks from small jars; (g): rim of hemispherical bowl.

Tinajón: 1 rim (Figure 4.20a); 3 sherds from neck

Jar shoulder, perforated for suspension: 1 (Figure 4.20d)

Vertical necks from small globular jars: 3 (Figure 4.20e, f)

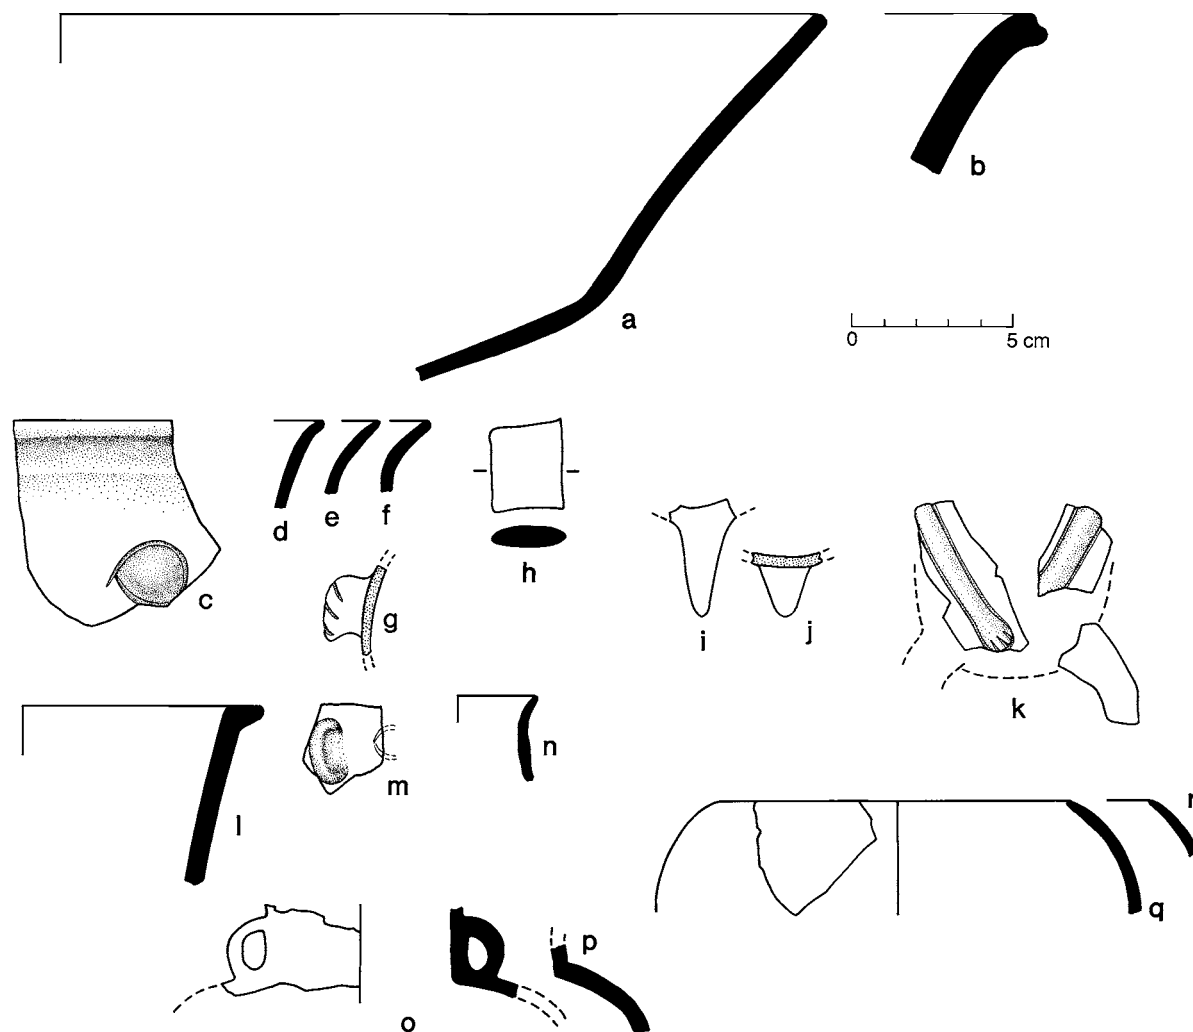
Figure 4.21. Camacho Black vessels from Feature 6, Structure D. (a): large composite silhouette bowl with graphite-like double-burnished surface; (b): everted rim from neck of large amphora (standard variety); (c): sherd from neck of amphora with modeled and incised human eye (highly burnished variety); (d–f): flaring necks from small jars; (g): incised lug from shoulder of amphora; (h): fragment of strap handle; (i, j): possible vessel supports (solid); (k): fragments of human effigy like the one found in Collca 1; (l): everted rim from amphora (standard variety); (m): modeled ear (and part of incised eye) from face on neck of miniature amphora (highly burnished “graphite” variety); (n): neck of miniature amphora; (o, p): globular jars with strap handle linking neck and body; (q, r): small bowls with incurved rim.

Camacho Black (Standard Variety) (Figure 4.21b, l)
Large amphora rims, slightly everted: 2

Camacho Black (Highly Burnished Variety) (Figure 4.21a, c–h)

Amphora (?) neck with human face modeled on it, highly burnished: 1 (Figure 4.21c)

Miniature Camacho Black Vessels (Highly Burnished) (Figure 4.21i–k, m–r)

Ear from face on neck of miniature amphora, atypical pink paste, slipped black and burnished (“graphite” finish): 1 (Figure 4.21m)

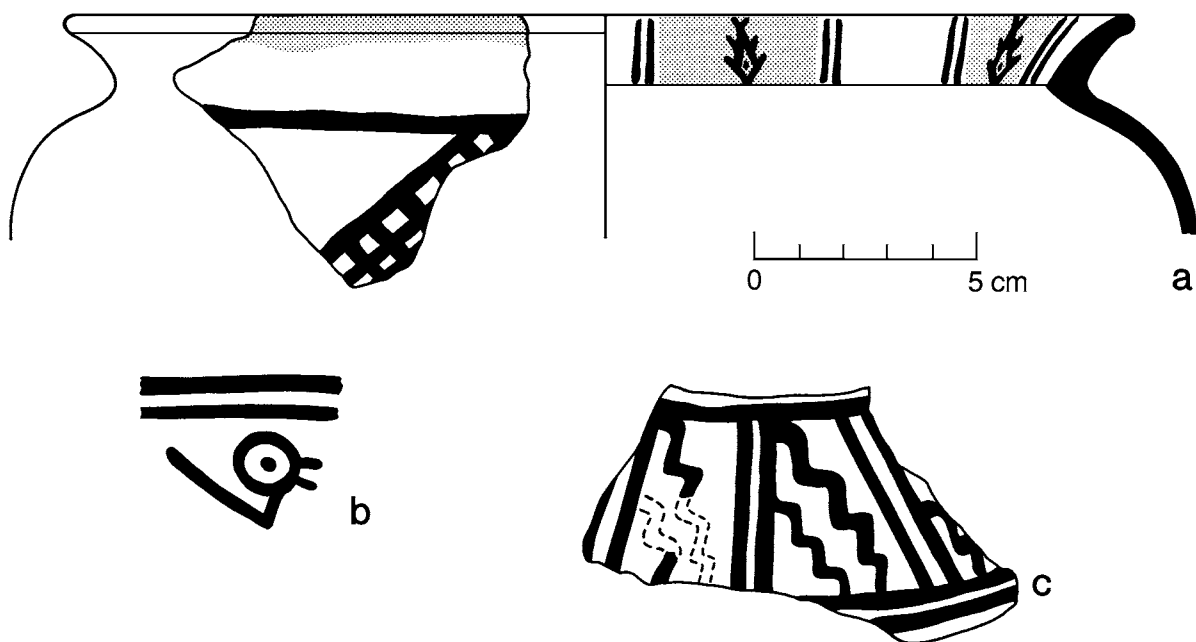
Figure 4.22. Pingüino Buff vessels from Feature 6, Structure D. (a): globular jar with wide mouth, painted on the exterior of the body and the interior of the neck in black and white, with some areas left natural buff; (b): reconstruction of bird motif from body sherd of globular jar; (c): body sherd from globular jar, painted black and white.

Small globular jars with wide mouth, painted black and white or black/white/red on the exterior and the inner rim: 5 rims (Figures 4.22, 4.23)

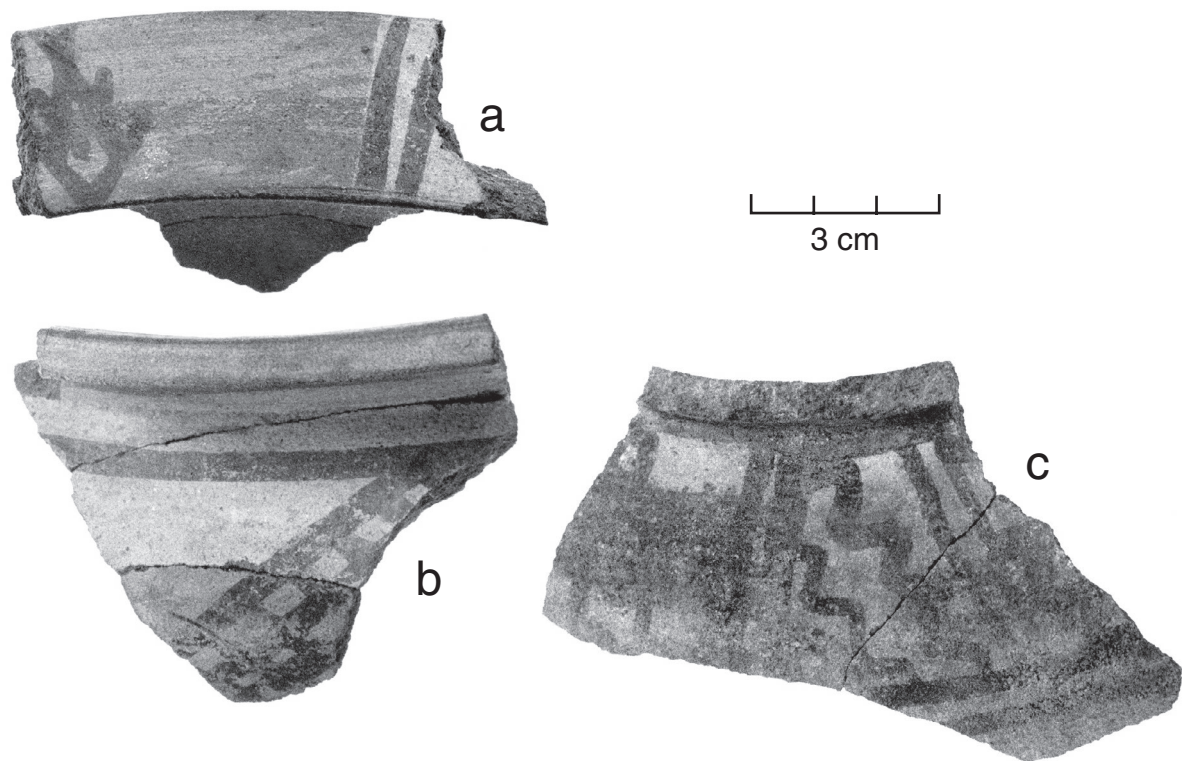
Figure 4.23. Pingüino Buff sherds from Feature 6, Structure D. (a, b): globular jar with wide mouth, painted on the exterior of the body and the interior of the rim in black and white, with some areas left natural buff. (a): interior surface of rim; (b): exterior of shoulder; (c): body sherd from globular jar, painted black and white.

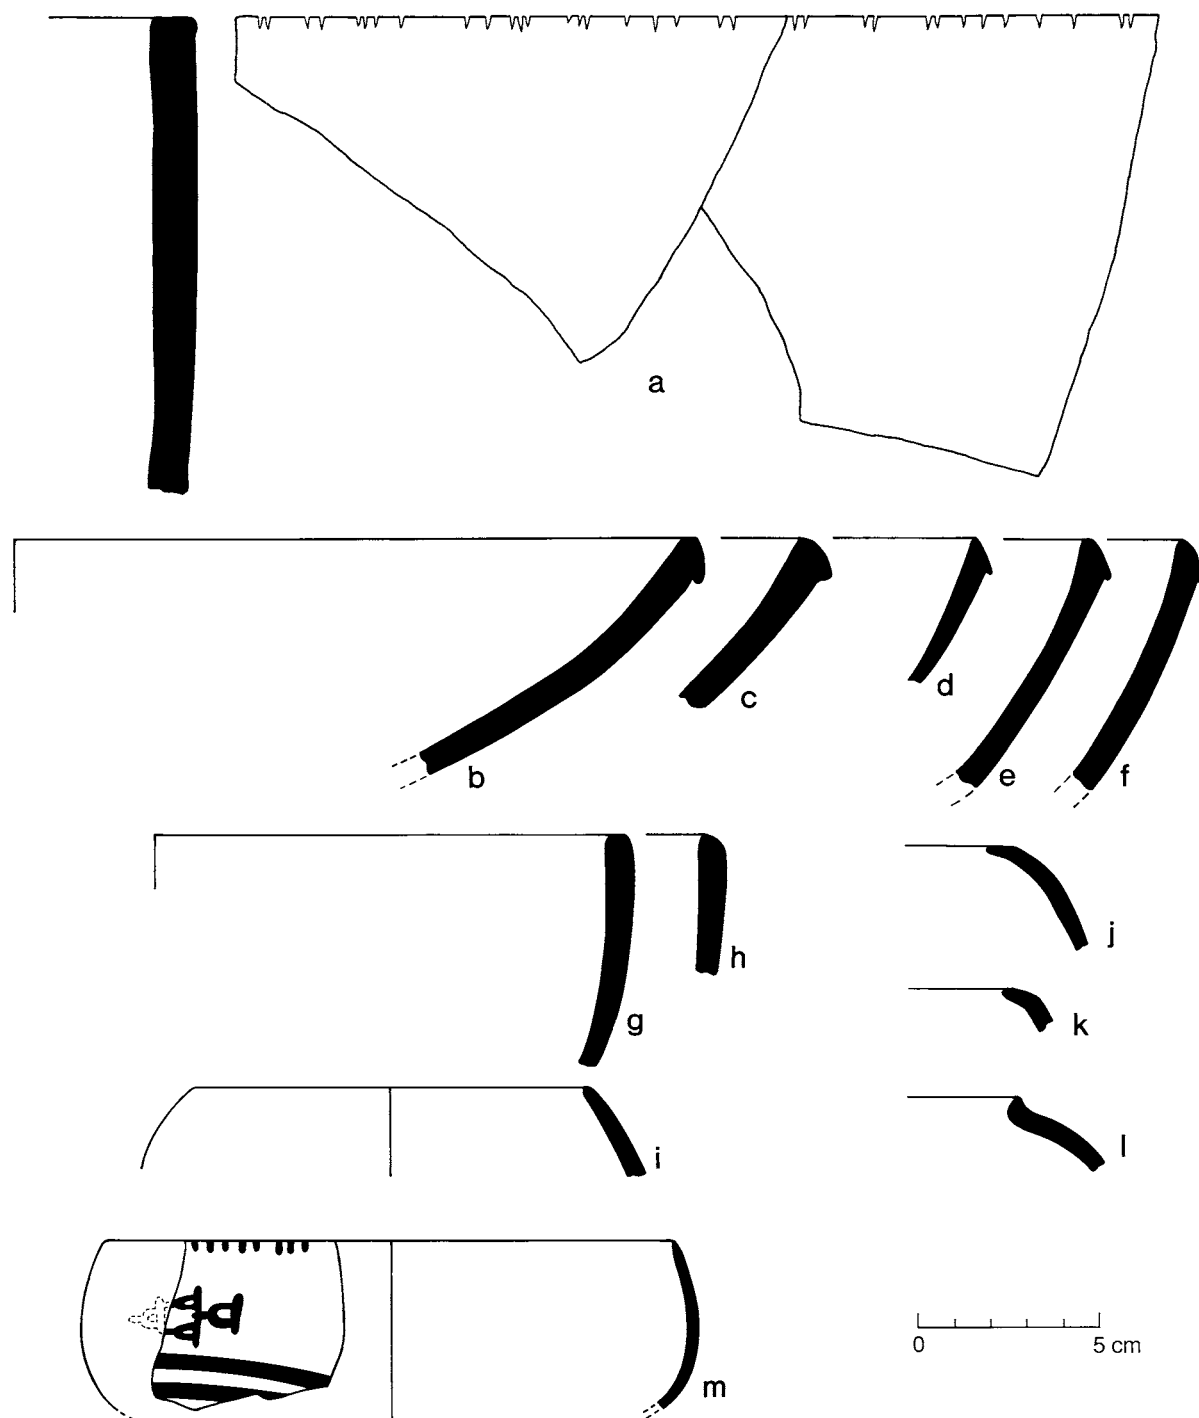
Figure 4.24. Pinguino Buff vessels from Feature 6, Structure D. (*a*): large bowl (rim diameter greater than 50 cm) with rim ticking on the exterior; smoothed on the exterior over a wash of the same Pinguino clay; wiped on the interior (with no wash); (*b–f*): bowls with cambered rim, burnished on both surfaces over a wash of the same Pinguino clay; (*g, h*): hemispherical bowls, burnished on both surfaces; (*i*): incurved-rim bowl; (*j, k*): small bowls with incurved rim; (*l*): rim from small bowl or jar with upturned, incurved rim; (*m*): hemispherical bowl, slipped white on the exterior and painted black on white with “school of fish” motif.

Large bowls with cambered rim: 10 rims (Figure 4.24b–f)

Large bowl (?) with rim ticking: 2 rims (Figure 4.24a)

Small bowls, incurved rim: 3 painted rims
 Painted rims, small: 2
 Miscellaneous painted body sherds: 20
 Tiny handle from miniature jar: 1
 Fragments of rectangular box-like vessel,
 painted black and white: 2 (Figure 4.28d)
 Rims of hemispherical bowls: 6 (Figure
 4.24g, h)
 Rims of incurved rim bowls: 2 (Figure
 4.24j-l)
 Body sherd of large jar, painted black and
 white in band on shoulder and
 black/white/red on body: 1 (Figure 4.29a)
 Jar body sherds, painted black and white: 2
 Hemispherical bowl rim, slipped white on
 exterior only, painted in black and white
 with “school of fish” motif: 1 (Figures
 4.24m, 4.29c)
 Worked sherd, painted black: 1

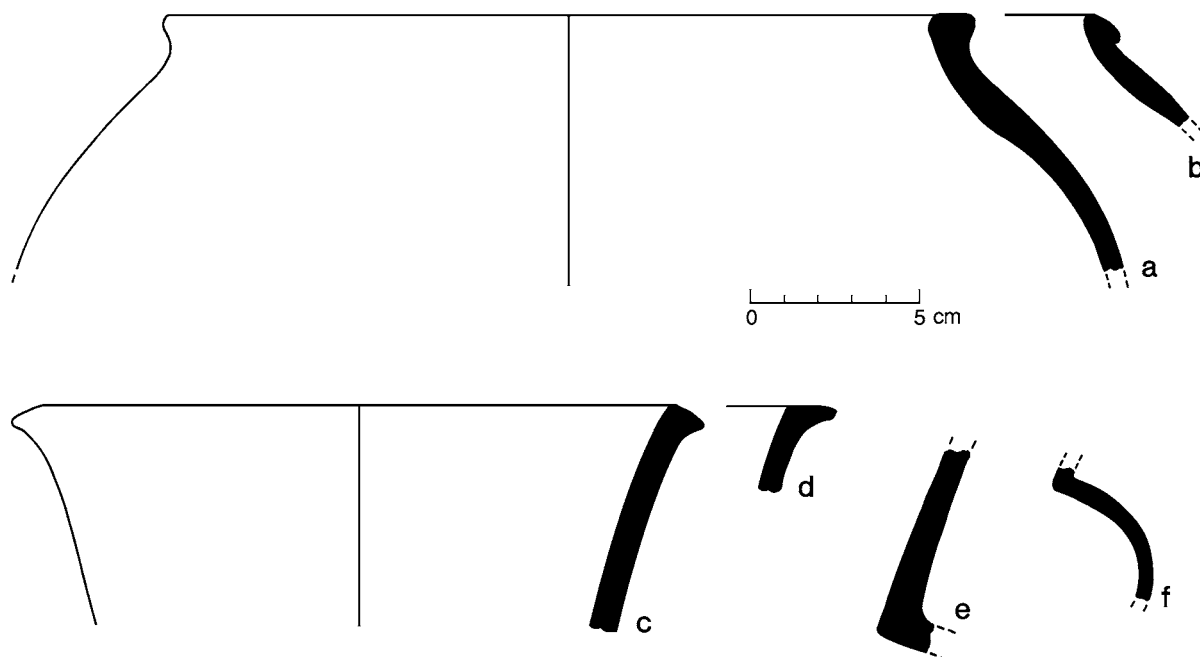
Figure 4.25. Ceramics from Feature 6, Structure D. (a): globular jar with rolled rim, more like Pingüino Buff than anything else, but with atypically coarse temper; traces of white paint or wash on exterior; (b): Pingüino Buff jar with rolled rim, painted black/white/red, but eroded; (c, d): funnel necks from Pingüino Buff jars with everted rims; (e): Pingüino Buff jar neck with white paint on exterior; (f): sherd from Pingüino Buff globular jar with wide mouth, painted black and white on exterior; design eroded.

Globular jar with wide mouth, painted black and white on exterior of body and interior of rim, shoulder sherd: 1 (Figure 4.25f)

Globular jars with rolled rim: 3 rims (one painted black/white/red) (Figure 4.25a, b)

Large jars with everted rim, funnel necks: 5 (one painted white) (Figure 4.25c, d)

Fragment of jar neck, white paint stripe on exterior: 1 (Figure 4.25e)

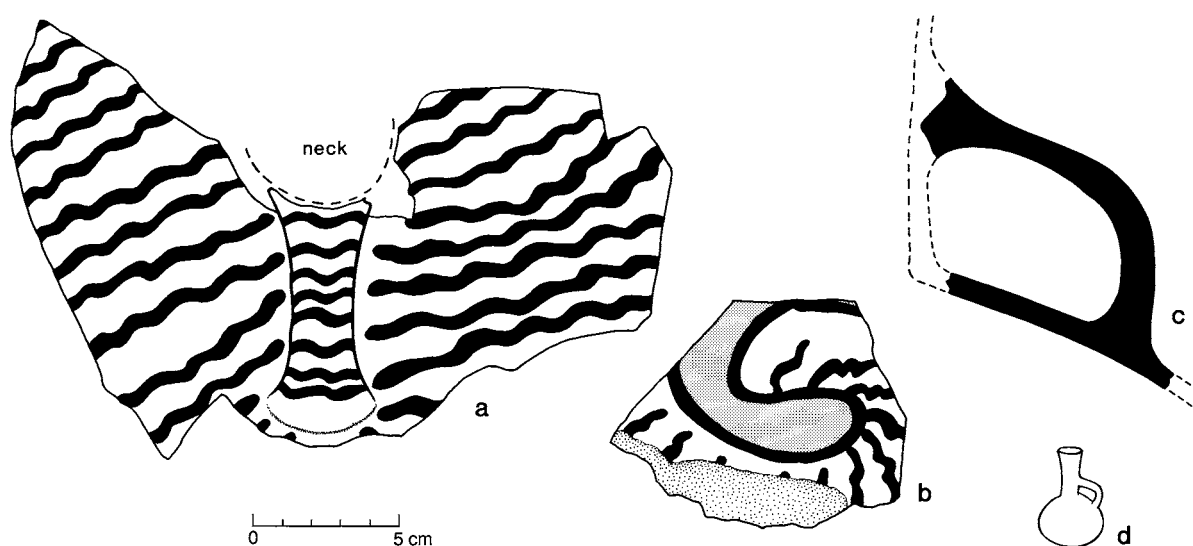
Figure 4.26. Unusual Pingüino Buff vessel from Feature 6, Structure D. This vessel appears to have been a tall-necked jar with a strap handle linking the neck and body. It has been painted black and white, with zones of burnished natural buff left unpainted. (a): top view, showing position of handle and neck; (b): basal sherd, showing raised modeled area with black-and-white paint, curving around a natural buff area; (c): side view of strap handle; (d): artist's reconstruction of vessel shape.

body; has effigy modeling (Figures 4.26, 4.27): 2 handle fragments; 12 body sherds

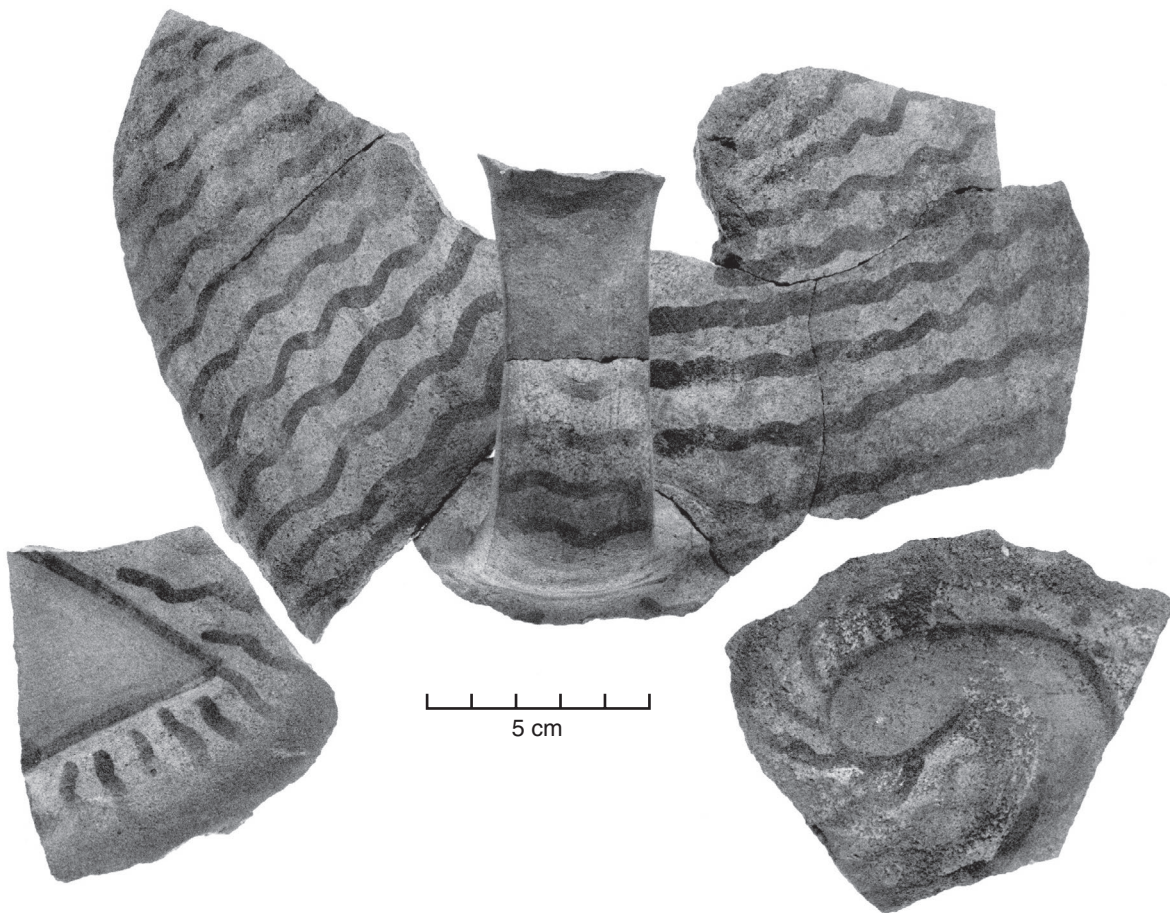
Figure 4.27. Sherds from an unusual Pingüino Buff vessel from Feature 6, Structure D. This jar was painted in black and white, with zones of burnished buff left unpainted.

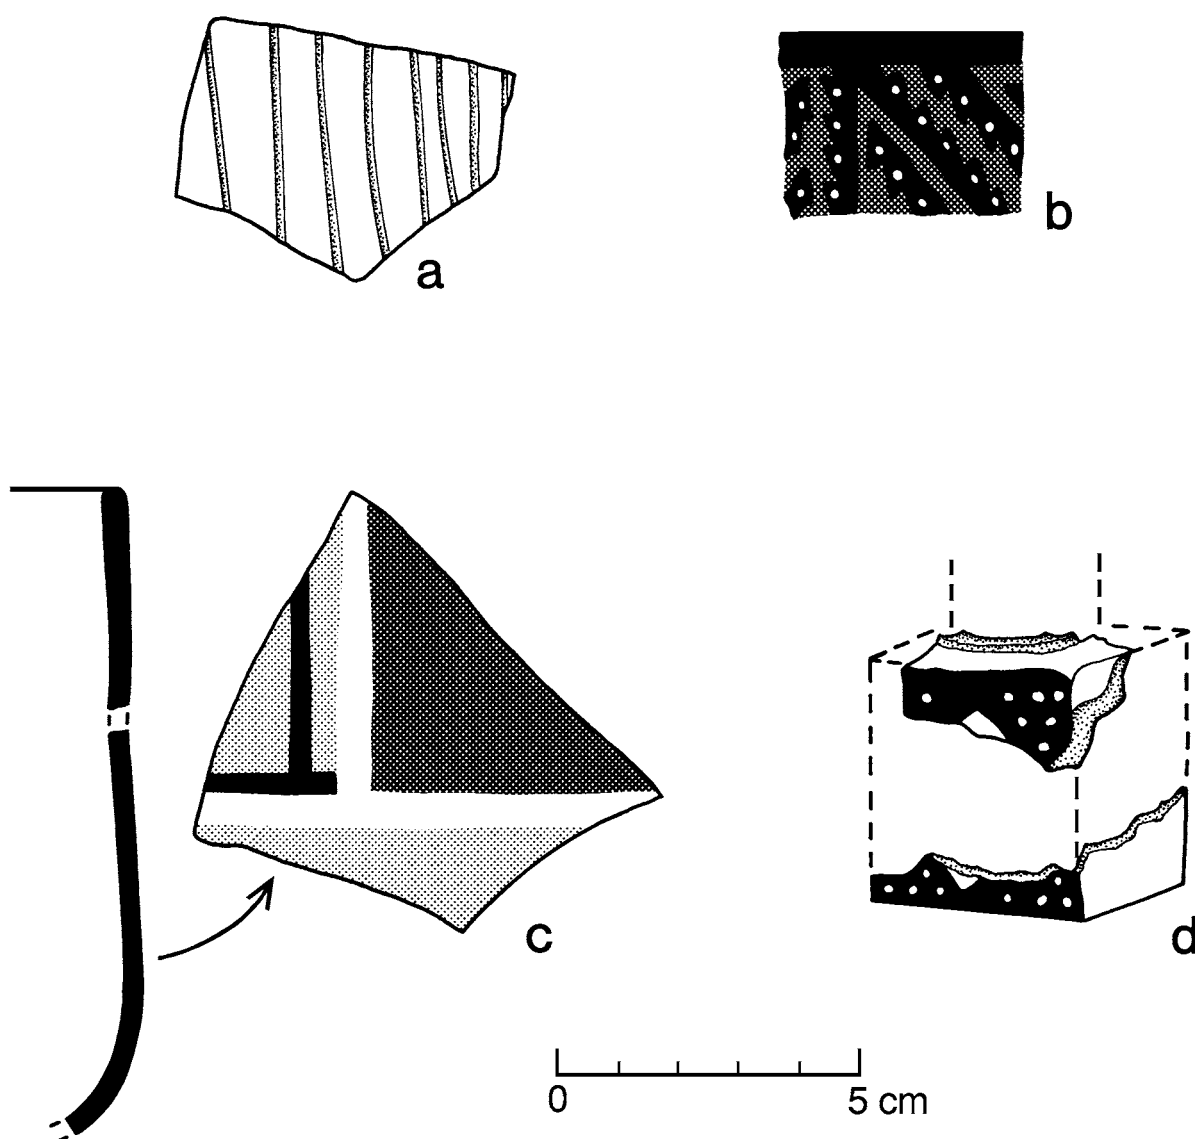
Figure 4.28. Unusual sherds from Feature 6, Structure D. (a): sherd from small jar with parallel grooving, and paste resembling that of Trambollo Burnished Brown; (b): body sherd with paste resembling that of Pingüino Buff, painted with an unusual “nested zigzag chevron” design in black/white/red; (c): bowl sherd with design in black/white/red over natural brown; (d): box-like Pingüino Buff vessel, painted black and white.

Jar sherds with shallow parallel grooving: 5
 (Figure 4.28a)
 Sherds with Pingüino Buff-like paste, paint-
 ed design of zigzag nested chevrons in
 black/white/red (red is 10 R 4/6); very
 neat execution of painting: 3 (Figures
 4.28b, 4.29e, f)

Sherds from bowls not unlike some Trambollo Burnished Brown specimens but with a redder paste; design painted over natural brown in black/white/red (red is 7.5 R 4/6): 2 (Figure 4.28c)
 Sherds probably from a jar neck with a painted face on it, but on Camacho

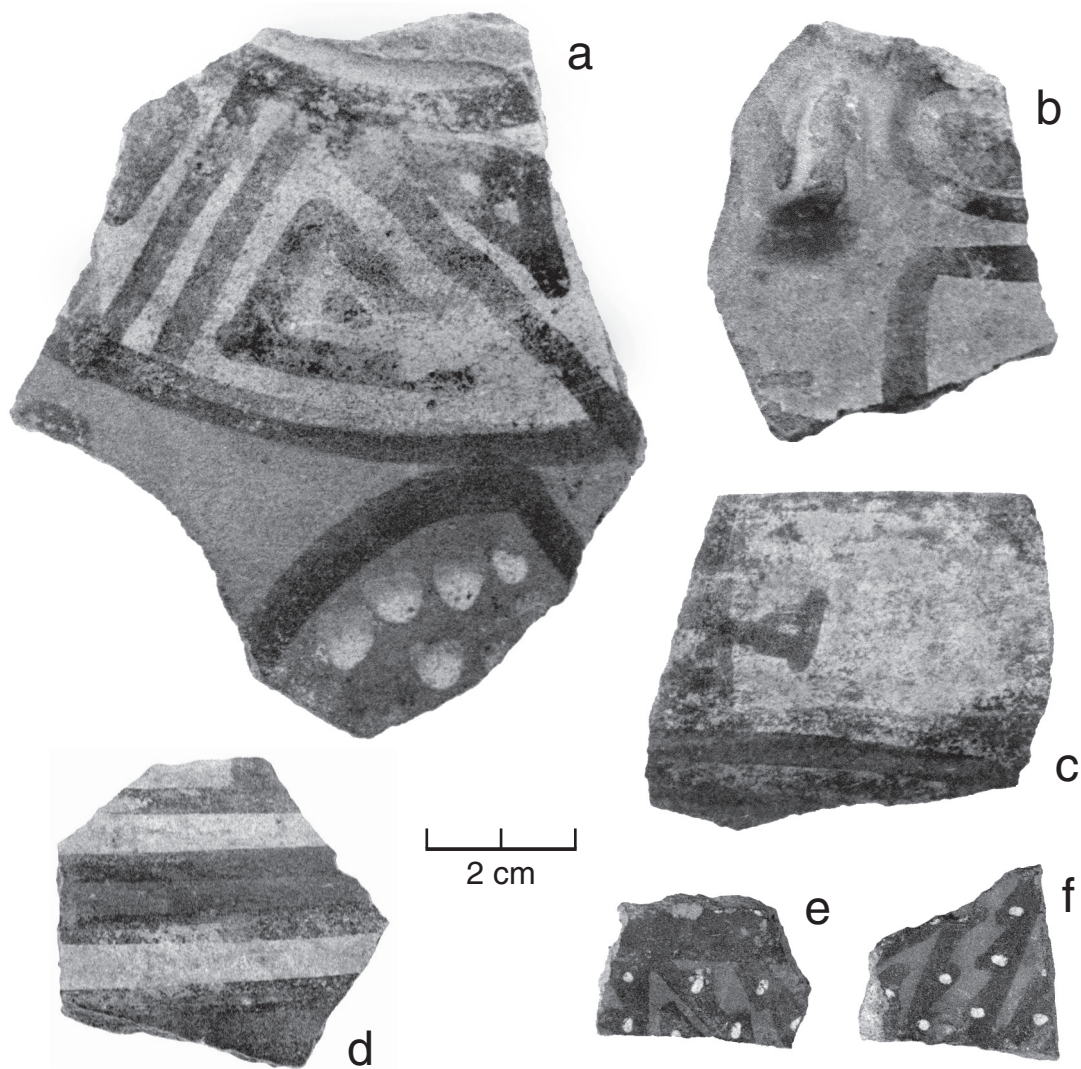
Figure 4.29. Miscellaneous Pingüino Buff (or Pingüino-like) sherds from Feature 6, Structure D. (a): jar body sherd painted with a band of black-and-white geometric designs and an oval area of white dots on red paint; (b): part of a human face painted in black/white/red; (c): “school of fish” motif painted in black on white; (d): horizontal striping in black/white/red; (e, f): unusual sherds with Pingüino-like paste and “nested zigzag chevron” motif in black/white/red.

Vertical jar necks with modeled and/or painted human faces: 7 (Figure 4.29b)

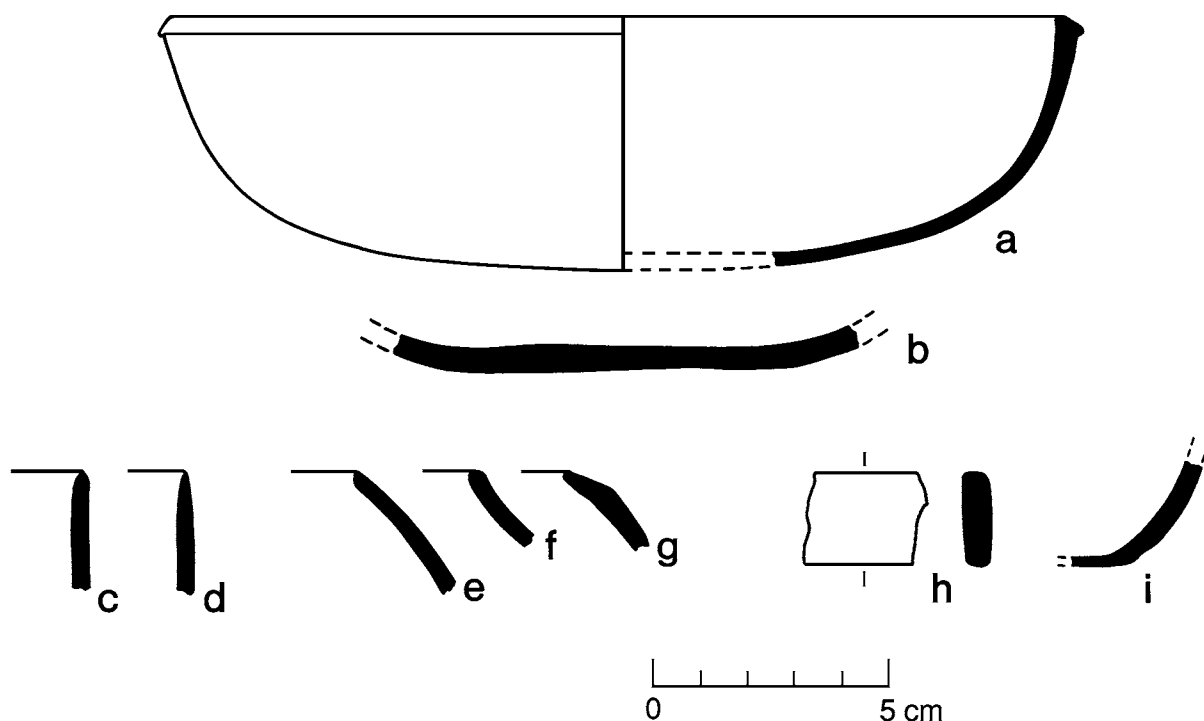
Figure 4.30. Trambollo Burnished Brown vessels from Feature 6, Structure D. (a): hemispherical bowl with cambered rim; (b): flattened base of bowl; (c, d): plain rims from hemispherical bowls; (e–g): incurved rims from hemispherical bowls; (h): fragment of strap handle; (i): possible jar sherd, showing angle between wall and base.

Trambollo Burnished Brown (Figure 4.30)

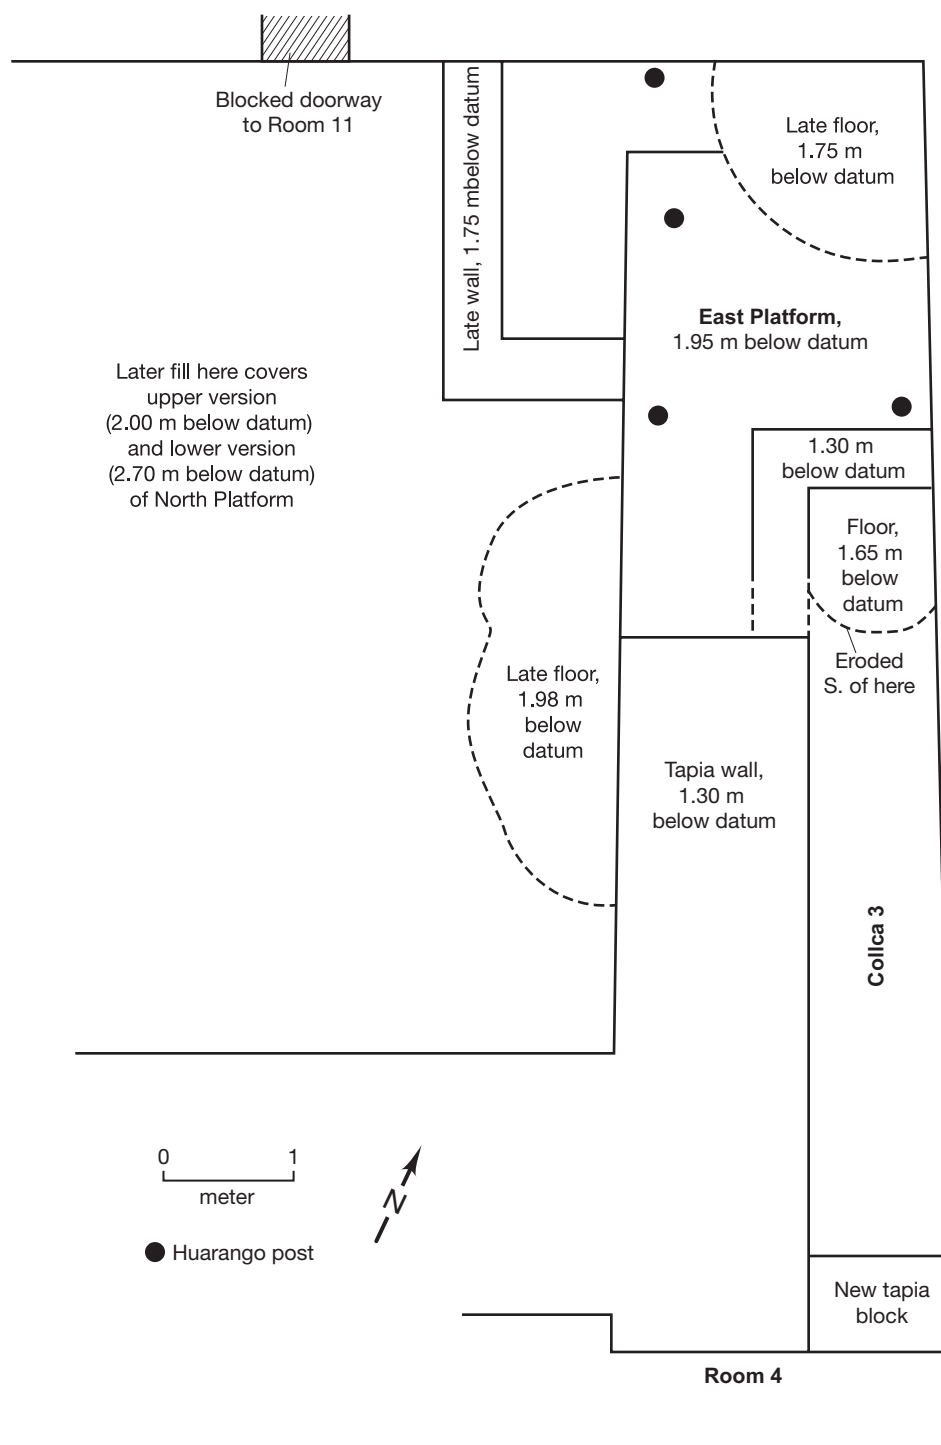
Figure 4.31. The eastern limits of the Southwest Canchón, Structure D, showing the superimposed walls, floors, and posts added above the original plan late in the occupation of the structure.

series of walls and floors was built. To put these new floors in perspective, one can compare Figure 4.1 and Figure 4.31. It will be seen that the North Platform, whose original surface lay 2.79 m below datum, was covered first by (1) a slight-

ly enlarged platform which was 9 cm higher, and then by (2) a later clay floor which lay only 1.98 m below datum. A remnant of that clay floor can be seen resting against the East Platform in Figure 4.31.

burying the small stairway seen in Figure 4.1. Over the fill went a clay floor at 1.75 m below datum. Owing to later erosion, only a patch of this floor had survived in the extreme northeast corner. This patch can be seen both on the drawing (Figure 4.31) and in Figure 4.32, a photograph. Even later in time, a wattle-and-daub “squatters’ house” was built in this corner; four of its wooden posts are shown in Figure 4.31. The posts were

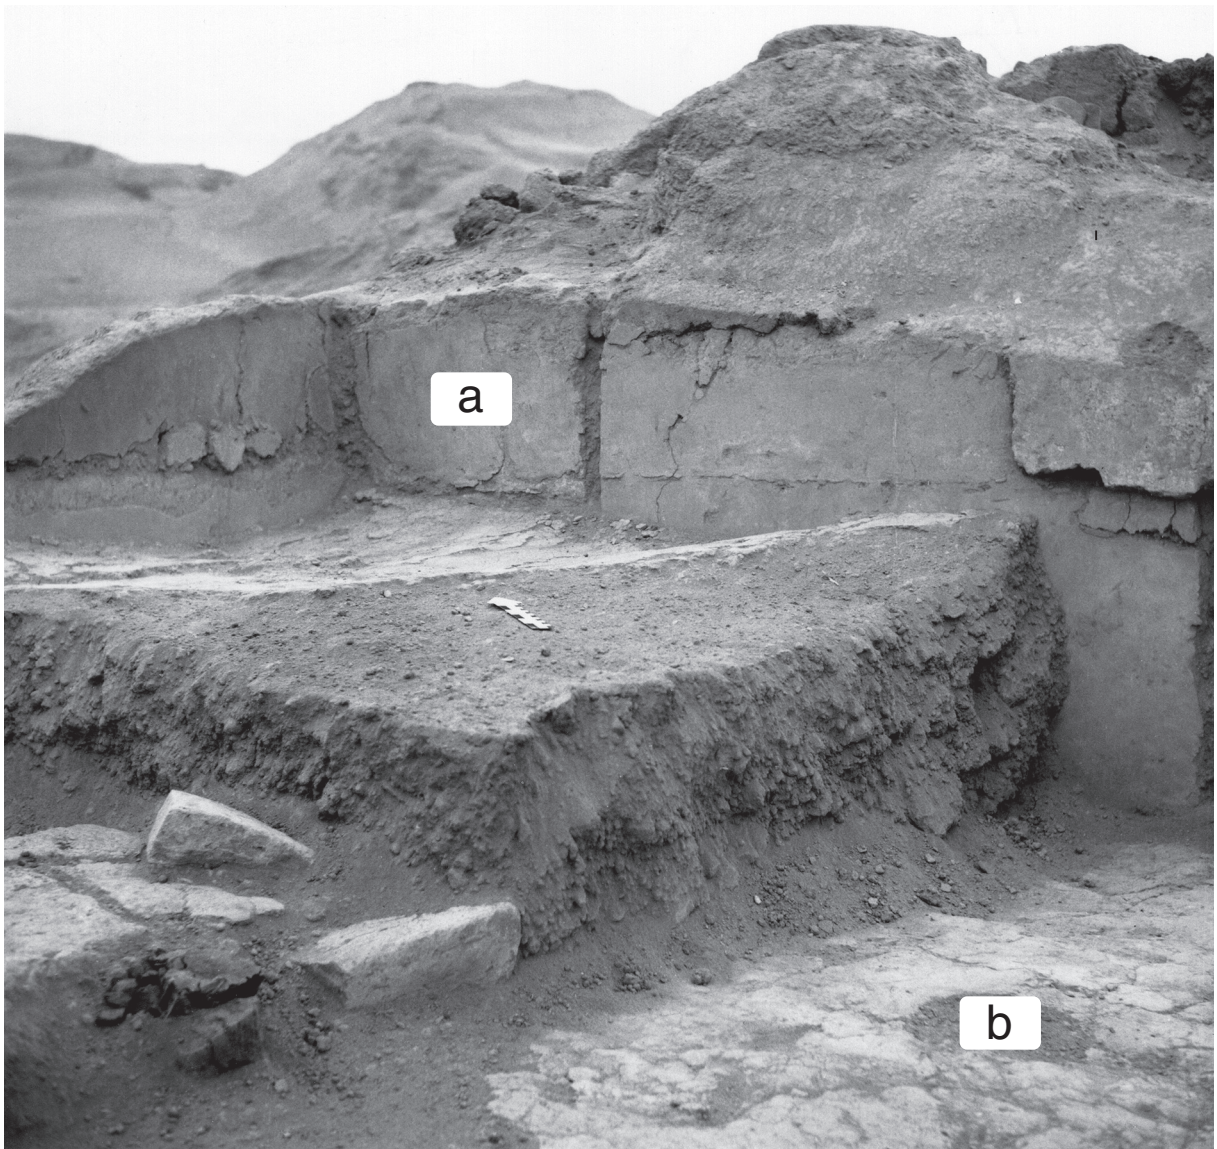
Figure 4.32. The northeast corner of the Southwest Canchón, Structure D. The north arrow lies near a patch of whitish plaster floor at a depth of 1.75 m below datum. This floor was added at a very late stage in the use of Structure D. The earthen fill below it completely covered Collca 3 (*b*) and the rest of the East Platform, and obscured all but the uppermost third of the blocked corridor (*a*) that once led toward Room 7. (For a view of this same area following removal of the late floor, see Figure 4.14.)

It is possible that the floor shown at 1.75 m below datum in Figure 4.32 was built after Structure D had ceased to function as an elite residential compound. However, we doubt that the floor postdated the Late Intermediate period. It was built at a time when tapia was still the wall construction material of choice, and no clear Late Horizon ceramics were found in association.

In an effort to date these late constructions, we collected sherds from various contexts, both above and below them. The ceramics sealed *below* the upper floor shown in Figure 4.32 (and *above* the original East Platform) were a nondescript and largely redeposited collection; nevertheless, the sherds are all typical of the Late Intermediate period. The list is as follows:

Next, let us examine a collection of diagnostic sherds found resting on the surface of the upper floor (1.75 m below datum) seen in Figure 4.32. Those sherds also appear to be Late Intermediate types and vessel shapes. The diagnostics are as follows:

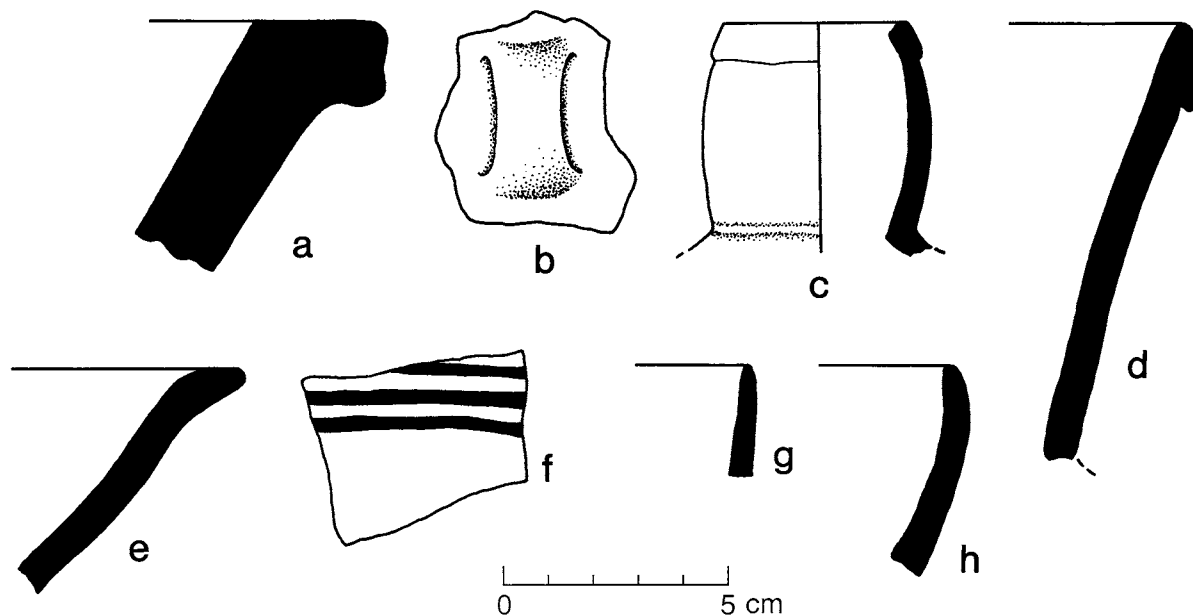
Figure 4.33. Selected sherds from the uppermost (most recent) floor, stratigraphically above the platforms in the Southwest Canchón, Structure D. Sherds *a–d* are Camacho Reddish Brown. (*a*): rim of *tinajón*; (*b*): strap handle; (*c*): neck from small jar with cambered rim; (*d*): cambered rim from large jar; (*e*): Camacho Black (standard variety) rim from jar or amphora. Sherds *f–h* are Pingüino Buff. (*f*): jar sherd, painted black and white; (*g*): rim of small hemispherical bowl; (*h*): rim of large hemispherical bowl.

Camacho Reddish Brown (Figure 4.33a–d)

Camacho Black (Standard Variety) (Figure 4.33e)

Pingüino Buff (Figure 4.33f–h)

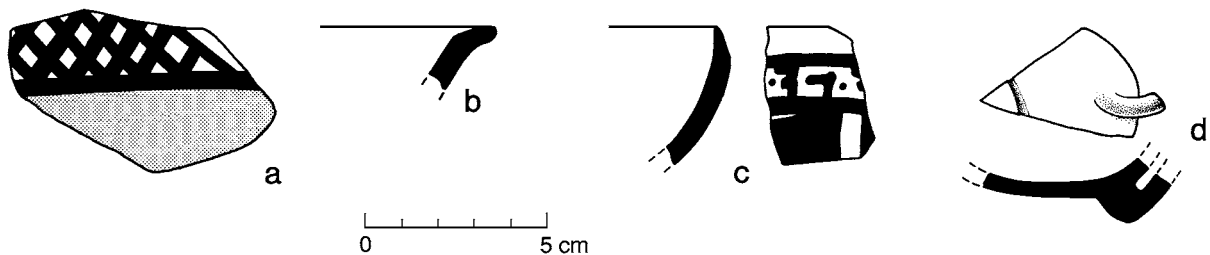
Figure 4.34. Pingüino Buff sherds from various proveniences in the Southwest Canchón, Structure D. Sherds *a–c* are from general fill. (*a*): sherd from globular jar, painted black and white on natural buff with a cross-hatched triangle motif; (*b*): everted jar rim, painted black and white on natural on the rim interior; (*c*): rim of hemispherical bowl, slipped white on interior and exterior, given a red wash on the interior, and painted black and white on the exterior; (*d*): sherd from some sort of effigy vessel, found under a very late floor in the extreme north-east corner of the canchón, stratigraphically above the East Platform.

Figure 4.34 shows four more diagnostic sherds from later fill in the Southwest Canchón. The three from general fill are as follows:

Pingüino Buff (Figure 4.34a–c)

Hollow effigy vessel with thin white slip or wash; fragment of possible arm: 1 (this sherd, shown in Figure 4.34d, is from a possible effigy vessel and was found under a small patch of late floor above the East Platform)
