MONOGRAPH 62
COTSEN INSTITUTE OF ARCHAEOLOGY
UNIVERSITY OF CALIFORNIA, LOS ANGELES

EXCAVATIONS AT
CERRO AZUL, PERU
THE ARCHITECTURE AND POTTERY
JOYCE MARCUS

Excavations at Cerro Azul, Peru

THE ARCHITECTURE AND POTTERY

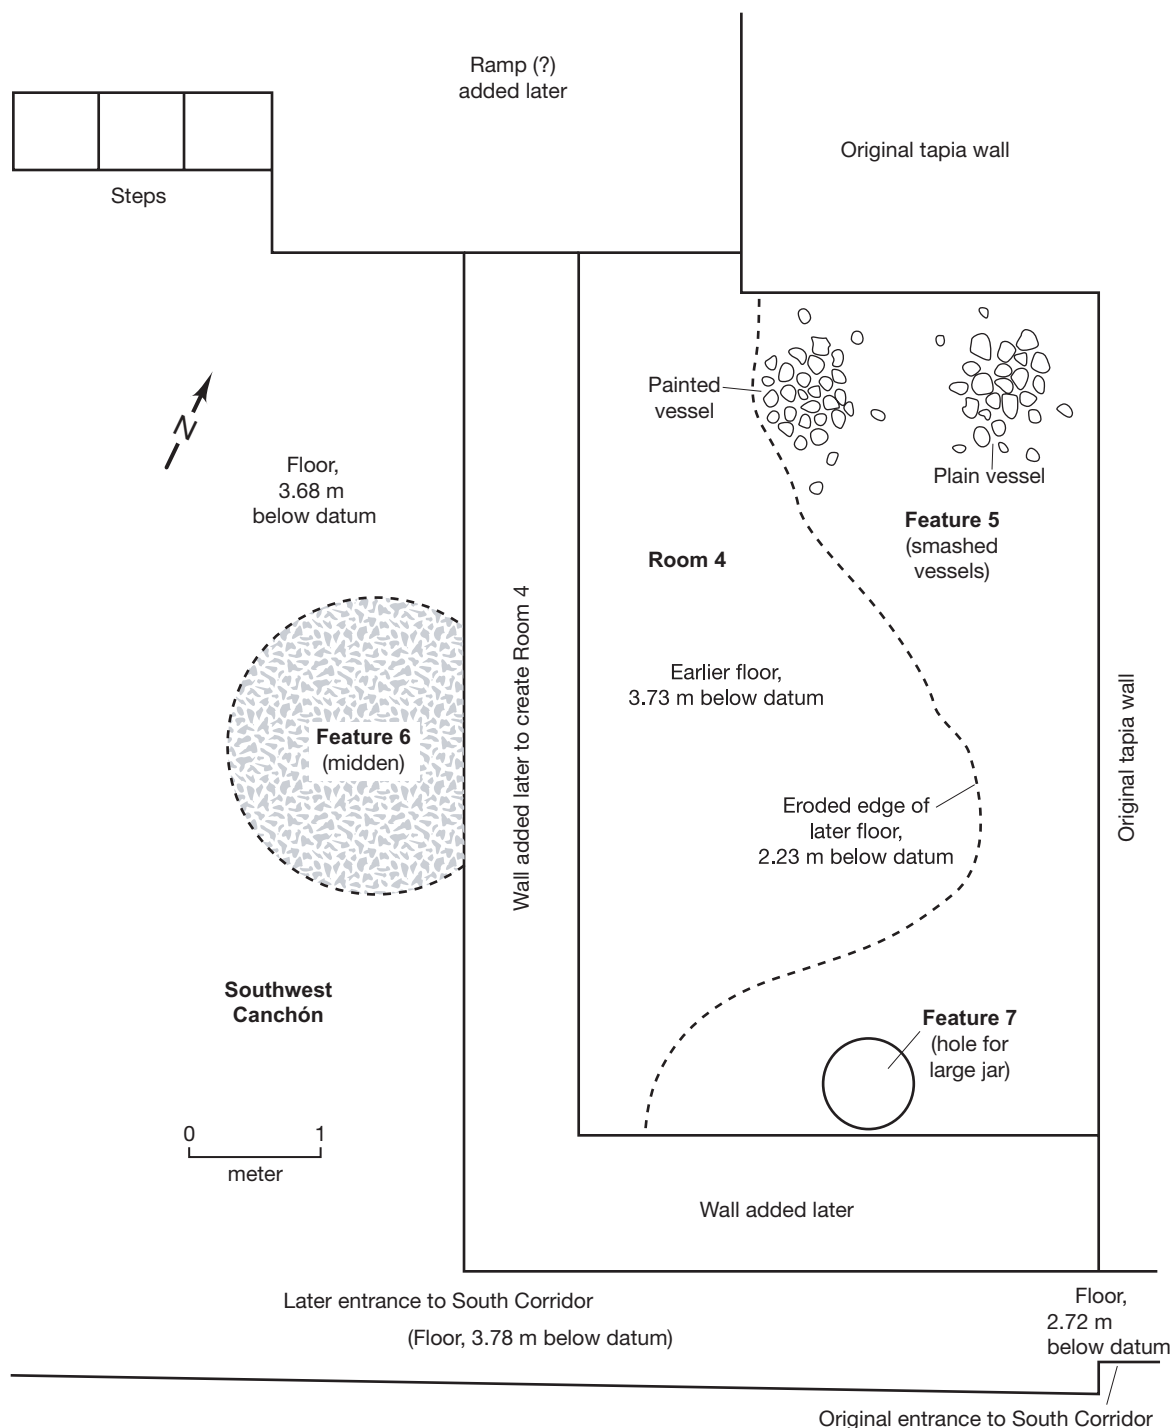
Figure 4.35. Room 4 and its surroundings, Structure D. It appears that the space occupied by Room 4 was originally part of the Southwest Canchón. At some point, an L-shaped tapia wall was added to create Room 4. This wall increased the length of the South Corridor as shown.

Canchón. By adding a new L-shaped tapia wall, as shown in Figure 4.35, they created Room 4 in the southeast corner of the canchón. This new L-shaped wall was inferior in quality to the earlier walls nearby. The earlier walls had smooth, well-

achieved via ladder from what appeared to be a low ramp (now greatly eroded), added to the old stair-and-wall access to the East Platform (Figure 4.35). The storage capacity of Room 4 at the time of its creation would have been more than 40 m^3 .

It is worth noting that the new L-shaped wall did more than create Room 4. As can be seen in Figure 4.35, its east–west arm added 4.85 m to the

The later clay floor of Room 4—2.23 m below datum—had once filled the entire room. By 1984, however, its western, or seaward, side had been partially eroded (Figure 4.35). Near its southern limit we found Feature 7, a circular depression made in the floor in order to keep a large globular jar sitting upright. The jar was no longer present.

Near the northern limit of the floor we discovered a mass of sherds, most of them coming from two vessels that had collapsed in situ under the weight of the overlying earth (Figure 4.35). One of these vessels was a partially restorable Pingüino

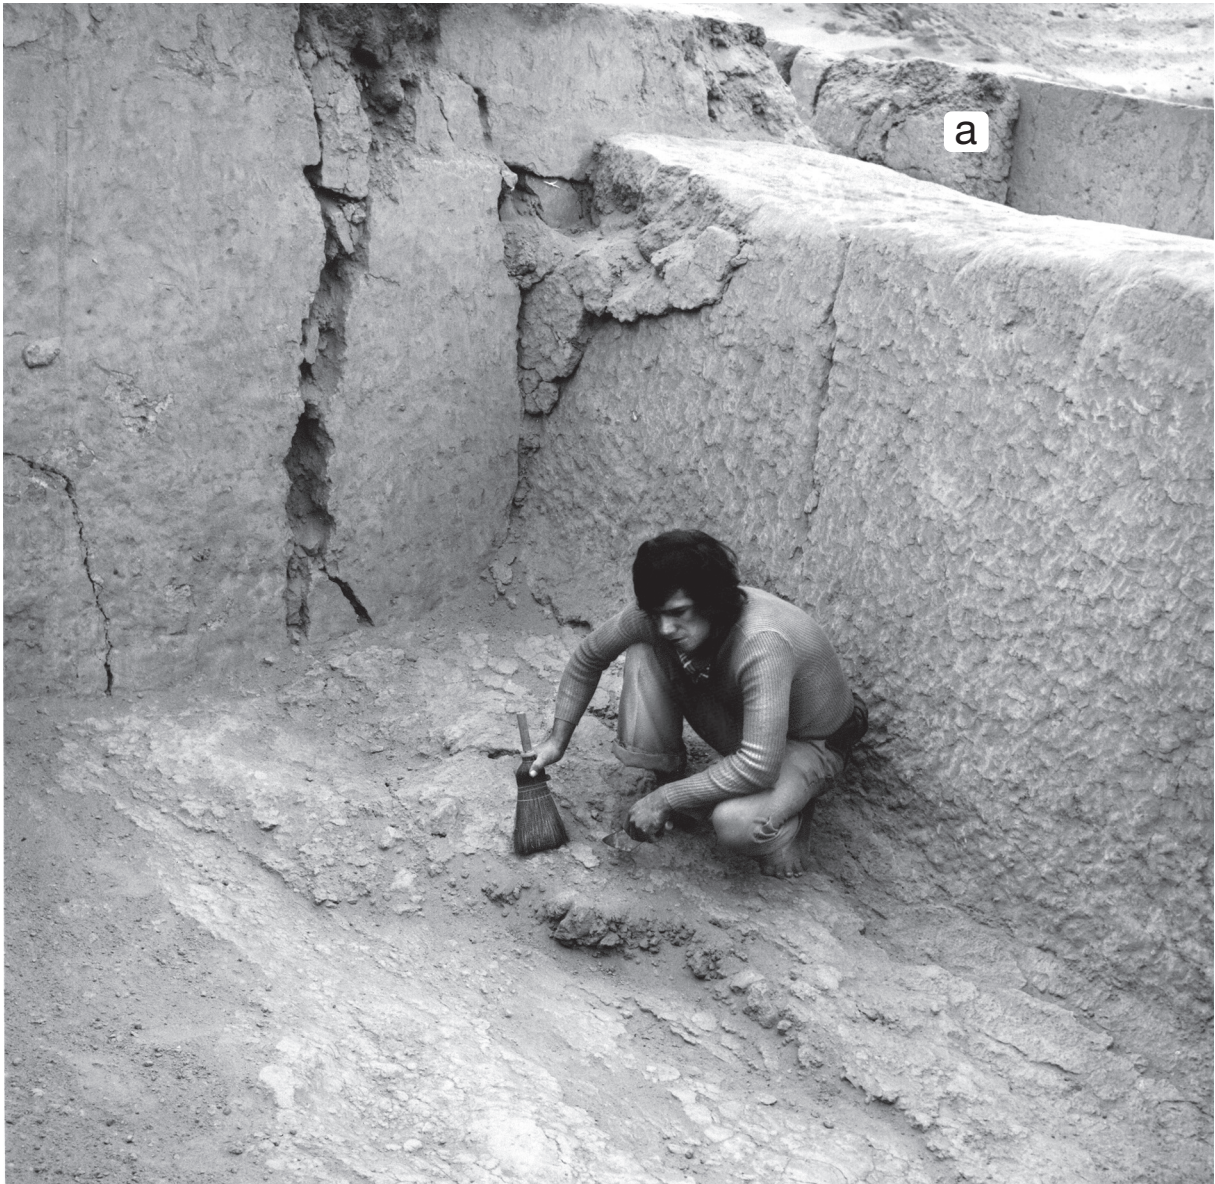
Figure 4.36. Alberto Barraza sweeps the original (lowest) floor of Room 4. His back faces the wall that was added in order to create Room 4 out of an area of the Southwest Canchón. (Since the room's original floor had once been part of the floor of that canchón, it occurred at roughly the same depth, 3.73 m below datum.) The tapia block marked *a* is the south jamb of the original doorway to the South Corridor (see Figure 4.1).

The interior dimensions of Room 4 were roughly 6.67×4.03 m. Its floor (which was part of the original floor of the Southwest Canchón) lay at 3.73 m below datum (Figure 4.36). It seems almost certain that Room 4 was designed for storage, since its walls were more than 1.5 m high yet had no doorway. Entry would probably have been

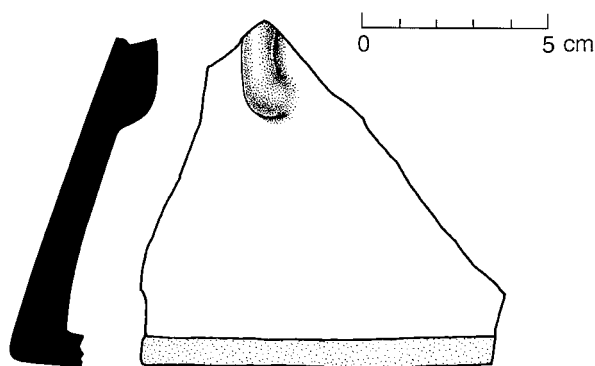
Figure 4.37. Sherd from amphora neck with modeled human ear, Camacho Black (standard variety). This sherd was found in the deep sounding in Room 4, Structure D, which probably produced the oldest collection of ceramics from Structure D. Depth, 3.73–4.73 m below datum.

Typical amphora neck with modeled human ear from a face: 1 (Figure 4.37)

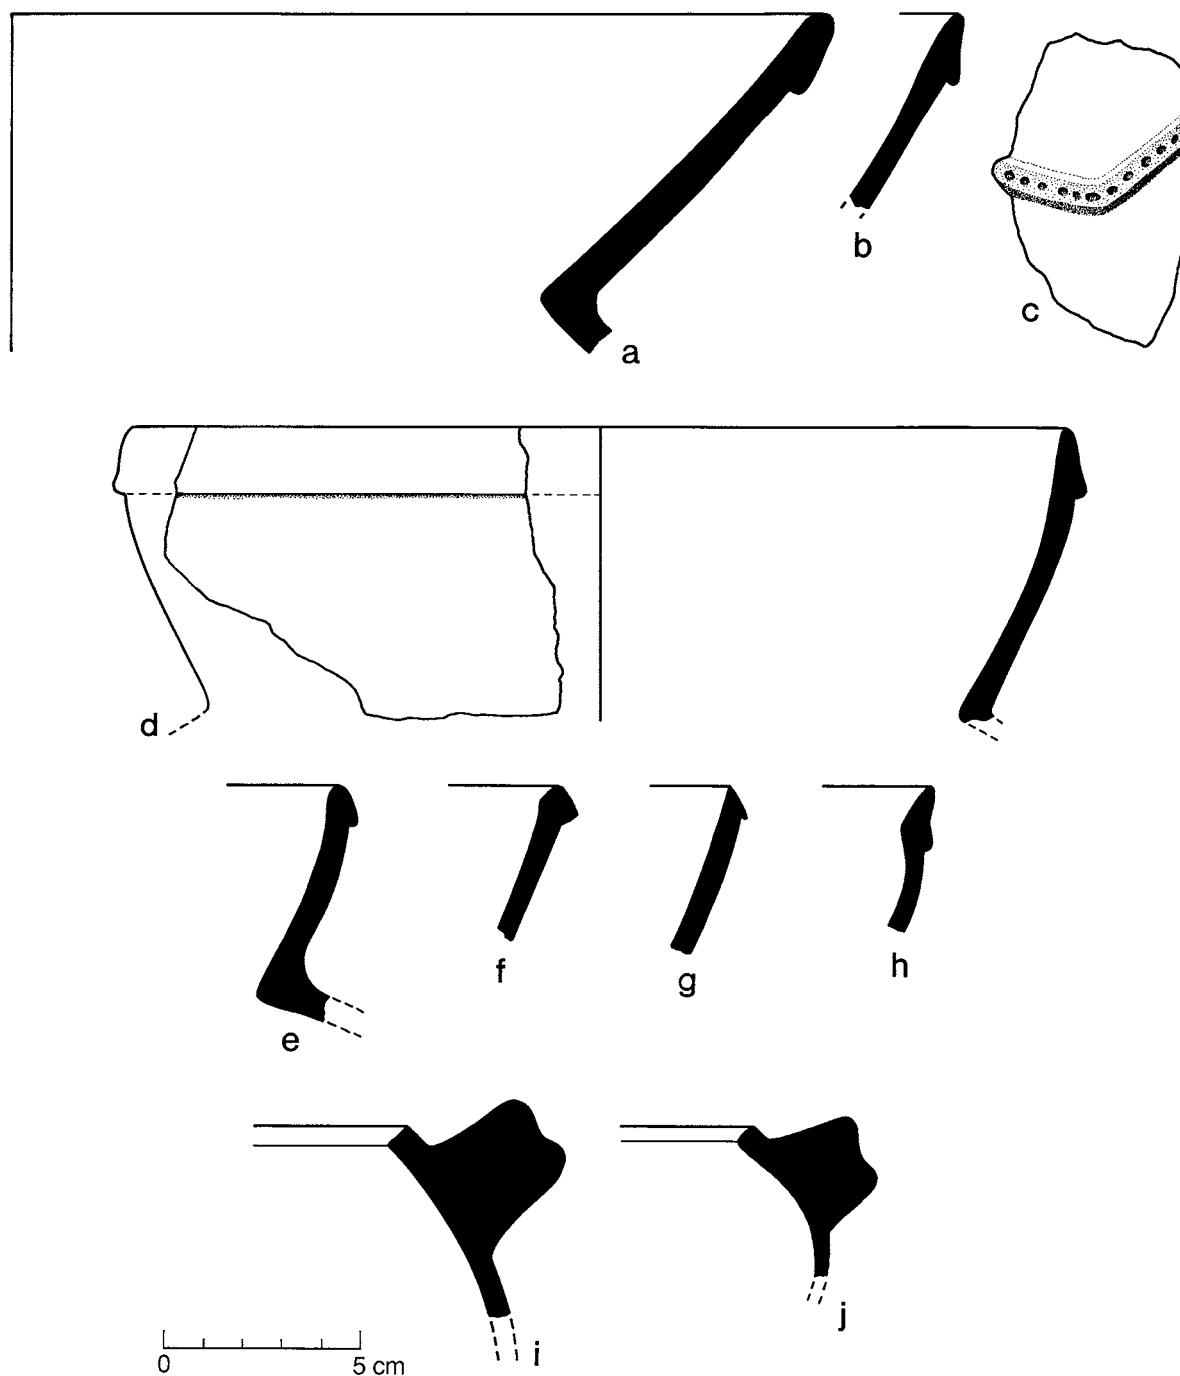
Figure 4.38. Camacho Reddish Brown vessels from the fill 1.5 m below the floor on which Feature 5 lay, Room 4, Structure D. (*a, b, d–h*): jars with cambered rims; (*c*): jar body sherd with what may be a modeled, punctate human arm on the exterior (based on more complete specimens); (*i, j*): cooking pots with restricted orifice and strap handles; fire-blackened on the exterior.

First, let us look at the sherds from the fill just above the original floor, 3.73 m below datum or 1.5 m below the floor on which we discovered Features 5 and 7 (Figures 4.38–4.40). Those sherds are as follows:

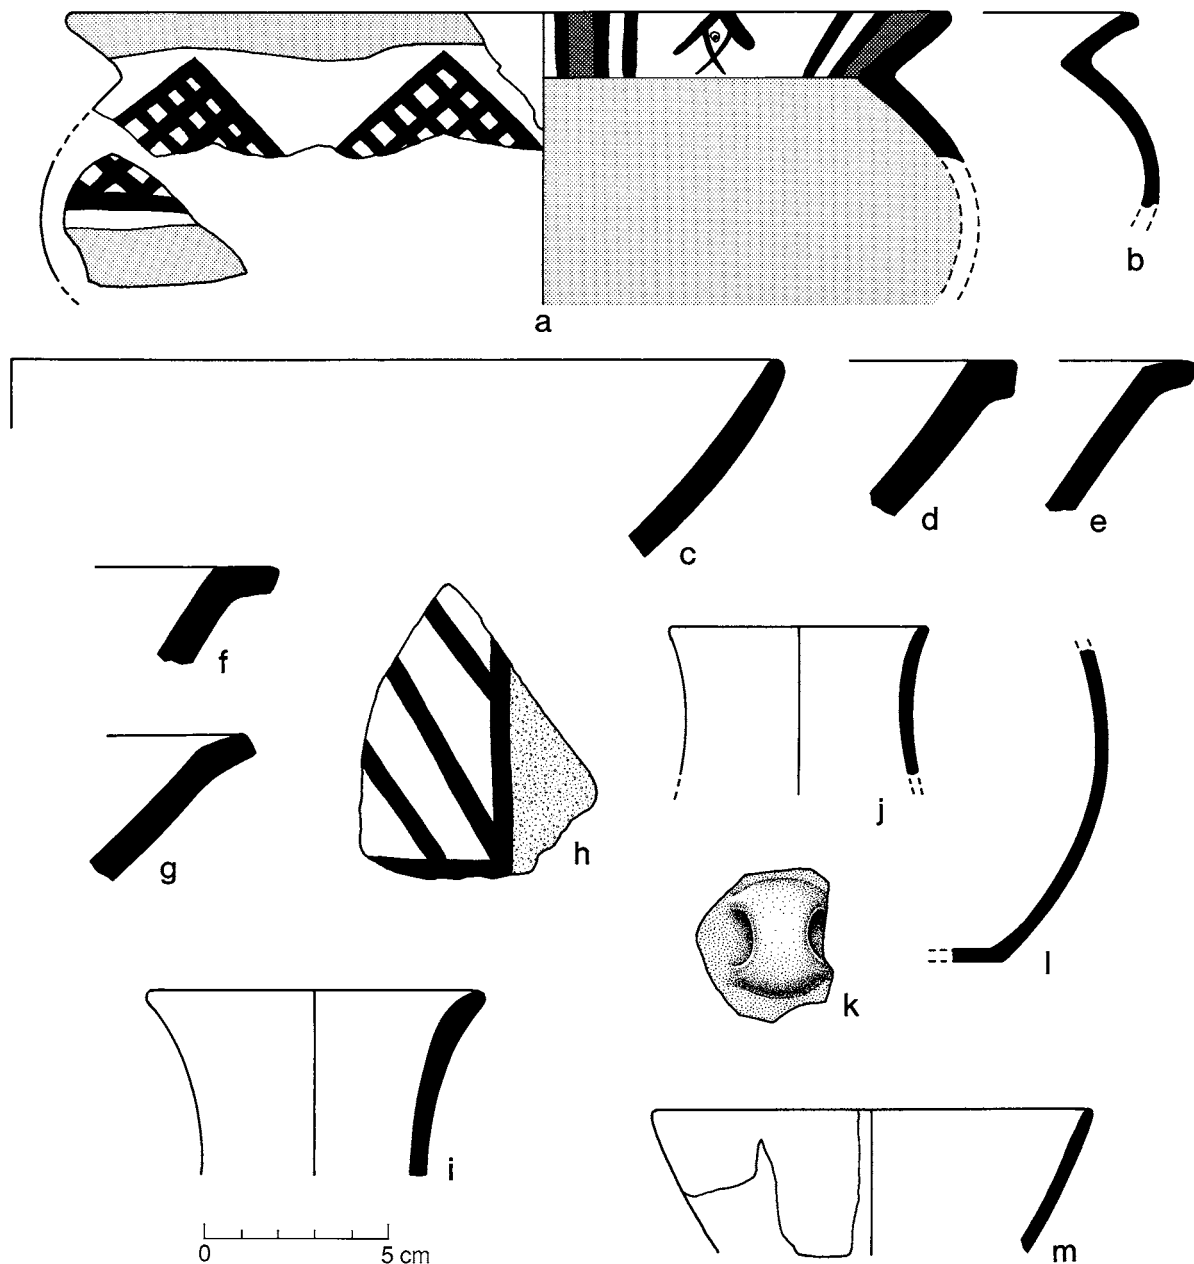
Figure 4.39. Ceramics from the fill 1.5 m below the floor on which Feature 5 lay, Room 4, Structure D. Sherds *a–e* are Pingüino Buff. (*a, b*): globular jars with wide mouth; *a* is painted black and white over natural buff on the exterior and black/white/red on the interior of the rim; the red is 2.5 YR 5/4 (reddish brown); (*c*): large hemispherical bowl, given wash or “self slip” of same clay as the paste; (*d, e*): slightly everted rims from large jars; (*f, g*): everted rims of large jars in atypical orange ware which looks superficially like Pingüino Buff, but has coarser temper; (*h*): Pingüino Buff jar body sherd painted black, white, and faded muddy brownish gray (?); (*i*): jar or amphora rim, Camacho Black (standard variety). Sherds *j–m* are Camacho Black (highly burnished variety). (*j*): small jar rim; (*l*): small jar base; (*k*): strap handle from jar; (*m*): hemispherical bowl.

- arm: 1
Body sherds: 23
- Camacho Black (Standard Variety) (Figure 4.39i)*
Jar or amphora rim: 1
- Camacho Black (Highly Burnished Variety) (Figure 4.39j–m)*
Small jars: 2 rims, 3 body sherds (1 is a base), 1 strap handle
Hemispherical bowls: 3 rim sherds
Plain body sherds: 5
- Globular jar with wide mouth, painted black/white/red on interior of rim, and black and white on exterior, rims: 4
Shoulders of globular jars with wide mouth: 5
Slightly everted rims, large jars: 3
Strap handle from large jar: 1
Neck, large jar, painted white: 1
Jar body sherds, painted black/white/red: 3
Large hemispherical bowls: 2 rims
Body sherds, unpainted: 10
Body sherds, traces of white paint: 11
- Pingüino Buff (Figures 4.39a–e, b, 4.40)*
- Atypical Orange Variety of Pingüino Buff (superfi-*

cially similar to standard *Pingüino Buff*, but with coarser temper) (Figure 4.39f, g)

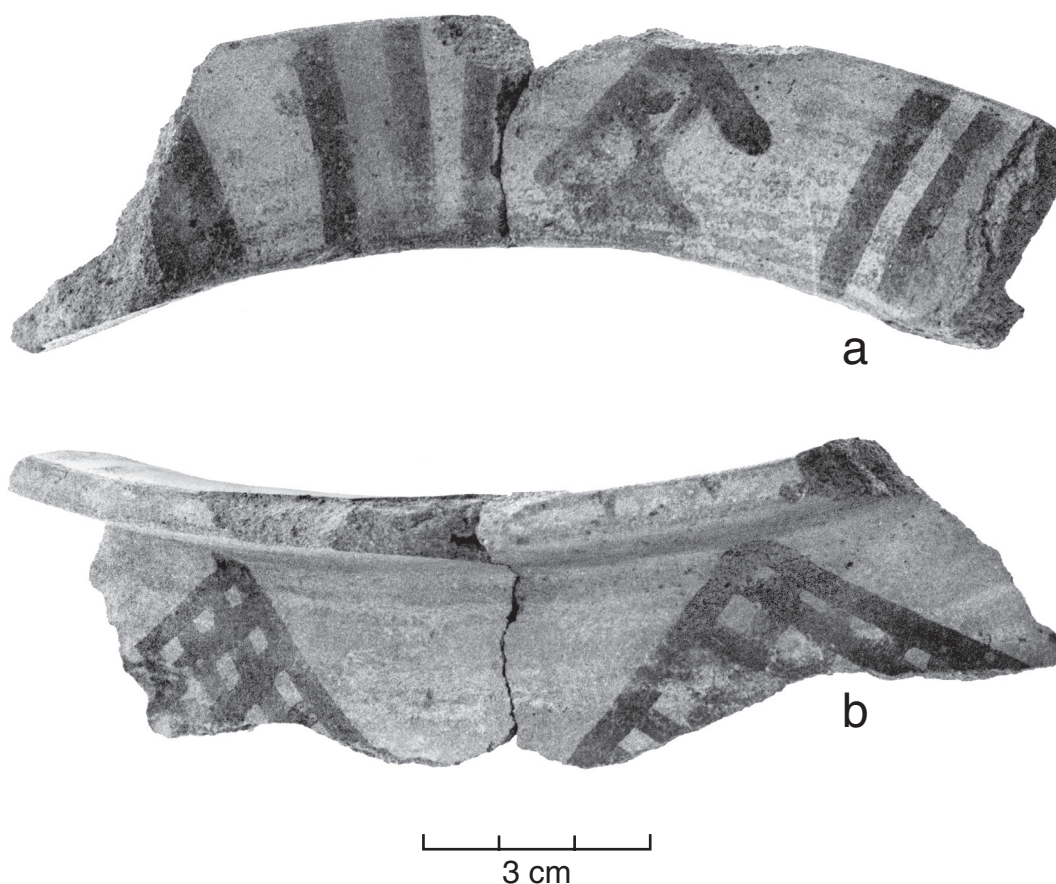
Figure 4.40. Two views of a Pingüino Buff globular jar with a wide mouth, found in the fill 1.5 m below the floor on which Feature 5 lay, Room 4, Structure D. Sherd *a* shows the “fish motif” painted on the inside of the rim in black/white/red; *b* shows the “mountain motif” painted on the jar shoulder in black and white over natural buff.

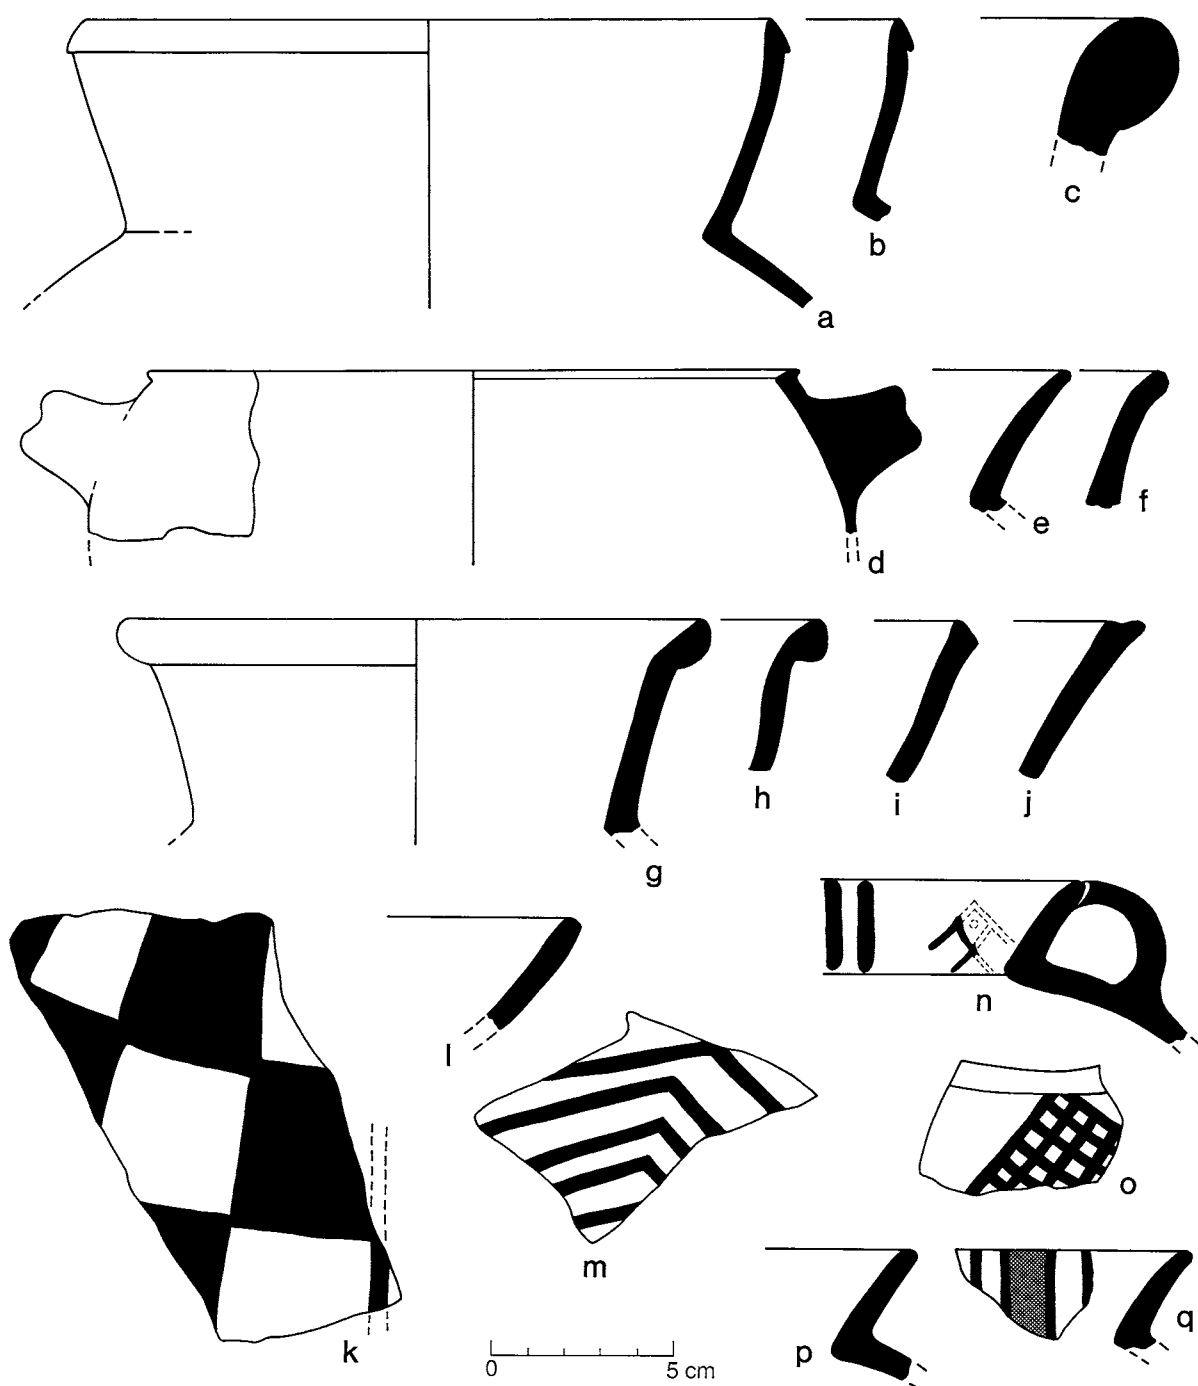
Figure 4.41. Ceramics from the fill 1.0 m below the floor on which Feature 5 lay, Room 4, Structure D. Sherds *a–j* are Camacho Reddish Brown. (*a, b*): jars with cambered rims; (*c*): large bolstered rim, possibly from *tinajón*; (*d*): cooking pot with restricted orifice and strap handles; (*e, f*): jar rims; (*g, h*): jars with bolstered everted rims; (*i*): beveled jar rim; (*j*): grooved-on-top jar rim. Sherds *k–q* are Pingüino Buff. (*k*): jar body sherds, painted black and white in squares; (*l*): rim of large, shallow hemispherical bowl; (*m*): jar body sherd with black chevrons painted on white slip; (*n–q*): globular jars painted on the exterior and on the interior of the rim; sherds *n* and *o* are painted in black and white, and *q* is painted black/white/red. The motif on *p* is too eroded to draw.

Next, let us turn to the sherds found in the fill roughly half a meter above the original floor, or about 1.0 m below the floor where Features 5 and 7 were found (Figures 4.41, 4.42). These sherds are as follows:

For the most part, the vast majority of the sherds from the fill separating the earliest and latest floors within Room 4 fit comfortably in the Late Intermediate of Cerro Azul. To be sure, there are a few anomalous-looking sherds (Figures 4.41k, 4.43i, m); nevertheless, it is not clear whether they are anomalous because they are trade pieces from other regions or because they are from earlier periods within the same re-

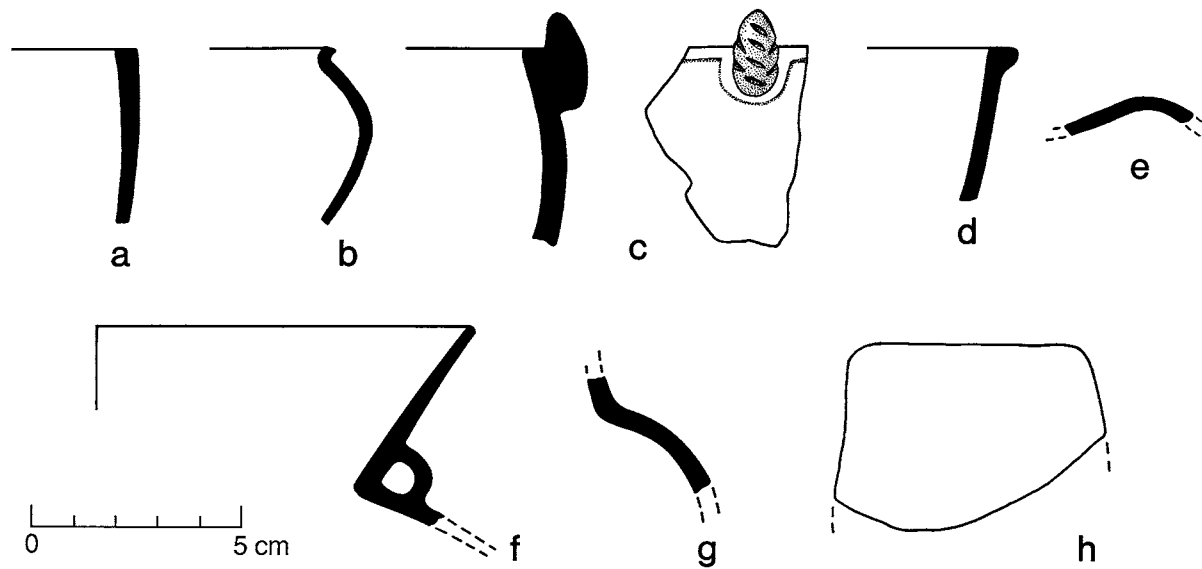
Figure 4.42. Ceramics from the fill 1.0 m below the floor on which Feature 5 lay, Room 4, Structure D. Sherds *a–e* are Camacho Black (highly burnished variety). (*a*): hemispherical bowl, “graphite” surface; (*b*): miniature jar with rolled rim; (*c*): two views of hemispherical bowl with maize cob lug on rim; (*d*, *e*): side and top views of hemispherical bowl with eccentric rim. Sherds *f–h* are Trambollo Burnished Brown. (*f*): small jar with funnel neck and strap handle; (*g*): shoulder of miniature jar; (*h*): rectangular sherd, possibly an unslipped figurine head (?).

Camacho Black (Highly Burnished Variety) (Figure 4.42a–e)

Trambollo Burnished Brown (Figure 4.42f–h)

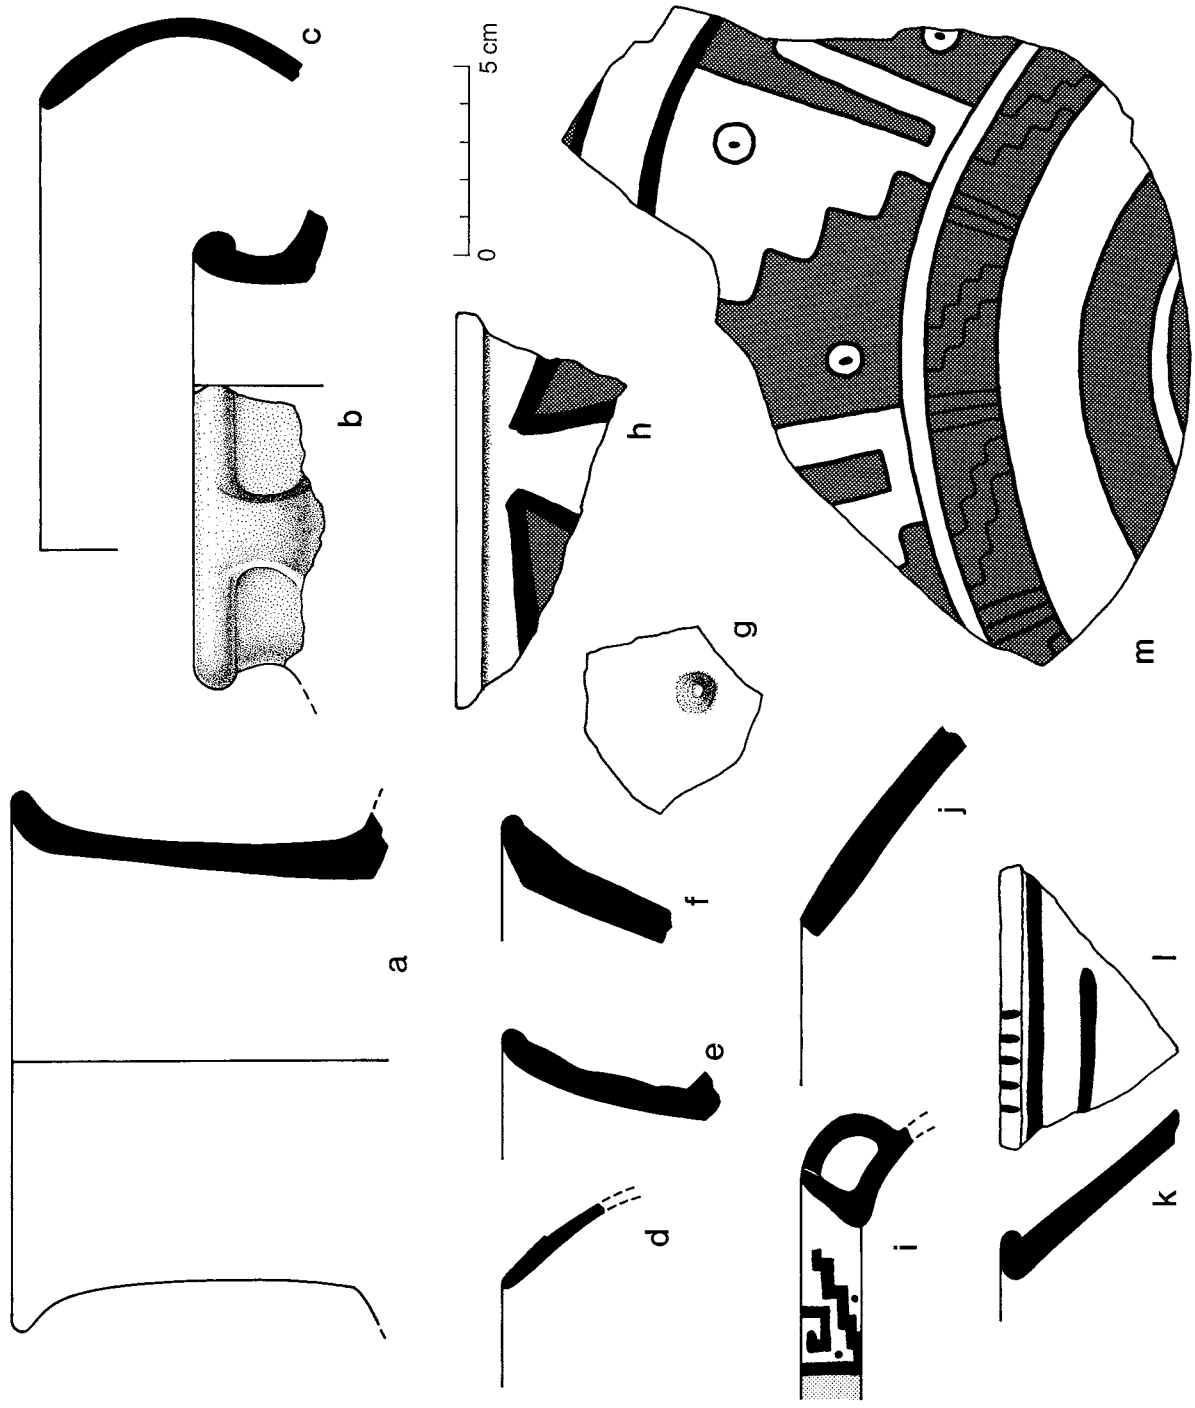
Figure 4.43. Ceramics from the fill immediately below the floor on which Feature 5 lay, Room 4, Structure D. (*a*): amphora neck of Camacho Black (standard variety). Sherds *b*–*g* are Camacho Reddish Brown. (*b*): small jar with cambered rim and strap handle; (*c*, *d*): cooking pots with restricted orifice; (*e*, *f*): jar rims; (*g*): jar shoulder with appliqué nipple; (*h*): jar rim, painted in black and red in a style usually seen on Pingüino Buff, but with Camacho Reddish Brown paste, temper, and surface treatment. Sherds *i*–*l* are Pingüino Buff. (*i*): globular jar with wide mouth, painted black and white on the exterior and on the interior of the rim; (*j*): large bowl with restricted orifice, white slip on exterior; (*k*, *l*): jar with rolled rim, painted black and white on exterior and rim; (*m*): aberrant sherd, either from another region or an earlier time period; it is painted in red (10 R 4/6) and white (10 YR 8/4) but appears worn and old.

Camacho Black (Standard Variety) (Figure 4.43a)

Pingüino Buff (Figures 4.43i–l, 4.44)

Small globular jar with wide mouth, painted black and white on interior of rim, black and white on exterior of body, with strap handle: 1 (Figure 4.43i)

Jar with rolled rim, painted black and white on exterior and rim: 1 (Figure 4.43k, l)

One aberrant sherd from a bucket-shaped bowl that might be from a different time period or a different region is shown in Figure 4.43m. This sherd is old and worn and may have been accidentally introduced into Structure D in fill dug up elsewhere. It is painted with opposing step-fret designs in a style atypical for Cerro Azul. Broadly similar vessels have been assigned to Ica 3C by Menzel (1976:Fig. 4.44).

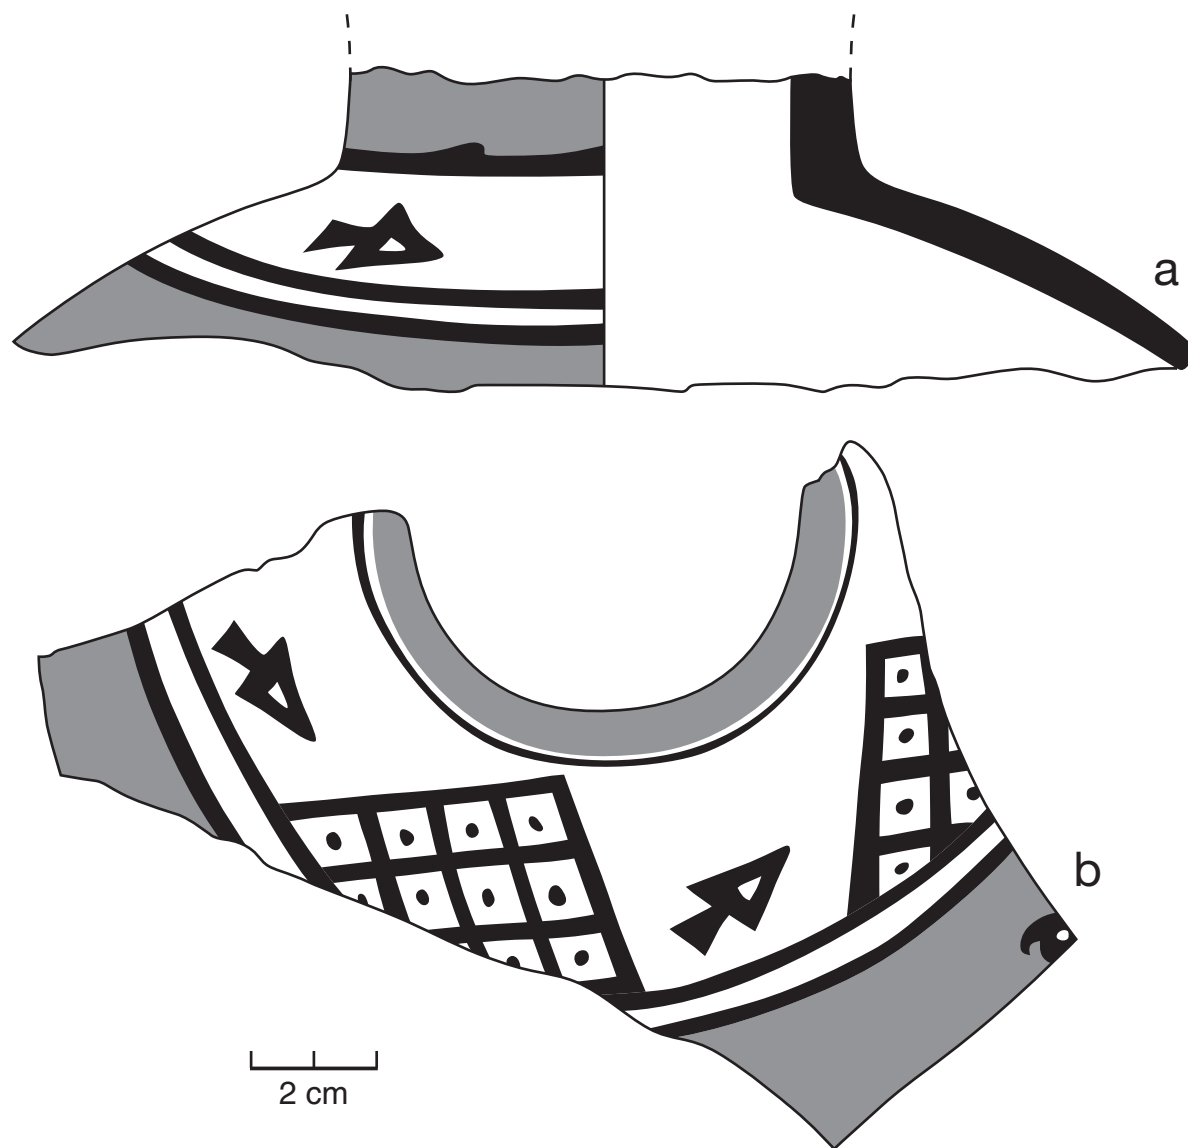
Figure 4.44. Neck and shoulder from Pingüino Buff jar, painted black and white over natural buff (shown as gray screen). Found in Room 4, Structure D, in the fill immediately below the floor on which Feature 5 lay. Motifs include fish and checkerboard mountains. (*a*): side view; (*b*): top view.

Neck and shoulder of jar with fish and mountains painted in black and white on natural buff (Figure 4.44)

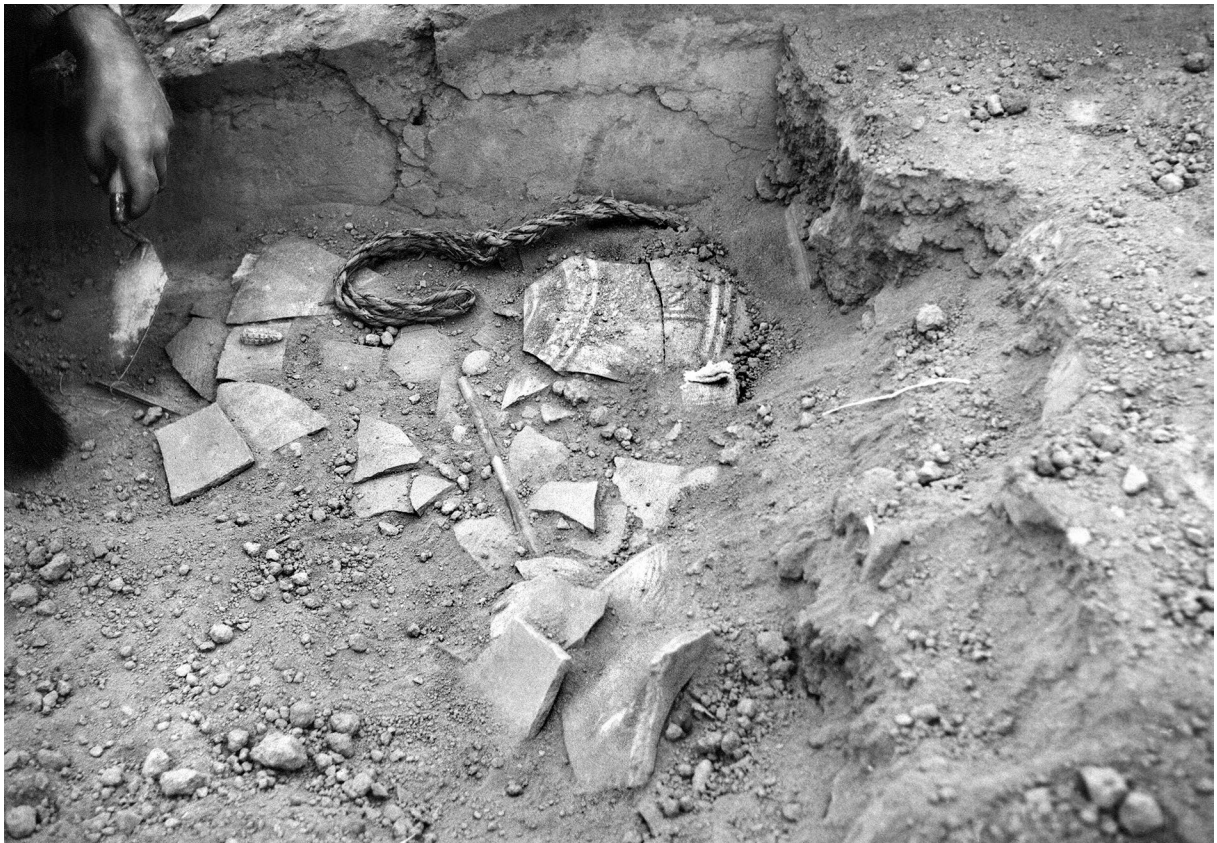
Figure 4.45. Room 4 of Structure D had a stratigraphic sequence of superimposed floors; the uppermost occurred at a depth of 2.23 m below datum. As Alberto Barraza began uncovering this floor, he discovered a cluster of partially restorable vessels and a length of coarse rope. In this mass of sherds—designated Feature 5—one could see the remains of a large Pingüino Buff jar with maize-cob-shaped lugs and an elaborate painted design.

Buff globular jar with two effigy lugs in the shape of maize cobs. The other was a Camacho Black amphora. A length of coarse rope, evidently used as a harness around the Pingüino Buff jar, was found among the sherds (Figure 4.45). Large numbers of Camacho Reddish Brown jar sherds were also found in this mass of pottery.

We designated this deposit of collapsed vessels Feature 5. Since it appeared to be a primary deposit—vessels left in situ on a floor, where they eventually broke under their own weight and that of the overburden—Feature 5 provided us with useful data on the average size of sherds from primary contexts (see the final section of Chapter 3). A random sample of 100 Camacho Reddish

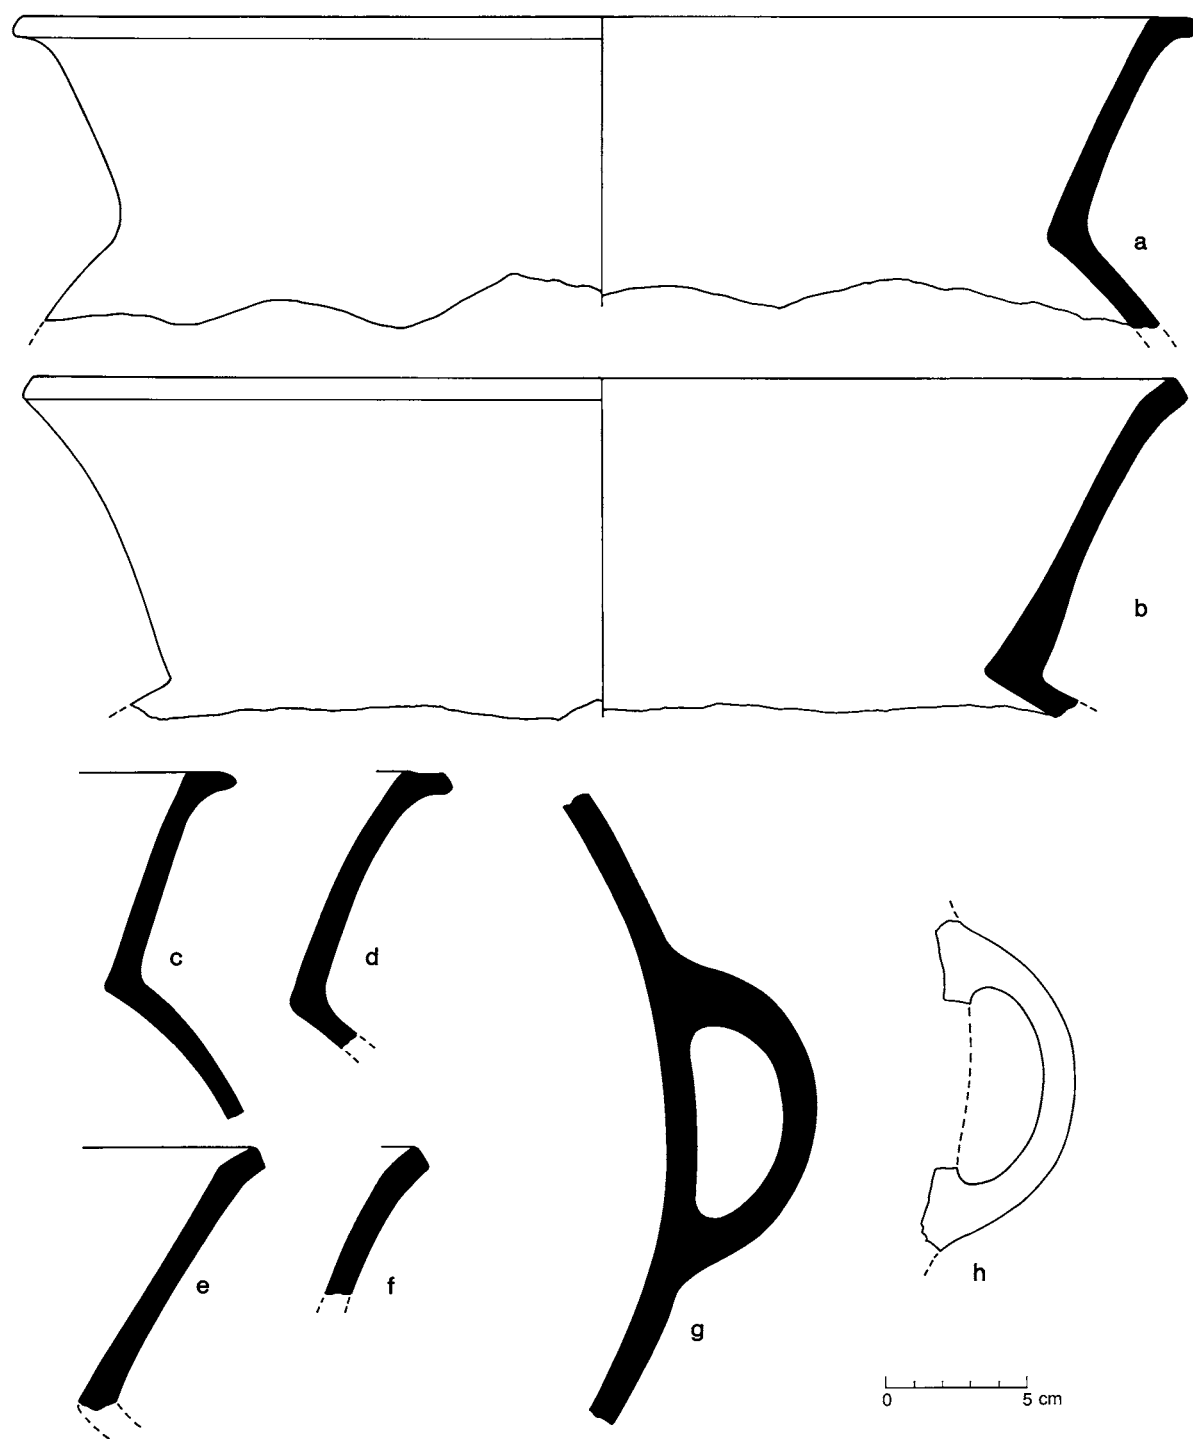
Figure 4.46. Vessels found in Feature 5, Structure D. (*a, c, d*): Camacho Reddish Brown jars with everted rims. (*b, e, f*): Camacho Black (standard variety) amphorae with slightly beveled rims; (*g, h*): Camacho Black (standard variety) strap handles from large amphorae.

A representative sample of ceramics from Feature 5 is illustrated in Figures 4.46–4.51. This is perhaps the largest sherd sample from primary context we recovered in Structure D, and it is prototypically Late Intermediate. Its Camacho Reddish Brown storage jars, Camacho Black amphorae, and Pingüino Buff globular jars with the crosshatched “mountain motif” are all common at Cerro Azul. So is the grooved sherd shown in Figure 4.49, which may depict the ribs of a “fat skeleton” (see Chapter 3). Finally, the partially restorable Pingüino Buff globular jar shown in Figures 4.50 and 4.51 combines many elements we found elsewhere in Structure D: maize-cob effigy lugs, painted flocks of birds, and checkerboards with dots or geometric motifs. Had the western half of the upper floor of Room 4 not eroded away, we suspect we would have recovered all of this vessel.

Camacho Reddish Brown (Figures 4.46a, c, d; 4.47a, b)

Camacho Black (Standard Variety) (Figure 4.46b, e–h)

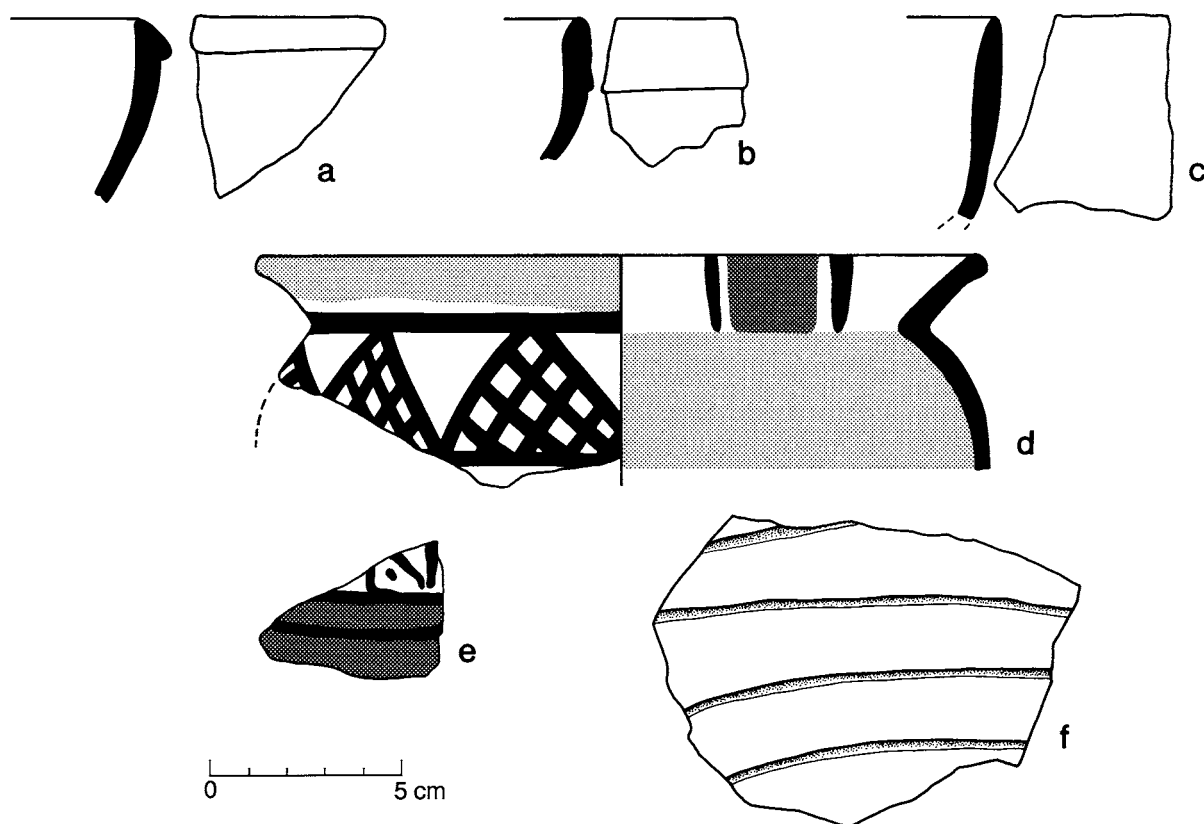
Figure 4.47. Vessels from Feature 5, Structure D. (*a, b*): Camacho Reddish Brown cambered rims, probably from jars; (*c*): rim sherd from Pingüino Buff hemispherical bowl, with atypical gray firing clouds and an atypical gray core to the paste. Sherds *d–f* are Pingüino Buff. (*d*): globular jar, painted black and white on the exterior and black/white/red on the interior of the rim; the white is 2.5 Y 8/2 (white); the black is 7.5 R 3/0 (very dark gray); the red is 10 R 5/2 (weak red). (*e*): jar sherd painted black/white/red on the exterior; the red is 10 R 4/6 (red). (*f*): jar sherd, burnished and shallowly grooved on the exterior.

Pingüino Buff (Figures 4.47c–f, 4.48, 4.49)

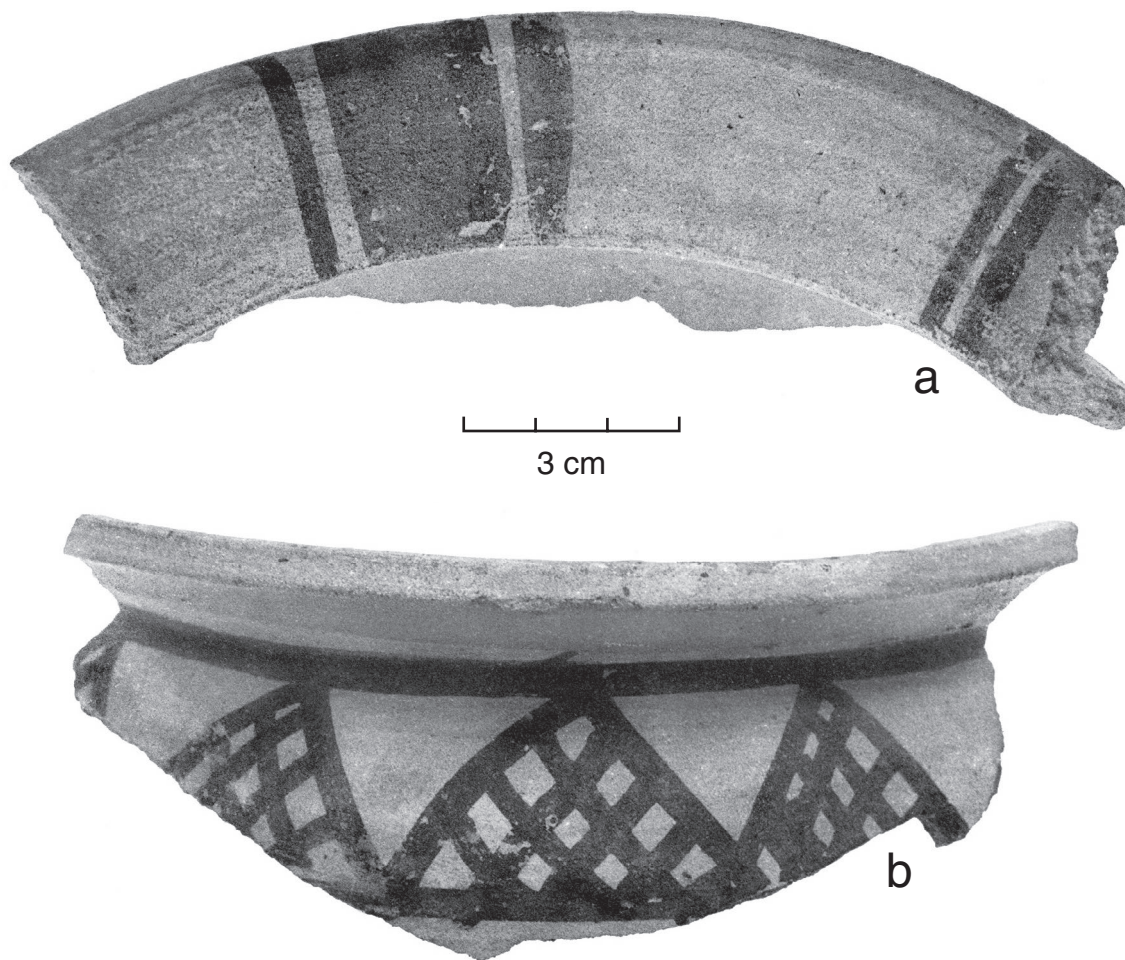
Figure 4.48. Two views of a Pingüino Buff globular jar with a wide mouth from Feature 5, Structure D. Sherd *a* shows the inside of the rim, painted in black/white/red; *b* shows the “mountain motif” painted on the jar shoulder in black and white.

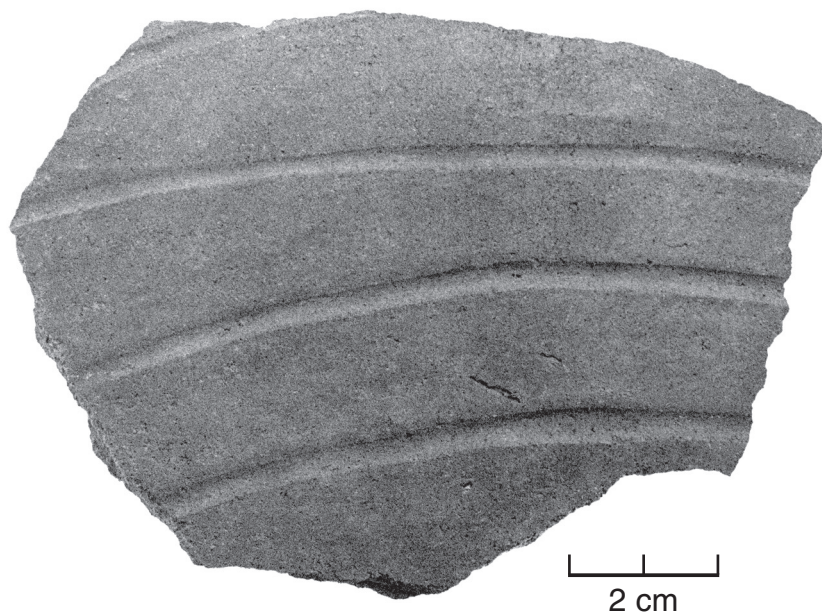
Figure 4.49. Pingüino Buff jar sherd, burnished and shallowly grooved on the exterior, found in Feature 5, Structure D. This may be a sherd from a “fat skeleton” effigy vessel.

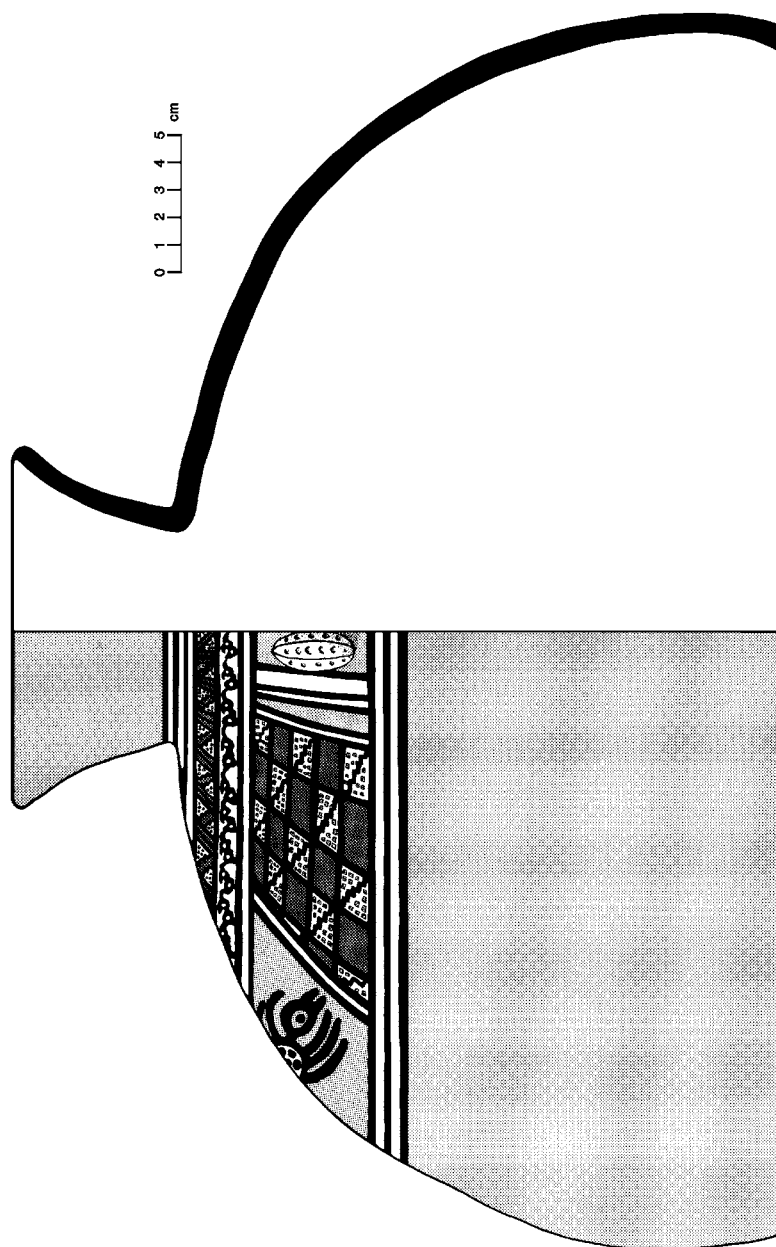
Figure 4.50. Partially restorable Pingüino Buff globular jar with funnel neck, Feature 5, Structure D. The vessel is painted on the exterior in black/white/red over natural buff and has two lugs in the form of maize cobs. The natural buff areas are 2.5 YR 5/6 (red) to 5 YR 6/6 (reddish yellow) and fire-blackened in places. The clay body (paste) is 10 R 6/6 (light red). The white paint is 10 YR 8/3 (whitish yellow); the red paint is 10 R 4/6 (red); and the black paint is 10 YR 3/1 (very dark gray).

Partially restorable Pingüino Buff globular jar with funnel neck, painted in white/black/red and bearing 2 effigy maize-cob lugs (Figures 4.50–4.51)

Body sherds, plain, mostly from the globular pot in Figures 4.50 and 4.51: 62
