MONOGRAPH 62
COTSEN INSTITUTE OF ARCHAEOLOGY
UNIVERSITY OF CALIFORNIA, LOS ANGELES

EXCAVATIONS AT
CERRO AZUL, PERU
THE ARCHITECTURE AND POTTERY
JOYCE MARCUS

Excavations at Cerro Azul, Peru

THE ARCHITECTURE AND POTTERY

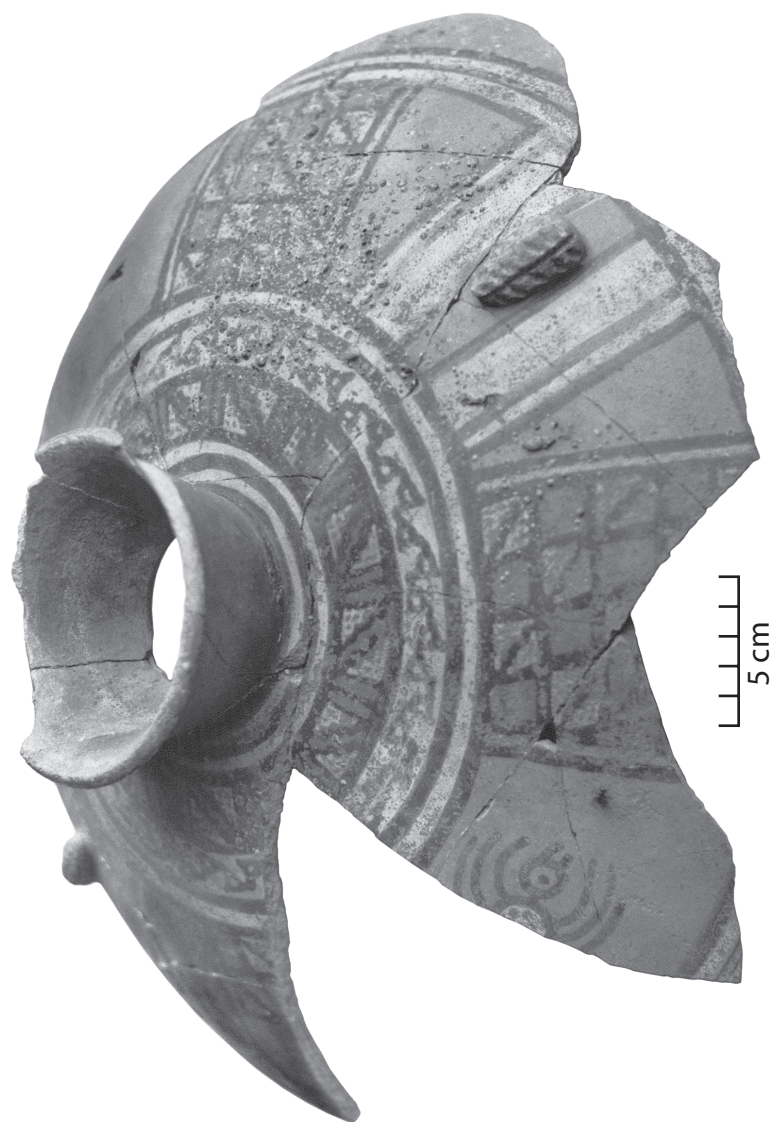
Figure 4.51. Partially restorable Pingüino Buff globular jar with funnel neck, Feature 5, Structure D. The vessel is painted on the exterior in black/white/red over natural buff and has two lugs in the form of maize cobs.

Partially restorable Pingüino Buff globular jar with funnel neck, painted in white/black/red and bearing 2 effigy maize-cob lugs (Figures 4.50–4.51)

Body sherds, plain, mostly from the globular pot in Figures 4.50 and 4.51: 62

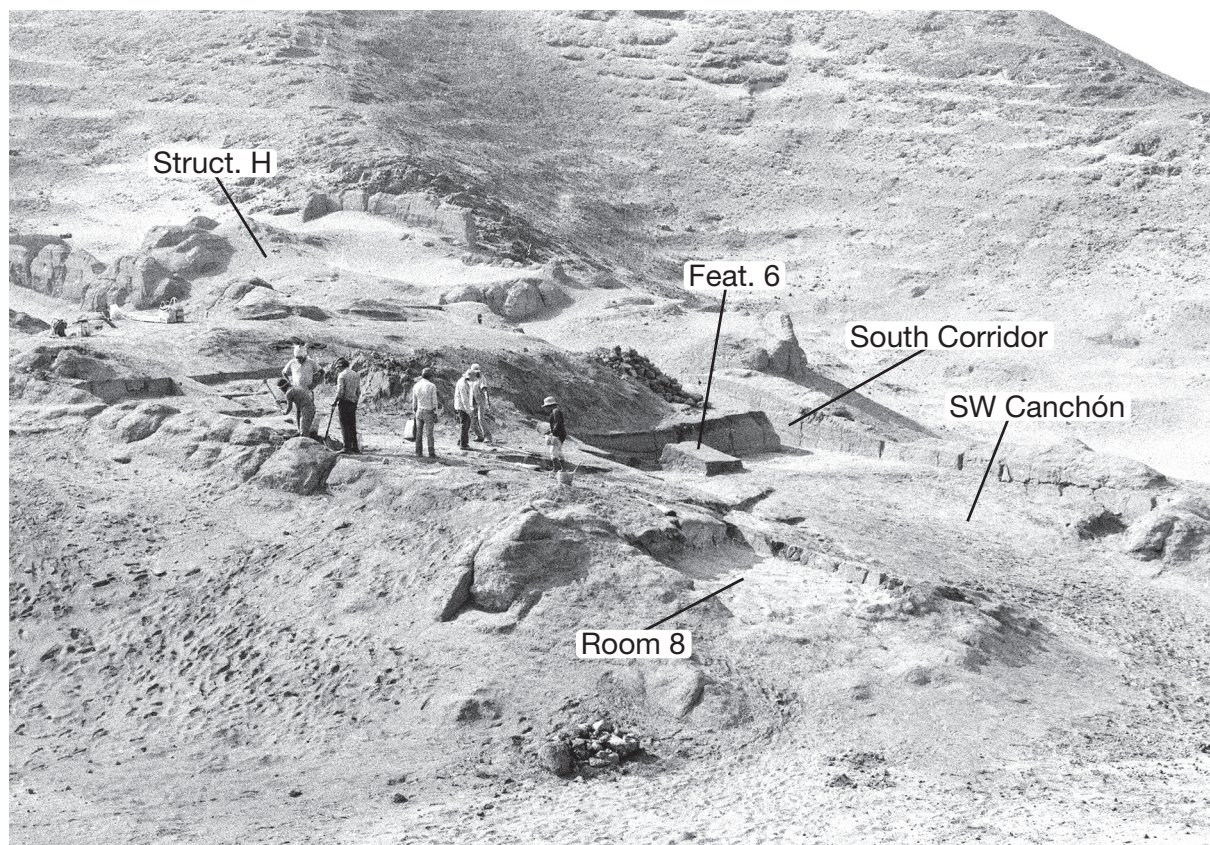
Figure 4.52. Structure D seen from Structure C at a relatively early stage of excavation. Part of the South Corridor and the Southwest Canchón have been exposed, and Feature 6, an important midden, has been left on a pedestal so that it can be excavated later with small tools and fine screens. Room 8 has been exposed only to the level of the fine sand with fish remains. Rooms 9, 10, and 11 have not yet been excavated. In the distance can be seen the terraces of Cerro Camacho and the ruins of Structure H.

We suspect that one of the main products exported from Cerro Azul to other communities in the Kingdom of Huarco was dried fish. The location of Room 8 (Figure 4.52) makes it likely

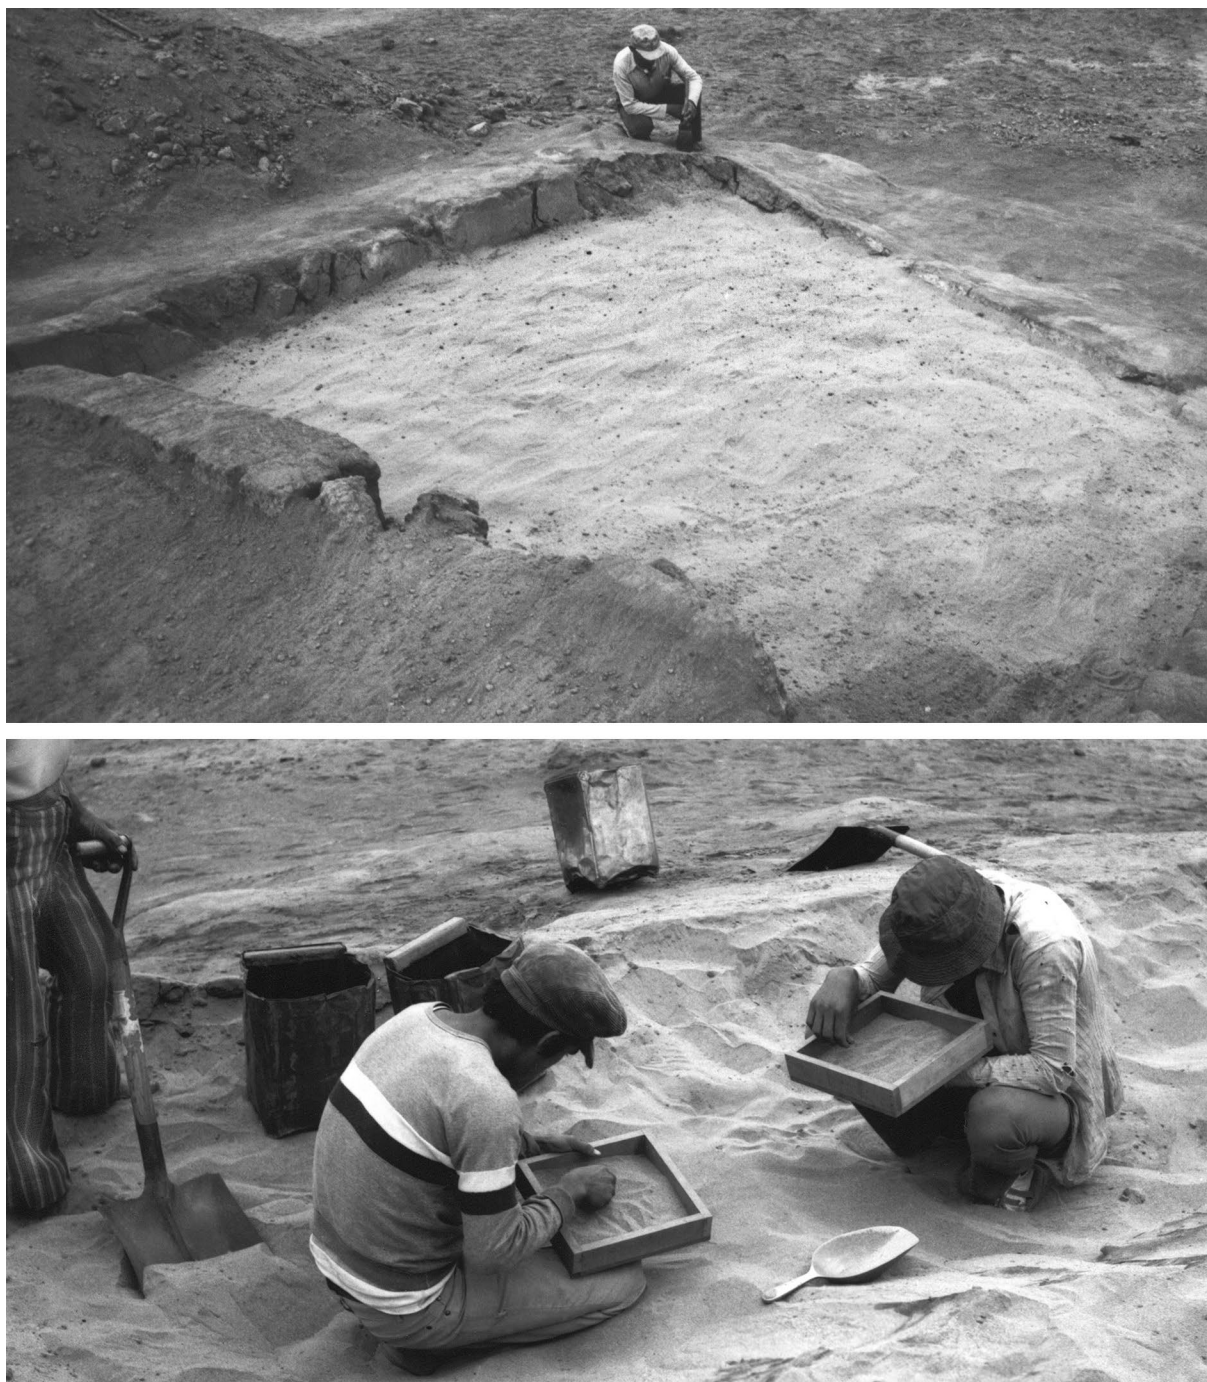
Figure 4.53. Room 8 of Structure D, a sand-filled room used for storage of dried fish. (*Top*): Edalio Aguidos has just finished sweeping the surface of the room's tapia walls. (*Bottom*): Cirilo Cruz and Ramón Landa are passing the sand from the room through fine carburetor mesh, in a search for fish remains.

When we discovered Room 8, it still had more than a meter of sand in it (Figures 4.52, 4.53). We

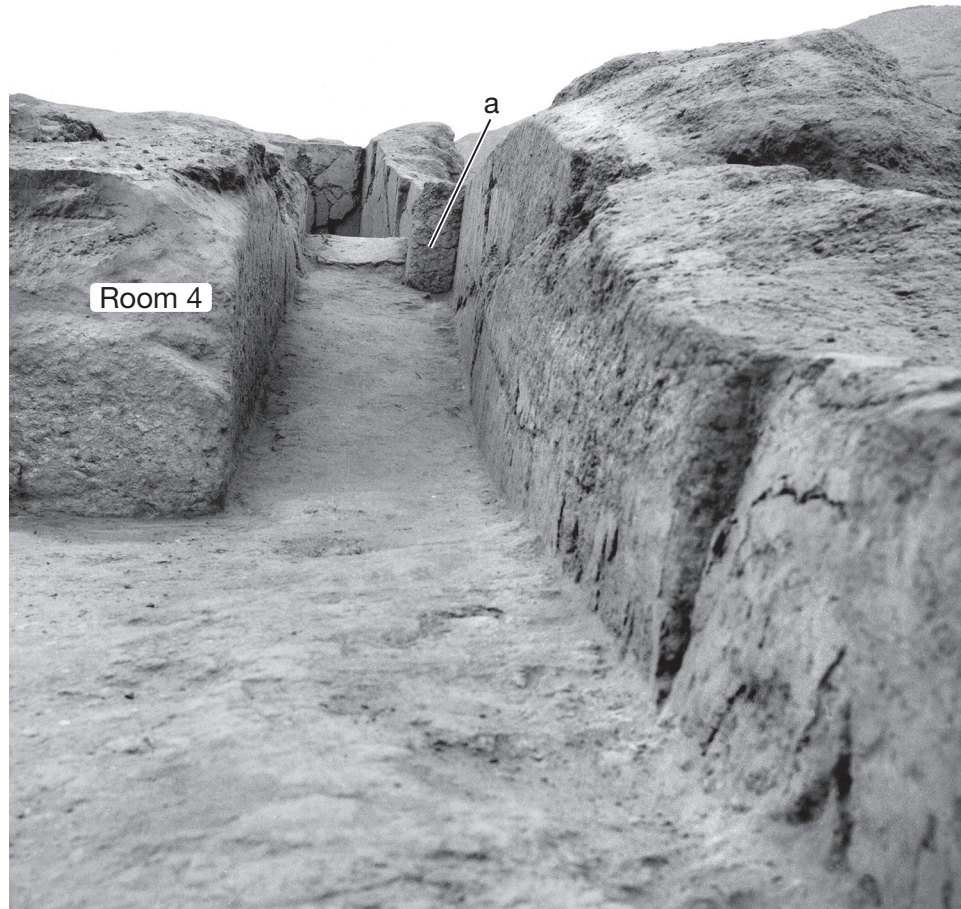
Figure 4.54. The later entrance to the east-west arm of the South Corridor, seen from the Southwest Canchón. The point marked *a* is the south jamb of the original entrance (see Figure 4.1). In order to create Room 4, the later occupants of Structure D built a new wall that added 4.85 m to the length of the South Corridor.

Originally, both the west and north entrances to the South Corridor were given *tapia* thresholds. That changed when an L-shaped wall was added to create Room 4 (Figure 4.35). This new wall added 4.85 m to the length of the corridor, and the new entrance was given no threshold. Figure 4.54 provides a view down the east-west arm of the South Corridor, showing the relationship between the old and new entrances. The letter *a* indicates the south jamb of the old entrance; to its left can be seen the *tapia* threshold. The photograph also shows how this stretch of corridor rises (from 3.78 m below datum near the new entrance to 2.72 m below datum near the old entrance).

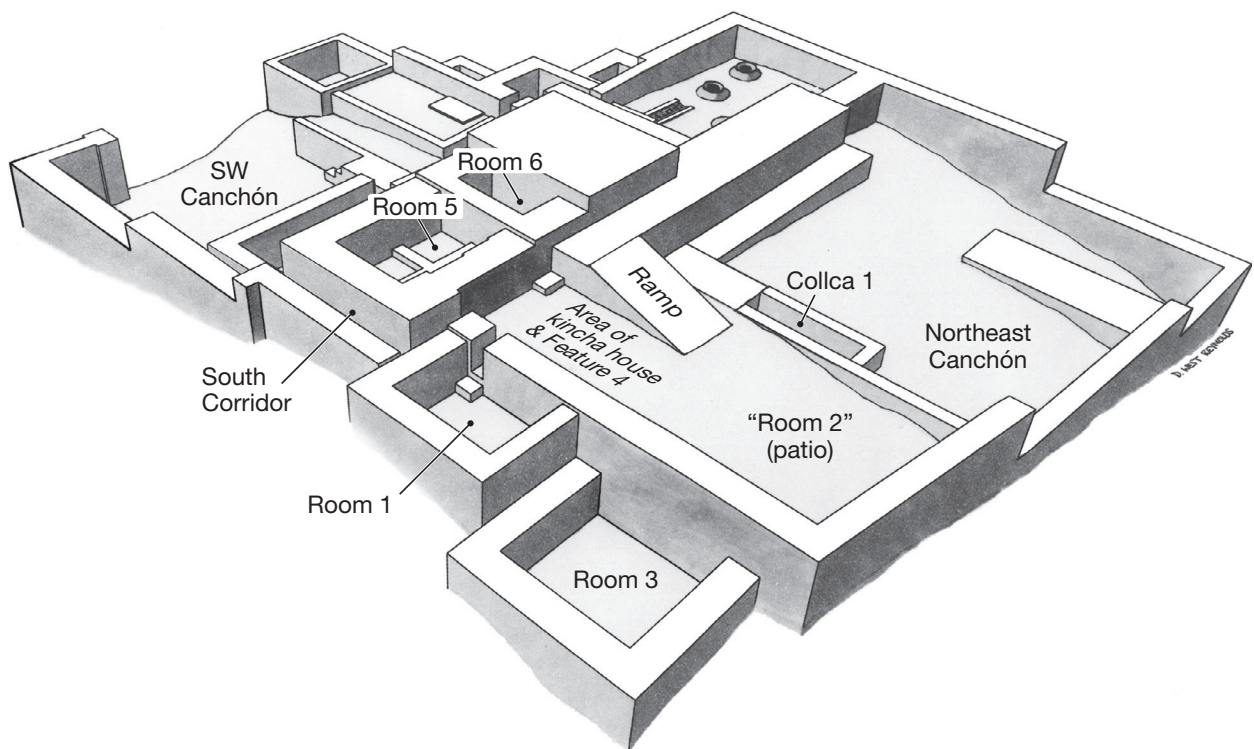
Figure 5.1. Artist’s conception of the southeast quadrant of Structure D.

Figure 5.1 presents an artist’s conception of the southeast quadrant of Structure D. It shows how the L-shaped South Corridor would have led residents single file from the Southwest Canchón into the Room 2 patio. Figure 5.2 displays both of the original entrances to the corridor. The entrance

As seen in Figure 5.1, both Room 1 and Room 3 lay adjacent to the Room 2 patio. Room 1 had originally been connected to the patio by a 64-cm-wide door with a sill and a step. Exactly how one would have entered Room 3 is less clear, owing to later erosion of its walls. We suspect that Room 3 would originally have been accessible from Room 1. If that is so, then Rooms 1 and 3 would have constituted a two-room residential apartment, with Room 3 the more private room and Room 1 providing access to the Room 2 patio.

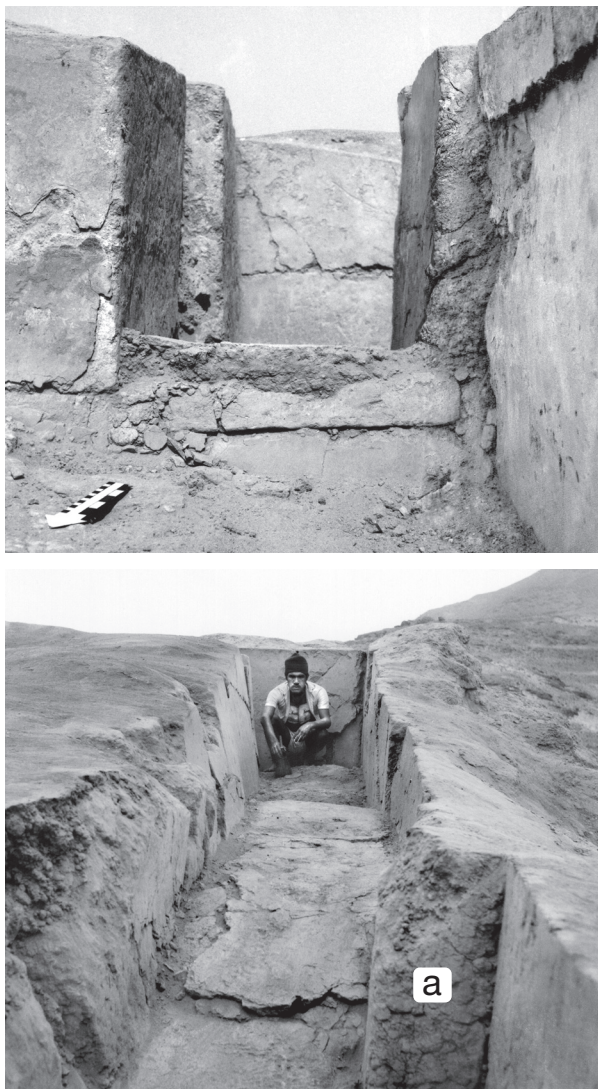
Figure 5.2. The original entrances to the South Corridor. (Top): The doorway from “Room 2” to the north–south arm of the corridor. (Bottom): The original doorway from the Southwest Canchón to the east–west arm of the corridor; (a) marks the south jamb. Edgar Zavala sits at the point where the north–south and east–west arms converge.

leading from Room 2 (Figure 5.2, top) had a raised threshold made from a large *tapia* block.

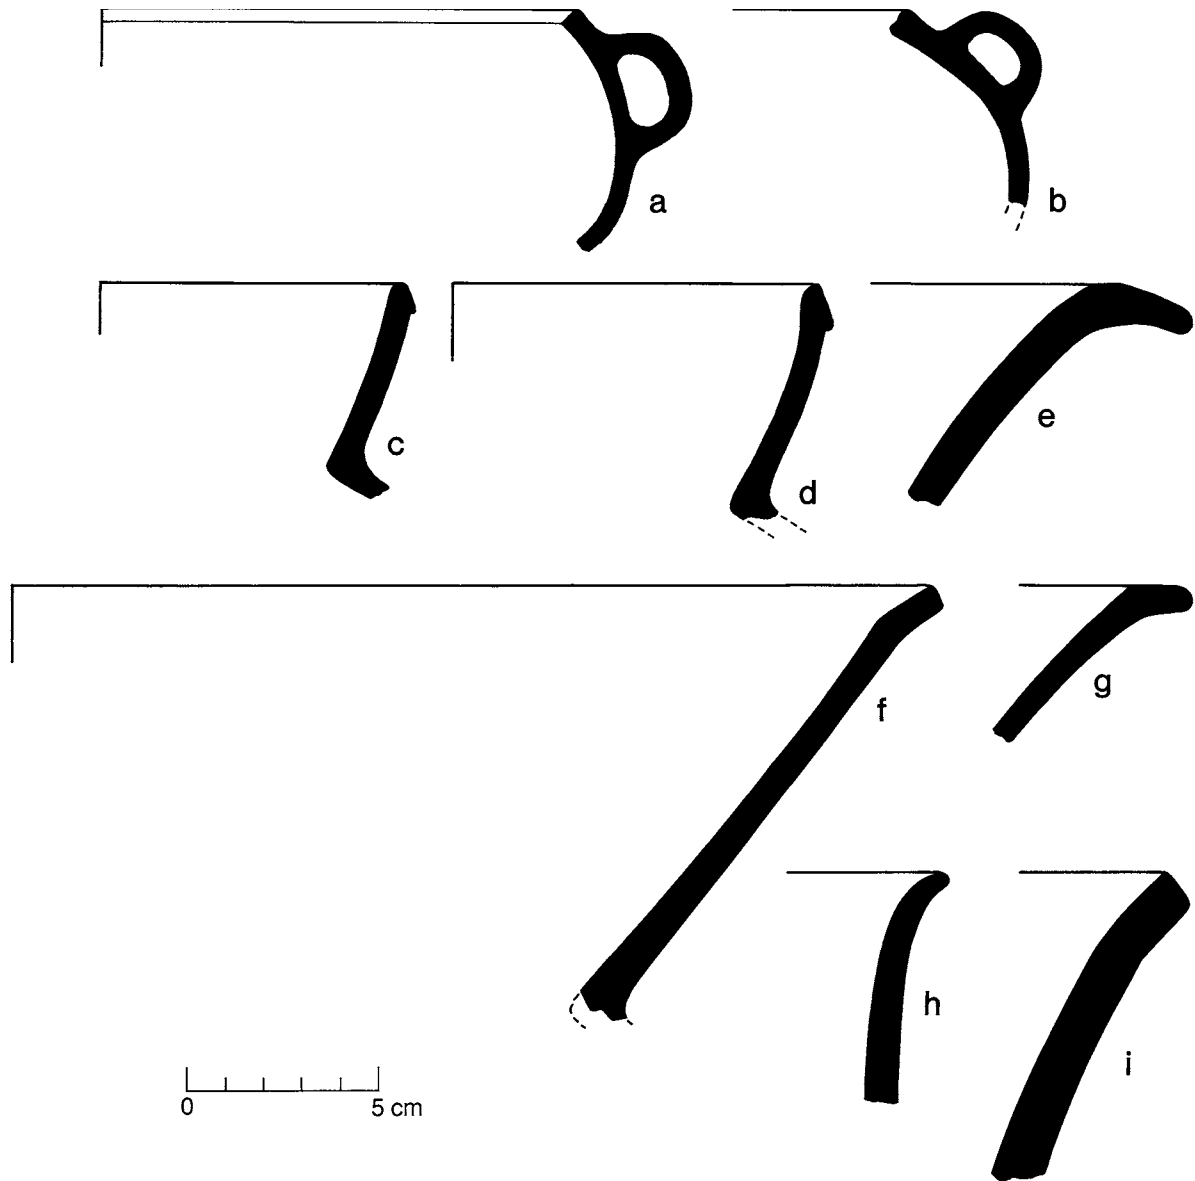
Figure 5.3. Ceramics from the floor of the South Corridor, Structure D. Sherds *a–g* are Camacho Reddish Brown. (*a, b*): cooking pots with restricted orifice and vertically set strap handles; (*c, d*): jars with cambered rims; (*e, g*): necks of large jars with everted rims; (*f*): neck of large jar with beveled rim. Sherds *b* and *i* are Camacho Black (standard variety). (*b*): amphora (?) with everted rim; (*i*): jar or amphora with beveled rim. (*a, c*, and *g* were found with a large pile of maize cobs.)

A small number of sherds were found in the mass of maize cobs and elsewhere on the floor of the South Corridor. Some of these sherds are illustrated in Figures 5.3 and 5.4, with the captions indicating which were found with the maize cobs and which were found elsewhere.

Camacho Reddish Brown (Figure 5.3a, c, g)

Camacho Reddish Brown (Figure 5.3b, d–f)

Camacho Black (Standard Variety) (Figure 5.3*b–i*)

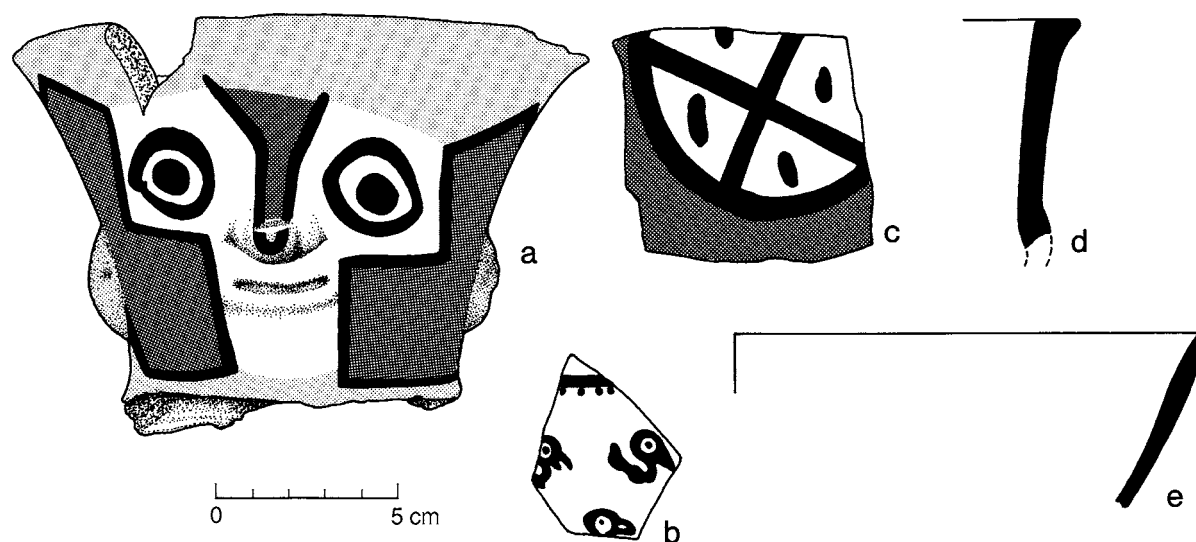
Figure 5.4. Ceramics from the floor of the South Corridor, Structure D. Sherds *a–d* are Pingüino Buff. (*a*): funnel neck from jar, painted black/white/red over natural buff. The facial paint resembles that used for figurines. The natural buff is 2.5 YR 6/6 (light red); the red paint is 7.5 R 3/6 (dark red). (*b*): jar sherd with bird motif painted in black on white; (*c*): jar body sherd painted in black/white/red (the red is 10 R 4/6); (*d*): jar neck with painted and modeled human face; the eye has been pushed out from the inside. Sherd *e* is a Trambollo Burnished Brown hemispherical bowl. (*b*, *d*, and *e* were found with a large pile of maize cobs.)

Pingüino Buff (Figure 5.4b, d)

Trambollo Burnished Brown (Figure 5.4e)

Pingüino Buff (Figure 5.4*a, c*)

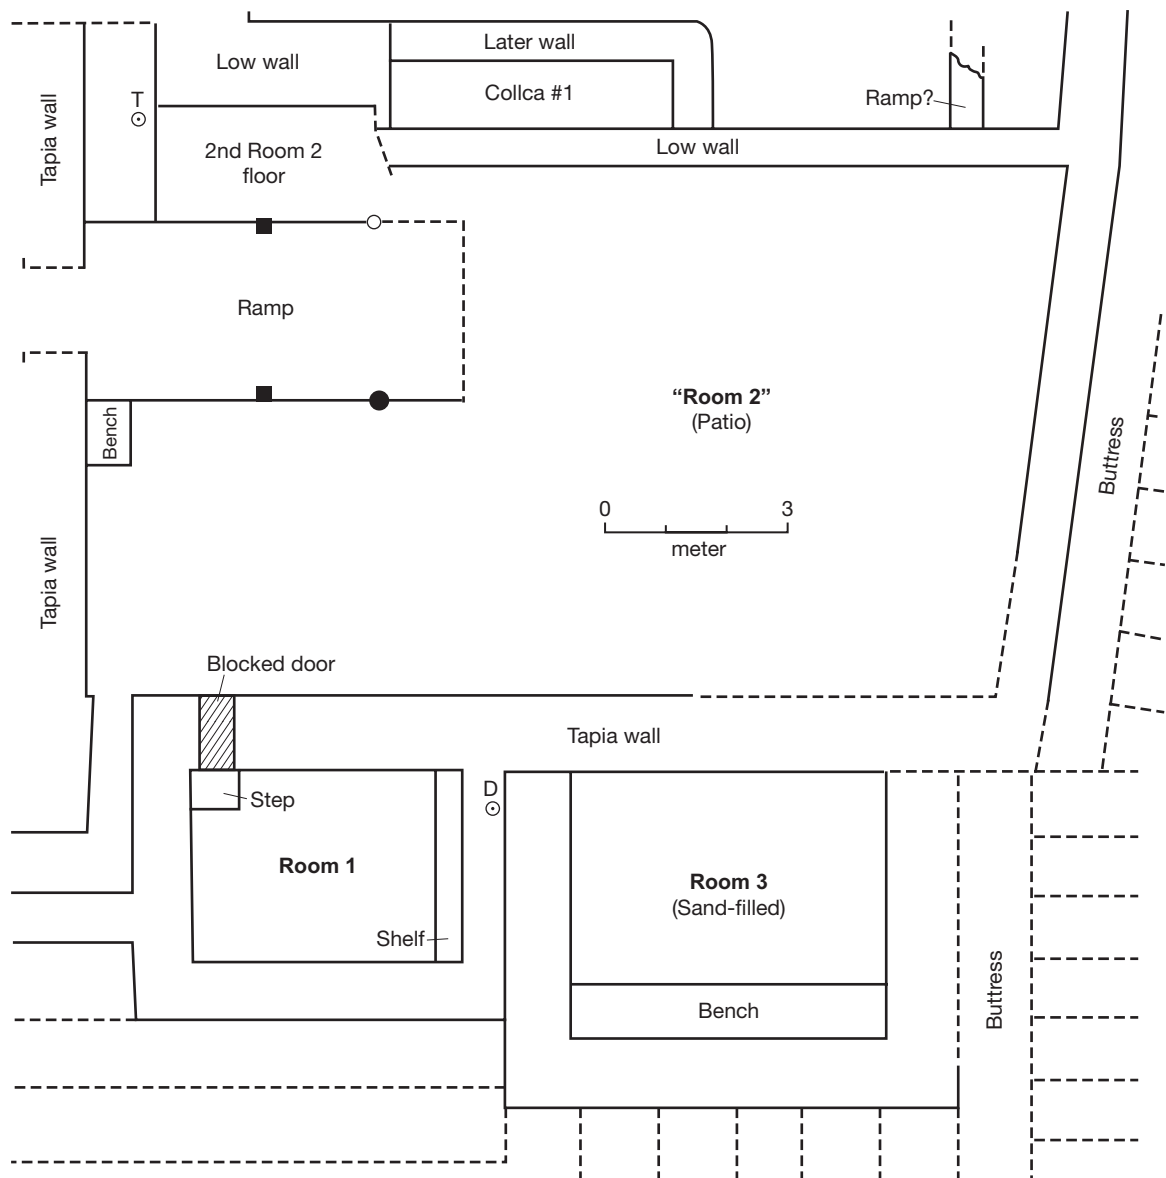
Figure 5.5. Plan of Rooms 1, 2, and 3 of Structure D.

and 3). We suspect that early in the history of Structure D, this complex of two rooms and a private patio was the living quarters of the compound's most important family (Figure 5.5). Unfortunately, as we will see below, earthquake damage later reduced the suitability of Rooms 1 and 2 for this purpose.

From Room 2, one could reach a series of smaller rooms to the west by means of a ramp, now badly eroded. The ramp had originally been about 6.16 m long east–west and 3.01 m wide north–south and was reinforced by *huarango* posts, some of which were round in cross section and others of which were square (Figure 5.5). It seems to take off from the uppermost floor of the

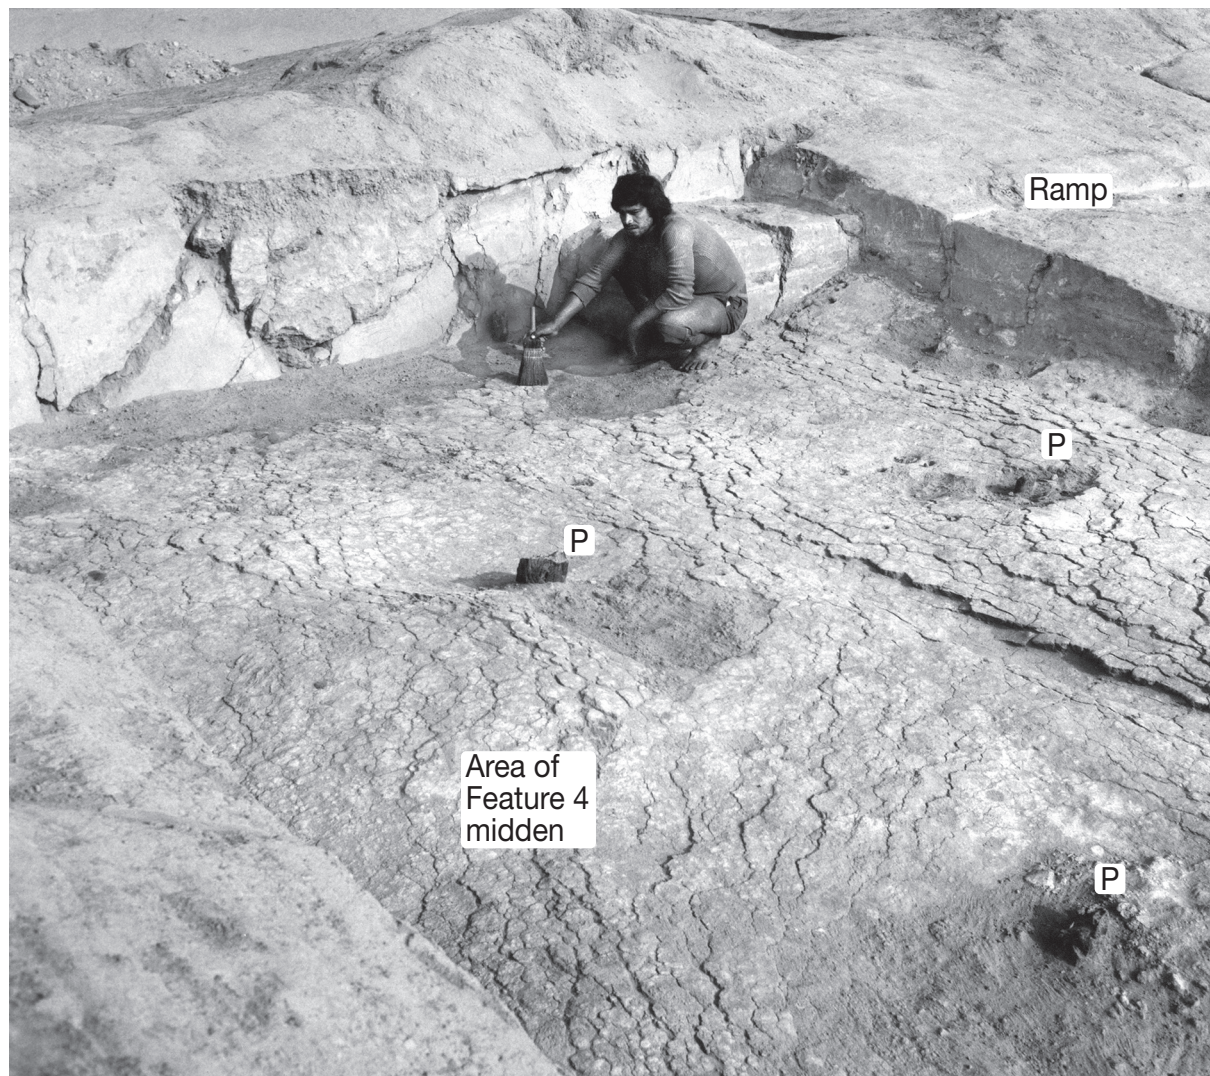
Figure 5.6. “Room 2” of Structure D, seen from the east. The Feature 4 midden has been removed, but several of the *huarango* posts (P) from the *kincha* structure associated with the midden remain (see also Figure 5.9).

Figures 5.6, 5.7, and 5.8 show the southern portion of Room 2, the bench, the ramp, and one of the square *huarango* posts in the north side of the ramp.

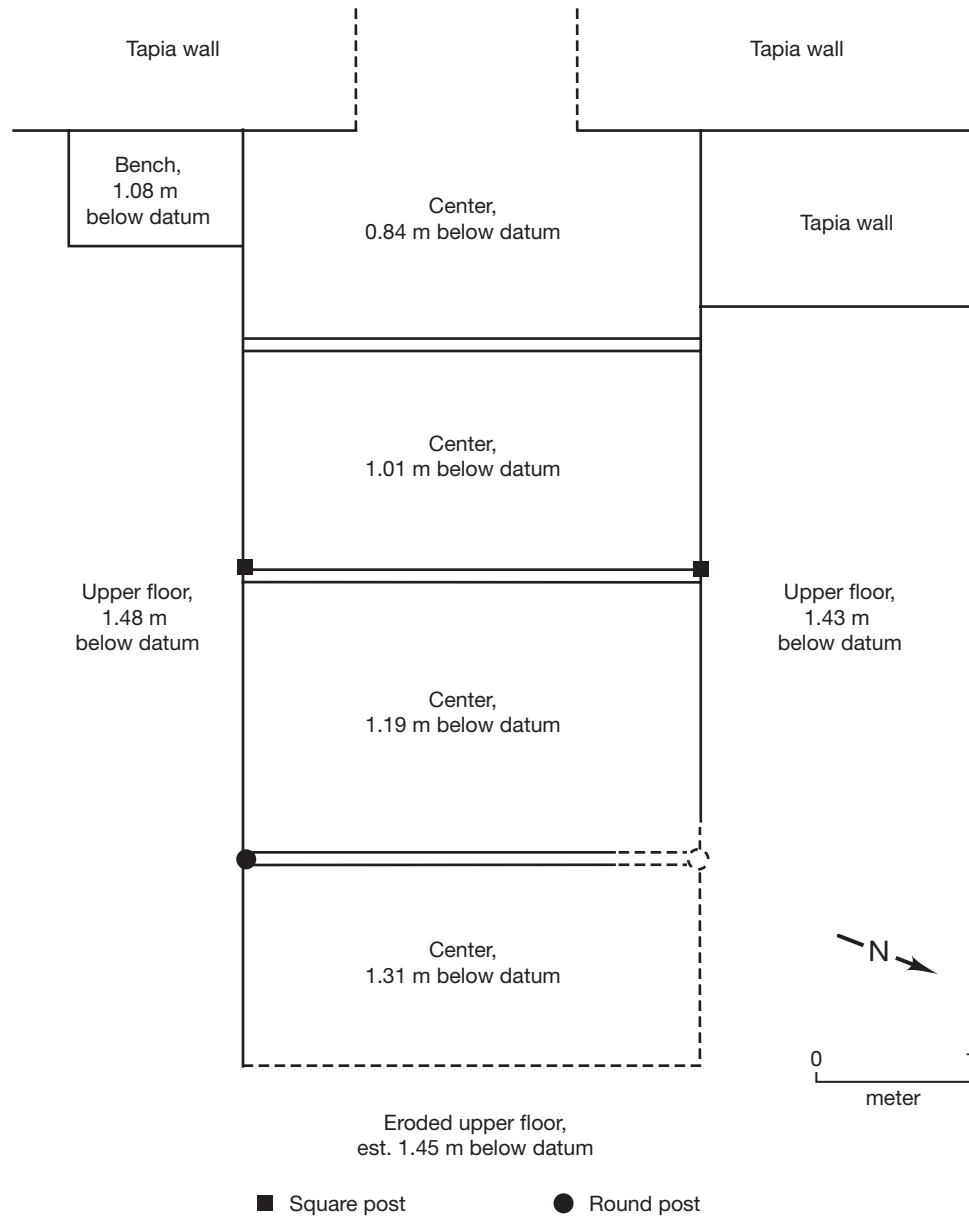
Figure 5.7. The ramp leading from “Room 2,” Structure D, to the area of Room 6. The ramp was composed of four large tapia blocks which sloped down from 84 cm below datum to roughly 1.45 m below datum.

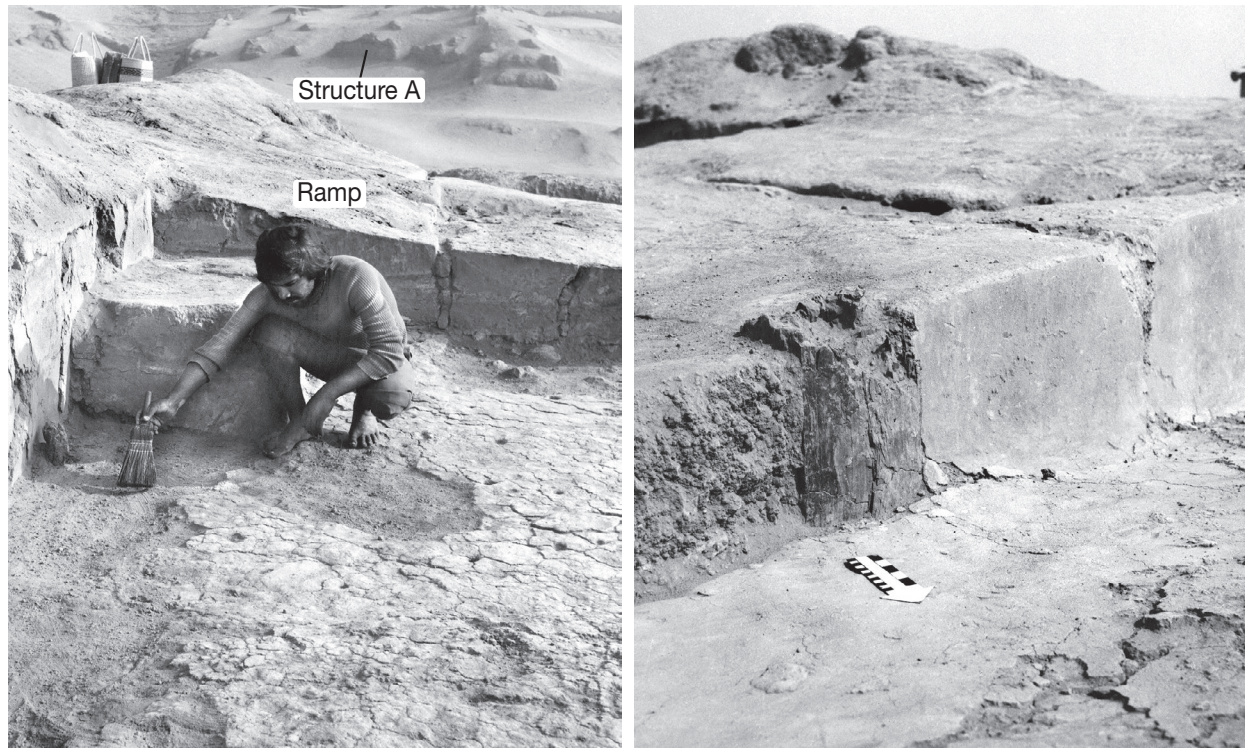
Figure 5.8. Two views of the ramp in “Room 2.” (Left): Alberto Barraza sweeps the floor of the Room 2 patio; his back is to the ramp. (Structure A can be seen in the background.) (Right): A square wooden post set in the north side of the ramp. This ramp dates to the most recent construction phase of Structure D.

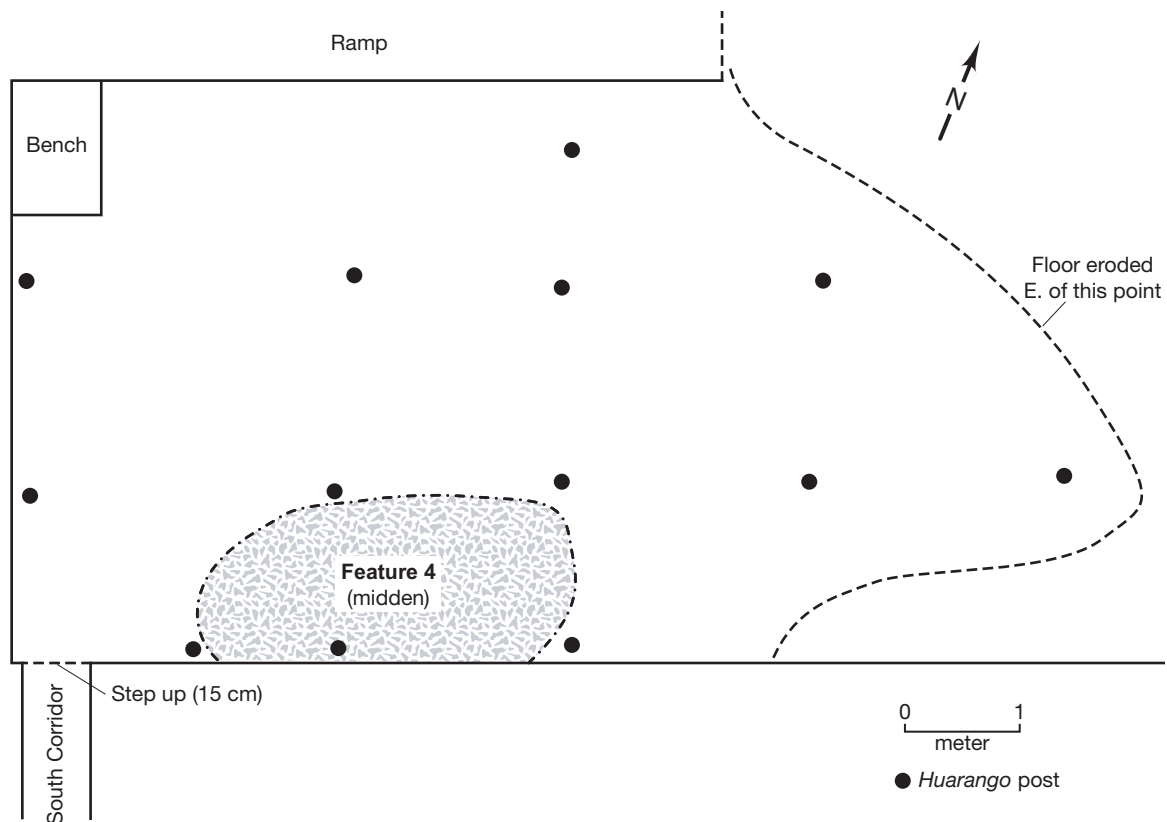
Figure 5.9. The southwest quadrant of “Room 2,” Structure D, showing the Feature 4 midden and some 13 *huarango* posts from a possible Late Horizon *kincha* house associated with it.

squatters had built a *kincha* house in the Room 2 patio. This wattle-and-daub house occupied the south half of the patio, that is, the area between the ramp and the entrance to the South Corridor (Figure 5.9). The construction involved a large number of small *huarango* posts, 13 of which could still be found in situ and others of which had eroded away with the patio floor. Figure 5.10 shows the way the floor had collapsed in places when the posts were driven through it. Judging by the fragments that had fallen to the patio floor, it appears that the walls of the “squatters’ house” were of canes daubed with clay, while the roof was of matting made from *totorá* or bulrushes (*Scirpus* sp.). The floor was a layer of fine greenish sand.

ed the house’s occupants from disposing of a pile of refuse left near the southern limit of the house. This refuse pile—essentially a midden 3×1.5 m in extent—was designated Feature 4 (Figure 5.9).

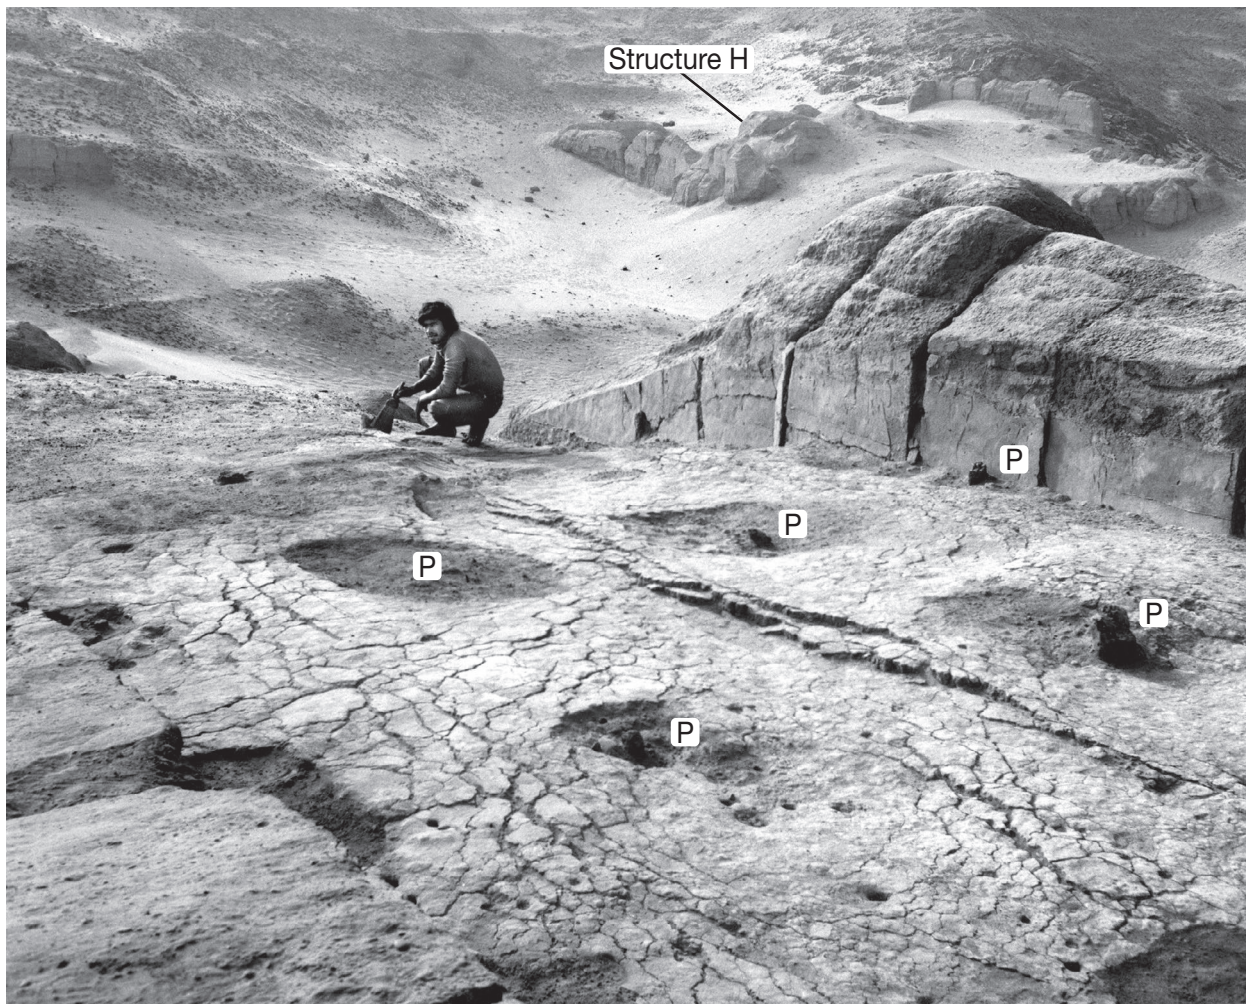
Figure 5.10. “Room 2” of Structure D seen from the west. In the foreground, one can see the dark circles left when the *huarango* posts of a later *kincha* structure broke through the original floor of this unit, which was actually an interior patio rather than a room. (Surviving posts are indicated by the letter “P.”) Structure H can be seen in the distance.

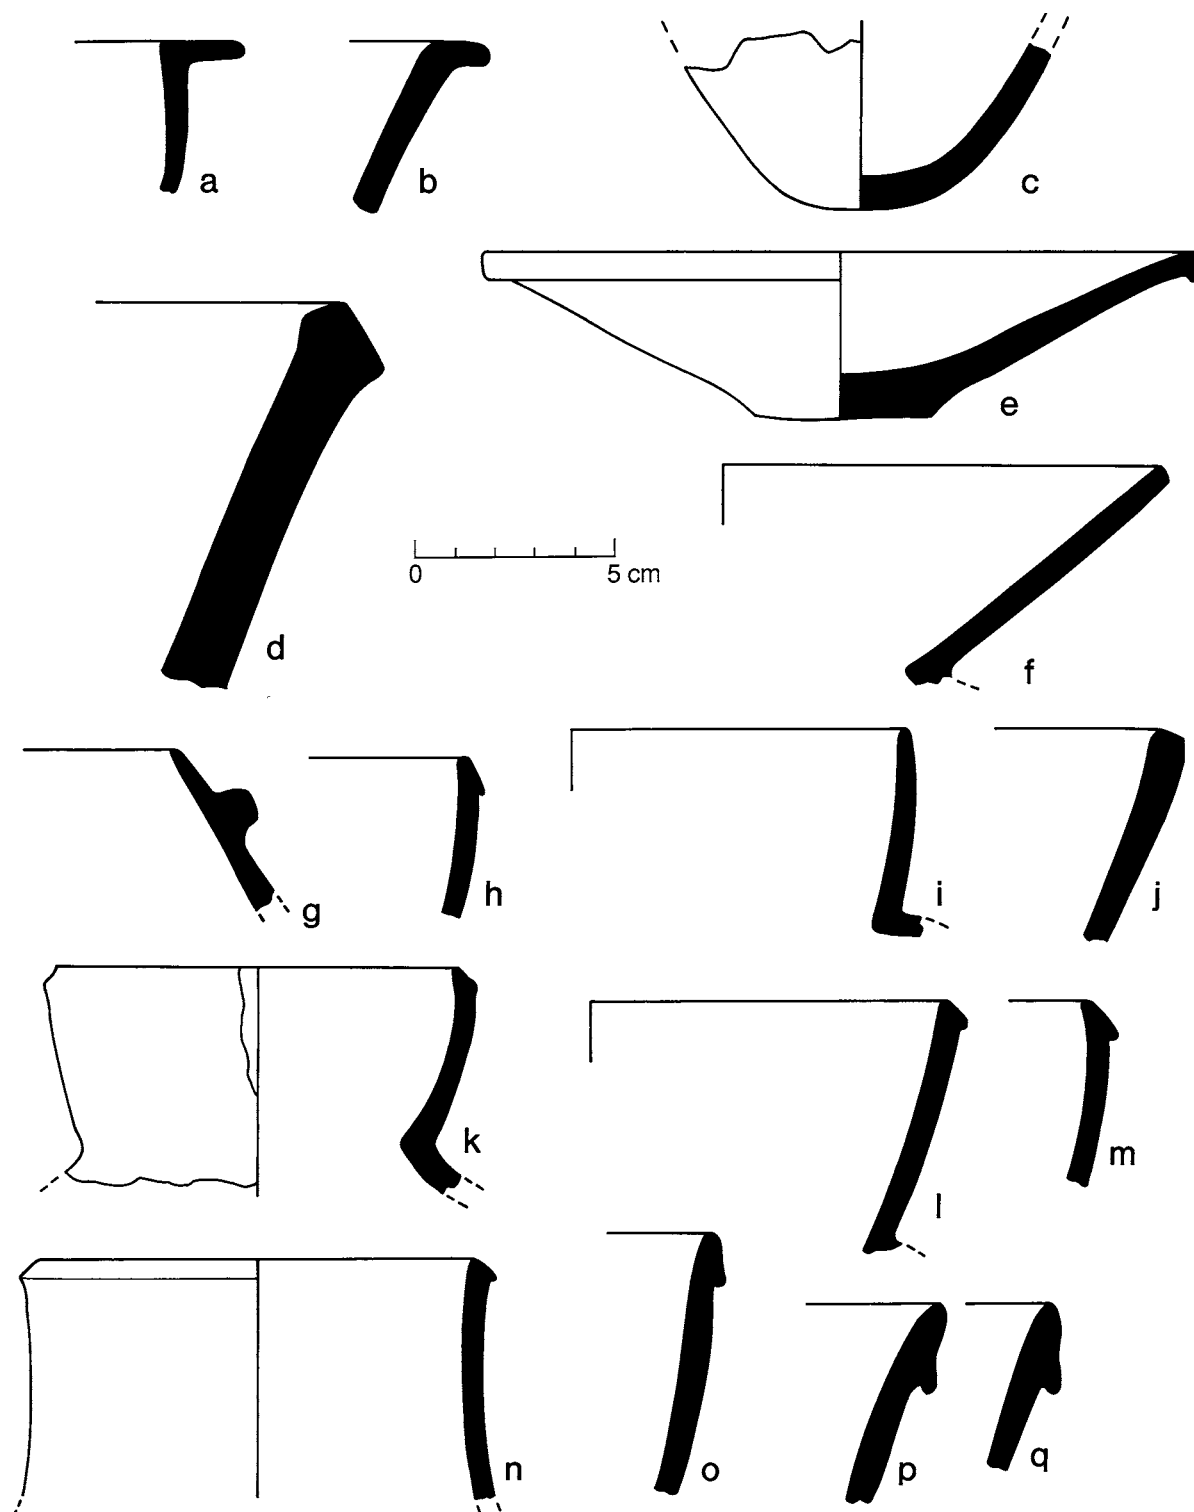
Figure 5.11. Camacho Reddish Brown vessels from Feature 4, Structure D. (*a, b*): jars with wide everted rim; (*c*): conical base from amphora; (*d*): rim of *batun maccma*; (*e*): saucer-shaped vessel, possibly a pot rest; (*f*): jar with plain rim, atypically burnished on the exterior; (*g*): cooking pot with restricted orifice and rim flange; (*h, l, m*): cambered rims from jars; (*i, j*): jars with plain rims; (*k*): small jar with slightly cambered rim; (*n*): unusual jar neck with cambered rim; (*o-q*): unusual cambered rims which, since they are burnished on the interior, might be from bowls rather than jars.

Camacho Reddish Brown (Figures 5.11, 5.12)

Hatun maccma: 1 rim (Figure 5.11d), 1 shoulder

Large storage jars, only slightly smaller than *batun maccma*: 2 shoulders
 Fire-blackened cooking pot with rim flange and restricted orifice: 1 rim (Figure 5.11g)
 Fire-blackened cooking pot with bolstered rim and restricted orifice: 1 rim (Figure 5.12d)
 Bowls with cambered rim: 5 rims (Figure 5.11o–q)
 Jars with cambered rim: 8 rims (Figure 5.11h, k–m)
 Jars with plain rim: 6 rims (Figure 5.11f, i–j)
 Jars with everted rim: 4 rims (Figure 5.12a)

Jars with wide everted rim: 2 rims (Figure 11a, b)
 Strap handles from jars: 5
 Jars with rolled rim: 4 rims (Figure 5.12b, c)
 Jar shoulder: 1
 Jar with appliqué “nipples” on shoulder: 1 sherd (Figure 5.12e)
 Conical base from amphora (or jar): 1 (Figure 5.11c)
 Heavy, shallow “saucer” (possible pot stand or pot rest): 2 rim sherds (Figure 5.11e) (this vessel shape is unusual for the Late Intermediate and might have been more common in the Late Horizon)

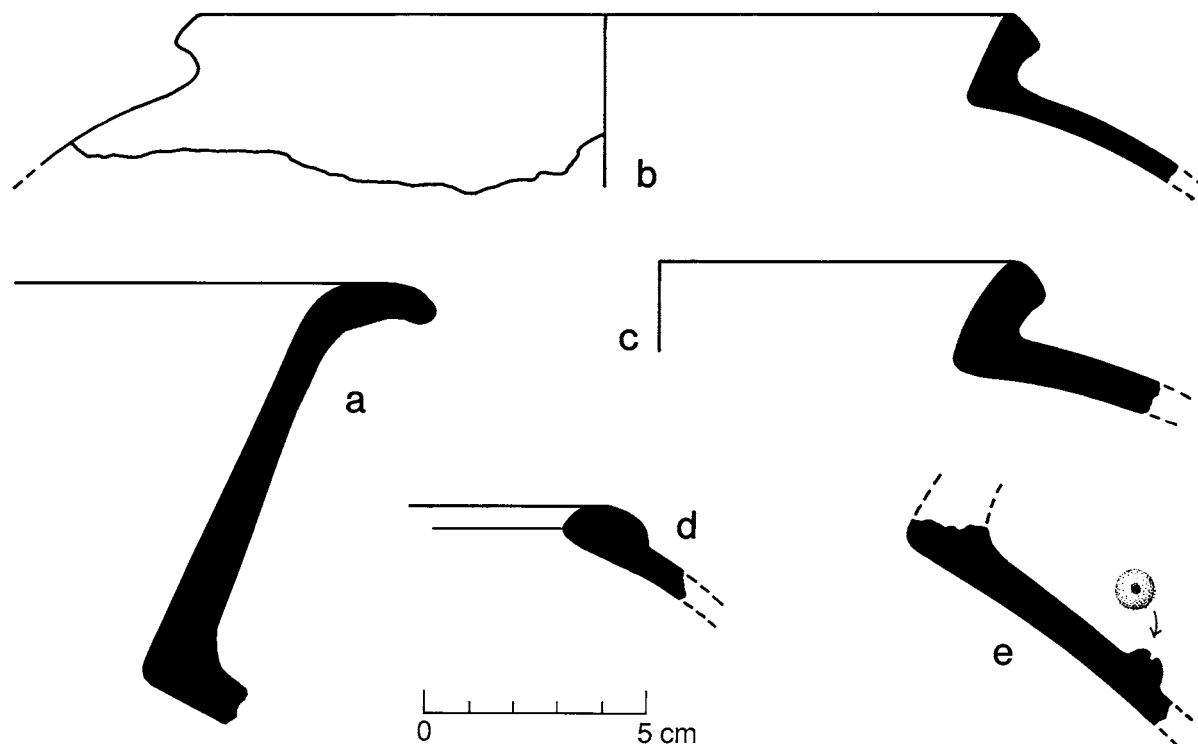
Figure 5.12. Camacho Reddish Brown vessels from Feature 4, Structure D. (a): jar with everted rim; (b, c): jars with rolled rims; (d): cooking pot with restricted orifice and bolstered rim; (e): jar shoulder with appliqué nipples placed 5 cm apart.

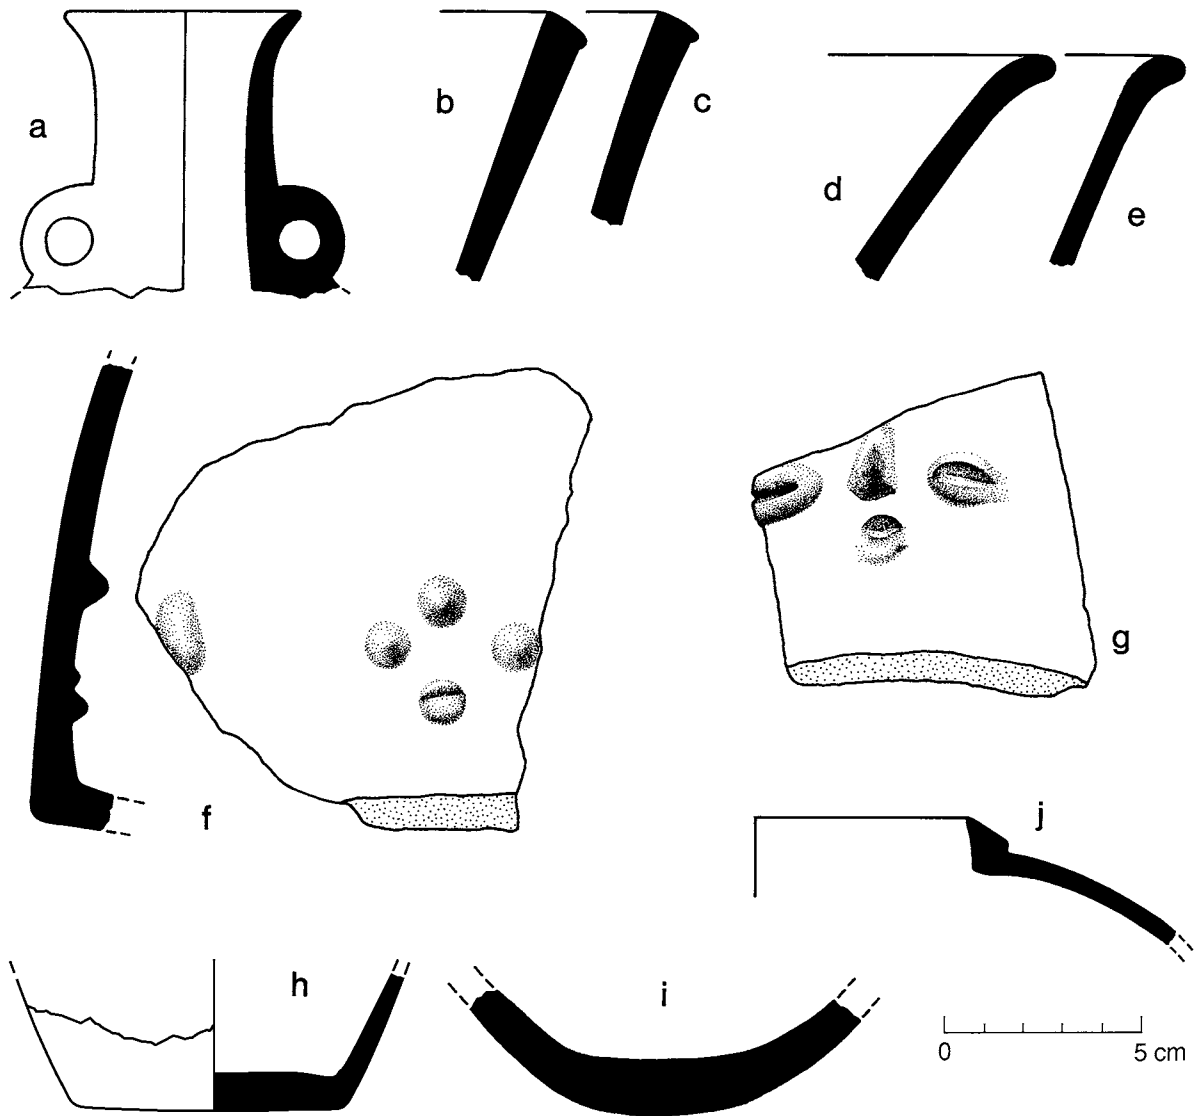
Figure 5.13. Ceramics from Feature 4, Structure D. Sherds *a–i* are Camacho Black (standard variety). (*a*): tall neck from small amphora with two loop handles; (*b, c*): refired rims from jars or amphorae; (*d, e*): everted rims from jars or amphorae; (*f, g*): modeled faces from the necks of jars or amphorae; *g* has “coffee-bean” eyes; (*h, i*): bases from amphorae; (*j*): Camacho Black (highly burnished variety) globular jar with rolled rim; a similar vessel was found in the upper fill of Room 5.

Camacho Black (Standard Variety) (Figure 5.13a–i)

- Refired rims from jars/amphorae: 2 (Figure 5.13b, c)
- Everted rims from jars or amphorae: 2 (Figure 5.13d, e)
- Neck from small amphora with loop handles: 1 (Figure 5.13a)
- Strap handle, jar or amphora: 1
- Tall jar neck with 2 loop handles from small amphora (?): 1
- Conical bases from standard amphorae: 2 (Figure 5.13i)
- Circular flat base from well-made amphora: 1 (Figure 5.13h)
- Jar or amphora necks with modeled human faces featuring “coffee-bean” eyes: 2 (Figure 5.13f, g)

Camacho Black (Highly Burnished Variety) (Figure 5.13j)
