MONOGRAPH 62
COTSEN INSTITUTE OF ARCHAEOLOGY
UNIVERSITY OF CALIFORNIA, LOS ANGELES

EXCAVATIONS AT
CERRO AZUL, PERU
THE ARCHITECTURE AND POTTERY
JOYCE MARCUS

Excavations at Cerro Azul, Peru

THE ARCHITECTURE AND POTTERY

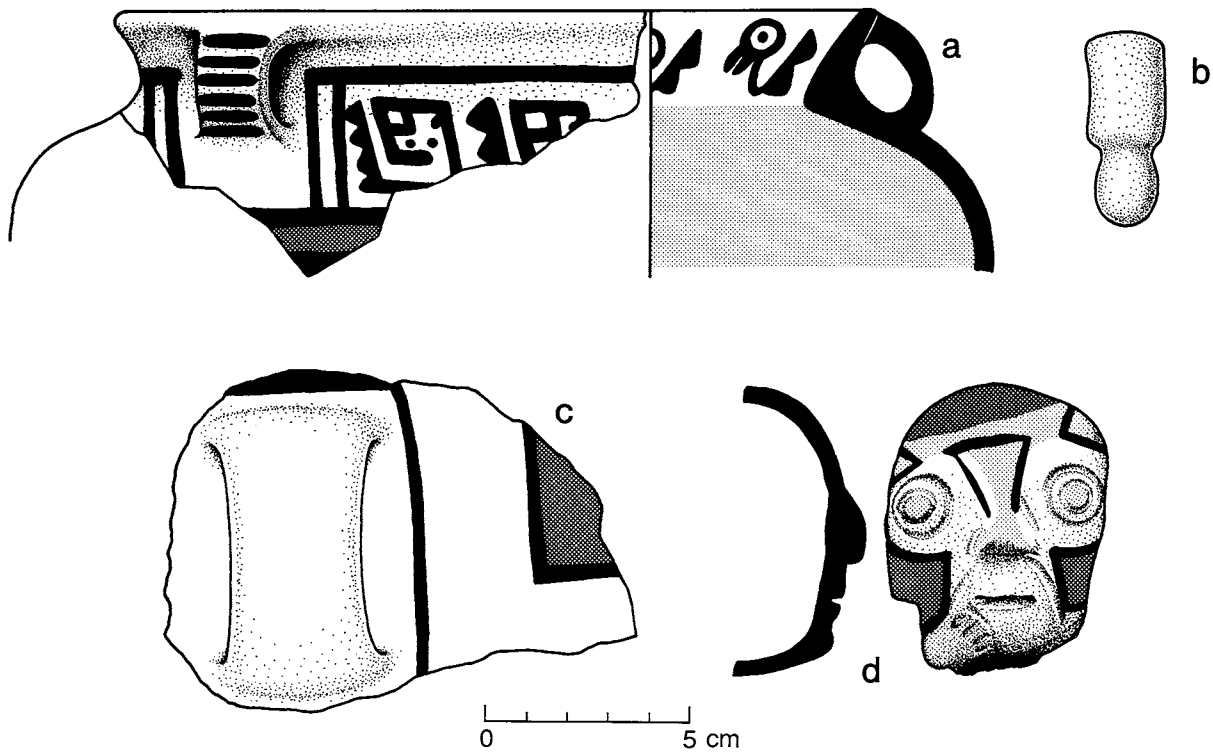
Figure 5.14. Pingüino Buff vessels from Feature 4, Structure D. (a): globular jar with strap handles, painted black and white on the interior of the rim and black/white/red on the exterior; (b): possible lug from a jar shoulder; (c): sherd from large jar with strap handle, painted back/white/red; (d): effigy head from unknown vessel, painted black/white/red over natural buff.

- Jar neck, traces of dark wash: 1
- Everted-rim fragment from jar: 1
- Fragment of strap handle from large jar, plain: 1
- Possible lug from jar shoulder: 1 (Figure 5.14b)
- Fragment of large jar with strap handle, painted black/white/red: 1 (Figure 5.14c)
- Fragment of jar neck, modeled (perhaps in the form of a human face): 1
- Jar shoulder, traces of white-on-natural paint: 1
- Painted body sherd from jar, too small to show design: 1
- Body sherd from a jar, traces of white paint: 1
- Body sherd from a jar, traces of white and red paint: 1
- Globular jar, painted black/white/red on exterior, black and white on interior of rim; strap handles: 1 rim (Figure 5.14a)

Unique effigy (Figure 5.14d)

Burnished fragment of a hollow human fig-

ure that is incised, modeled, and painted black/white/red. Made on a paste with a black core and an oxidized buff layer near the surface, atypical for Pingüino Buff.

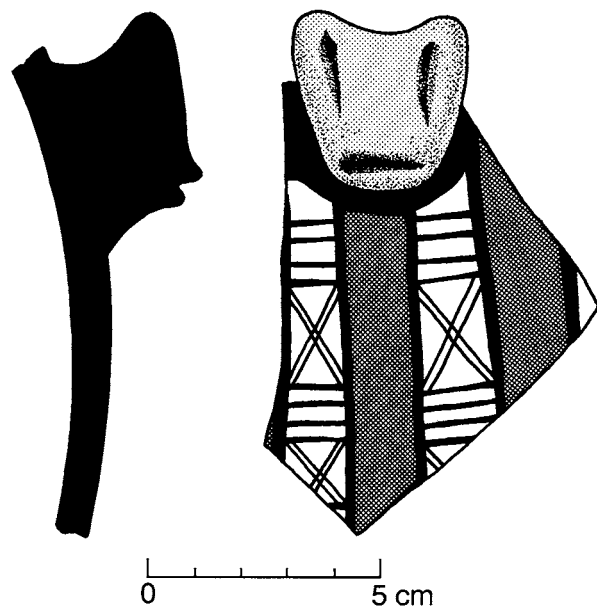
Figure 5.15. Sherd from a local imitation of an Inka *aryballos*, Feature 4, Structure D. The vessel is Pingüino Buff, painted black/white/red on natural buff. The white is 2.5 Y 8/4 (pale yellow); the red is 10 R 4/3 (weak red); the natural buff is 2.5 YR 6/6; and the black is more like a very dark brownish gray.

As for the ceramics from Feature 4 (Figures 5.11–5.15), most are continuations of Late Intermediate types and vessel shapes. A few sherds, however, such as the aforementioned *aryballos* (Figure 5.15) and a unique effigy vessel (Figure 5.14d), suggest that the Feature 4 debris dates to the Late Horizon. The low frequency of sherds restricted to the Late Horizon does not surprise us, because we doubt that the Inka conquest of Huarco brought about an overnight change in ceramics.

Locally made version of Inka *aryballos*, fragment: 1 (Figure 5.15)

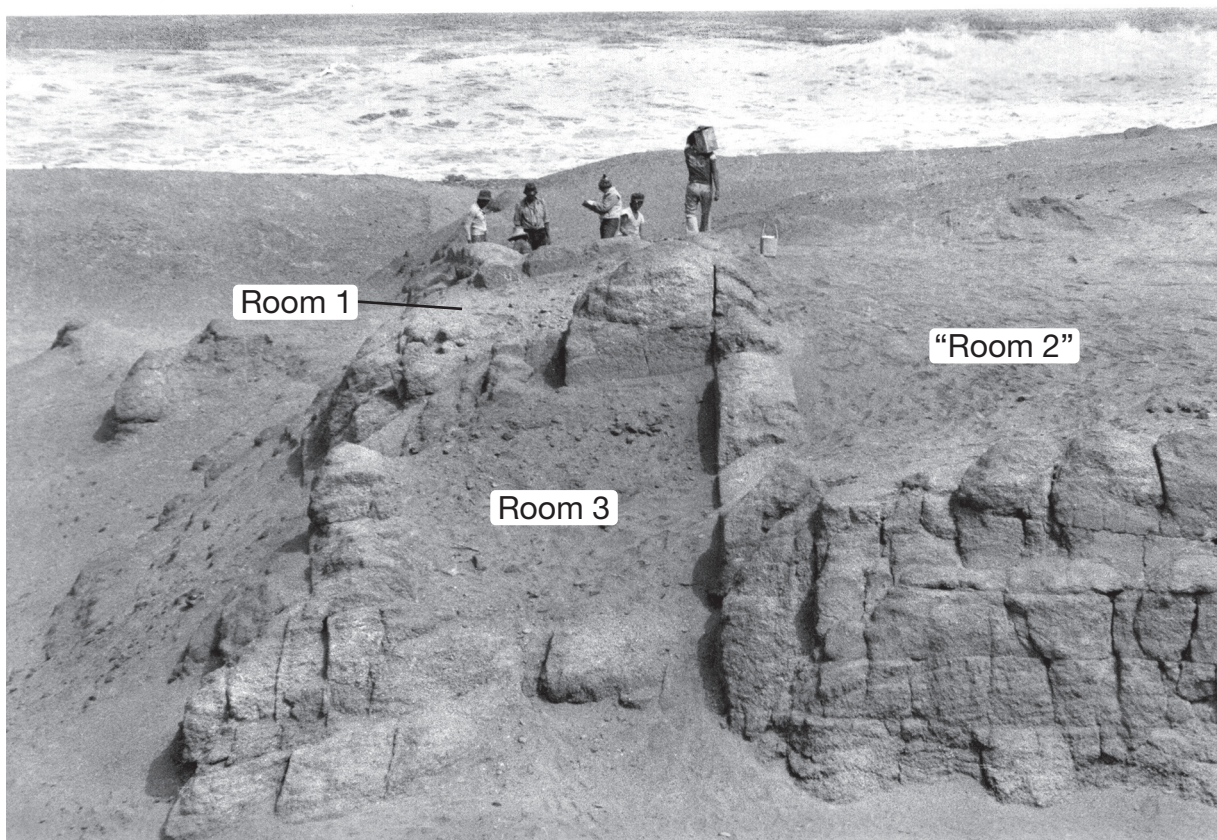
Figure 5.16. The southeast corner of Structure D seen from the east, with Rooms 1 and 3 outlined but still unexcavated. Work is in progress on the South Corridor. This view shows some of the massive *tapia* buttresses that were added to the exterior of Structure D, presumably to stabilize it after an episode of seismic damage.

Figure 5.16 shows how these rooms appeared before excavation. In the photograph, one can see that the wall separating Rooms 1 and 3 had been so broken down and eroded that one could no

longer determine how the two rooms might have been connected.

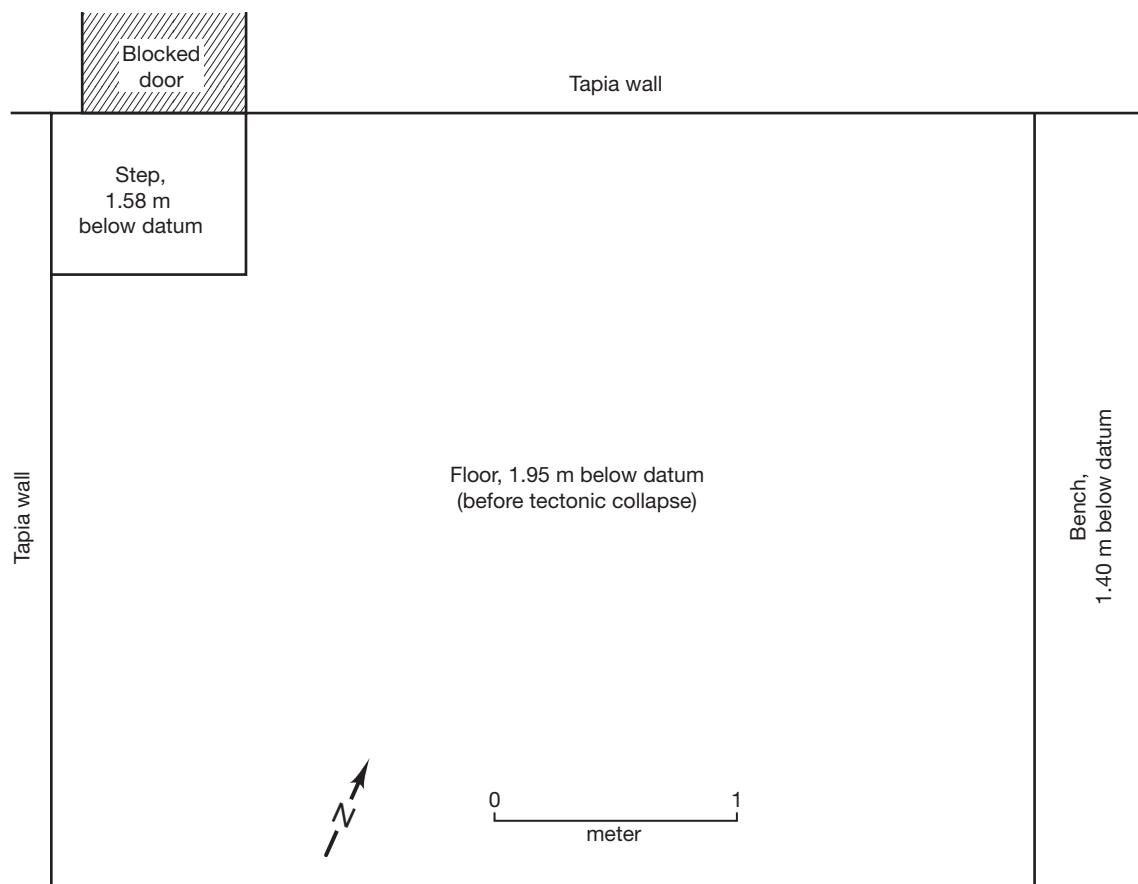
Figure 5.17. Plan of Room 1, Structure D, as it would have looked before the walls and floor were split by tectonic movement.

Figure 5.17 gives the plan of Room 1 as we encountered it. The room measured 4.48×3.30 m, and its final floor lay 1.95 m below datum (before suffering earthquake damage). Because this floor was half a meter lower than the floor of the adjacent patio (Room 2), anyone entering Room 1 would have had to step down into it. As shown in Figure 5.17, a tapia step had been placed just inside the door to facilitate this; the surface of the step was 1.58 m below datum, just 37 cm above the final floor of the room.

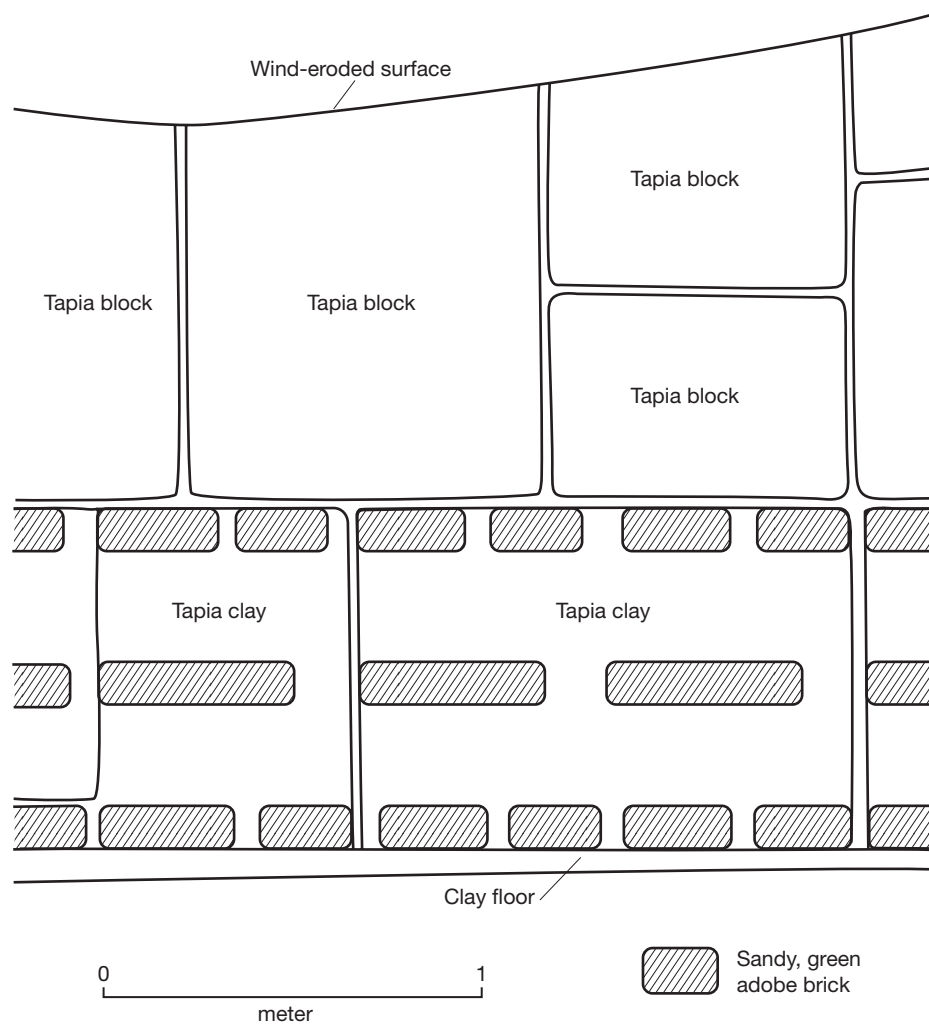
Figure 5.18. A portion of the north wall of Room 1, Structure D, showing the combination of adobe and tapia construction. The upper wall is composed of tapia blocks, like most rooms in the building. The lower 90 cm of the wall have what appear to be a decorative arrangement of green adobes set in tapia clay. The upper and lower rows of adobes show their short axes (22–28 cm), while the middle row show their long axes (50 cm).

One of the most interesting features of Room 1 is the decoration of its north wall. As shown in Figures 5.18 and 5.19, the lower 90 cm of that wall had what appears to be a decorative arrangement of green adobe bricks ($50 \times 25 \times 10$ cm on average) set in tapia clay. The upper and lower rows of adobes present their short axes (22–28 cm), while the middle row present their long axes (50 cm). As Figure 5.19 shows, the green adobes continue behind our putative sleeping bench, suggesting that the bench had been a later addition rather than part of the original room. This wall features the only use of adobes in Structure D, leading me to suspect that their purpose was to decorate the room for an important family.

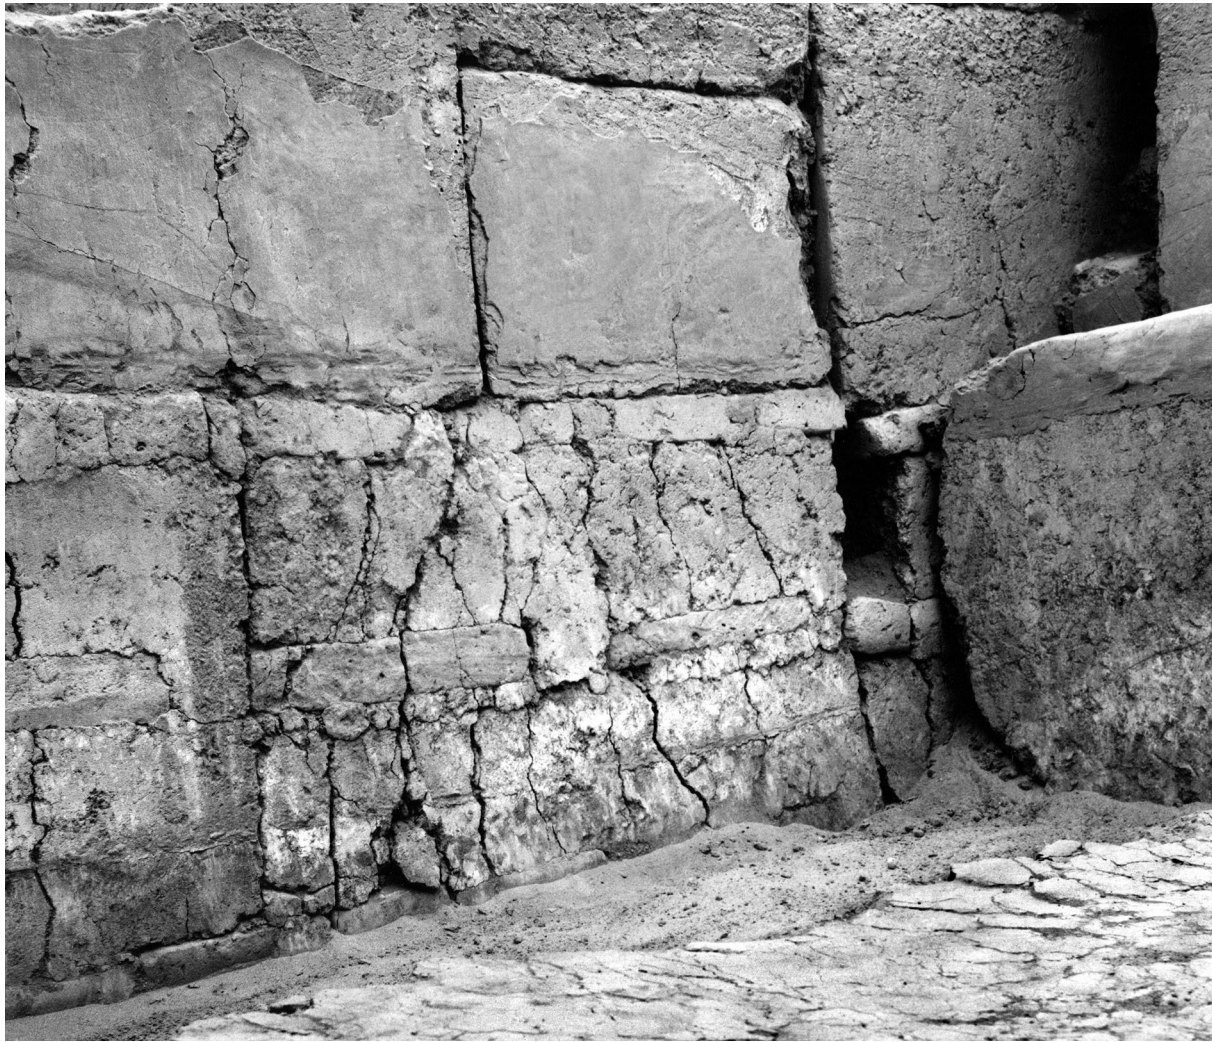
Figure 5.19. Room 1 of Structure D, showing details of the adobes interdigitated with tapia blocks in the north wall.

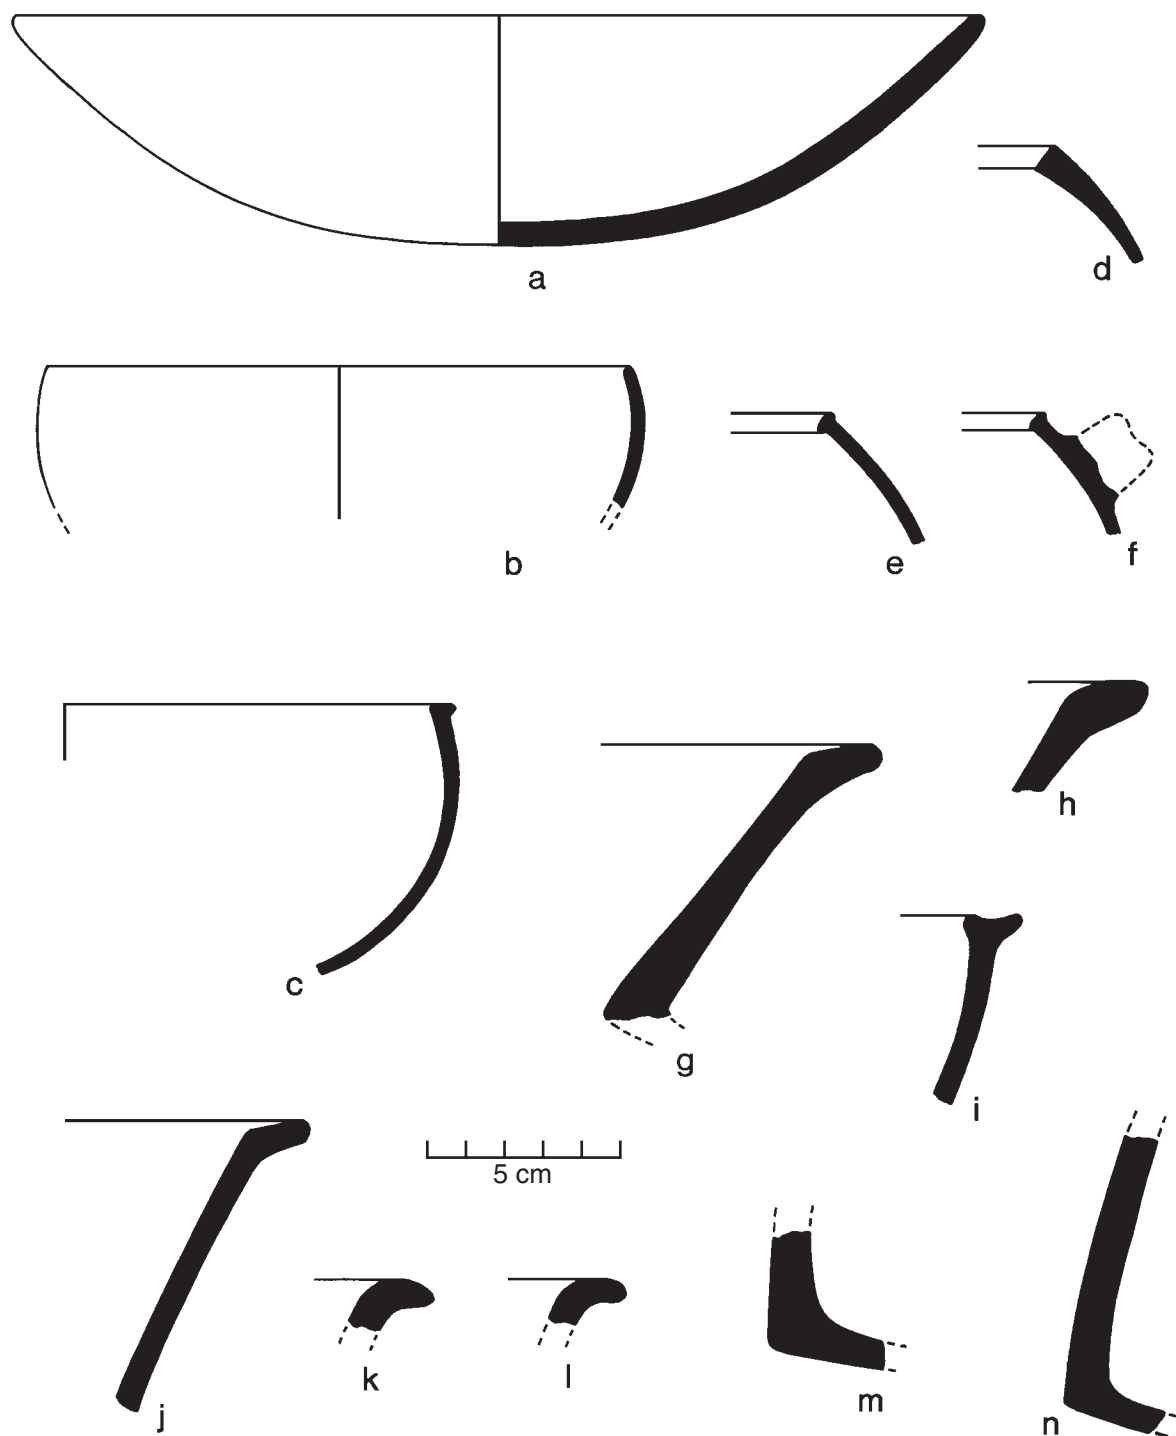
Figure 5.20. Sherds from the fill above the floor of Room 1, Structure D. Sherds *a, b* are Trambollo Burnished Brown. (*a*): large shallow dish, reconstructed from 14 sherds. The pattern of wear suggests that this dish was used as the pot stand or pot rest for a round-bottomed jar (?) that was turned constantly, rubbing the upper 4 cm of the dish all while leaving the inner base unworn. (*b*): small hemispherical bowl; (*c*): Camacho Black (highly burnished variety) hemispherical bowl with slightly cambered rim. Sherds *d–i* are Camacho Reddish Brown. (*d–f*): rims of cooking pots with restricted orifice, some fire-blackened; *f* had strap handles; (*g, h*): slightly everted rims from large jars (rim diameters would have been close to 50 cm); (*i*): grooved and everted jar rim; (*j*): jar with everted rim, atypical orange variety of Pingüino Buff. The surface color ranges from 2.5 YR 6/8 to 2.5 YR 6/4. Sherds *k–n* are Pingüino Buff. (*k, l*): everted rims from jars; (*m, n*): jar necks.

Camacho Reddish Brown (Figure 5.20d–i)

Camacho Black (Highly Burnished Variety) (Figure 5.20c)

Pingüino Buff (Figure 5.20k–n)

Atypical Orange Variety of Pingüino Buff (Figure 5.20j)

Trambollo Burnished Brown (Figure 5.20a, b)

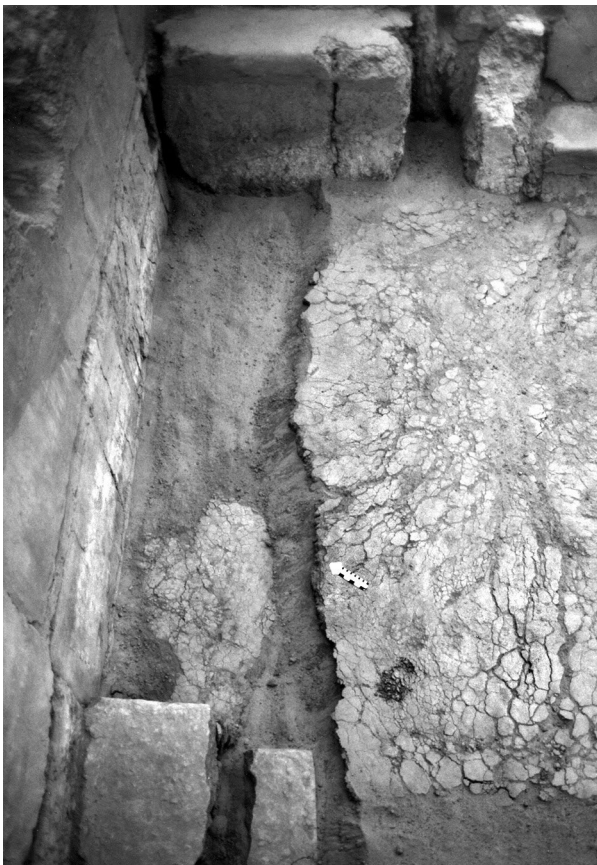
Figure 5.22. Room 1 of Structure D had been so damaged by an earthquake that its doorway was blocked off, and its function was changed from elite residence to dried fish storage. Note the massive crack running from the door step (*bottom*) to the sleeping bench or shelf (*top*). The white arrow points north.

Unfortunately, it also left the room more vulnerable to earthquake damage than would have been the case had they placed it closer to the center of the building. Figures 5.22 and 5.23 show what happened when an earthquake finally struck. Figure 5.22 shows a long, irregular crack running east–west through Room 1, splitting the floor, the step in front of the door, and the sleeping bench

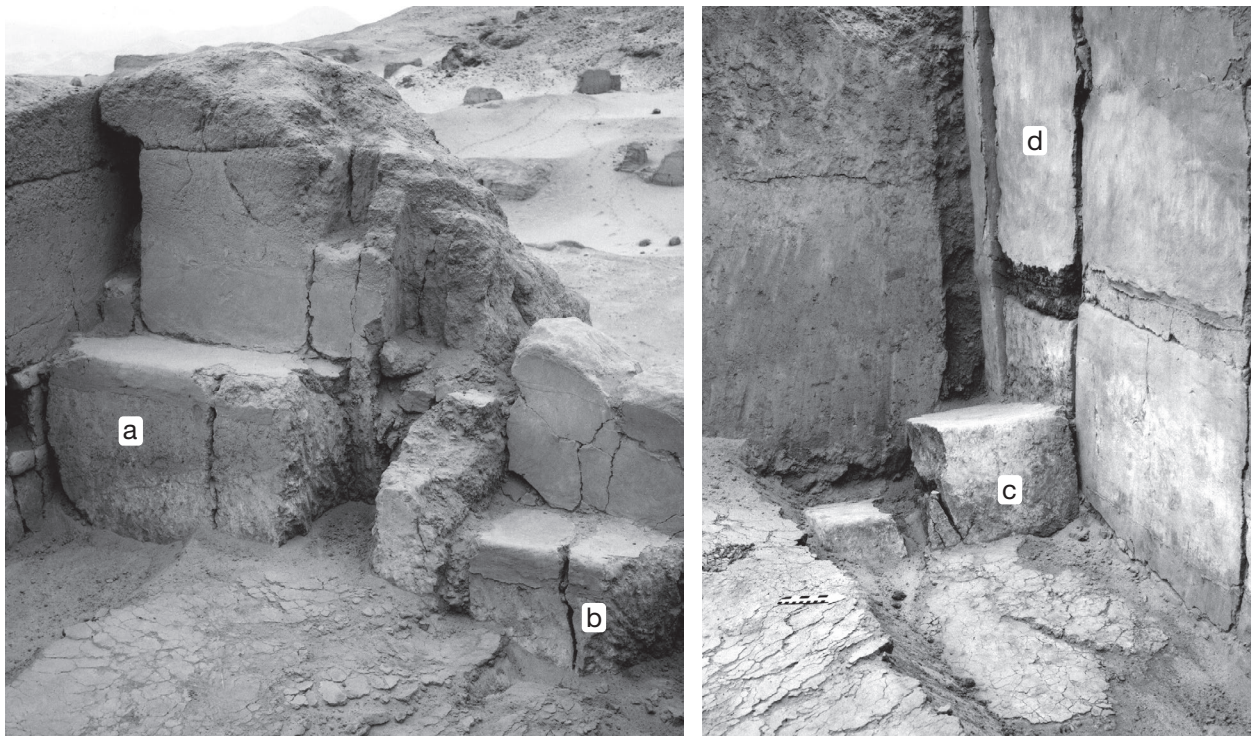
Figure 5.23. Two views of seismic damage to Room 1, Structure D. (*Left*): We see how a massive crack split the sleeping bench or shelf into north (*a*) and south (*b*) halves and dropped the latter into a depression. (*Right*): We see how the door step (*c*) broke off the threshold, dropped with a section of the floor, and broke in two. The doorway was later blocked with tapia (*d*).

or shelf along the east wall; the northern part of the floor then dropped 25–30 cm. Figure 5.23 shows in detail how the sleeping bench (*a*, *b*) and door step (*c*) were split in half. At this point, Room 1 became unsuitable for occupancy by an elite family. Its door was blocked with tapia (Figures 5.17, 5.23d), and it was filled with sand and converted to a fish storage room.

Room 3, immediately adjacent to Room 1, had also suffered earthquake damage. As the photograph on the left in Figure 5.23 shows, the massive crack that destroyed Room 1 extended through the intervening wall and into Room 3, obliterating any evidence of a door between the two rooms.

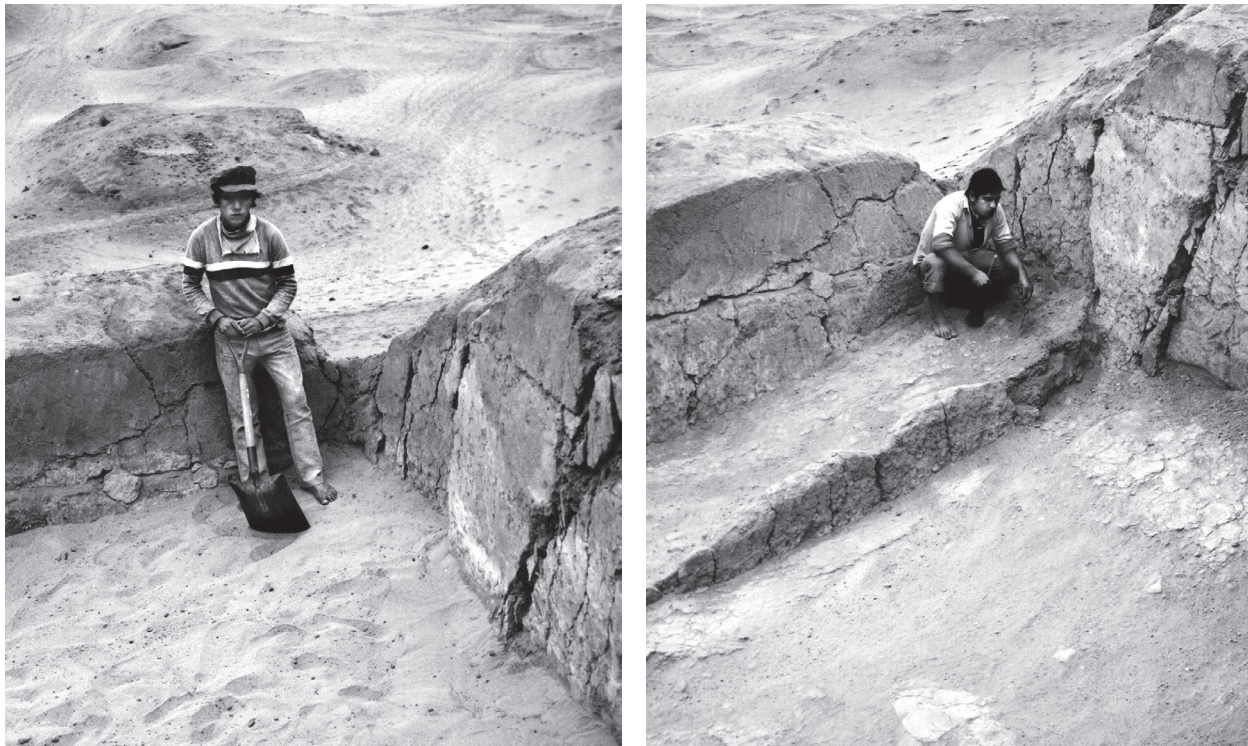
Figure 5.24. Two stages in the excavation of Room 3, Structure D. (*Left*): The southeast corner of the room, excavated to the level of the layer of sand used for storage of dried fish (Cirilo Cruz serves as scale). (*Right*): The same corner, after the removal of the sand (Alberto Barraza as scale). Fragments of the original floor and a sleeping bench are visible. Room 3 had originally been residential in function, but was converted to fish storage after suffering seismic damage.

Room 3 measured 5.20 × 4.45 m and, like Room 1, it had been converted from elite residential quarters to fish storage after being severely damaged. Figure 5.24 shows two stages in the ex-

cavation of Room 3. On the left, we see the thick layer of sand added to the room late in its history. We passed this sand through three sizes of screen in order to recover any remaining traces of fish. Eventually, at depths ranging from 3.69 m to 3.79 m below datum, we reached what was left of the original floor, now badly deteriorated (Figure 5.24, right). We estimate that in its damaged condition, Room 3 might have accommodated roughly 69 m³ of sand and fish.

As Figure 5.24 (right) shows, Room 3 had a 25-cm-high tapia sleeping bench along its east wall, reminiscent of the bench in Room 1. However, Room 3 lacked the decorative use of green adobes seen in Room 1.

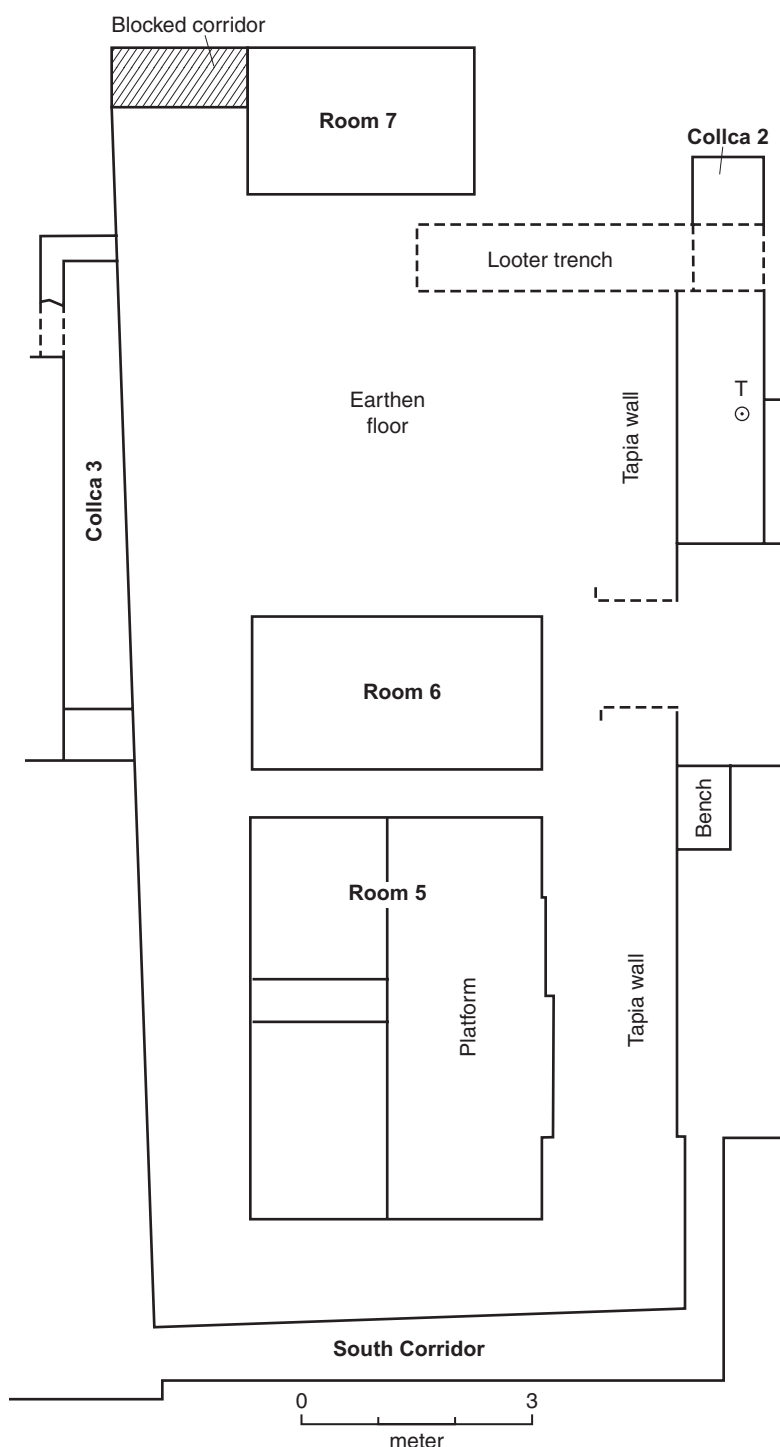
Figure 5.31. Plan of Rooms 5, 6, and 7 of Structure D. The dot marked with a “T” is the place where the alidade was set up.

Figure 5.31 shows this central point of the building. Rooms 5 and 6 could be mapped, but had been eroded down almost to their floors. It is likely that the area marked “earthen floor,” just north of Room 6, was part of a third room whose walls had completely eroded away prior to our arrival.

At a later stage, a tapia platform was built along the east wall of the room (Figure 5.31), and

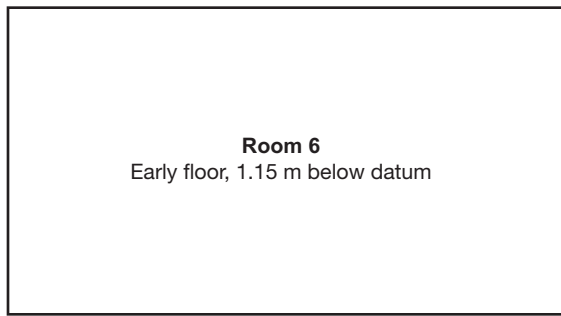
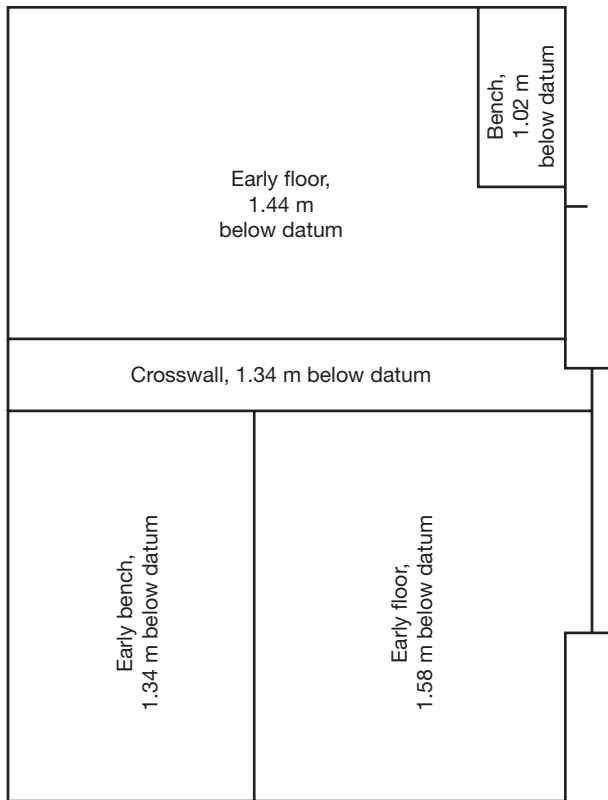
Figure 5.32. Rooms 5 and 6 of Structure D as they might have looked early in the history of the building.

Figures 5.32 and 5.33 show the earliest and latest stages of Room 5. In Figure 5.32, we see that it was divided into a number of storage cells by an east–west crosswall. To the north of the crosswall was an early floor, 1.44 m below datum. In the northeast corner of that floor was a small bench (1.02 m below datum) which may have

served as a step by which the room could be entered from above. To the south of the crosswall was an early floor (1.58 m below datum) and a storage bench or shelf of almost equal size, 1.34 m below datum.

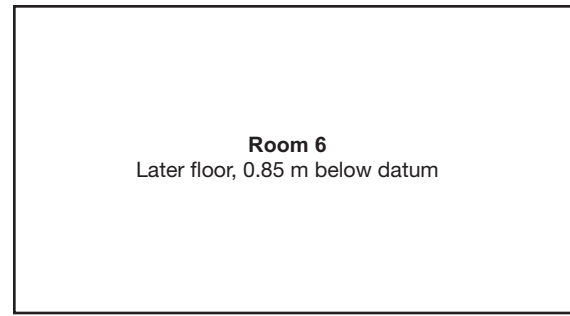
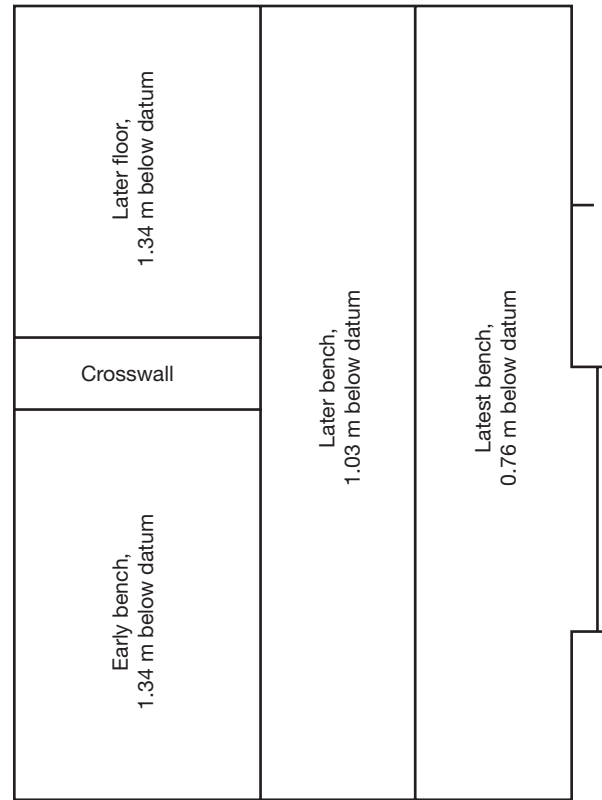
Figure 5.33. Rooms 5 and 6 of Structure D as they might have looked late in the history of the building. In the case of Room 5, the early bench is a survival from the first stage of construction. The later bench filled the eastern half of the room during a later stage of construction; the latest bench was superimposed on the latter during the final stage of construction.

Finally, as shown in Figure 5.33, Room 5 was modified again. A new bench, half the size of the platform, was built along the east wall, some 76 cm below datum. This gave the room a long, narrow floor at 1.34 m below datum; a “later” sleeping bench at 1.03 m below datum; and a “latest” sleeping bench at 0.76 m below datum. The photograph in Figure 5.34 shows the eroded remnants of the “early,” “later,” and “latest” stages of Room 5. By observing the workman sitting on the

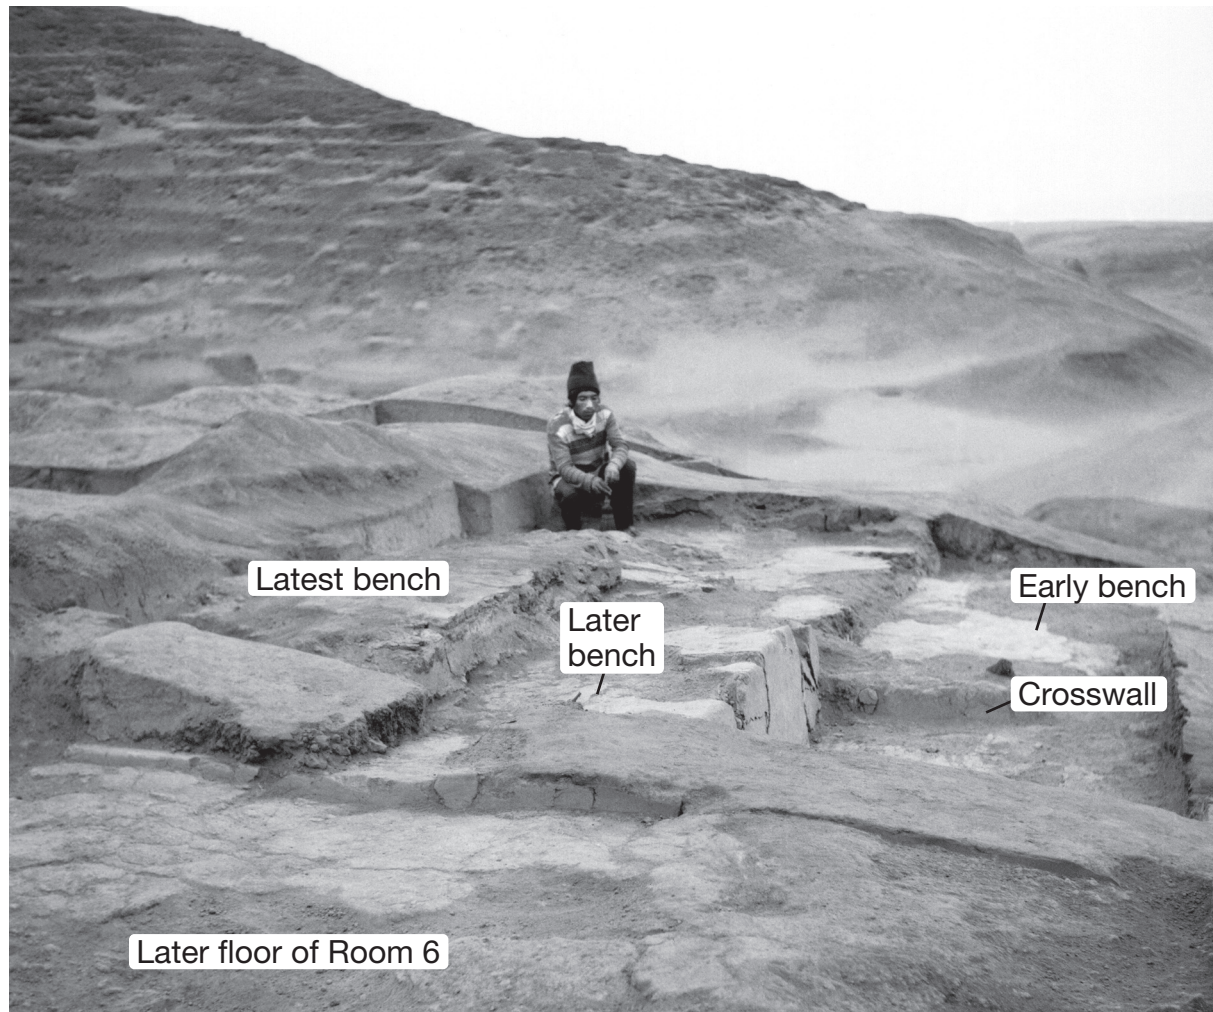
Figure 5.34. Rooms 5 and 6 of Structure D, seen from the north, showing their later configuration (refer to Figure 5.33 for details). Edgar Zavala squats on the “Latest bench” of Room 5 (0.76 m below datum).

Finally, let us look at the ceramics found in the upper fill of Room 5, stratigraphically above the “latest” sleeping bench shown in Figure 5.34. Only diagnostic sherds were recorded from this overlying fill. They are as follows:

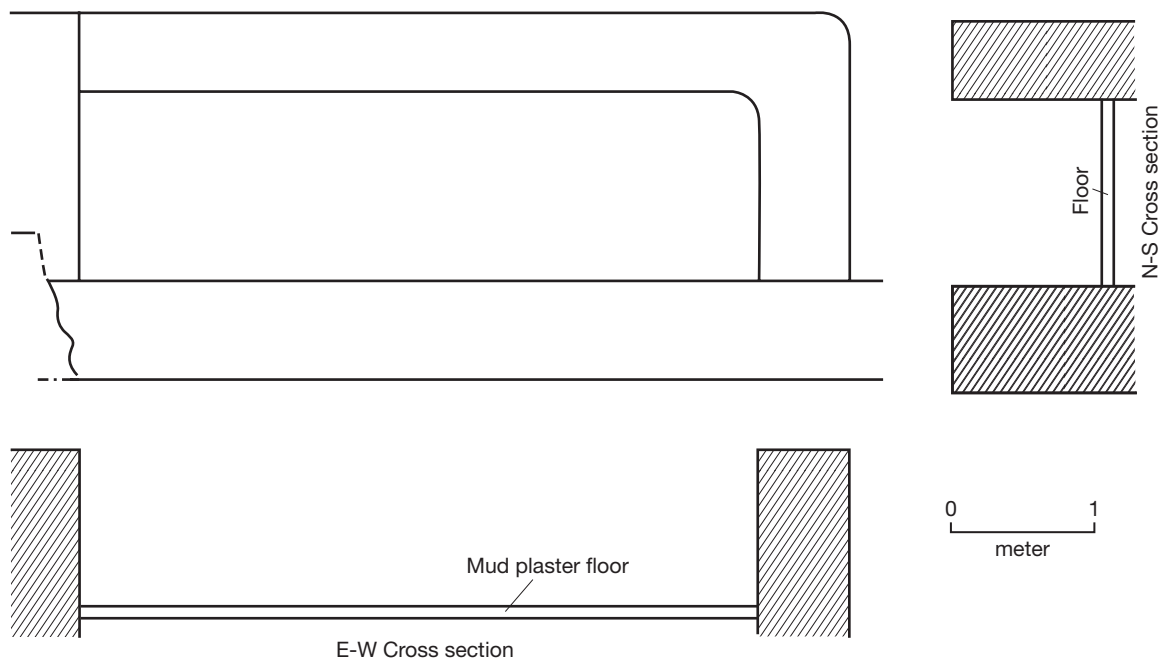
Figure 6.2. Plan and cross sections of Collca 1, a storage cell built between “Room 2” and the Northeast Canchón of Structure D. Its storage capacity was 6.48 m^3 .

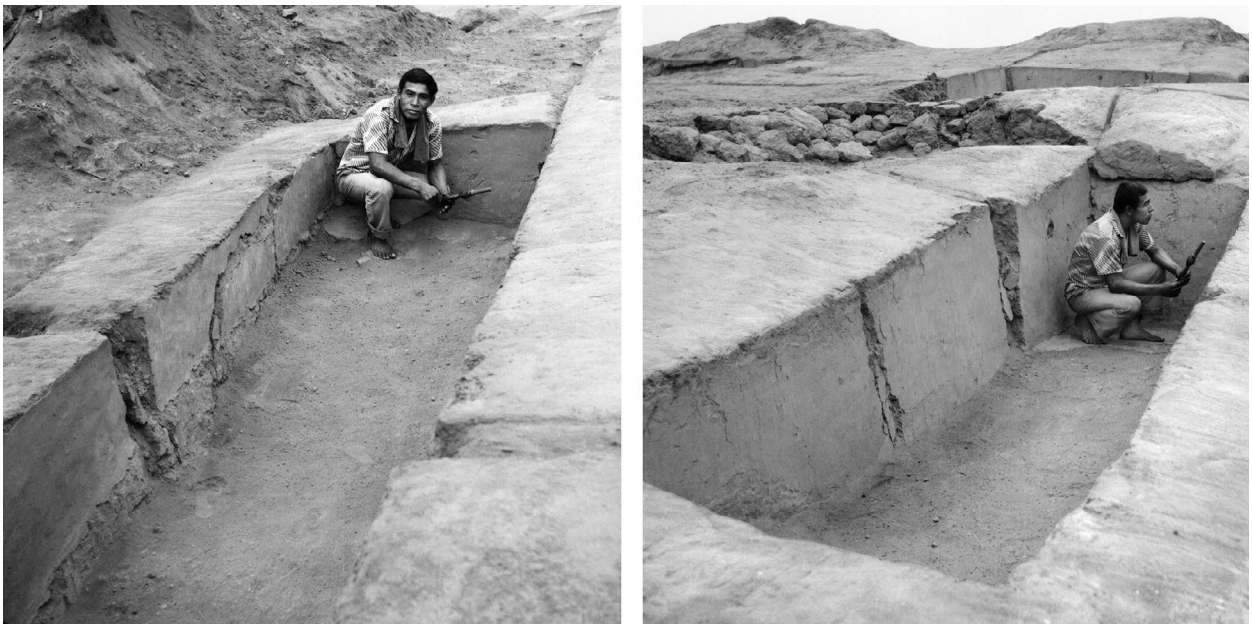
Figure 6.3. Two views of Collca 1, Structure D. (*Left*): César Francia squats in the east end, his back facing the L-shaped wall that was added to create this storage cell. (*Right*): César squats in the west end, with his back against the north wall of “Room 2.”

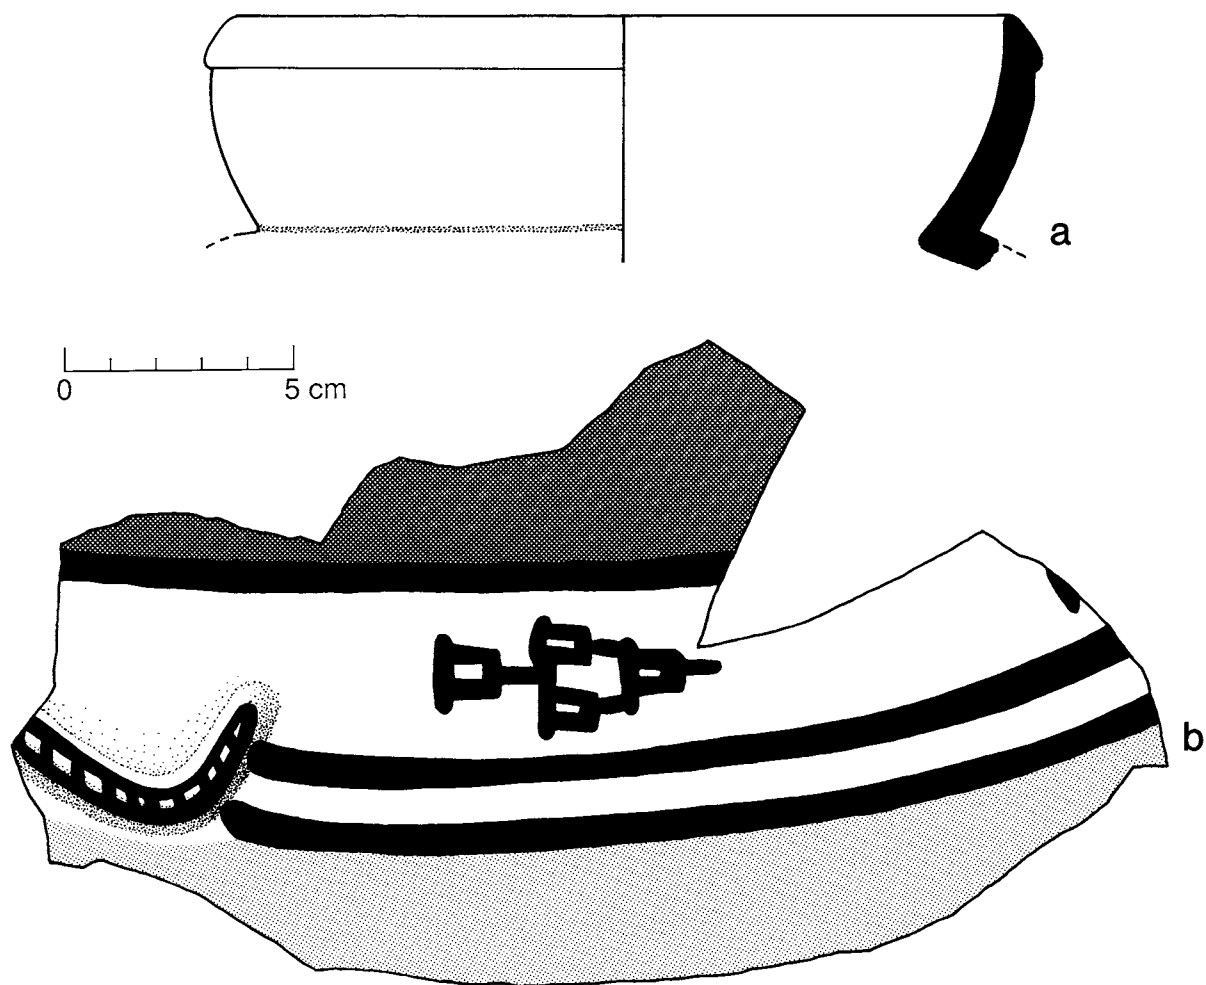
Figure 6.6. Ceramics from ash-filled hollows in the northwest corner of the floor, Northeast Canchón, Structure D. (a): Camacho Reddish Brown jar neck with cambered rim. (b): portion of large jar with painted design in black/white/red. This jar was atypical in having Camacho Reddish Brown (rather than Pingüino Buff) paste. The natural surface is 2.5 YR 5/4 (reddish brown). The red paint is 10 R 3/4 (dusky red).

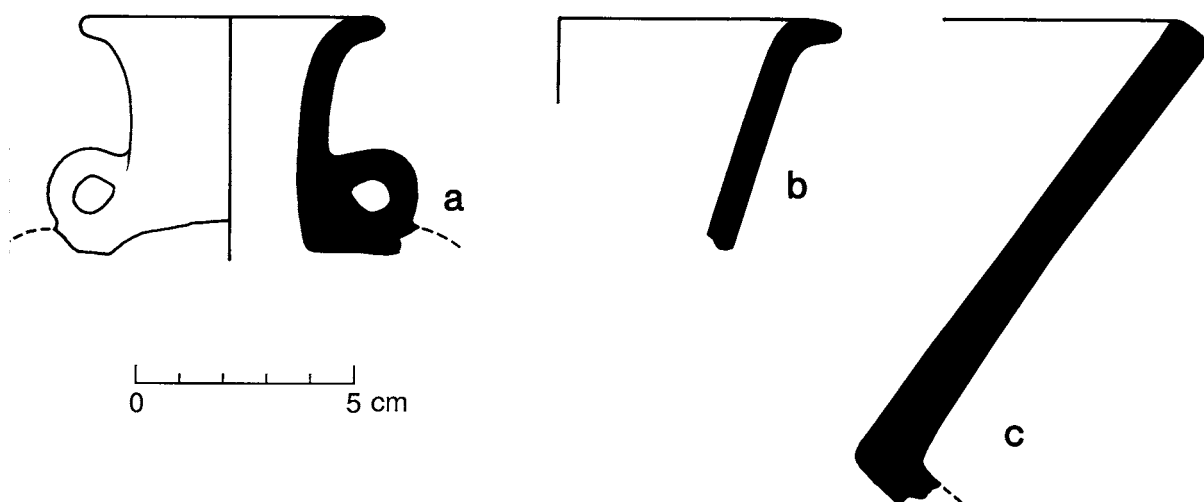
Figure 6.7. Camacho Black (standard variety) vessels from ash-filled hollows in the northwest corner of the floor, Northeast Canchón, Structure D. (a): small amphora with loop handles; (b): everted rim from amphora; (c): plain rim from large jar.

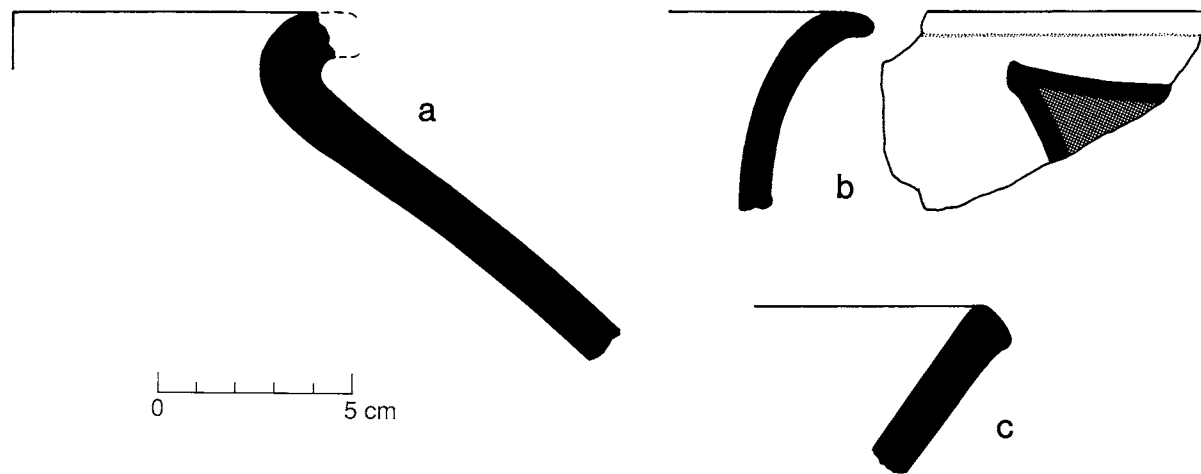
Figure 6.8. Pingüino Buff vessels from ash-filled hollows in the northwest corner of the floor, Northeast Canchón, Structure D. (a): jar neck with rolled rim; (b): jar neck with everted rim, painted in black and red on natural; the red is 10 R 4/4 (weak red); the design was probably a human face with facial paint; (c): plain rim from large jar.

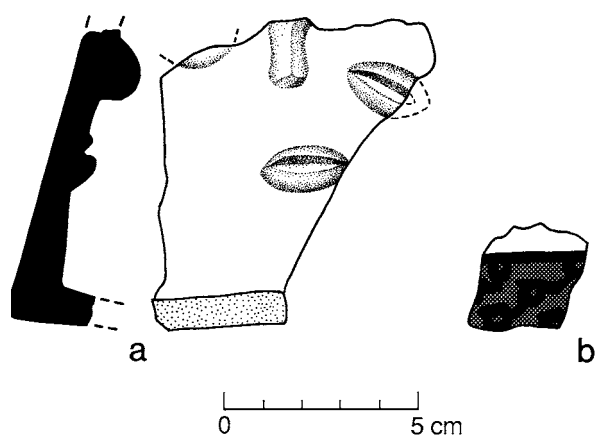
Figure 6.9. Sherds from a depth of 0–20 cm in the Northeast Canchón, Structure D. (a): neck from Camacho Black jar or amphora (standard variety) with human face modeled on it; the eye is “coffee-bean” type; (b): small Pingüino Buff jar body sherd with motif painted in black over a red wash.

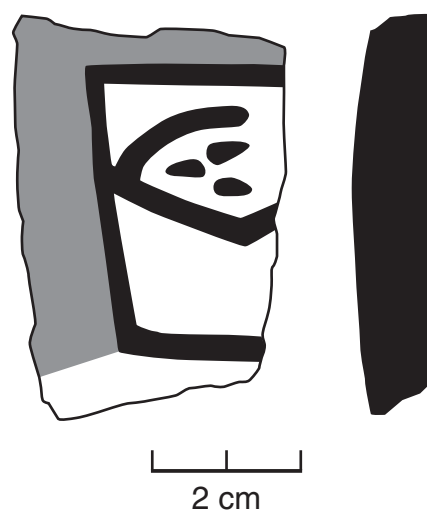
Figure 6.10. Pingüino Buff jar body sherd, painted black and white over a natural buff that has been given a reddish wash (shown in gray). Found in the fill of the Northeast Canchón, Structure D.

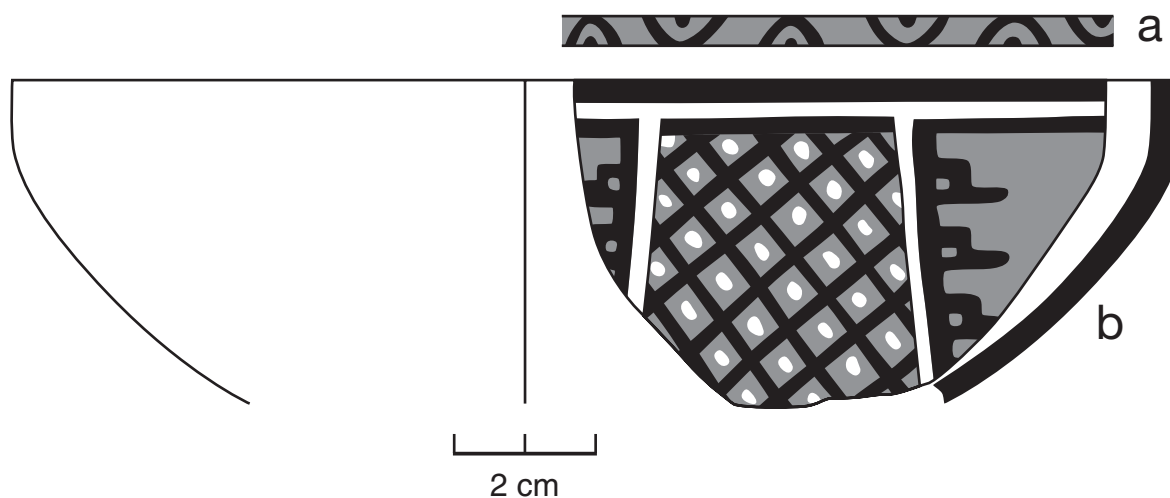
Figure 6.11. Fragment of unusual, probably nonlocal hemispherical bowl, found on the surface of the fill in the Northeast Canchón, Structure D. This bowl has been painted in black and white over a natural reddish brown surface (shown in gray). Both surfaces had been lightly burnished, and the interior surface had been made slightly redder by the addition of a red wash prior to burnishing. (a): the top of the rim; (b): the wall.

Finally, an unusual Pingüino Buff sherd (shown in Figure 6.11) was found on the surface of the Northeast Canchón fill, after sweeping but before excavation began.

Rim from a hemispherical bowl with a likely rim diameter of 16 cm, bearing on its interior a screen pattern with black lines over a red wash (10 R 4/6), with white dots in the screen: 1
