MONOGRAPH 62
COTSEN INSTITUTE OF ARCHAEOLOGY
UNIVERSITY OF CALIFORNIA, LOS ANGELES

EXCAVATIONS AT
CERRO AZUL, PERU
THE ARCHITECTURE AND POTTERY
JOYCE MARCUS

Excavations at Cerro Azul, Peru

THE ARCHITECTURE AND POTTERY

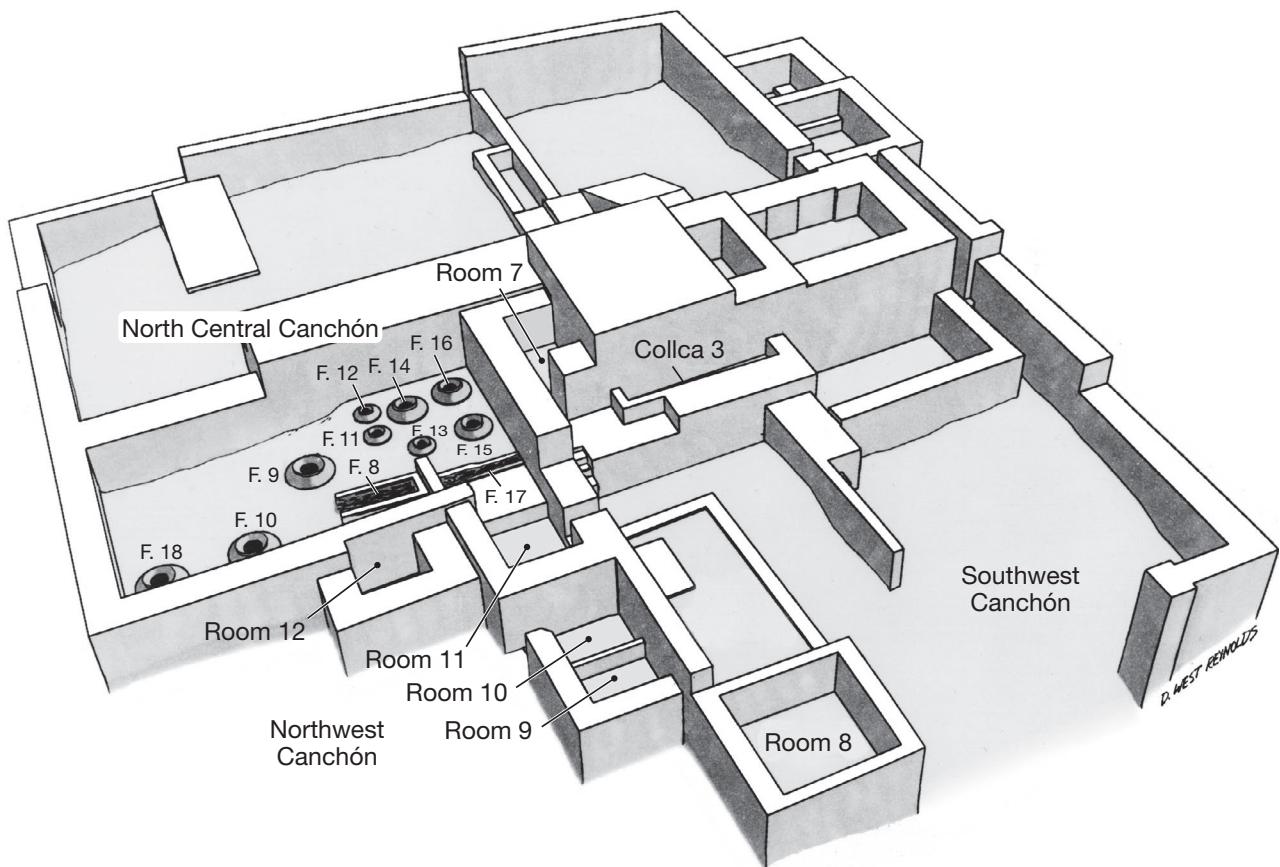
Figure 7.1. Artist's conception of the northwest quadrant of Structure D.

Our tour of Structure D concludes with the northwest quadrant, a three-dimensional view of which can be seen in Figure 7.1. Our evidence suggests that that quadrant had once been dominated by two canchones, only one of which had survived to be excavated. The survivor was the North Central Canchón, an apparent kitchen/brewery that contributed some of our most interesting data.

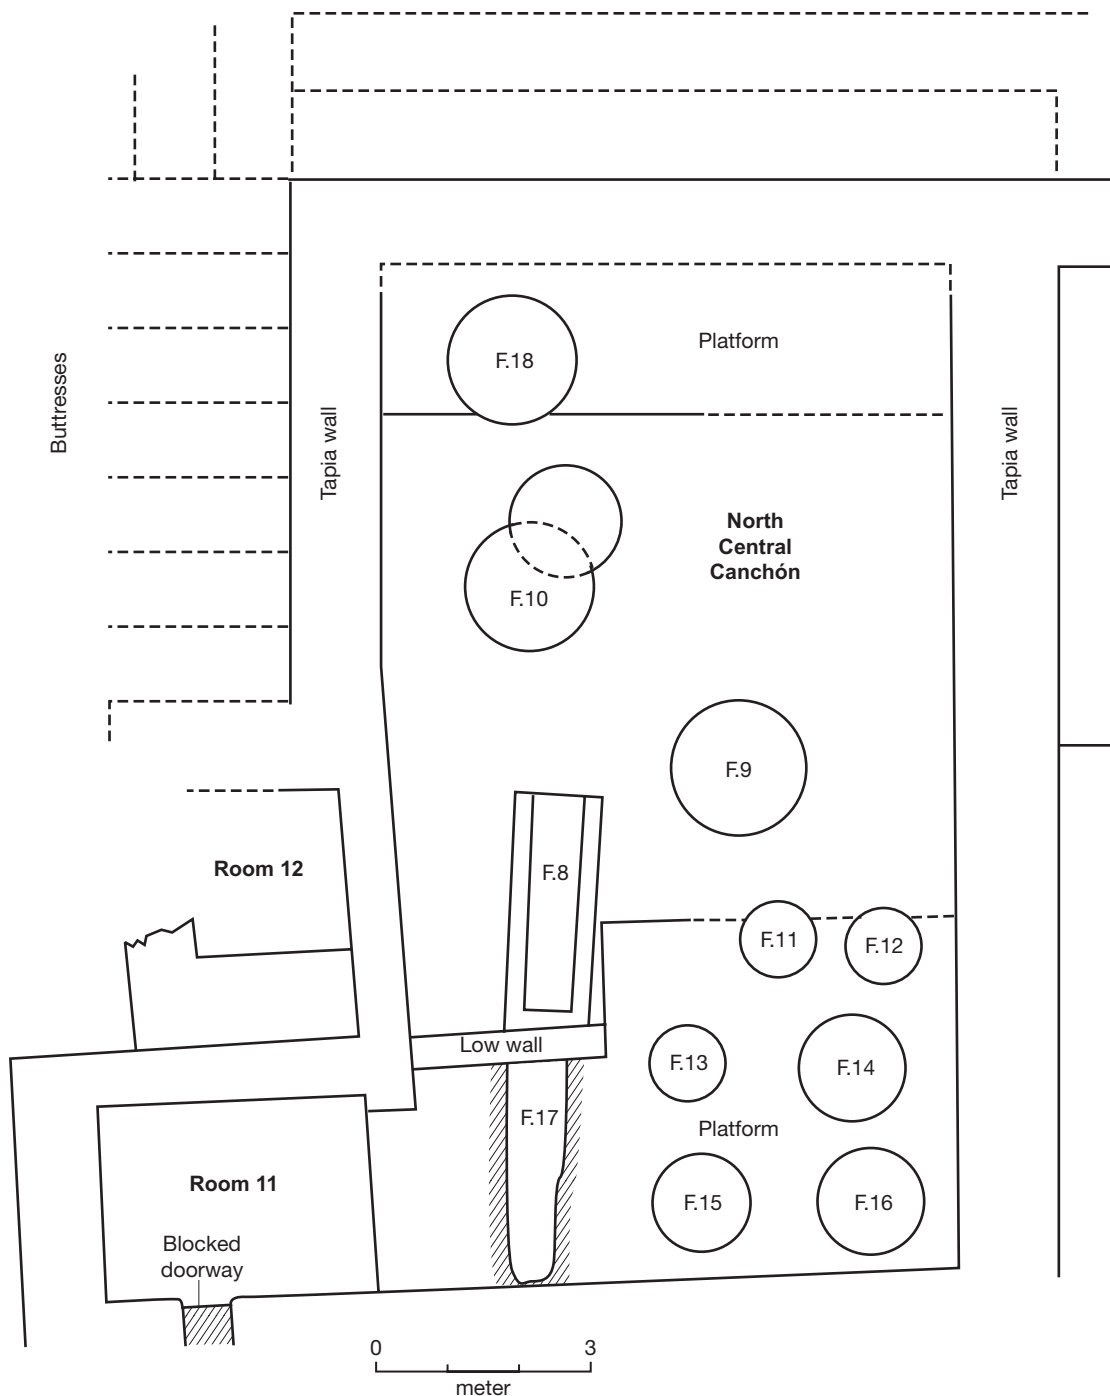
Figure 7.2. Plan of the North Central Canchón as well as Rooms 11 and 12 of Structure D.

Central Canchón through a gap in its west wall (Figure 7.2).

The North Central Canchón measures roughly 14×7.8 m (Figure 7.2). The depth of its irregular floor runs from roughly 3.14 m to 3.40 m below datum. At the south end of the canchón we found a raised work platform, 2.70 m below datum. At the north end of the canchón was a smaller work platform that may once have been

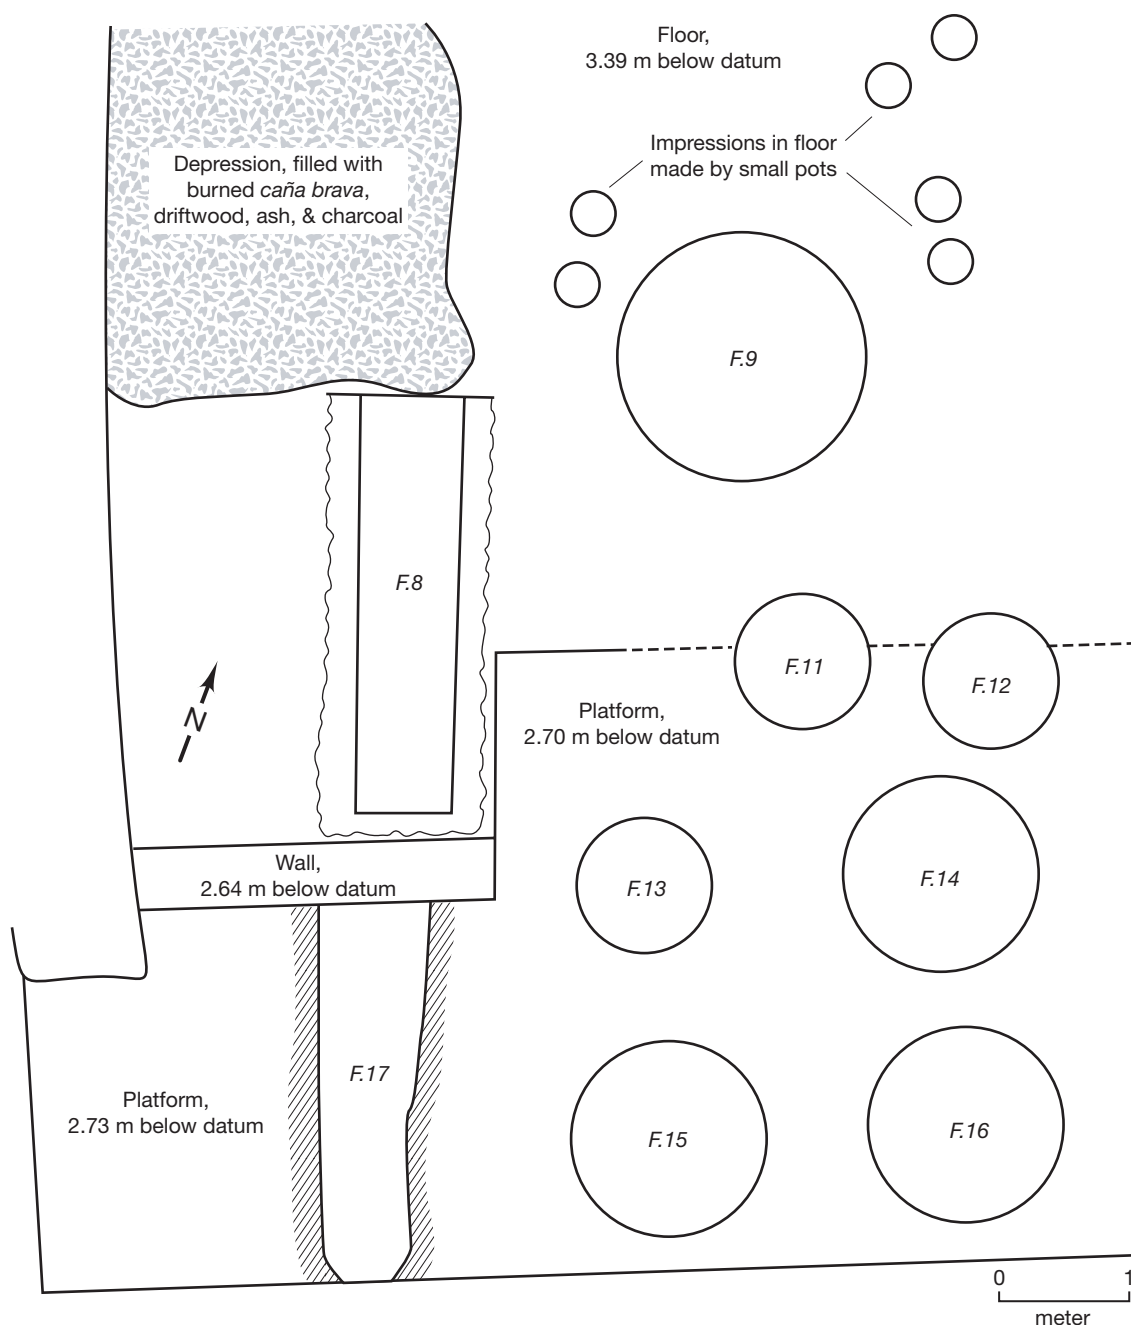
Figure 7.3. The south half of the North Central Canchón, Structure D, showing the location of Features 8, 9, and 11–17.

The North Central Canchón had a very high density of features. Included were two hearth trenches (Features 8 and 17) and the cavities left by at least nine storage vessels that had been set in the floor (Features 9–16 and 18). In addition to these cavities, there were at least half a dozen impressions in the floor made by the round bases of smaller pots (Figure 7.3).

Feature 12 (Figure 7.3) lay near Feature 11; it had a maximum diameter of about 1.16 m.

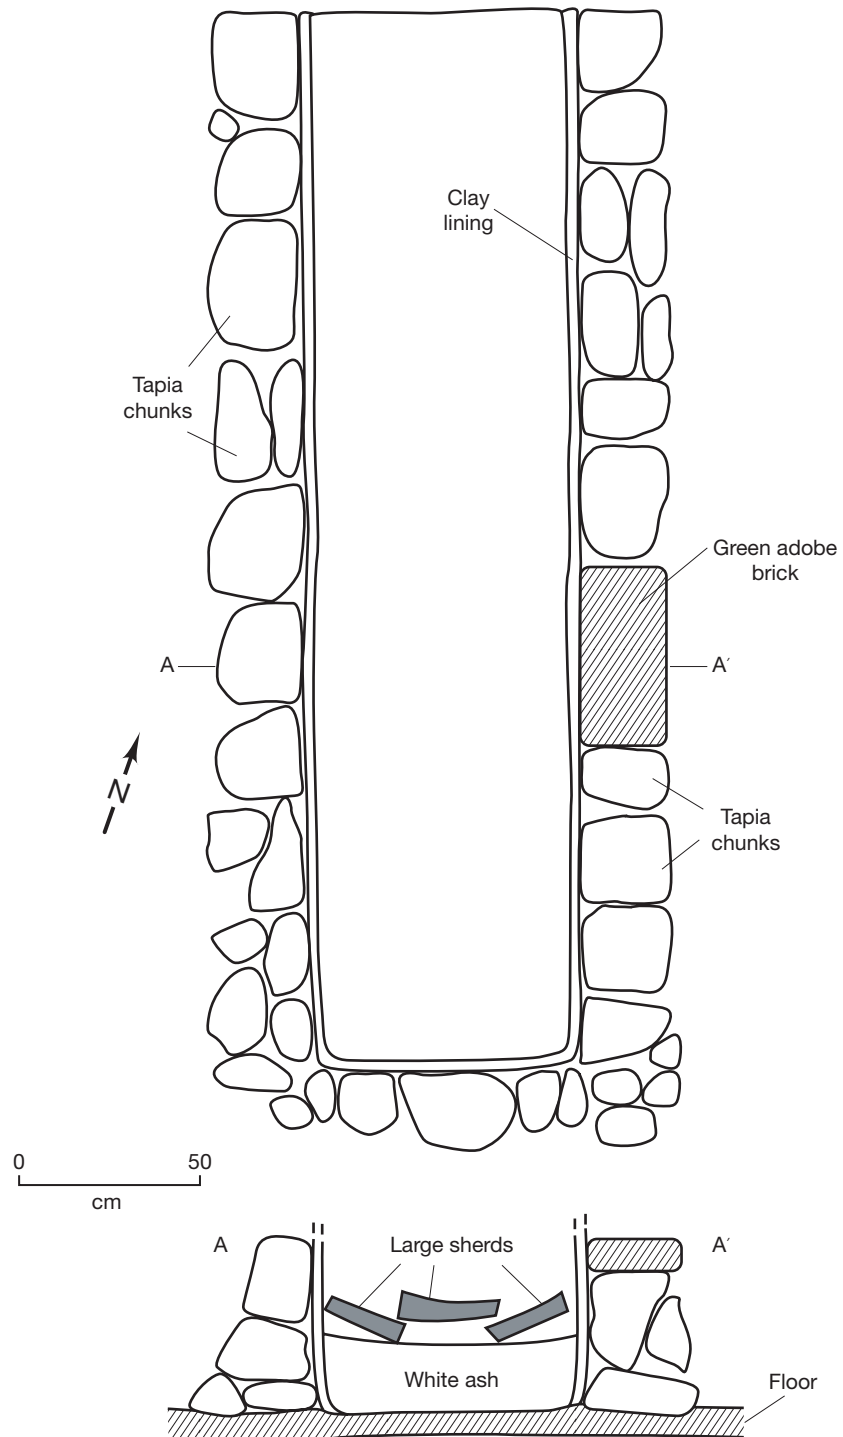
Figure 7.4. Plan and cross section of Feature 8, a hearth trench in the North Central Canchón, Structure D.

(Figure 7.4). Its walls had been constructed of tapia chunks and an occasional green adobe identical to those used as decoration in Room 3 ($50 \times 25 \times 10$ cm). The interior of Feature 8 had been given a smooth lining of clay.

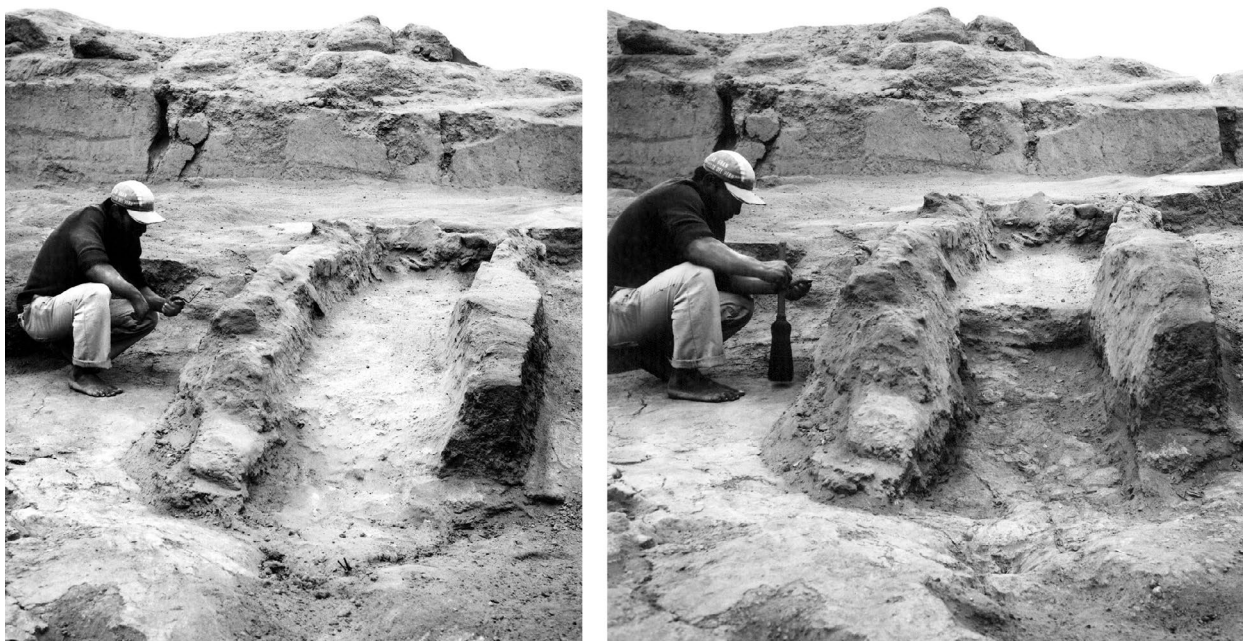
Figure 7.5. Two stages in the excavation of Feature 8, a hearth trench in the North Central Canchón, Structure D. (*Left*): The feature seen from the north, before the removal of any ash. (*Right*): The same feature after removal of ash from the north half.

partially filled with white ash (Figure 7.5) and yielded occasional large jar sherds. The fuel that was used apparently consisted of whatever discarded wood or cane happened to be available—for example, *caña brava* (*Gynerium* sp.), driftwood from the beach, a broken weaving shuttle, and some broken wooden posts that appear to be willow (*Salix* sp.).

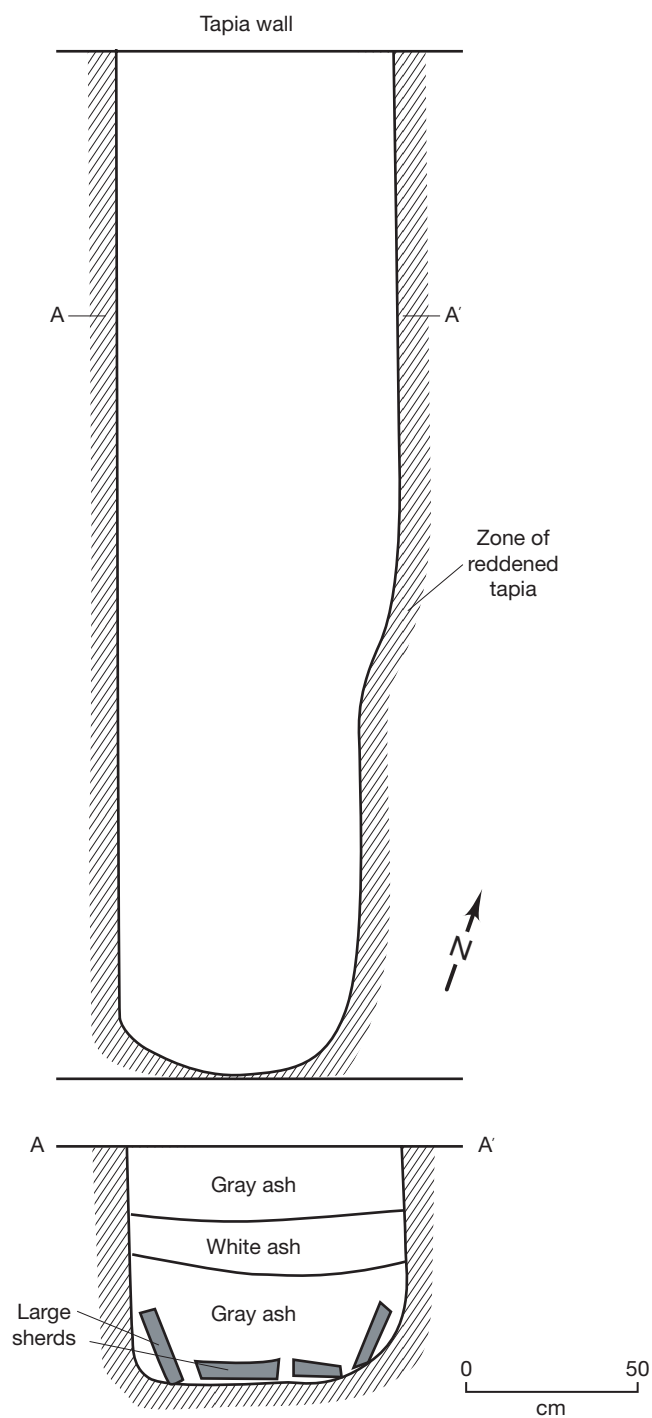
Figure 7.6. Plan and cross section of Feature 17, a hearth trench cut 70 cm into the solid tapia platform at the base of the North Central Canchón, Structure D.

Feature 17, the second hearth trench, was less well made. My impression is that it had been hastily prepared in order to increase (perhaps even double) the boiling capacity of the canchón. Feature 17 had no formal walls or clay lining; it was simply a long, narrow trench, dug down 70 cm through the platform at the south end of the canchón (Figures 7.6, 7.7). Its interior dimensions

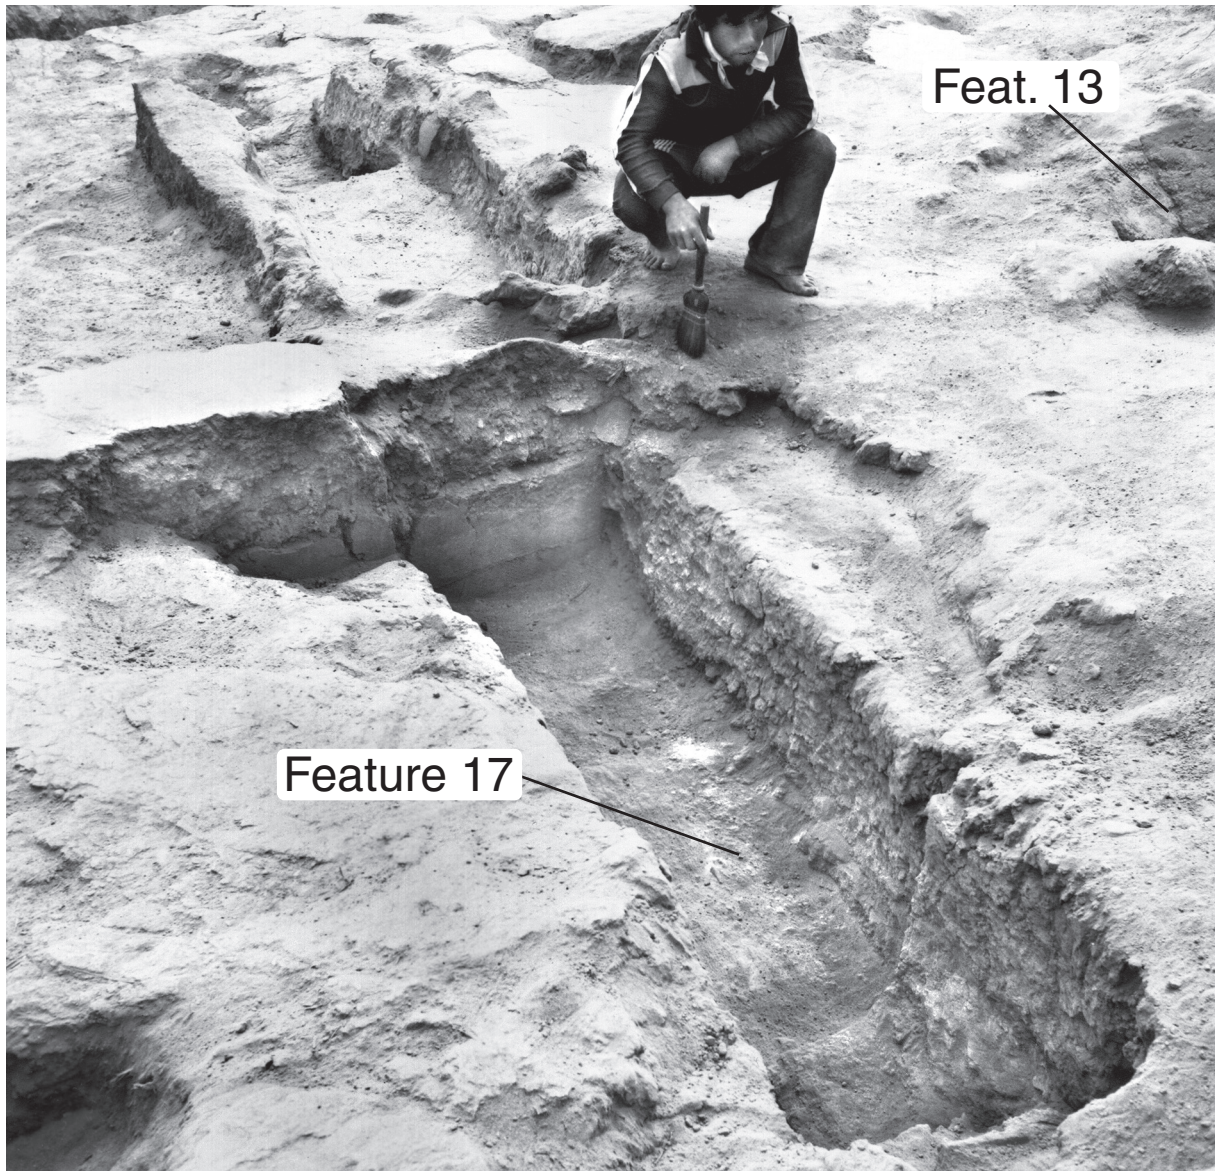
Figure 7.7. Feature 17, a hearth trench in the North Central Canchón, seen from the south. This view shows how Feature 17 was laid out with its north end touching a preexisting tapia crosswall. Also visible are Feature 8 (another hearth trench) and Feature 13, the impression of a large storage vessel once buried in the floor of the canchón. José Aguidos serves as scale.

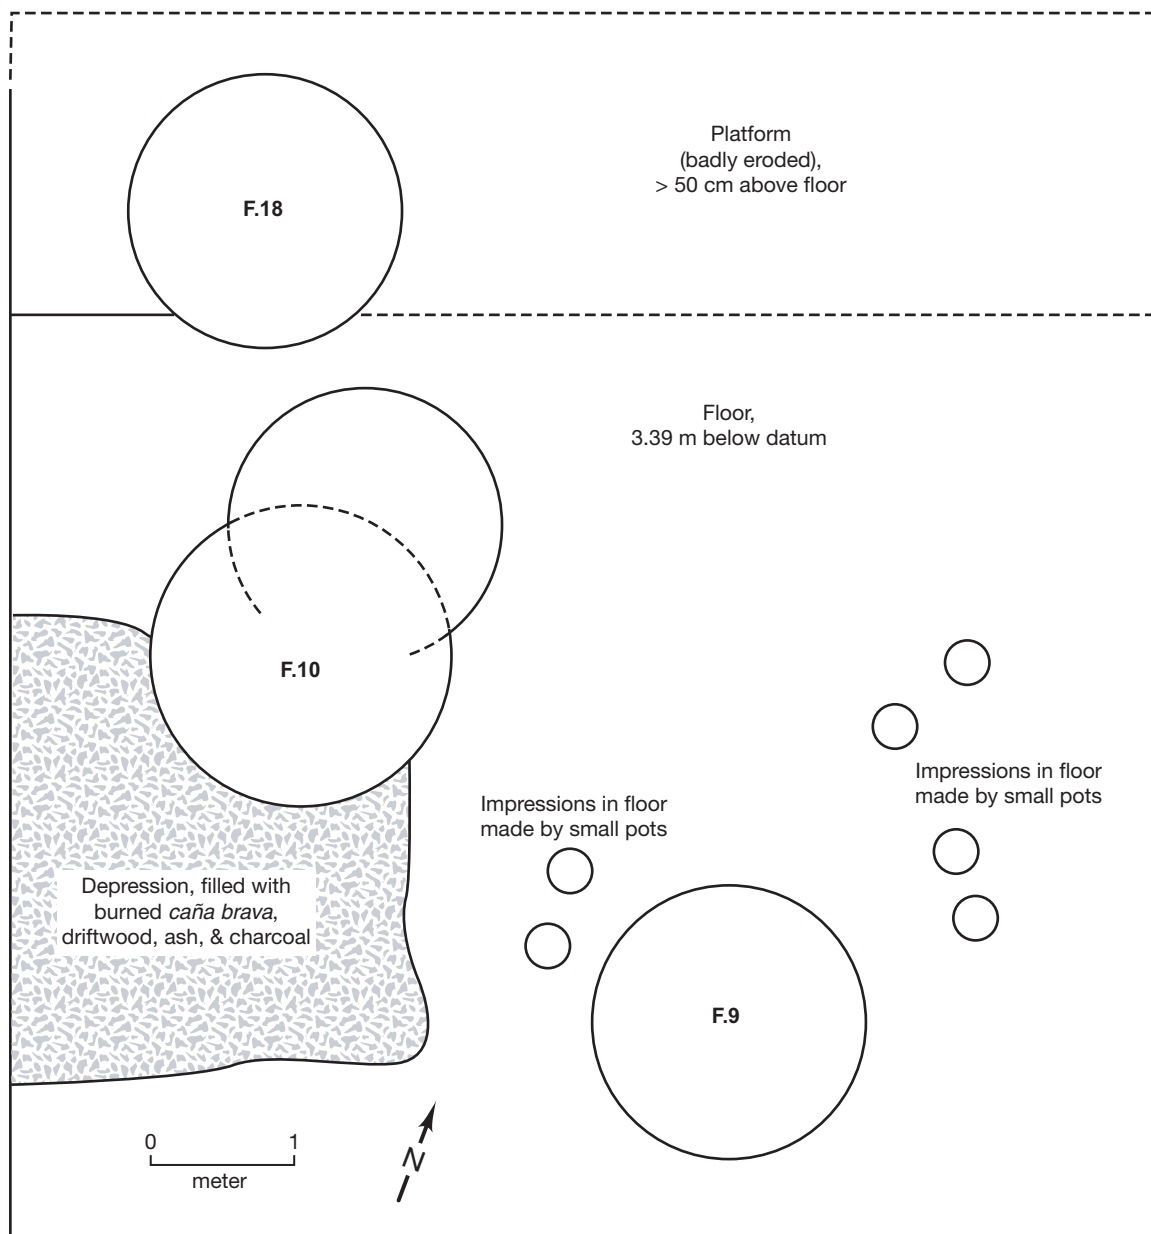
Figure 7.8. The north half of the North Central Canchón, Structure D, showing the location of Features 9, 10, and 18.

Feature 9 (Figure 7.9) was a *batun macma* with a storage capacity of roughly 1944 liters. Its maximum diameter was 2 m, and its conical base had rested on a flat beach cobble. At least half a dozen smaller vessels had evidently rested in concave impressions on the floor near Feature 9 (Figure 7.8); they may have been used to dip *chicha* from the larger vessel as needed.

As Figure 7.8 suggests, the Feature 10 jar appears to have been sunk into an area previously used for another vessel, to which no feature number was assigned because its cavity had been filled in.

Feature 18 (Figure 7.8) had been set into the tapia platform at the northern end of the North Central Canchón. Its diameter was about 1.7 m, and discarded inside it we found a patinated wooden stick of the type traditionally used to stir batches of *chicha*.

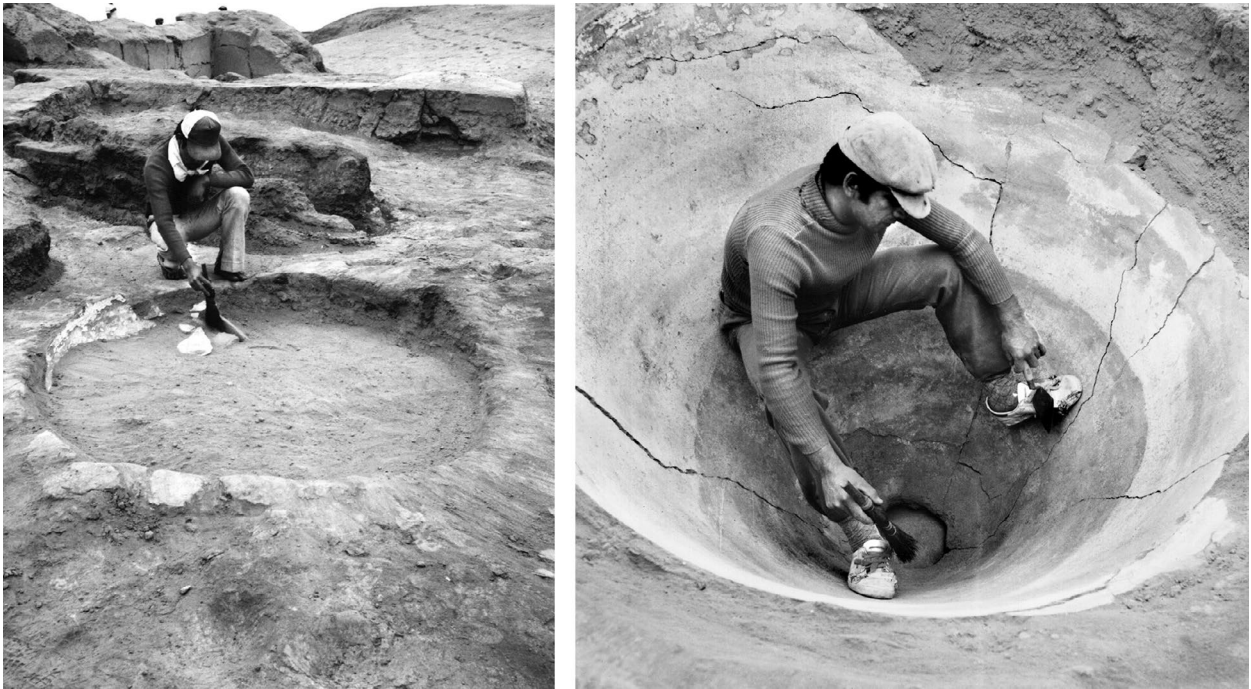
Figure 7.9. Stages in the excavation of Feature 9, a *batun maccma* with a storage capacity of nearly 2000 liters, which had been buried in the floor of the North Central Cancón. (Left): César Francia begins the excavation. (Right): Alberto Barraza sweeps the circular beach cobble on which the conical base of the giant vessel once rested.

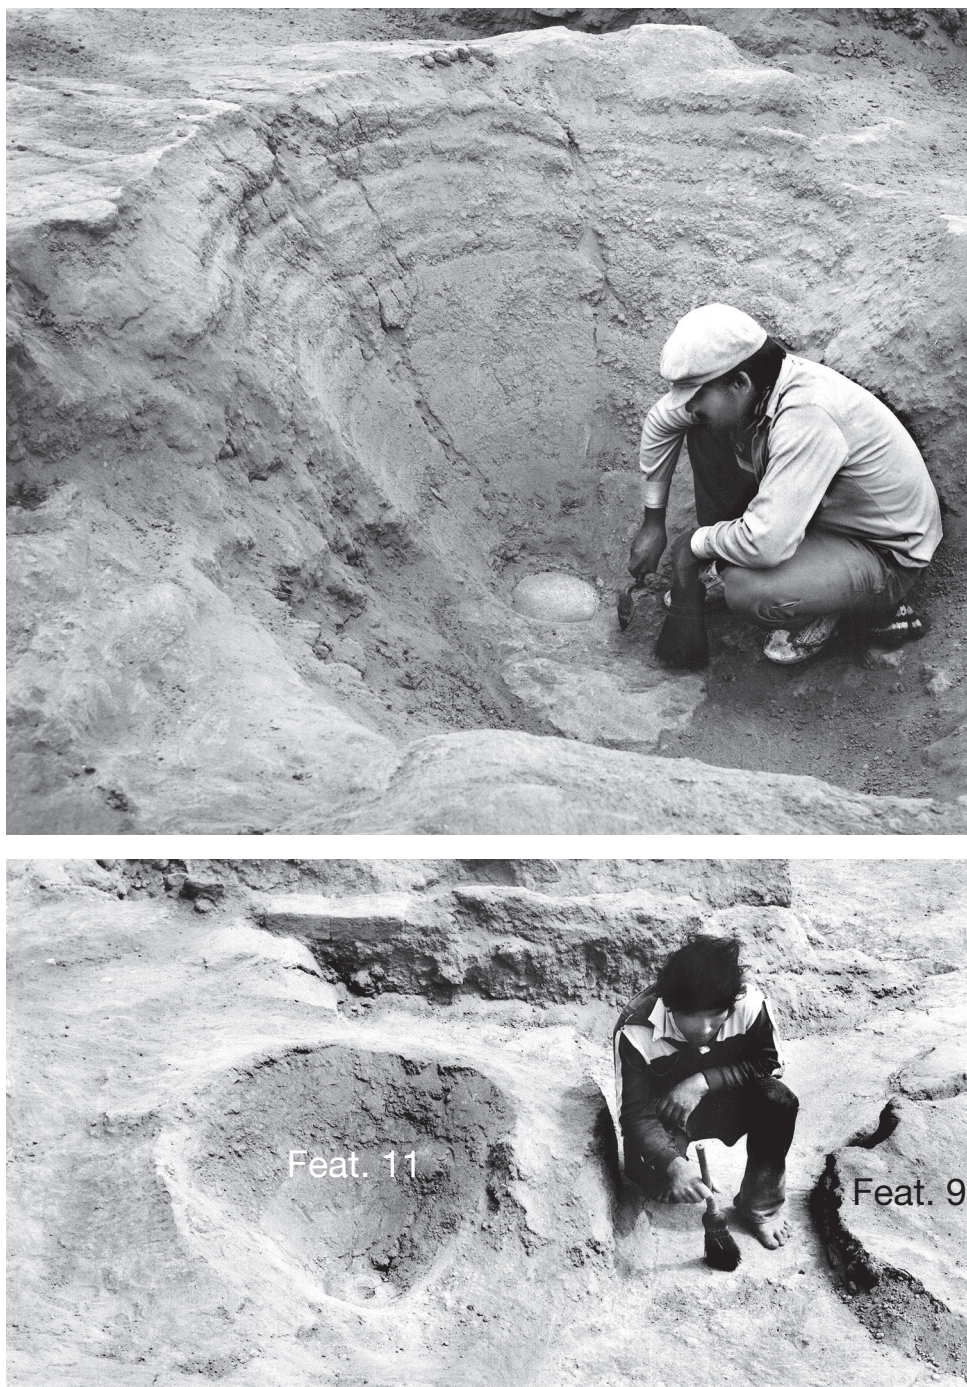
Figure 7.10. The impressions of large vessels buried in the floor of the North Central Canchón. (*Top*): Feature 10 seen from the east, showing the beach cobble placed below the conical base of the vessel, presumably to provide support. (*Bottom*): José Aguidos sweeps between Feature 11 (*left*) and Feature 9 (*right*). Feature 9 had been located but not yet excavated at this point.

Feature 10 (Figure 7.10, top), like Feature 9, had been a *batun macma* with a maximum diameter of 2 m and a storage capacity close to 2000 liters. Aside

from a few sherds, only the impression in the ground survived. As the upper half of Figure 7.10 shows, that impression bears the parallel grooves of a vessel unsmoothed on the exterior. Feature 10 had probably been formed and fired in place.

Feature 11 (Figure 7.10, bottom) is the impression of a vessel about half the size of Feature 10; its maximum diameter is roughly 1.0 m. A doughnut-shaped beach cobble (which might once have been an artifact) had been placed beneath its conical base. A *batán* or grinding slab had been discarded in Feature 11; it appears to be the kind of slab on which the grinding stones found in Feature 10 might have been used.

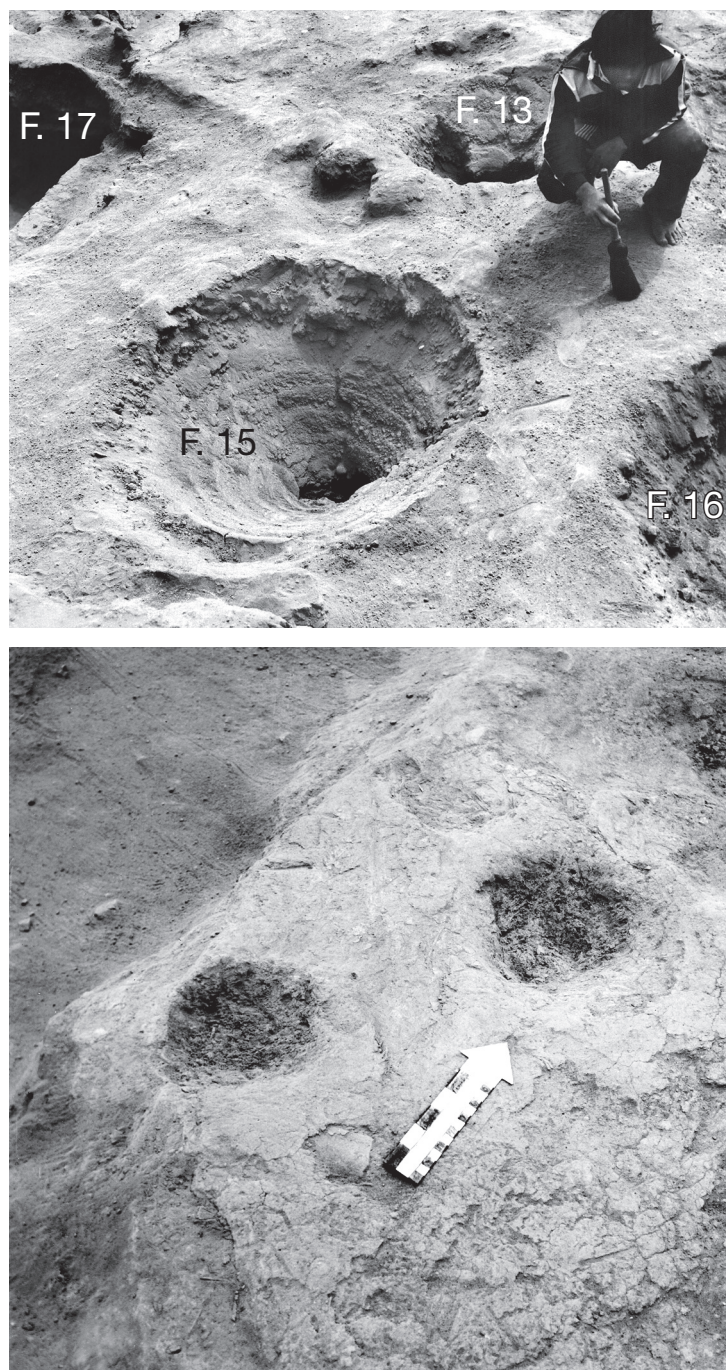
Figure 7.11. Features in the floor of the North Central Canchón. (*Top*): Features 13, 15, 16, and 17. (*Bottom*): Shallow impressions in the floor made by small pots. The north arrow is marked in both centimeters (*right side*) and inches (*left side*).

Feature 13 (Figures 7.3 and 7.11, top) is one of four storage jars placed near the center of the tapia platform east of Feature 17. Its diameter was only 90 cm, making it one of the smallest vessels, with a capacity of roughly 126 liters.

Features 14, 15, and 16 (Figures 7.3 and 7.11, top) were set in the same tapia platform as Feature 13. Features 14 and 15 had diameters close to 1.4 m

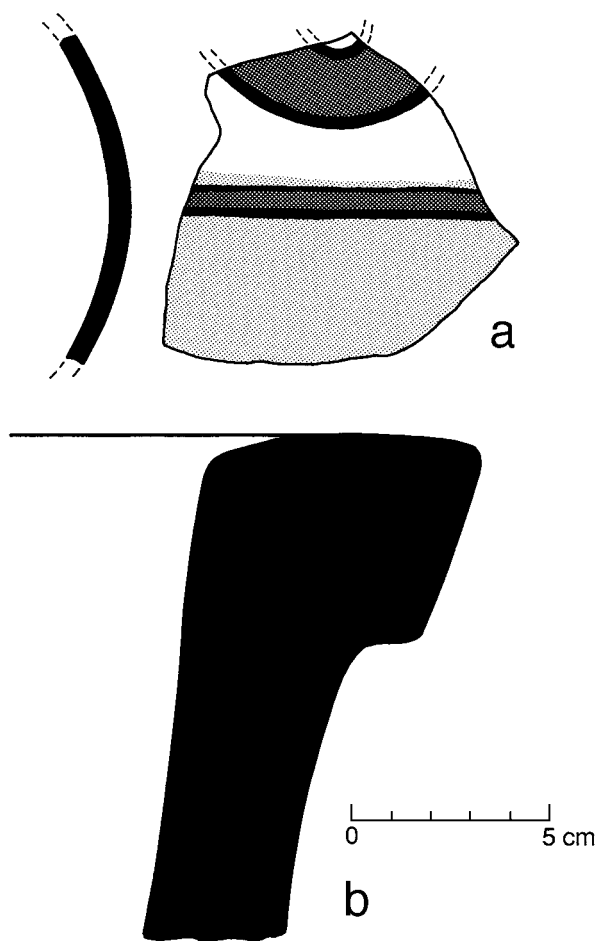
Figure 7.12. Sherds found inside Feature 9, Structure D. (a): unusual jar sherd featuring light brown paint over gray paste. A design has been painted over the brown surface in black/white/red. The red paint is 7.5 R 3/4 to 4/4 (weak red to dusky red). Similar sherds were found elsewhere in the North Central Canchón. (b): everted rim from the neck of a *batun macma*. The vessel was made of extremely coarse clay with temper particles up to 5 mm in diameter. Its paste is 2.5 YR 6/6 (light red) and the exterior surface is 5 YR 6/3 (light reddish brown). The part of the vessel that would have been above ground has been given a light wash of the same reddish clay.

Camacho Reddish Brown (Figure 7.12b)

Unusual Painted Vessel (Figure 7.12a)

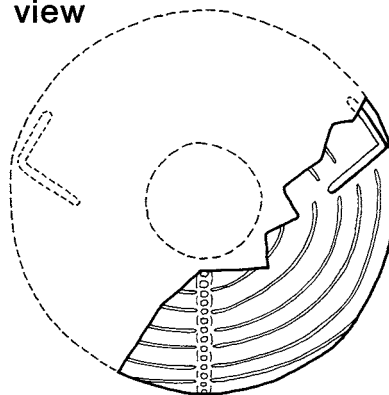
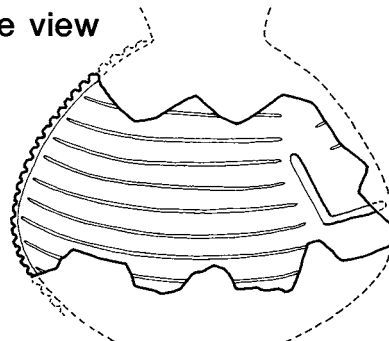
Figure 7.13. Partially restorable vessel that fell (or was thrown) into Feature 9, Structure D. This jar depicts a “fat skeleton.” A human spinal column runs up the back, with grooves coming off the spine at intervals to represent ribs. On each side is a spindly arm, and there was probably a face on the neck. The paste resembles Pingüino Buff’s, but the surface seems to have a brown wash on it which would be atypical for Pingüino vessels. The lower third of the vessel is fire-blackened or smudged. Where not blackened, the surface color is 10 R 4/4 to 2/5 YR 4/2 (weak red).

"Fat Skeleton" Vessel (Figure 7.13)

Partially restorable effigy vessel with Pingüino Buff-like paste but atypical brown wash, depicting a skeletonized person: 1 (this vessel appears to have been used for cooking, something for which effigy vessels were rarely used)

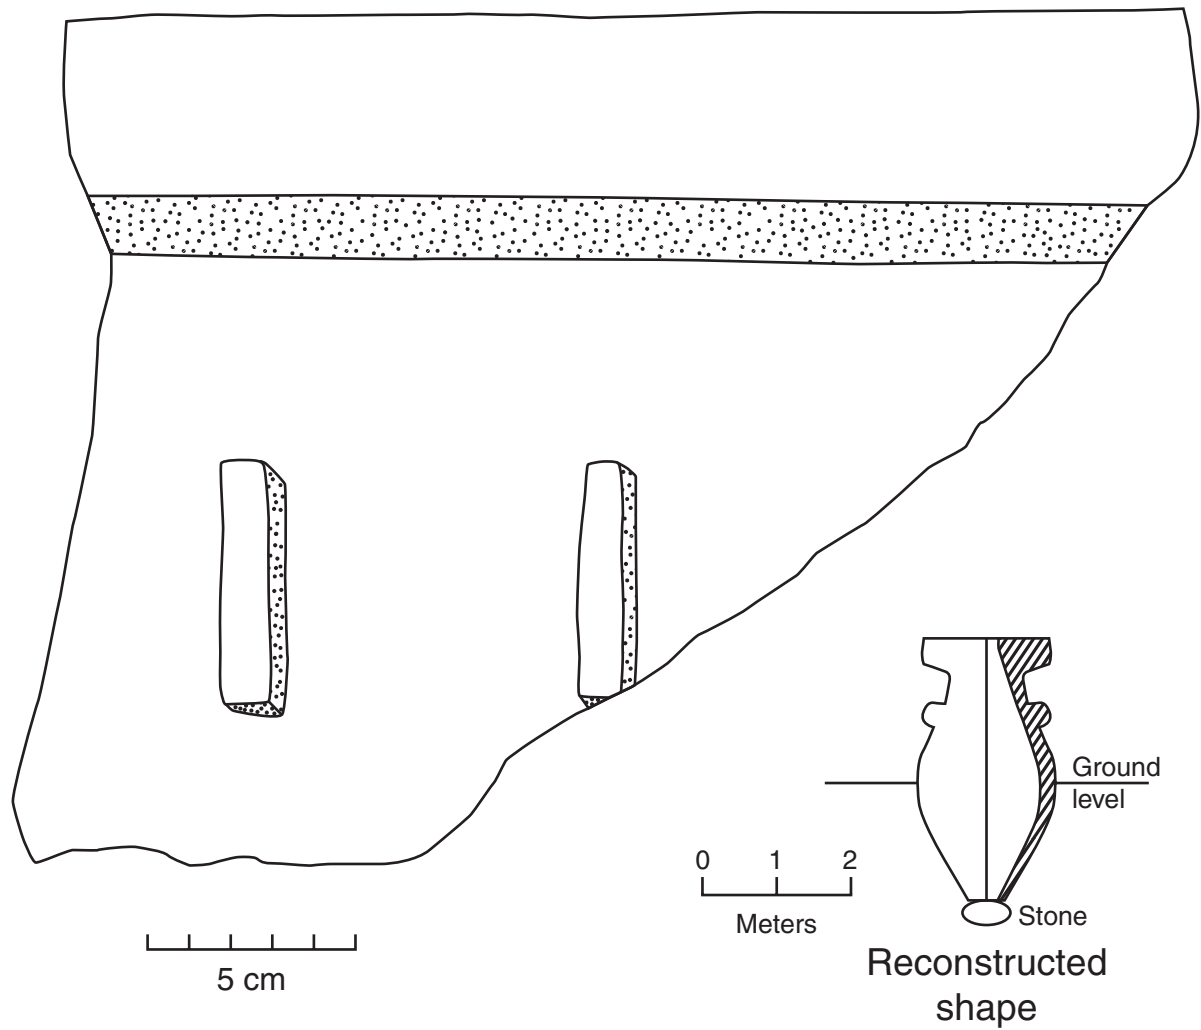
Figure 7.14. Rim sherd from *batun macma* that had fallen into Feature 10 of the North Central Canchón. The two protuberances on the vessel wall are stubs from a broken horizontally set handle. At lower right is an artist's reconstruction of how the vessel was set in the ground, with its base deliberately resting on a stone.

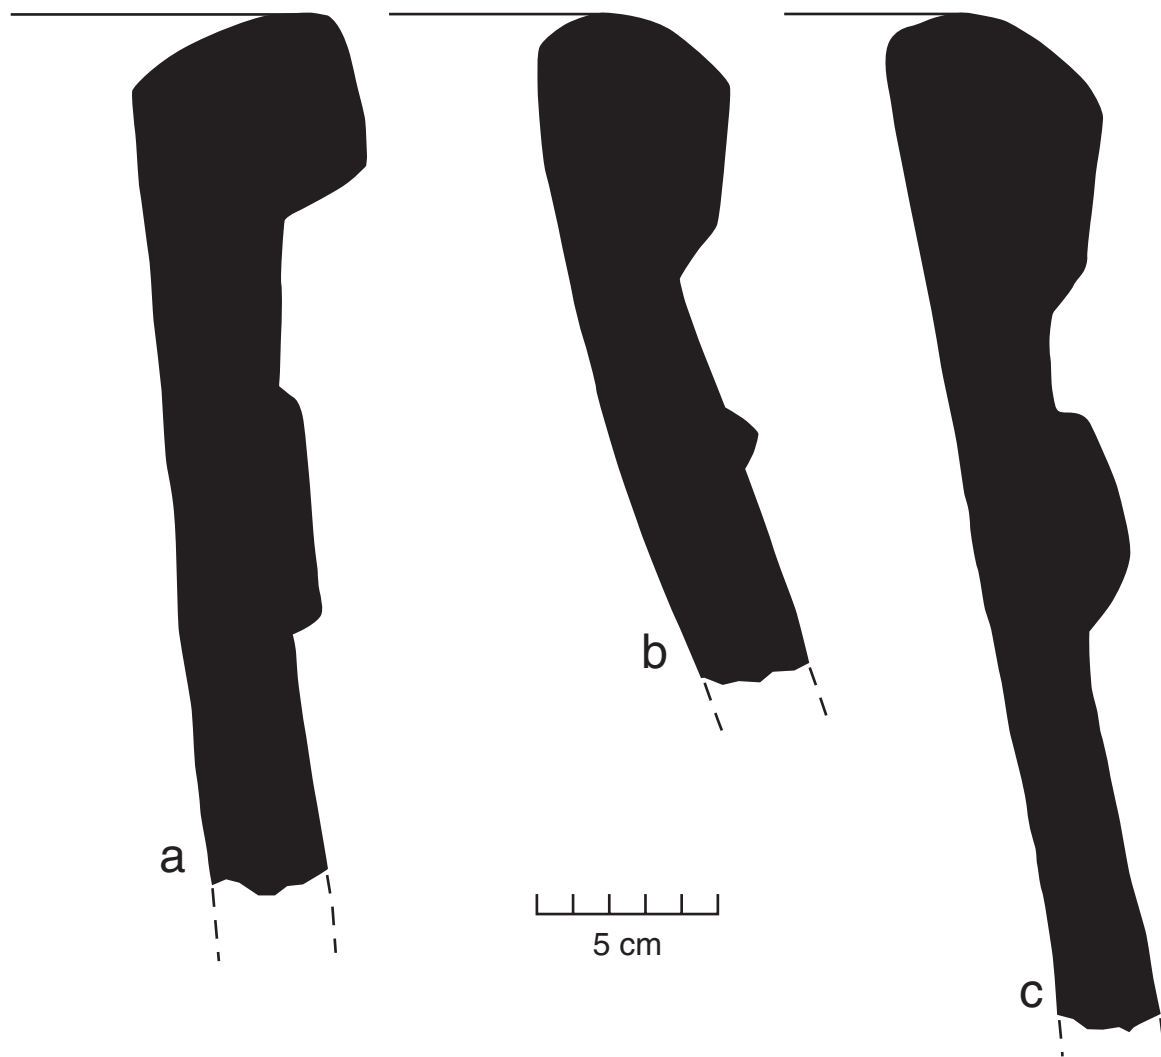
Figure 7.15. Rims of *batun maccma*, or large *chicha* storage vessels, that had fallen into Feature 10 of the North Central Canchón. All vessels had rim diameters in the range of 1.6 m. The protuberance on the wall of *a* is the stub of a broken handle; that on the wall of *b* is a “pinched point” decoration; that on the wall of *c* is a large decorative adornment.

7.15	Rims of <i>batun maccma</i> , or large chicha storage vessels, in Feature 10 of the North Central Canchón	194
7.16	Rim sherds from <i>batun maccma</i> , found resting on the floor of the North Central Canchón, Structure D	196

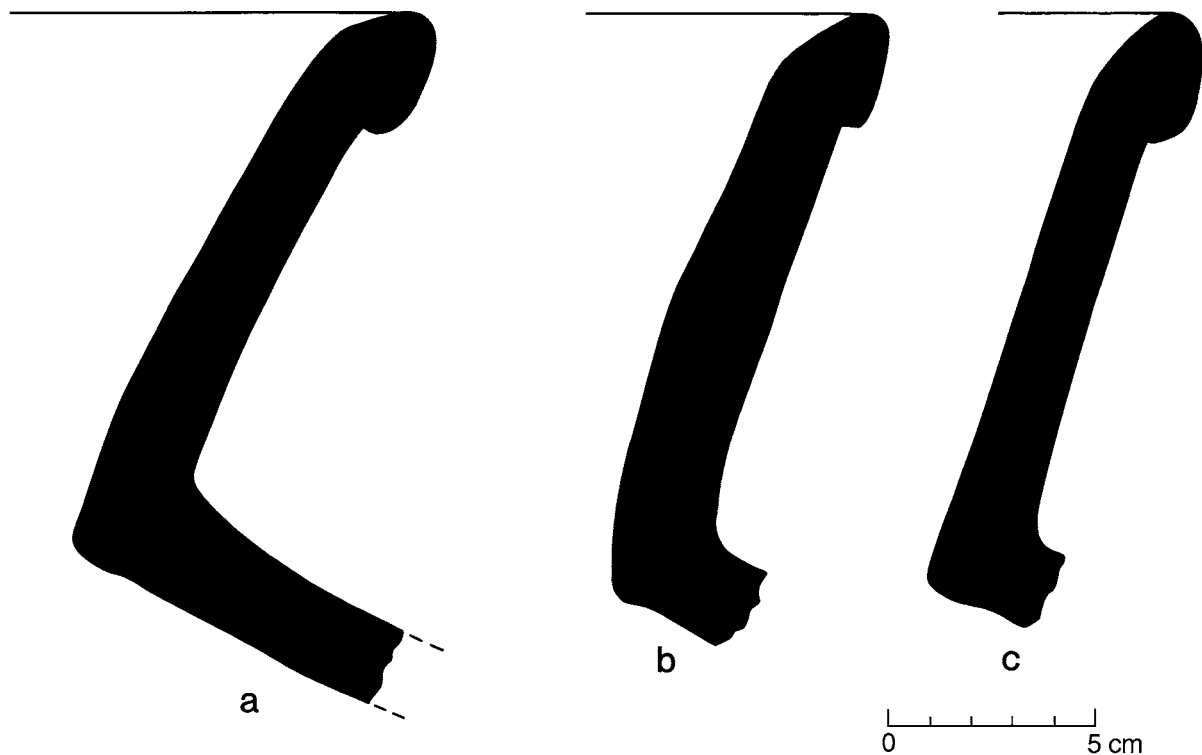
Figure 7.16. Rim sherds from *batun maccma*, found resting on the floor of the North Central Canchón, Structure D. The rim diameters of the complete vessels are estimated to have ranged from 60–70 cm to more than 1.0 m.

Scattered throughout the canchón were rim sherds broken off the large storage vessels that had been set in the floor. Figure 7.16 presents a sample of these rim sherds, whose diameters ranged from 60–70 cm to more than 1.0 m.

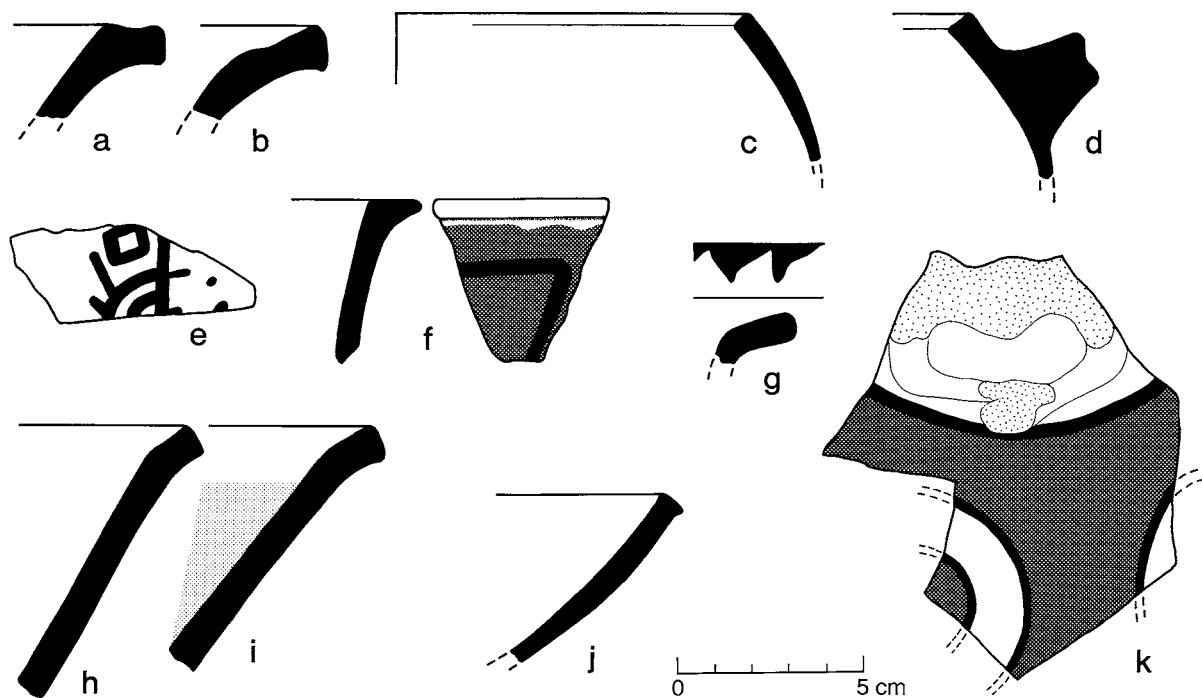
Figure 7.17. Diagnostic sherds from various proveniences in the North Central Canchón, Structure D. Sherds *a–d* are Camacho Reddish Brown. (*a, b*): everted rims from large jars; (*c, d*): cooking pots with restricted orifice and horizontally set strap handles; fire-blackened. Sherds *e–j* are Pingüino Buff. (*e*): jar body sherd with design painted in black over a red wash; (*f*): funnel neck with face painted in black and red; (*g*): everted jar rim, painted with black rim ticking over a white background; (*h*): everted rim of jar, plain; (*i*): everted rim of jar, painted white-on-natural; (*j*): rim of subhemispherical bowl with fugitive light red slip; (*k*): unusual jar shoulder sherd with gray paste, modeled figure on shoulder; cream slipped; painted black/red/cream.

Camacho Reddish Brown (Figure 7.17a–d)

Pingüino Buff (Figure 7.17e–i)

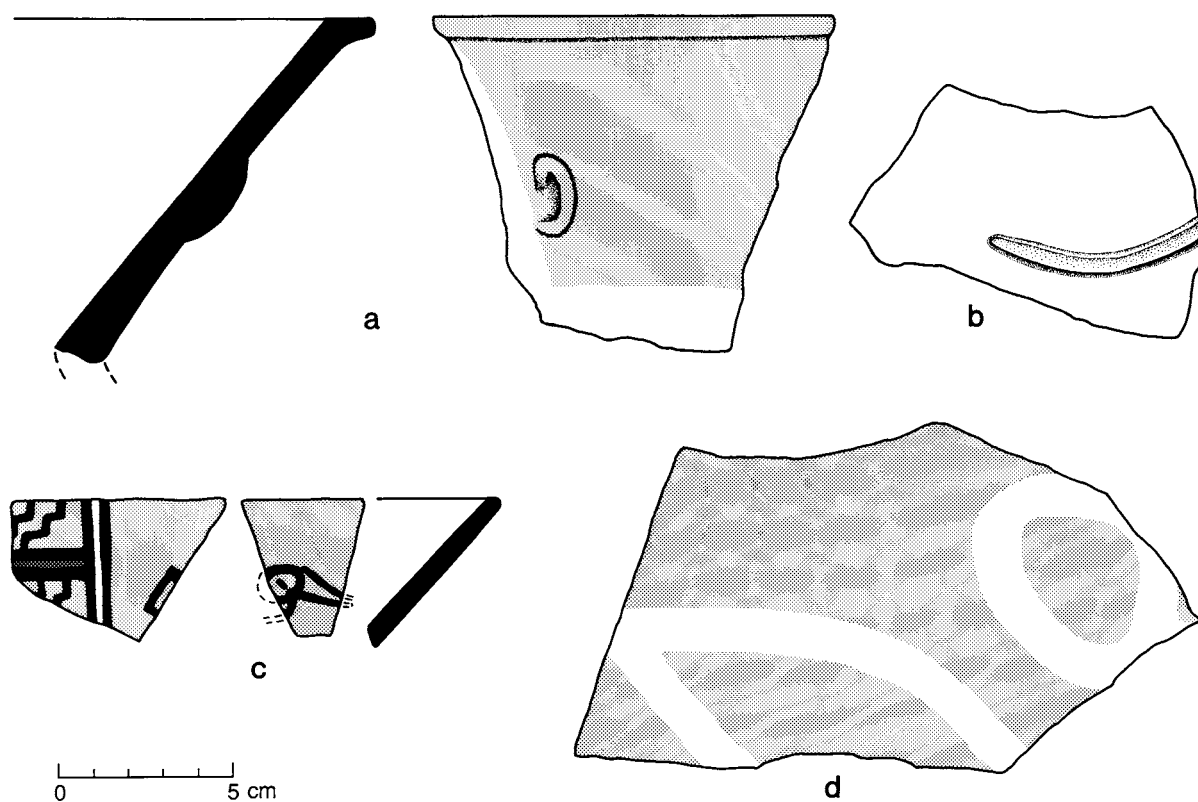
Figure 7.18. Pingüino Buff vessels found while cleaning around Features 11–16 in the North Central Canchón, Structure D. (*a*): large jar with modeled left ear from what is presumably a face, painted white on natural; (*b*): body sherd from large jar, showing what may be a modeled arm; (*c*): two sherds from large shallow bowl, painted on the interior in black/white/red; (*d*): sherd from shoulder of large jar, painted white on natural.

Pingüino Buff (Figure 7.18)
