MONOGRAPH 62
COTSEN INSTITUTE OF ARCHAEOLOGY
UNIVERSITY OF CALIFORNIA, LOS ANGELES

EXCAVATIONS AT
CERRO AZUL, PERU
THE ARCHITECTURE AND POTTERY
JOYCE MARCUS

Excavations at Cerro Azul, Peru

THE ARCHITECTURE AND POTTERY

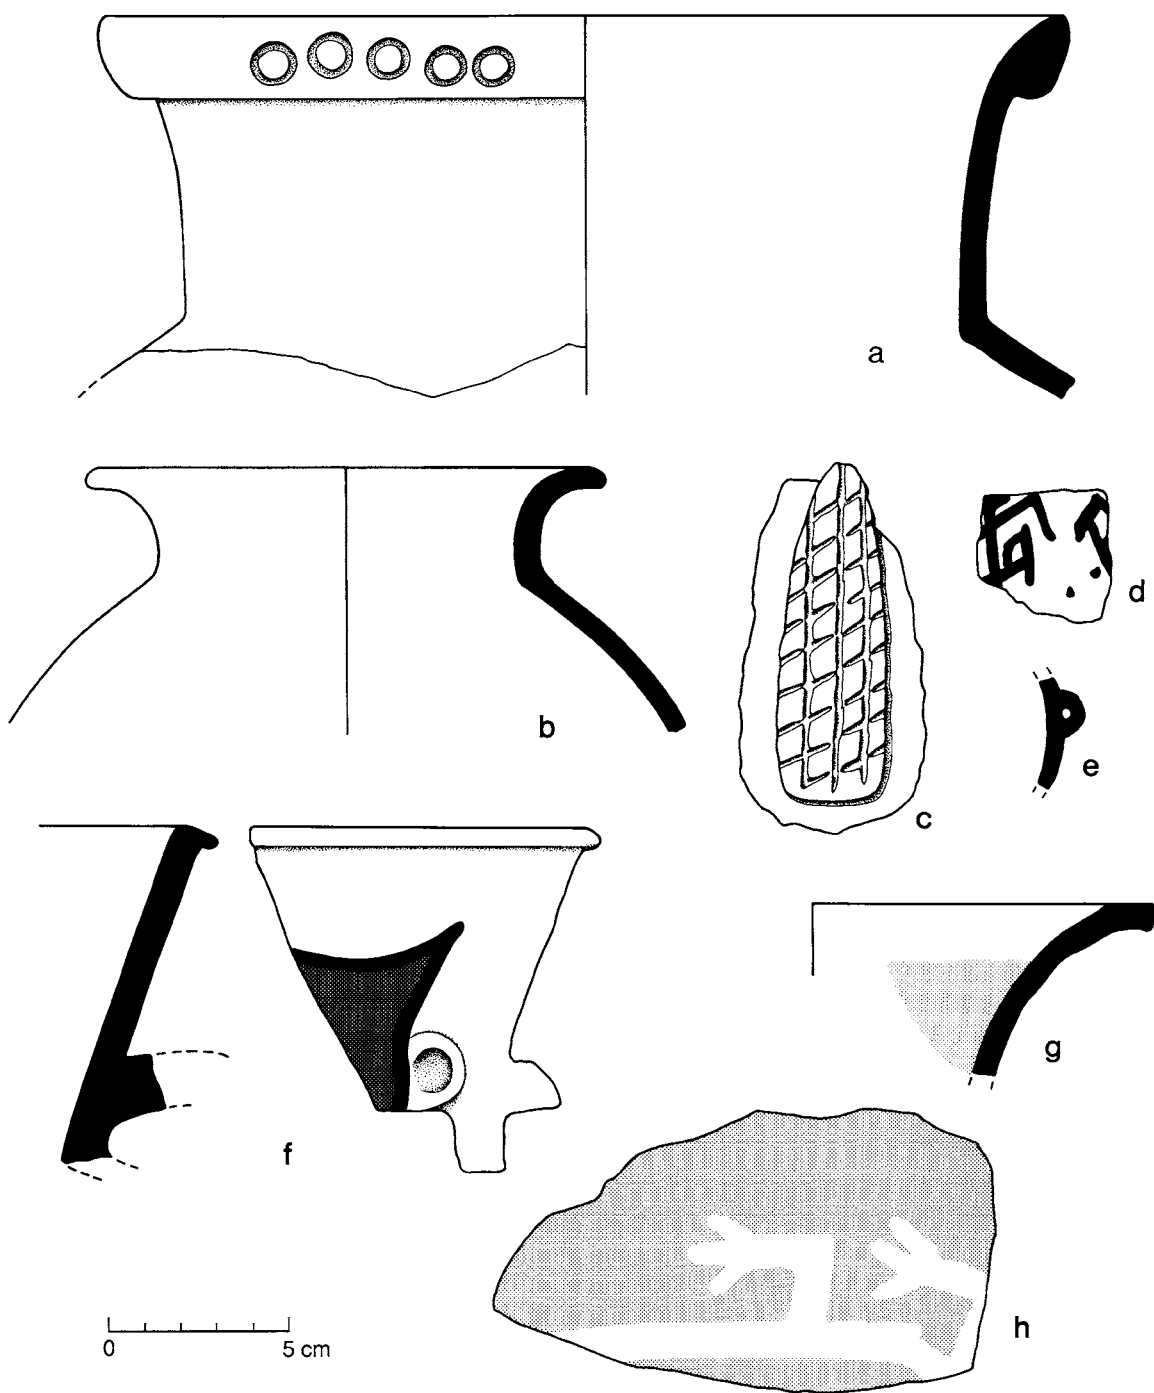
Figure 7.19. Ceramics from the floor of the North Central Canchón, Structure D. Sherds *a–c* are Camacho Reddish Brown. (*a*): jar with cambered rim, decorated with cane-end punctations in groups of five; (*b*): fire-blackened jar with everted rim; (*c*): maize-cob lug modeled on large jar; (*d*): sherd from gray-paste jar, painted black on white; (*e*): unusual jar body sherd with gray paste and white-on-black painting; (*e*): loop handle from miniature pot, Trambollo Burnished Brown (?). Sherds *f–h* are Pingüino Buff. (*f*): funnel neck from jar with modeled human head showing facial paint; there was a strap handle behind the ears (the red paint is 10 R 6/8 and is outlined in black); (*g*): jar with everted rim, painted white on natural on the interior; (*h*): jar body sherd painted white on natural.

Finally, an additional 17 diagnostic sherds were found scattered around the canchón floor, not near any of the features (Figure 7.19). Six of these sherds are from Camacho Reddish Brown jars and include an effigy maize cob lug that may have been a symbolic reference to the jars' contents: *chicha*. Nine more sherds are from Pingüino Buff jars of the type we suspect were for storage or transportation of liquids. The two remaining sherds are from unusual items, of whose function we are unsure. The whole collection is as follows:

Camacho Reddish Brown (Figure 7.19a–c)

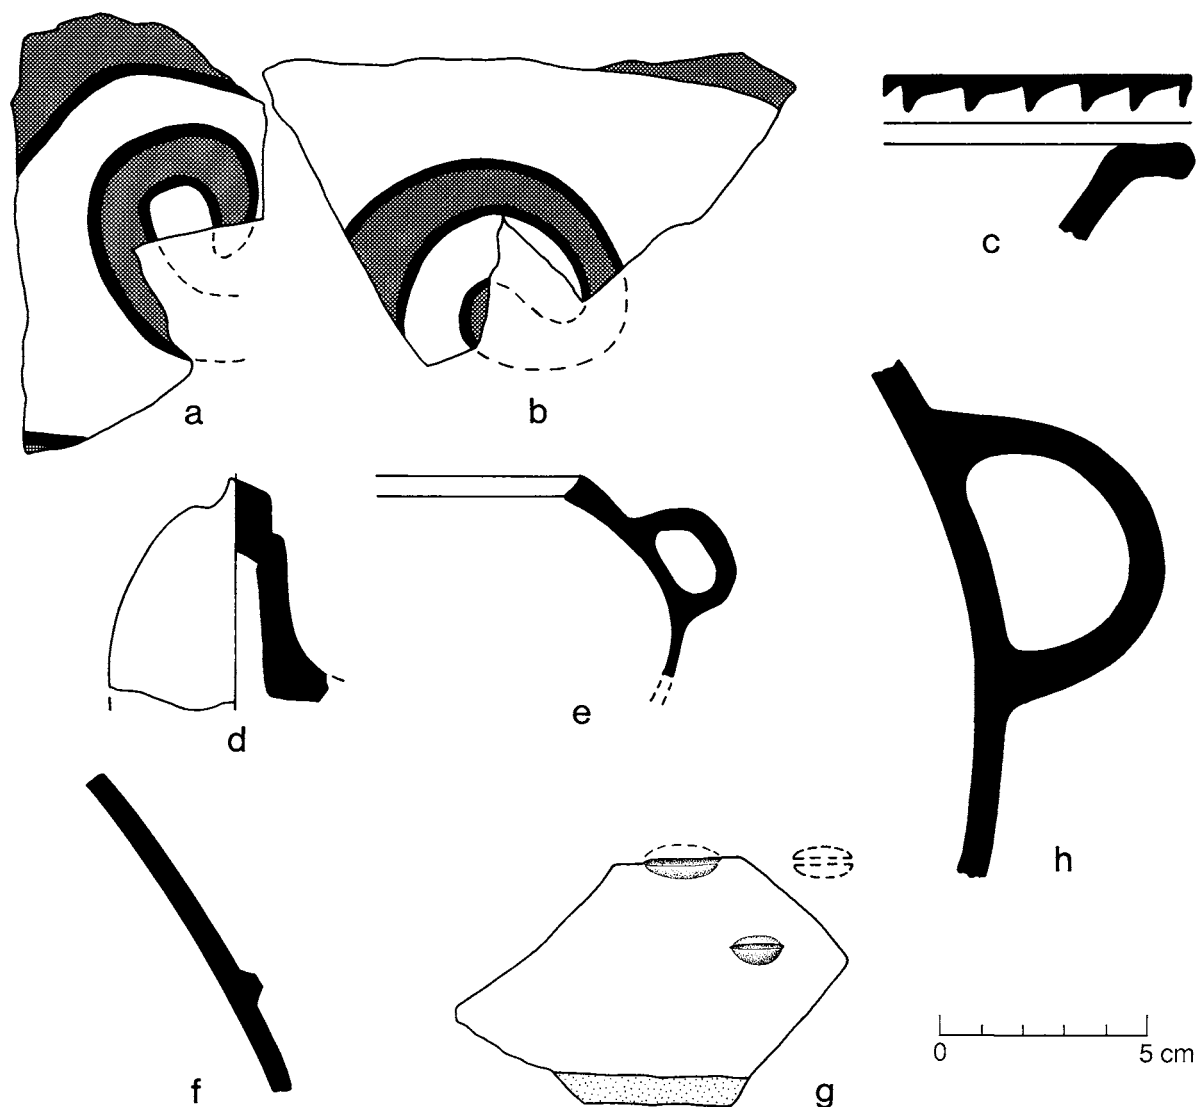
Figure 7.20. Ceramics from the fill of the North Central Canchón, Structure D, near Feature 8. (*a, b*): unusual jar sherds with gray paste, painted black/white/red with concentric swirls; the red is 7.5 R 4/4 (weak red); (*c*): everted rim from Pingüino Buff jar, painted white on the exterior, painted black on the rim as shown; (*d*): sherd from possible cucurbit effigy. Sherds *e* and *f* are Camacho Reddish Brown. (*e*): cooking pot with restricted orifice and strap handle, fire-blackened; (*f*): jar sherd with appliqué nipple. Sherds *g* and *h* are Camacho Black (standard variety). (*g*): amphora sherd with appliqué “coffee-bean” eye and mouth; (*h*): amphora sherd with strap handle.

Twenty-six sherds were found in the fill near the Feature 8 hearth trench. Included were vessels not usually found lying directly on the floor—for example, Camacho Black amphorae, and some unusual painted jars that could be from another region. Their concentric swirl motif resembles that seen on one of the sherds from Feature 9 (see Figure 7.12a). We therefore concluded that many of the sherds from the lower fill had entered the canchón after its abandonment, rather than belonging to the original occupation. The entire collection is as follows:

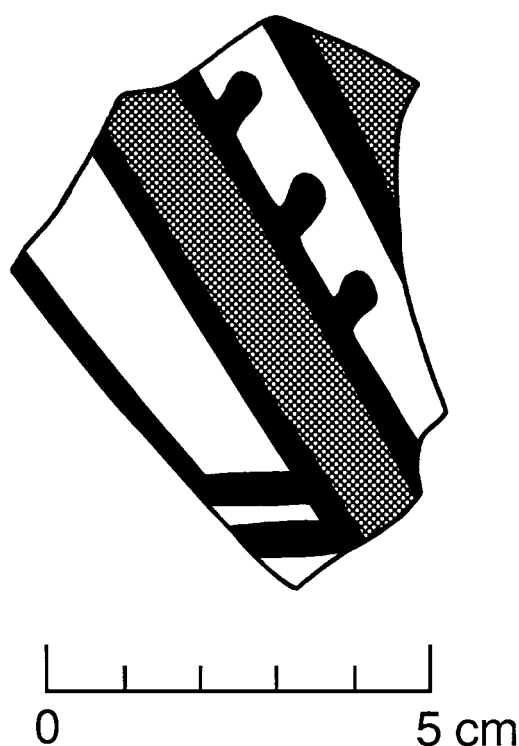
Figure 7.21. Pingüino Buff jar sherd from the fill of the North Central Canchón. The vessel was painted black/white/red on the exterior with the same chevron motif seen on sherds from the fill of Room 11 (see Figure 7.29).

Elsewhere in the general fill of the North Central Canchón, we found the interesting sherd seen in Figure 7.21. It is a Pingüino Buff jar sherd with nested chevrons painted in black/white/red, very similar to a specimen found in the fill of Room 11 (see Figure 7.29, later in this chapter). The two sherds are so similar that they could have

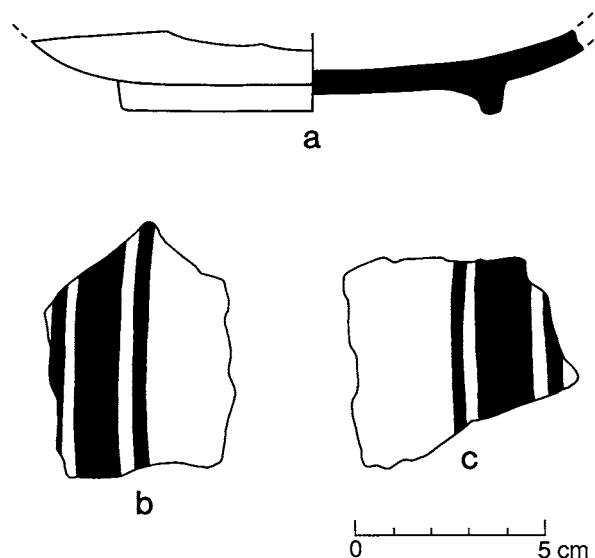
Figure 7.22. Ceramics found resting on the surface of the fill in the North Central Canchón, Structure D. This collection appears to be very late Late Horizon at the earliest, and perhaps even Colonial. (Its closest ties are to material from a late feature on Cerro del Fraile.) All specimens have a brick red paste and a cream slip. (a): vessel with a ring base, unknown in the Late Intermediate period; (b, c): black-on-cream painted body sherds.

sherds have black-on-cream stripes and resemble vessels from Late Horizon/Early Colonial deposits elsewhere at Cerro Azul (Figure 7.22b, c). These sherds, therefore, may have been left on the surface well after the canchón filled in.

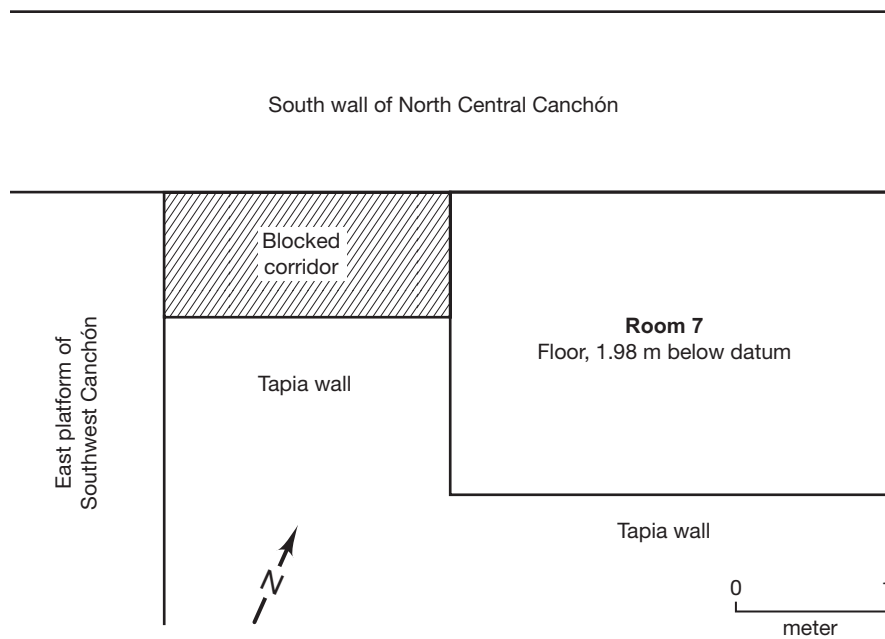
Figure 7.23. Detail of Room 7, showing the corridor that had once connected it to the Southwest Canción. At a later stage of the building's occupation, the corridor was blocked with tapia.

Also assigned to the northwest quadrant of Structure D is Room 7, a small room on the opposite side of the south wall of the North Central Canchón (Figure 7.23). Room 7 measures 2.89 × 1.99 m, and early in the history of the building had been connected to the East Platform of the

Southwest Canchón by a narrow corridor. At a later time, that corridor was blocked with *tapia* (see Figures 4.13 and 4.14 of Chapter 4). Access to Room 7 may have been blocked because it suffered severe earthquake damage (Figure 7.24).

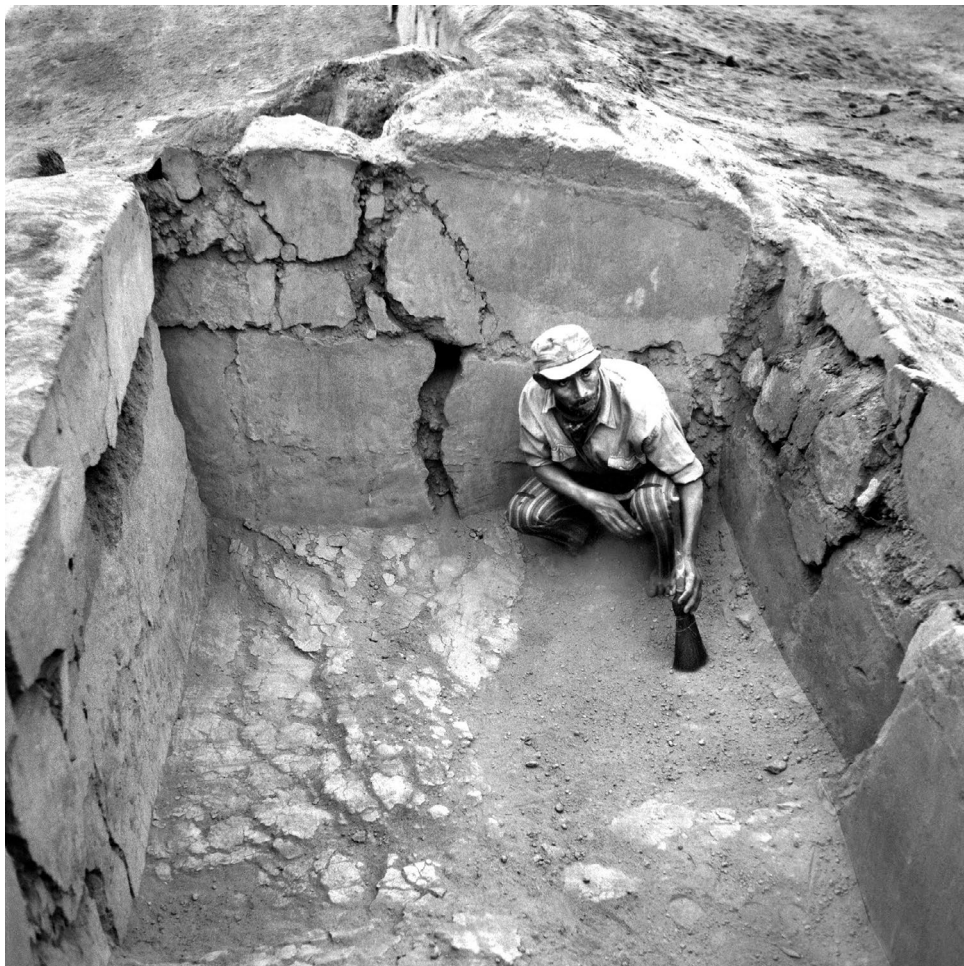
Figure 7.24. Room 7, Structure D, seen from the east. Earthquake damage is evident on the south and west walls. The floor had also collapsed in the northwest corner, where Edalio Aguidos is sweeping.

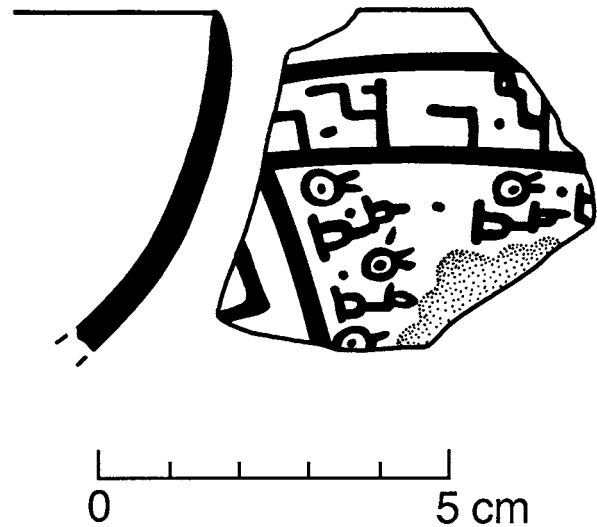
Figure 7.25. Pingüino Buff sherd found on the floor of Room 7, Structure D. The sherd is from a hemispherical bowl with a white wash on the interior and exterior, painted on the exterior in black and white.

Pingüino Buff (Figure 7.25)

Hemispherical bowl, given a white wash on the interior and exterior, then painted with a very fine-line black-on-white design. Rim diameter, ca. 18 cm.

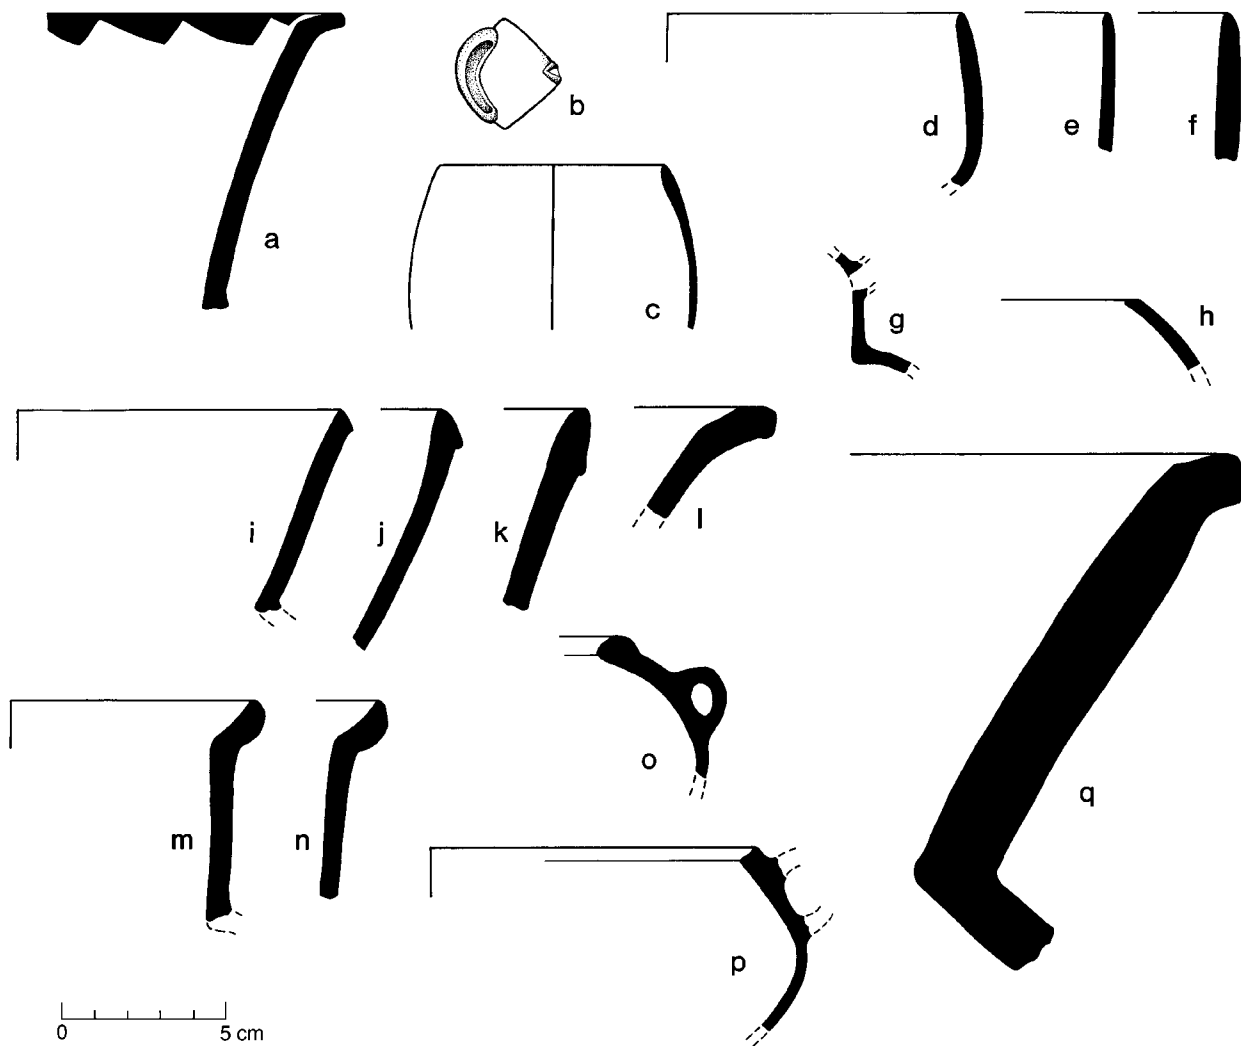
Figure 7.26. Ceramics from the fill of Room 7, Structure D. (a): Pingüino Buff jar neck with everted rim and black rim ticking on interior. Sherds b and c are Camacho Black (highly burnished variety). (b): fragment of modeled human face (ear and part of eye) from jar neck (?); (c): miniature incurved-rim bowl. Sherds d–f are hemispherical bowl rims; d is Camacho Black (standard variety); e and f are Pingüino Buff with a somewhat atypical paste. Sherds g and h are Trambollo Burnished Brown. (g): miniature jar with plastic decoration; (h): small incurved-rim bowl. Sherds i–p are Camacho Reddish Brown. (i–k): cambered rims from jars; (l): simple everted rim from jar; (m, n): everted and bolstered rims from jars; (o, p): cooking pots with restricted orifice and vertically set strap handles; (q): rim of *batun maccma* tossed into Room 7 late in its history. Surface color 10 R 4/8 (red) to 2.5 YR 6/8 (light red).

Camacho Reddish Brown (Figure 7.26i–p)

Camacho Black (Standard Variety) (Figure 7.26d)

Camacho Black (Highly Burnished Variety) (Figure 7.26b, c)

Trambollo Burnished Brown (Figure 7.26g, h)

Pingüino Buff (Figure 7.26a, e, f)

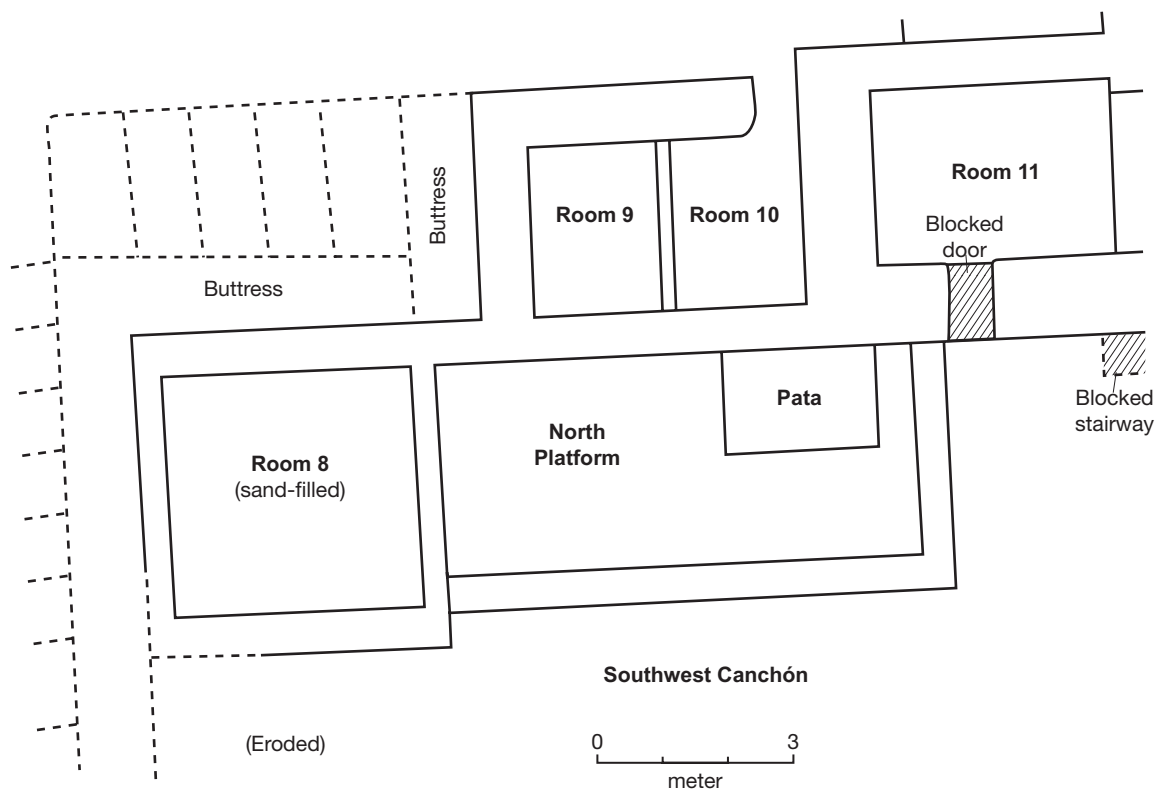
Figure 7.27. Plan of Rooms 8, 9, 10, and 11 of Structure D.

storage room for the North Central Canchón. Supplies for the kitchen/brewery could have been carried directly from unloaded llamas in the Southwest Canchón, through a doorway and into Room 11 (Figure 7.27). At a late stage of occupation, that doorway was blocked (Figure 7.28, bottom).

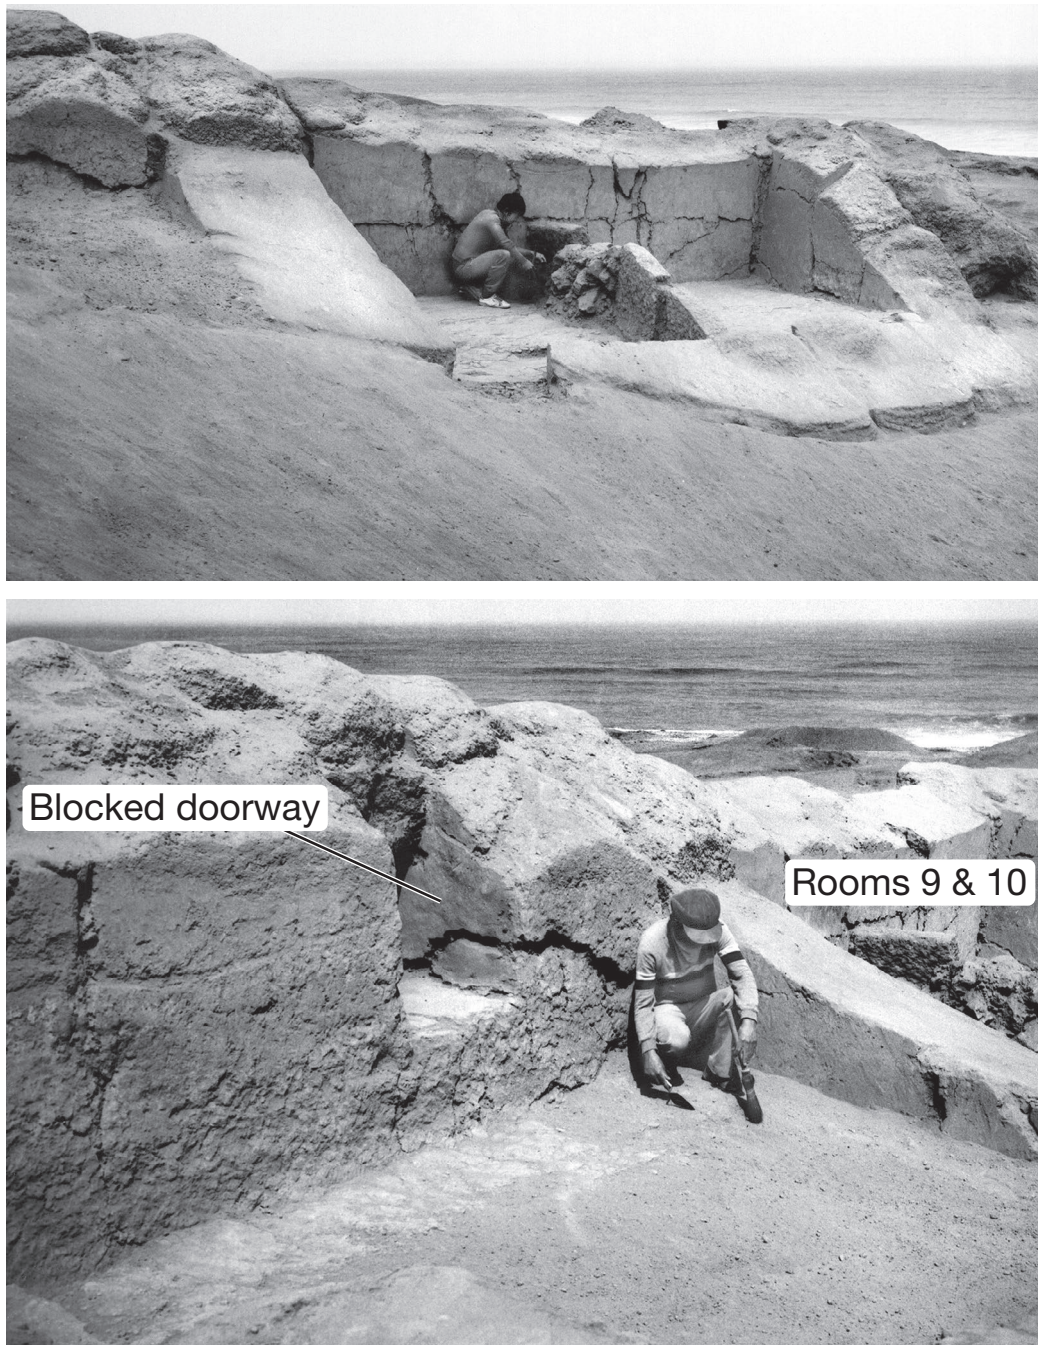
Figure 7.28. Excavation of Rooms 9, 10, and 11. (*Top*): Alberto Barraza cleans the narrow wall separating Rooms 9 and 10 (view from the north). (*Bottom*): Cirilo Cruz cleans the southwest corner of Room 11 (view from the northeast). Rooms 9 and 10 appear in the background. To the left of Cirilo is a blocked doorway which formerly allowed one to enter Room 11 from the Southwest Canchón.

Immediately west of Room 11 lay Rooms 9 and 10 (Figure 7.30; see also Figure 7.28, top). Although two numbers were assigned to them, it was clear that we were dealing with a single original room, later divided into two.

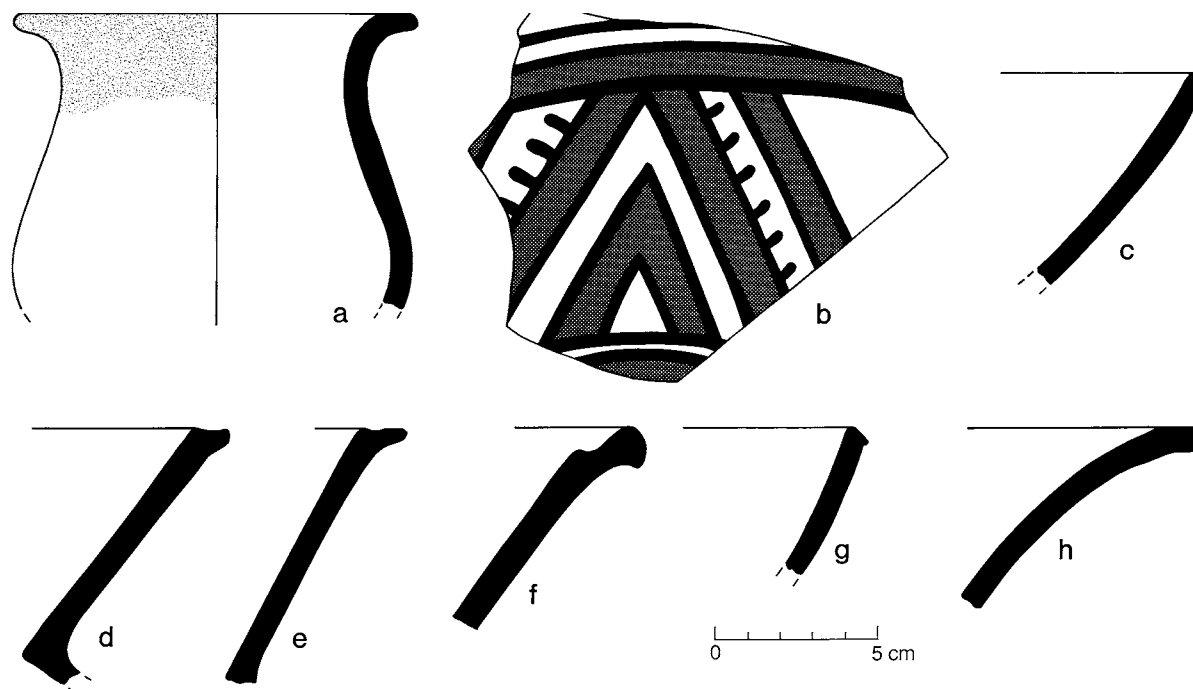
Figure 7.29. Ceramics from the fill of Room 11, Structure D. Sherds *a–c* are Pingüino Buff. (*a*): jar with everted rim and weak red wash extending 3 cm down the neck; (*b*): body sherd of large jar, painted black/white/red on the exterior; the red is 10 R 4/3 (weak red); (*c*): rim of large hemispherical bowl (rim diameter, 40 cm). Sherds *d–g* are Camacho Reddish Brown. (*d–f*): everted rims from large jars (the rim profile of *f* results from pinching the everted rim between thumb and index finger while turning the vessel); (*g*): cambered rim from jar. (*h*): flaring rim from large jar, made on an atypical orange version of Pingüino Buff; the gritty temper is like that of Camacho Reddish Brown.

Camacho Reddish Brown (Figure 7.29d–g)

Pingüino Buff (Figure 7.29a–c)

Jar with flaring rim: 1 rim (Figure 7.29h)

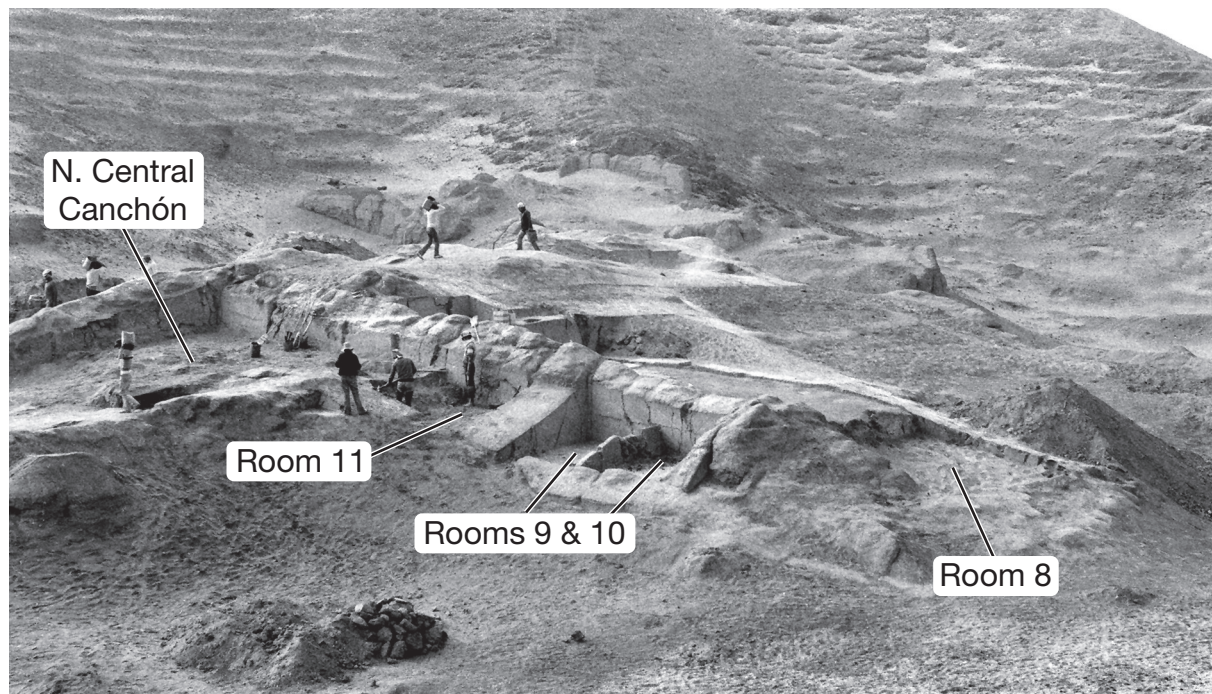
Figure 7.30. Structure D, seen from Structure C, during excavation of the North Central Canchón. Rooms 9, 10, and 11 have all been excavated. Areas that were completed, drawn, and photographed early in the excavation of Structure D, such as the Southwest Canchón, have already been backfilled. This was done partly to discourage looting and partly to reduce the area that would have to be backfilled at the end of the project.

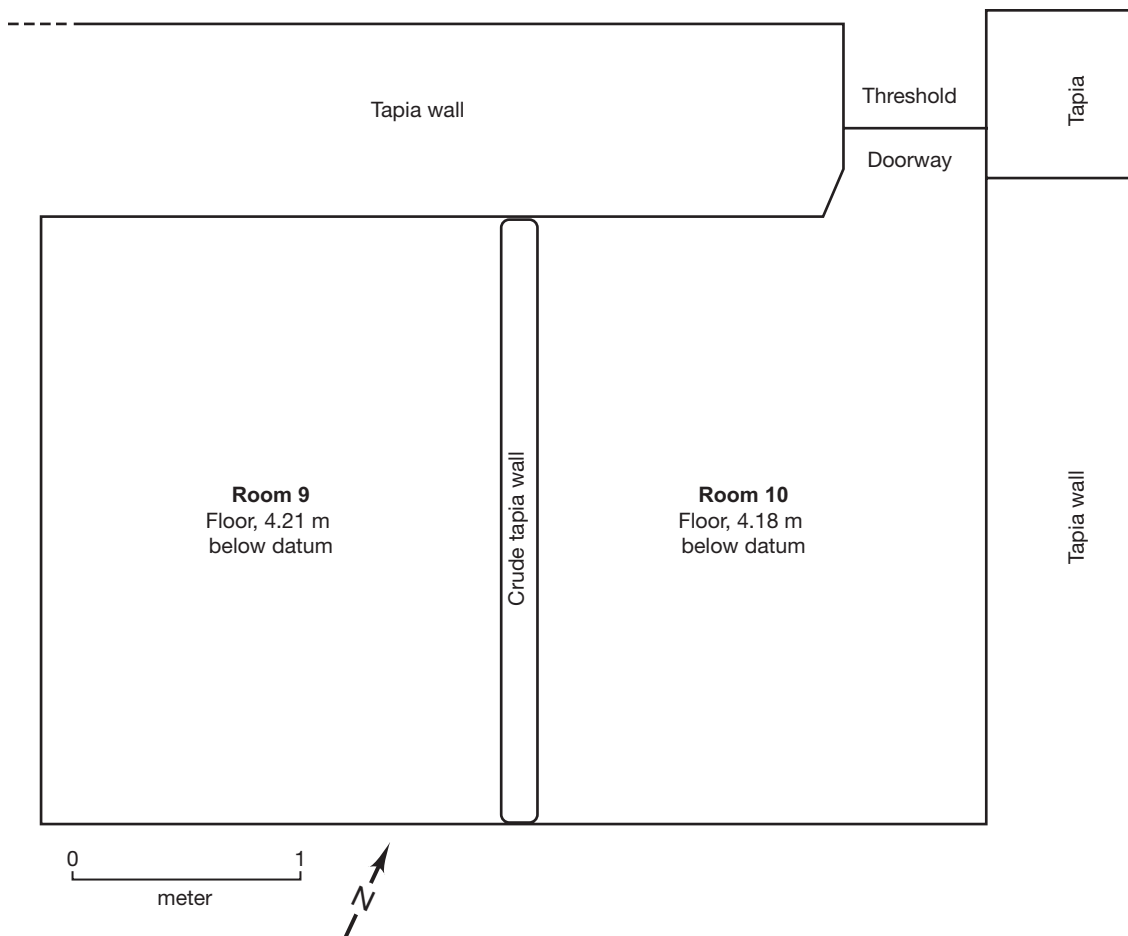
Figure 7.31. Plan of Rooms 9 and 10, Structure D. Later divided into two spaces by a crude tapia wall 15 cm wide and 70 cm high, these two rooms had originally been one. They shared a single floor (the difference in depth below surface is due to a 3-cm slope).

Early in the occupation of Structure D, the architects had laid out a room 4.18 m long east–west and 2.70 m wide north–south (Figure 7.31). Its floor lay at roughly 4.20 m below datum. A small doorway with a threshold 64 cm wide led from the northeast corner of the room to our postulated Northwest Cancón. At a later date, this room was divided into two by the addition of a crude narrow wall of tapia blocks (Figures 7.31, 7.32). This wall was about 15 cm thick and 70 cm high; it originally had a central doorway, but that was later blocked with tapia fragments, as shown in Figure 7.32.

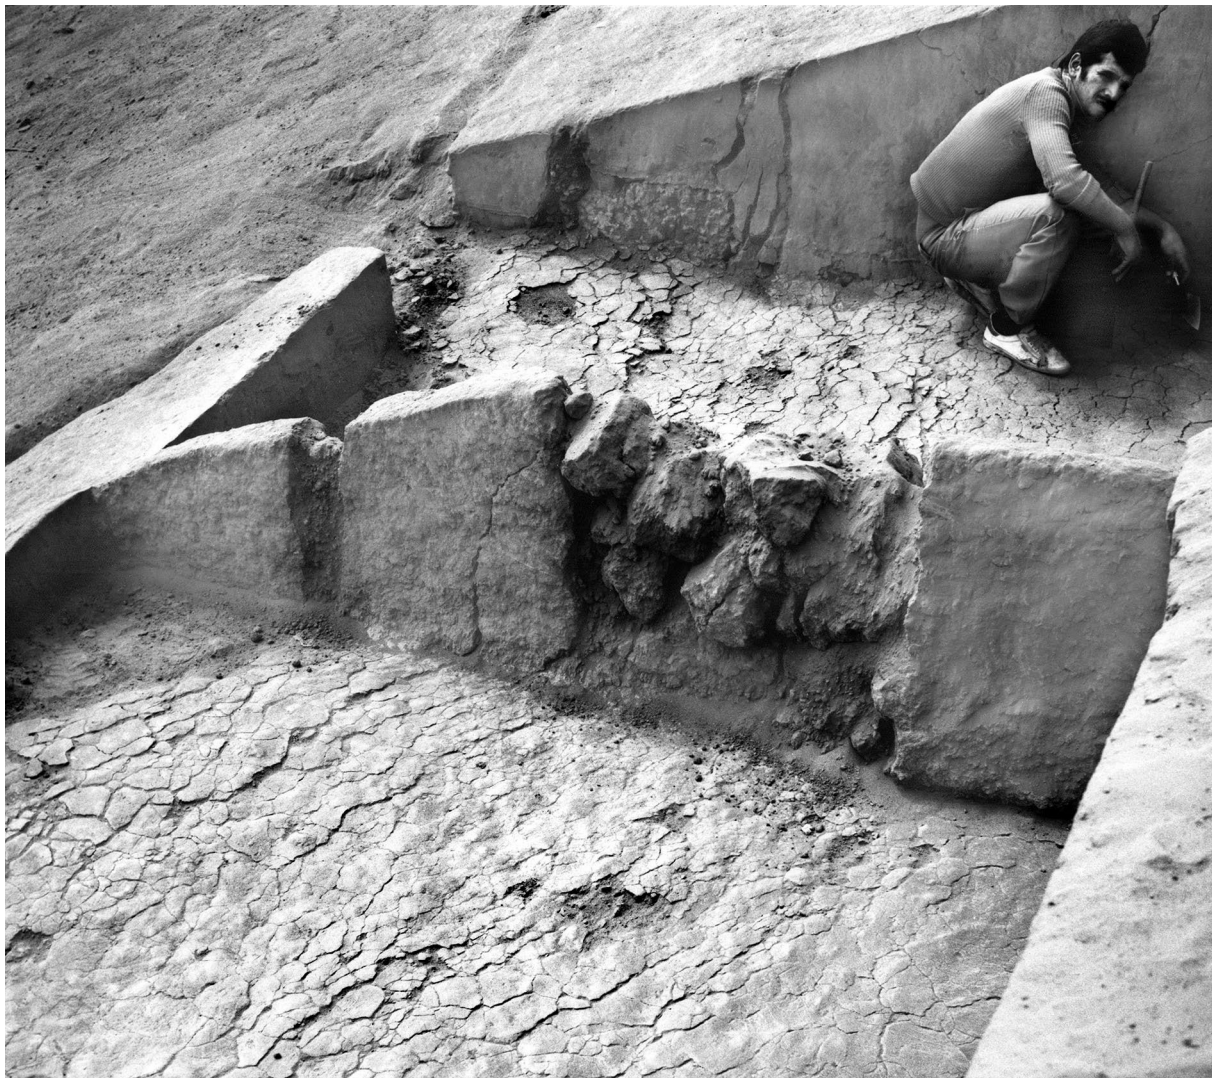
Figure 7.32. Rooms 9 (foreground) and 10 (background) seen from the southwest. These two rooms had been created by dividing a preexisting room into two smaller spaces with a narrow tapia wall. The new wall originally had a doorway, later blocked with large tapia fragments as seen here. Guinea pigs were then kept in Room 9, while Room 10 (which opened to the outside) was used for their stored bedding and food.

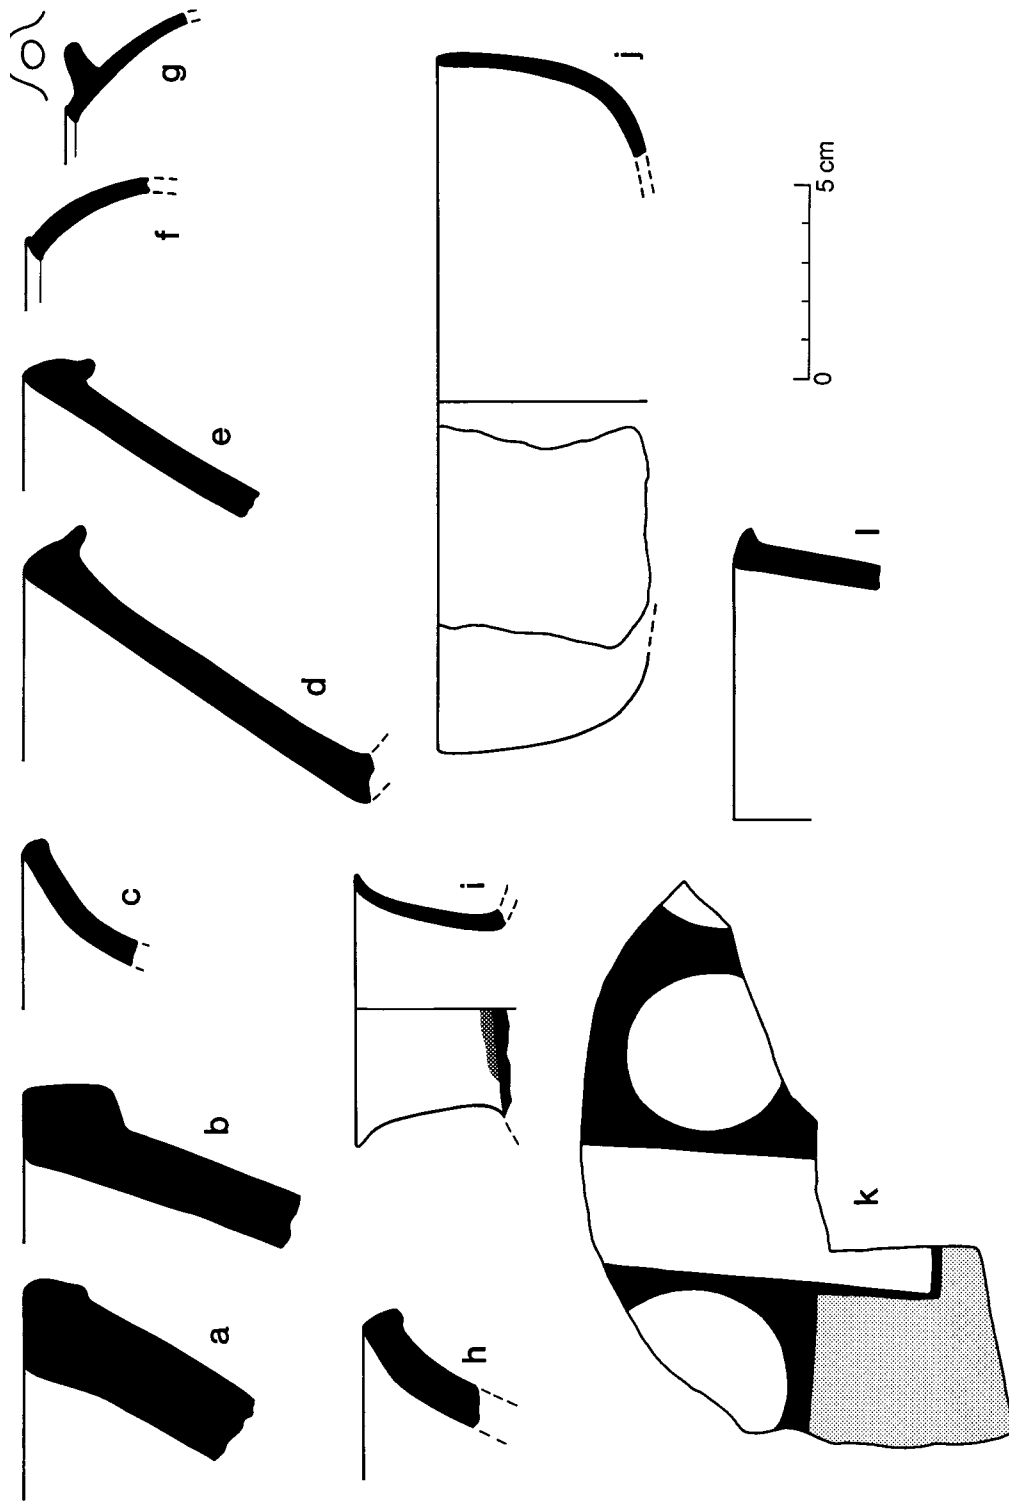
Figure 7.33. Ceramics found in the fill above the low wall separating Rooms 9 and 10, Structure D. Sherds *a–g* are Camacho Reddish Brown. (*a, b*): rims of 500-liter *tingiones*; (*c*): jar with simple flaring rim; (*d, e*): cambered rims from large jars; (*f, g*): cooking pots with restricted orifice; *g* has a horizontally set loop handle. (*h*): Camacho Black everted rim from jar or amphora; (*i*): atypical jar neck. The paste and temper resemble Camacho Reddish Brown's, but the surface color is pinkish orange like Pingüino Buff's, and the black-and-red paint on the exterior is also like Pingüino's. (*j*): Trambollo Burnished Brown hemispherical bowl. Sherds *k* and *l* are Pingüino Buff. (*k*): Three conjoining sherds from a jar body, showing white-on-black disks painted over burnished natural buff; (*l*): slightly everted rim from jar.

Camacho Reddish Brown (Figure 7.33a–g)

Camacho Black (Standard Variety) (Figure 7.33h)

Trambollo Burnished Brown (Figure 7.33j)

Pingüino Buff (Figure 7.33k, l)

Atypical sherd (Figure 7.33i)

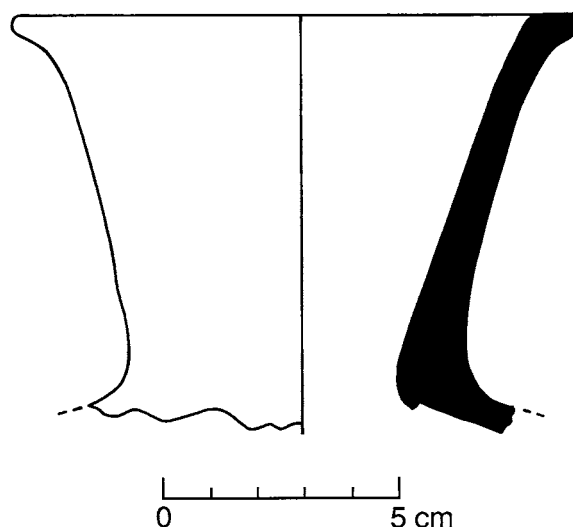
Figure 7.34. Funnel neck from globular Camacho Black jar (standard variety), found in Feature 3 of Structure D.

The offering consists of maize cobs, burned llama bones, and the funnel neck of a Camacho Black globular jar (standard variety). The remainder of the jar was never found. The neck is illustrated in Figure 7.34.

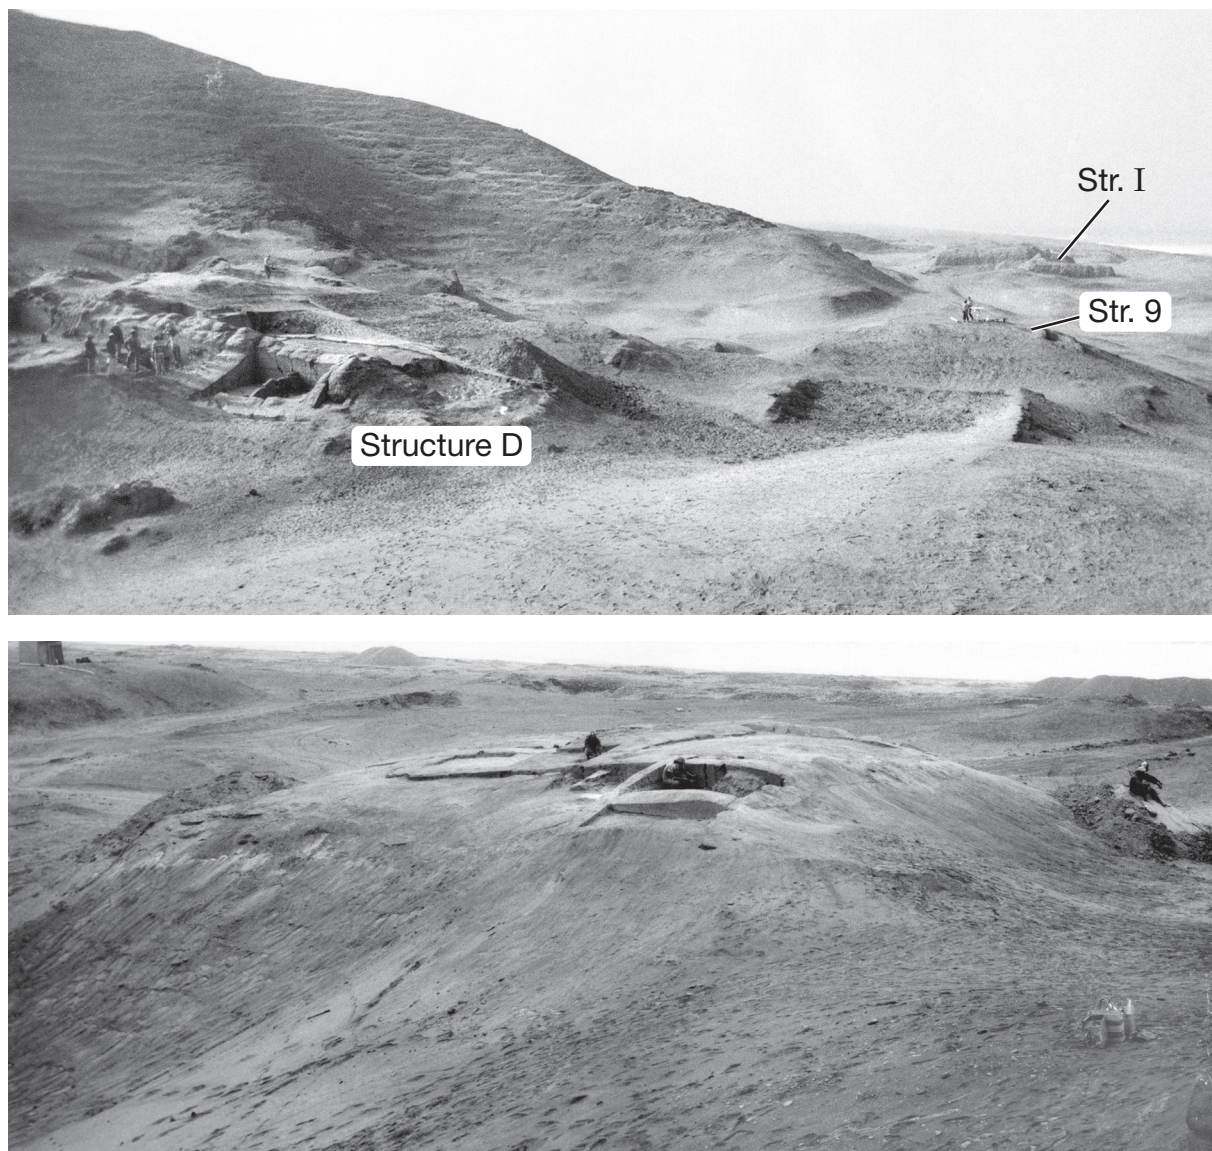
Figure 8.1. Two views of Structure 9. (*Top*): a view of Structures D and 9 from the north, showing their relationship. (Structure I can be seen in the distance.) (*Bottom*): excavation beginning on Structure 9. This view shows the northeast corner of the building, with Rooms 3 and 4 partially exposed.

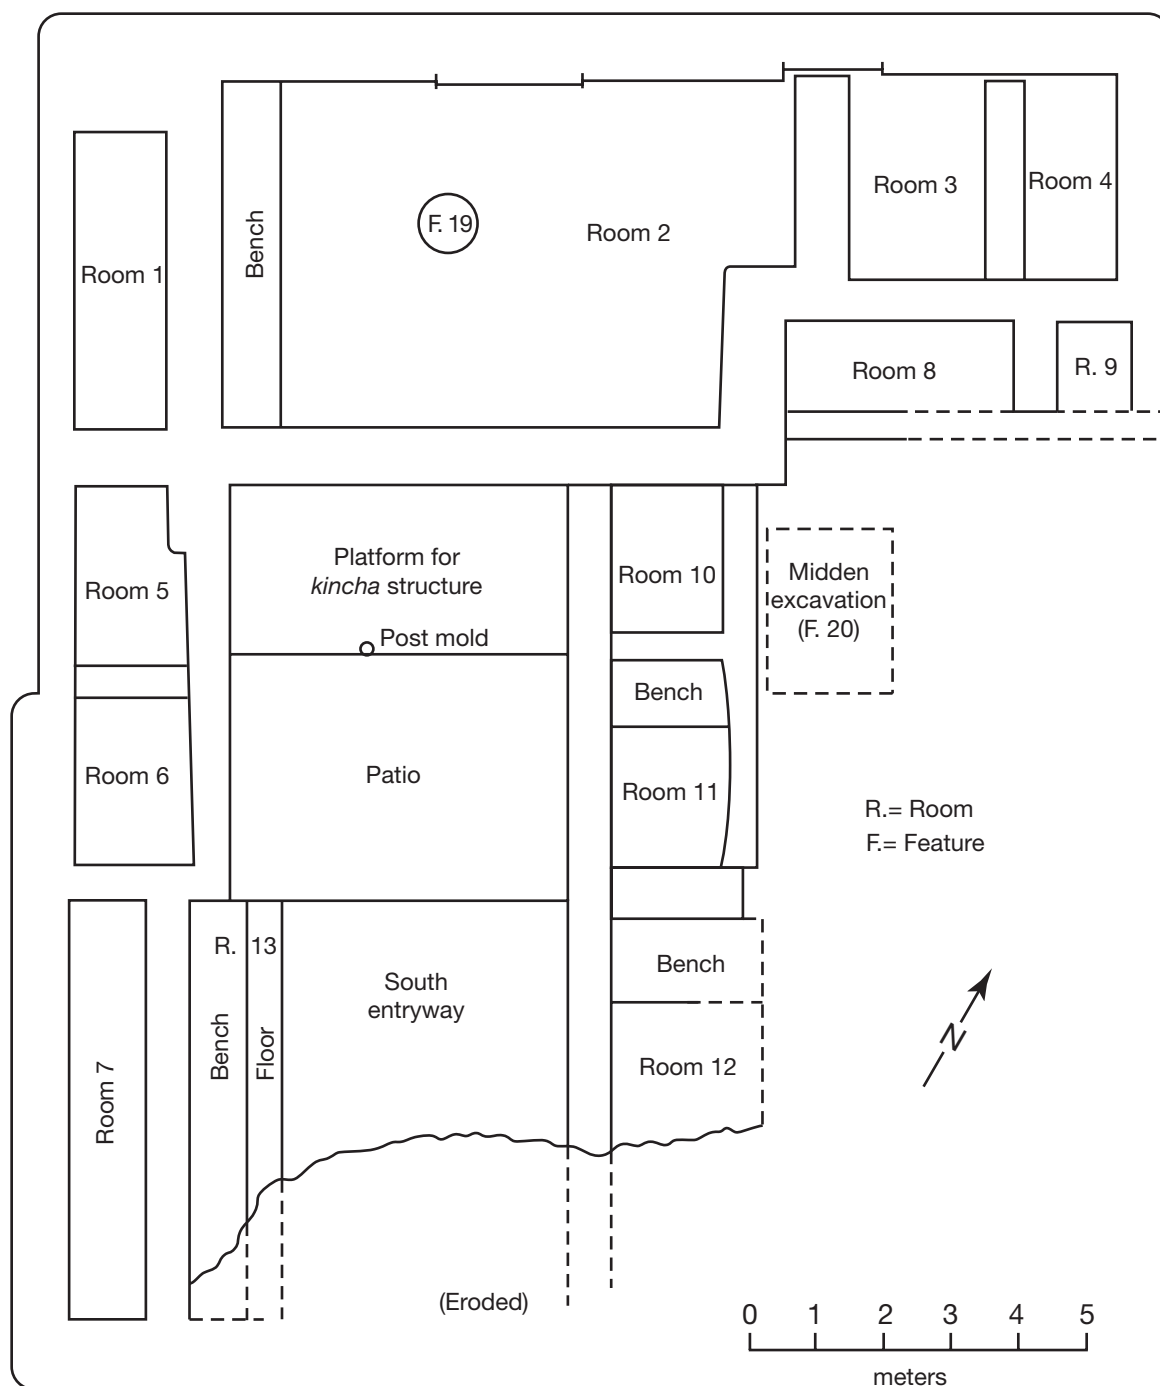
Figure 8.2. Plan of Structure 9, showing rooms and features from both earlier and later stages of occupation.

7.34	Funnel neck from globular Camacho Black jar (standard variety), found in Feature 3 of Structure D.	212
8.1	Two views of Structure 9.	214
8.2	Plan of Structure 9, showing rooms and features from both earlier and later stages of occupation	215

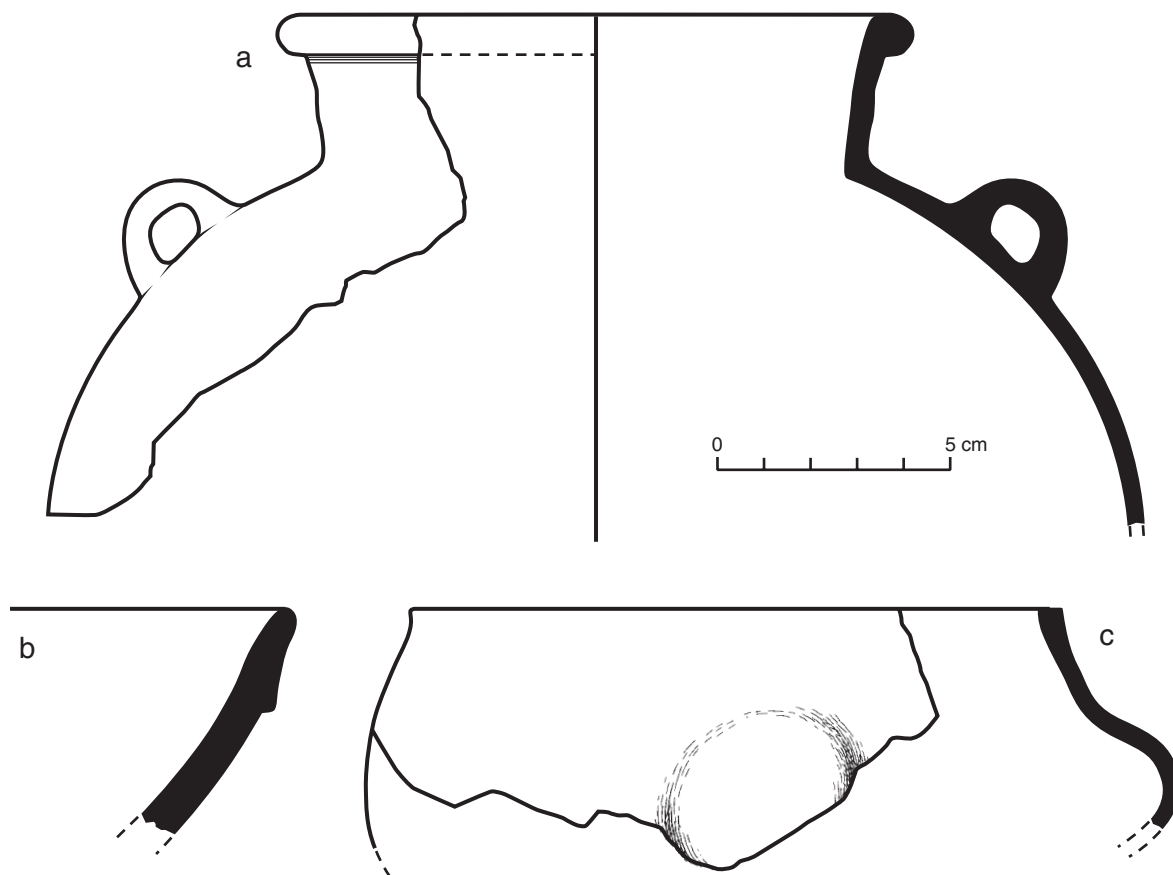
Figure 8.4. Camacho Reddish Brown sherds found on the surface of Structure 9 while the area of Rooms 3–5 was being swept prior to excavation. (a): globular jar with low neck, bolstered rim, and vertically set strap handle; fire-blackened; (b): cambered rim from large jar; (c): unusual vessel with red slip; "swelling" pushed through from the interior.

Camacho Reddish Brown (Figure 8.4)
