MONOGRAPH 62
COTSEN INSTITUTE OF ARCHAEOLOGY
UNIVERSITY OF CALIFORNIA, LOS ANGELES

EXCAVATIONS AT
CERRO AZUL, PERU
THE ARCHITECTURE AND POTTERY
JOYCE MARCUS

Excavations at Cerro Azul, Peru

THE ARCHITECTURE AND POTTERY

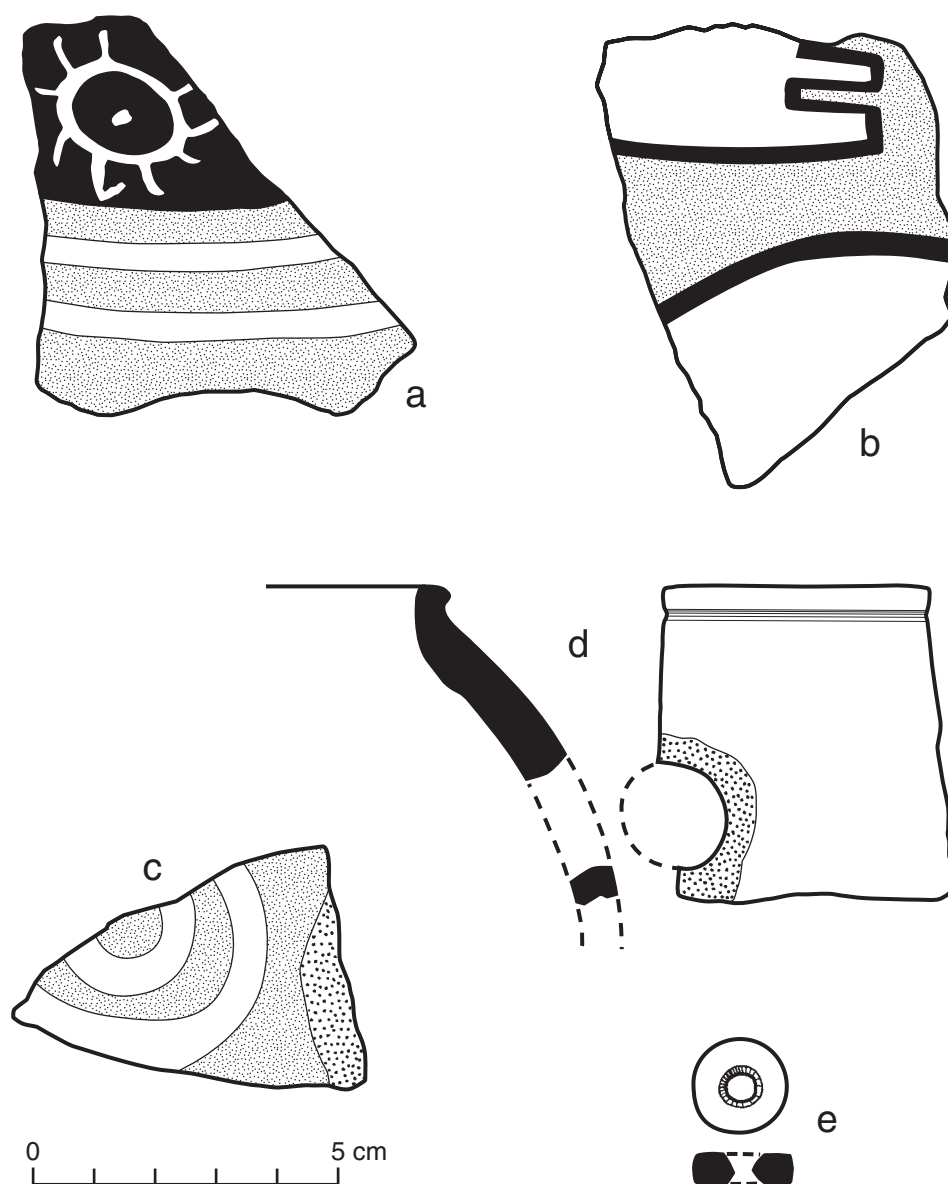
Figure 8.5. Miscellaneous sherds found on the surface of Structure 9 while it was being swept prior to excavation. (a): jar body sherd, paste similar to Pingüino Buff but not identical. An octopus motif is painted in white on a zone of chocolate brown wash; below are two stripes of white paint on natural buff (light stipple indicates natural buff). (b): Pingüino Buff jar body sherd, painted in black and white on natural. The white is a kind of cream wash (light stipple indicates natural buff). (c): Pingüino Buff jar neck sherd which bore a painted and modeled human face. The eye is painted in white on natural (light stipple indicates natural buff; coarse stipple shows where the nose broke off). (d): Pingüino Buff incurved-rim bowl with rolled rim and broken-off spout (?) of some kind; coarse stipple indicates broken surface. (e): drilled sherd disk made from a Pingüino Buff sherd, slipped cream white on one side; biconically drilled.

Jar shoulder showing black-and-white painting over natural buff: 1
 Jar shoulder with white slip: 1
 Jar sherd with raised arm (?) modeled on it: 1
 Jar body sherd, painted black and white over natural buff with cream wash: 1 (Figure 8.5b)
 Jar neck with eye of painted and modeled face; nose broken off; painted white on natural: 1 (Figure 8.5c)

Incurved-rim bowl with rolled rim and broken-off spout (?), highly burnished: 1 rim (Figure 8.5d)
 Rim of neckless jar with cream slip, painted black on white with "school of fish" motif: 1 (Figure 8.6a)
 Small strap handle from jar: 1
 Jar body sherd, painted black and white: 1
 Jar body sherd, painted black over cream slip, "school of fish" motif: 1 (Figure 8.6c)

Jar body sherd with zone of chocolate brown wash above natural buff, octopus motif in white paint: 1 (Figure 8.5a)

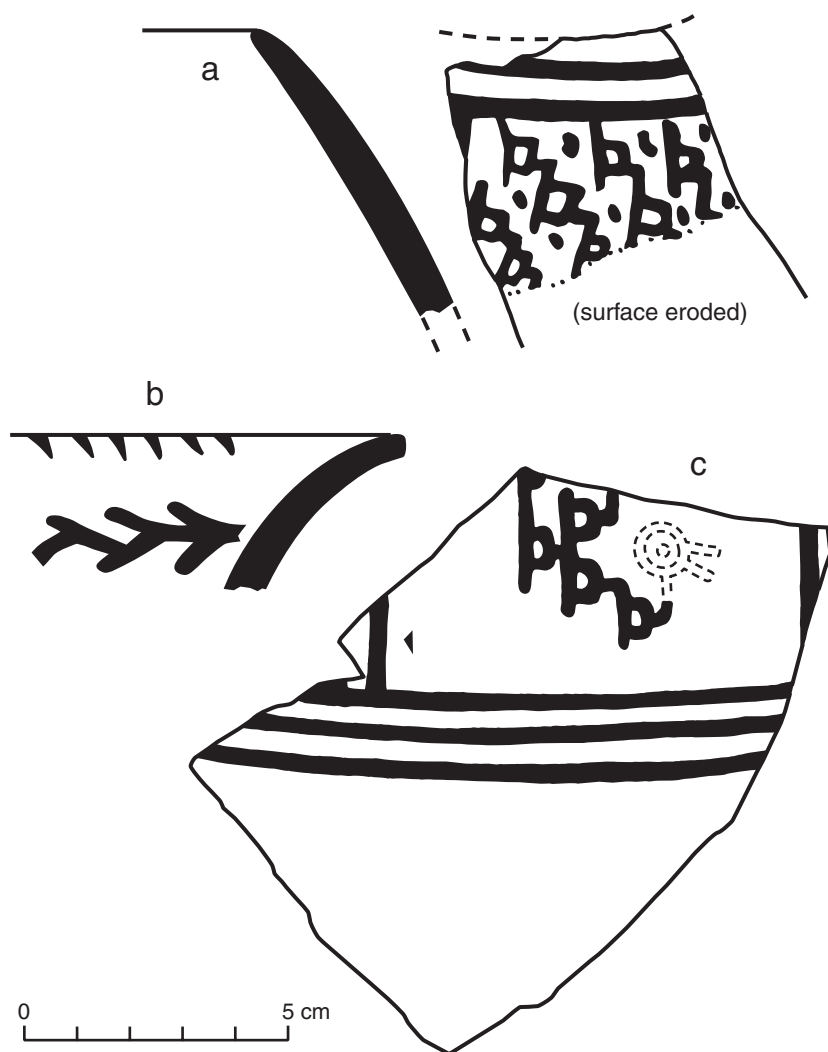
Figure 8.6. Eroded Pinguino Buff sherds found on the surface of Structure 9 while the west side was being swept prior to excavation. (a): neckless jar with yellowish cream slip, painted in black on white with a “school-of-fish” motif (?); (b): flaring rim of jar (?) painted in black over a thin watery white wash; (c): jar body sherd with a yellowish cream slip on the exterior; design painted in black over that.

- Jar with plain rim, white wash: 1 rim (Figure 8.7d)
- Jar with cambered rim: 1 rim (Figure 8.7c)
- Jar (?) with flaring rim; painted black over thin white wash; rim ticking: 1 rim (Figure 8.6b)
- Large jar with flaring rim, painted white on natural: 1 rim (Figure 8.7b)
- Funnel neck from jar with everted rim, corner of painted face (upper left cheek area), painted black and red on natural: 1
- Neck from amphora or jar showing left cheek area of face, painted black/white/red: 1 (Figure 8.8)

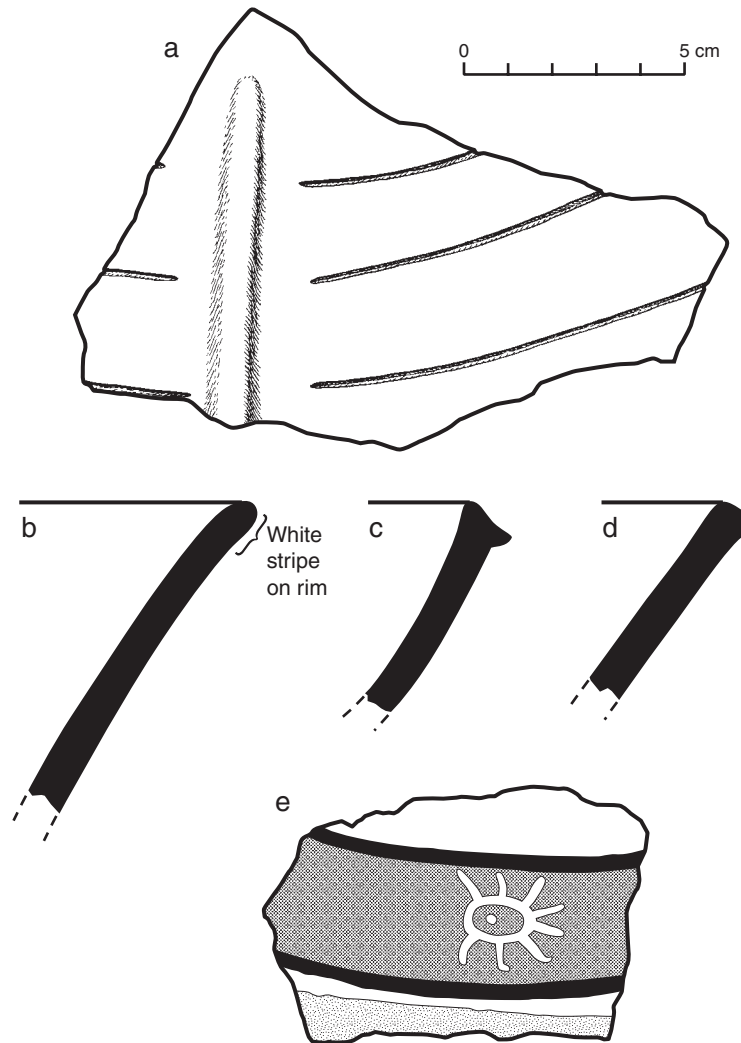
Figure 8.7. Pinguino Buff sherds found on the surface of Structure 9 while the area of Rooms 3–5 was being swept prior to excavation. (a): body sherd from a “fat skeleton” pot, reminiscent of one found in Structure D (see Figure 7.13). The ribs are incised and run outward from a modeled spinal column which is not divided into individual vertebrae (fire-smudged on lower part). (b): flaring rim of large jar, painted white on natural as shown; (c): cambered rim from jar; (d): plain rim from jar, given a white wash on the exterior and the top of the rim; (e): jar body sherd with cream-white wash or slip above, natural buff (shown as light stipple) below; octopus motif painted in white over red band bordered with black.

Jar body sherd, painted black/white/red (10 R 3/2); octopus motif: 1 (Figure 8.7e)
 Sherd from “fat skeleton,” showing spine and incised ribs: 1 (Figure 8.7a)
 Body sherds: 9

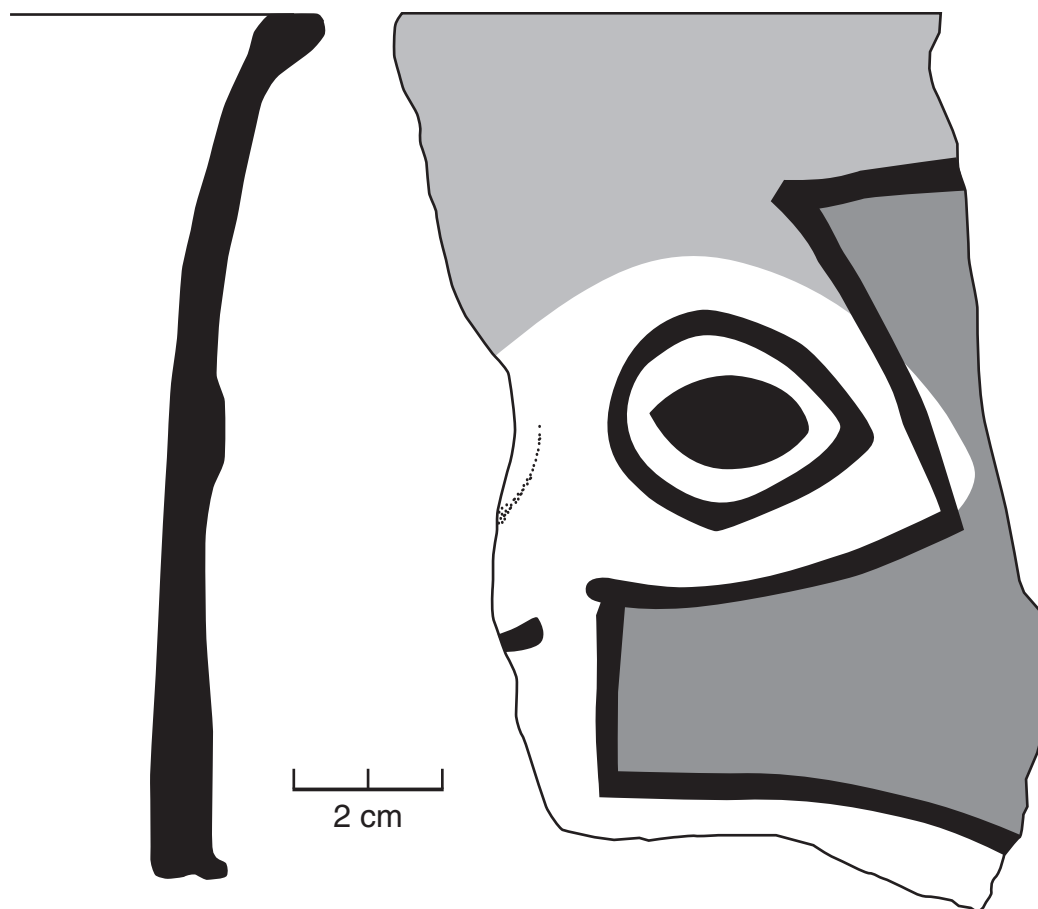
Figure 8.8. Pingüino Buff amphora (or jar) neck with human face modeled and painted on the exterior in black/white/red over natural buff (shown as light gray screen). Found on the surface above the South Entryway of Structure 9 while it was being swept prior to excavation. Both the nose and the eye are in raised relief.

area prior to excavation, we found the neck of a Pingüino Buff amphora or jar, painted and modeled as a human face, with the usual zoned red facial painting (2.5 YR 3/4, dark reddish brown) (Figure 8.8). At a depth of 177 cm below datum, in association with the earlier stage of the entryway (Figure 8.9, top), we recovered a collection of 24 sherds, five of which are shown in Figure 8.10. The full list is as follows:

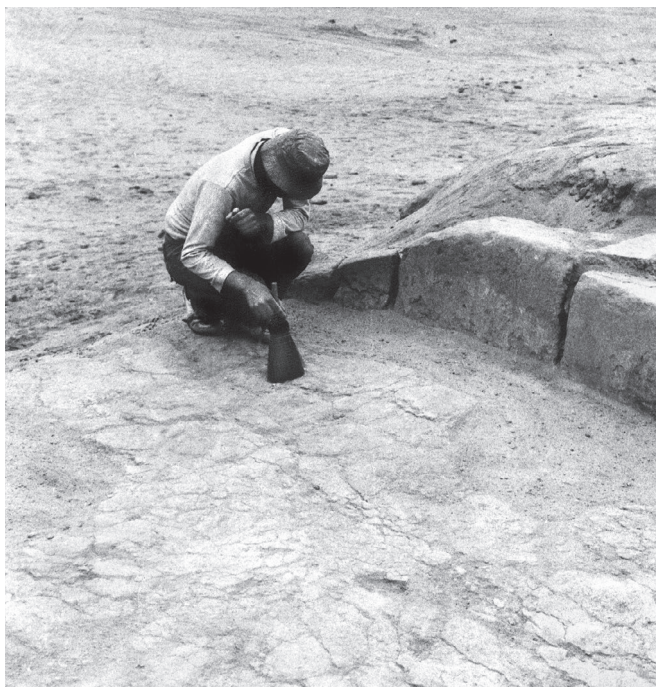
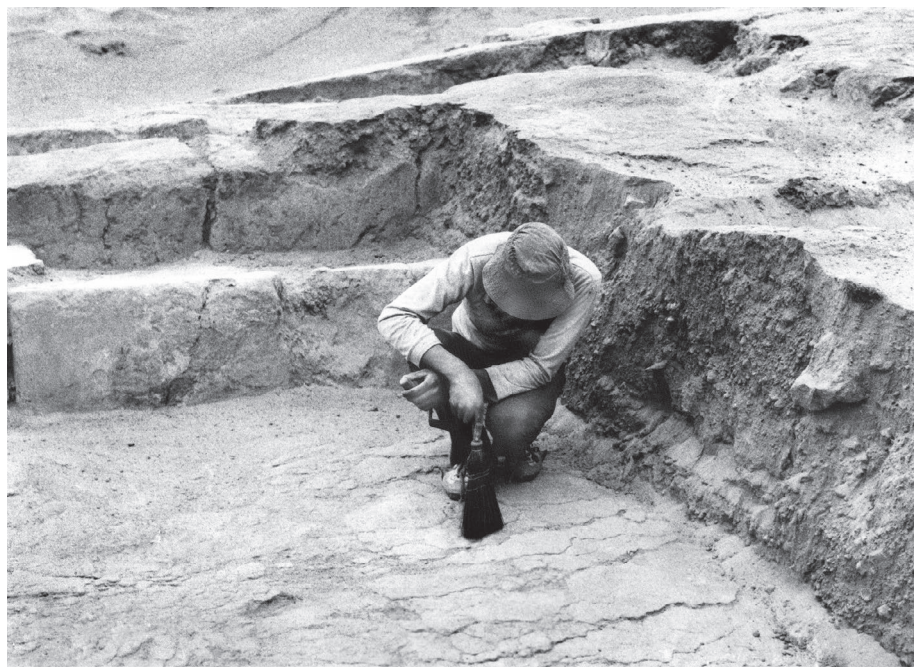
Figure 8.9. Two views of an earlier stage of the South Entryway (floor, 177 cm below datum), Structure 9. (*Top*): view from the north. (*Bottom*): view from the east. To the right of the workman, one can see the fill placed over the earlier floor and the bench of Room 13.

datum, the floor 127 cm below datum, and the earlier version of the entryway 177 cm below datum (Figure 8.9, top). At a later stage of occupation, Room 13 and the earlier entryway were filled in, and a new clay floor was laid over them at a depth of 99 cm below datum. This new floor widened the entryway by covering Room 13 completely (Figure 8.9, bottom).

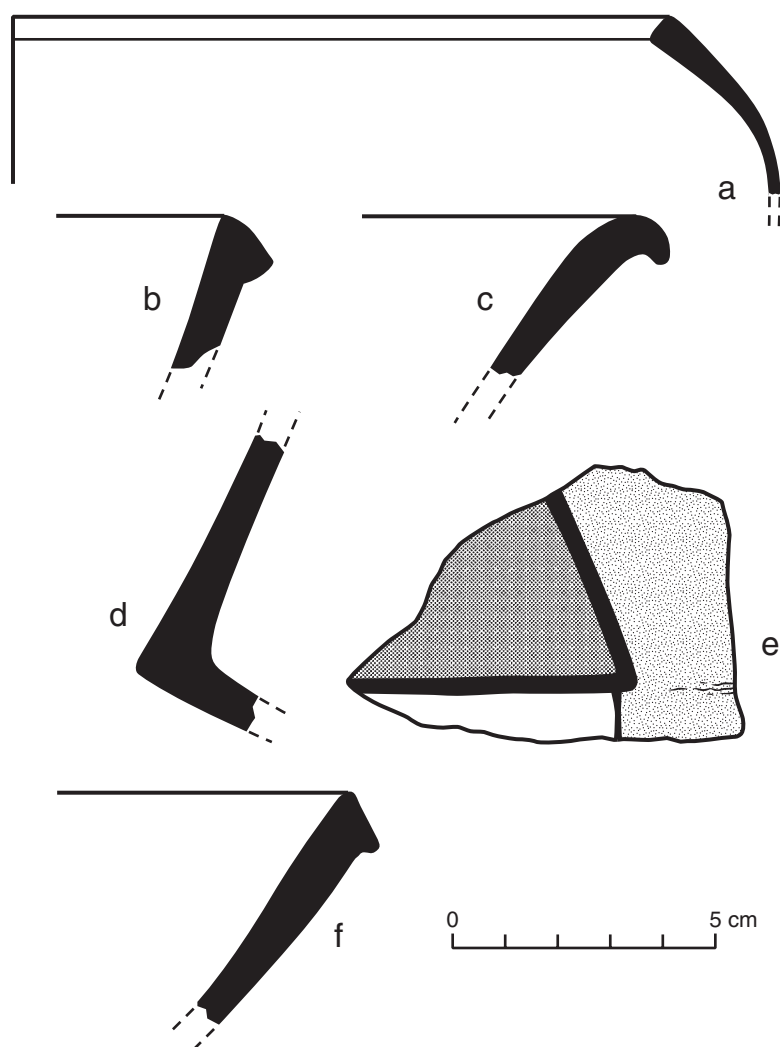
Figure 8.10. Ceramics found at a depth of 177 cm below the surface in the South Entryway of Structure 9. (a): Camacho Reddish Brown cooking pot with restricted orifice, fire-blackened; (b): Camacho Reddish Brown jar with cambered rim; (c): Camacho Black (standard variety) jar with everted rim. (d, e): Pingüino Buff jar with funnel neck, painted on the exterior in black/white/red; the design was probably a human face with facial painting. (d): profile; (e): exterior of sherd (medium screen indicates red; light stipple indicates natural buff); (f): Pingüino Buff bowl with weak white wash on exterior; cambered rim.

Camacho Reddish Brown (Figure 8.10a, b)

Camacho Black (Standard Variety) (Figure 8.10c)

Pingüino Buff (Figure 8.10d–f)

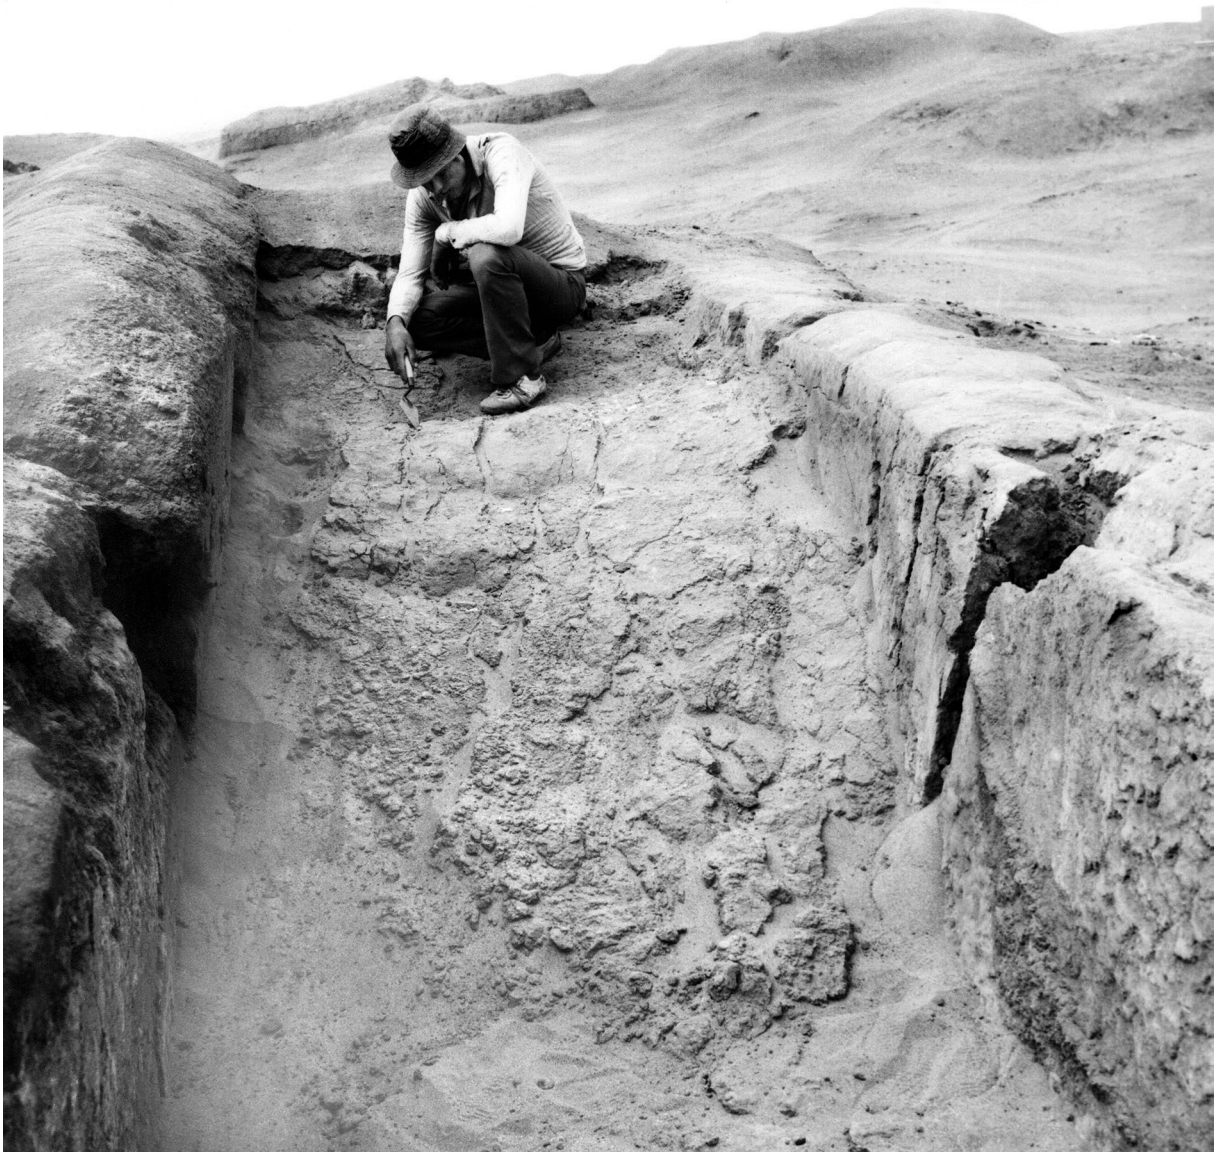
Figure 8.11. Room 1 of Structure 9, seen from the north after all the sand had been removed. This photo shows the strong buckling of the floor caused by seismic activity. This damage led to Room 1 being converted to fish storage.

8.10	Ceramics found at a depth of 177 cm below the surface in the South Entryway of Structure 9	222
8.11	This photo of Room 1, Structure 9 shows the strong buckling of the floor caused by seismic activity	223

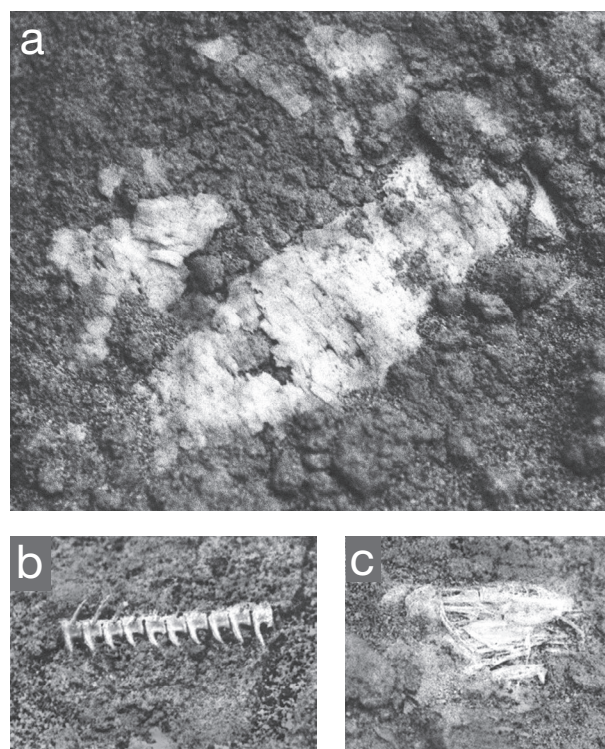
Figure 8.12. Fish remains from Room 1 of Structure 9. (a): patch of fish skin and scales adhering to the clay floor; (b): section of fish vertebrae incorporated into a sand layer; (c): crushed anchovy skull adhering to clay floor.

only for fish storage; accordingly, it had been filled with sand. We fine-screened the entire room and recovered a sample of fish bone, both from the sand itself and from places where fish skin and scales were adhering to the clay floor (Figure 8.12).

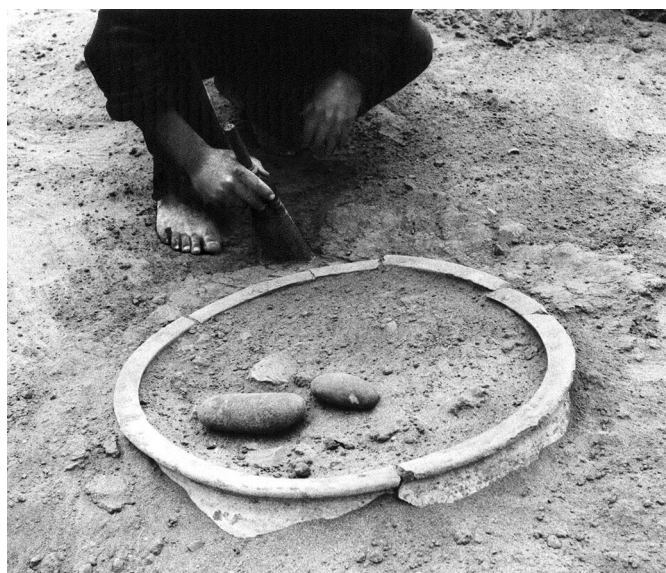
Figure 8.14. Feature 19, a large vessel set in the uppermost floor of Room 2, Structure 9, as it was first encountered. View from the west. The two objects resting on the fill inside the vessel are beach cobbles.

At a still later stage of occupation, the function of Room 2 changed again. A well-made clay floor was laid over the sand at a depth of 12 cm below datum. The most interesting feature found in association with this later floor was a large *tina-jón* or conical storage vessel buried near the center of the room, its rim only 15–20 cm above the floor (Figure 8.14).

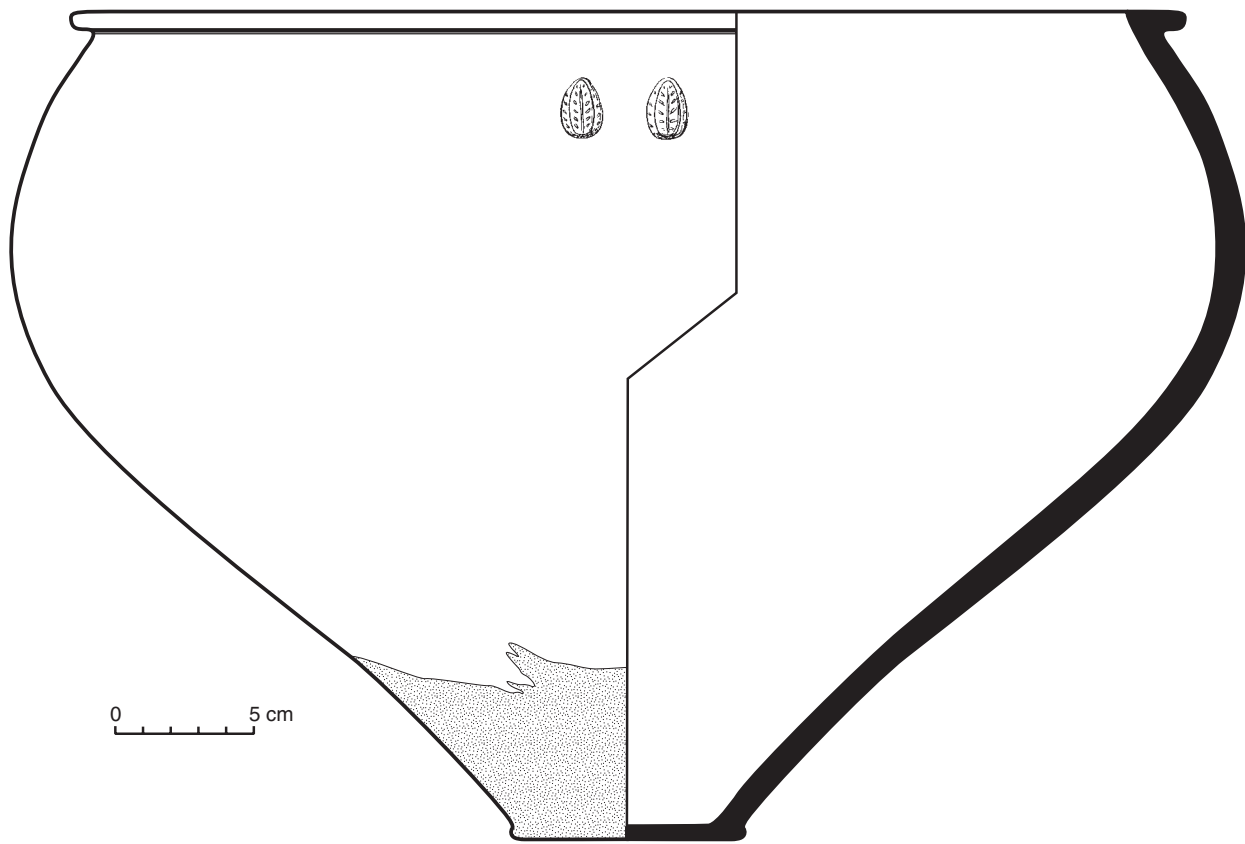
Figure 8.15. Reconstruction drawing of large Pingüino Buff *tinajón* designated Feature 19, found in Room 2, Structure 9. This large storage vessel had been buried in sand to within 15–20 cm of its rim. The vessel has an everted rim and appliqué lugs in the shape of maize cobs. The interior of the vessel is smoothed but unslipped. The exterior has a sloppily applied, streaky white wash which extends down to about 15 cm above the base (light stipple indicates natural buff). Rim diameter: 81 cm. Height: 60 cm.

Designated Feature 19, this large storage vessel had broken during the intervening centuries but could be reconstructed (Figure 8.15). Both its shape and the way it had been buried reminded us of the *batun maccma* or *chicha* storage vessels found in the North Central Canchón of Structure D (Chapter 7). This vessel was smaller than a *batun maccma* and was made of Pingüino Buff rather than a coarse version of Camacho Reddish Brown. However, it had similar maize-cob effigy lugs, suggesting that it too might have been used to store *chicha*.

Feature 19 was 60 cm high and had a rim diameter of 81 cm. The exterior had a sloppily ap-

plied, streaky white wash that extended down over the natural buff surface to a point roughly

15 cm from the base. The interior of the vessel was smoothed but unslipped. The best-preserved side had a pair of lugs in the shape of maize cobs, each 4.2 cm long and 1.7 cm wide (Figure 8.16). We assume that the other side of the vessel, which is not preserved, had a matching pair of lugs. Such paired lugs, set 3.5 cm apart, 5 cm below the rim, would have allowed the heavy vessel to be carried with a rope harness.

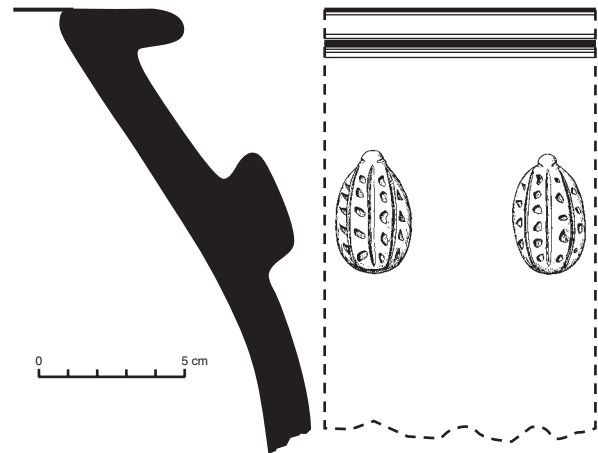
Figure 8.16. One large sherd of the Pingüino Buff *tinajón* designated Feature 19, found in Room 2, Structure 9. The drawing shows how two modeled lugs, incised and punctated to resemble maize cobs, were placed as a pair on the upper shoulder of the jar just below the everted rim. (It is assumed that a matching pair of lugs was placed on the opposite side of the vessel.) Like the entire upper portion of the jar's exterior, the lugs are covered with a white wash.

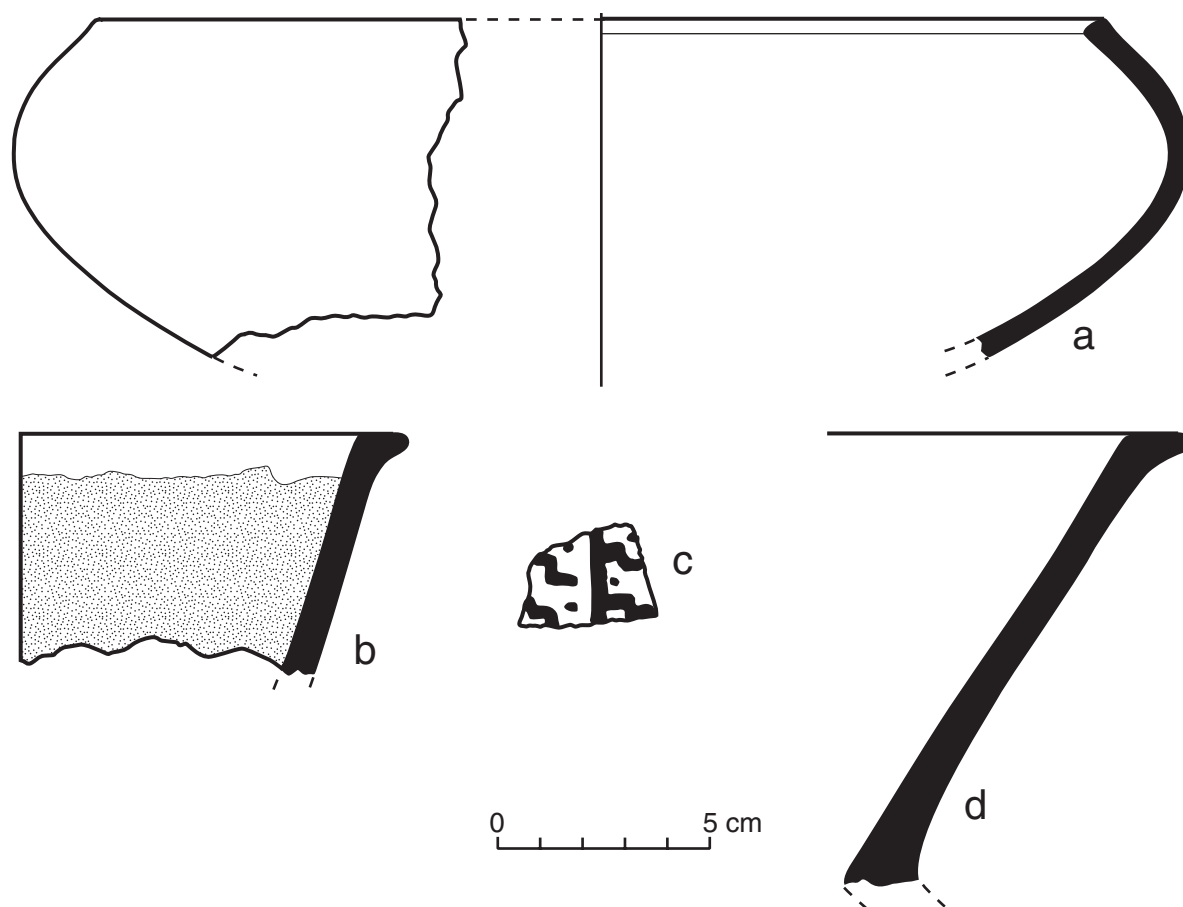
Figure 8.17. Ceramics found above the floor of Room 3, Structure 9. (a): Camacho Reddish Brown cooking pot with restricted orifice; fire-blackened (this vessel may have had strap handles, but too little was found to confirm it). (b): Pingüino Buff funnel neck from jar with everted rim; interior painted white on natural (light stipple indicates natural buff). (c): Pingüino Buff sherd, probably from the shoulder of a globular jar; exterior painted black on white. (d): Camacho Black (standard variety) everted rim from jar or amphora.

The collection of pottery from the fill is only slightly larger, consisting of six sherds. A sample of these sherds can be seen in Figure 8.17, and the full collection is as follows:

Camacho Reddish Brown (Figure 8.17a)

Camacho Black (Standard Variety) (Figure 8.17d)

Pingüino Buff (Figure 8.17b, c)

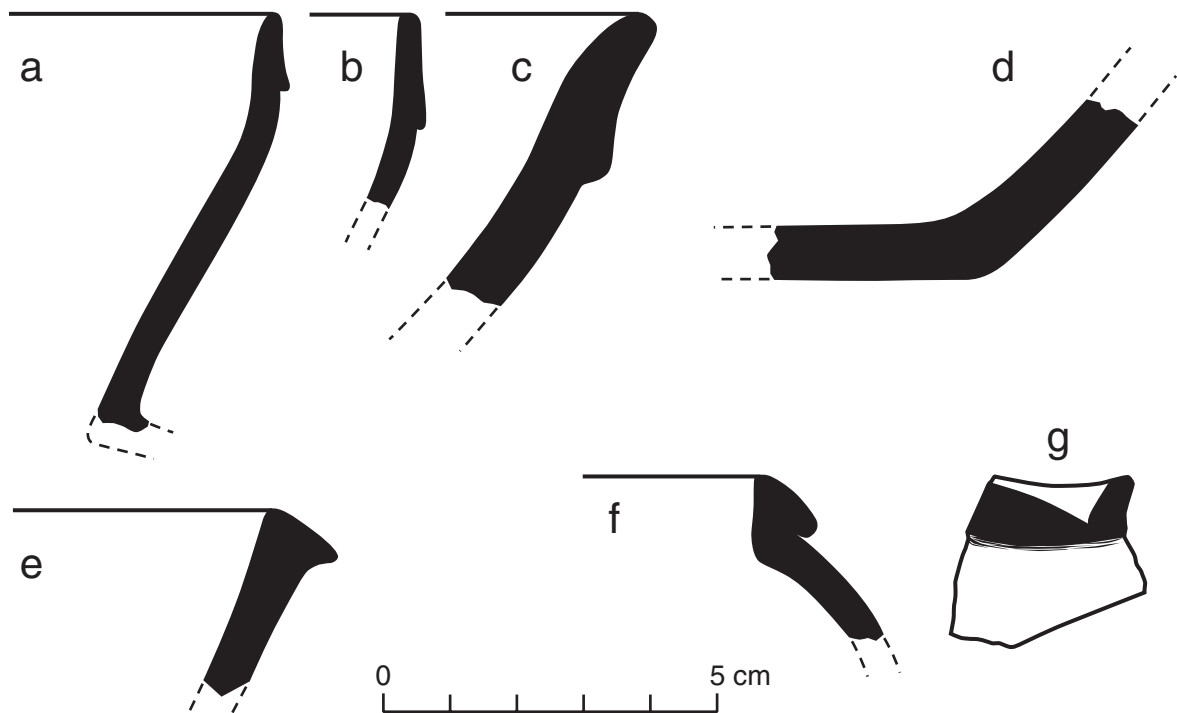
Figure 8.18. Ceramics found above the floor of Room 4, Structure 9. (a–c): Camacho Reddish Brown jars with cambered rims; (d): Camacho Reddish Brown jar or amphora base; (e): Pingüino Buff everted rim, probably from funnel-necked jar; eroded, possibly painted white on natural. (f, g): Pingüino Buff neckless jar with rolled rim, painted in black and white on natural on the top of the rim. (f): profile; (g): exterior of sherd.

Room 4 contained greenish gray sand, as well as some brownish earth and maize cobs. We recovered 54 sherds from the floor, some of which are shown in Figure 8.18. The full collection is as follows:

Camacho Reddish Brown (Figure 8.18a–d)

Pingüino Buff (Figure 8.18e–g)

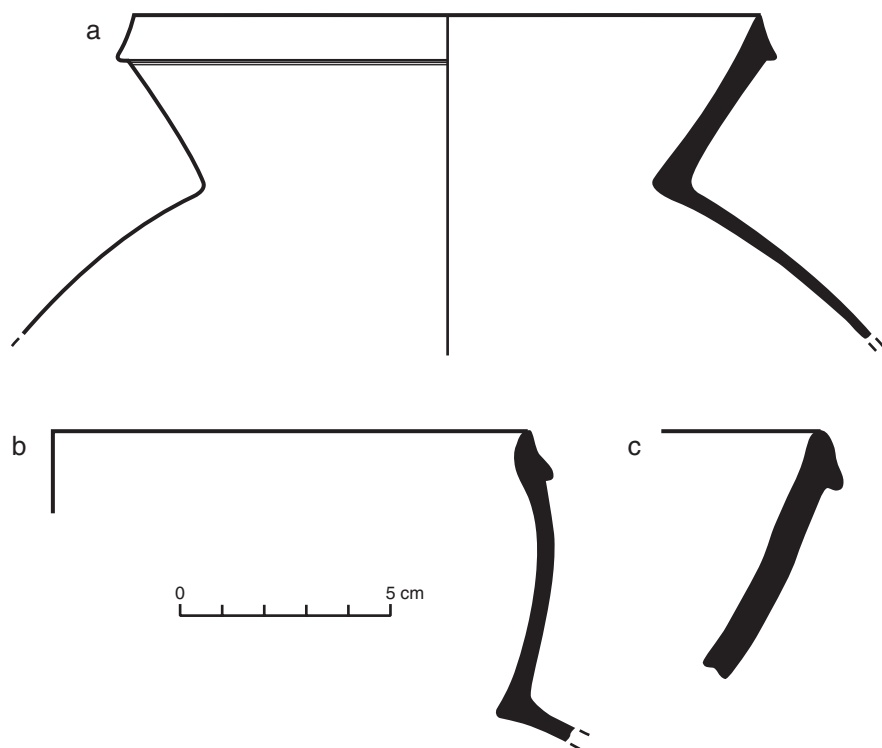
Figure 8.19. Camacho Reddish Brown vessels from Room 8, Structure 9. (*a*): jar with cambered rim, fire-blackened; (*b*, *c*): jars with cambered rims.

Camacho Reddish Brown (Figures 8.19–8.21)

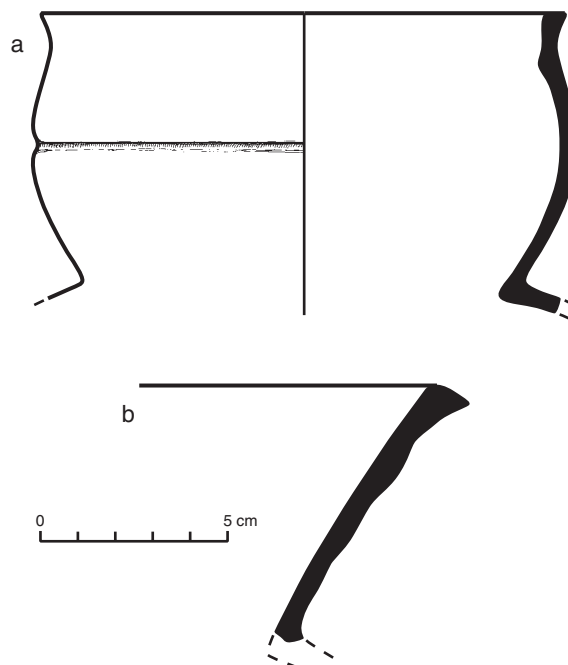
Figure 8.20. Camacho Reddish Brown vessels from Room 8, Structure 9. (*a*): unusual jar neck, shaped like a bowl with a shallow horizontal groove encircling it; (*b*): flaring rim from jar.

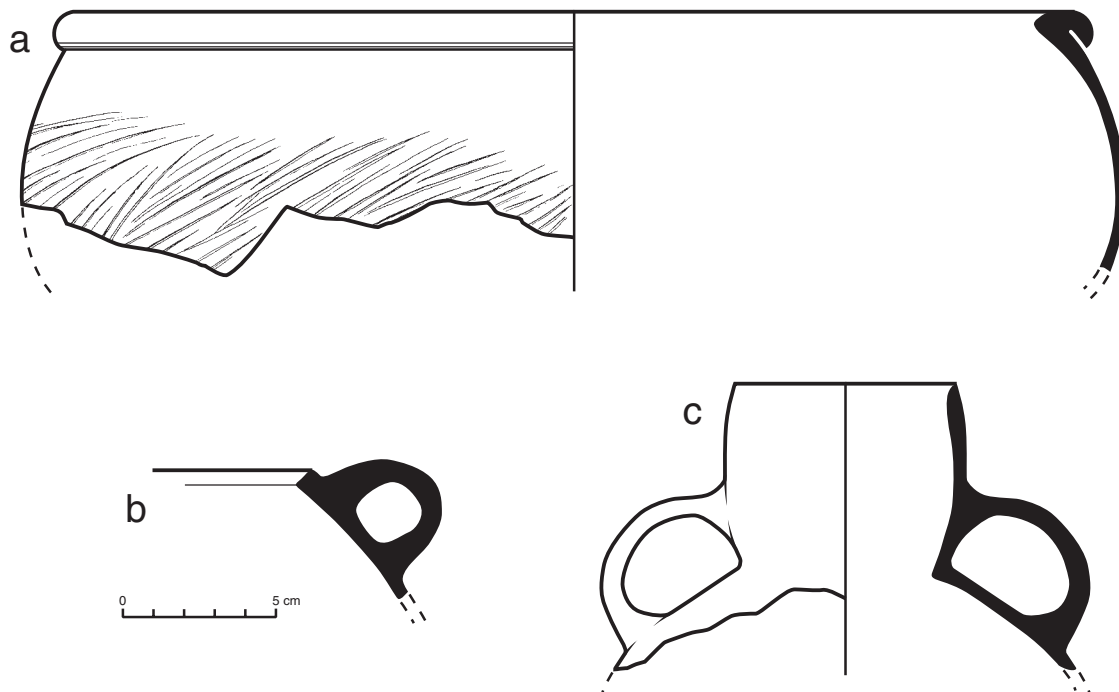
Figure 8.21. Camacho Reddish Brown vessels from Room 8, Structure 9. (a): cooking pot with restricted orifice and rolled rim; brushed on the exterior; fire-smudged below the midsection; (b): cooking pot with restricted orifice and vertically set strap handle; fire-blackened; (c): jar with narrow neck, plain rim, and strap handles linking the neck and shoulder; fire-blackened.

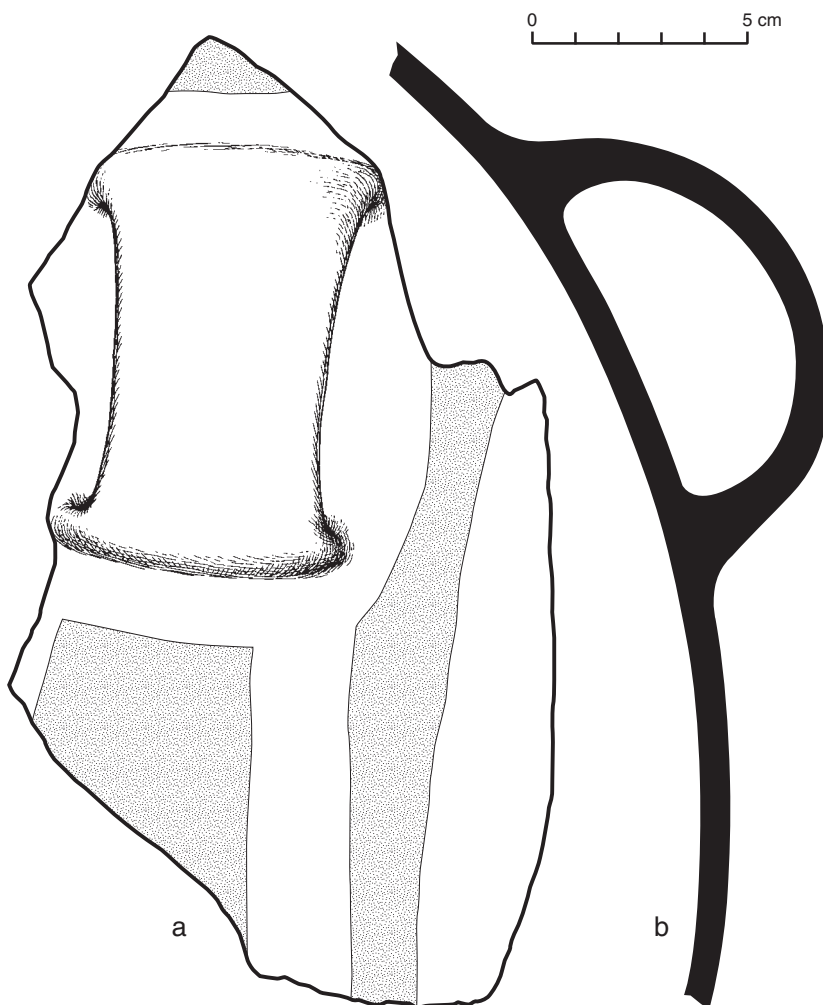
Figure 8.22. Pingüino Buff vessel from Room 8, Structure 9. (a, b): Pingüino Buff jar body sherd with vertically set strap handle and sloppy white-on-natural painting. (a): exterior of sherd; (b): profile. Light stipple indicates natural buff.

Large strap handle from jar listed above, fitting with several large body sherds: 1 (Figure 8.22)

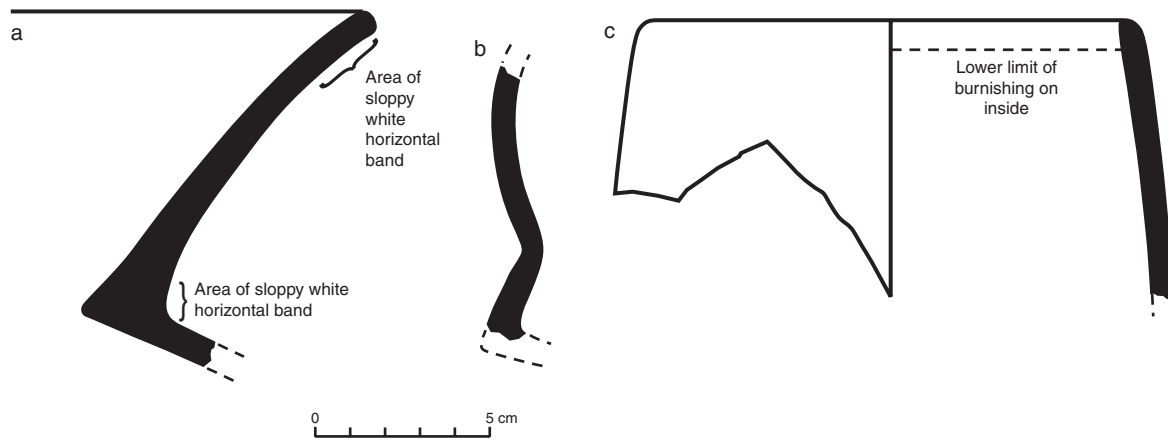
Figure 8.23. Pingüino Buff vessels from Room 8, Structure 9. (a): rim from funnel-necked jar with sloppy white bands painted on the exterior as shown; (b): jar neck with “swelling” pushed through from the interior; (c): cylindrical jar neck, highly burnished on the exterior; burnished on the interior only to 1 cm below the rim, as shown by the dashed line.

Large jar with funnel neck, painted white on natural: 2 rims (Figure 8.23a)

- Globular jars with wide mouth, painted black and white on rim, black and white on exterior of body: 1 with strap handle, 1 without (Figure 8.24a–c)
- Jar neck with “swelling” pushed through from interior: 1 (Figure 8.23b)
- Cylindrical jar neck, highly burnished on exterior: 3 rims (from same vessel) (Figure 8.23c)
- Open bowl, highly burnished on interior and exterior: 1 rim (Figure 8.24d)
- Burnished body sherds: 5 (fairly large)

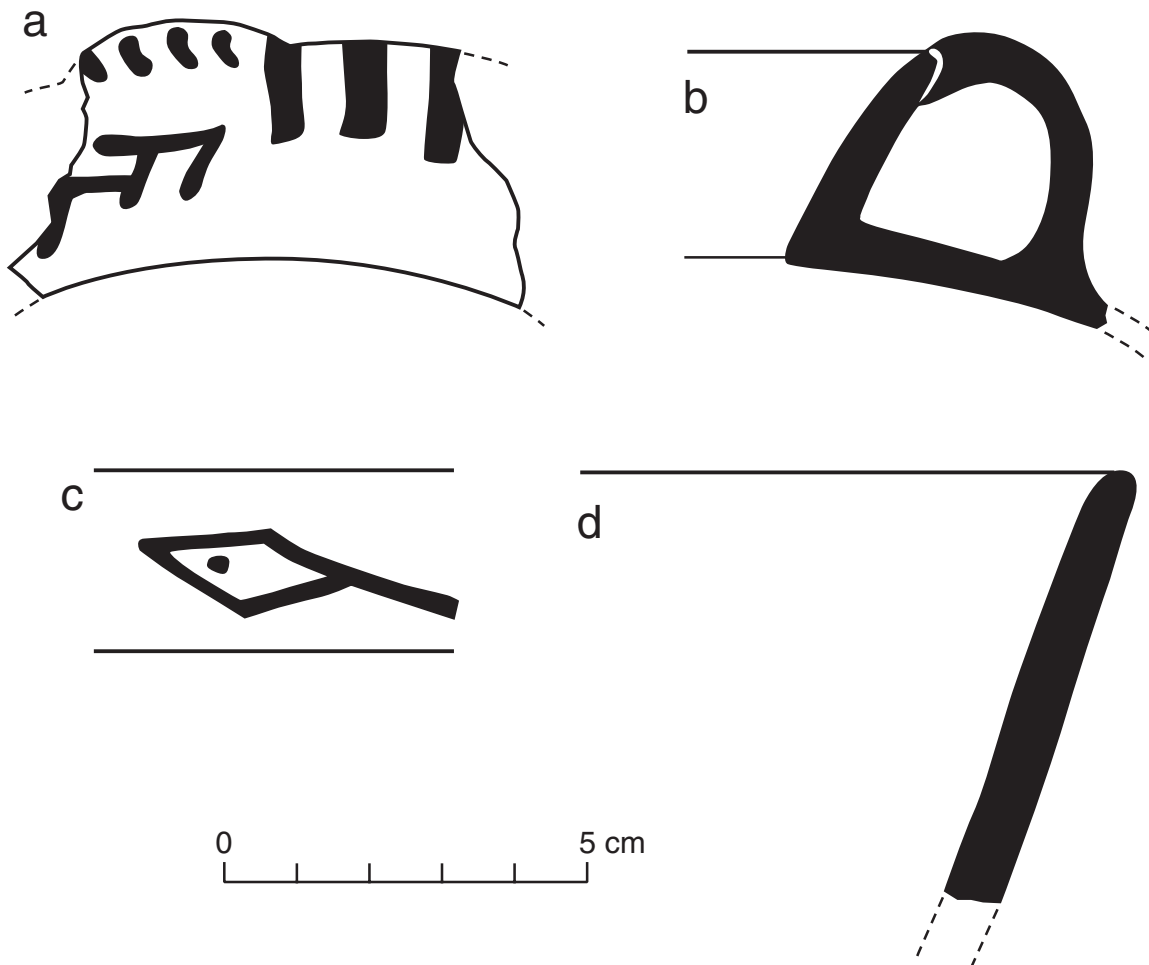
Figure 8.24. Pingüino Buff vessels from Room 8, Structure 9. (a, b): globular jar with wide mouth, strap handle linking the rim to the shoulder; painted black and white on the interior of the rim. (a): interior of rim, showing motifs; (b): profile. What appears to be a bump on the upper margin of a is really the attachment of the strap handle shown in b (there are horizontal black-on-white stripes on the handle, not shown). (c): reconstruction of eroded fish motif painted in black on white inside the rim of a second jar like the one shown in a; (d): open bowl, burnished inside and out.

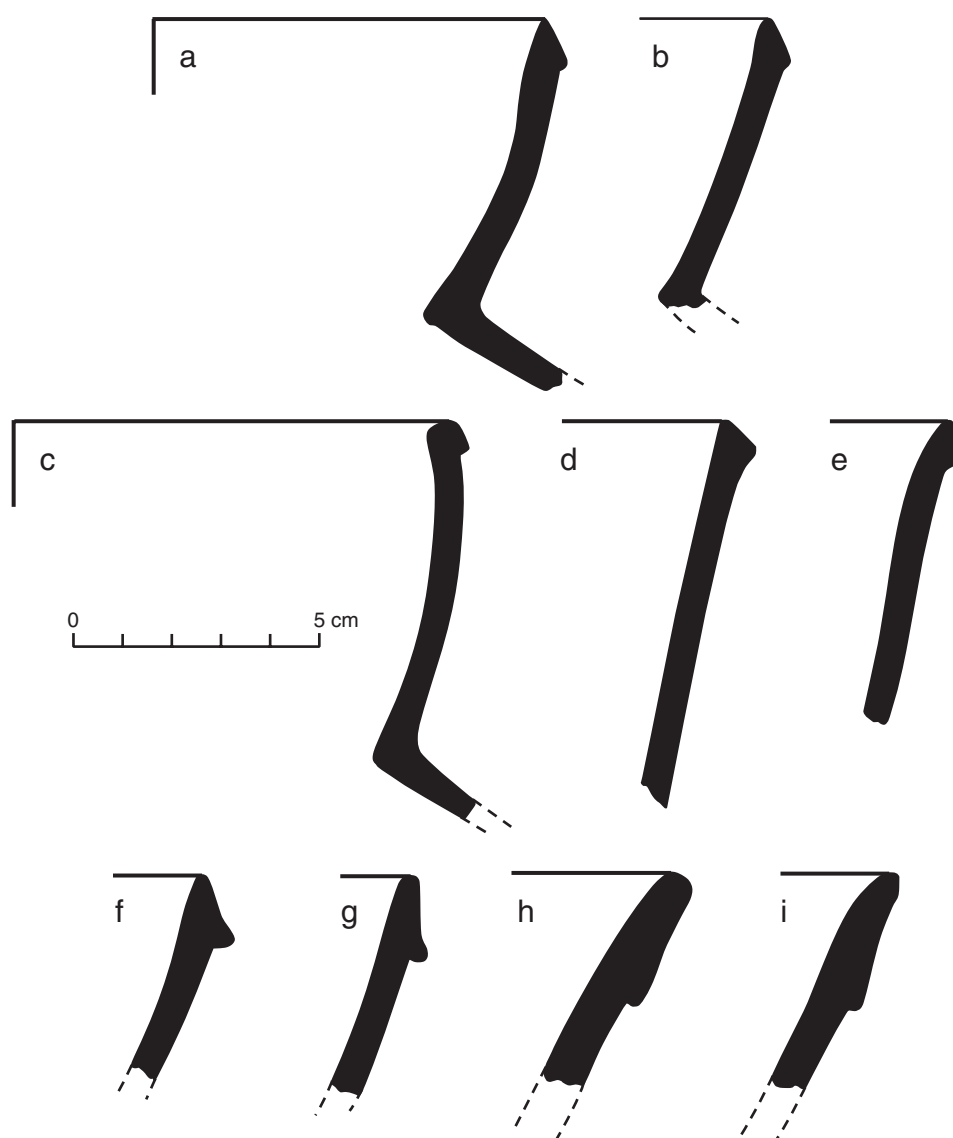
Figure 8.26. Camacho Reddish Brown vessels from the fill of Room 5, Structure 9. All specimens are jars with cambered rims; the drawing is intended to show the variety of rim forms. Two rims had the form shown in *a* and *b*; two had the form shown in *c*; one had the form shown in *d*; one had the form shown in *e*; three have the form shown in *f* and *g*; and two had the form shown in *h* and *i*.

Camacho Reddish Brown (Figures 8.26–8.28)

Jars with cambered rims: 15 rim sherds

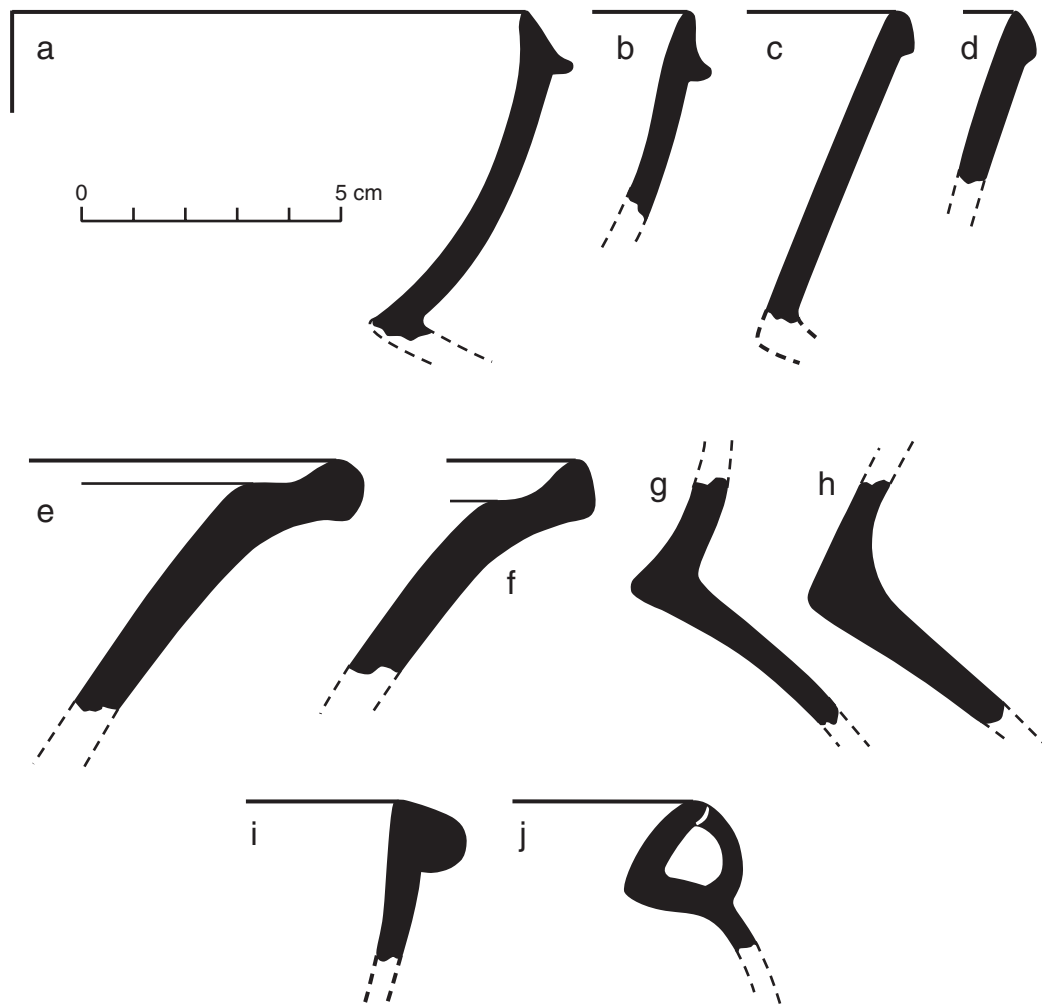
Figure 8.27. Camacho Reddish Brown vessels from the fill of Room 5, Structure 9. All specimens are jars. Sherds *a–d* show varieties of cambered rims. Two specimens had the form shown in *a* and *b*; two more had the form shown in *c* and *d*. (*e, f*): jars with everted rims; (*g, h*): jar shoulders; (*i*): jar with bolstered rim; (*j*): small globular jar with strap handle linking rim and shoulder.

Jar shoulders: 7
 Jar with bolstered rim: 1 rim
 Jar with low neck, plain rim, strap handle linking rim and shoulder: 1 neck
 Strap handles from jars: 4
 Cooking pots with restricted orifice: 7 rims (fire-blackened)
 Cooking pots with restricted orifice and horizontally set strap handle: 2 sherds
 Body sherds, mostly from jars: 105

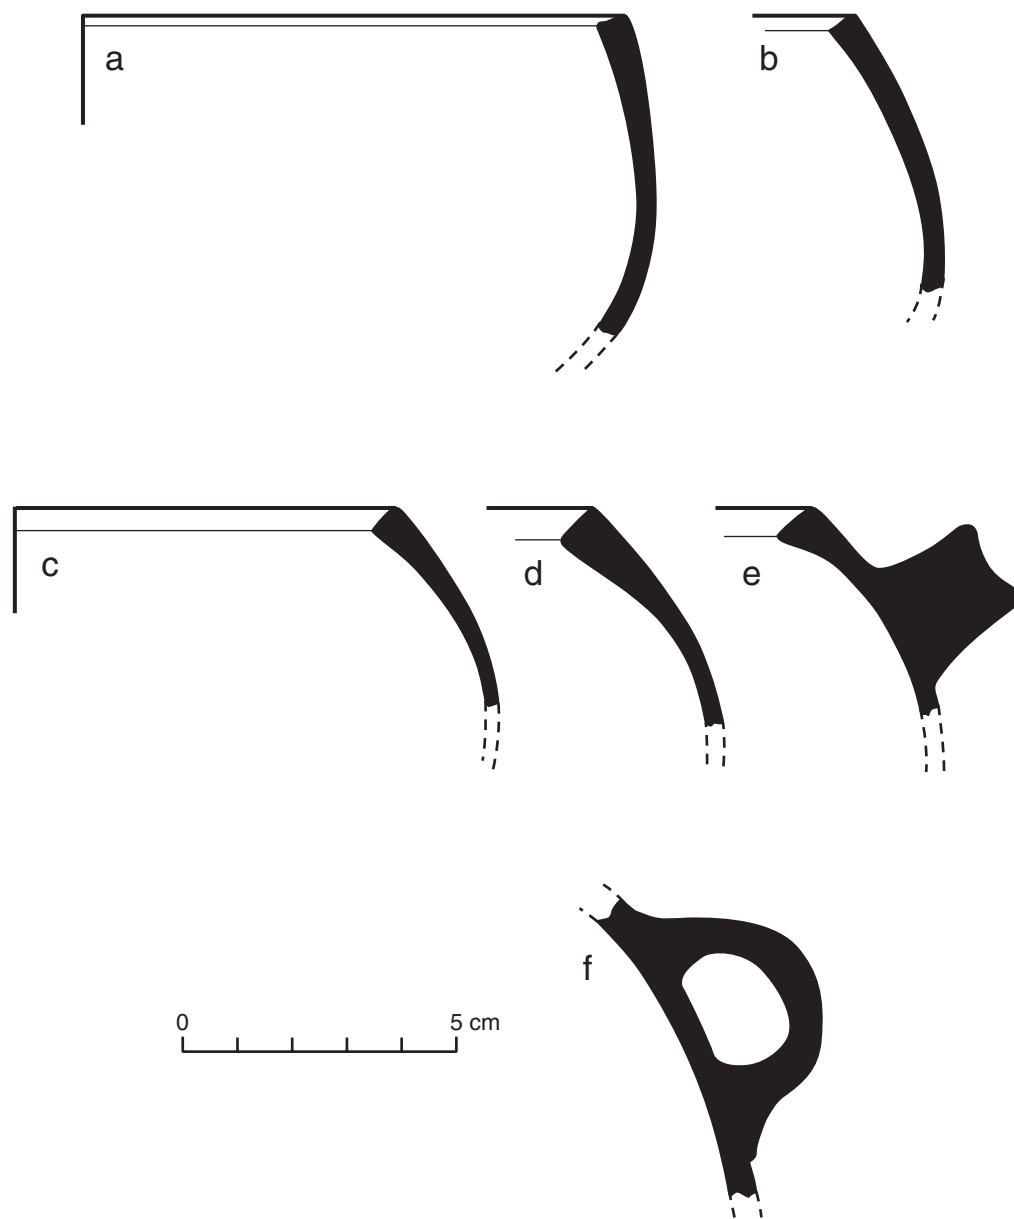
Figure 8.28. Camacho Reddish Brown vessels from the fill of Room 5, Structure 9. (*a–e*): cooking pots with restricted orifice; the drawing is intended to show the variety of rim forms. Sherd *e* has a horizontally set strap handle; (*f*): vertically set strap handle, possibly from a jar.
