MONOGRAPH 62
COTSEN INSTITUTE OF ARCHAEOLOGY
UNIVERSITY OF CALIFORNIA, LOS ANGELES

EXCAVATIONS AT
CERRO AZUL, PERU
THE ARCHITECTURE AND POTTERY
JOYCE MARCUS

Excavations at Cerro Azul, Peru

THE ARCHITECTURE AND POTTERY

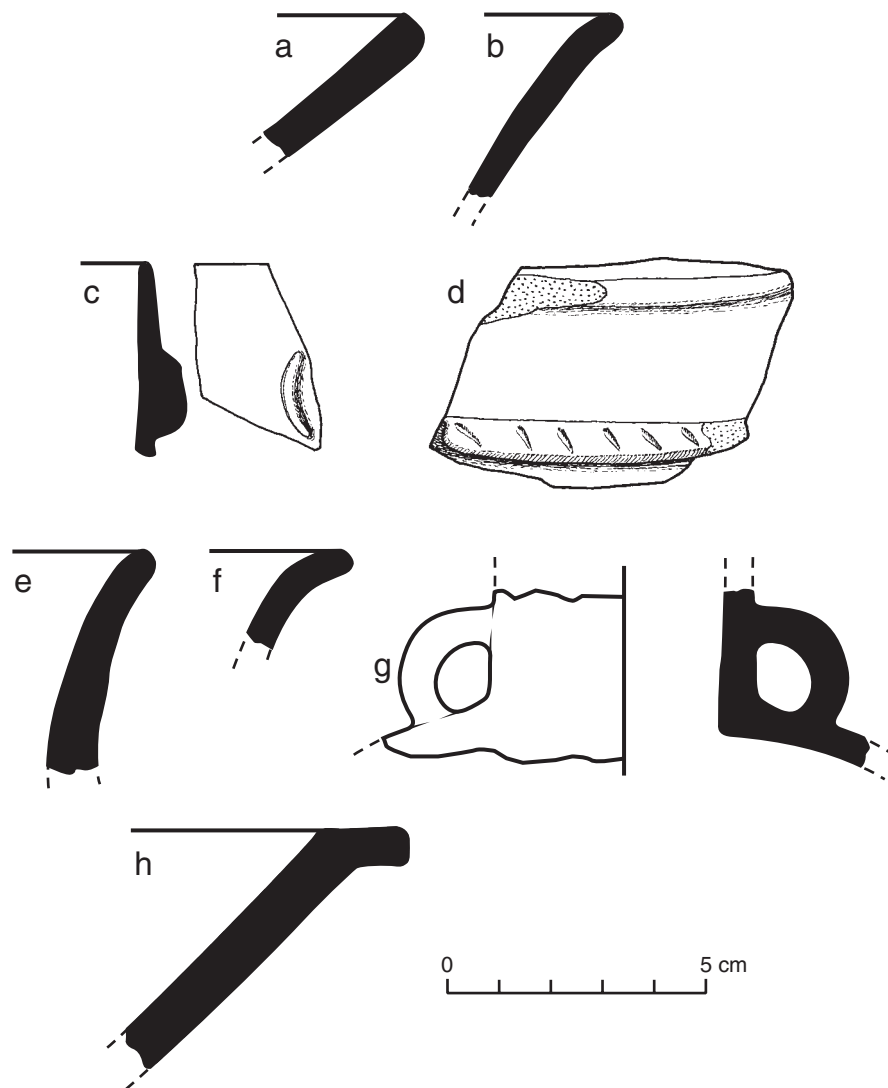
Figure 8.29. Vessels from the fill of Room 5, Structure 9. (a–d): Camacho Black, highly burnished variety. (a): outleaned wall of open bowl; (b): flaring rim from open bowl; (c): rim of small jar with modeled ear from human face; (d): fragment of vessel with incised decorative flanges (stipple indicates damaged areas). (e–g): Camacho Black, standard variety. (e, f): flaring rims from jars; (g): jar neck with strap handles linking neck and shoulder. (h): atypical orange variety of Pingüino Buff, everted rim from jar.

Camacho Black (Standard Variety) (Figure 8.29e–g)

Camacho Black (Highly Burnished Variety) (Figure 8.29a–d)

Outleaned wall bowl: 1 rim sherd
 Flaring rim from open bowl: 1
 Neck of miniature bottle (?) with ear from modeled human face: 1
 Jar body sherd from miniature vessel with modeled arm (?): 1
 Small effigy vessel with incised flanges: 3 body sherds

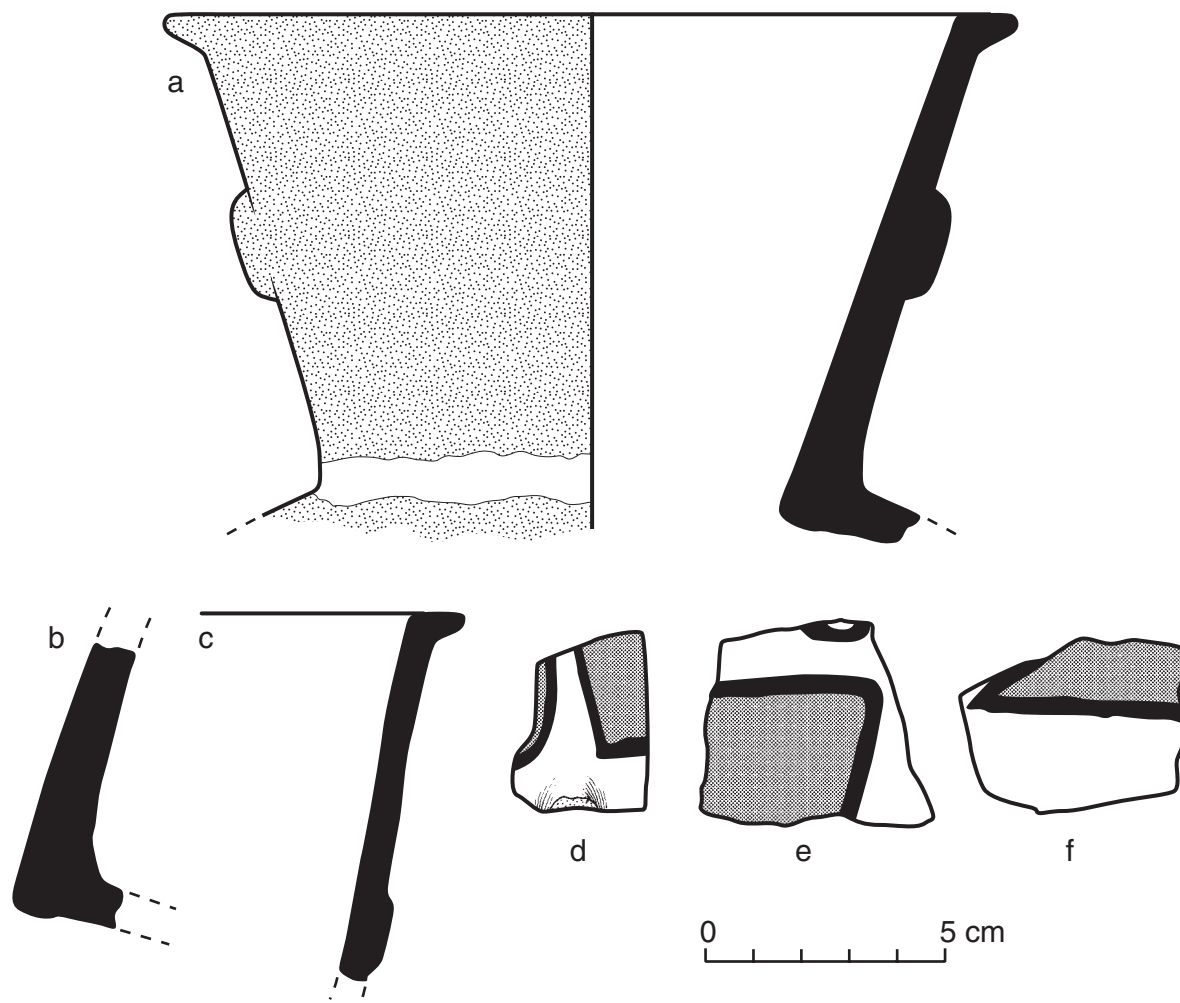
Figure 8.30. Pinguino Buff vessels from the fill of Room 5, Structure 9. (a): funnel neck from jar with everted rim (reconstructed from one large sherd). This jar had a modeled human face on its neck, most of it now missing. The base of the neck had a horizontal white stripe (light stipple indicates natural buff). (b): jar neck similar to a, but with a red stripe instead of a white one; (c): everted rim of jar, with trace of modeled human ear and facial painting. (d-f): sherds from jar necks with modeled and painted faces; the colors involved are cream white, black, and red (10 R 4/4), the latter shown by medium screen. Sherd d shows the bridge of the nose; e shows the eye and cheek; f shows the lower face.

Pingüino Buff (Figures 8.30, 8.31)

Large funnel-neck jars with everted rim,
face modeled on neck, painted white on
natural: 2 rims, 2 neck sherds
Large funnel neck from jar, burnished,
painted red on shoulder: 2 neck sherds
Funnel neck from jar, everted rim, face with
black/white/red paint on neck: 1 rim

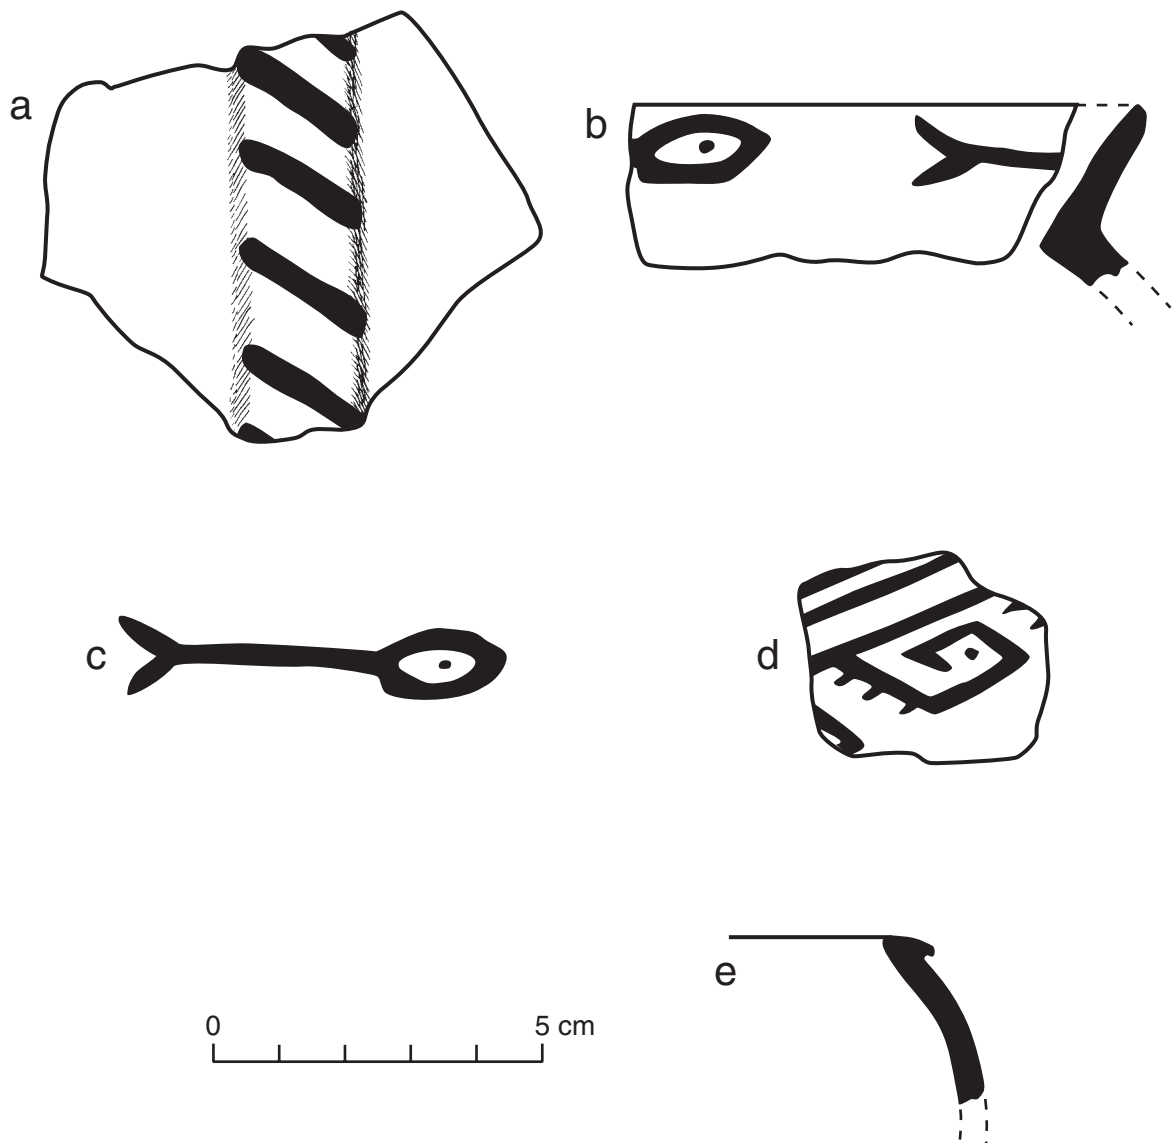
Figure 8.31. Pingüino Buff vessels from the fill of Room 5, Structure 9. (a): jar body sherd with raised vertical band painted black and white; natural buff to either side. (b): globular jar with wide mouth, painted black on natural on inside of rim as shown. The motif (reconstructed in c) is probably a fish, perhaps an anchovy. (d): jar body sherd, painted in black and white as shown; (e): small bowl with incurved and bolstered rim.

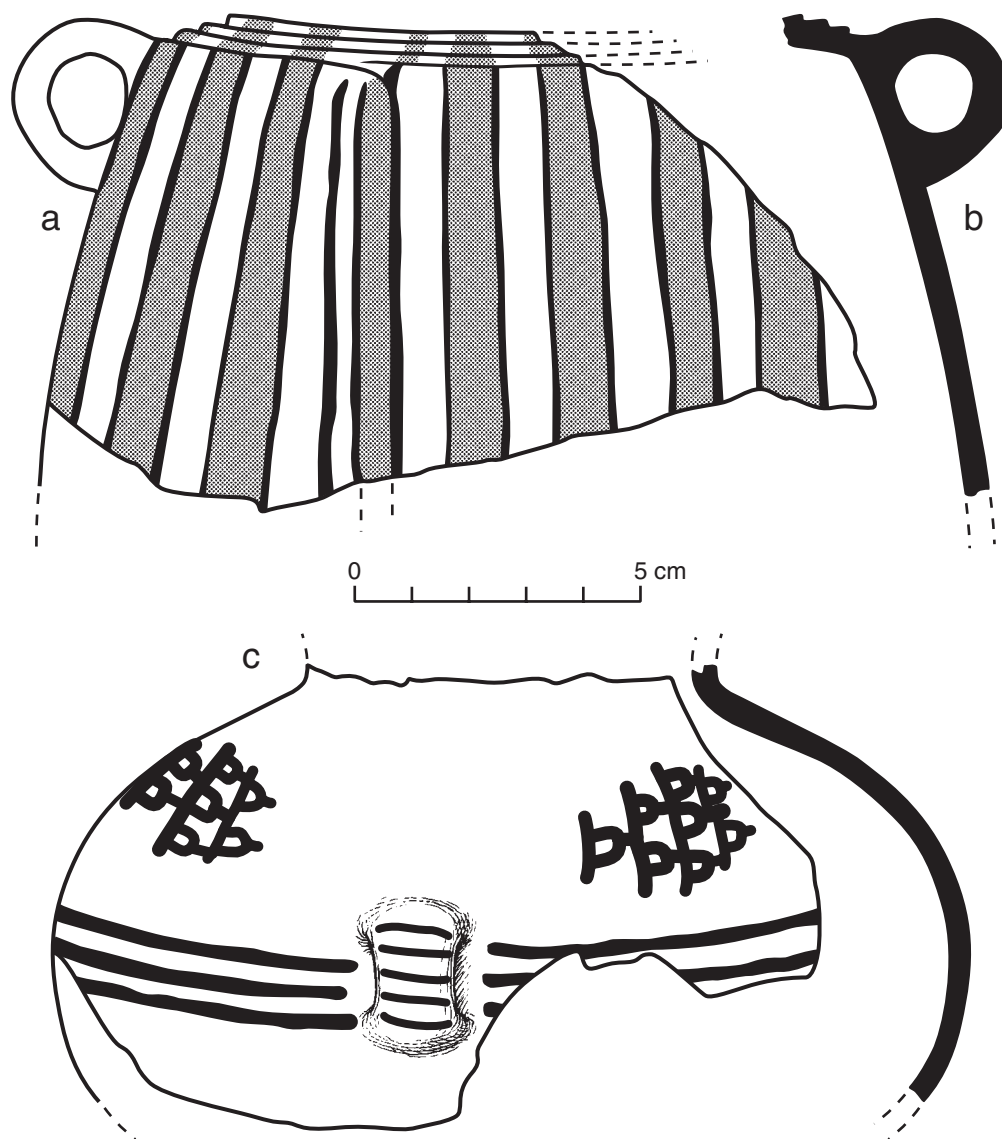
Figure 8.32. Ceramics from the fill of Room 5, Structure 9. (*a*, *b*): unique vessel made in the atypical orange variety of Pingüino Buff. The vessel is painted in imitation of a typical Late Intermediate brown-and-white striped burial wrapping; it has loop handles. Sherd *a* shows the vessel exterior; *b* shows the profile. (*c*): unique jar with vertically set strap handle, painted in black over a strong cream slip, featuring a “school of fish” motif.

Atypical Orange Variety of Pinguino Buff (Figures 8.29b; 8.32a, b)

brown-and-white striped cloth, perhaps a funerary wrapping, with a small strap handle: 6 sherds (Figure 8.32a, b)
[cream stripes = 10 YR 8/4; brown stripes = 10 R 3/2]

and white with “school of fish” motif; paste is most like Trambollo Burnished Brown, but vessel is atypical: 2 sherds (Figure 8.32c)

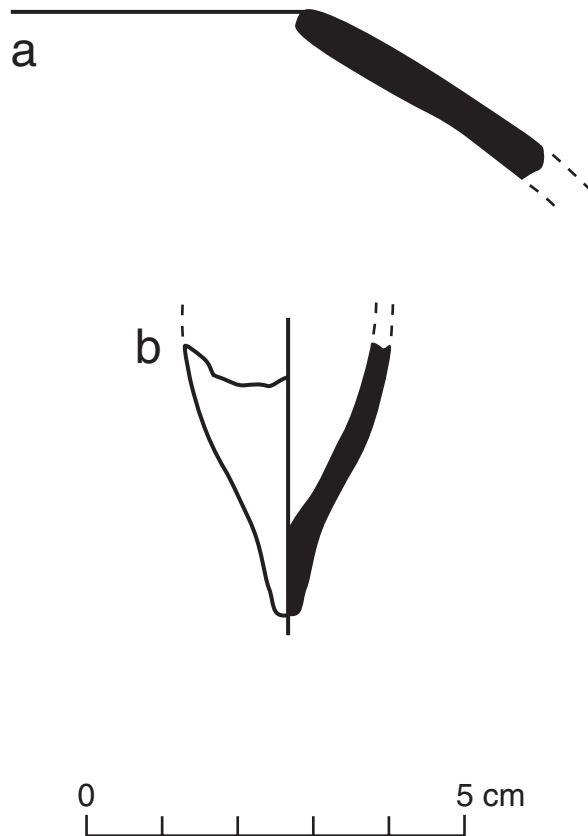
Figure 8.33. Unusual ceramics from the fill of Room 5, Structure 9. (a): eroded rim of hole-mouth jar, unknown ware, with pale brown paste and surface; (b): hollow appendage with traces of black/white/red paint, unknown ware.

Rim of jar with restricted orifice; pale brown surface and paste like Trambollo Burnished Brown, but eroded, unclassifiable: 1 (Figure 8.33a)

sandy light brown paste: 1 (Figure 8.33b)
 Jar body sherd with “hand” motif. Light brown, painted white and black; paste shows gray core sandwiched between reddish layers; fire-blackened on inside of jar: 1

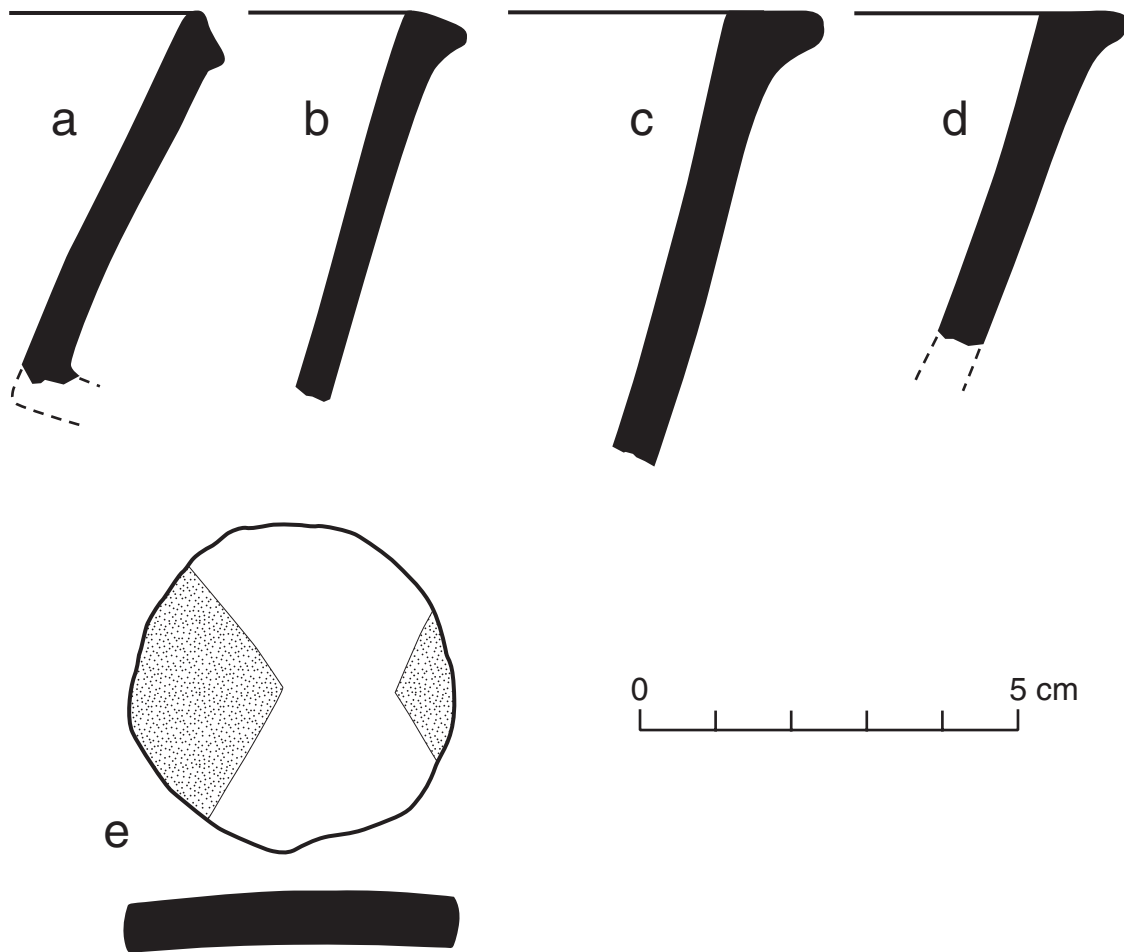
Figure 8.34. Ceramics found just above the sand layer in Room 5, Structure 9. (a): Camacho Reddish Brown jar neck with cambered rim; (b): Camacho Reddish Brown jar neck with everted rim. (c, d): Pingüino Buff everted rims from funnel-necked jars; (e): Pingüino Buff chipped sherd disk from vessel painted white on natural (light stipple indicates natural buff).

The collection of sherds found above the sand fill (and hence stratigraphically later) is smaller and shows less variety. These sherds, some of which are illustrated in Figure 8.34, are as follows:

Camacho Reddish Brown (Figure 8.34a, b)

Pingüino Buff (Figure 8.34c–e)

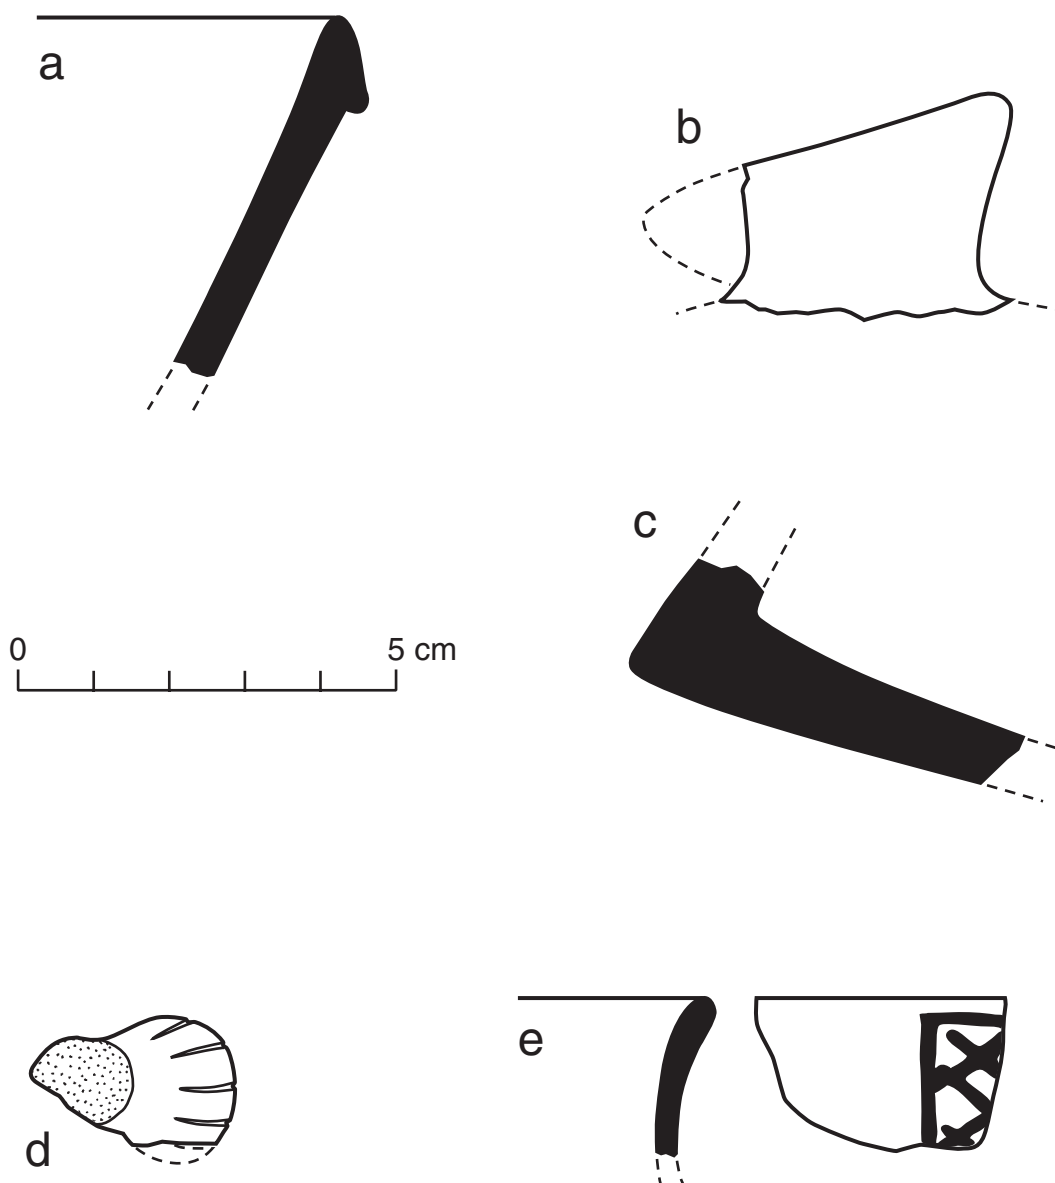
Figure 8.35. Ceramics from Room 6, Structure 9. All these sherds go with the period of the room's early use, before it was converted to fish storage. (a): Camacho Reddish Brown jar with cambered rim; (b): Camacho Black (highly burnished variety) triangular lug from jar; (c): Pingüino Buff jar shoulder; (d): foot (?) from effigy vessel, unclassified pottery type; (e): Pingüino Buff neck of small jar, painted black and white on exterior.

Let us begin with the oldest ceramics from Room 6, those found in the layer of tapia debris immediately above the floor (Figure 8.35). They are as follows:

Foot (?) from human effigy vessel of some kind (Figure 8.35d)

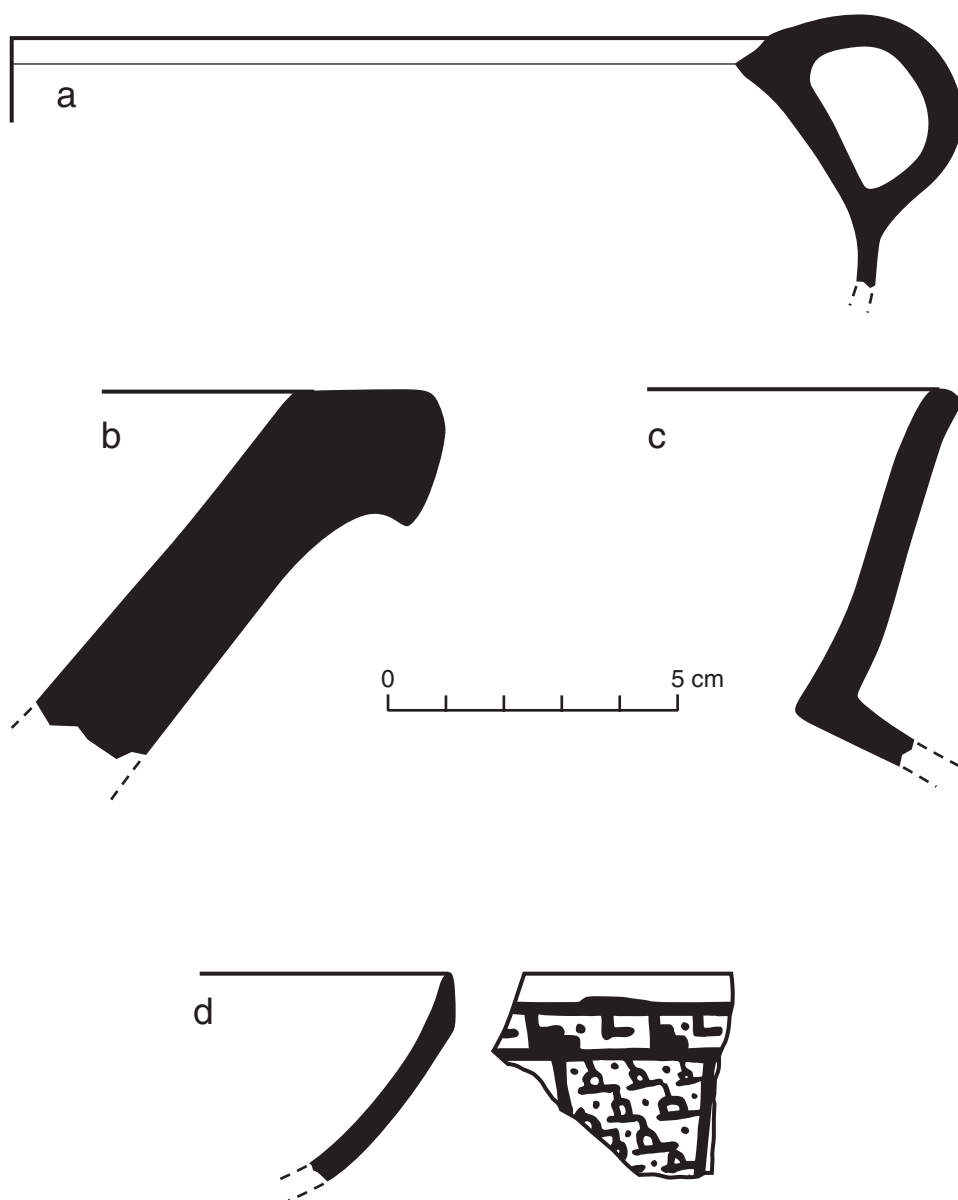
Figure 8.36. Ceramics from Room 6, Structure 9. All these sherds were thrown in on top of the sand layer used to convert the room to fish storage. Sherds *a–c* are Camacho Reddish Brown. (*a*): cooking pot with restricted orifice and vertically set strap handle (fire-blackened); (*b*): rim from large *tinajón*; (*c*): jar rim. (*d*): Pingüino Buff hemispherical bowl sherd, slipped white on interior and exterior, painted black on white on exterior.

ceased to function as a fish storage unit (Figure 8.36). These sherds are as follows:

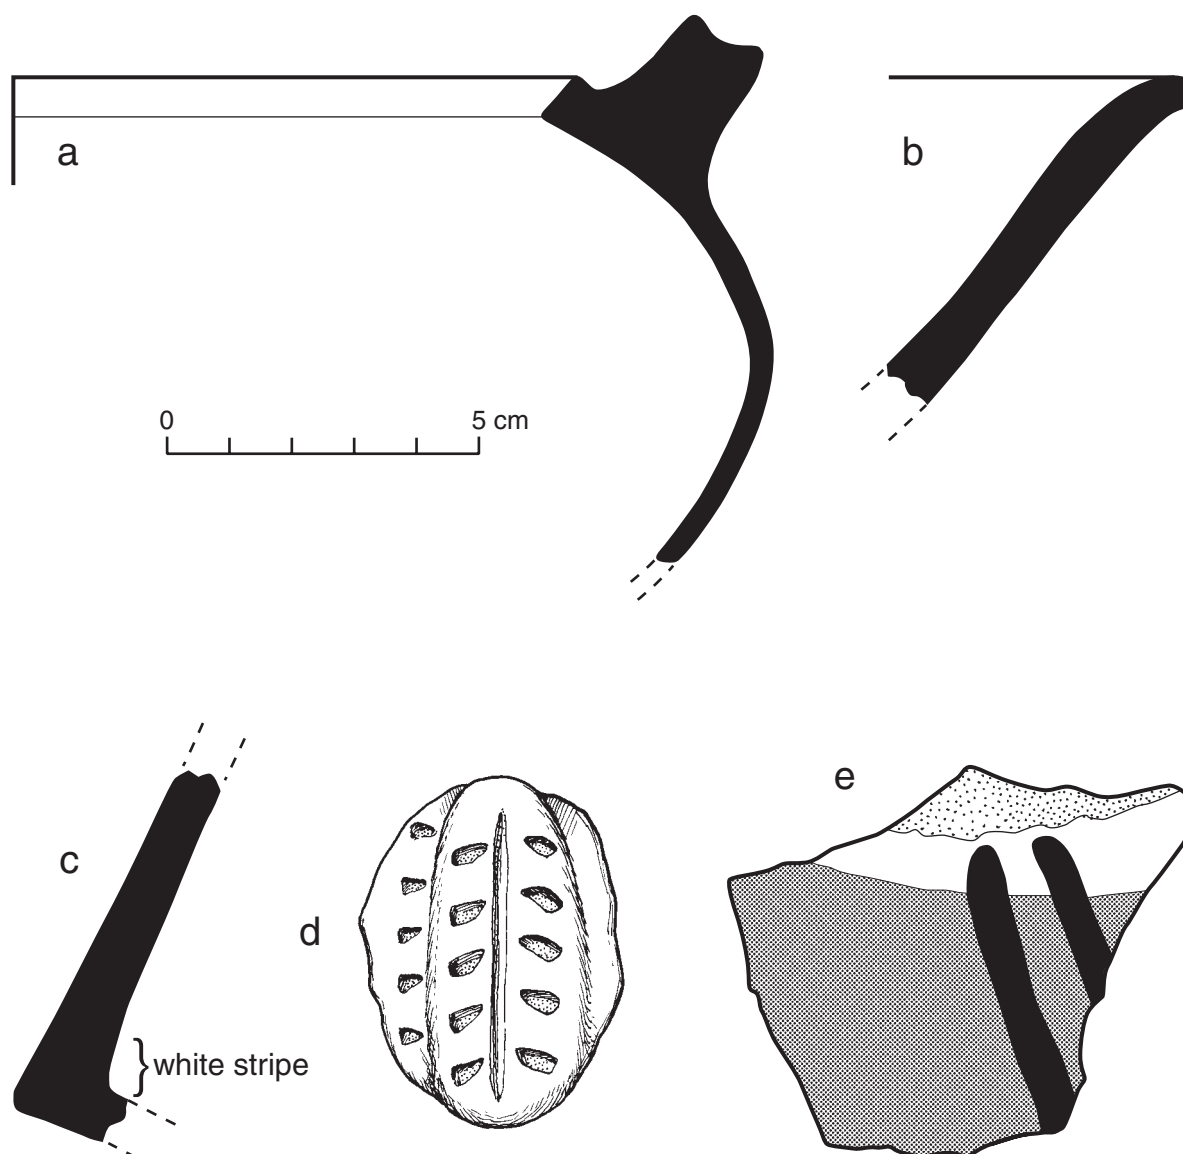
Figure 8.37. Ceramics from Room 7, Structure 9. All specimens were found stratigraphically above the sand. (a): Camacho Reddish Brown cooking pot with restricted orifice and horizontally set strap handle (fire-blackened); (b): flaring rim from large Pingüino Buff jar; (c): funnel neck from Pingüino Buff jar, painted white on natural (the area of a horizontal white stripe is indicated); (d): maize-cob-shaped lug from a large *tinajón*, superficially resembling Pingüino Buff, but with atypically coarse temper; (e): body sherd from a Pingüino Buff jar, painted in black and white over a weak red wash (10 R 4/4); the light stipple indicates natural buff, the dense screen red wash.

After the room ceased to function as a fish storage unit, a small number of sherds were thrown in on top of the sand (Figure 8.37).

Cooking pot with restricted orifice, horizontally set strap handle: 1 rim (Figure 8.37a)

Base of funnel neck from jar, painted white on natural: 1 (Figure 8.37c)

Jar shoulder with red wash, painted black and white: 1 (Figure 8.37e)

Flaring rim from large jar: 1 (Figure 8.37b)

Maize-cob lug from large *tinajón*, Pingüino-like paste and white wash, but temper much too coarse to be Pingüino: 1 (Figure 8.37d)

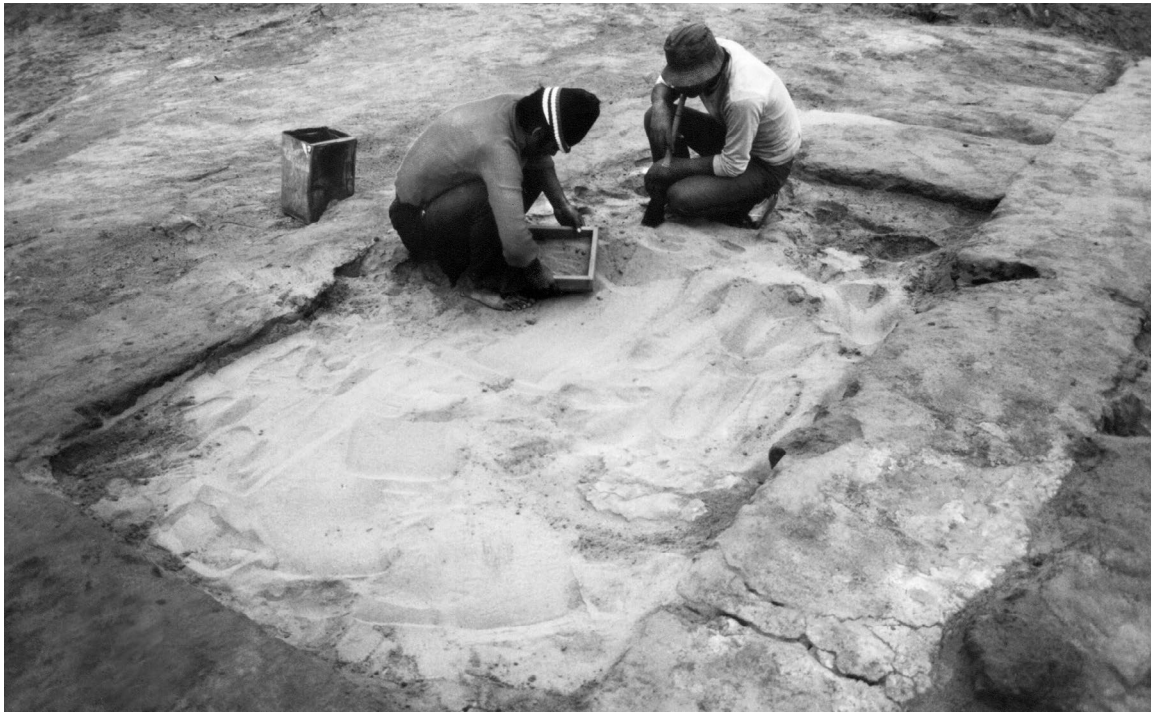
Figure 8.38. Room 11 of Structure 9, a sand-filled room used for storage of dried fish. Workmen are screening the sand through fine brass carburetor mesh to remove the fish bone. This room produced abundant remains of anchovies and occasional remains of sardines, corvina, and bonito.

Like so many other rooms in Structure 9, however, Room 11 had eventually been converted to fish storage and filled with greenish gray sand. This sand, in fact, filled the surviving room so completely that we only discovered the *tapia* bench after we had sieved the upper part of the fill for fish bones (Figure 8.38). Most of the fish remains consist of anchovies (*Engraulis ringens*), but there were also traces of sardines (*Sardinops sagax*) and even larger fish such as corvina (*Sciaena gilberti*) and bonito (*Sarda sarda*). When our workmen reached the floor, they found many identifiable fish bones stuck to it because, in spite of the hygroscopic properties of the sand, the *tapia* floor had remained damp from the salt fog of the coast (Figure 8.39). These fish remains will be discussed in a future volume.

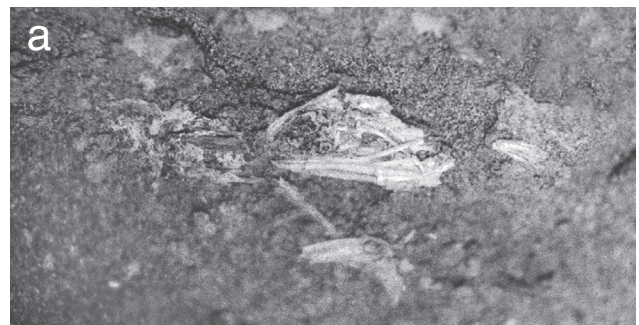
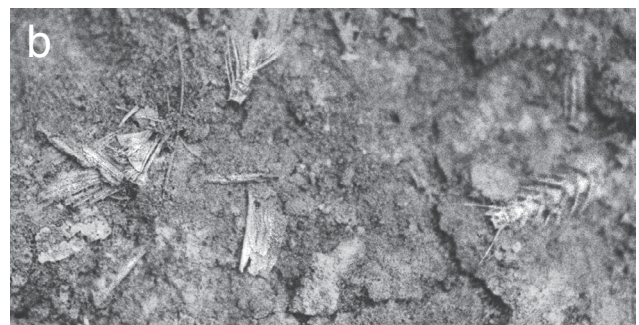
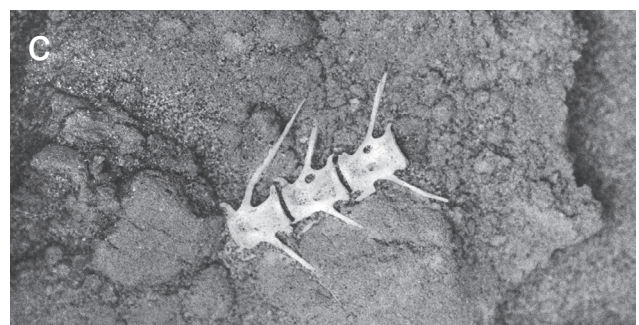
Figure 8.39. Fish remains stuck to the sandy floor of Room 11, Structure 9. (a): head of anchovy (*Engraulis ringens*); (b): remains of small fish (mostly anchovies and sardines); (c): three vertebrae of a larger fish.

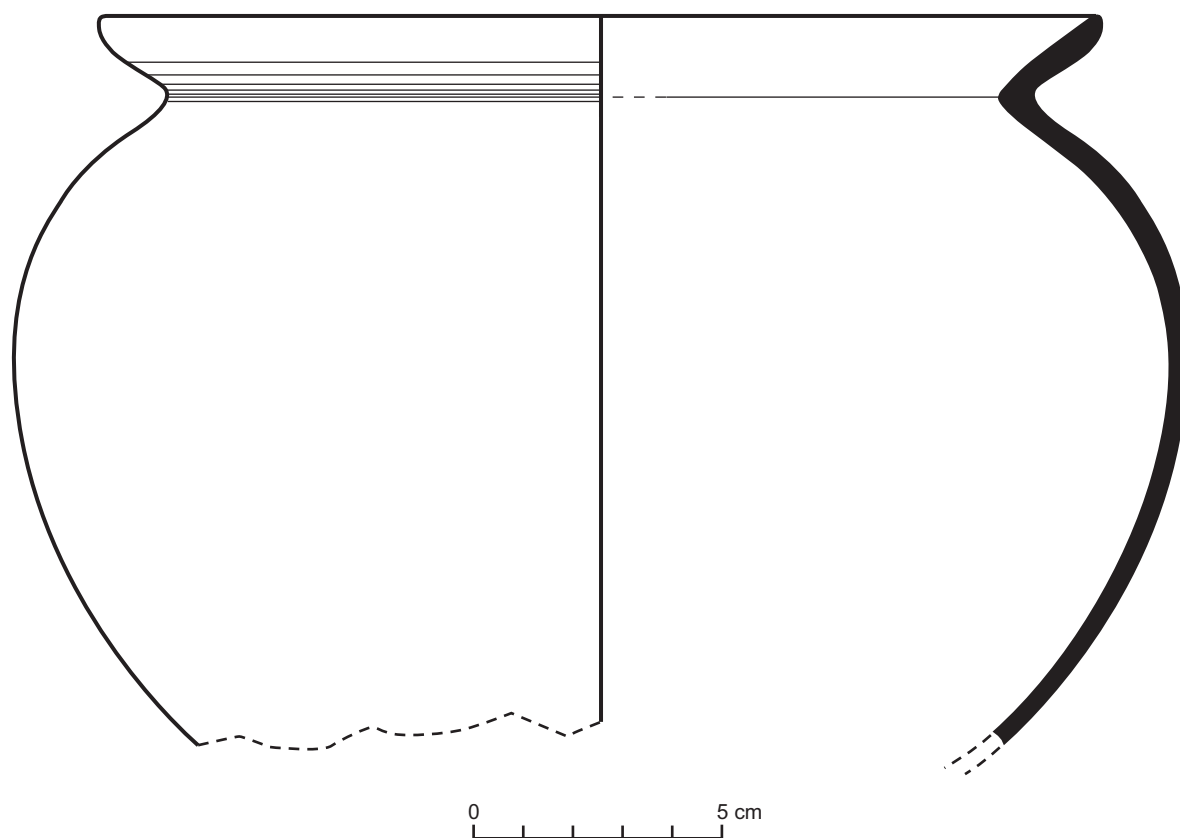
Figure 8.40. Camacho Black (standard variety) globular jar with wide mouth and plain rim, from fill of Room 12 in Structure 9 (reconstructed from several large sherds).

Camacho Black (Standard Variety) (Figure 8.40)

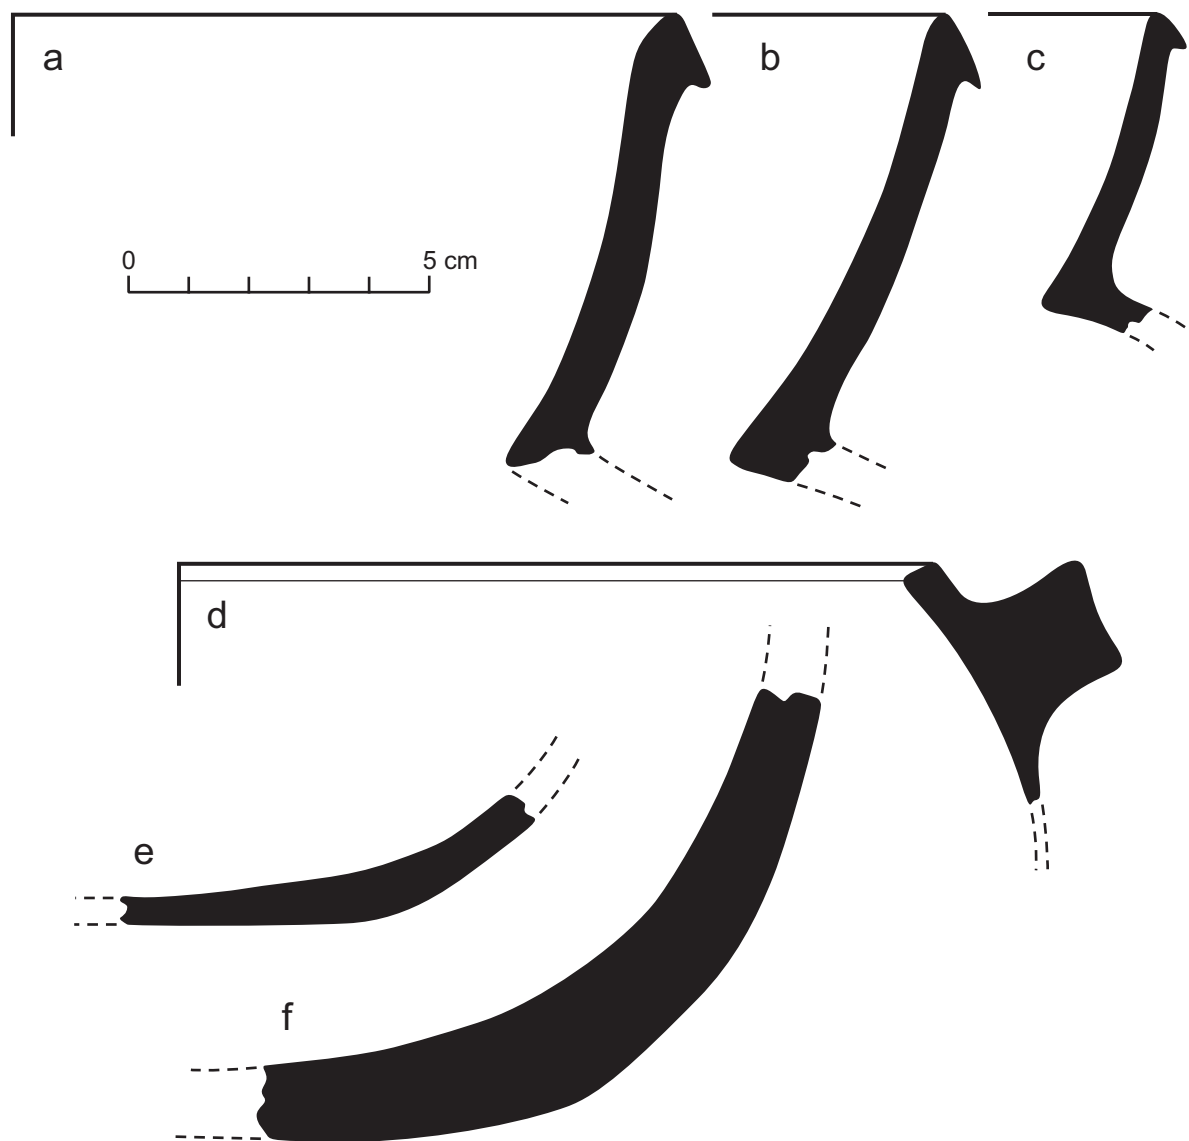
Figure 8.41. Camacho Reddish Brown vessels from Feature 20, Structure 9. (a–c): cambered rims from jars; (d): cooking pot with restricted orifice and horizontally set strap handle (fire-blackened); (e, f): bases from jars.

Camacho Reddish Brown (Figures 8.41, 8.42a–e)

Jars with cambered rims: 4 rims (Figure 8.41a–c)

Jar basal sherds: 2 (Figure 8.41e, f)

Cooking pot with restricted orifice, horizontally set strap handle: 1 rim (Figure 8.41d)

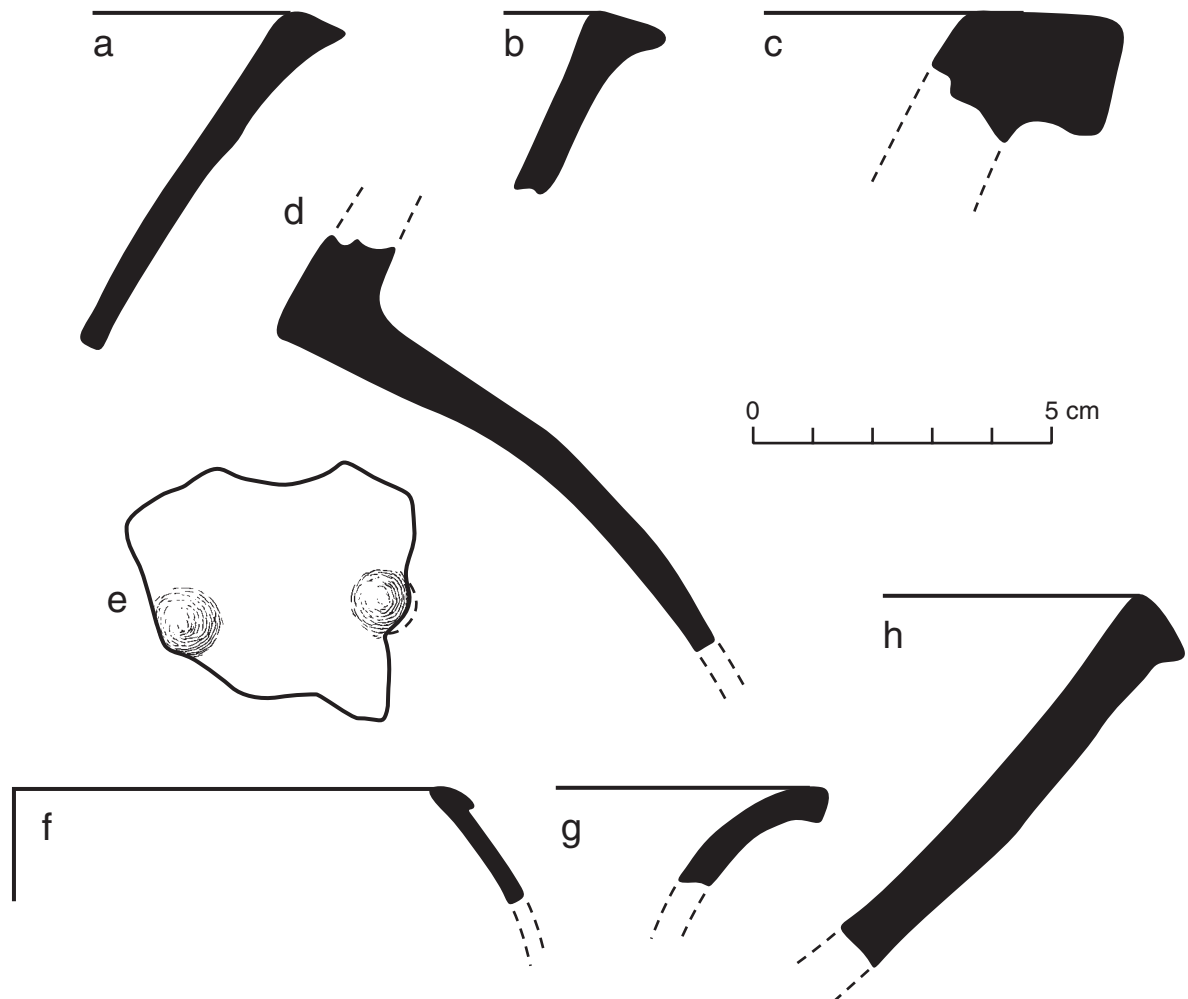
Figure 8.42. Ceramics from Feature 20, Structure 9. Sherds *a–e* are Camacho Reddish Brown. (*a, b*): slightly everted rims from jars; (*c*): rim from large *tinajón*; (*d*): jar shoulder; (*e*): fragment of jar shoulder with appliqué “nipples.” Sherds *f–h* are Camacho Black. (*f*): small, burnished, neckless jar with rolled rim (heavily pitted and eroded, but probably the highly burnished variety); (*g*): flaring rim from jar (standard variety); (*h*): cambered rim from jar (standard variety); interior surface only roughly finished.

Jars with slightly everted rims: 3 rims (Figure 8.42a, b)

Jar shoulders: 8 (plain or brushed) (Figure 8.42d)

Jar shoulder with 2 appliqué “nipples”: 1
(Figure 8.42e)

Large *tinajón*: 1 rim (Figure 8.42c)

Camacho Black (Standard Variety) (Figure 8.42f–h)

Cambered rims from jars: 3 (Figure 8.42h)

Flaring rims from jars: 3 (Figure 8.42g)

Camacho Black (Highly Burnished Variety?)
(Figure 8.42f)

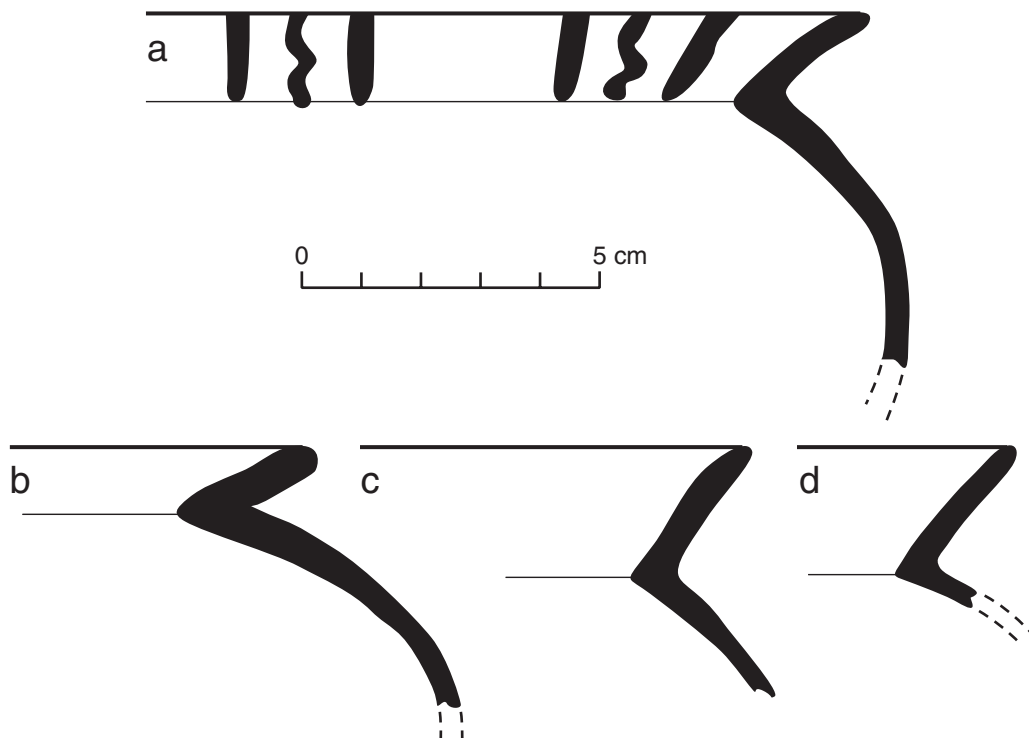
Figure 8.43. Pingüino Buff jar rims from Feature 20, Structure 9. (a): globular jar with wide mouth, given a cream-white slip and painted in black and white on the interior of the rim (the exterior of the vessel is eroded); (b): globular jar with wide mouth, unslipped and unpainted; (c): thin-walled jar with low flaring neck; (d): thin-walled jar with low flaring neck, highly burnished.

Globular jars with wide mouth, painted black and white over cream slip inside rim: 3 rims, 2 shoulders (Figure 8.43a)

Globular jars with wide mouth, unpainted: 7 rims (1 with strap handle), 3 shoulders (Figure 8.43b)

Thin-walled jars with low flaring neck: 2 rims (Figure 8.43c)

Thin-walled jars with low flaring neck,
highly burnished: 2 rims (Figure 8.43d)
Plain rims from large jars: 3 (Figure 8.44a)
Flaring rims from large jars: 3 (Figure 8.44b)
Slightly everted rims from large jars: 1
Funnel neck from jar, painted white on natural: 2 rims, 2 neck sherds from same vessel (Figure 8.44c)
Large neckless jar with rolled rim, given white wash and painted black and white on rim and shoulder: 1 rim (Figure 8.44d, e)

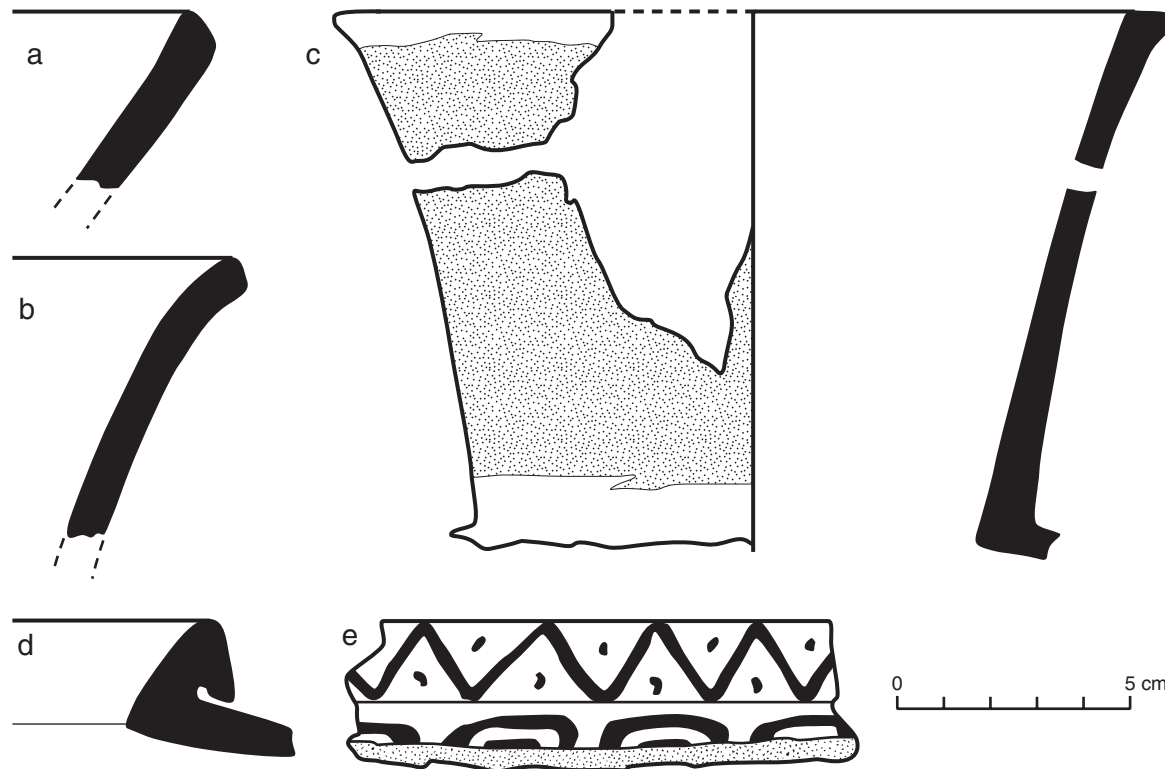
Figure 8.44. Pingüino Buff vessels from Feature 20, Structure 9. (a): plain rim from jar; (b): flaring rim from large jar; (c): funnel neck from jar, painted white on natural (light stipple indicates natural buff; sloppy white bands appear above and below); (d): rim profile of large low-necked jar with rolled rim; (e): exterior of sherd shown in d, covered with white wash and painted in black and white (coarse stipple indicates broken edge of sherd).

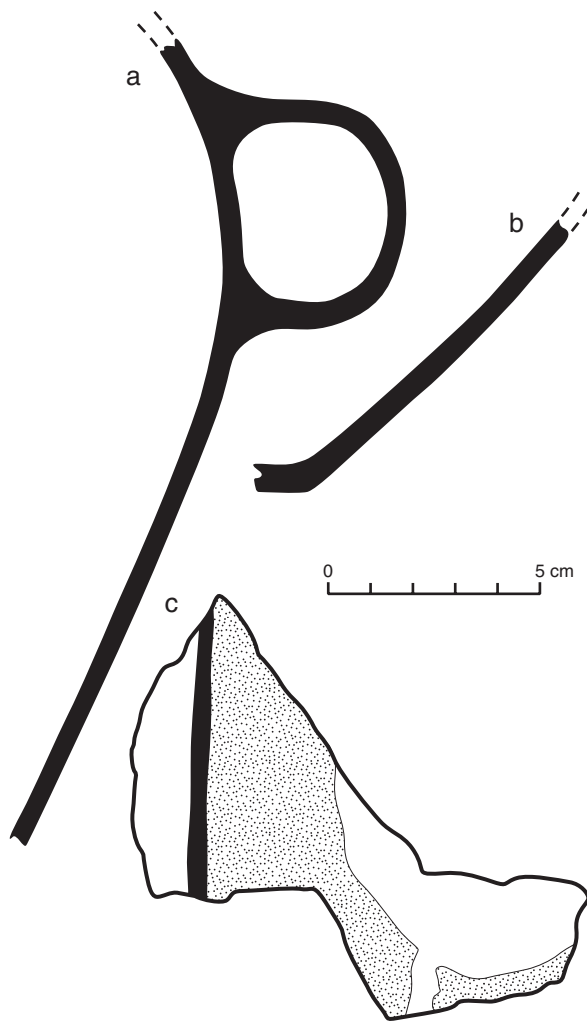
Figure 8.45. Pingüino Buff vessels from Feature 20 midden, Structure 9. (a): amphora or conical jar with strap handle; (b): jar base and lower wall; (c): jar body sherd with both black-on-white and white-on-natural painting on exterior (light stipple indicates natural buff).

Amphora or conical jar: 2 bases (Figure 8.45b)
Amphora or conical jar with strap handle: 1 sherd (Figure 8.45a)
Strap handle from large jar, painted black and red over white wash: 1 sherd (Figures 8.46a, 8.49a)
Jar body sherds, painted black and red on white: 8 (Figure 8.46b, c)
Jar body sherds, painted black and white on natural buff or white on natural: 4 (Figures 8.45c, 8.48b)

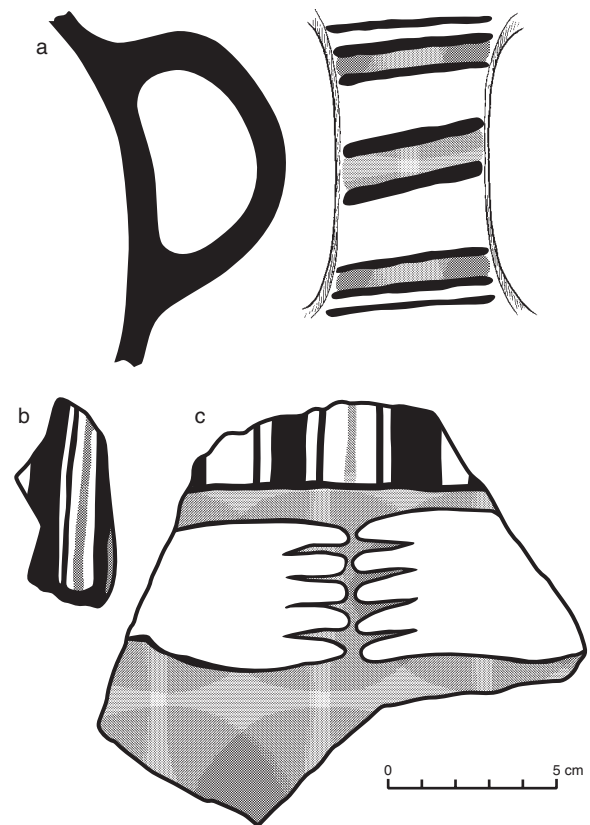
Figure 8.46. Pingüino Buff vessels from Feature 20, Structure 9. (a): strap handle from large jar, vertically set, painted in black and red over a sloppy white wash; the red (indicated by medium screen) is specular hematite, 10 R 3/4; (b): jar body sherd painted in black and red over a white slip; (c): jar sherd with areas of white slip and red slip (the latter is 10 R 4/6), highly burnished and painted in black and red on white (red is indicated by medium screen).

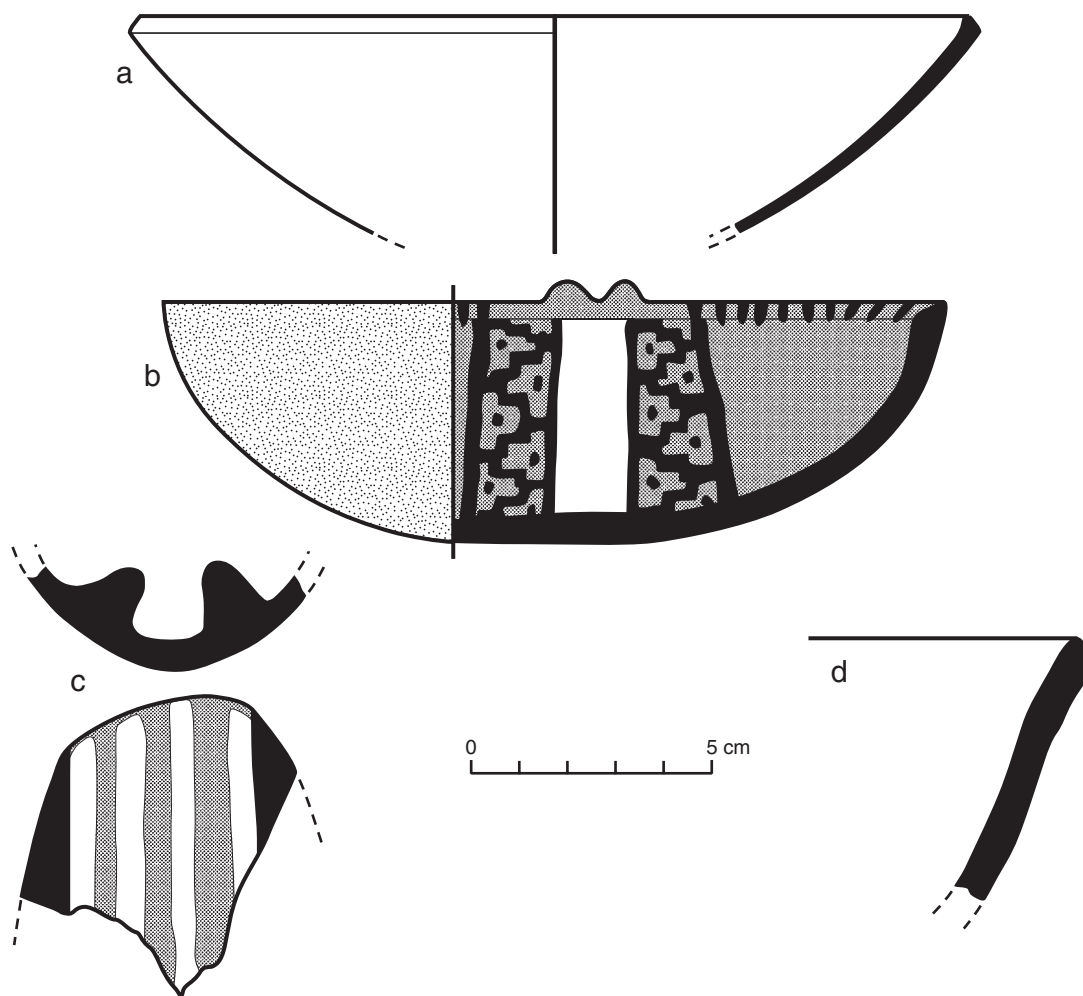
Figure 8.47. Pinguino Buff vessels from Feature 20 midden, Structure 9. (a): shallow bowl, burnished on interior (reconstructed); (b): hemispherical bowl with eccentric bumps on rim, slipped red on the interior, painted in black and white over that; the red is 7.5 R 4/6 (in this reconstruction, based on four sherds, red is represented by medium screen and natural buff by light stipple); (c): unique ceramic “tongue” with modeled teeth on one side (*top*), painted in black and white over a red slip on the other side (*bottom*); (d): rim of large bowl.

Large bowl, plain rim, burnished on interior and exterior: 1 rim (Figure 8.47d)

Shallow bowl, burnished on interior: 3 rims (Figure 8.47a)

5 rims, 5 body sherds, all from the same vessel (Figures 8.47b, 8.48a)

Unique “tongue-shaped” sherd with conical modeled teeth on one side, painted black and white on red on the other side: 1 (Figures 8.47c; 8.49b, c)
