MONOGRAPH 62
COTSEN INSTITUTE OF ARCHAEOLOGY
UNIVERSITY OF CALIFORNIA, LOS ANGELES

EXCAVATIONS AT
CERRO AZUL, PERU
THE ARCHITECTURE AND POTTERY
JOYCE MARCUS

Excavations at Cerro Azul, Peru

THE ARCHITECTURE AND POTTERY

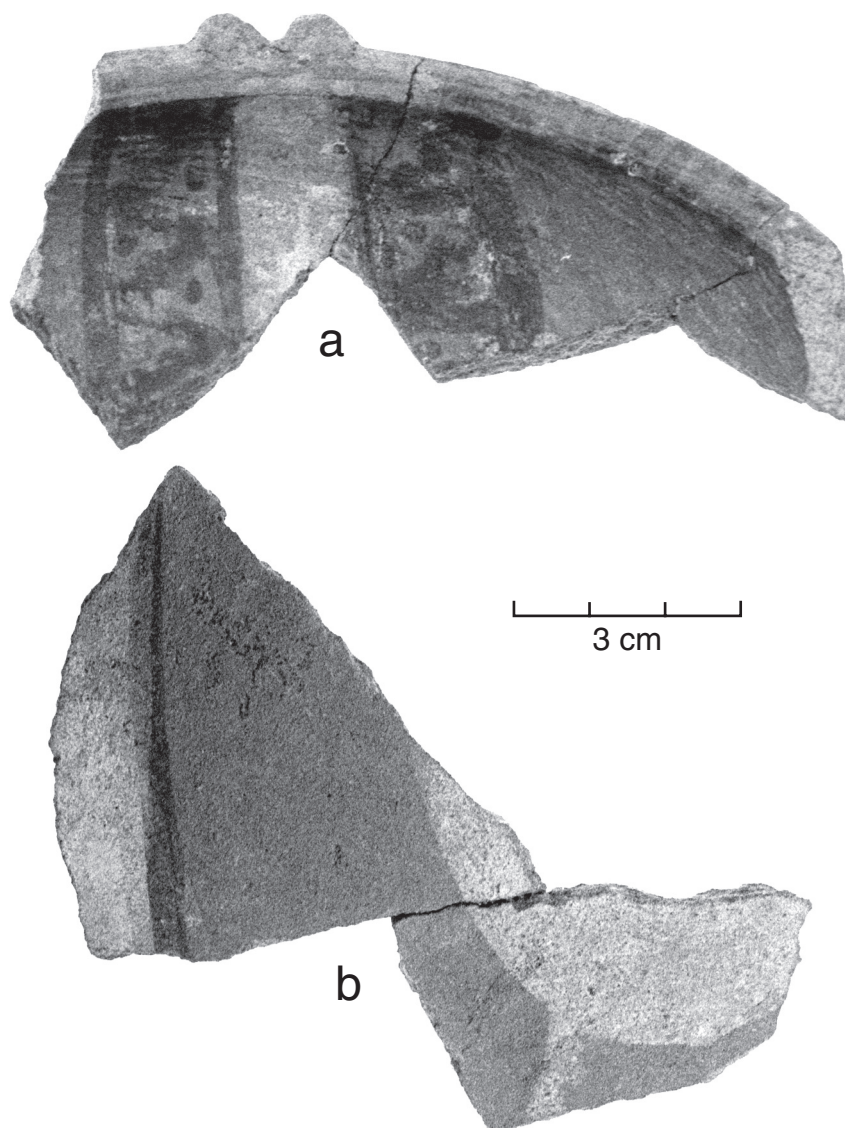
Figure 8.48. Pingüino Buff sherds from Feature 20, Structure 9. (a): two conjoining sherds from a hemispherical bowl with eccentric bumps on the rim, slipped red on the interior, painted in black and white over that; (b): jar body sherd with both black-on-white and white-on-natural painting on the exterior.

Amphora or conical jar: 2 bases (Figure 8.45b)
Amphora or conical jar with strap handle: 1 sherd (Figure 8.45a)
Strap handle from large jar, painted black and red over white wash: 1 sherd (Figures 8.46a, 8.49a)
Jar body sherds, painted black and red on white: 8 (Figure 8.46b, c)
Jar body sherds, painted black and white on natural buff or white on natural: 4 (Figures 8.45c, 8.48b)

5 rims, 5 body sherds, all from the same vessel (Figures 8.47b, 8.48a)

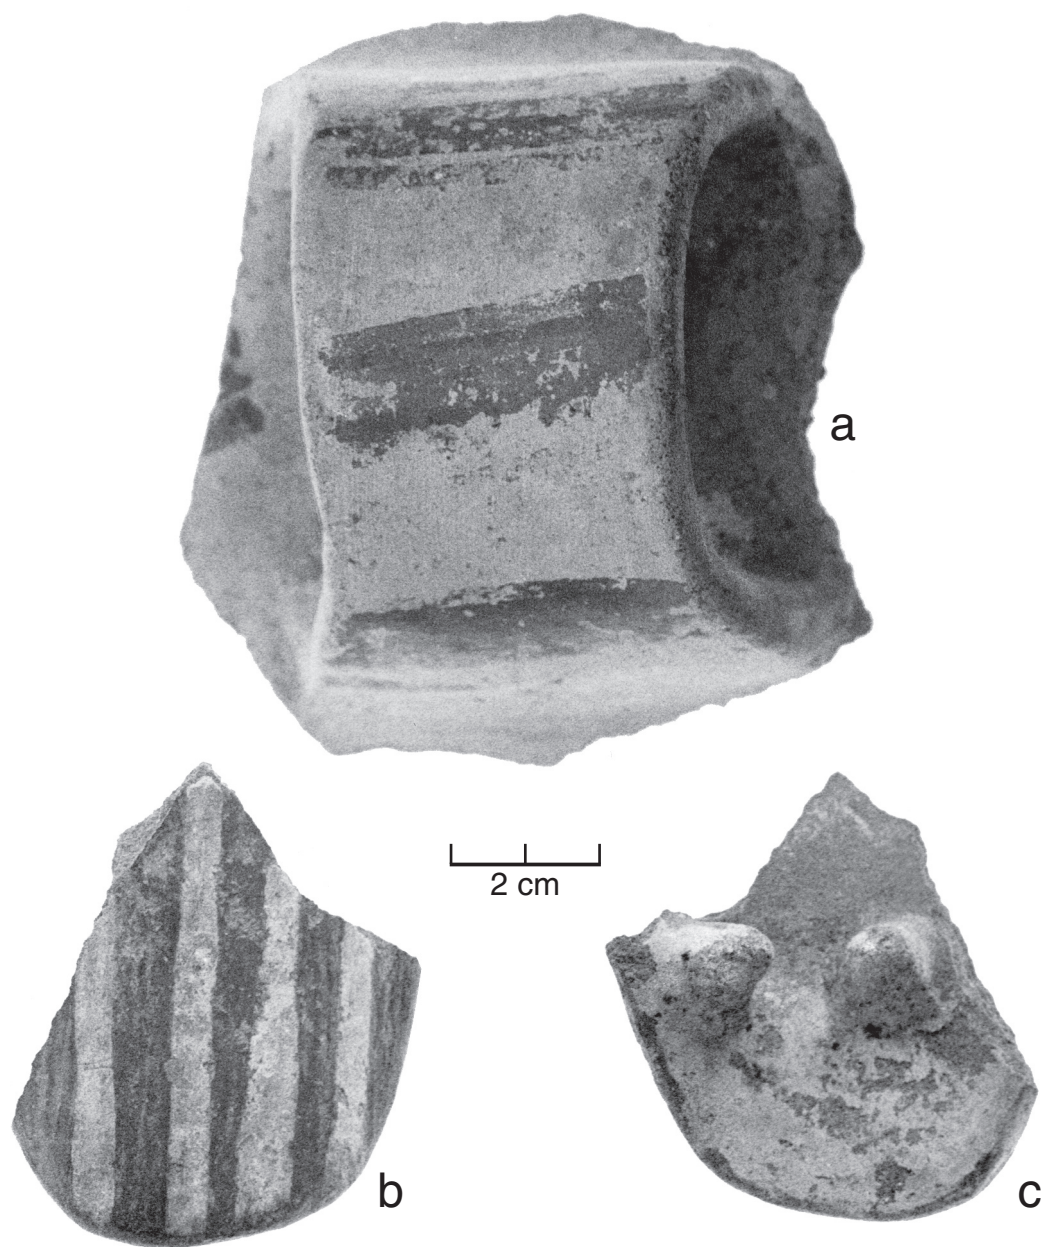
Figure 8.49. Pingüino Buff sherds from Feature 20, Structure 9. (a): strap handle from large jar, vertically set, painted black and red over white wash; (b, c): both sides of a unique ceramic “tongue” with modeled teeth on one side and black-and-white stripes painted over a red slip on the other side.

Unique “tongue-shaped” sherd with conical modeled teeth on one side, painted black and white on red on the other side: 1 (Figures 8.47c; 8.49b, c)

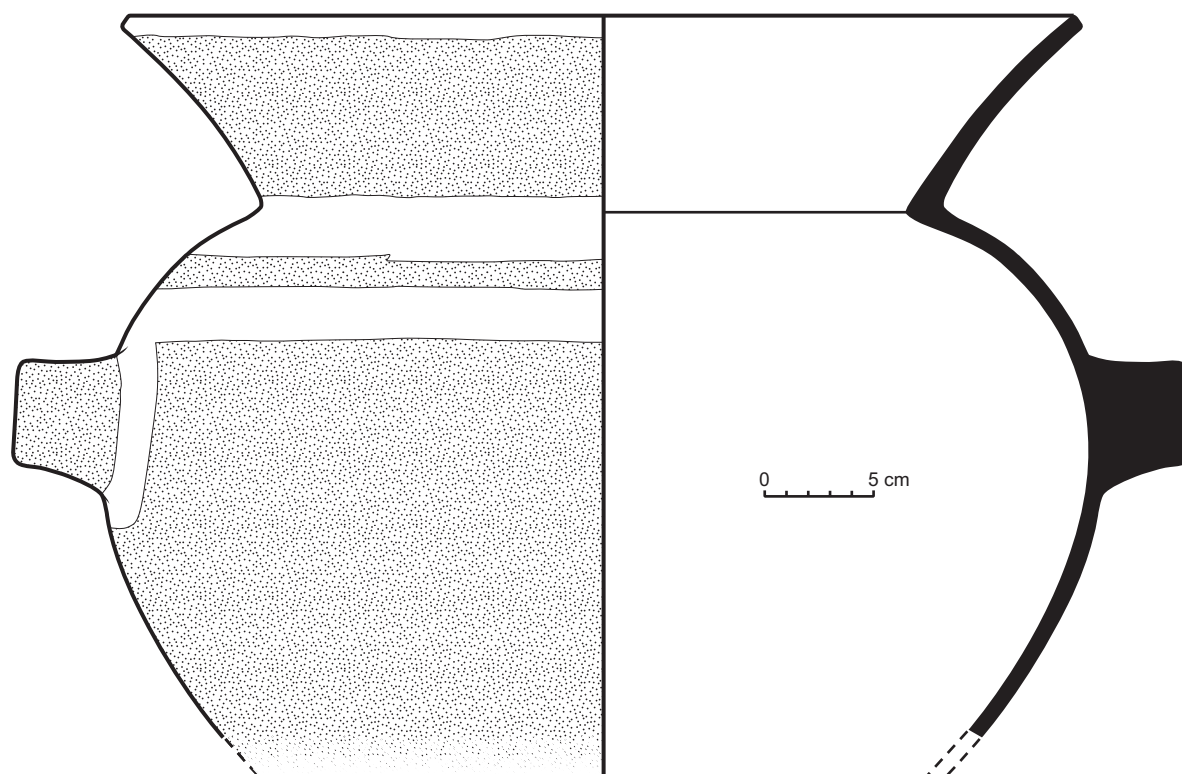
Figure 8.50. Large Pingüino Buff jar from Feature 20 midden, Structure 9 (reconstruction drawing based on 24 sherds). The jar has horizontally set strap handles. It is painted white on natural on the exterior, with one white stripe at the rim, two on the shoulder, and another encircling each strap handle. The natural buff is 2.5 YR 5/4 (reddish brown), while the white paint is a yellowish cream color (2.5 Y 8/2 to 2.5 Y 8/4).

ural: 3 rims, 4 shoulders, 17 body sherds from the same vessel (Figure 8.50)

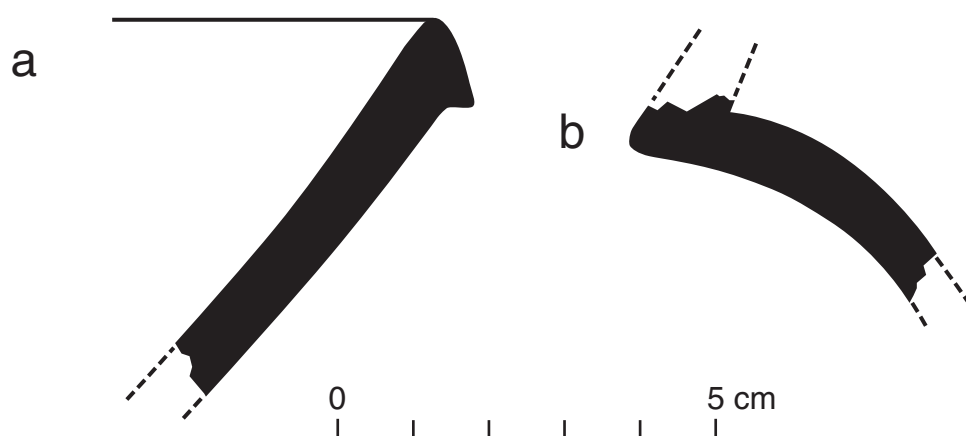
Figure 8.51. Sherds from Feature 20 midden, Structure 9. Both belong to the atypical orange variety of Pingüino Buff. (a): cambered rim from jar, coarse temper, pinkish-orange; (b): jar shoulder with white wash on the exterior; temper too coarse to be typical Pingüino Buff, surface color too orange.

Atypical Orange Variety of Pingüino Buff (Figure 8.51)

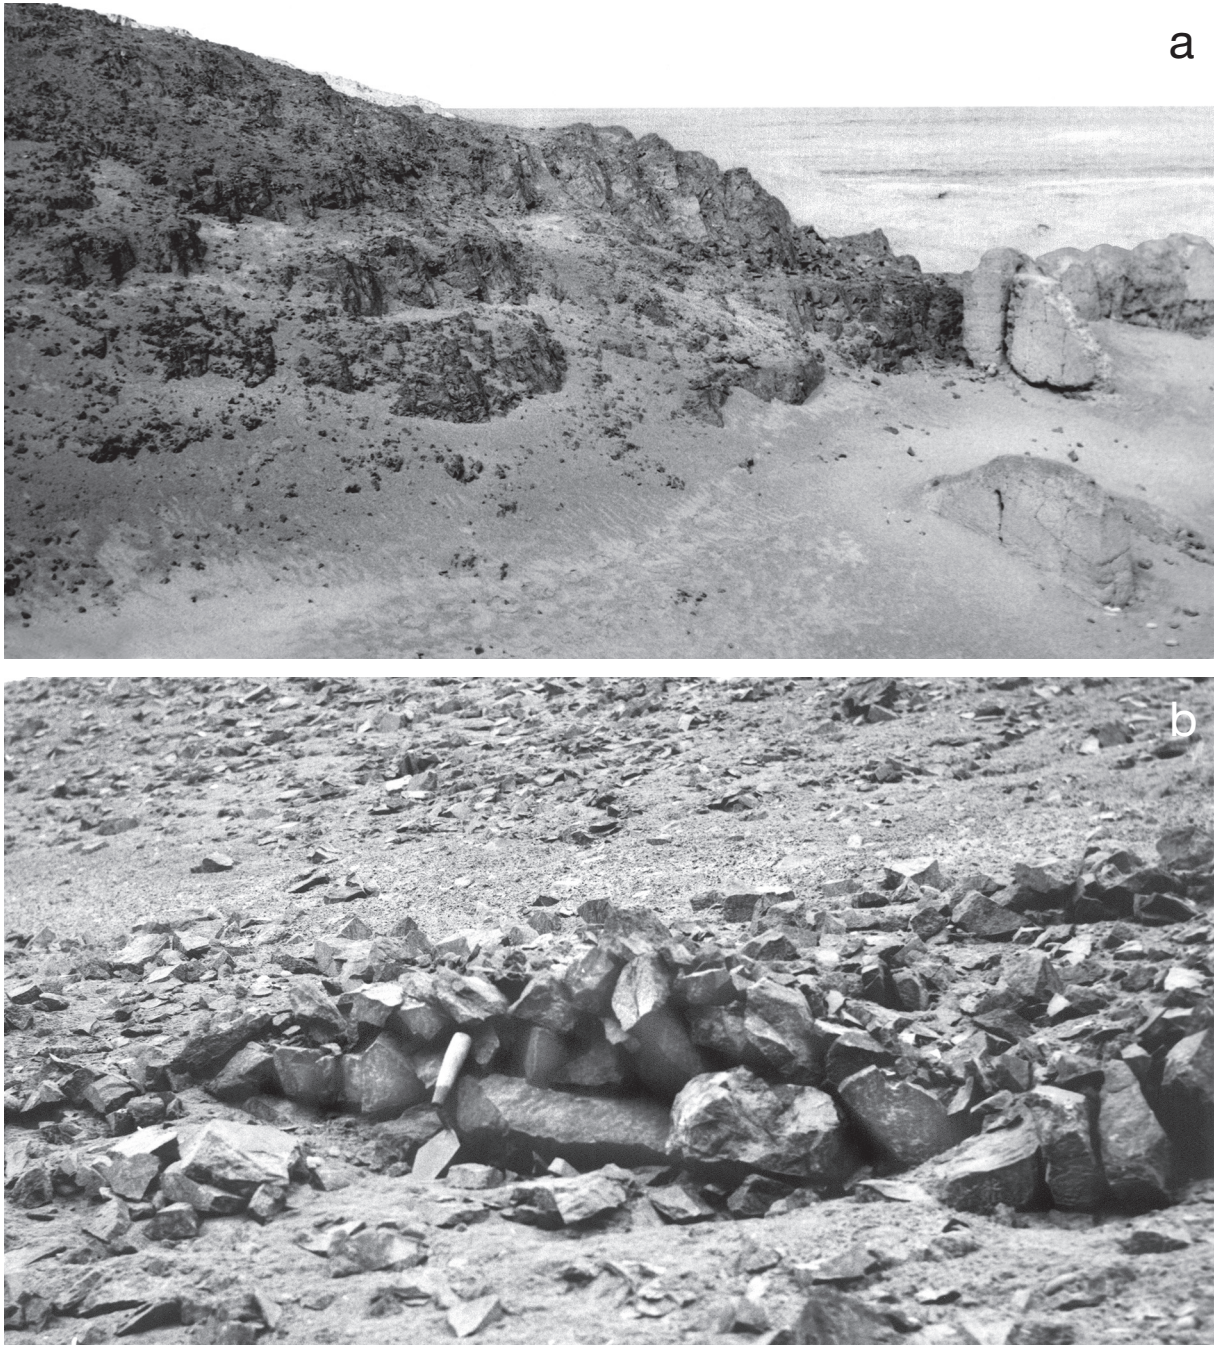
Figure 9.5. The creation of terraces on Cerro Camacho. (a): a rocky ridge adjacent to Structure H, showing the way the bedrock descends in natural steps. Such steps often formed the cores of terraces. (b): a terrace in Quebrada 6, showing how rough retaining walls of natural scree were used to extend terraces and keep them level.

The creation of terraces may have been suggested by the conformation of Cerro Camacho itself. Figure 9.5a shows how the bedrock descends in a series of natural steps. In many cases, it appears that the Late Intermediate trash-dumpers had taken advantage of these natural steps, making each the core of a new terrace. In order to prevent the trash from sliding downhill as it grew beyond the natural step, the creators of the terrace built simple retaining walls, using readily available loose stones from the scree of the hill (Figure 9.5b).

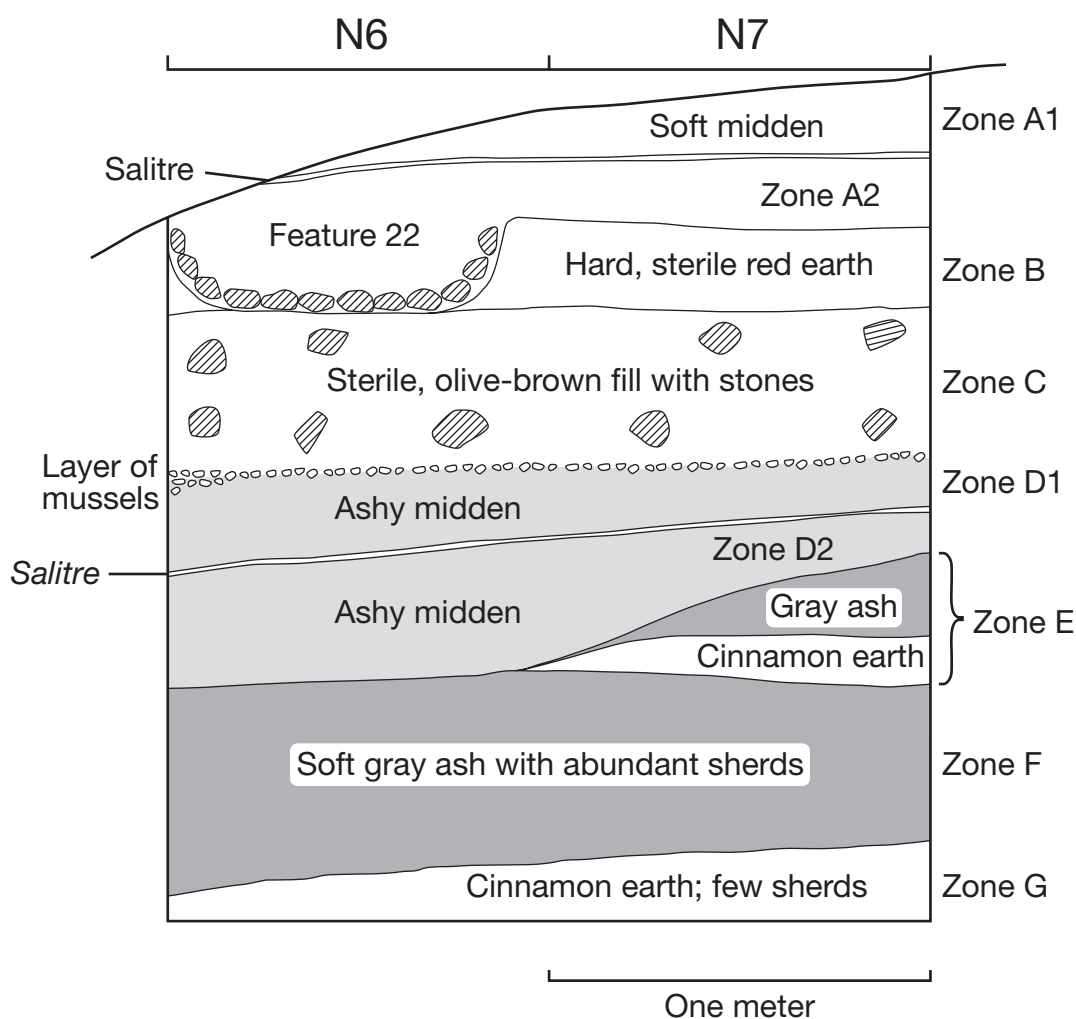
Figure 9.7. Quebrada 5, Terrace 16: a profile of the east wall of Squares N6 and N7.

The most interesting cultural feature we found on Terrace 16 had been cut down into the hard sterile earth mentioned above. This is Feature 22, a stone-lined, basin-shaped hearth (Figure 9.7). Feature 22 is oval in outline (90 cm north-south and more than 1.0 m east-west) and had been excavated 22 cm into the red earth below. This hearth had been used to roast a sea lion (*Otaria byronia*) over heated stones. Sea lion bones (and miniscule amounts of smaller fauna) were found in Zone A2, the layer of refuse associated with Feature 22.

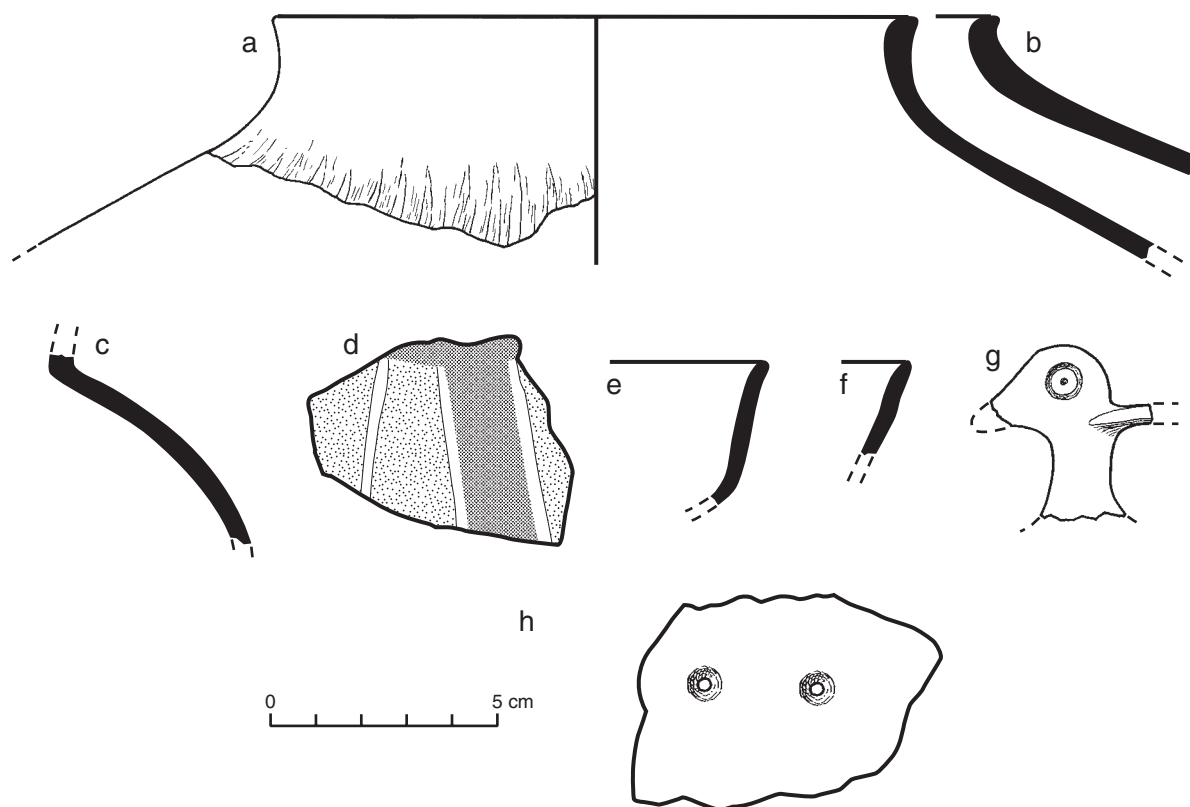
Figure 9.8. Sherds from Zone F of Terrace 16, Quebrada 5. (*a, b*): Camacho Reddish Brown jars with very low necks and plain rims. The bodies are brushed below the neck. (*c, d*): Trambollo Burnished Brown thin-walled jar, painted white and purple over natural buff; (*c*): profile; (*d*): exterior surface of sherd. Light stipple indicates natural buff (2.5 YR 5/6); medium screen indicates purplish red (5 R 3/2); the white is light cream (2.5 Y 8/4). (*e, f*): Trambollo Burnished Brown, small carinated bowls; (*g*): Pingüino Buff bird effigy bridge spout; (*h*): Camacho Reddish Brown, jar body sherd with two holes drilled from the exterior of the vessel.

Trambollo Burnished Brown (Figure 9.8c–f)

Another interesting feature of the Zone F collection is the group of eight drilled body sherds (Figure 9.8h), some of which show sawing and cutting marks as well as drill holes. One possibility is that these sherds are waste products from the process of creating net weights from body sherds. At least one fine-mesh fishing net from Cerro Azul was found with an 11-g worked sherd tied on as a weight (Marcus 1987a:Fig. 47A).

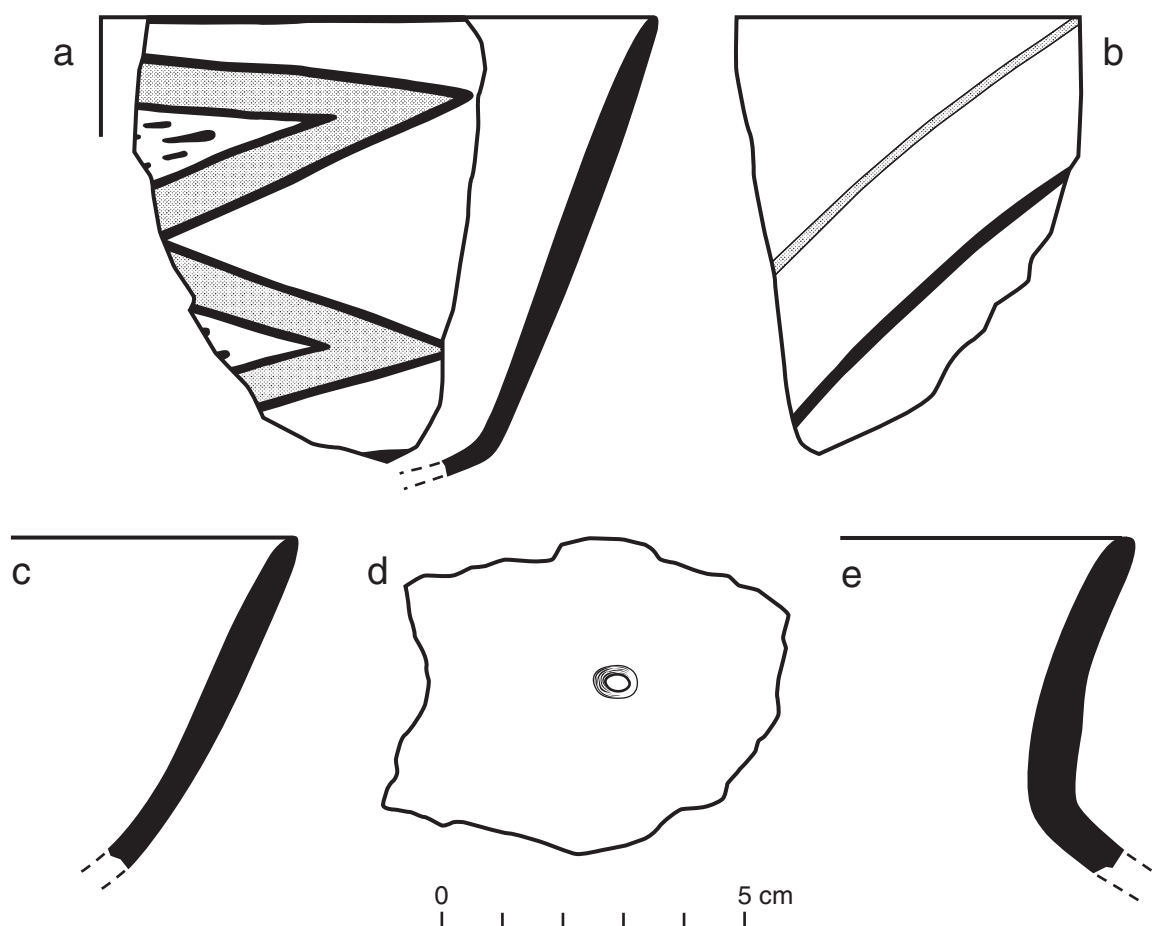
Figure 9.9. Sherds from Zone E of Terrace 16, Quebrada 5. (a, b): Pingüino Buff bowl, painted black and yellow on both exterior and interior. Yellow paint (2.5 Y 8/6) is indicated by light screen. (a): interior of vessel; (b): exterior. (c): rim of Pingüino Buff bowl, nearly hemispherical. (d): Camacho Reddish Brown jar body sherd, drilled through from the exterior; (e): Camacho Reddish Brown, slightly flaring rim from jar.

This is a Pingüino Buff bowl, painted black and yellow on both the interior and exterior (Figure 9.9a, b). Like the black-and-yellow painted bowls discussed earlier in Chapter 3 (Figure 3.19), this choice of color and design on the interior of a bowl reminds one of earlier sites like Cerro del Oro. The full sherd collection is as follows:

Camacho Reddish Brown (Figure 9.9d, e)

Pingüino Buff (Figure 9.9a–c)

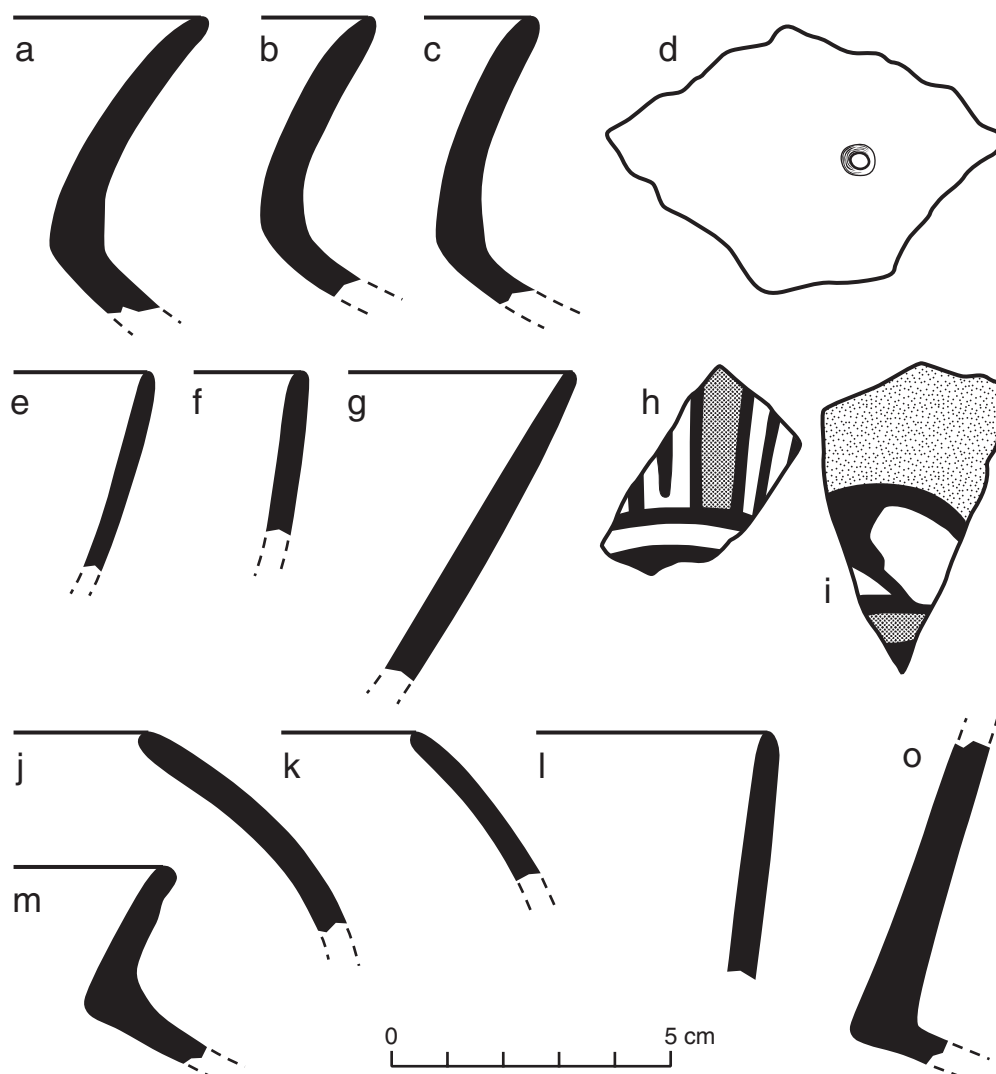
Figure 9.10. Sherds from Zone D of Terrace 16, Quebrada 5. (*a-c*): Camacho Reddish Brown, flaring rims from jars; (*d*): Camacho Reddish Brown jar body sherd, drilled from the exterior of the vessel; (*e, f*): Trambollo Burnished Brown, rims from hemispherical bowls; (*g*): Trambollo Burnished Brown, rim from open bowl; (*h, i*): Trambollo Burnished Brown, bowl body sherds, painted black/white/red on the interior of the base (light stipple indicates natural brown; medium screen indicates red); (*j, k*): Pingüino Buff rims from neckless jars, slipped cream white on the exterior; (*l*): Pingüino Buff rim from hemispherical bowl, discolored in firing; (*m*): Pingüino Buff rim from globular jar with wide mouth; (*o*): Pingüino Buff sherd from funnel-necked jar, painted white on natural.

Camacho Reddish Brown (Figure 9.10a–d)

Pingüino Buff (Figure 9.10j–o)

Trambollo Burnished Brown (Figure 9.10e-i)

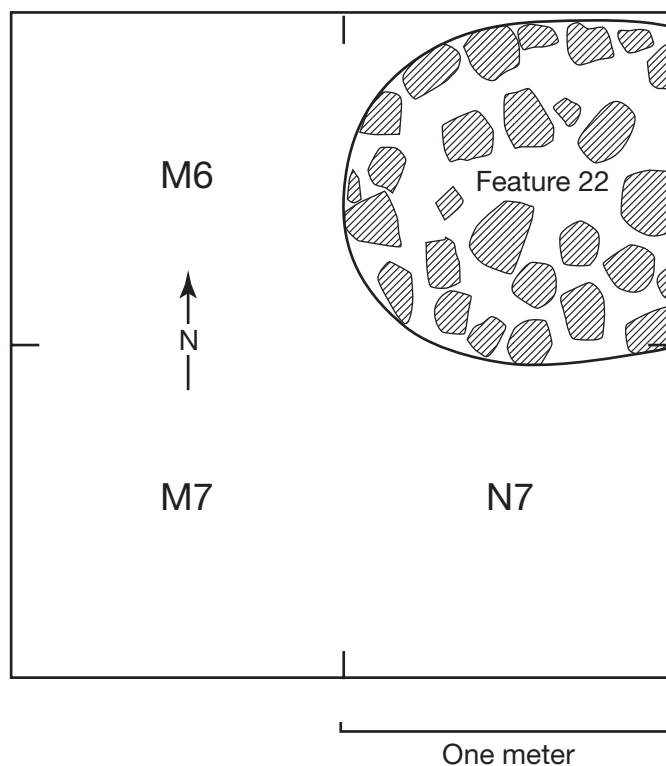
Figure 9.11. Quebrada 5, Terrace 16. Plan of Squares M6–N7 at the level of Zone A2. Feature 22 was a basin-shaped hearth filled with fire-cracked rocks, ash, and sea lion bones.

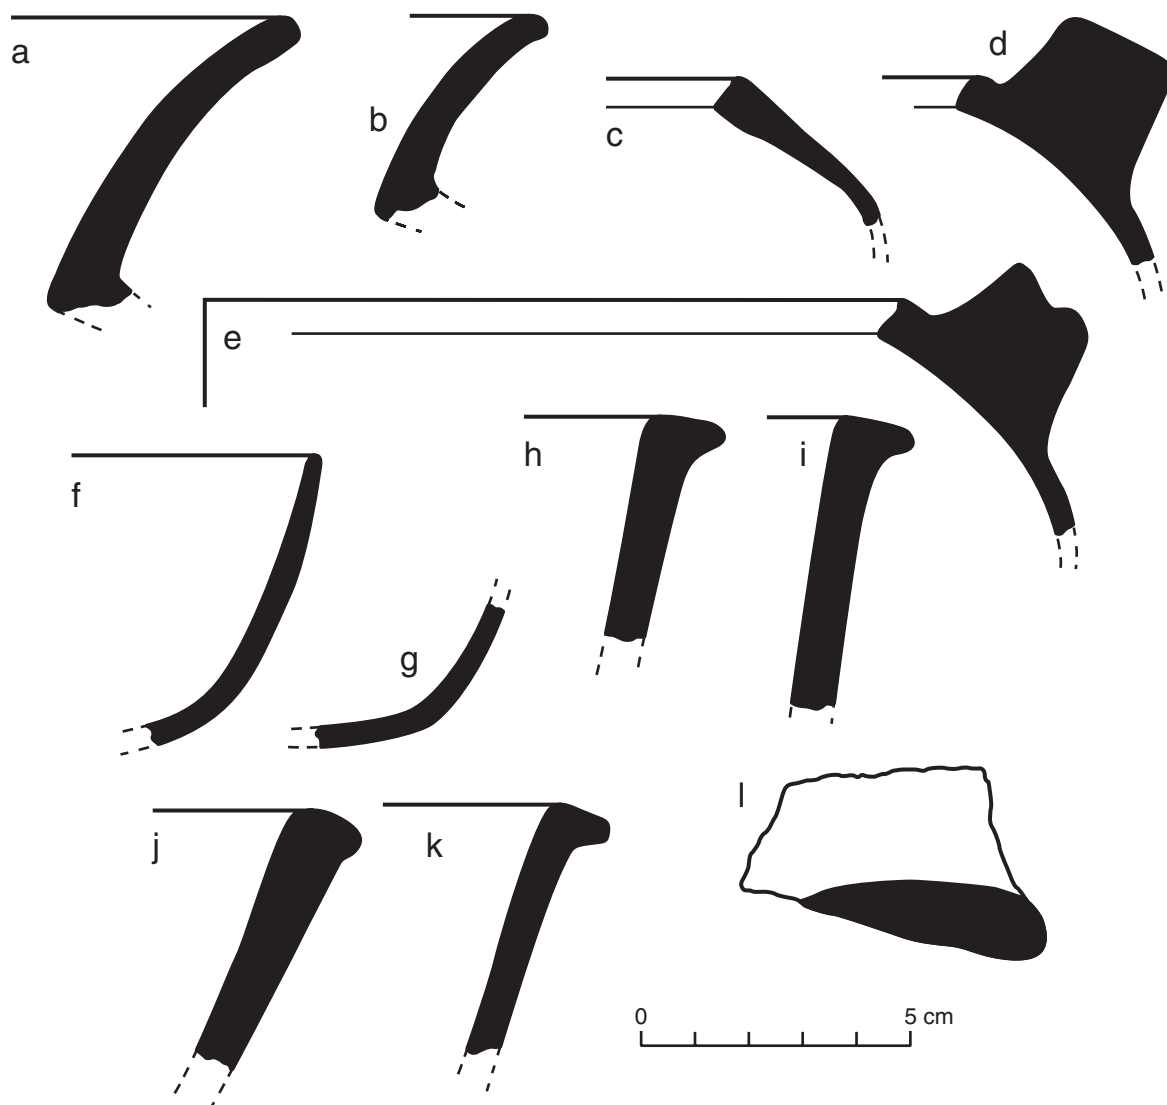
Figure 9.12. Sherds from Zone A of Terrace 16, Quebrada 5. (*a, b*): Camacho Reddish Brown, flaring rims from jars; (*c–e*): Camacho Reddish Brown, cooking pots with restricted orifice, fire-blackened. Sherds *d* and *e* have horizontally set strap handles. (*f, g*): Trambollo Burnished Brown, sherds from hemispherical bowls; (*h, i*): Pingüino Buff, everted rims of funnel-necked jars; (*j*): Pingüino Buff, slightly everted or bolstered rim of thick jar; (*k*): Pingüino Buff everted jar rim, discolored; (*l*): Pingüino Buff bowl body sherd with glossy black paint on interior.

A glance at Figure 9.12 shows that this collection is contemporaneous with the occupation of Structure D. The strap-handled, restricted-orifice cooking pots in Camacho Reddish Brown are prototypical; so are the Pingüino Buff jars with funnel necks or slightly everted rims. Camacho Black, standard variety, is also present. The full list of diagnostic sherds is as follows:

Camacho Reddish Brown (Figure 9.12a–e)

Pingüino Buff (Figure 9.12b–l)

Trambollo Burnished Brown (Figure 9.12*f, g*)
 Hemispherical bowl: 1 rim sherd, 1 body sherd

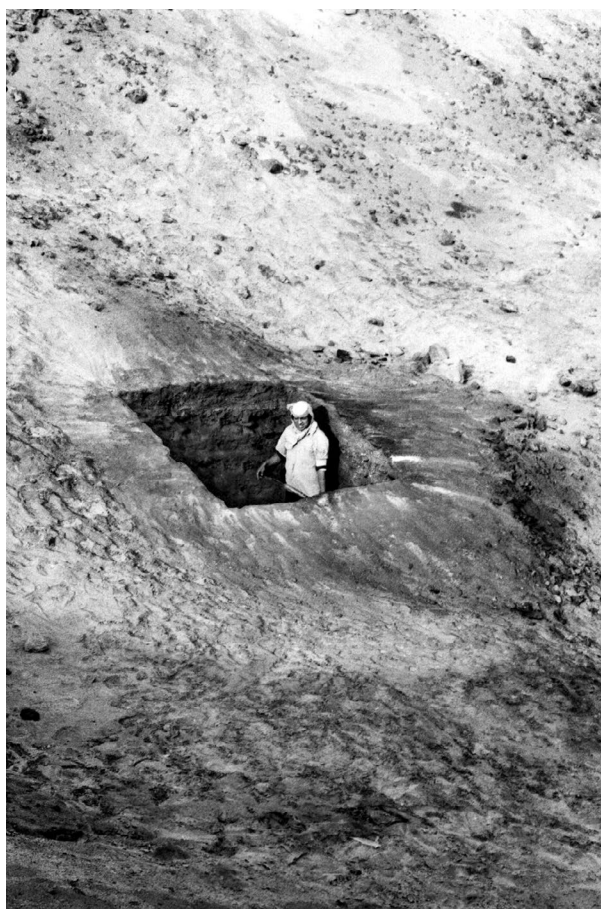
Figure 9.13. Quebrada 5, Terrace 16. Pedro Manuel Zavala stands in the excavation, which has now reached a depth of 1.5 m.

Terrace 16 is relatively deep (Figure 9.13) and shows two phases of activity. Early in the Late Intermediate period (perhaps A.D. 1100–1300), it was used for the dumping of refuse from one or more *tapia* compounds. Then came a period of disuse, during which sterile deposits formed on the terrace. At a later stage of the Late Intermediate, perhaps A.D. 1300–1470, Terrace

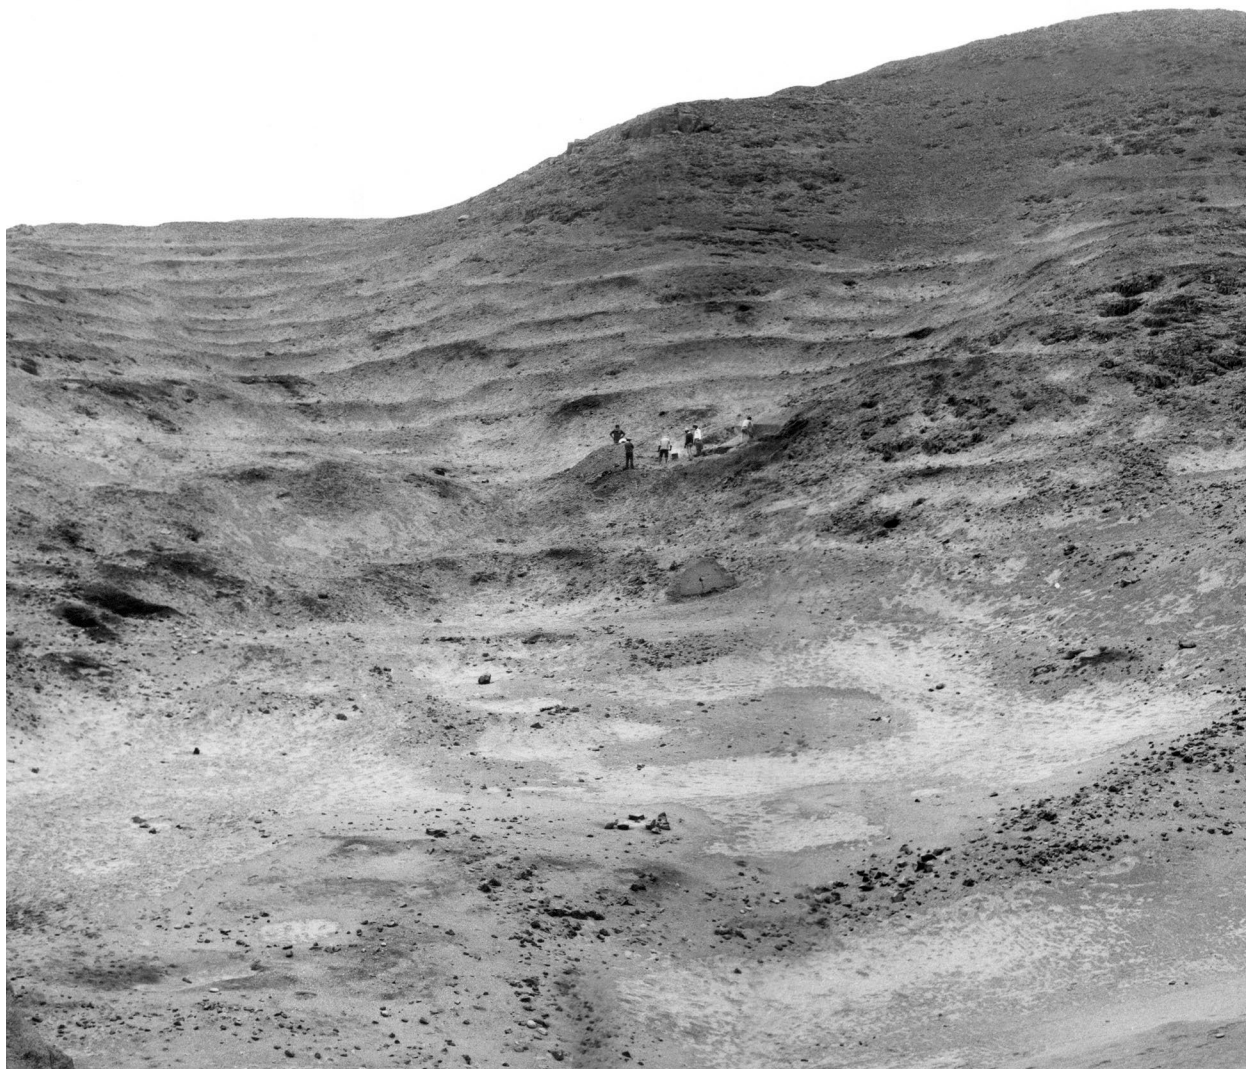
Figure 9.14. Quebrada 5, seen from a high point on Structure F. Work is in progress in Structure 11, on the south side of the quebrada. (Note the old looters' holes on the slope at the far left and the oval depression in the foreground.)

As Quebrada 5 descends to the level of Structure E, it widens into the shape of a crescent whose arms enclose an oval depression (see Figure 2.2 in Chapter 2). This crescent-shaped area could be seen as having northern, central, and southern sectors. Figure 9.14 shows the oval depression in the mouth of the quebrada, a series of old looters' holes on the slopes of the northern sector, and our crew of workmen beginning an excavation in the southern sector.

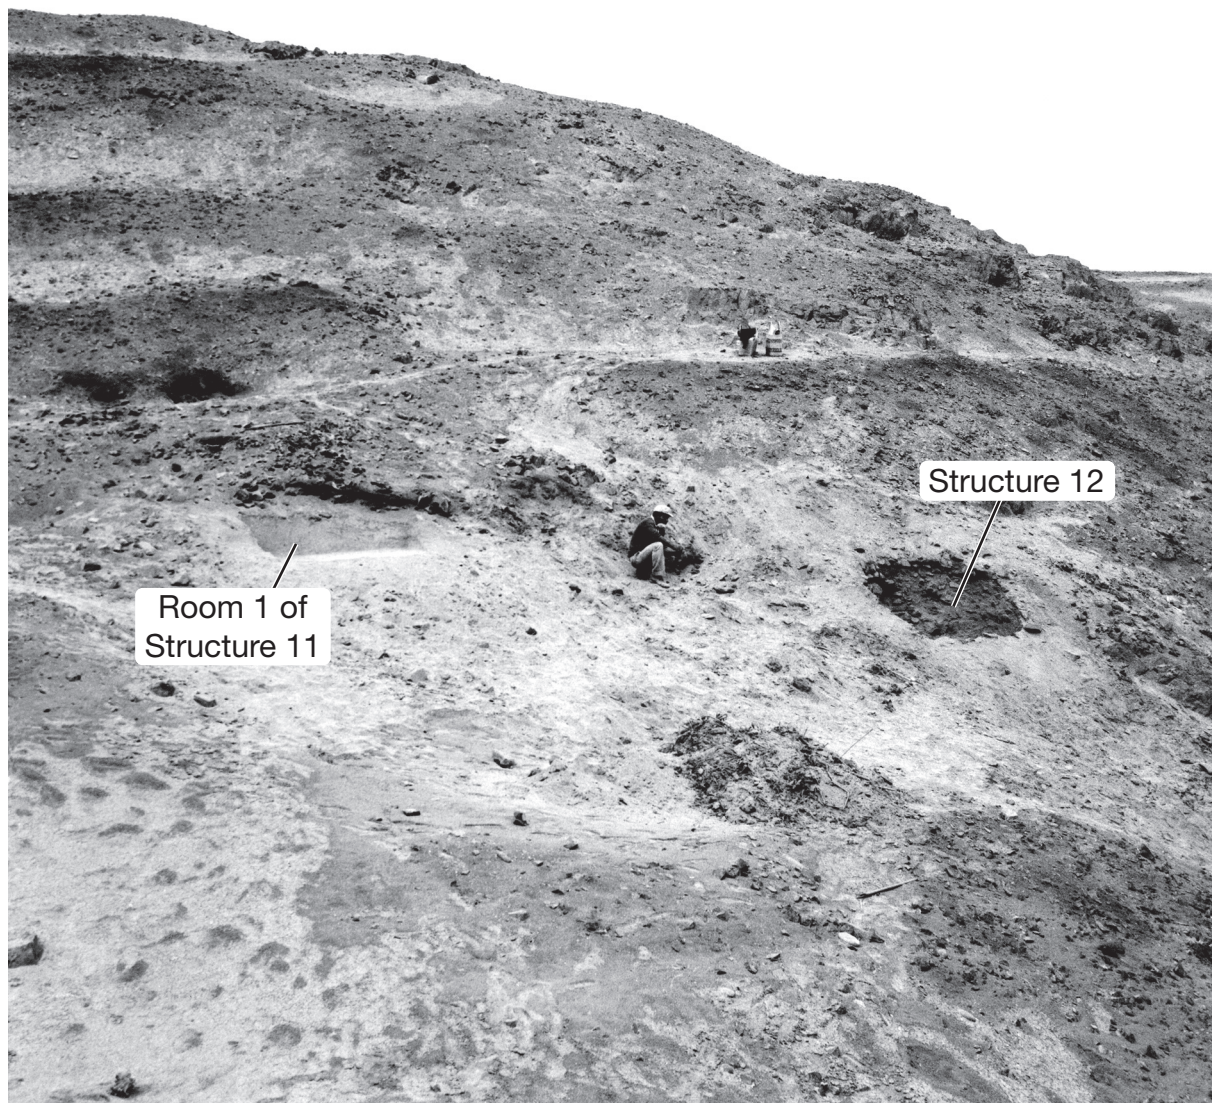
Figure 9.15. Quebrada 5-south, showing Structures 11 (a *tapia*-walled storage unit) and 12 (a looted burial cist) not long after their initial discovery. (At this point, only Room 1 of Structure 11 had been exposed.)

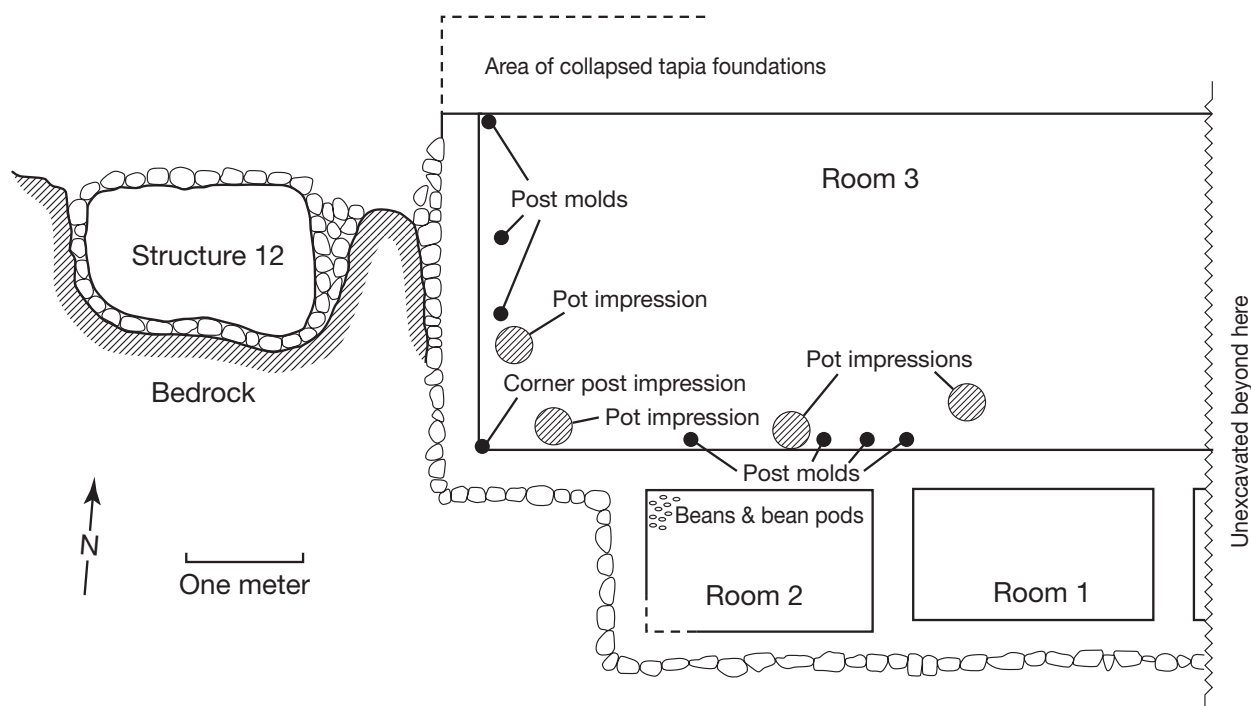
Figure 9.16. Quebrada 5-south: plan of Structures 11 (R) and 12 (L).

Figure 9.16 shows the three rooms we exposed, and Figure 9.17 presents a north-south cross section through Structure 11. The building had at least two phases of construction and had lost its northern tapia wall to wind erosion. Our excavations revealed a line of small storage units, including Rooms 1 and 2, which continue beyond our excavation. Below and to the north of these small units is a much larger room—Room 3—of which we exposed an area 2.6×1.5 m. Figure 9.18 shows the surviving remnant of Room 1, and Figure 9.19 documents the exposure of Room 3. In the lower half of Figure 9.19, one can see bedding lines from post-abandonment wind erosion on the south wall of Room 3.

There were desiccated beans and maize in Room 1, and in the corner of Room 2 was a deposit of *Phaseolus* beans still in their pods (see Figure 9.16). When questioned, our workmen told us that because the quebradas are farther from the ocean and its salt fog, they would have been better places to store vegetal foods than the *tapia* compounds nearer to the beach.

For its part, at least late in its history, Room 3 may temporarily have become residential; a *kincha* house was built in it. The evidence consists of (1) eight post molds, which we discovered along the west and south limits of the floor (Figure 9.16), and (2) several fallen chunks of clay daub

Structure 12 is a typical Late Intermediate burial cist, found just to the west of Structure 11 (Figure 9.16). The cist is roughly 2 m wide east to west and an average of 1.4 m wide north to south (Figure 9.23a). Its creators had dug down through midden debris until they reached the bedrock of the quebrada, which (as described earlier in this chapter) descends in the form of natural steps (Figure 9.23b). At an average depth of 1.28 m below the surface, the builders laid in a clay floor to compensate for the irregularities in the bedrock.

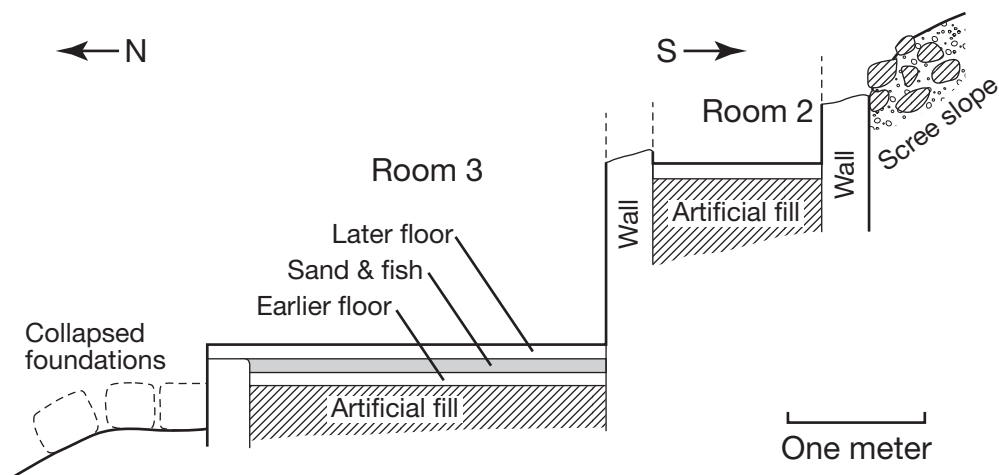
Figure 9.17. Quebrada 5-south. North-south cross section through Rooms 2 and 3 of Structure 11.

Figure 9.17 provides some insights into the construction history of Structure 11. The building was set against the stony slope of the quebrada, with any available loose stones used to fill in the irregular gaps between bedrock and the tapia walls. The downhill (north) wall of the building had been buttressed with tapia blocks. Artificial fill had been used to level the clay floors of Rooms 2 and 3. At some point, Room 3 had been given a second clay floor, 10 cm above the first. The space between the two floors had been filled with sand containing the bones of anchovies and sardines.

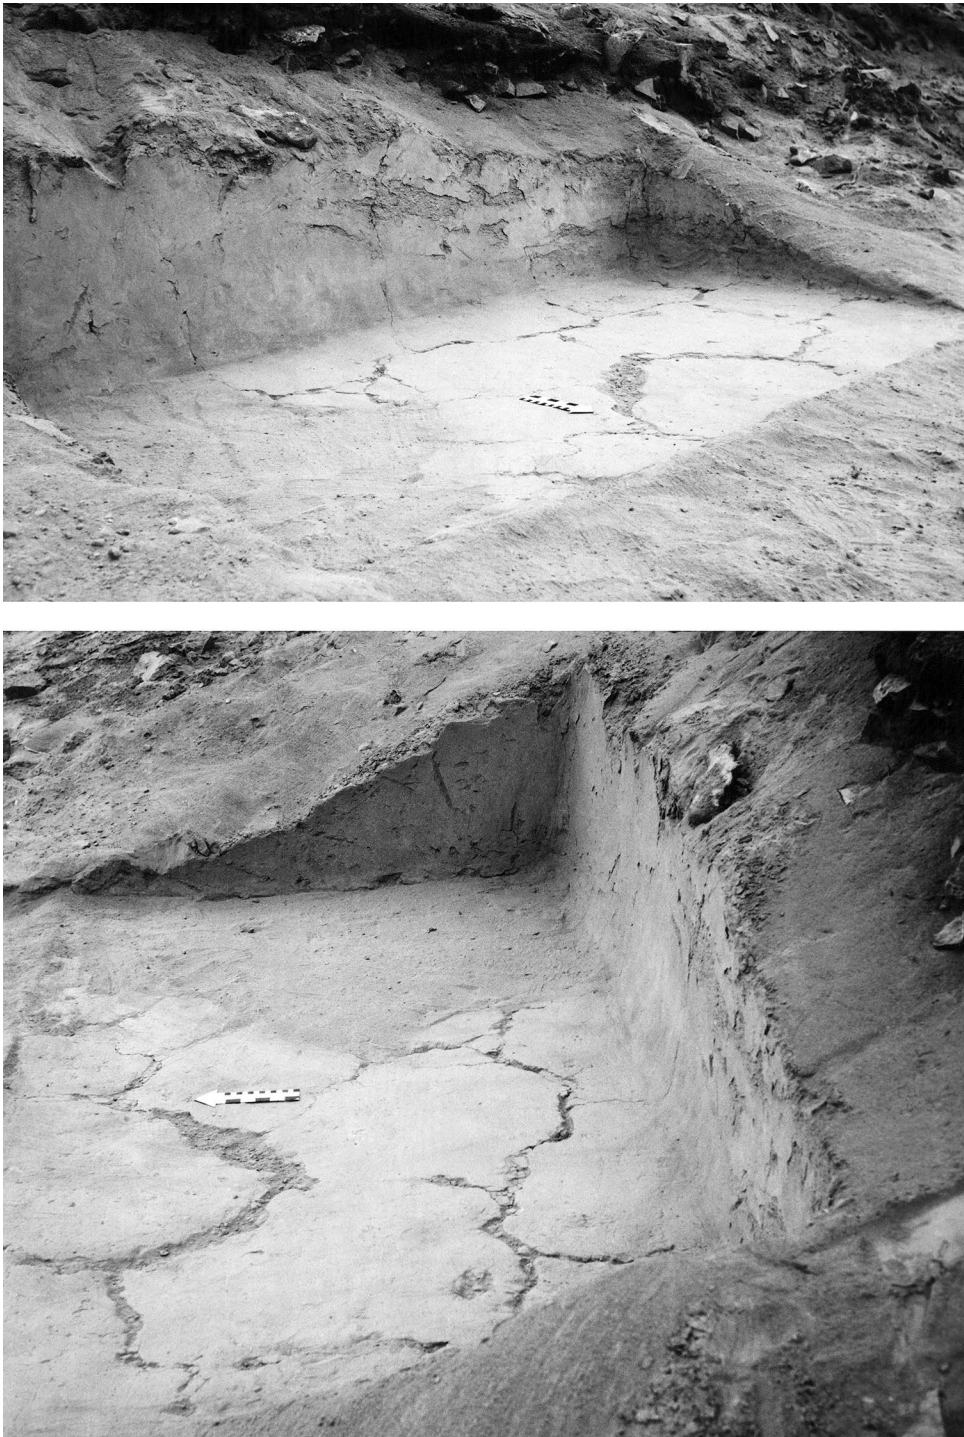
Figure 9.18. Two views of Room 1, Structure 11. (*Top*): the room as seen from the northeast. (*Bottom*): a view from the west.

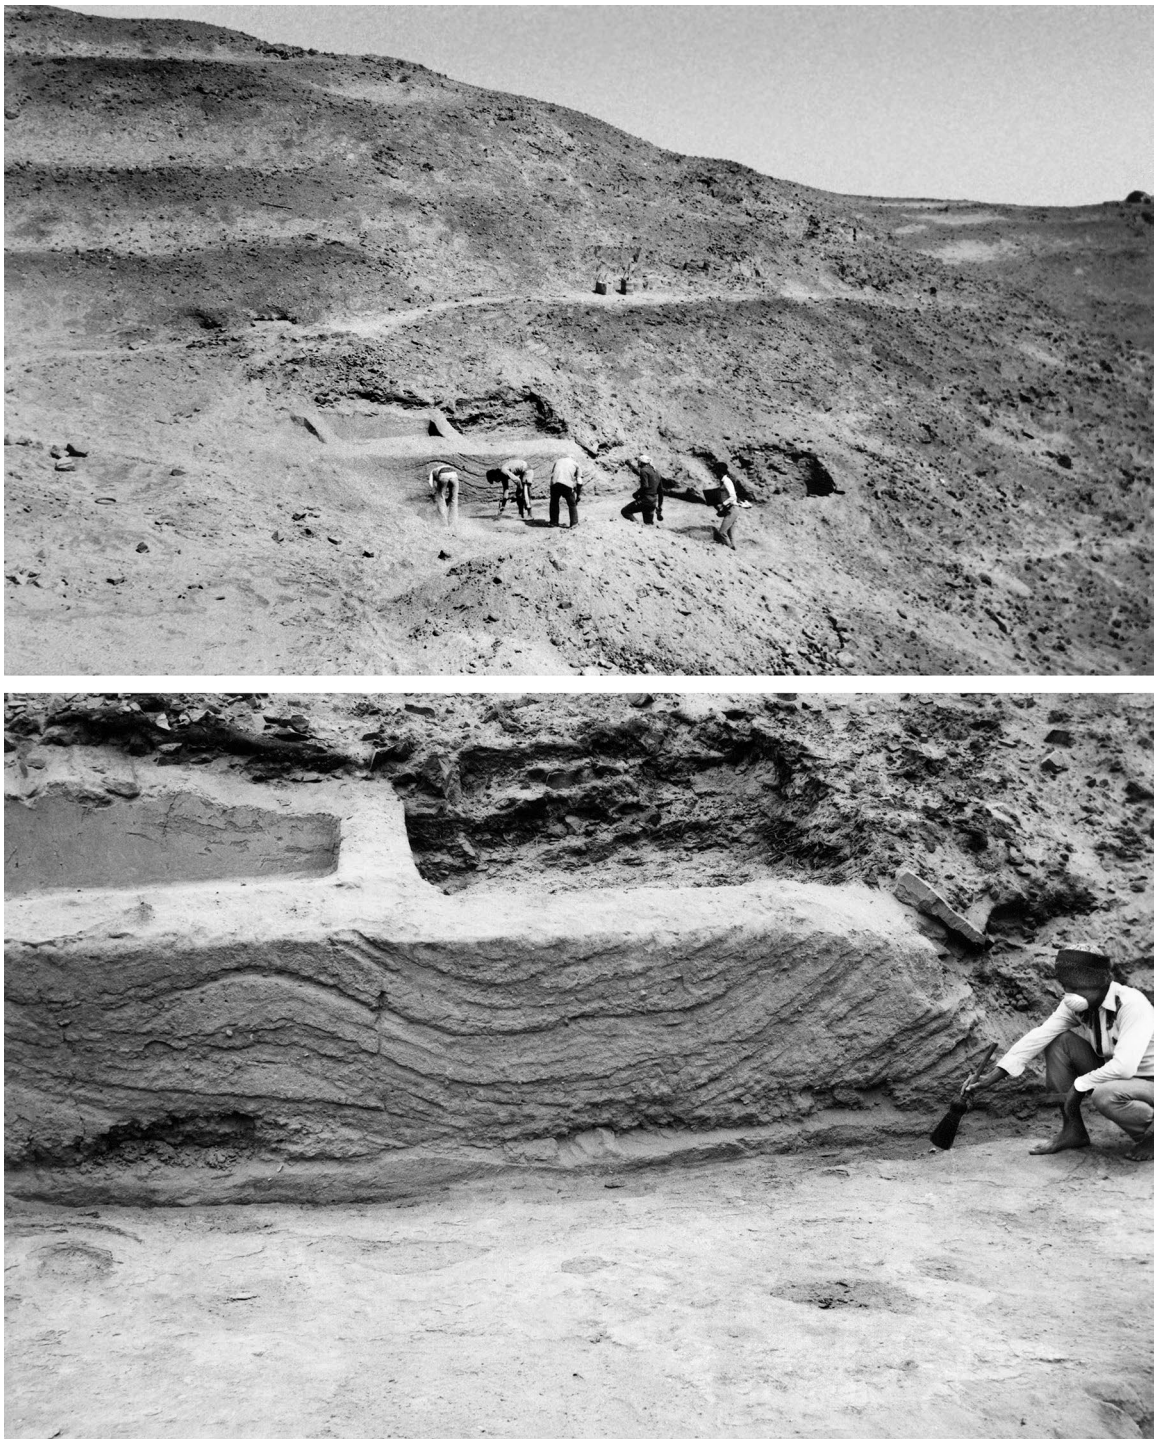
Figure 9.19. Two views of Room 3, Structure 11. (*Top*): workmen are exposing the floor of the room. (*Bottom*): Iván Francia (with dust mask in place) sweeps below the south wall of Room 3. Bedding lines left by wind erosion show how the room slowly filled in with sand after abandonment.
