MONOGRAPH 62
COTSEN INSTITUTE OF ARCHAEOLOGY
UNIVERSITY OF CALIFORNIA, LOS ANGELES

EXCAVATIONS AT
CERRO AZUL, PERU
THE ARCHITECTURE AND POTTERY
JOYCE MARCUS

Excavations at Cerro Azul, Peru

THE ARCHITECTURE AND POTTERY

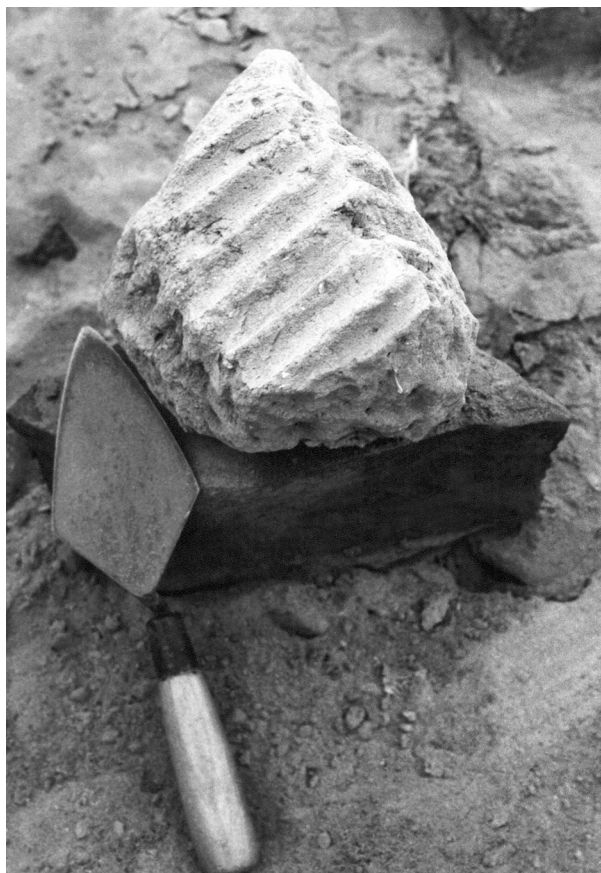
Figure 9.20. A chunk of cane-impressed daub from a *kincha* building placed in Room 3 of Structure 11.

For its part, at least late in its history, Room 3 may temporarily have become residential; a *kincha* house was built in it. The evidence consists of (1) eight post molds, which we discovered along the west and south limits of the floor (Figure 9.16), and (2) several fallen chunks of clay daub

with cane impressions (Figure 9.20). In the later of the two clay floors, we also found four impressions left by convex-based ceramic vessels (probably jars) that had rested on the floor for some time. Like the *kincha* house in the center of Structure 9, this building may have been the residence of a lower-level administrator who oversaw the filling and emptying of the storage units.

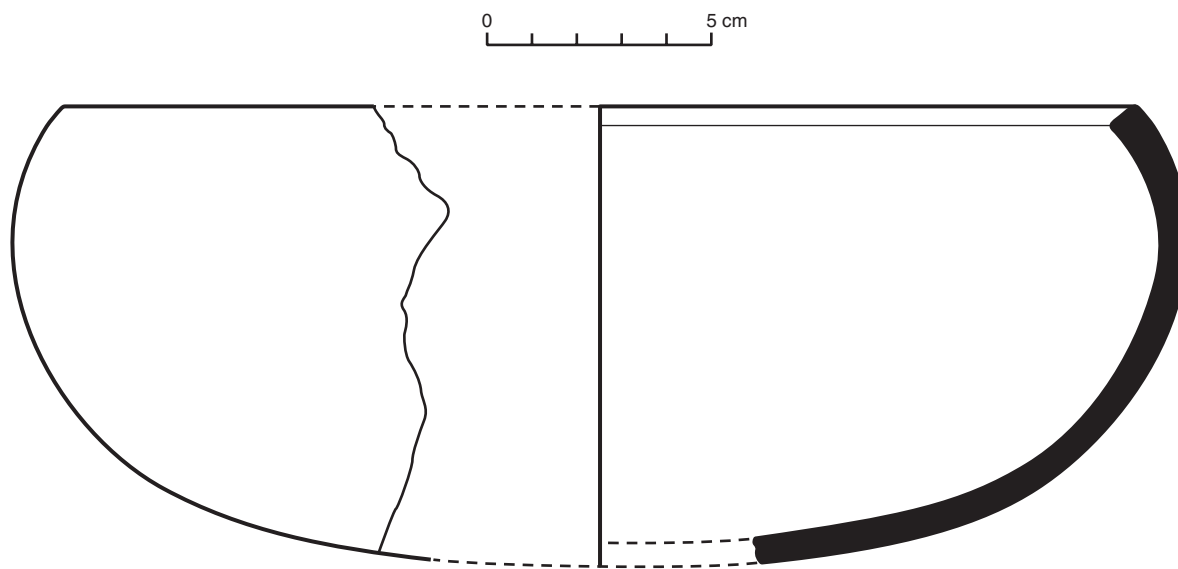
Figure 9.21. Vessel from the fill of Room 3, Structure 11, Quebrada 5-south. This is a Camacho Reddish Brown cooking pot with restricted orifice, fire-blackened and carbon-crusts over the entire exterior. Reconstructed from one large sherd, this vessel may have had strap handles on the missing portion.

sociated with the *kincha* house, were recovered (Figures 9.21, 9.22). This ceramic collection appears to be a primary deposit, that is, a collection of cooking and storage wares left in Room 3 at the time of its abandonment, and eventually damaged by erosion and the weight of the overburden. It has the look of lower-status domestic pottery. The full collection of sherds is as follows:

Camacho Reddish Brown (Figures 9.21, 9.22a–c)

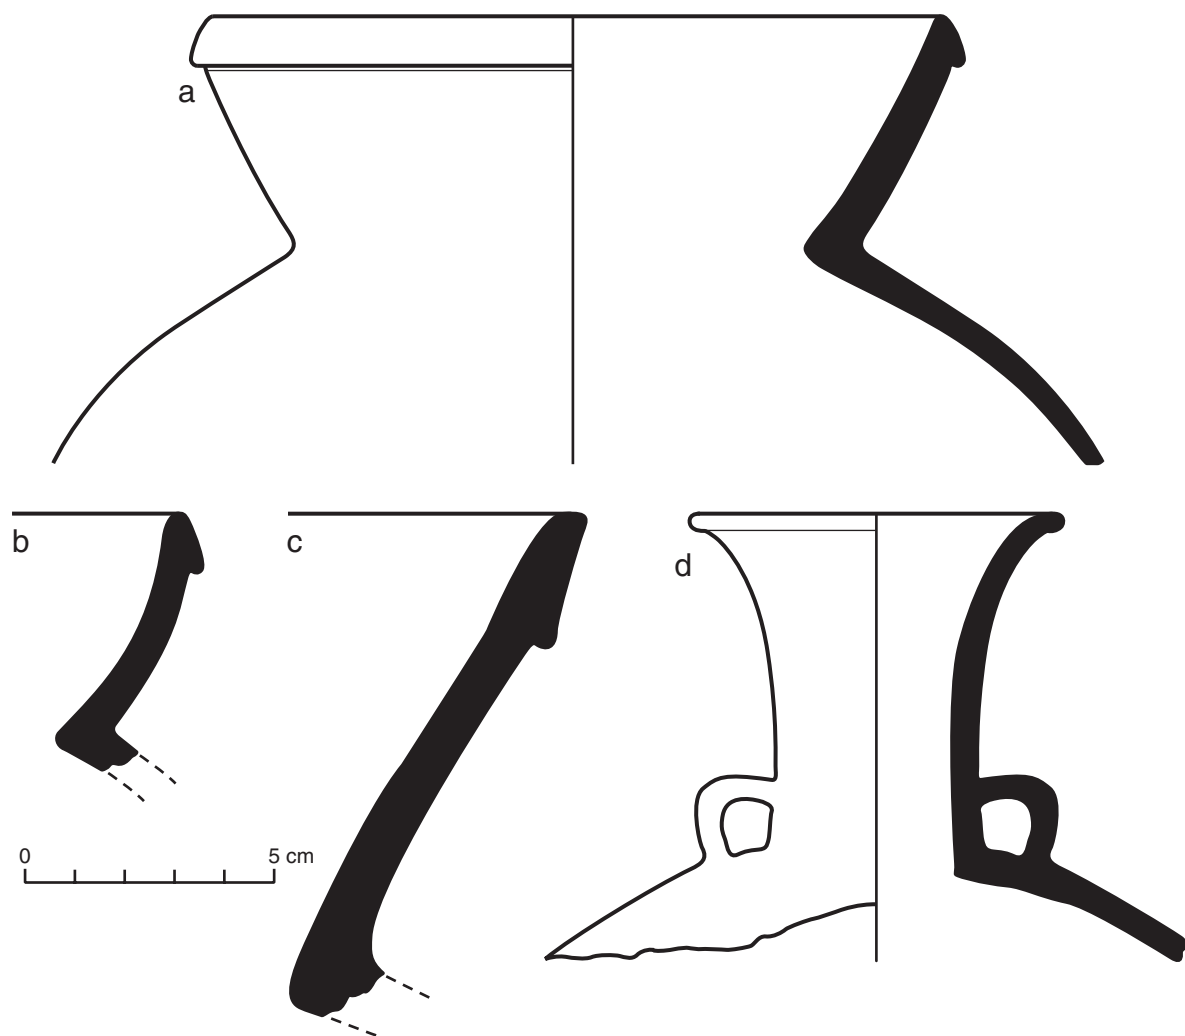
Figure 9.22. Sherds from the fill of Room 3, Structure 11, Quebrada 5-south. (*a–c*): Examples of Camacho Reddish Brown jars with cambered rims; (*d*): apparently misfired Camacho Black jar or amphora with paired handles connecting the neck and shoulder. The vessel shape is right for Camacho Black, but the jar seems to have been accidentally oxidized during firing, so that the paste came out pale orange (5 YR 7/6) and the exterior surface dark orange (2.5 YR 5/8).

Possible misfired Camacho Black? (Figure 9.22d)

Jar or amphora with tall neck and two strap handles linking neck and shoulder (the paste is light orange and the surface is dark orange, looking like an accidentally oxidized Camacho Black): 1 neck

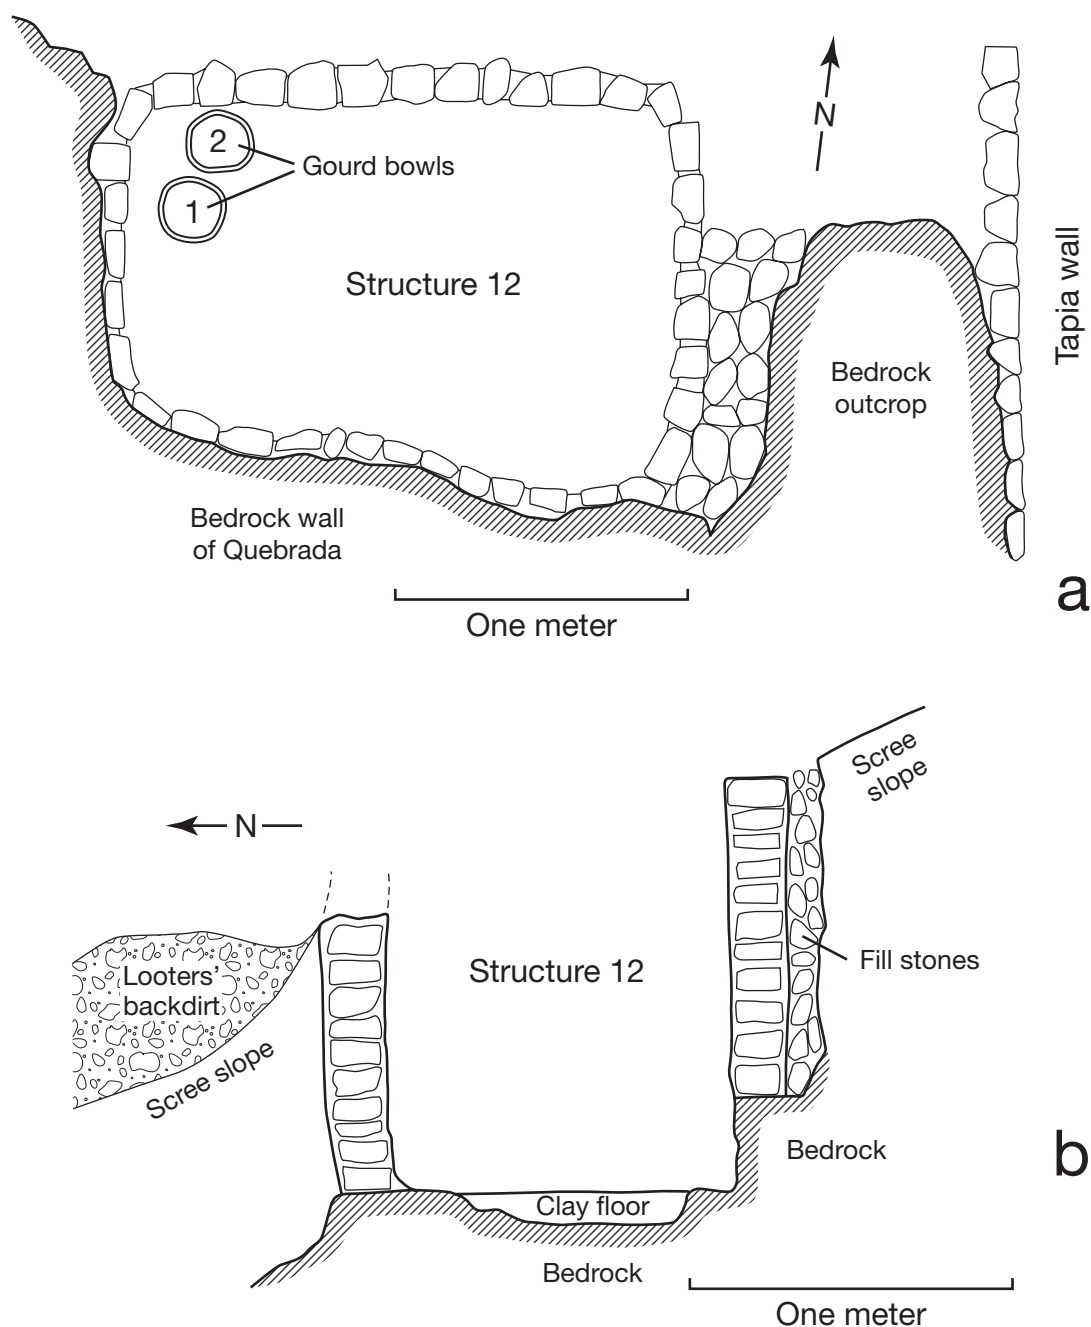
Figure 9.23. Quebrada 5-south. (a): plan of Structure 12, a looted burial cist to the west of Structure 11; (b): north-south cross section through Structure 12.

Structure 12 is a typical Late Intermediate burial cist, found just to the west of Structure 11 (Figure 9.16). The cist is roughly 2 m wide east to west and an average of 1.4 m wide north to south (Figure 9.23a). Its creators had dug down through midden debris until they reached the bedrock of the quebrada, which (as described earlier in this chapter) descends in the form of natural steps (Figure 9.23b). At an average depth of 1.28 m below the surface, the builders laid in a clay floor to compensate for the irregularities in the bedrock.

(2) did not empty the cist completely. Several large sections of broken vessels were found in the looters' backdirt pile, whose location is shown in Figure 9.23b. Hidden in the slumped debris covering the clay floor of the cist we discovered two hemispherical gourd bowls that had evidently

held food offerings (including dried fish) for one or more of the burials (for location, see Figure 9.23a). We do not know how many individuals had been buried in Structure 12, but the human bones left by the looters show that at least one adult and one child had been present.

In places, Structures 11 and 12 are separated by an outcrop of bedrock that projects north from the wall of the quebrada. In other places, they are separated by tightly packed midden debris. In Figure 9.23a, this midden deposit lies in the area occupied by the north arrow.

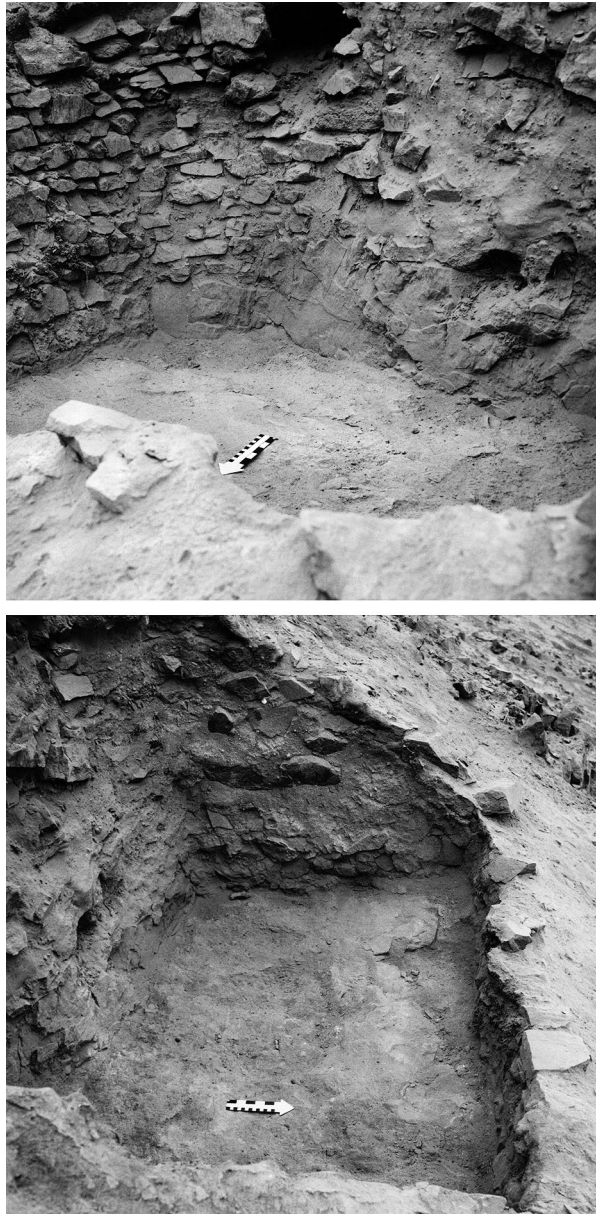
Figure 9.24. Two views of Structure 12, a looted, dry-laid stone masonry burial cist. (*Top*): the southeast corner. (*Bottom*): the west end. (Arrow points north and is marked in both centimeters and inches.)

As can be seen in Figure 9.24, the walls of the cist are composed of unmodified stones picked up from the slope of the quebrada and stacked carefully atop each other. Once stacked, the stones were held in place by a layer of clay plaster. How the cist had been roofed is unknown. It appears that over the centuries, the earth and midden debris concealing Structure 12 had eroded away to the point where the tops of the stone walls were exposed; this had attracted the attention of looters.

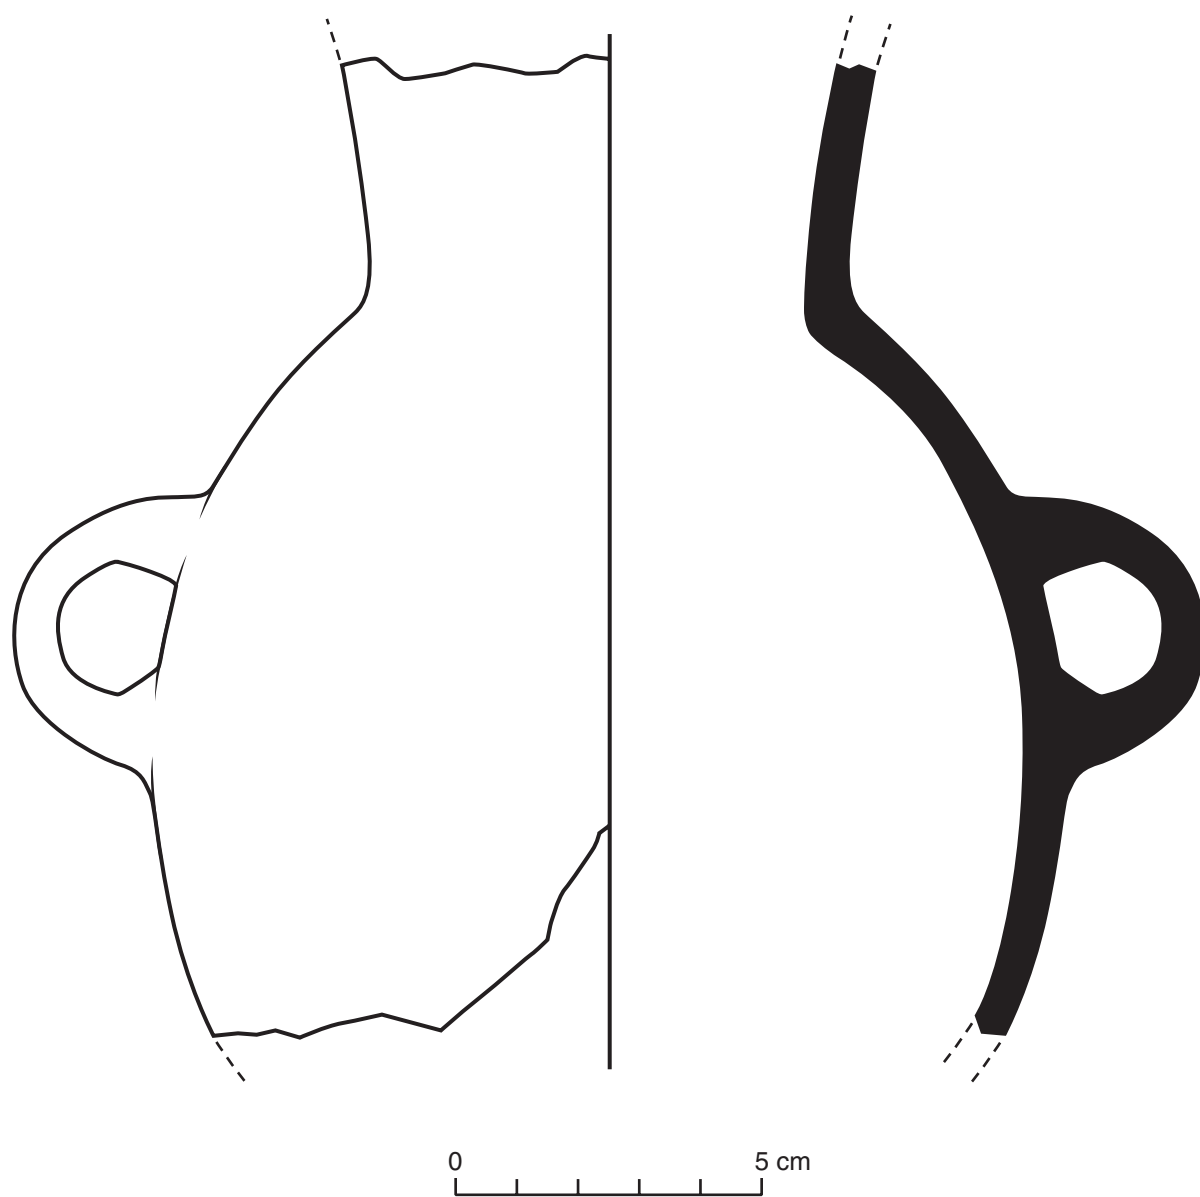
Figure 9.25. Vessel from Structure 12 in Quebrada 5-south. This amphora, originally from Structure 12 but found in looters' backdirt, is too eroded to be classified. The paste is uniformly gray, but there are traces of bur-nished pinkish reddish surface in places (reconstruction based on partial vessel).

Figures 9.25 and 9.26 present some of the larger sherds from the looters' backdirt. They include a badly eroded amphora (Figure 9.25), a

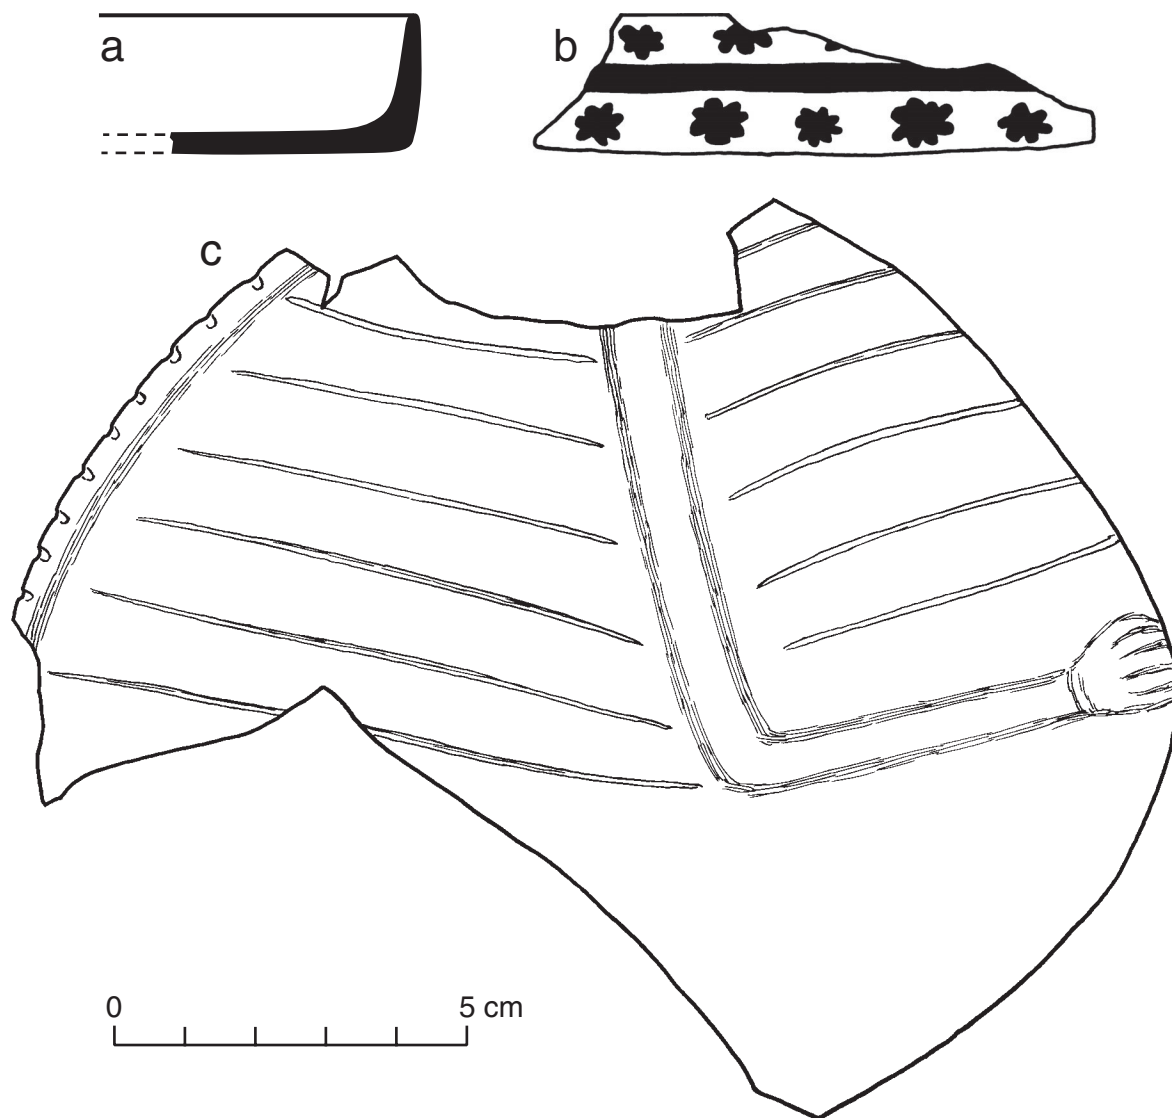
Figure 9.26. Sherds from Structure 12 in Quebrada 5-south. (*a, b*): Pingüino Buff shallow dish or saucer, slipped cream white and painted in black and white on the exterior, left natural buff (and burnished) on the interior. (*a*): profile; (*b*): exterior of sherd. (*c*): Camacho Black “fat skeleton” vessel with ribs and vertebral column indicated by modeling and incising. Highly burnished. Found in looters’ backdirt; probably from a looted burial in Structure 12.

black-and-white painted Pingüino Buff dish (Figure 9.26a, b), and a highly burnished Camacho Black "fat skeleton" vessel (Figure 9.26c).

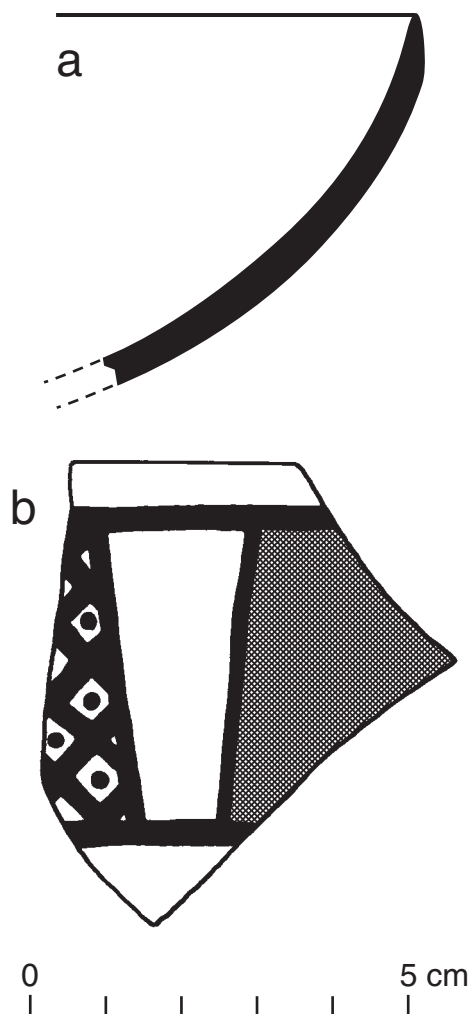
Figure 9.27. Pingüino Buff sherd from the midden deposit between Structures 11 and 12, Quebrada 5-south. The sherd is from a hemispherical bowl, slipped white on both interior and exterior, painted on the exterior in black and purplish gray over white. (a): profile; (b): exterior of sherd. Dark screen indicates purplish gray (5 R 3/1).

One sherd from this deposit, however, attracted my attention because it may date to an earlier stage of the Late Intermediate than the bulk of Structures D and 9. It comes from a hemispherical Pingüino Buff bowl, slipped white on both interior and exterior, and painted on the exterior in black and purplish gray (Figure 9.27). The use of purplish paint reminds us of some of the sherds with “Life Saver” motifs which come from deep levels in other quebradas (see Figure 3.20c, Chapter 3).

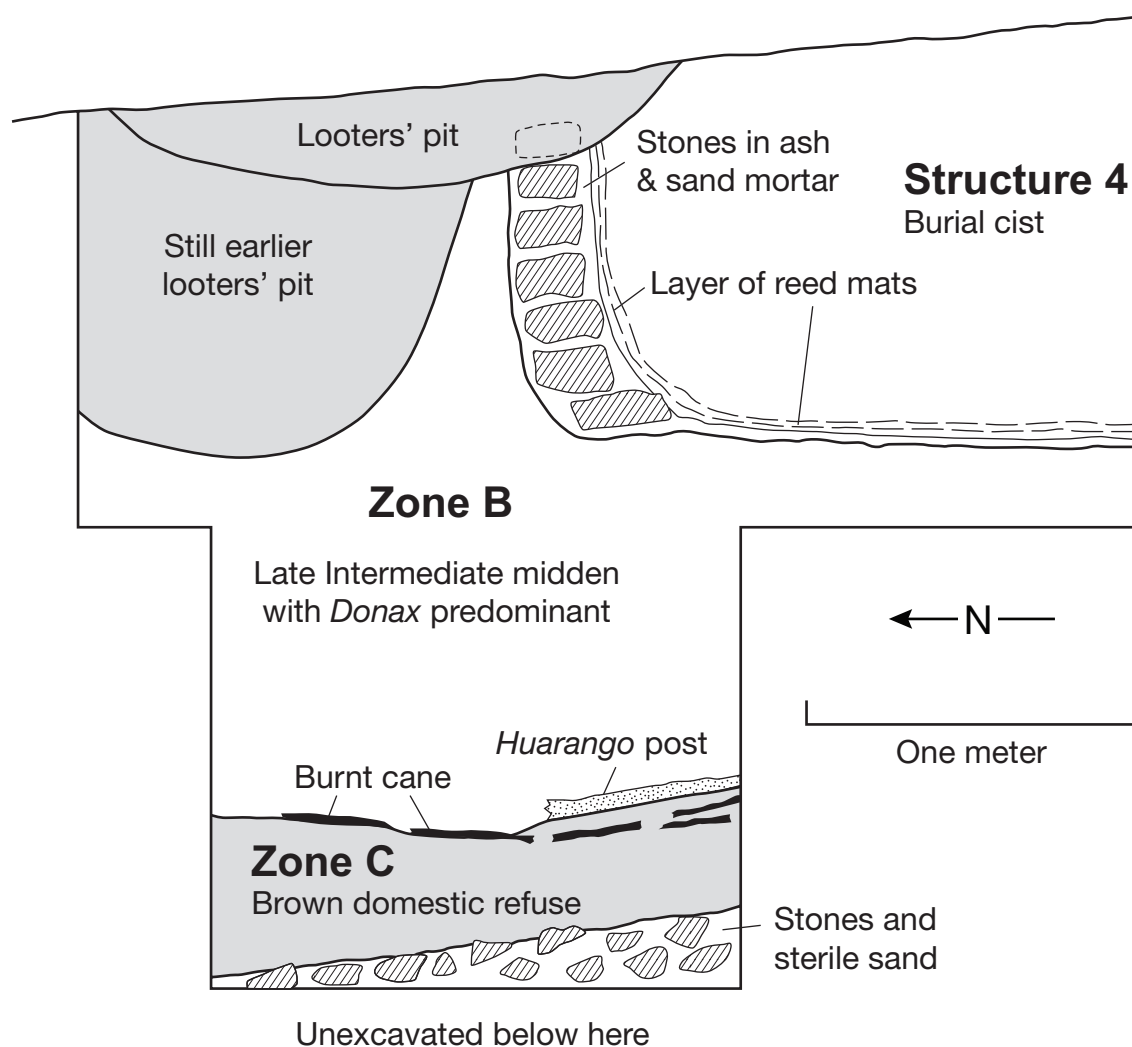
Figure 9.28. The north-south cross section of a deep sounding into Terrace 9 of Quebrada 5a, below the level of the Structure 4 burial cist.

Figure 9.28 presents the north-south cross section of this sounding, which is 1.6 m wide and reaches a layer of sterile sand and stones at an average depth of 2.6 m below the surface of Terrace 9. We ended the excavation at this point, and while we presume that this deposit of stones and sterile sand overlies bedrock, we cannot guarantee it.

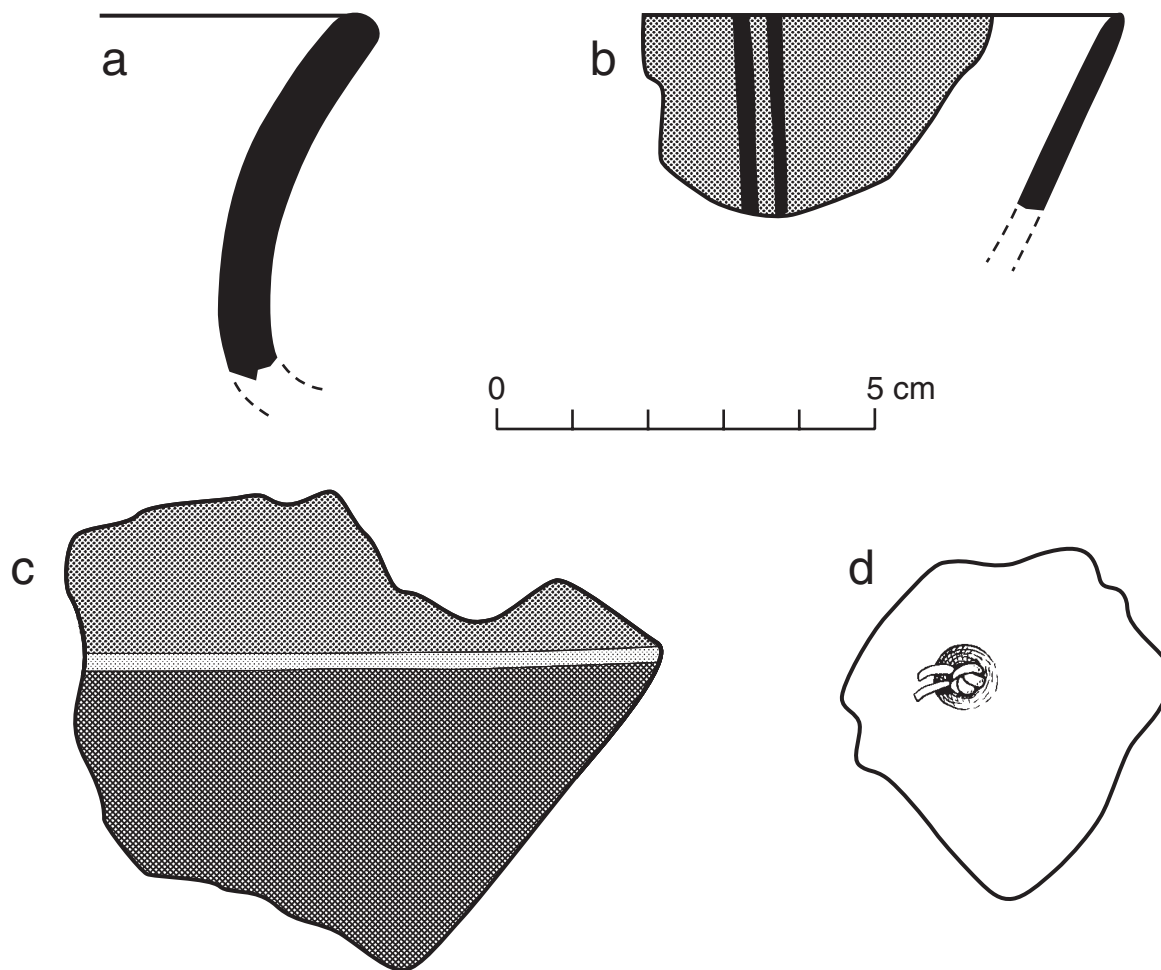
Figure 9.29. Sherds from Lower Zone C of the 5 × 5 m excavation block, Terrace 9, Quebrada 5a. (a): Camacho Reddish Brown, flaring rim from fire-blackened jar; (b): unclassified ware, thin-walled open bowl with sandy reddish clay body, slipped red (10 R 4/6) on the interior, then painted with vertical black lines; (c): unclassified ware, thin-walled jar with polychrome painting on the exterior. A horizontal yellow-cream band crosses the sherd. Above the band, it is slipped red (10 R 4/6); below the band, it is slipped purple (10 R 4/2). (d): Camacho Reddish Brown jar body sherd perforated for suspension, with cotton cord and knot preserved inside the perforation.

screened. The lowest of these levels produced 42 sherds; four of the most interesting are illustrated in Figure 9.29. The total inventory is as follows:

Camacho Reddish Brown (Figure 9.29a, d)

Open bowl, slipped red on interior, painted with neat black lines over this; left light brown on exterior: 1 rim (Figure 9.29b)

Jar body sherds, slipped in zones on exterior; zoning band yellow-cream; slipped red above band, purple below: 5 (Figure 9.29c)

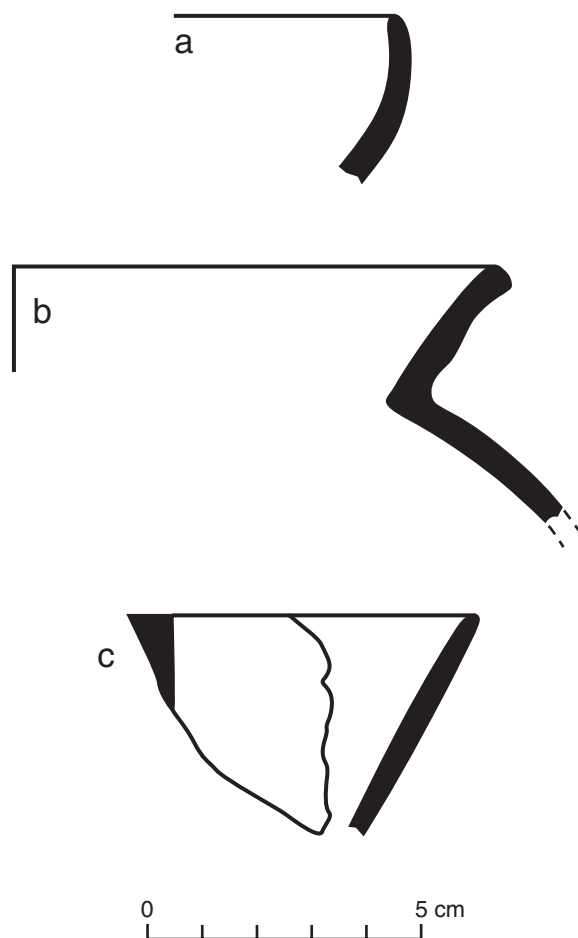
Figure 9.30. Sherds from Middle Zone C of the 5 × 5 m excavation block, Terrace 9, Quebrada 5a. (a): unclassified ware, hemispherical bowl with sandy reddish clay body, slipped red (2.5 YR 3/6) on both exterior and interior; (b): Pingüino Buff globular jar with wide mouth, apparently unpainted; (c): unclassified ware, open bowl, clay body reddish brown with a gray core, slipped yellow-cream (7.5 YR 6/4) on both exterior and interior, painted “graphite” black on the interior.

The middle arbitrary level taken from Zone C yielded 48 sherds, three of which are illustrated in Figure 9.30. The total collection of sherds is as follows:

Pingüino Buff (Figure 9.30b)

Hemispherical bowl, slipped red on interior and exterior: 1 rim (Figure 9.30a)

Open bowl, slipped yellow-cream on interior and exterior; painted “graphite” black on interior: 1 rim (Figure 9.30c)

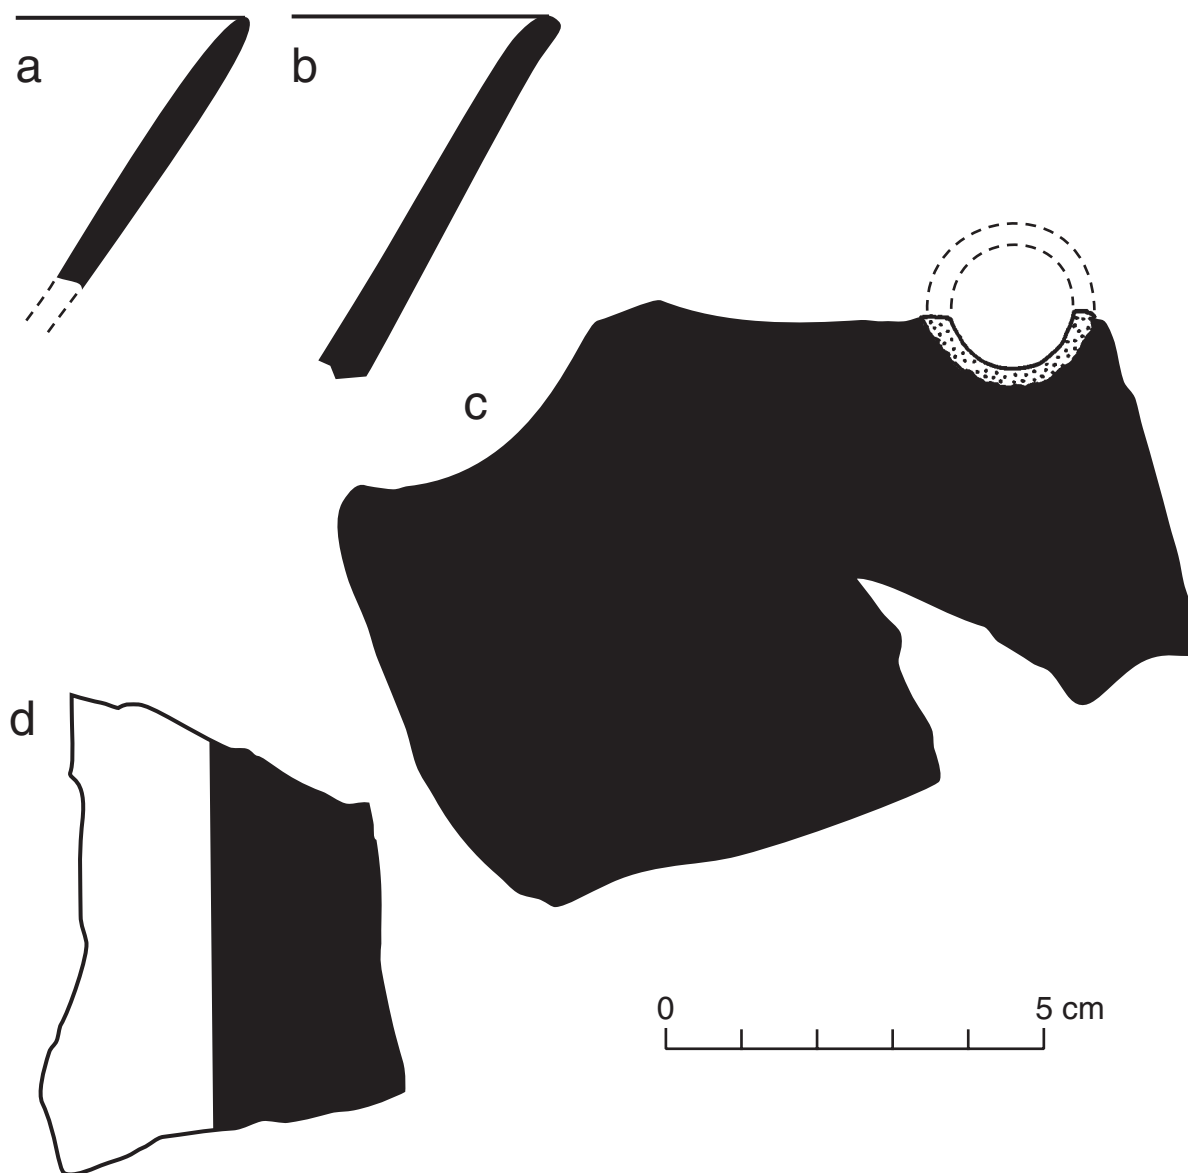
Figure 9.31. Sherds from Upper Zone C of the 5 × 5 m excavation block, Terrace 9, Quebrada 5a. (*a*): unclassified ware with sandy reddish clay body, open bowl covered with red wash (10 R 5/6) on the interior; (*b*): unclassified ware with fine reddish brown clay body, open bowl with reddish brown wash (2.5 R 4/4), burnished; (*c*): unclassified ware with sandy reddish clay body, jar body slipped “graphite” black on the exterior; one area shows a broken-off spout or tubular opening 1.5 cm in diameter; the black slip is shiny, metallic, and almost purplish black; (*d*): unclassified ware with sandy reddish clay body, jar body sherd with a zone of “graphite” black paint over natural brown exterior.

Open bowl with reddish brown wash, burnished: 1 rim (Figure 9.31b)

Jar body sherds, slipped shiny “graphite” black: 3 (one has a broken-off spout or tubular opening [Figure 9.31c])

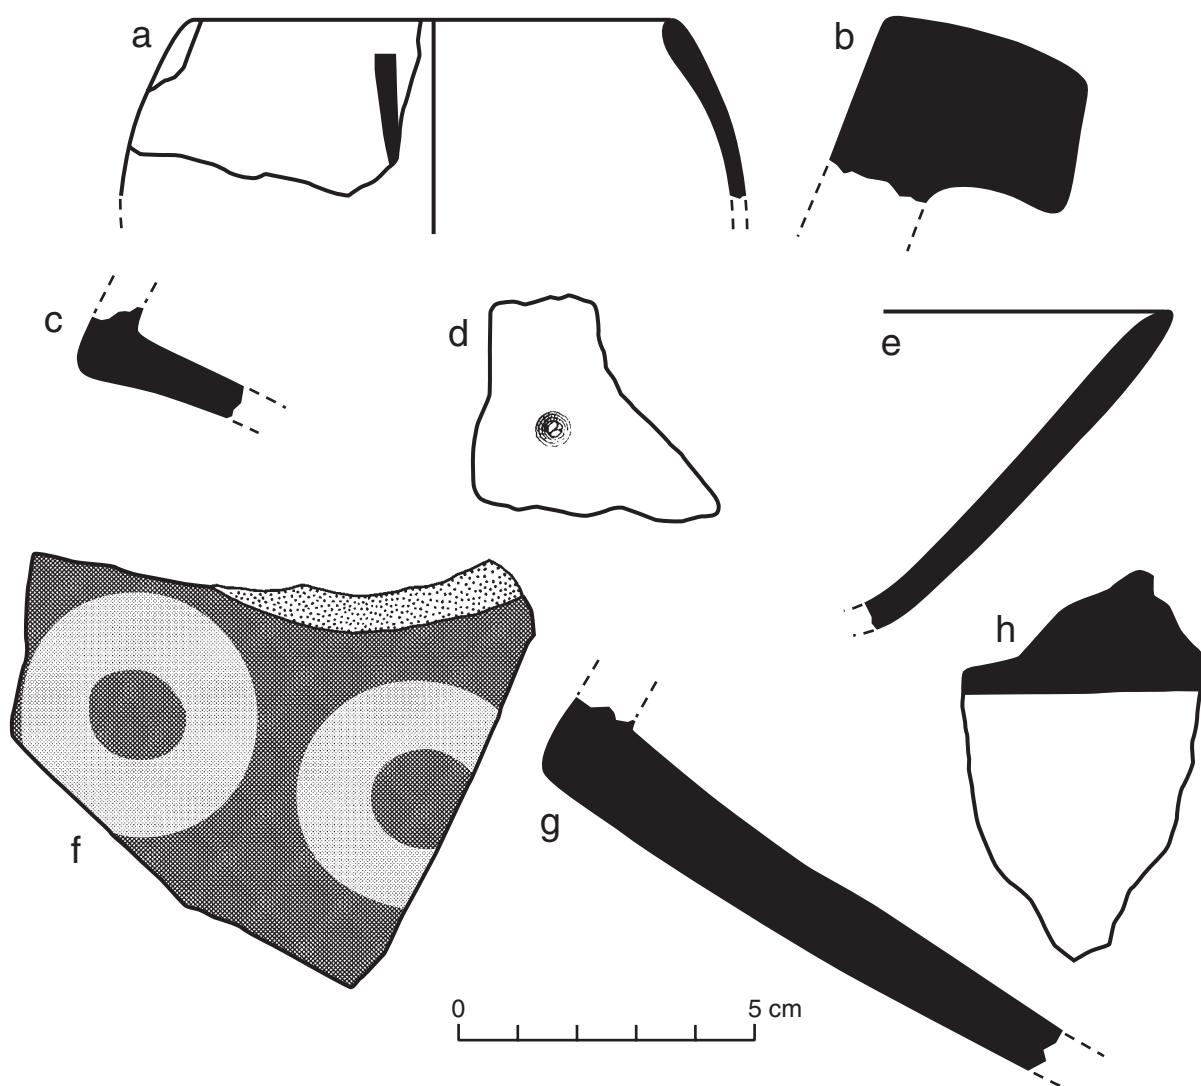
Figure 9.32. Sherds found in Zone B, a Late Intermediate midden below Structures 4 and 5, Terrace 9, Quebrada 5a. (a): Trambollo Burnished Brown, small bowl with restricted orifice, painted black on natural on the exterior; (b): Camacho Reddish Brown, bolstered rim from large storage jar; (c): Camacho Reddish Brown jar shoulder, fire-blackened; (d): Camacho Reddish Brown, body sherd from a jar with a hole drilled through from the exterior; a knot from a cord is still stuck in the hole; (e): Pingüino Buff (?) open bowl; interior color 2.5 YR 4/6, exterior color 2.5 YR 5/4; (f): Pingüino Buff jar shoulder, exterior covered with purplish paint (10 R 4/2); yellow-cream “Life Savers” have been painted over the purple, and light stipple shows the broken edge of the sherd; (g): Pingüino Buff, shoulder of large jar; (h): unclassified ware characterized by fine, sandy paste with a gray core between brown layers; this body sherd has a zone of shiny “graphite” black paint over natural brown, with the brown being 5 YR 4/3 in the Munsell system.

Rim sherd from a *tinajón* (500-liter size): 1 (Figure 9.32b)

Jar shoulder, fire-blackened: 1 (Figure 9.32c)

Shoulder of large jar, plain: 1 (Figure 9.32g)

Thin-walled jar sherds with purplish paint (10 R 4/2) on exterior; “Life Savers” painted in yellow-cream (2.5 Y 7/4) over purple: 2 (Figure 9.32f)

Rim of open bowl; paste transitional between the unclassified reddish-to-brownish ware of Zone C and more typical Pingüino Buff: 1 (Figure 9.32e)

Small bowl with restricted orifice, painted black on natural: 1 rim (Figure 9.32a)

Jar body sherds with zones of “graphite” black paint: 2 (Figure 9.32h)

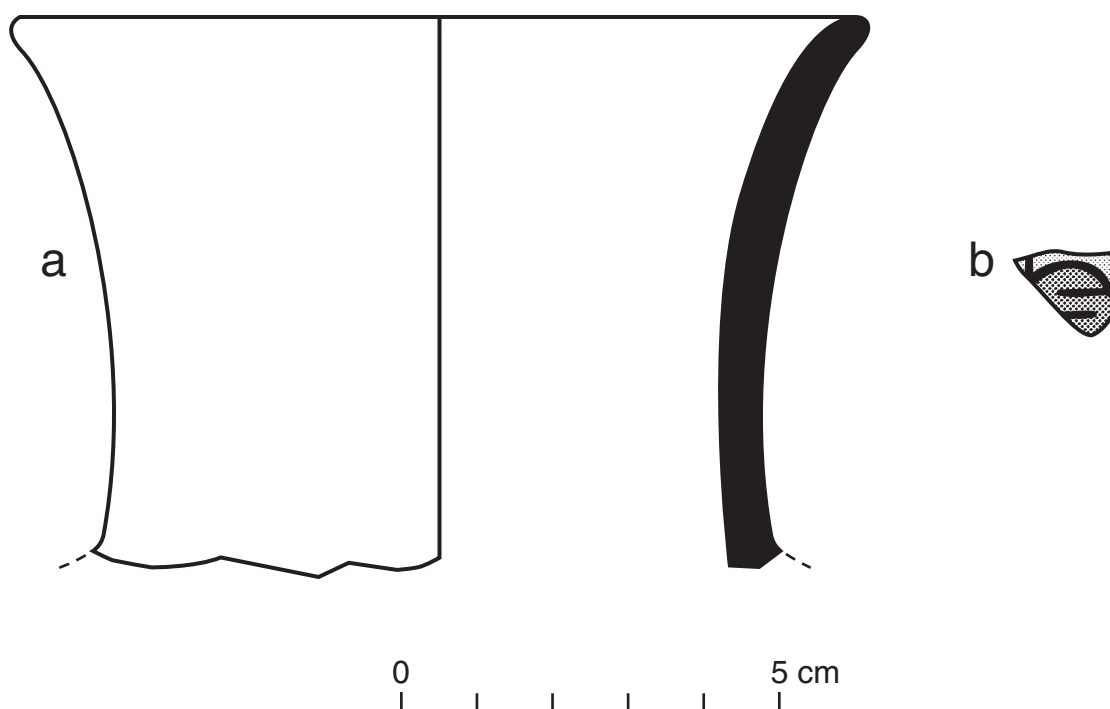
Figure 9.33. Sherds found in stratigraphic Zone B, a Late Intermediate midden below Structures 4 and 5, Terrace 9, Quebrada 5a. (a): Camacho Black (standard variety) neck of jar or amphora; (b): unique body sherd with fine red clay body. The vessel is slipped yellow-cream (2.5 Y 6/4) on the exterior, then painted in black and red (10 R 3/4) over the slip. (The finely executed motif looks like the “S” on Superman’s chest.)

Neck from jar or amphora: 1 (Figure 9.33a)

Body sherd with fine red paste, slipped yellow-cream and highly burnished on exterior; “Superman’s S” motif painted in black and red over slip: 1 (Figure 9.33b)

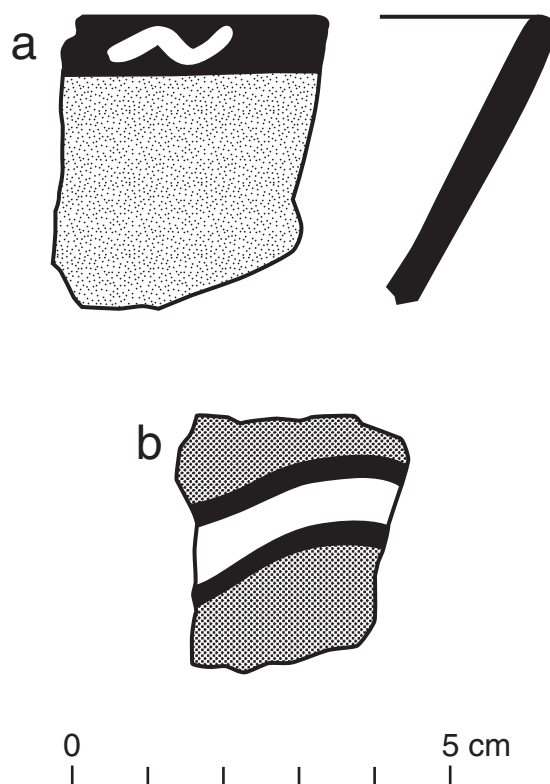
Figure 9.34. Additional sherds from Zone B of Terrace 9, Quebrada 5a. (These sherds were not part of the screened sample.) (a): Trambollo Burnished Brown bowl sherd with plain rim, burnished on the interior, with a chocolate brown band (5 YR 3/2) painted on the rim and a cream-white “worm” motif painted over the band. The vessel exterior is plain; light stipple indicates natural brown. (b): possible Pingüino Buff bowl body sherd, slipped red (10 R 4/4) on the interior and painted in white and black over that (red shown as medium screen). The exterior (too eroded to illustrate) had been slipped cream-white, then painted in black over that.

Figure 9.34 presents two more sherds from Zone B; these are sherds from areas deemed too close to the burial cists to merit screening. One is a Trambollo Burnished Brown bowl rim, painted white on brown (Figure 9.34a). The other is an eroded sherd, possibly Pingüino Buff, painted white and black over a red slip (Figure 9.34b). Both sherds look to be a bit earlier than the bulk of the ceramics from Structures D and 9.

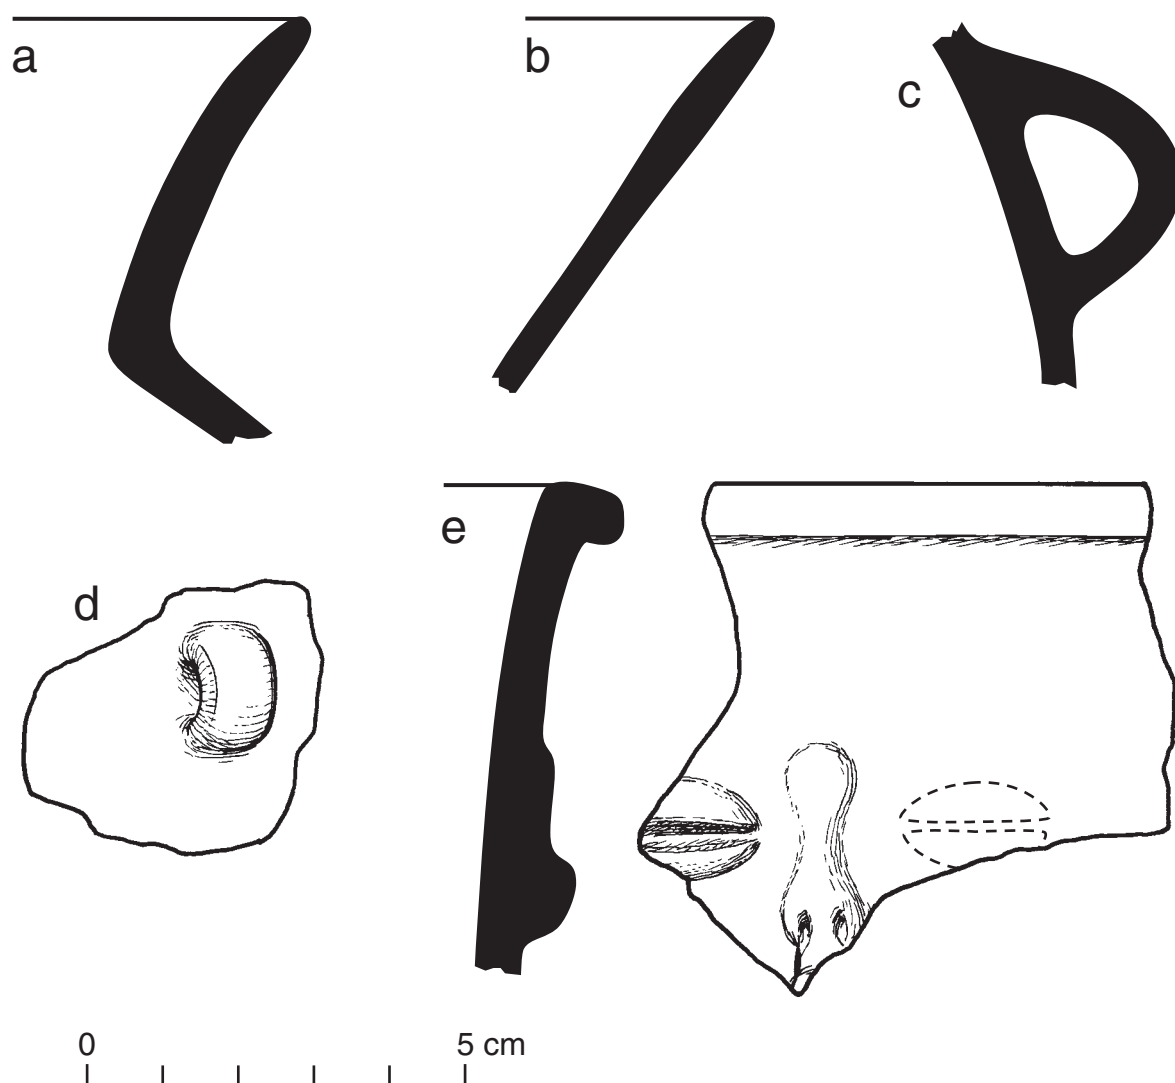
Figure 9.35. Sherds from 30 cm below the surface in stratigraphic Zone A of the 5 × 5 m excavation block, Terrace 9, Quebrada 5a. All sherds come from the northwest corner of the block. (a): Camacho Reddish Brown, flaring rim from jar; (b): Pingüino Buff, rim of wide, open, probably shallow bowl; (c): Camacho Reddish Brown, strap handle from cooking pot; (d): Camacho Black, loop handle from miniature jar; (e): Camacho Reddish Brown, amphora with modeled human face just below the bolstered rim. The eyes (one of which had eroded away) were the appliqué “coffee-bean” type.

Flaring rim from jar: 1 (Figure 9.35a)
 Strap handle from cooking pot, fire-blackened: 1 (Figure 9.35c)

Amphora neck with everted rim, modeled human face with “coffee-bean” eyes: 1 (Figure 9.35e)
 Body sherds: 8

Loop handle from miniature jar: 1 (Figure 9.35d)

Rim of open bowl, burnished on interior: 1 (Figure 9.35b)

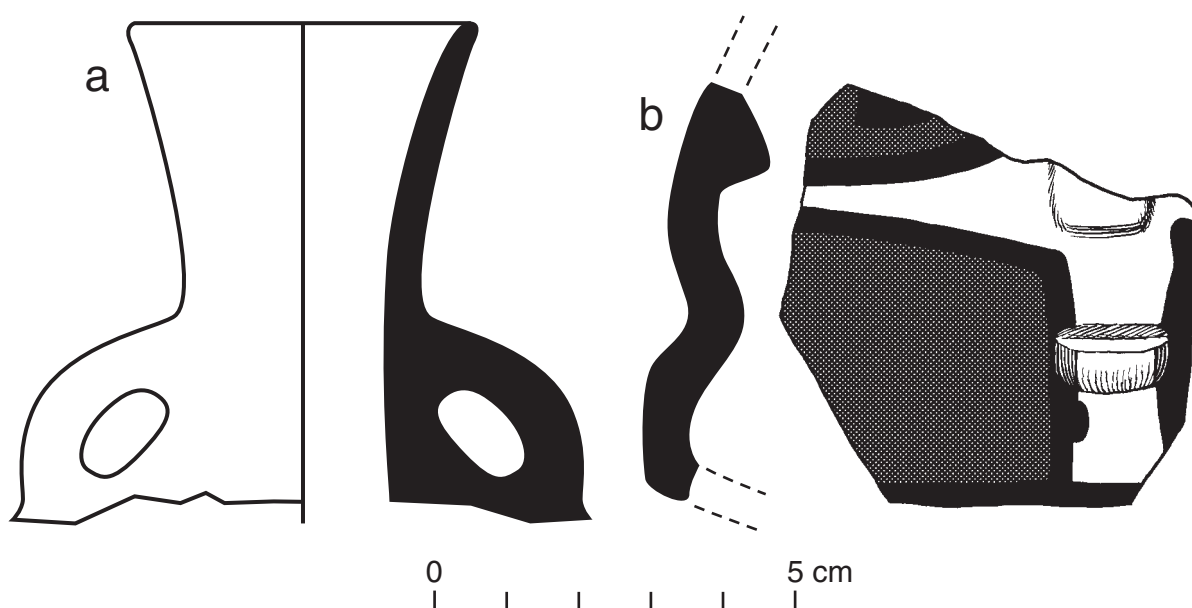
Figure 9.36. Sherds from vessels broken by the looters of Structure 4, Terrace 9, Quebrada 5a. (a): Camacho Black (“graphite” variety), small jar with two loop handles; (b): Pingüino Buff, jar neck with human face modeled on it, painted in black, white, and reddish brown (the latter shown as heavy screen).

Figure 9.36a shows a small jar with two loop handles in the highly burnished (“graphite”) variety of Camacho Black. Figure 9.36b shows a modeled and

painted human face from the neck of a Pingüino Buff jar. The black/white/red facial paint is typical of the main period of occupation of Structures D and 9.

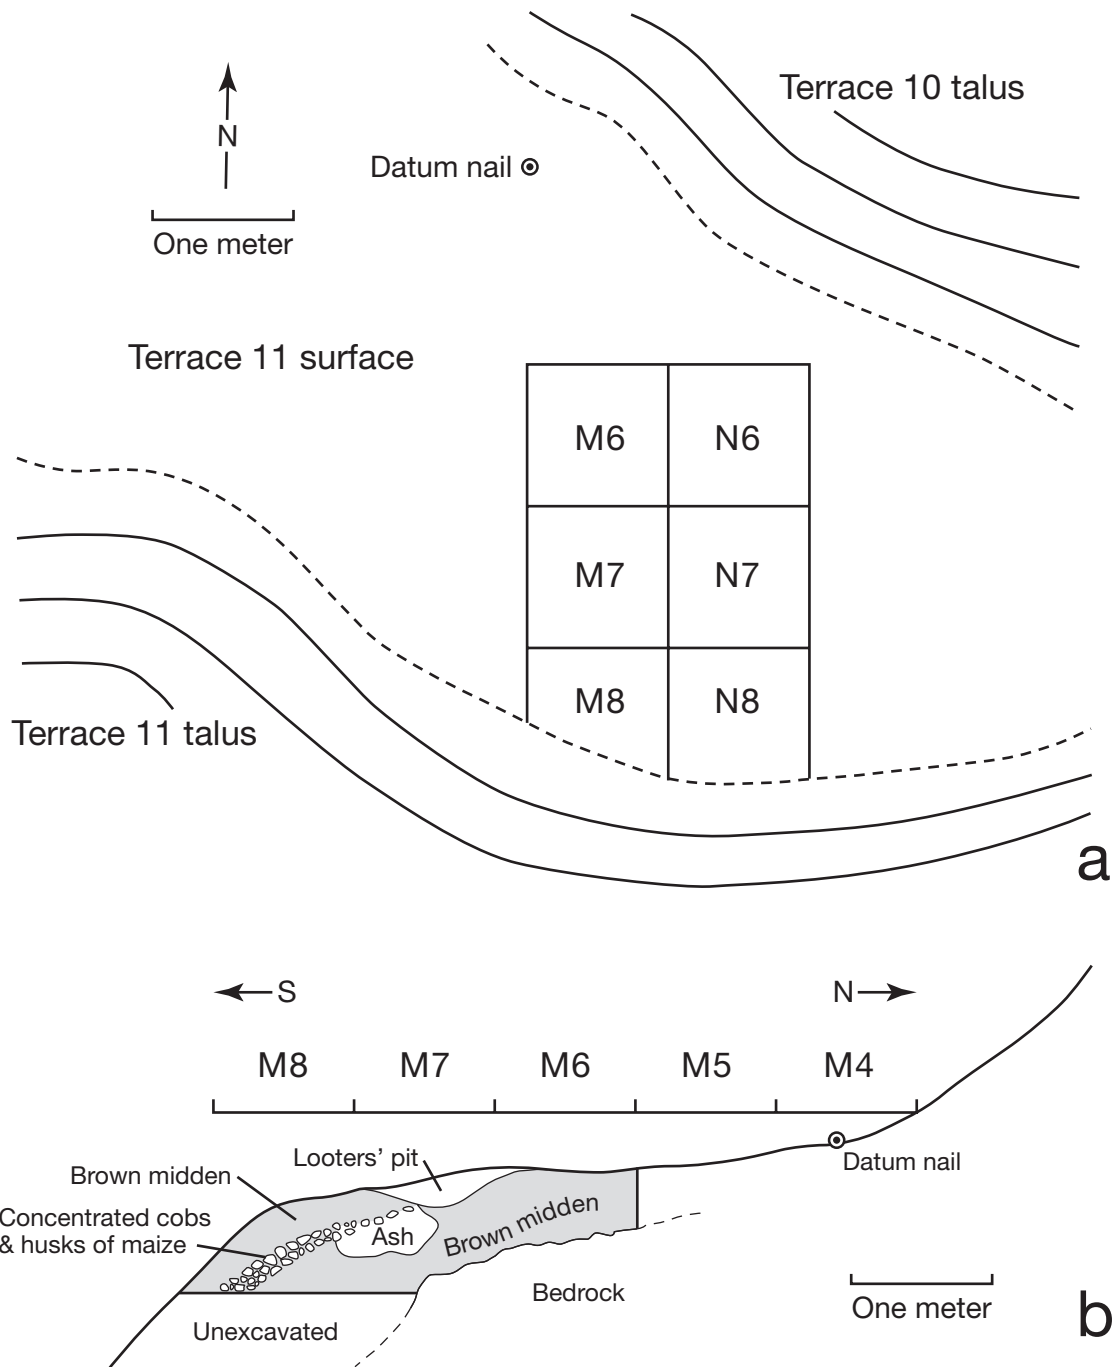
Figure 9.38. Excavation of Terrace 11, Quebrada 6. (a): plan view of the terrace showing Squares M6-N8. (b): profile of the west wall of Squares M6, M7, and M8.

One of the blackest terraces in Quebrada 6 is the eleventh, counting down from the summit of the hill (Figure 9.37). We chose a relatively flat part of Terrace 11 on which to lay out a north-south grid of 1×1 m squares (Figure 9.38). We labeled the two initial squares M6 and N6, which (by placing us near the middle of the alphabet) would enable us to expand any direction

The west profile of Squares M6 and M7 divides Terrace 11 into western and eastern halves.

(Chapter 4), except that all the materials appear to have been broken into smaller particles during their transport from one of the *tapia* compounds. As Figure 9.38b shows, there were lenses of ash

were deepest in Squares M8 and N8, where the midden had poured over the edge of Terrace 11 and slid down toward Terrace 12 (Figure 9.38b). Deposits were shallowest in Square N6, where bedrock was only 20 cm below the surface.

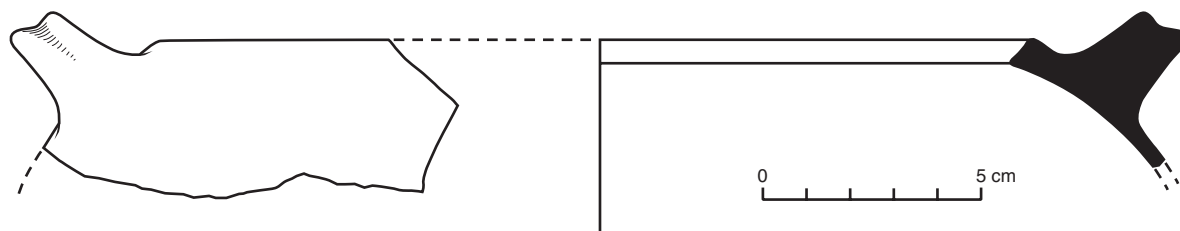
Figure 9.41. Reconstruction of a broken Camacho Reddish Brown vessel from 30–50 cm below the surface in Squares M8/N8 of Terrace 11, Quebrada 6. This is a cooking pot with restricted orifice and horizontally set strap handles; the vessel is fire-blackened.
