MONOGRAPH 62
COTSEN INSTITUTE OF ARCHAEOLOGY
UNIVERSITY OF CALIFORNIA, LOS ANGELES

EXCAVATIONS AT
CERRO AZUL, PERU
THE ARCHITECTURE AND POTTERY
JOYCE MARCUS

Excavations at Cerro Azul, Peru

THE ARCHITECTURE AND POTTERY

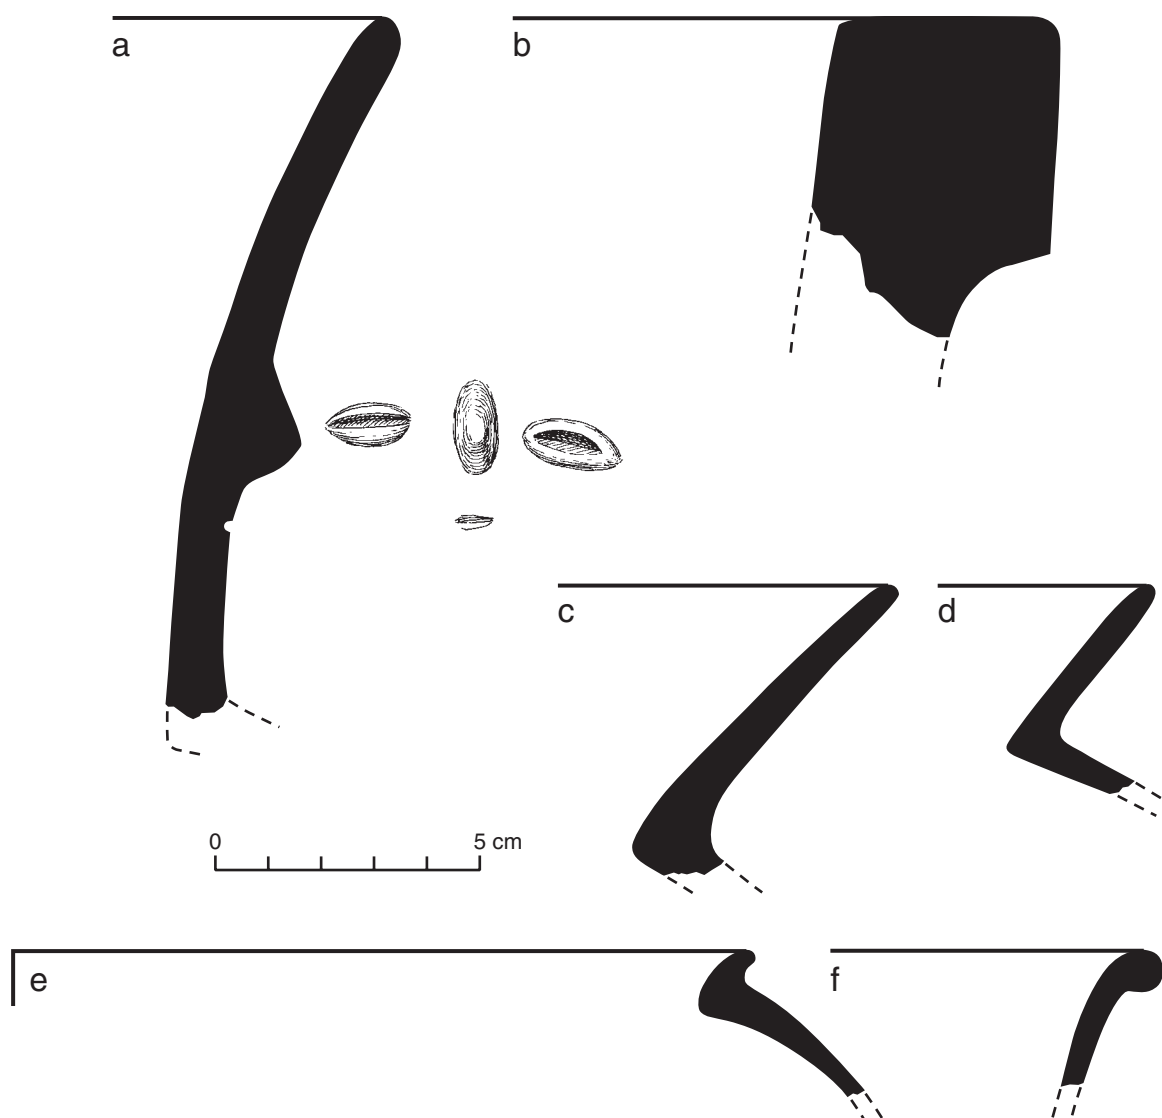
Figure 9.42. Sherds found at a depth of 30–50 cm below the surface in Squares M8/N8 of Terrace 11, Quebrada 6. (a): Camacho Black jar neck with a human face modeled on the exterior; the face, with its “coffee-bean” eyes, is shown to the right of the profile. Sherds b–f are Camacho Reddish Brown. (b): rim from *batun macema*. (c, d): plain rims from jars; (e): neckless jar with everted rim; (f): jar with bolstered rim.

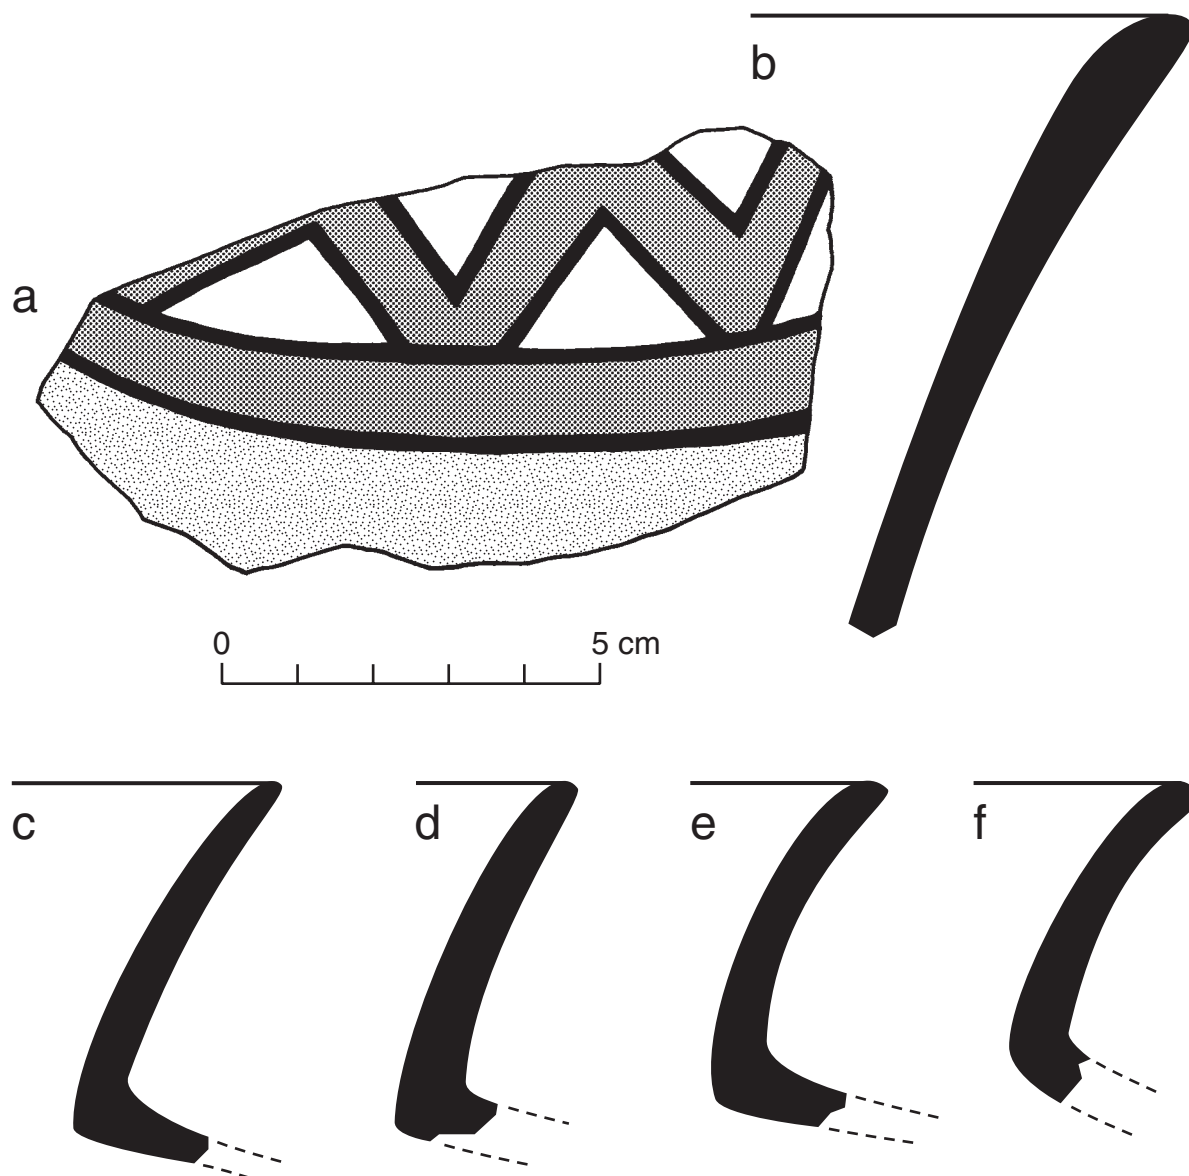
Figure 9.43. Sherds found from 30 cm below the surface down to bedrock in Squares M6/N6, Terrace 11, Quebrada 6. (a): Pingüino Buff, jar body sherd left natural buff below, slipped yellowish cream (10 YR 7/4) above, with geometric designs painted over the slip in black and red (10 R 3/6). Medium screen indicates red; light stipple indicates natural buff. (b): Pingüino Buff, rim from large jar. (c–f): Camacho Reddish Brown, four examples of jar rims that vary from plain (c) to slightly flaring or outcurved (f). Most are fire-blackened.

- Rim from large jar: 1 (Figure 9.43b)
- Jar body sherd, upper part slipped yellowish cream and painted black and red; lower part left natural buff: 1 (Figure 9.43a)
- Body sherds: 4

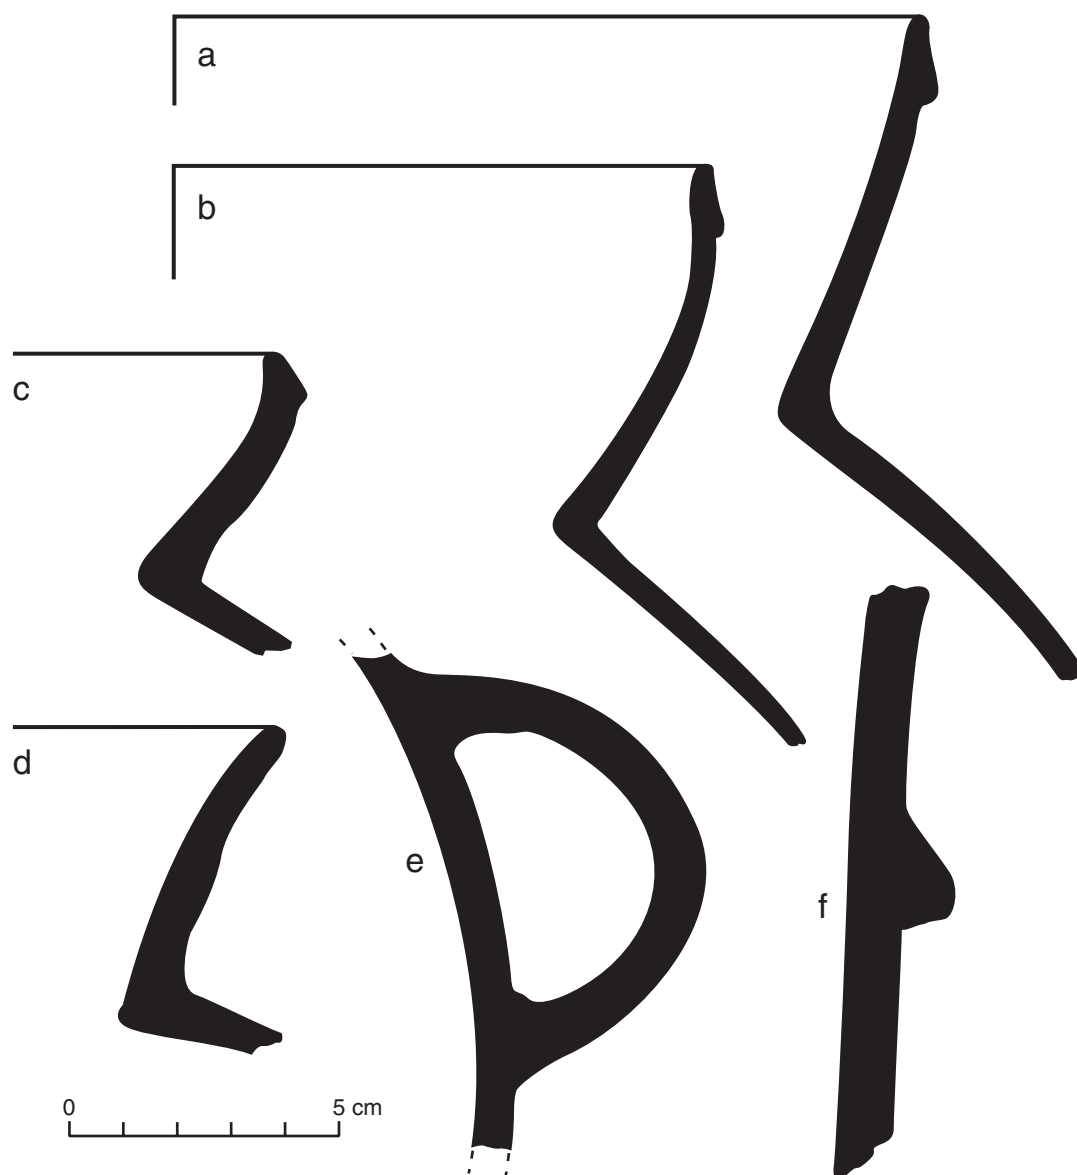
Figure 9.44. Sherds found at a depth of 30 cm in Square M8, Terrace 11, Quebrada 6. (*a–c*): Camacho Reddish Brown, cambered rims from jars; (*d*): Camacho Reddish Brown, slightly flaring rim from jar; (*e*): Camacho Black (standard variety), jar body sherd with vertically set strap handle; (*f*): Pingüino Buff (?) jar neck sherd with prominent nose from modeled human face; badly eroded.

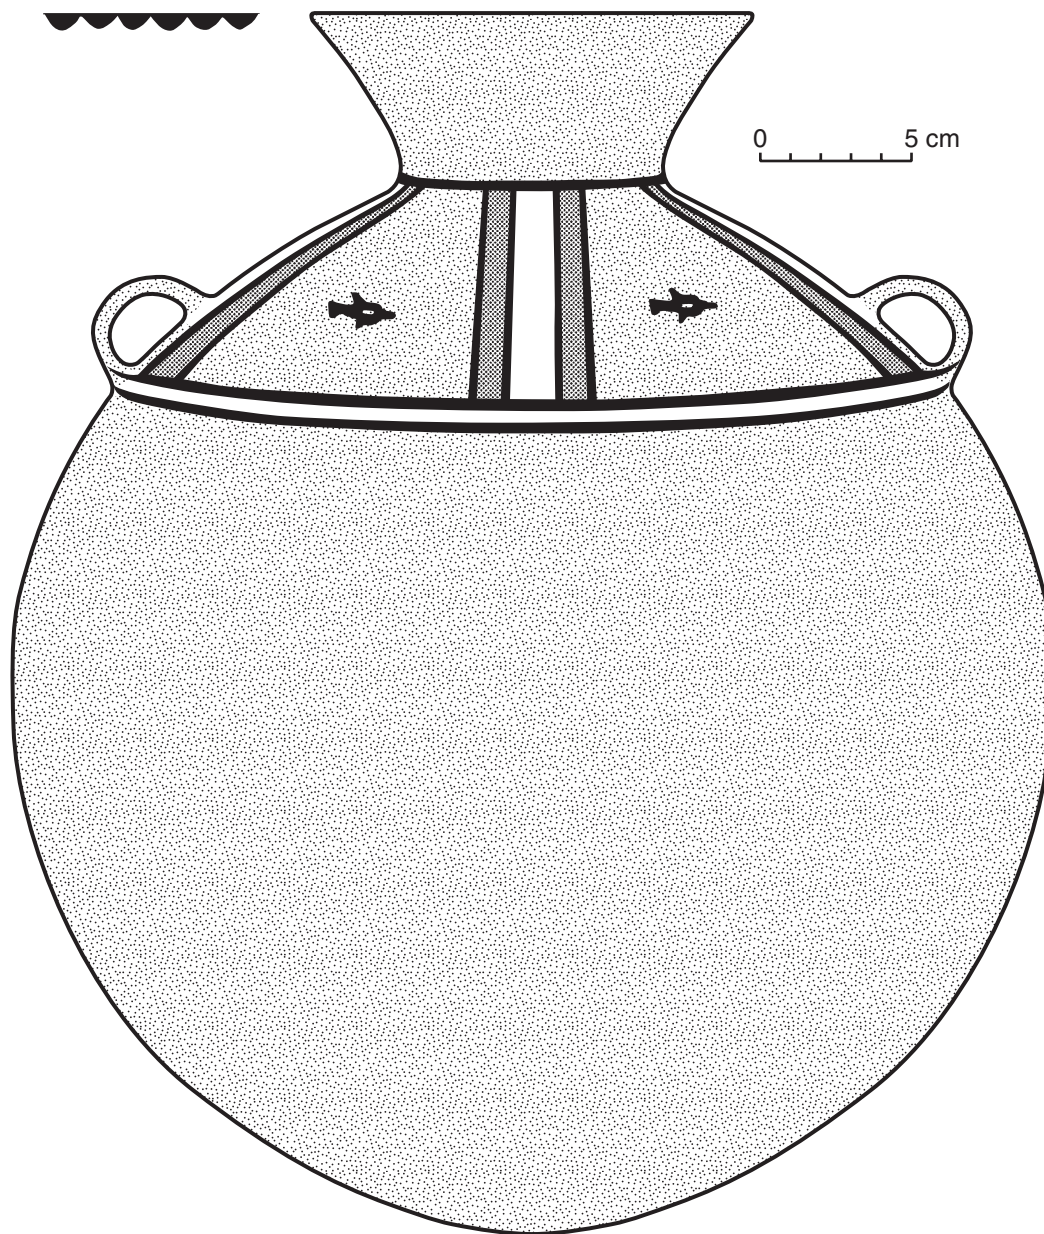
Figure 9.45. Reconstruction of a vessel in the atypical orange variety of Pingüino Buff, found broken at a depth of 30 cm in Square M8, Terrace 11, Quebrada 6. This is a jar with a lenticular body, flaring neck, and vertically set strap handles. The area covered by light stipple is natural buff. The shoulder of the vessel is divided into zones by painted stripes of black/white/dusky red (7.5 R 2/4-3/4); the red is shown as a medium screen. In the zones, simple fish motifs have been painted in black. A continuous band of black semicircles (shown to the left of the neck) runs around the rim interior.

- Jar with a funnel neck and vertically set strap handles, painted in black/white/ dusky red with stripes and fish motif: 1 complete neck, 3–4 shoulder sherds, 50–52 body sherds (Figure 9.45)

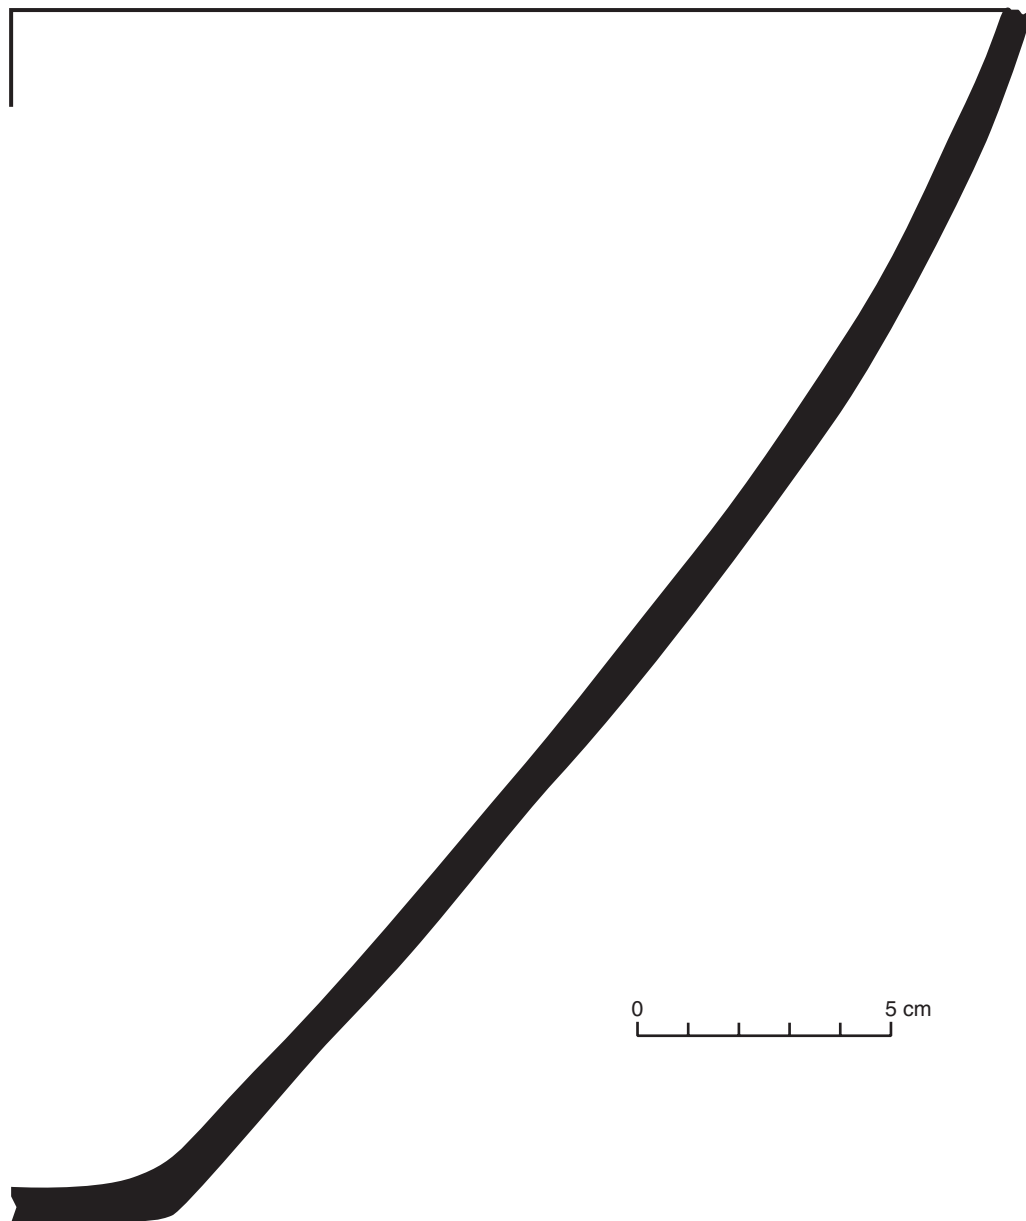
Figure 9.46. Reconstruction of a Camacho Black vessel found at a depth of 30 cm in Square M7, Terrace 11, Quebrada 6. The original vessel was an amphora. After it broke, its lower half was reused and is carbon-smudged from use as a cooking pot. The upper half was never found.

At a depth of 30 cm in Square M7 (immediately adjacent to the square mentioned above), we found the unusual vessel shown in Figure 9.46. The original vessel had been a large Camacho Black amphora (standard variety). At some point

it broke, and its lower half had been reused as a cooking pot. The upper half was never found.

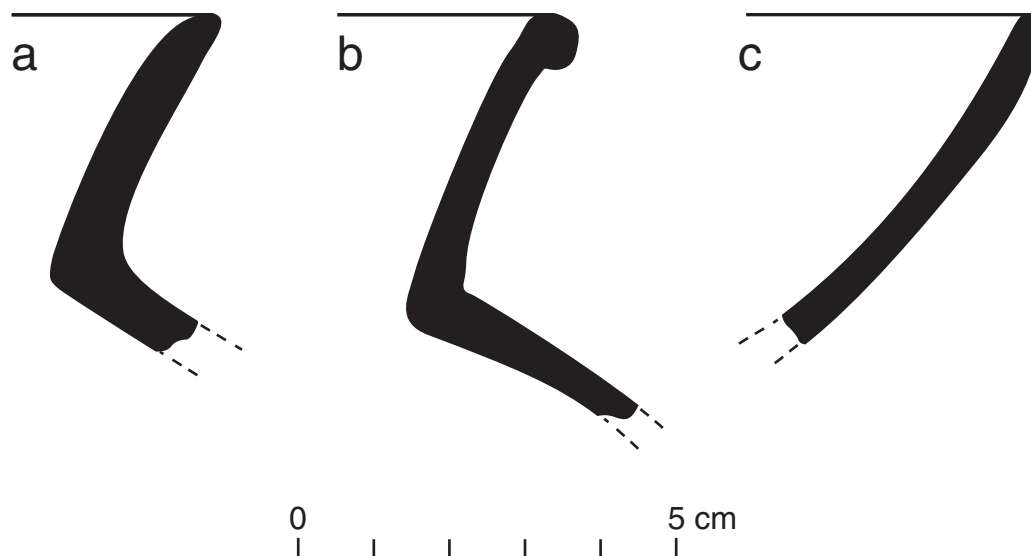
Figure 9.47. Sherds found at a depth of 30 cm in Square N8, Terrace 11, Quebrada 6. (a): Camacho Reddish Brown, plain rim from jar; (b): Camacho Reddish Brown, bolstered rim from jar; (c): Pingüino Buff, open bowl rim, burnished and given a white wash on both interior and exterior (discolored).

- Jar with plain rim: 1 rim (Figure 9.47a)
- Jar with bolstered rim: 1 rim (Figure 9.47b)
- Body sherds: 9 (almost all fire-blackened)

- Open bowl rim: 1 (discolored; burnished and white-washed on interior and exterior) (Figure 9.47c)
- Body sherds: 3

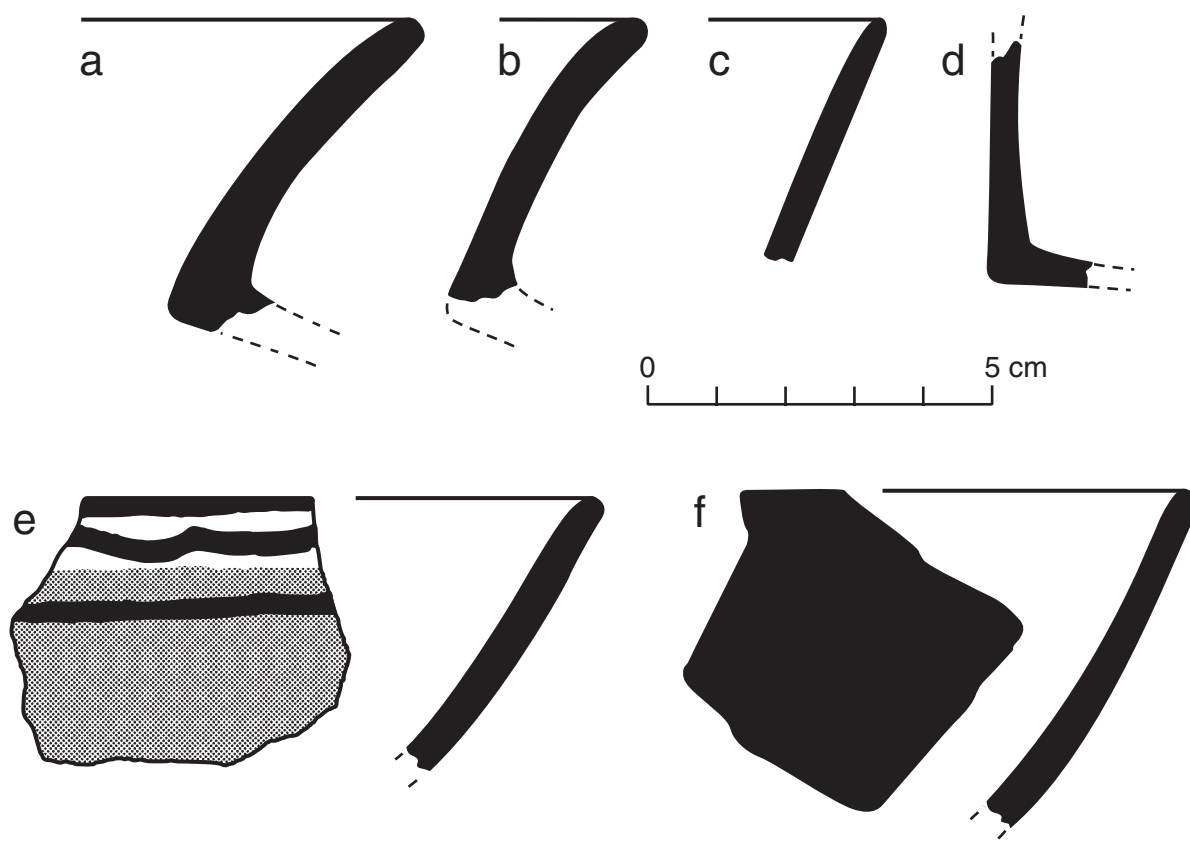
Figure 9.48. Sherds from 0–20 cm below the surface in Square M6, Terrace 11, Quebrada 6. (*a, b*): Camacho Reddish Brown, slightly flaring rims from jars; (*c*): Camacho Reddish Brown, plain rim from jar. (*d*): Pingüino Buff, vertical jar neck, painted “graphite” black on the exterior; (*e*): Camacho Reddish Brown, open bowl rim, given a dark red wash (10 R 3/4) on the interior and painted in black and white over that; the red is shown as a medium screen; (*f*): Pingüino Buff, open bowl rim, painted shiny black on the interior, probably in the form of large crescents (see Figure 9.49a).

- Jars with slightly flaring rims: 2 rims (Figure 9.48a, b)

- Jar with thin plain rim: 1 rim (Figure 9.48c)
- Open bowl rim, painted black and white over red wash: 1 (Figure 9.48e)
- Body sherds: 44 (mostly fire-blackened)

- Open bowl with large black crescents painted on interior: 2 rims (Figure 9.48f)
- Body sherds from bowl: 1
- Jar neck, painted “graphite” black: 1 (Figure 9.48d)
- Jar body sherd, traces of black and gray paint: 1
- Body sherds: 3

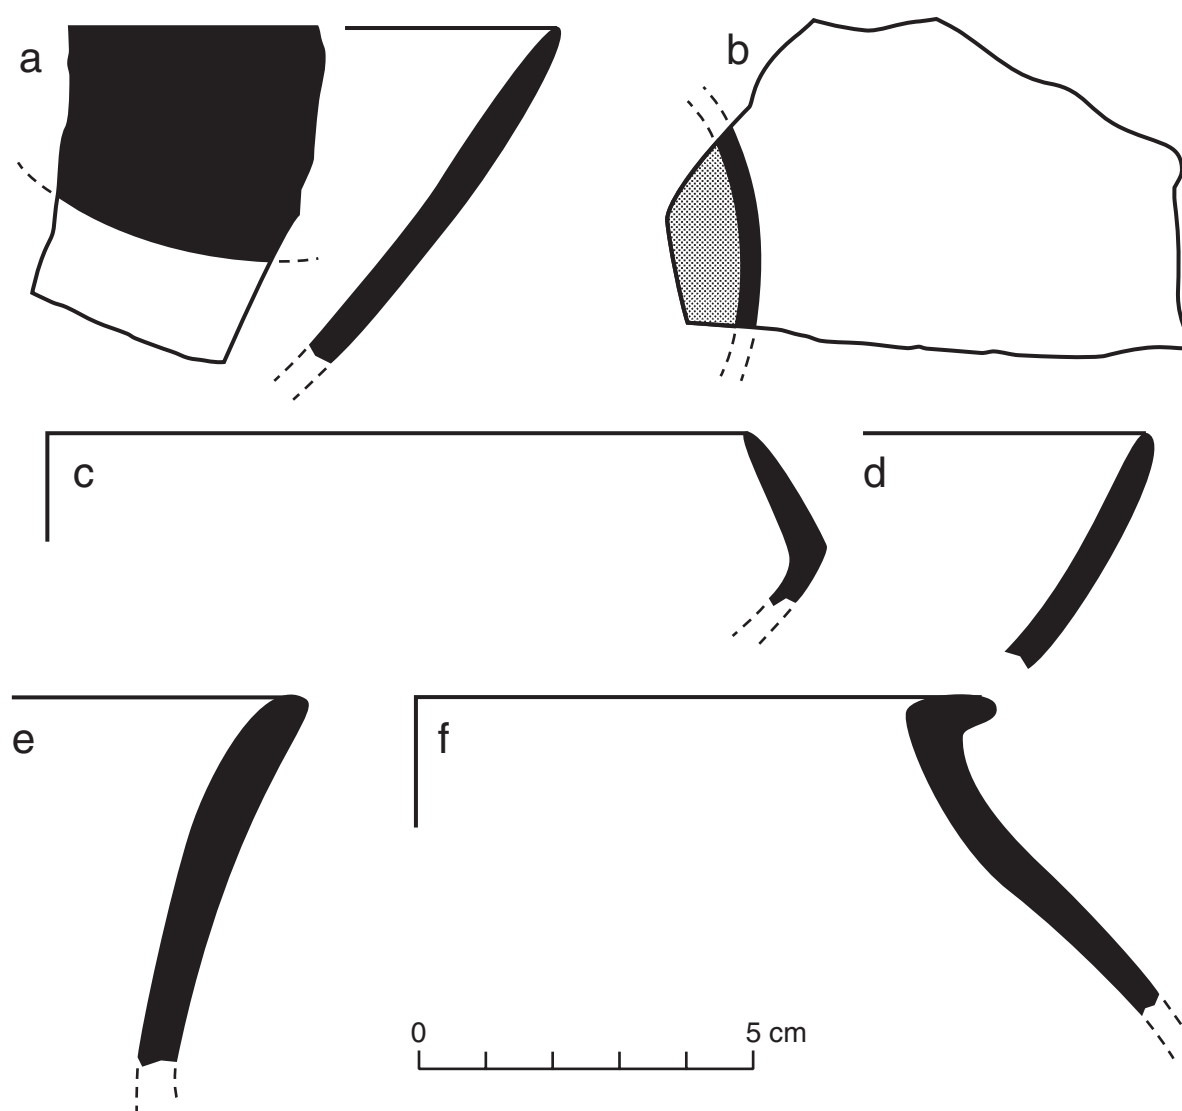
Figure 9.49. Sherds from 0–20 cm below the surface in Square N6, Terrace 11, Quebrada 6. (a): Pingüino Buff, open bowl with an area of black paint on the interior; this sherd is also painted black on the top of the rim; (b): Pingüino Buff, jar body sherd with burnished cream wash, over which a circular motif has been painted in gray (shown as light screen) and black; (c): Camacho Reddish Brown, carinated bowl, fire-blackened on the exterior. (d): Camacho Reddish Brown, open bowl, burnished inside and out and fire-blackened; (e): Camacho Reddish Brown, slightly flaring rim from jar; (f): Camacho Reddish Brown, neckless jar with everted rim.

- Neckless jar with everted rim: 1 rim (Figure 9.49f)

Jar with slightly flaring rim: 1 rim (Figure 9.49e)
 Open bowl, burnished: 1 rim (Figure 9.49d)
 Carinated bowl: 1 rim (Figure 9.49c)
 Strap handle fragment: 1
 Body sherds: 30

Open bowl with large black crescents painted on the interior: 1 rim (Figure 9.49a)
 Jar body sherd, traces of black and gray motif over cream wash: 1 (Figure 9.49b)

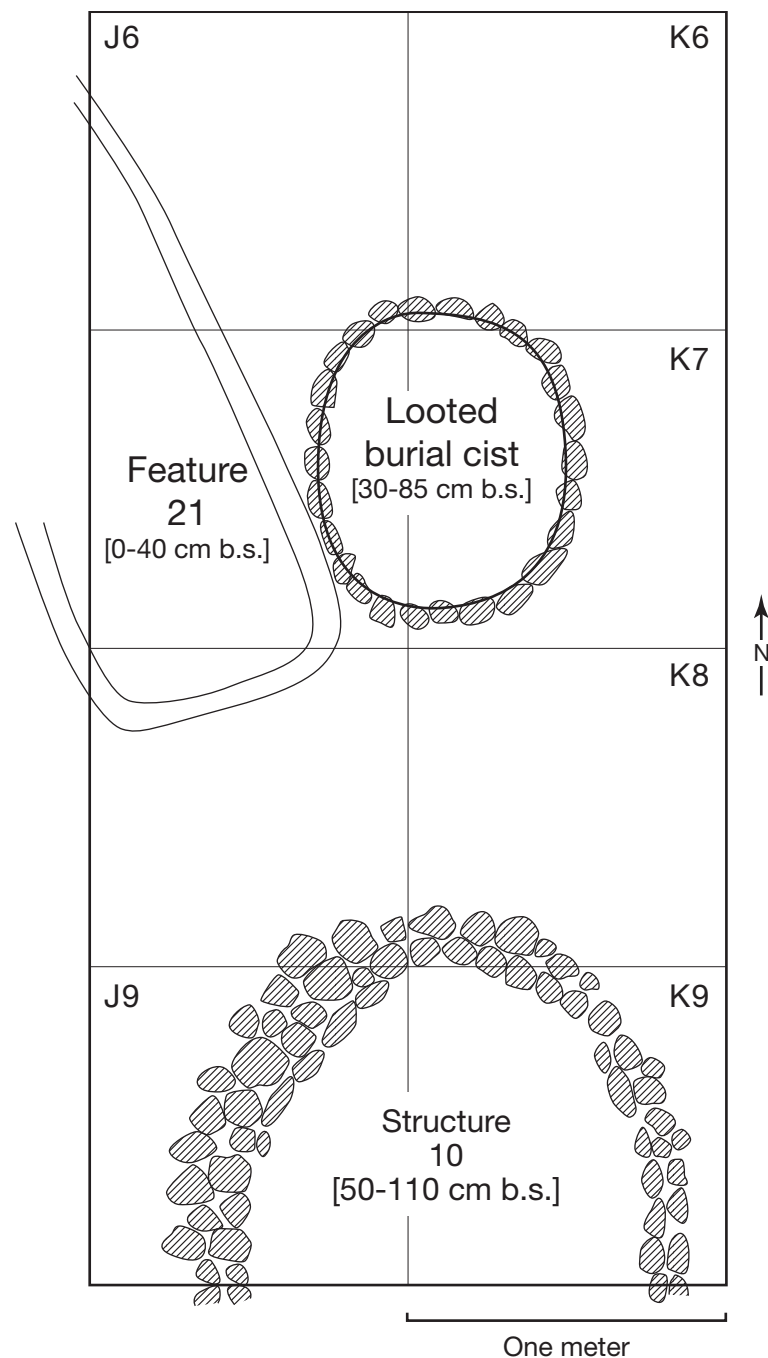
Figure 9.50. Quebrada 6, Terrace 12: plan of structures and features encountered in Squares J6–K9.

Now let us look at the constructions shown in Figure 9.50. The burial cist (roughly 70 × 100 cm and oval) had been emptied by looters, and was not given a structure number. The earth oven, designated Feature 21, extends outside our excavation block and could not be fully measured; its width is about 85–90 cm. Feature 21 contained ash, burnt bone, and fragments of maize.

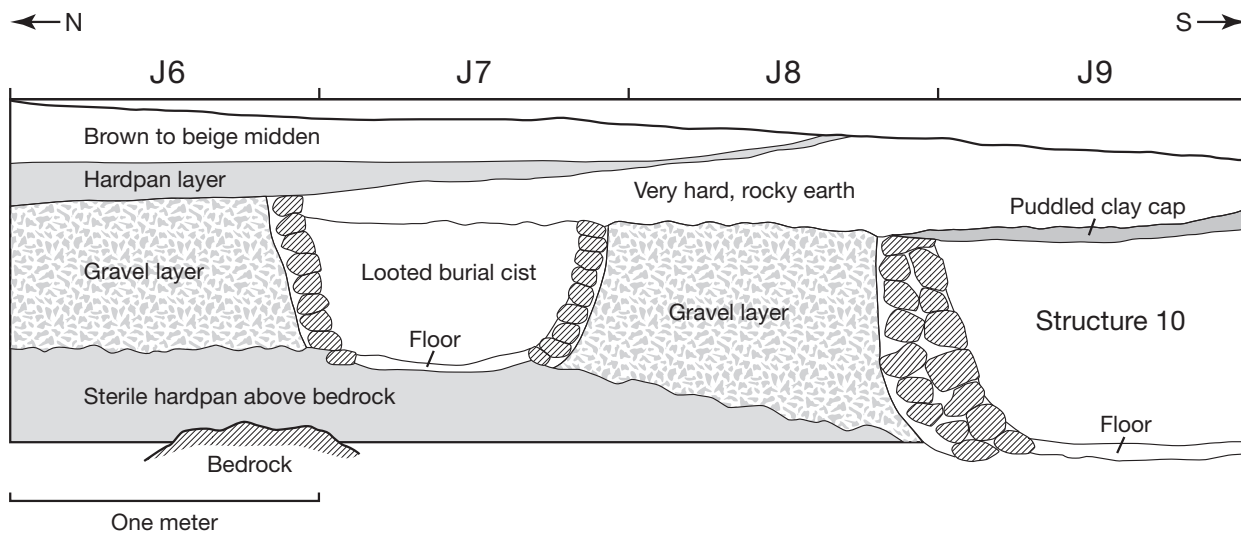
Figure 9.51. Quebrada 6, Terrace 12: east profile of Squares J6–J9.

Figure 9.51, a north–south cross section through our eight-square excavation block, shows the stratigraphic history of Terrace 12. The low-

est layer is sterile hardpan that had formed above bedrock. Over this hardpan, someone had created a burial cist and a storage cist from readily available scree stones set in clay; these structures were held in place by the thick layer of beach

gravel mentioned above. At a later date, someone had excavated down into the gravel layer and created a clay-lined subterranean earth oven.

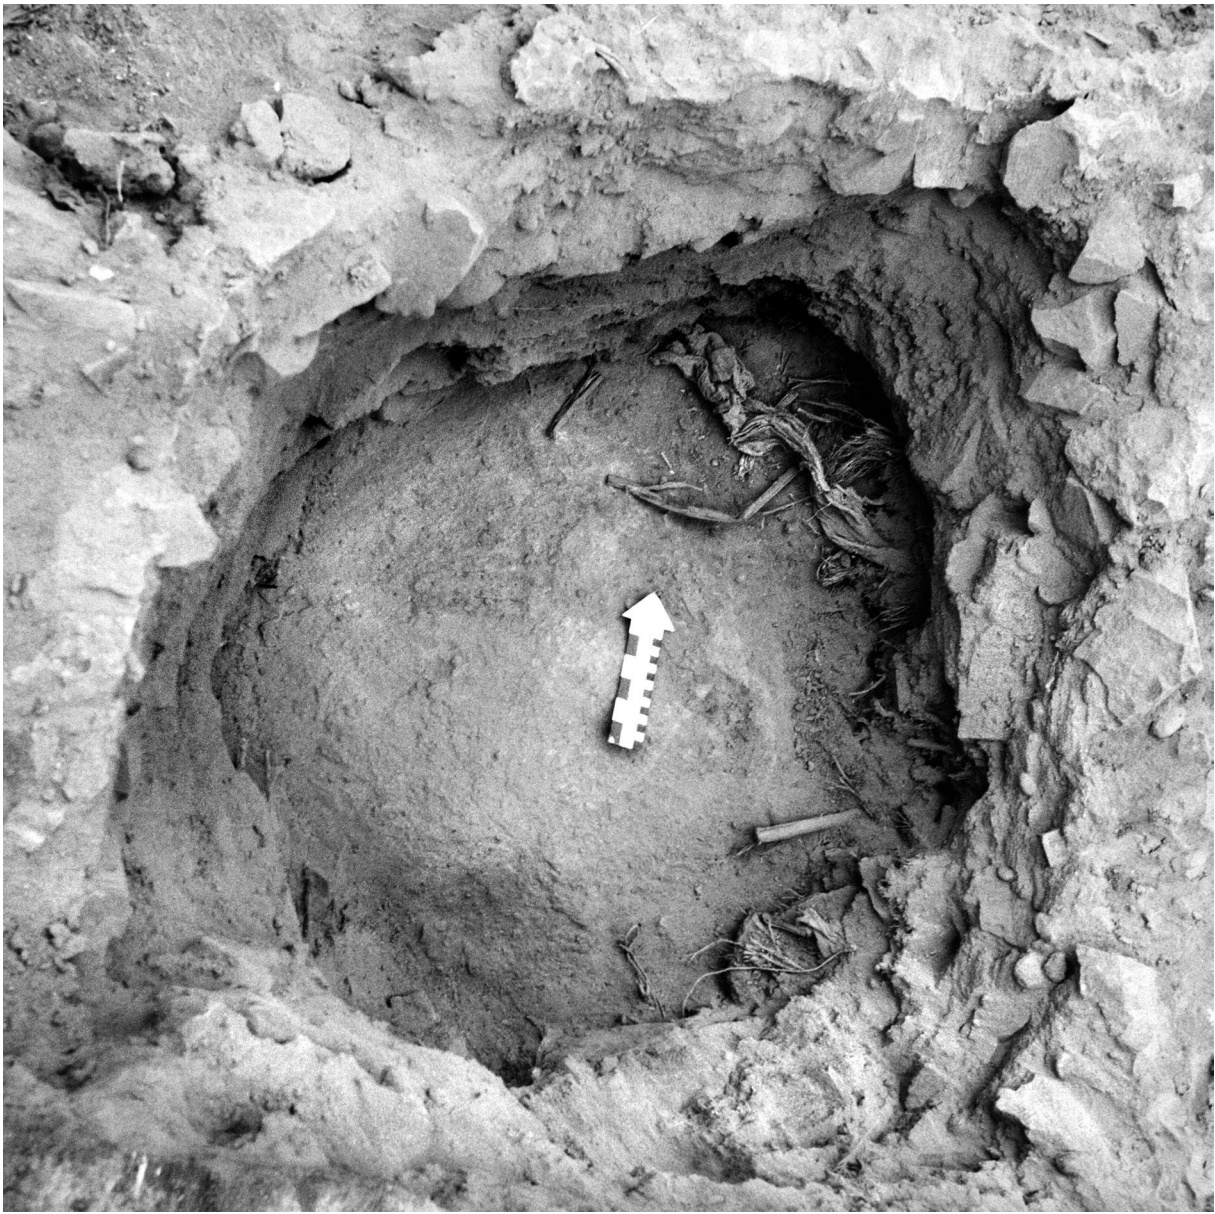
Figure 9.52. Structure 10, partially excavated. This stone-lined cist was found in Terrace 12, Quebrada 6. The north arrow is marked both in centimeters (R) and inches (L).

The most nearly intact of the three structures is the storage cist, designated Structure 10 (Figure 9.52). In addition to its stone masonry wall, this cist had a clay floor and was sealed by a puddled clay cap (Figure 9.51). It, too, extends outside our excavation block and could not be fully measured; its internal diameter is approximately 1.25 m. The clay cap was still intact, allowing us to conclude that Structure 10 had not been looted. It might have been used to store something perishable, but there is no evidence it had ever been used for burials. When opened, it contained only pieces of decomposing nets or net bags, cordage, and marine shell.

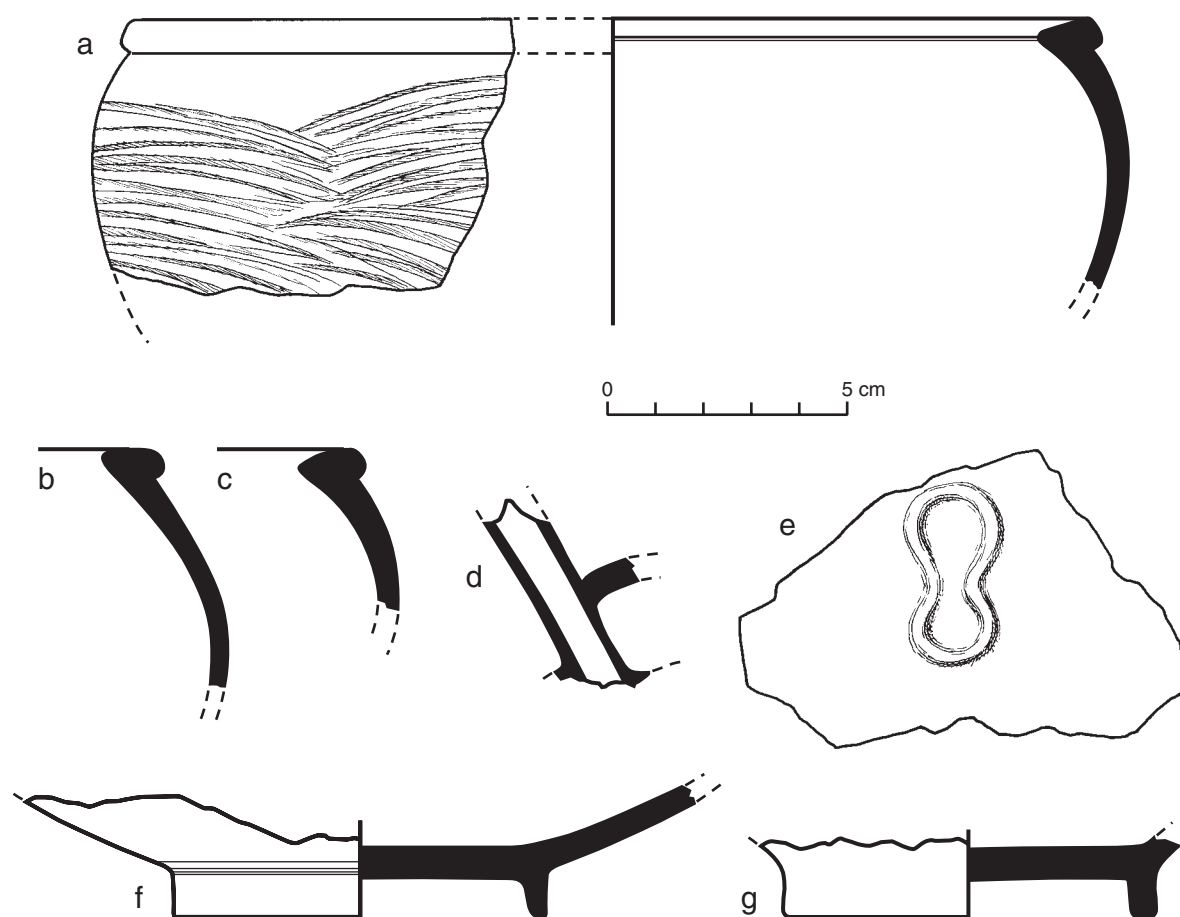
Figure 9.53. Sherds from 0–20 cm below the surface on Terrace 12, Quebrada 6. (a–c): Camacho Reddish Brown, cooking pots with restricted orifice, bolstered rim, brushed exterior, and fire blackening. (The “brushing,” indicated on *a*, is very coarse—that is, whisk broom size rather than hairbrush size.) (d): Pingüino Buff, fragment of bridge spout, from a vessel slipped glossy black on the exterior; (e): Camacho Reddish Brown, body sherd of large jar or *batun macema* with a raised, modeled “keyhole” on the exterior; (f, g): Pingüino Buff, ring bases from bowls, given a white wash and burnished on the interior and exterior.

Because so much of the matrix in Terrace 12 is sterile beach gravel, we recovered sherds only from the uppermost 20 cm—mostly from the brown to beige midden that had eroded down from a higher terrace. This pottery sample, seven sherds of which are illustrated in Figure 9.53, contains elements that appear in Late Horizon deposits elsewhere at Cerro Azul. Included in the latter are annular bases from bowls. The full inventory is as follows:

Cooking pots with restricted orifice, bolstered rim, burnished exterior, fire-blackened: 3 rims (Figure 9.53a–c)

Hatun macoma body sherd with raised (modeled) area in form of keyhole: 1 (Figure 9.53e)

Ring bases from bowls; white wash; burnished on interior and exterior: 2 (Figure 9.53f, g)

Slender vessel spout with bridge, slipped black: 1 (Figure 9.53d)

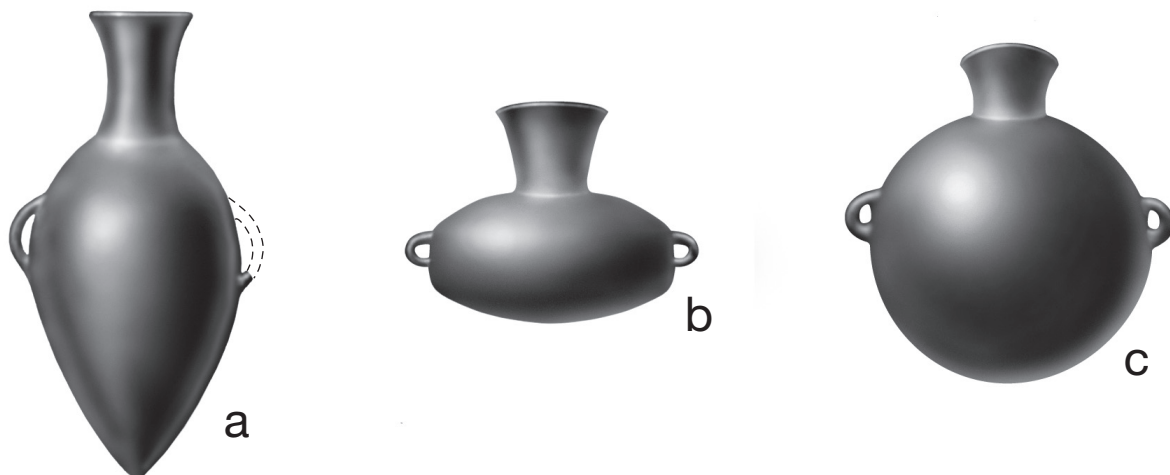
Figure 10.1. Blackware vessels of the Late Chíncha I period that resemble Camacho Black pottery from Cerro Azul. (a): amphora; (b): drum-shaped jar; (c): globular jar (redrawn from Kroeber and Strong 1924a:Figs. 7, 8).

of Cerro Azul. Many vessels from Chíncha are similar in shape and surface treatment to those found in burial cists at Cerro Azul and even to a few of the elite vessels in Structure D (Figure 10.1). Chíncha graves usually included vessels for eating (*mikuna*) and drinking (*upiana*), the kinds of activities in which elite individuals would engage during their afterlife.

Another ware finding counterparts in valleys to the south is the highly burnished ("graphite") variety of Camacho Black. This highly burnished variety was most often used for burial offerings and effigy vessels, many of them miniatures. Very similar vessels occurred in Chincha graves (Figure 10.1).

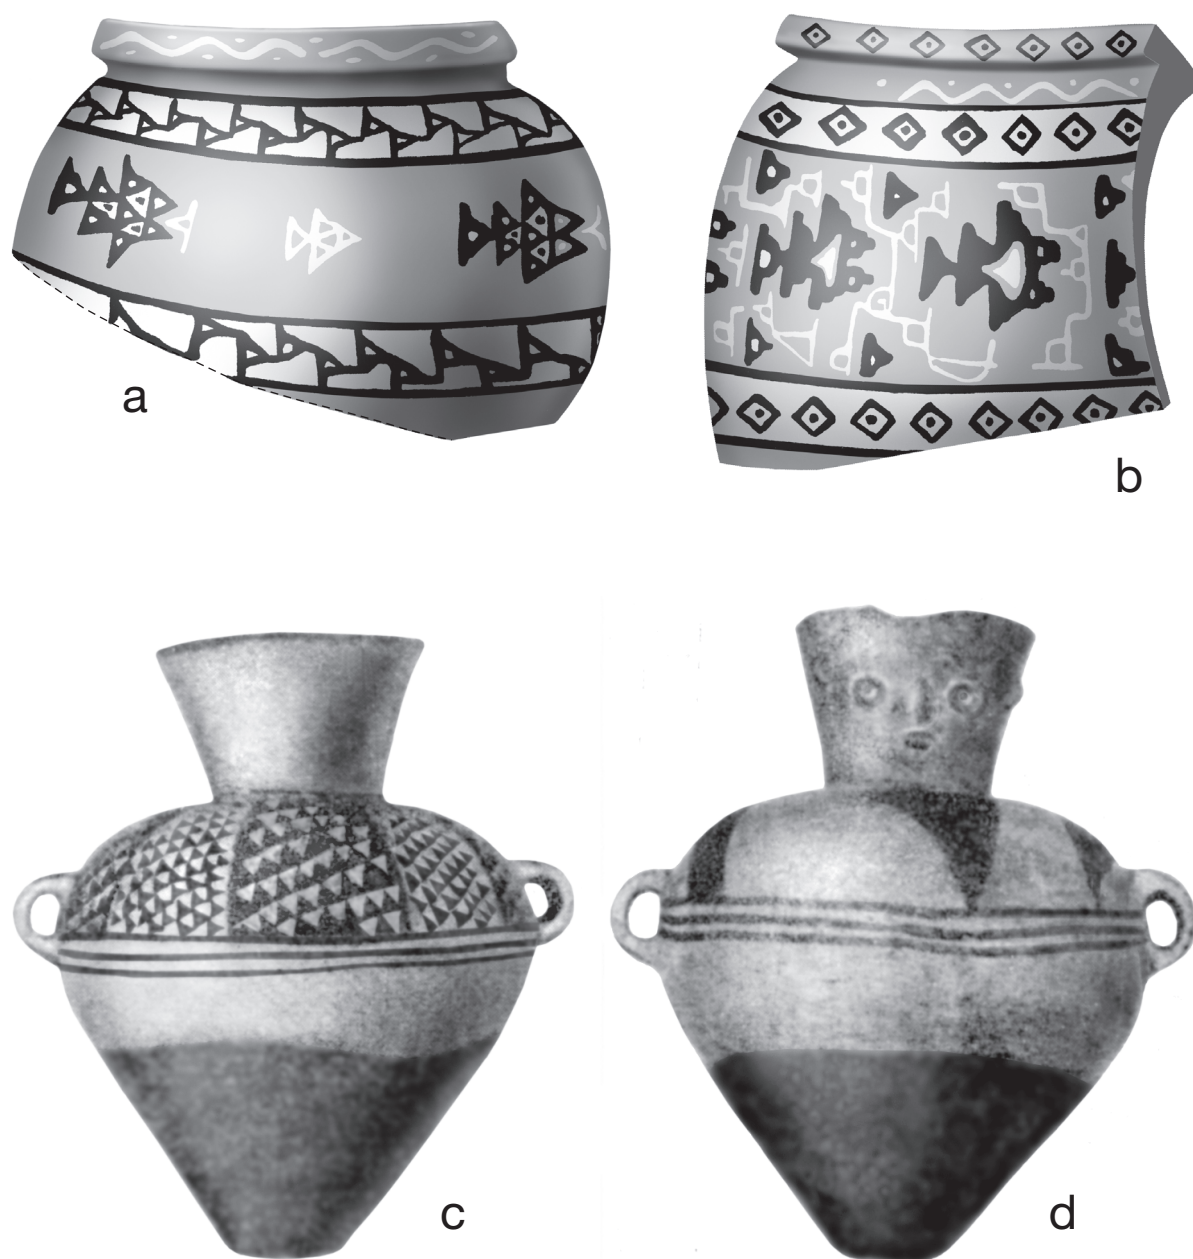
Figure 10.2. Painted vessels from the Late Chincha I period that resemble Pingüino Buff specimens from Cerro Azul. (*a, b*): sherds from globular jars with everted rims, painted black/white/red with the “school of fish” motif (redrawn from Kroeber and Strong 1924a: Fig. 6); (*c*): jar with funnel neck and geometric motifs; (*d*): jar with human face modeled on neck (*c* and *d* are redrawn from Kroeber and Strong 1924a: Pl. 12).

In addition to similarities in shape and surface treatment, Cerro Azul's Late Intermediate pottery shares motifs and style with painted Late Intermediate pottery from the Chíncha Valley (Figure 10.2). Furthermore, Late Intermediate figurines from the Chíncha Valley (Kroeber and Strong 1924a:Pl. 14; Sandweiss 1992:Figs. 33, 37) are similar to those found at Cerro Azul (Marcus 1987a:Figs. 21, 22). More than 100 years ago, Uhle noted that these figurines occurred only in graves that dated to his Late Chíncha period; his Late Horizon graves contained no ceramic figurines. Uhle's statement is repeated by Kroeber and Strong, who say, "It is thus clear that the white figurines of Chíncha are characteristic of the Late Chíncha I graves, are practically lacking

Earlier, Uhle had astutely noted that the designs seen on these sherds were reminiscent of textile patterns; indeed, some textiles of the period also show conventionalized flocks of birds or schools of fish like those on the ceramics. Kroeber and Strong (1924a:18) also suggest that "several of the continuous patterns might well have been copied directly from a fabric onto the bowl." In addition to the painting of motifs such as schools of fish, the pottery of both valleys shows similarities in the creation of zones, panels, and registers (Figure 10.2).
