Surface Treatment Macrotexture and Bicycle Ride Quality

Authors:
Hui Li, John T. Harvey, Calvin Thigpen, and Rongzong Wu

Part of Partnered Pavement Research Program (PPRC) Strategic Plan Element 4.47:
Impact of Chip Seal on Bicycle Ride Quality

DOCUMENT RETRIEVAL PAGE			Research Report: UCPRC-RR-2013-07		
Title: Surface Treatment Macrotecture and Bicycle Ride Quality					
Author: Hui Li, John T. Harvey, Calvin Thigpen, and Rongzong Wu					
Caltrans Technical Leads and Reviewers: S. Price, S. Balasubramanian K. McClain, H. Zhou					
Prepared for: California Department of Transportation Division of Research, Innovation, and System Information (DRISI) Office of Roadway Research		FHWA No.: CA142550A	Date Work Submitted: April 14, 2014		Date: December 2013
Strategic Plan No.: 4.47		Status: Stage 6, final		Version No.: 1	
Abstract: This memorandum summarizes the results of measurements of macrotecture on a set of Caltrans and local government pavement surface treatments, and the results of bicycle vibration measurements and a survey of bicycle ride quality on most of those sections. The work was performed to address concerns raised by local bicyclists regarding ride quality after a mo

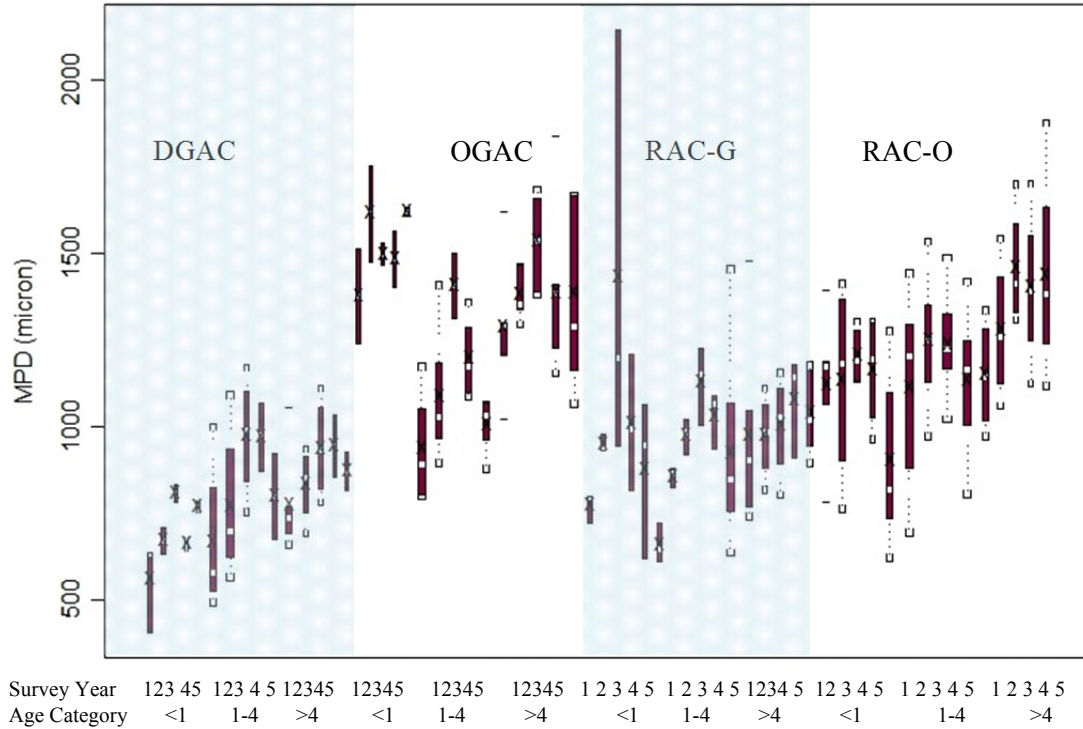
Figure 2.4: Comparison of MPD values for four commonly used asphalt surface mix types in California for different initial age categories (age category, survey years) and for five years of data collection (6).

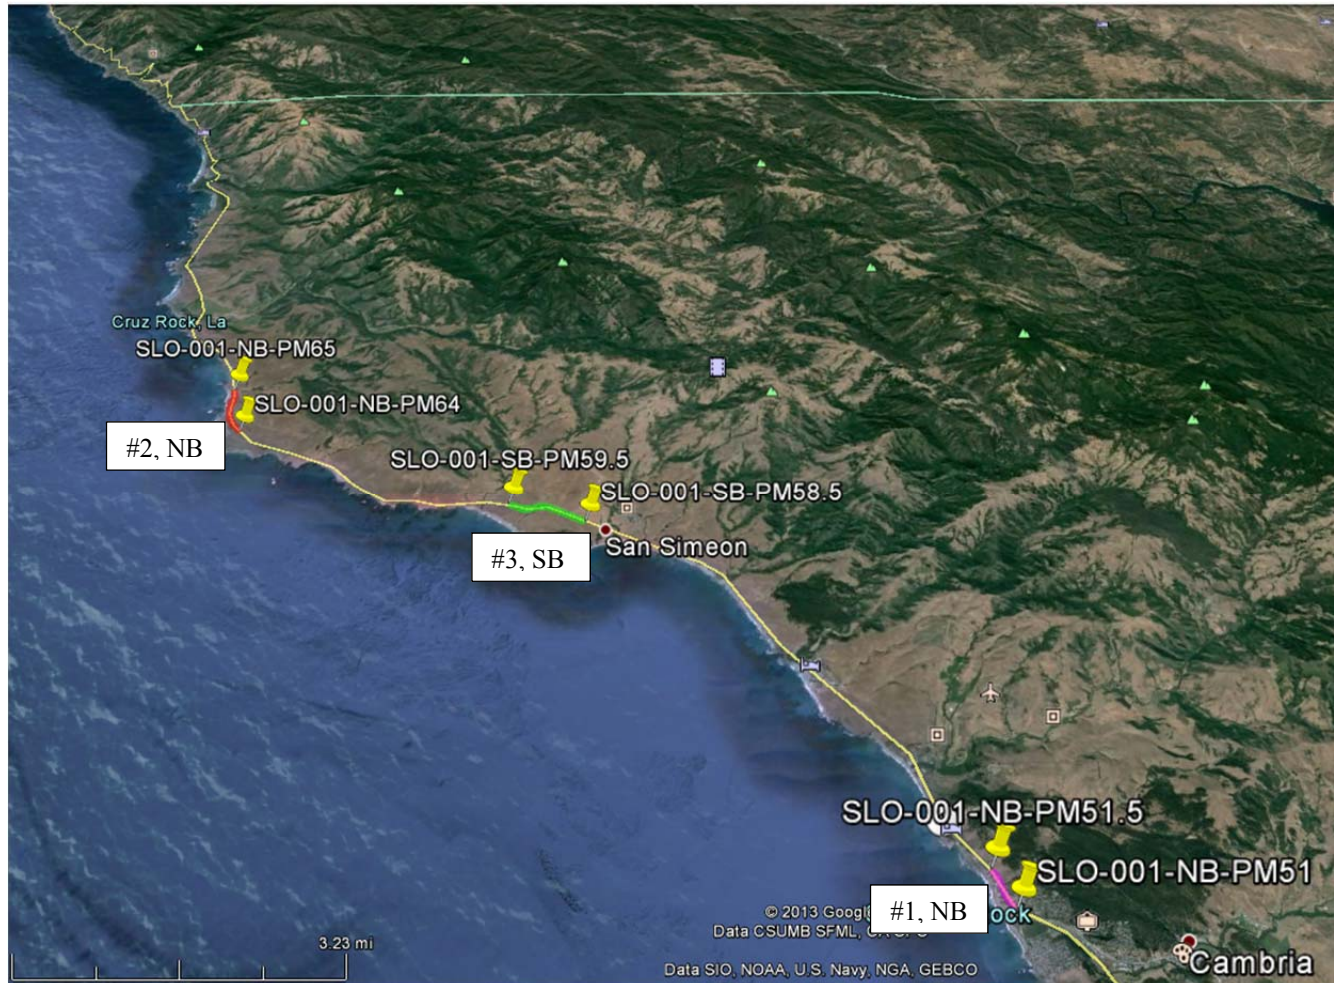
Figure 3.3: Subsections on SLO-1 used for the three bicycle ride quality surveys.
 (See Table 3.4 for section details.)

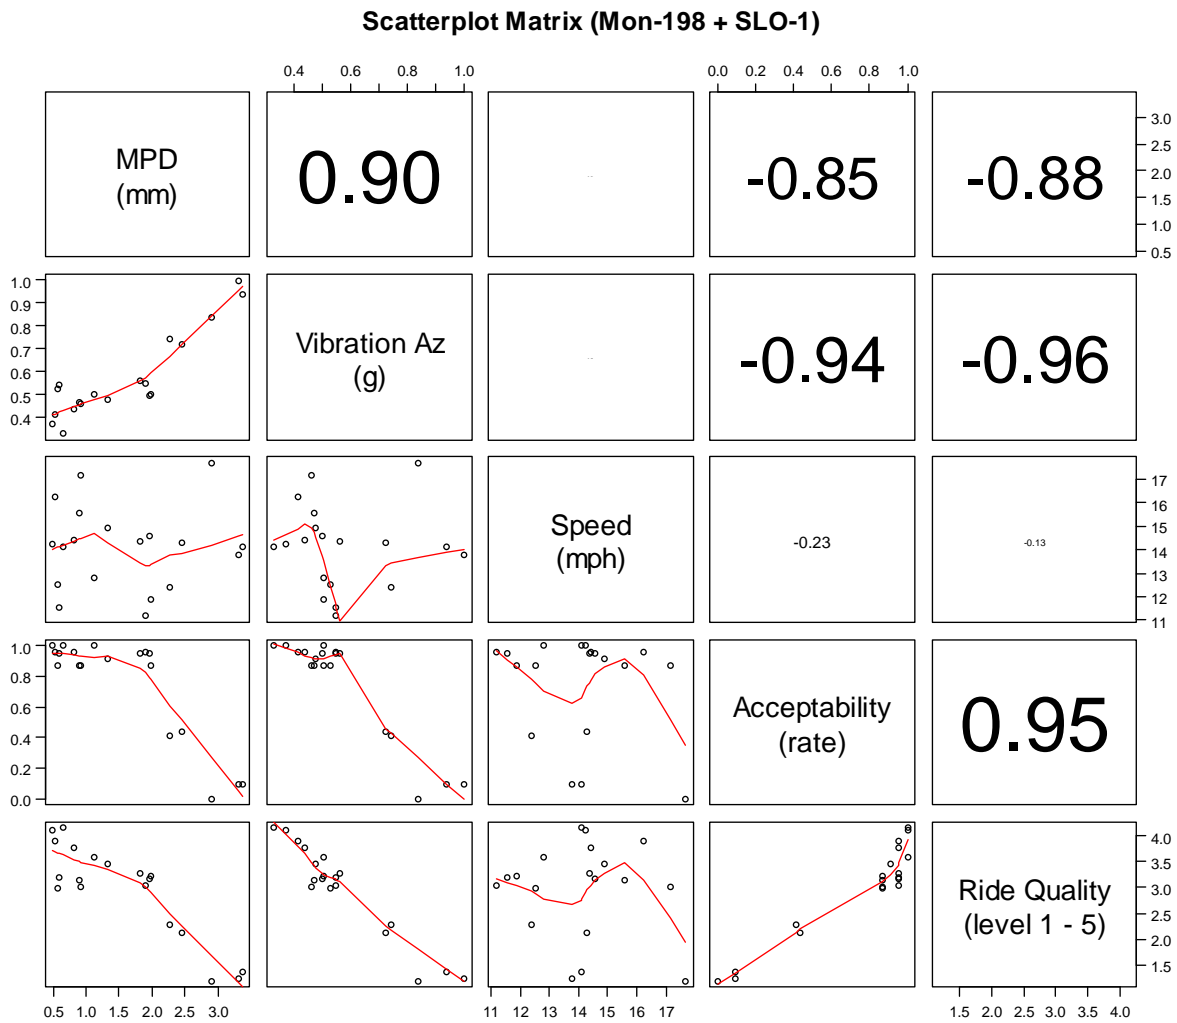
Figure 4.24: Correlations between MPD, acceleration, bicycling speed, acceptability, and ride quality level (Mon-198 test sections).

- a. High correlations were revealed between MPD, vertical bicycle acceleration, acceptability, and ride quality level.
- b. No significant correlation was found between other variables and bicycle speed (small set of speeds).

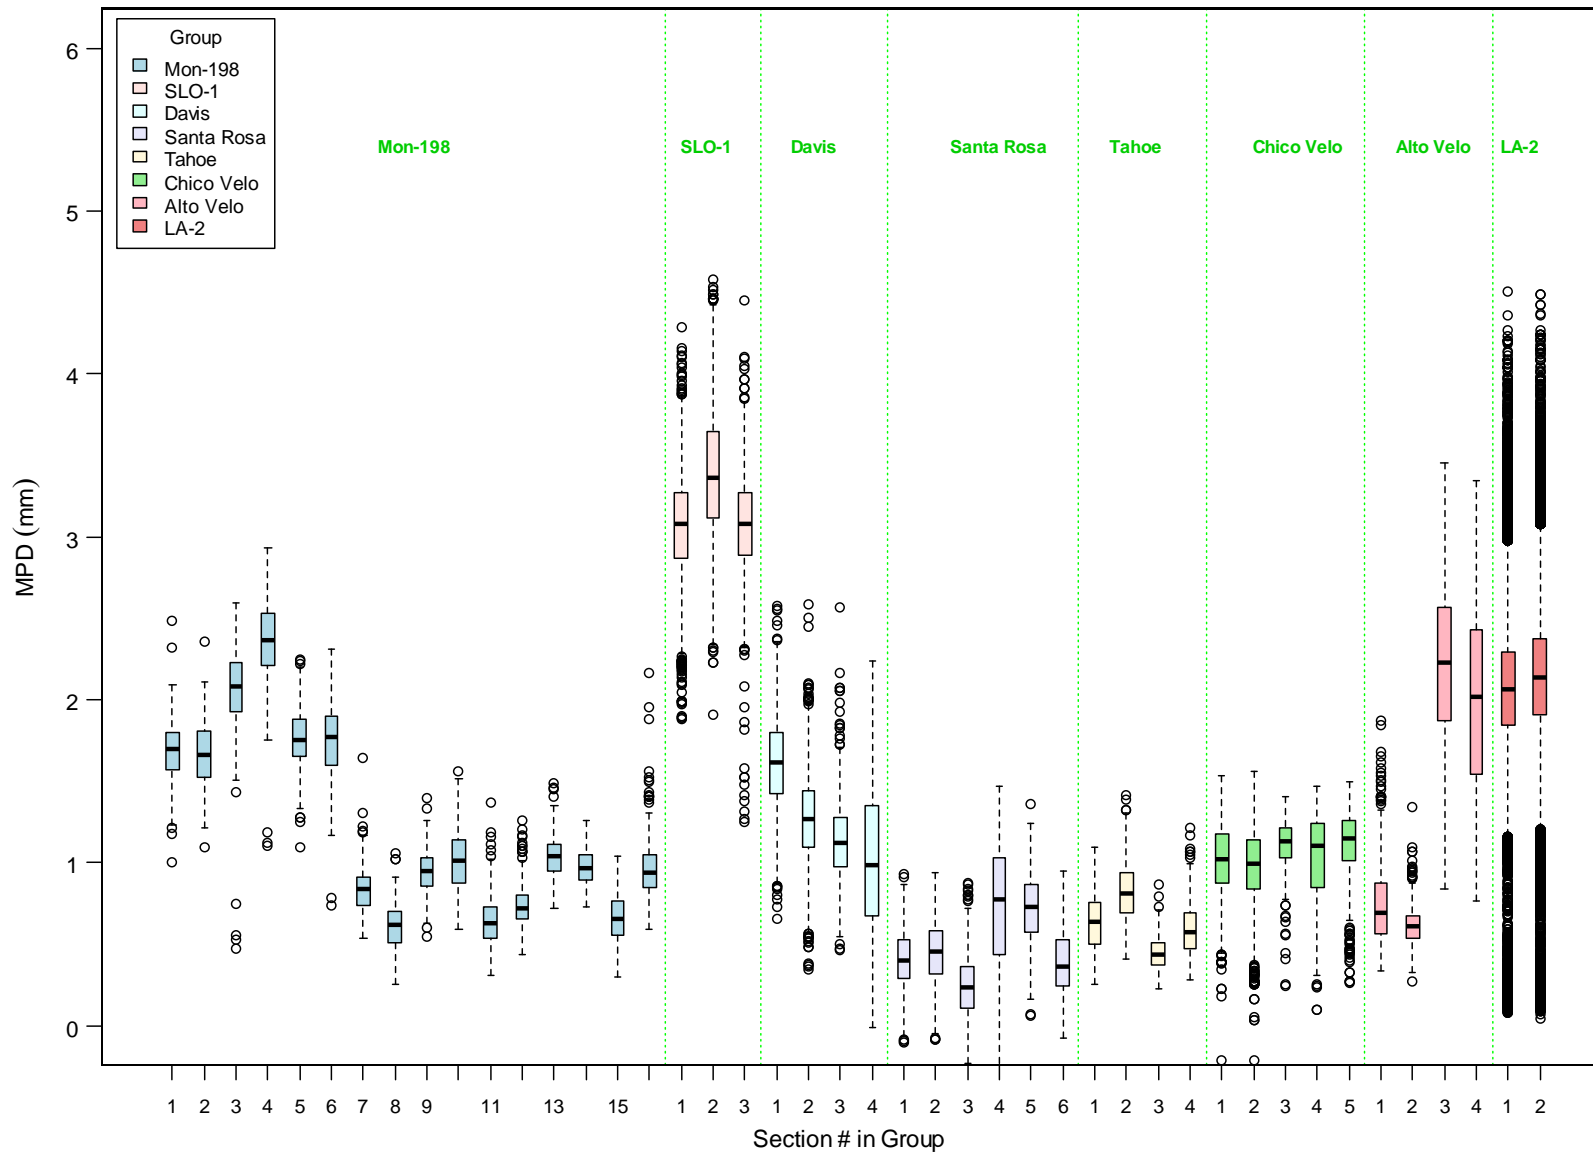
Figure 5.16: Summary boxplot of macrotexture measured using IP for survey sections of all groups (also see Figure 5.32.)
(Note: the Mon-198 group consists of the Mon-198 test sections).

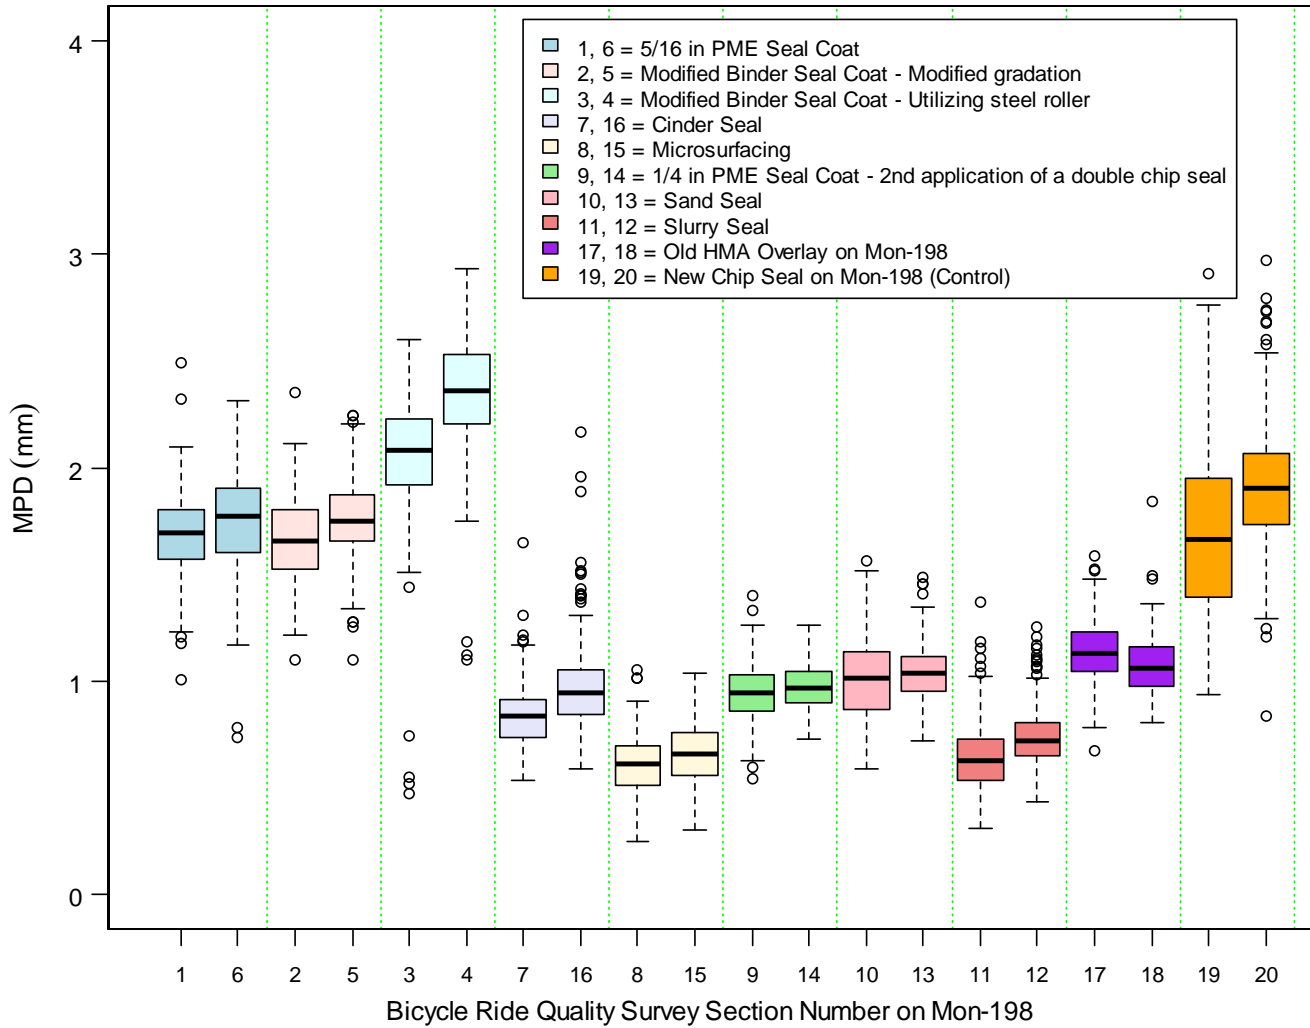
Figure 5.17: MPD measured with IP for the edge of traveled way (ETW, box on the left) and the left wheelpath (box on the right) for each of the Mon-198 treatment sections. (Note: see Table 3.4 for treatment descriptions.)

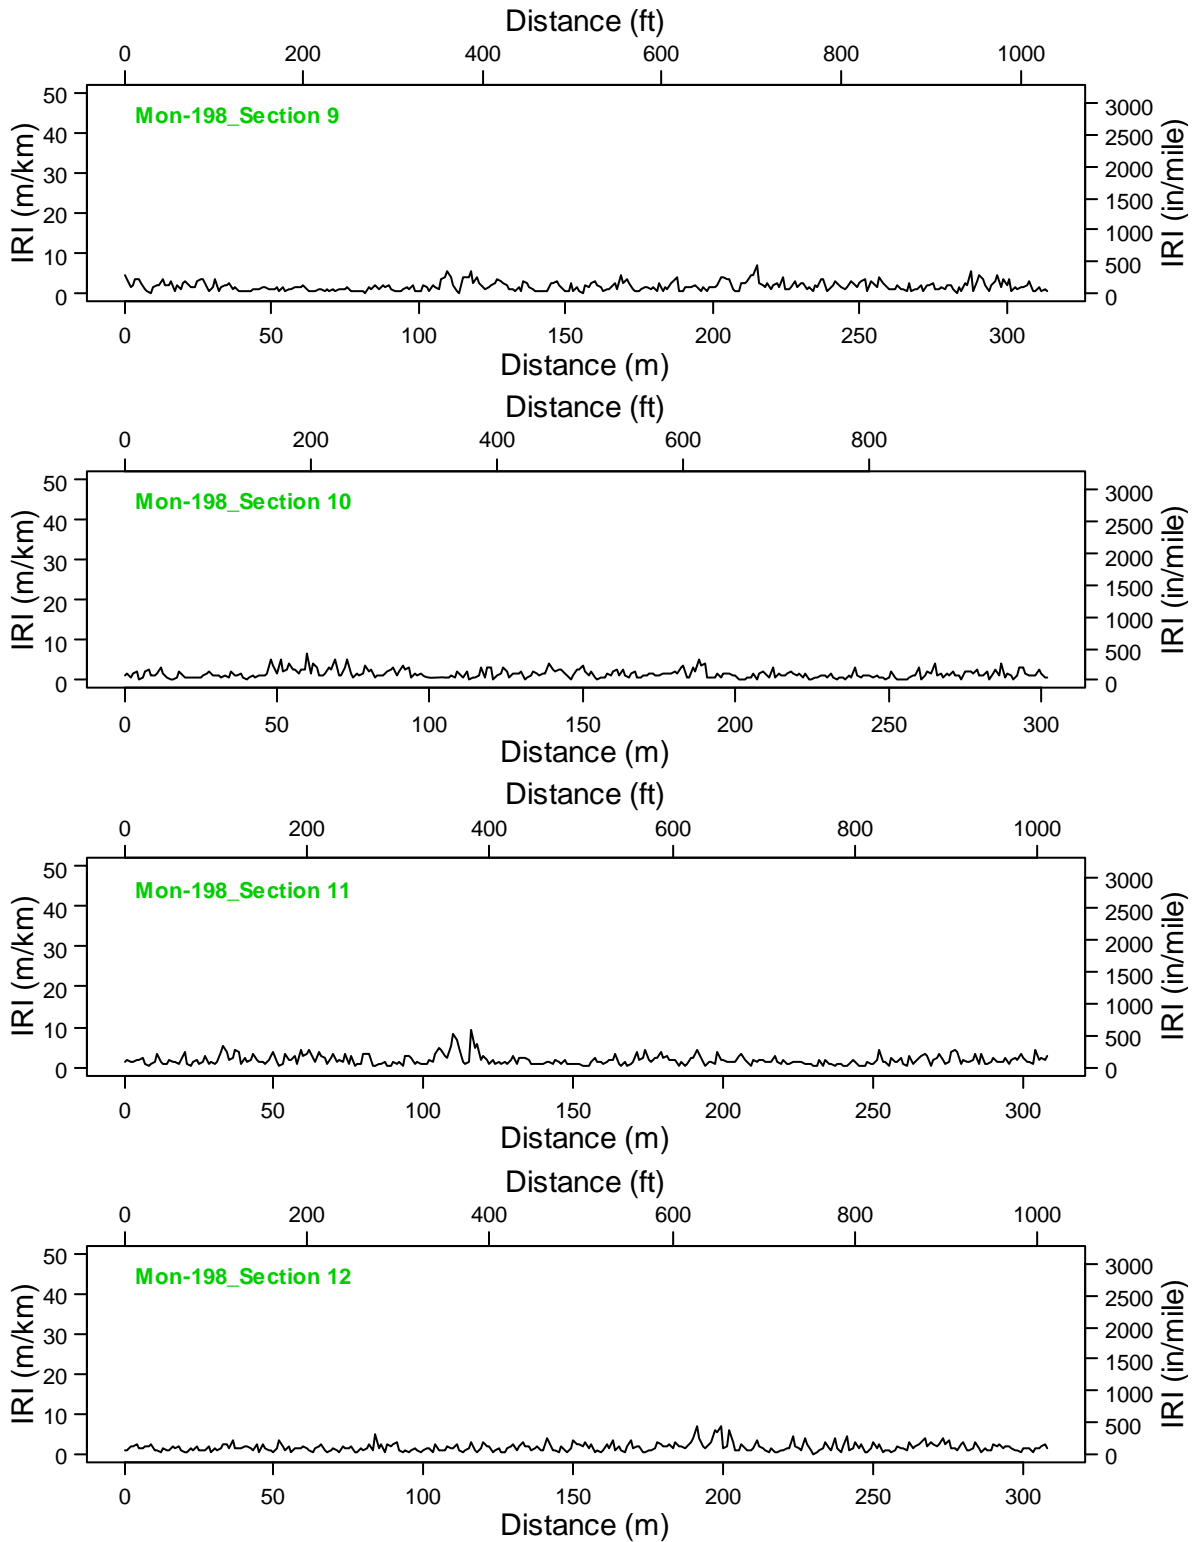
Figure 5.21: IRI of the Mon-198 group survey sections 9 to 12.
