Sensors (Basel, Switzerland), 18(2)

# Study of Impact Damage in PVA-ECC Beam under Low-Velocity Impact Loading Using Piezoceramic Transducers and PVDF Thin-Film Transducers

**Abstract:** Compared to conventional concrete, polyvinyl alcohol fiber reinforced engineering cementitious composite (PVA-ECC) offers high-strength, ductility, formability, and excellent fatigue resistance. However, impact-induced structural damage is a major concern and has not been previously characterized in PVA-ECC structures. We investigate the damage of PVA-ECC beams under low-velocity impact loading. A series of ball-drop impact tests were performed at different drop weights and heights to simulate various impact energies. The impact results of PVA-ECC beams were compared with mortar beams. A combination of polyvinylidene fluoride (PVDF) thin-film sensors and piezoceramic-based smart aggregate were used for impact monitoring, which included impact initiation and crack evolution. Short-time Fourier transform (STFT) of the signal received by PVDF thin-film sensors was performed to identify impact events, while active-sensing approach was utilized to detect impact-induced crack evolution by the attenuati

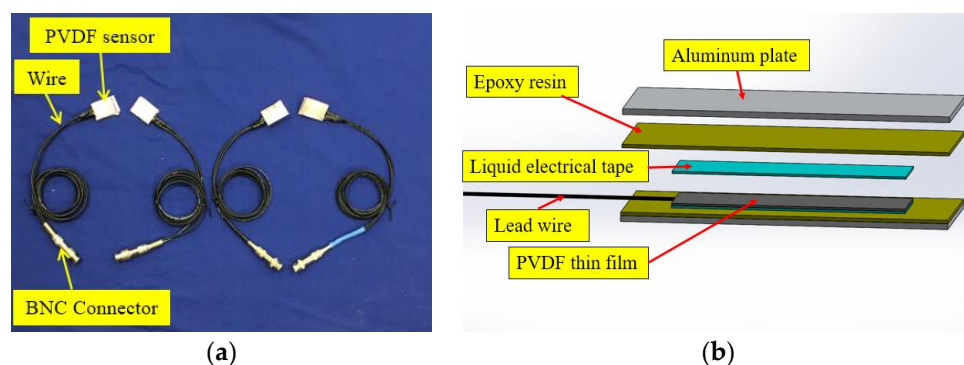
**Figure 1.** Embedded polyvinylidene fluoride (PVDF) thin-film sensor: (a) photo and (b) internal structure.

In this research, embeddable PVDF thin-film sensors were designed to detect the impact events, as shown in Figure 1. The PVDF thin-film sensors used in this experiment consists of two thickness of 2-mm aluminum plate and the middle PVDF film thickness is 0.05 mm. The PVDF thin-film sensor was connected by lead wires and isolated by liquid electrical tape. Subsequently, two aluminum plates house the sensor, and the entire module is stabilized with epoxy resin. The aluminum housing protects the PVDF thin-film from physical and chemical damage, as well as load imbalance when embedded within concrete structure. The detailed mechanical and material properties of PVDF and PZT transducers used in this research is given in Table 1.

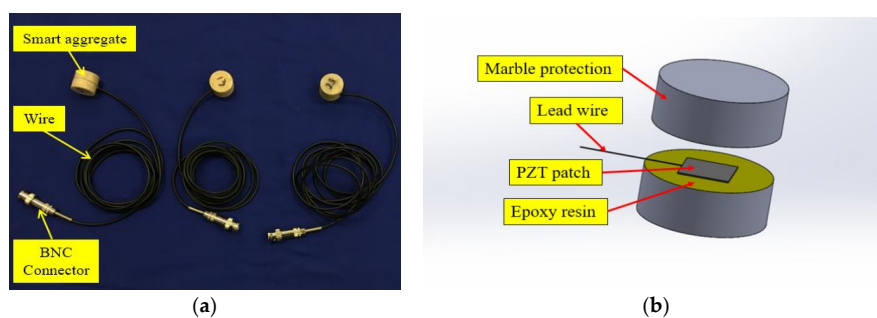
**Figure 2.** Smart aggregate (a) photo and (b) internal structure.

To evaluate the severity of damage of a concrete beam under discrete repeated impacts, the smart aggregate-based active sensing approach was employed in this research. Smart aggregate (SA) was designed by sandwiching a waterproofed PZT patch with two marble pieces, as shown in Figure 2. The Piezoelectric SA in this experiment is composed of two pieces of granite with 12 mm thickness, and a PZT sheet with a thickness of 0.3 mm in the middle of the smart aggregate. The cylindrical shaped smart aggregate has a radius of 25 mm and a height of 25 mm. In the active sensing approach, one SA was used as an actuator to generate guided waves, while the other SA was used as a sensor to detect the propagated wave response. When impact-induced cracks develop in concrete, the cracks function as stress relief which attenuates the wave propagation energy. The attenuation increases with the degree of failure, therefore the energy received by the SA sensor is an effective indicator to determine the degree of impact-induced cracks in concrete beams.

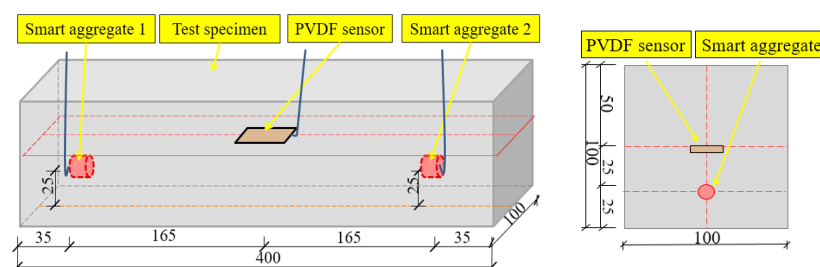
**Figure 3.** Detailed sensor location (unit: mm).

To investigate the impact loading behavior of PVA-ECC and mortar beams, a total of three PVA-ECC and three mortar beams were fabricated in the laboratory. The beams measured  $400 \times 100 \times 100$  mm, and the compositions of the beams are shown in Table 2. The detailed properties of PVA fibers are shown in Table 3. Within each beam, one PVDF thin-film sensor and two smart aggregates were positioned at predetermined locations with wooden sticks within the beam molds before casting, as shown in Figures 3 and 4. A PDVDF thin-film sensor was used for impact monitoring, and the PVDF film sensor was embedded in the location that is 1/2 thickness away from the surface of the beam to prevent the impact damage to the PVDF thin-film sensor. The crack of PVA-ECC beams is produced in the region of the maximum bending deformation under low-velocity impact loadings, and this region is near the center of the beam. To detect the crack of the PVA-ECC beams, a pair of SAs was embedded in the locations on both sides of the beams, so that to ensure the impact induced cracks occur between the SA pair. To minimize the effect of the sensor wires on the mechanical properties of the specimens, all the wires were placed in straight and come out from the top surface of the specimens. A mechanical vibrator was used during casting for concrete compaction, and the beams were subsequently cured for twenty-eight days.

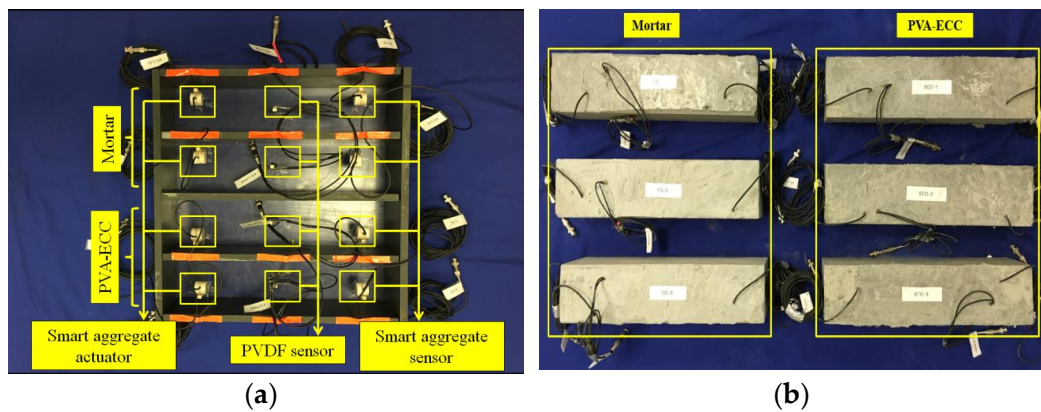
**Figure 4.** Specimen preparation. (a) molds with pre-installed PVDF sensors and smart aggregates (b) casted PVA-ECC and mortar beams.

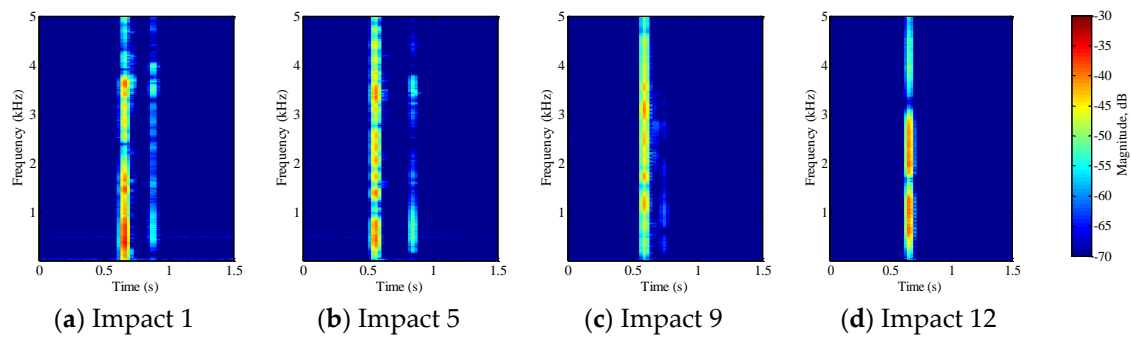
**Figure 6.** Short-time Fourier transform (STFT) of PVDF sensor signal for PVA-ECC 1.

The impact events detected by the embedded PVDF thin-film sensor in the three PVA-ECC beams are shown in Figures 6–8 respectively. The figures represent different stages in the deterioration of the impact-induced crack, and rightmost figures represents the complete failure of the specimen. Complete failure in this research means that the specimen suffers a fracture under the low-velocity impact loading. Within each figure, the impact time and the magnitude versus frequency of impact energy can be obtained by STFT. In addition, smaller impact events were seen immediately following the main impact events in PVA-ECC-1 and 2, which indicated that PVA-ECC specimens exhibited a bouncing effect. The bouncing effect causes free-falling lead balls to bounce up from the initial impact and cause a second smaller impact. However, the bouncing effect weakened as the impact-induced crack increased. As the PVA-ECC beam approached its ultimate bearing capacity, the bouncing effect ceased, as shown in Figures 6d and 7d. This observation implied that a failed PVA-ECC beam structure loses its bouncing effect. The frequency axis shows that the impact energy contributed to a range of impact frequencies. However, the magnitude versus frequency in these Figures does not present a clear trend, which is further elaborated in Section 5.3. For PVA-ECC-3, the drop weight and height were both increased and the beam failed after three impacts, therefore the bouncing effect was not observed in PVA-ECC-3.

In this research, a combination of PVDF thin-film sensors and smart aggregates were utilized to monitor impact initiation and crack evolution in PVA-ECC and mortar beams. Figures 6–9 show that STFT effectively detected impact events and displayed impact information, including impact time, frequency range, and magnitude versus frequency. The bouncing effect was observed and weakened with the increase of impact events. However, since the PVDF thin-film sensors were embedded close to the crack area of the beams, the impact energy detected by the PVDF sensors are influenced by the characteristics of the crack. Therefore, no clear trend of magnitude versus frequency was observed in Figures 6–9 from the repeated impact tests. The magnitude vs. frequency information is an important aspect of the results and should be correlated to the structural damage information. For future work, the location of the embedded PVDF thin-film sensors will be optimized to avoid direct effects from the impact-induced crack and the design of the PVDF thin-film sensor will be optimized. Spherical piezoceramic-based transducers might be a solution to eliminate the influence of the crack characteristics to the sensor signal [36,37]. On the other hand, the sampling frequency used in this test was 10 kHz, so the highest computed frequency based on STFT was 5 kHz. The wide frequency response (up to 500 kHz) due to the impact events will be investigated in future work.

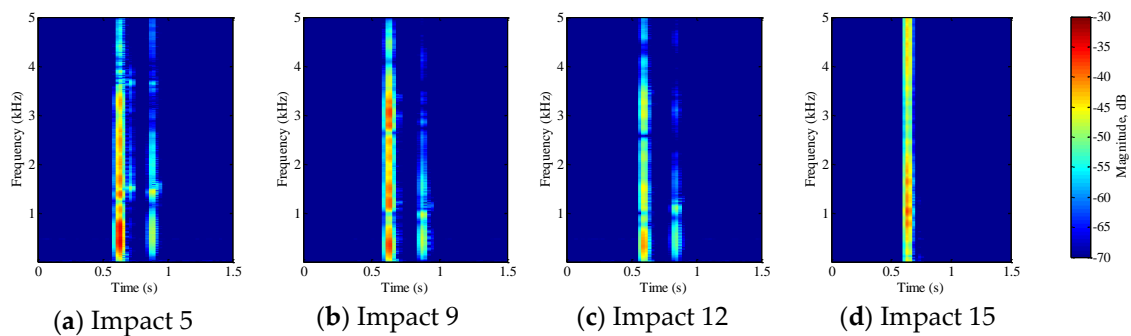
**Figure 7.** STFT of PVDF sensor signal for PVA-ECC 2.

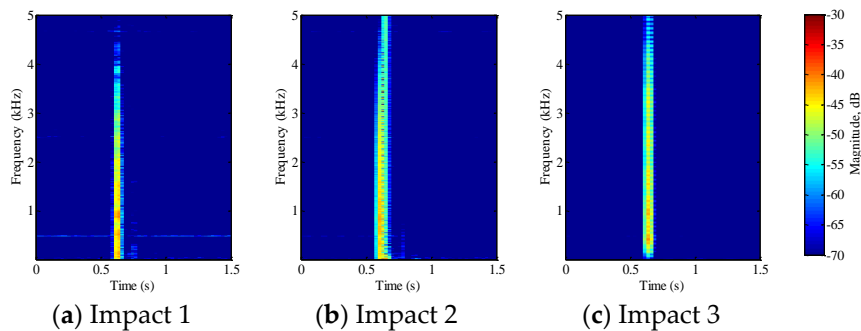
**Figure 8.** STFT of PVDF sensor signal for PVA-ECC 3.

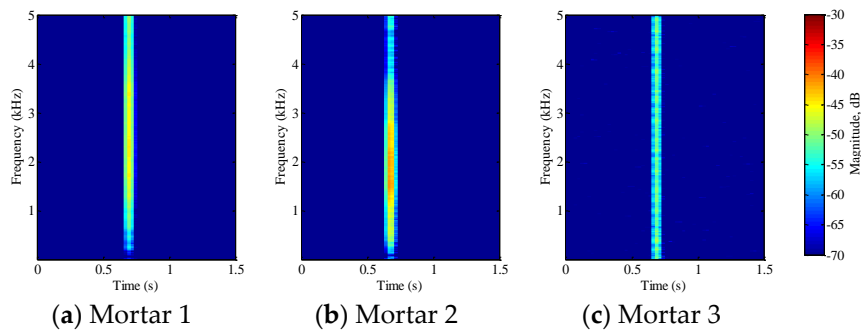
Figure 9. STFT of PVDF sensor signal for PVA-ECC 3.

For mortar beams, each beam completely failed after the first impact test. Figure 9 shows the STFT of the impact signal for each beam. When compared to PVA-ECC beams, mortar beams are prone to fail at the impact loading. With the same drop weight and height, PVA-ECC-1 survived until the 12th impact loading, while the mortar beams failed upon the first impact loading. Even with a reduced drop height of 0.5 m, the mortar beam was still incapable of bearing its integrity under this impact energy.

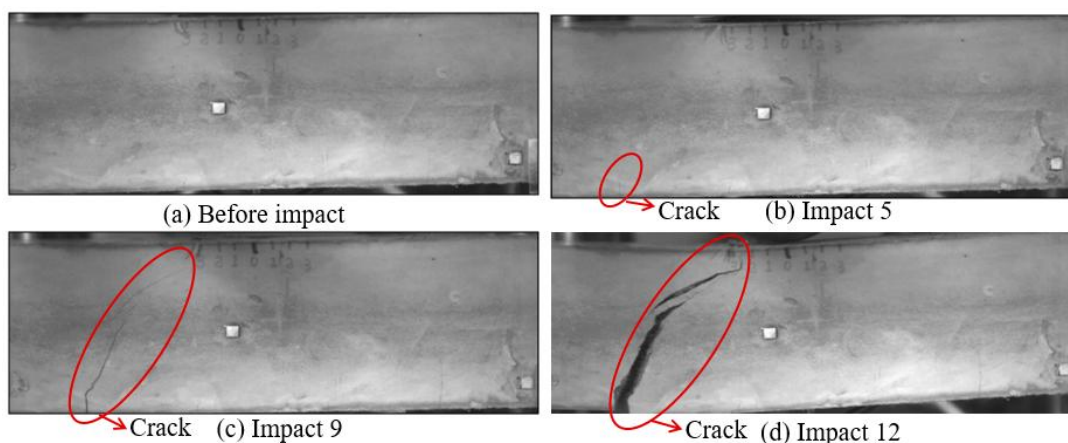
Figure 10. Results of crack detection in PVA-ECC-1 with high-speed video.

Low-velocity impact tests were repeated for each beam until the beam completely failed. For PVA-ECC-1 to 3, the impact counts were 12, 15, and 3, respectively. Figures 10–12 show the PVA-ECC-1 beam after impact tests, the time-domain signal received by the SA sensors, and the signal energy based on wavelet packet-based analysis. Due to space limitation, photos and time-domain signals are shown before impact, after impact 5, after impact 9, and after the last impact for each beam. Evolution of cracks for each beam can be observed. Figures 13–18 show the same measurements for PVA-ECC-2 and 3.

Between PVA-ECC-1 and 2, the drop height decreased from 1.5 to 1 m, which resulted in the impact test count increasing from 12 to 15. Since the crack acts as a stress relief, the propagated wave energy decreased which resulted in a decreased signal amplitude as received by the SA sensor. In both their time-domain signal response shown in Figures 6 and 7, it can be seen that the general amplitudes of the received signal decreased as the impact tests continued. In addition, wavelet packet-based signal energy plots provided a quantitative view to present the loss of the received signal energy. When the beam completely failed, the energy of the received signal approached 0 since the stress wave cannot propagate through a major crack. Compared with PVA-ECC-1, the drop weight of PVA-ECC-3 increased from 2.724 kg to 8.172 kg, which resulted in the impact test count decreasing from 12 to 3.

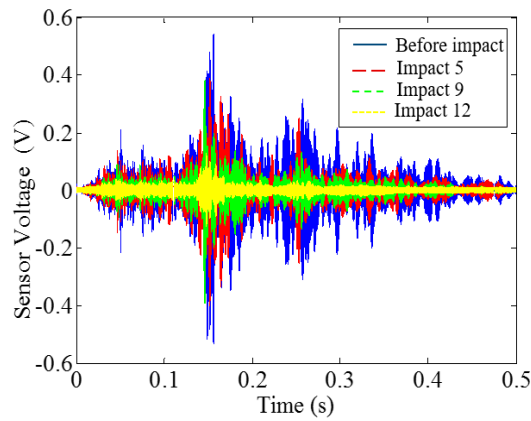
Figure 11. Time-domain signal received by smart aggregate (SA) sensor in PVA-ECC 1.

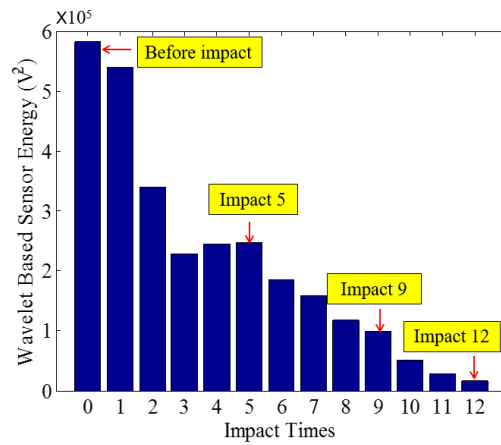
Figure 12. Wavelet packet-based energy plots of the received signal in PVA-ECC 1.

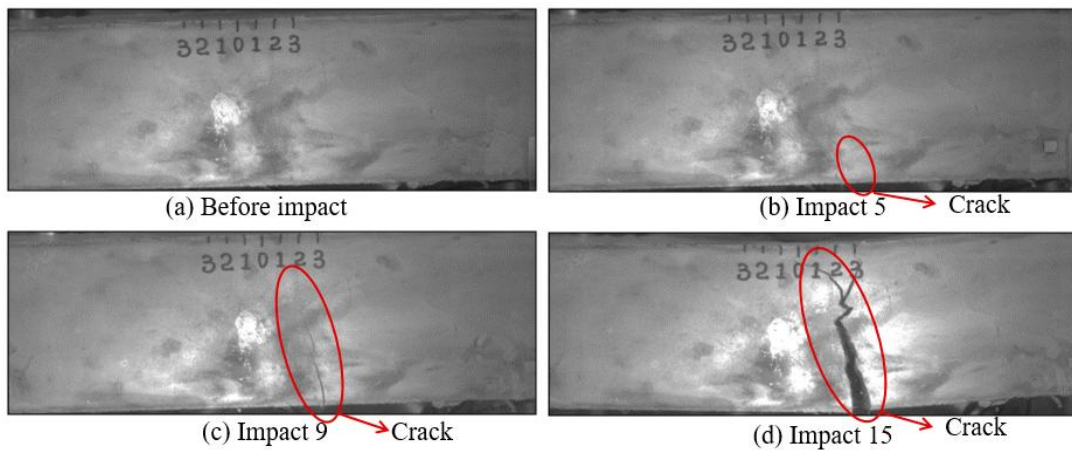
Figure 13. Results of crack detection in PVA-ECC-2 with high-speed video.

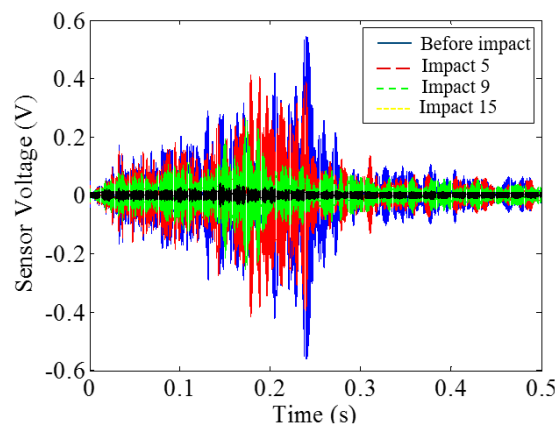
Figure 14. Time-domain signal received by SA sensor in PVA-ECC-2.

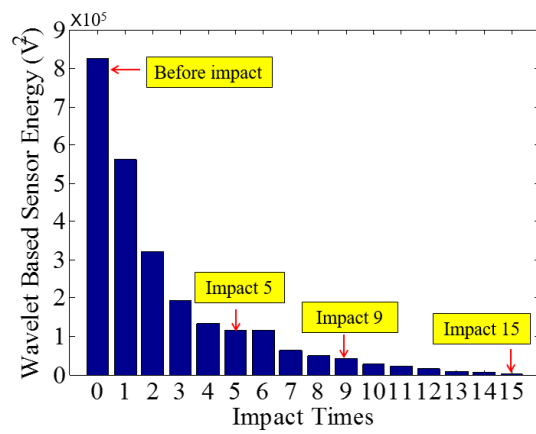
Figure 15. Wavelet packet-based energy plots of the received signal in PVA-ECC-2.

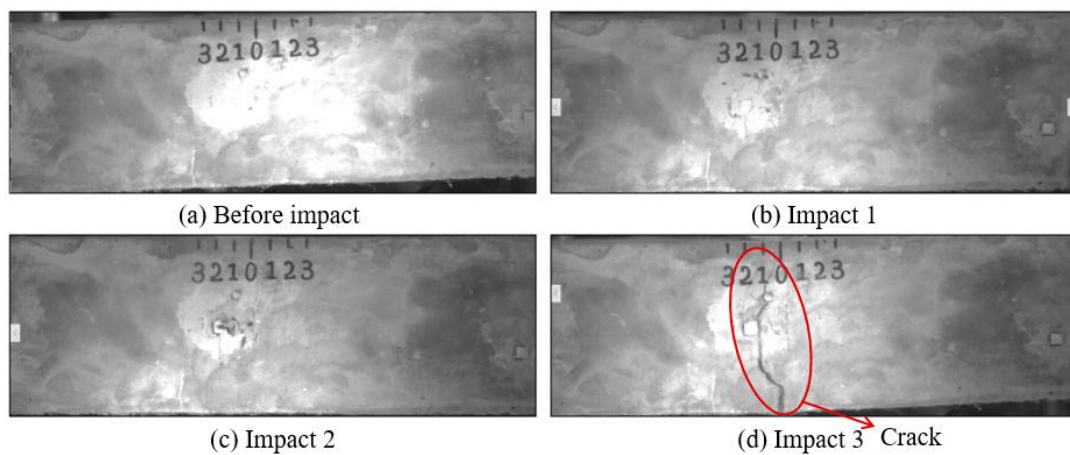
Figure 16. Results of crack detection in PVA-ECC-3 with high-speed video.

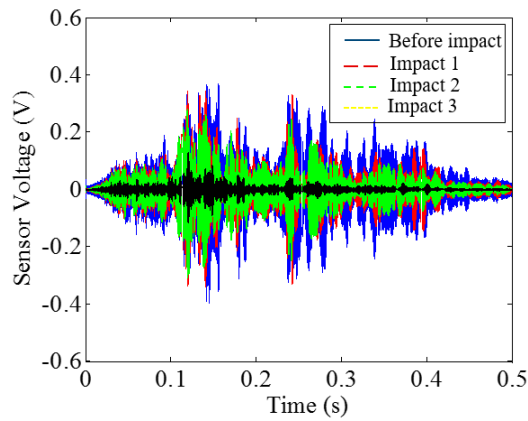
Figure 17. Time-domain signal received by SA sensor in PVA-ECC-3.

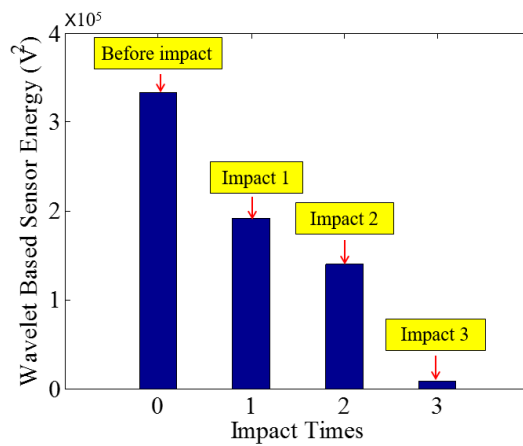
Figure 18. Wavelet packet-based energy plots of the received signal in PVA-ECC-3.

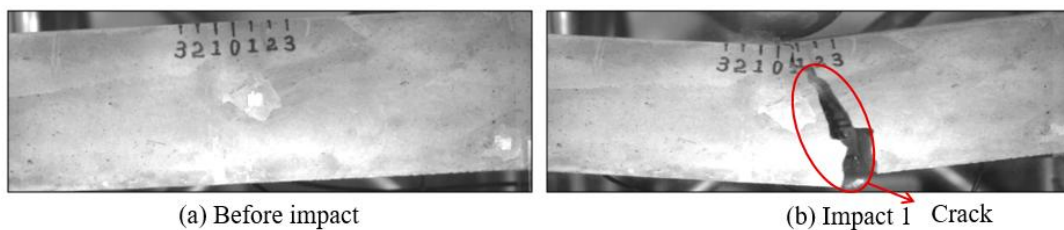
Figure 19. Results of crack detection of Mortar-1 with high-speed video.

Figures 19–27 show the Mortar-1, 2 and 3 beams respectively, after impact tests, the time-domain signal received by the SA sensors, and the signal energy based on wavelet packet-based analysis. Compared to PVA-ECC beams, the drop weight for all mortar beams was 2.724 kg. The only variable was the drop height which decreased from 1.5 to 0.5 m. It was seen that all mortar beams completely failed after the first impact, and no signal response was detected by the SA sensors. Similar results were verified by the wavelet packet-based energy plots. After the first impact test for each beam, the energy of the propagated signal rapidly zeros.

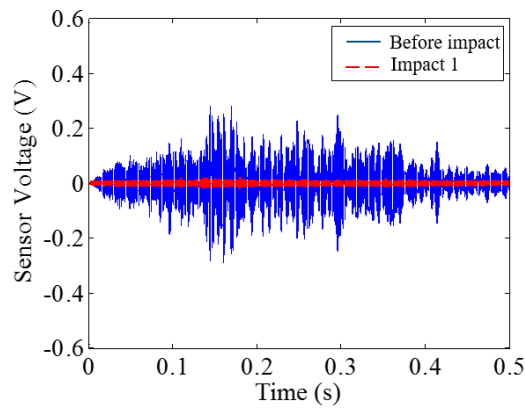
Figure 20. Time-domain signal received by SA sensor in Mortar-1.

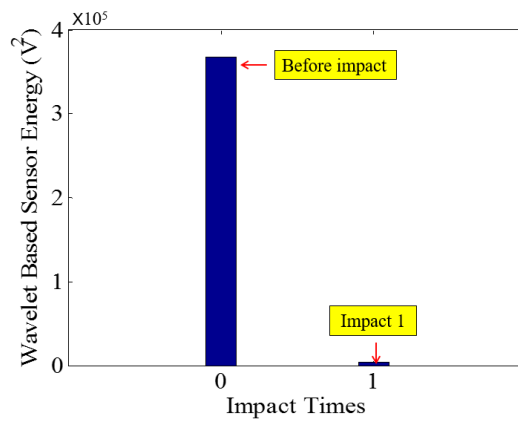
Figure 21. Wavelet packet-based energy plots of the received signal in Mortar-1.

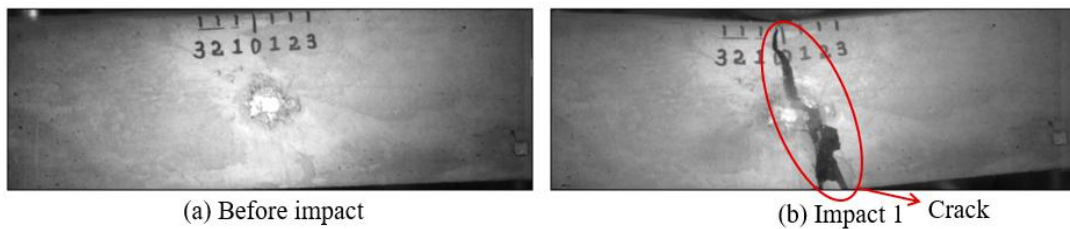
Figure 22. Results of crack detection of Mortar-2 with high-speed video.

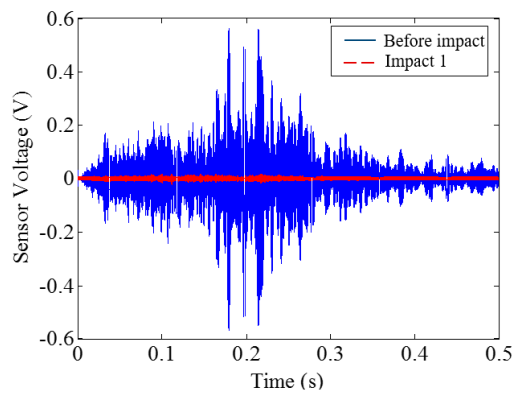
Figure 23. Time-domain signal received by SA sensor in Mortar-2.

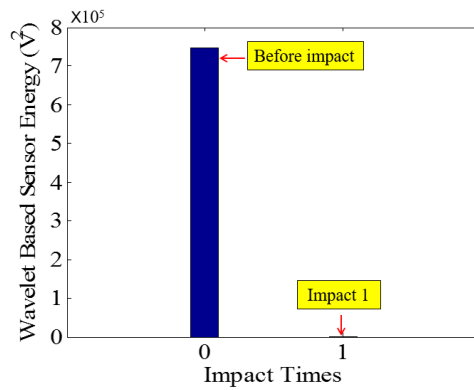
Figure 24. Wavelet packet-based energy plots of the received signal in Mortar-2.

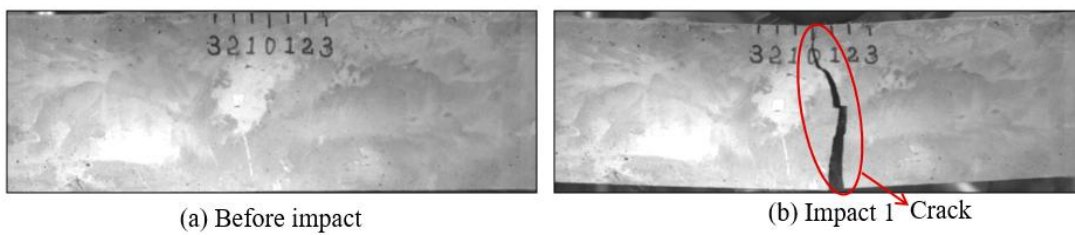
Figure 25. Results of crack detection of Mortar-3 with high-speed video.

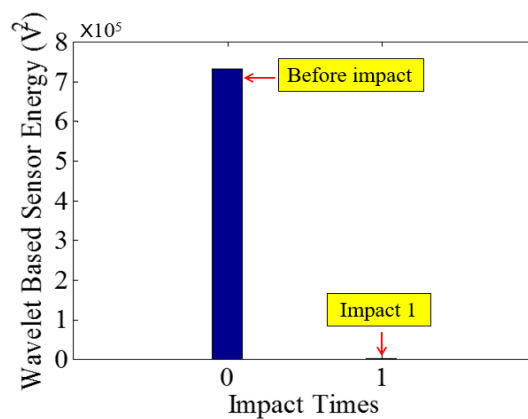
Figure 27. Wavelet packet-based energy plots of the received signal in Mortar-2.
