Spatial Variability of Saturated Hydraulic Conductivity and Thresholds for Slope Failure at Sedgwick Ranch, California

A Thesis submitted in partial satisfaction of the
requirements for the degree Master of Science
in Earth Science

Paul A. Alessio

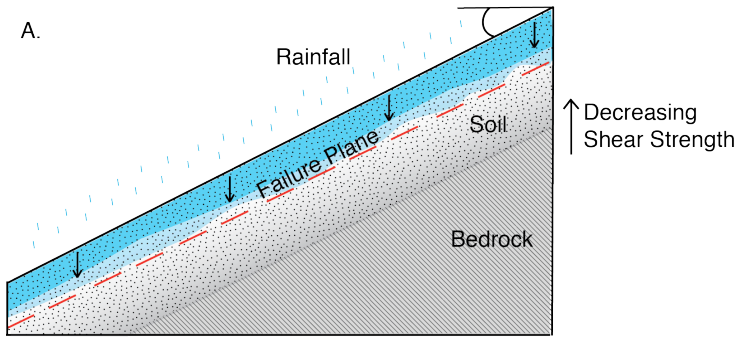
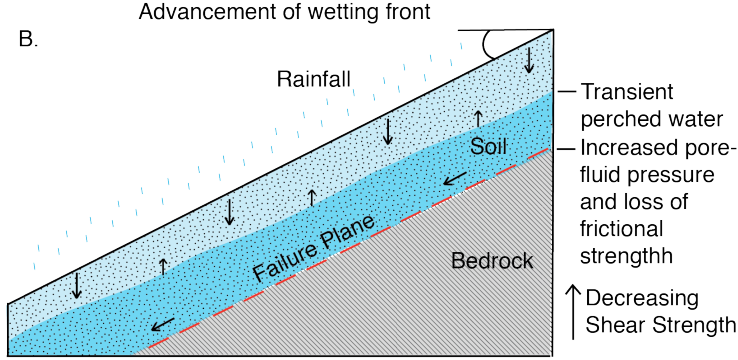
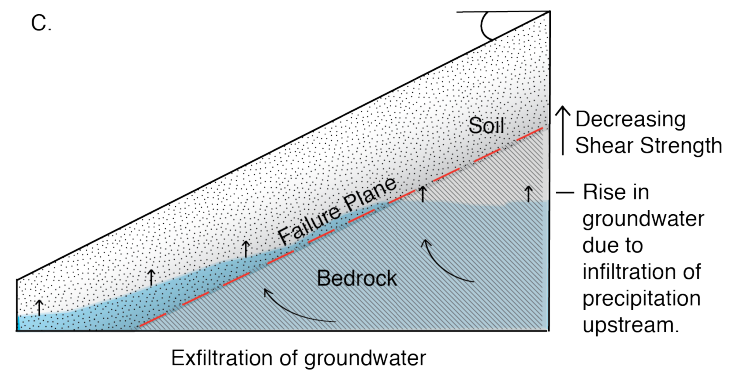
Figure 1: A conceptual cross section of a hillslope, portraying conditions that may lead to debris flow initiation. 1A) The advancement of the wetting front. 1B) Buildup of pore fluid pressure on a low-conductivity layer. 1C) Exfiltration of groundwater through bedrock. The dark grey layer at the bottom represents bedrock, and lighter shades represent soils with decreasing shear strength. The red dashed lines refer to potential failure planes. Black arrows are potential flow paths of water, either from the unsaturated zone (top) or groundwater (bottom).

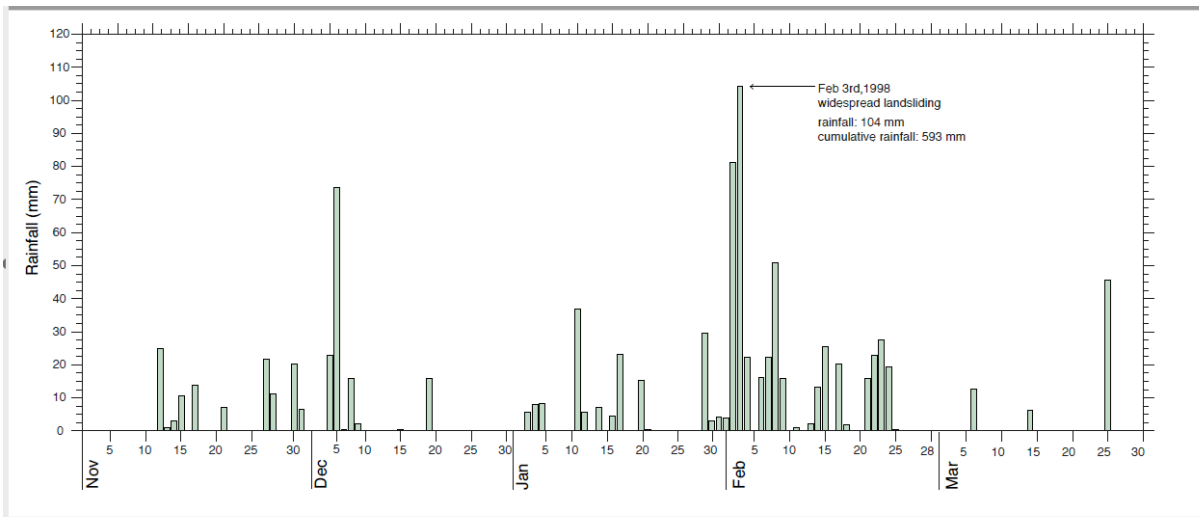
Figure 4: Daily rainfall totals from the Figueroa Mountain Ranger Station (3 km NE of Sedgwick Reserve). Landsliding occurred on Feb 3rd, 1998. Data acquired from NOAA.

The nearest rain gauge to Sedgwick Reserve that recorded the 1997-98' event is located at Figueroa Mountain Station, 4.5 km from the study site. Average rainfall at this station over the last 30 years is 544 mm/yr, and during 1997-98, 1164 mm of rain was recorded (Figure 4). Rainfall at this station is recorded in 24 hour intervals. The largest storm occurred on February, 3, 1998, dropping 104 mm of rain. Unfortunately, intensity-duration data from this particular station are missing for the 1997-1998 events. The nearest rain gauge that recorded rainfall intensities during 1997-98' is located in Foxen Canyon, 9.5 km away from the study area. Average and maximum rainfall intensities at various time intervals for Foxen Canyon correspond with a recurrence interval of 10-25 years for this area.

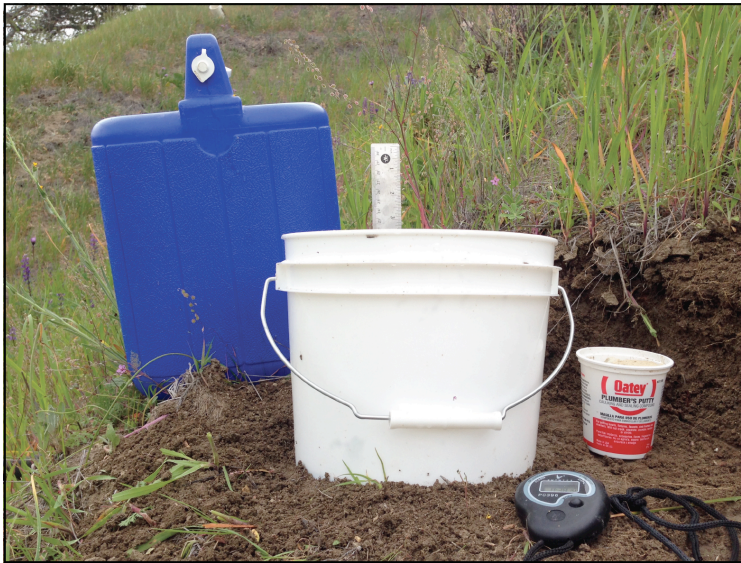
Figure 5: The falling-head single-ring infiltrometer, or bottomless bucket, used to make K_{sat} measurements. Plumber's putty was used to seal the outer edges to prevent leakage. A ruler was attached to the side to measure the rate of infiltration.

Implementation of the procedure includes a vertical-sided bottomless bucket, small shovel, a stopwatch, ruler, and several liters of water (Figure 5). The bucket used in the study is 20 cm high, and has a diameter of 24 cm at the top and bottom. A ruler was attached to the side of the bucket with a clip to measure the amount of infiltrated water.

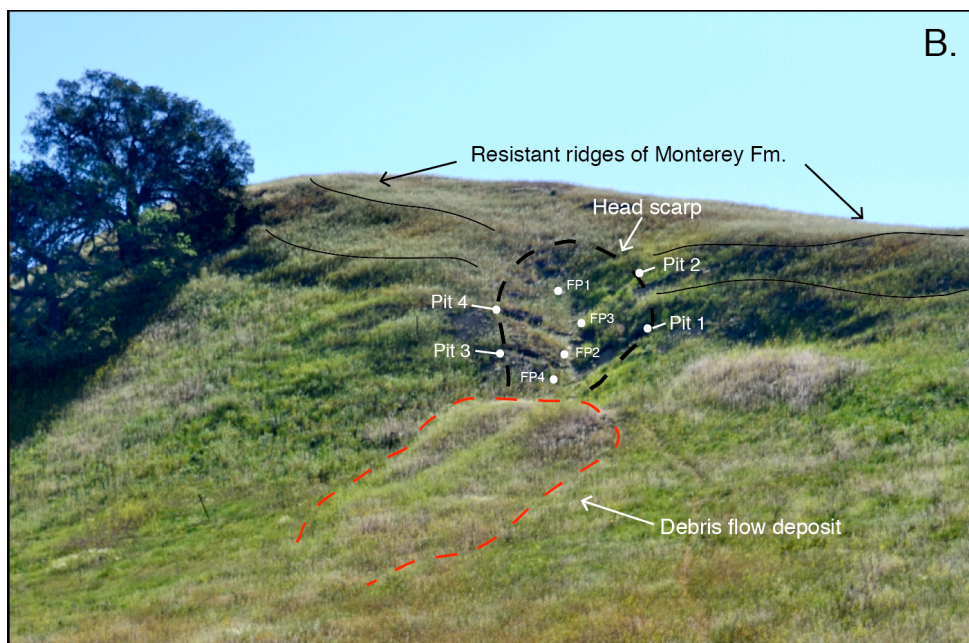
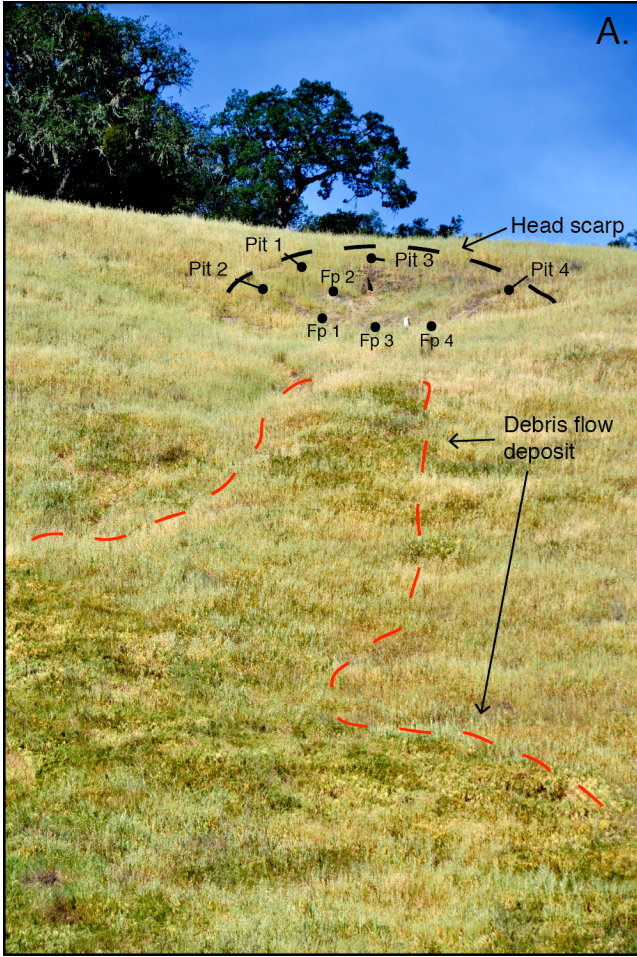
Figure 7: Infiltration measurements and pit locations are marked for each site. A dashed black line delineates the head scarp of the debris flow and red dashed lines outline the deposit. A) site 1 B) site 2 C) site 3.

Failure morphology and locations of measurements for site 1 are shown in Figure 7a. The underlying bedrock at site 1 is Paso Robles formation and the vegetation cover is predominately Mediterranean grasses. Site 1 is situated in a colluvial hollow, where the underlying Paso Robles Fm. forms a “u” shape that begins at the lateral scarps and meets in the center of the slide. This section of the hillslope is an unchanneled portion of the hillslope

Figure 7b displays the morphology of site 2 and the locations of infiltration measurements. The underlying bedrock at this site is the Monterey Formation and the vegetation cover consists predominately of Mediterranean grasses. Similar to site 1, site 2 is also situated in a hollow, where the bedrock was found to be “u” shaped, and converges at the deepest part in the center of the slide. Resistant ridges of Monterey formation flank both sides of the hollow, as seen in figure 7b. Failure occurred near the upper-middle portion of the hillslope at the concave-convex transition. The soil mantle consists of a 20 to 35 cm A horizon, followed by a 10 to 20 cm AC horizon (Figure 8b).

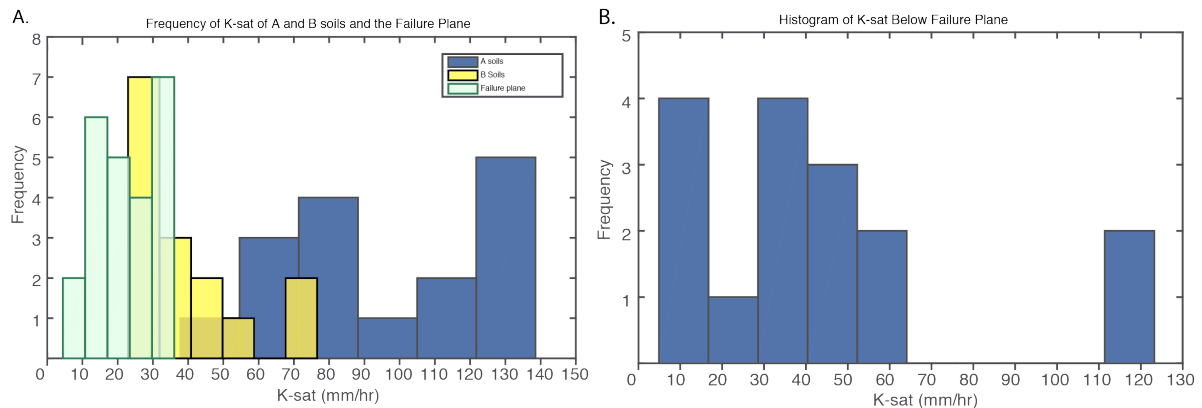
Figure 10: A) Histograms showing the frequency and distribution of K_{sat} in the A and B horizons and the failure plane. Note that the failure plane and A horizon measurements do not overlap, and the differences in kurtosis and skewness between the horizons. The failure plane exhibits the most narrow range of values. B) Histogram of K_{sat} below the failure plane. Note that K_{sat} exhibits a wide distribution, overlapping with all other horizons and contains two peaks centered around 10 and 35 mm/hr, near the average values for the failure plane and B horizon.

Histograms show the relative frequency and distribution of infiltration measurements in each group (Figures 10A and 10B). Soils from the A horizon exhibit the widest distribution, and range from 38-139 mm/hr, whereas K_{sat} at the failure plane are more tightly distributed and range from 4-33 mm/hr. K_{sat} values from the A horizon exhibit no overlap with the failure plane. K_{sat} values in the B horizon range from 25–77 mm/hr. A separate histogram shows the distribution of infiltration rates below the failure plane (figure 8b). With infiltration rates ranging from 5–123 mm/hr, bedrock below the failure plane exhibits a large range of values, overlaps with all other horizons, and contains two peaks centered around 10 and 35 mm/hr. The distribution of K_{sat} below the failure plane exhibits similar characteristics when compared to the B horizon and Failure plane distributions.

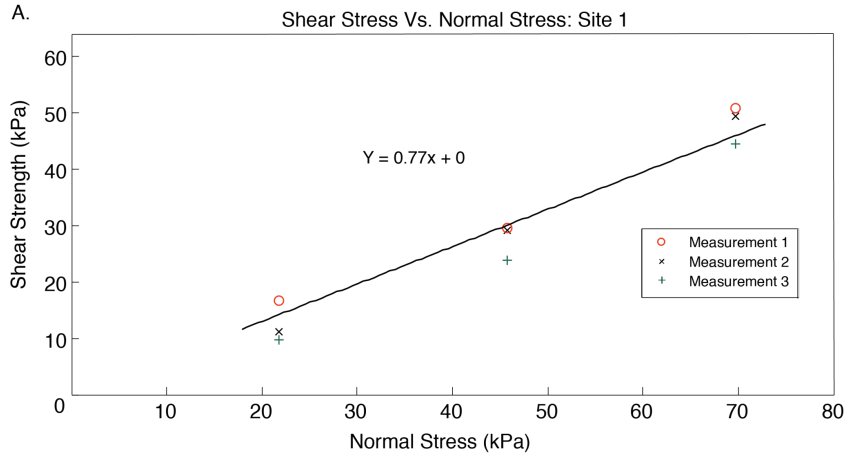
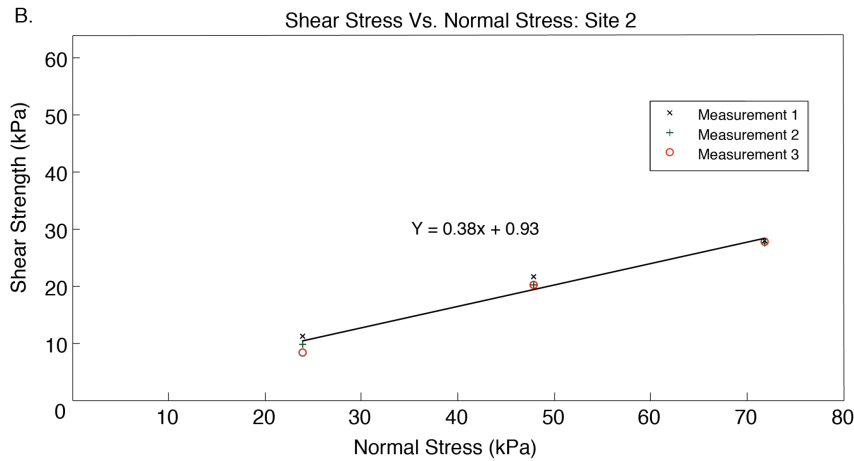
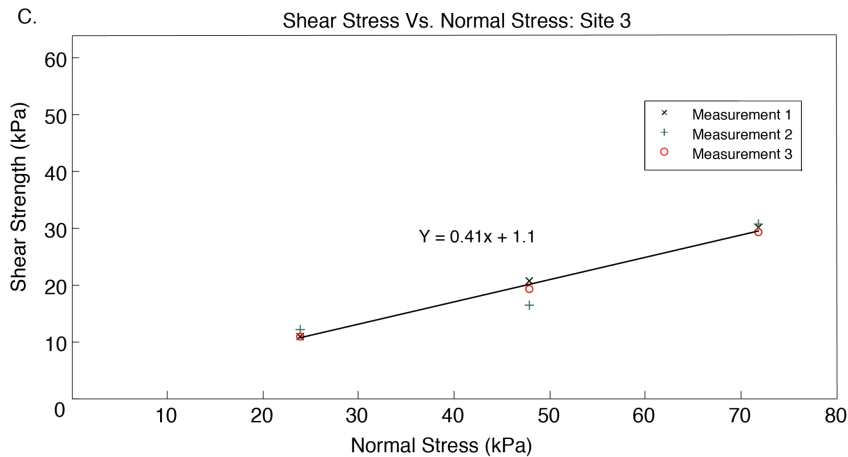
Figure 11: A) Direct shear measurements for site 1. B) Direct shear measurements for site 2. C) Direct shear measurements for site 3. The OLS regression lines for the three separate tests are plotted on each graph. The equation of the OLS line that was used to calculate cohesion, and the internal angle of friction is also displayed. Tests were performed at Pacific Soils, Santa Barbara, Ca

The results of the direct shear tests are provided in table 1. Figure 11 shows direct shear measurements with the best fit line and equation for the Mohr Coulomb fracture criteria for each site. Sites SR2 and SR3 both exhibit similar values for cohesion and angle of internal friction. Values for cohesion at SR2 and SR3 were found to be 0.93 and 1.08 kpa and the angle of internal friction was found to be 21° and 22°, respectively. Site 1 was found to be cohesionless and exhibited a higher internal friction angle of 34°. Values of cohesion for sites SR2 and SR3 are comparable to the value of 0.7 Kpa used by Gabet and Dunne (2002).
