Corrosion Performance of Steel and Nickel Alloys in Elevated Temperature Solar Salt

Doctor of Philosophy

Engineering – Nuclear Engineering

University of California, Berkeley

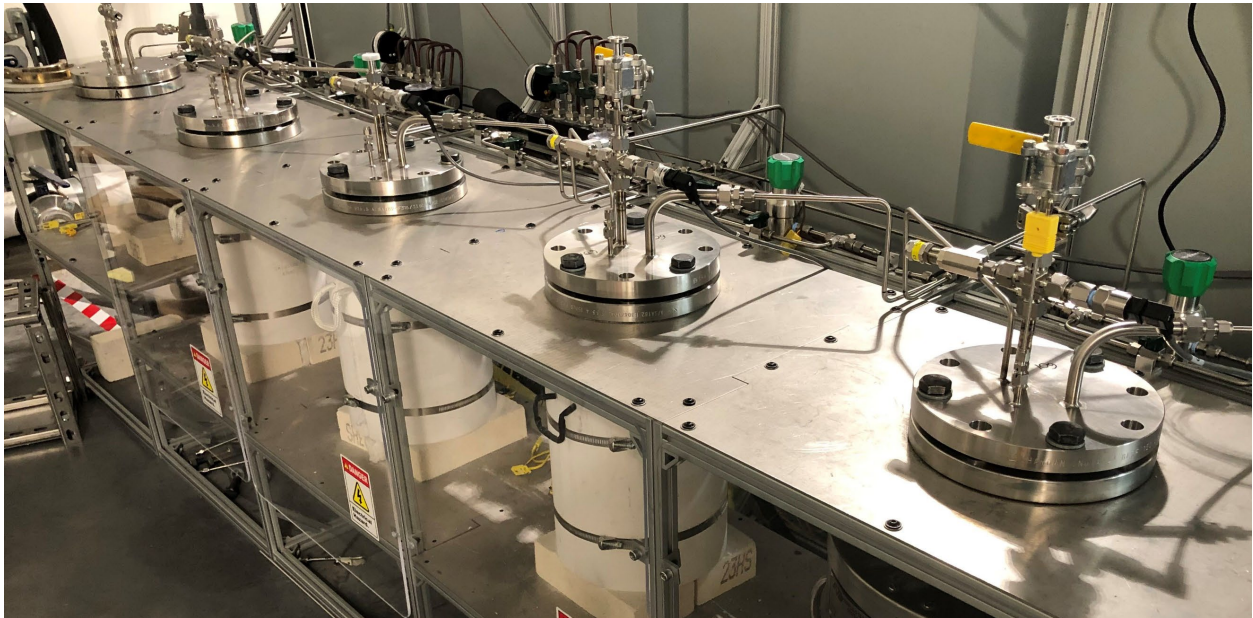
Figure 3.1: Five duplicate corrosion vessels utilized for Solar Salt corrosion experiments.

The overall corrosion setup involved five duplicate corrosion vessels that enabled the ability to run five corrosion experiments simultaneously within a study (Figure 3.1). A schematic of an individual corrosion vessel is provided in Figure 3.2. An alumina crucible obtained from AdValue Technology measuring 160mm in length and 84mm in diameter was used to hold the nitrate salt which was in turn placed inside a steel liner to protect the overall steel vessel from potential molten salt spillage. The vessel and liner were made from 316SS and enclosed an internal volume roughly measuring 300mm in length and 95mm in diameter. The furnace heating elements were located outside the steel vessel. The vessel head contained gas inlet and outlet connections as well as a port to feed a thermocouple into the molten salt for in-situ temperature monitoring. The vessels were sealed using a high temperature gasket, and pressure was controlled through utilizing a backpressure regulator. For all the experiments, the corrosion vessels were operated in a semi-sealed gas space. In other words, after setting the backpressure regulator to the target pressure setpoint, inlet gas flow was shut off but any gas generation during the experiments was allowed to vent to prevent additional pressure buildup. Ultra zero grade synthetic air was utilized as the initial gas cover space.

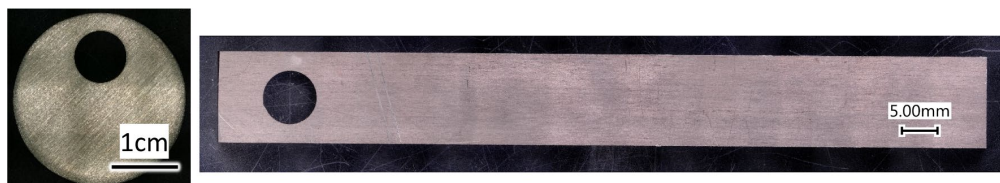
Figure 3.3: Examples of the coupon dimensions for experiment set 1. Left: 1-inch diameter sample machined from N60 rod. Right: 10cm sample machined from sheet.

Alloys utilized in this set of experiments were 316SS, 709, N60, 601, 617, 214, 224, 233, and the aluminide coating. Examples of corrosion coupon dimensions are shown in Figure 3.3. Being machined from a rod, the N60 coupons were circular measuring 1-inch in diameter and 3mm in thickness. All the other alloys were machined into rectangular coupons measuring roughly 10cm in length and 1.3cm in width. The 316SS and aluminide 316SS samples had thicknesses of 1.5mm while the other samples had thicknesses of 3mm. 7.5mm diameter holes were machined into the specimens to enable hanging of the samples.

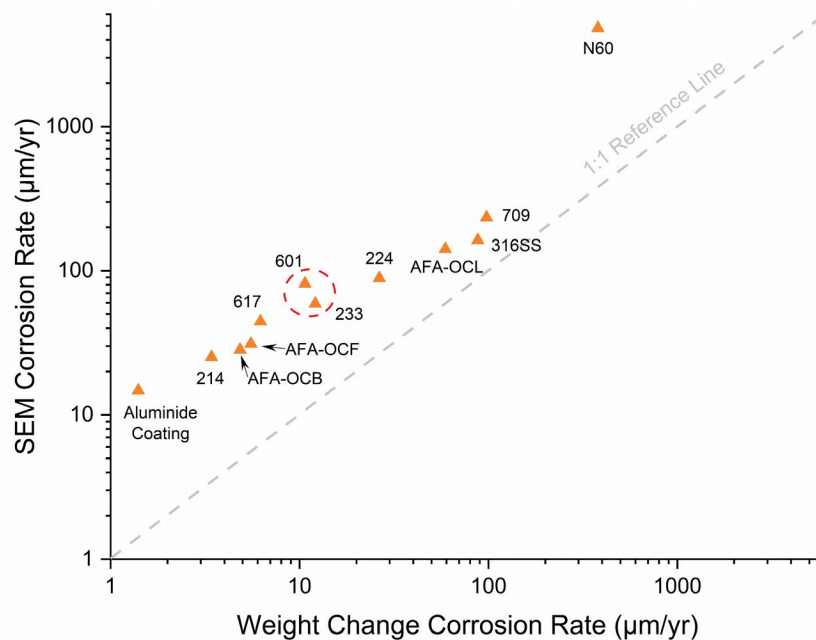
Figure 3.27: Comparison between corrosion rates obtained via SEM images vs. those obtained via weight change.

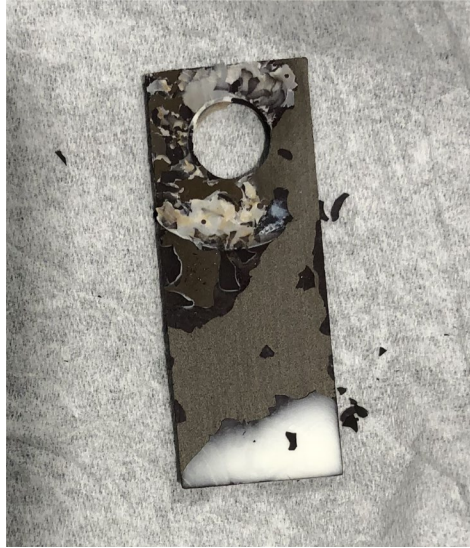
Figure 4.3: Extreme flaking observed from a 316SS sample exposed to 650°C Solar Salt during post-extraction storage.

It is of note that significant flaking of the oxide layers was observed during post-extraction storage of the 316SS sample surfaces exposed to 650°C Solar Salt. An extreme example is shown in Figure 4.3 in which large portions of oxide flaked off and exposed bare metal surface prior to any cleanings for weight change corrosion measurements. Some flaking did occur for the lower temperature salt-exposed 316SS samples, but in much reduced amounts as the test temperature decreased.

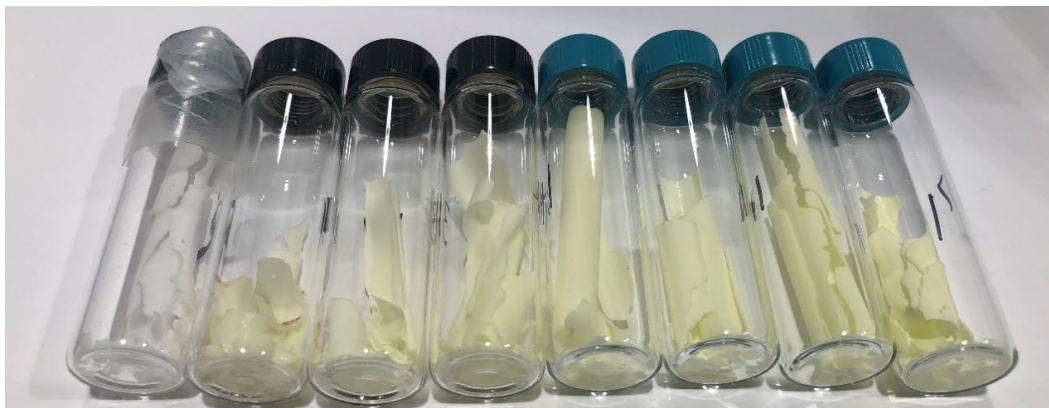
Figure 5.66: Solid nitrate salt samples taken from 590°C experiment from left to right: after initial bakeout, 500hr, 1000hr, 1000hr fresh salt bakeout, 2000hr, 3000hr, 4000hr, and 5000hr.

Figures 5.66-5.70 show the solid nitrate salt samples taken during the long-term corrosion study. Prior to any corrosion, the nitrate salt appears white and then yellows as exposure temperature and time increases. The yellow coloration is readily observed throughout literature and attributed to the presence of soluble chromate, Cr(6+), within the nitrate salt. However, for the 650°C 3000hr and 4000hr samples, the salt samples are unmistakably green in coloration. This was also observed in Dorcheh et al. 2016 and Krugenda et al. 2013 in elevated temperature Solar Salt corrosion studies,^{48,87} though no detailed explanation or understanding for this green coloration is readily available within literature. Keiser et al. 1979 asserted that only 5% of the dissolved Cr in 550°C HITEC nitrate salt was Cr(6+), concluding the rest must be Cr(2+) or Cr(3+).¹¹² Cr(3+) is known to exhibit green coloration within nitrate salt, however, other studies showed that Cr(3+) and its green color are relatively short lived and form yellow chromate starting at temperatures as low as 175°C.^{113,114} While salt samples in this study were not extracted at test temperatures, sample extractions were performed at 350°C and thus at a temperature still well above this transition point. Hexanitrate complexes (such as K₃[Cr(NO₃)₆]) are also claimed to have green coloration and therefore could be the culprit, but literature on these complexes especially in the context of nitrate salt corrosion is sparse.¹¹⁴ Unfortunately, this study is ill-equipped to fully ascertain the cause for the transition from yellow to green coloration in the 650°C Solar Salt experiment. It is noted that this occurred during a period of no temperature excursions, and the 5000hr salt sample appearing yellow again was likely due to the major temperature excursion between the 4000hr and 5000hr extractions.

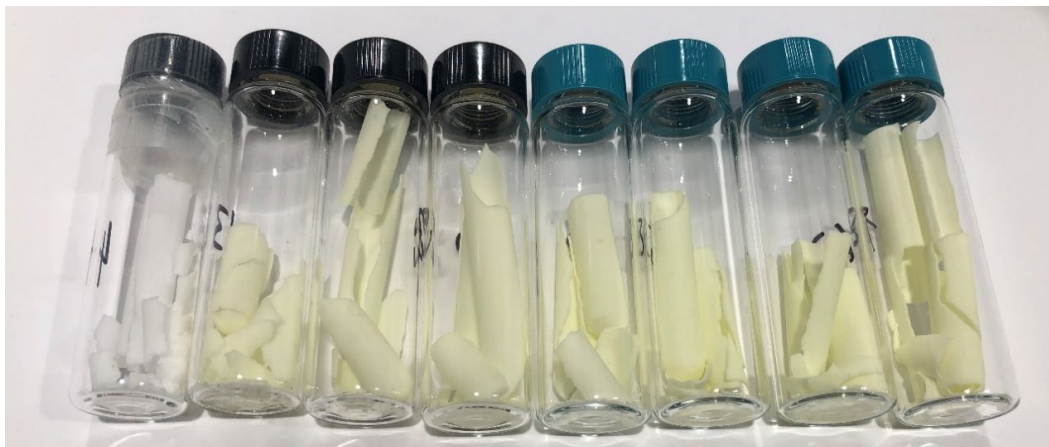
Figure 5.67: Solid nitrate salt samples taken from 600°C experiment from left to right: after initial bakeout, 500hr, 1000hr, 1000hr fresh salt bakeout, 2000hr, 3000hr, 4000hr, and 5000hr.

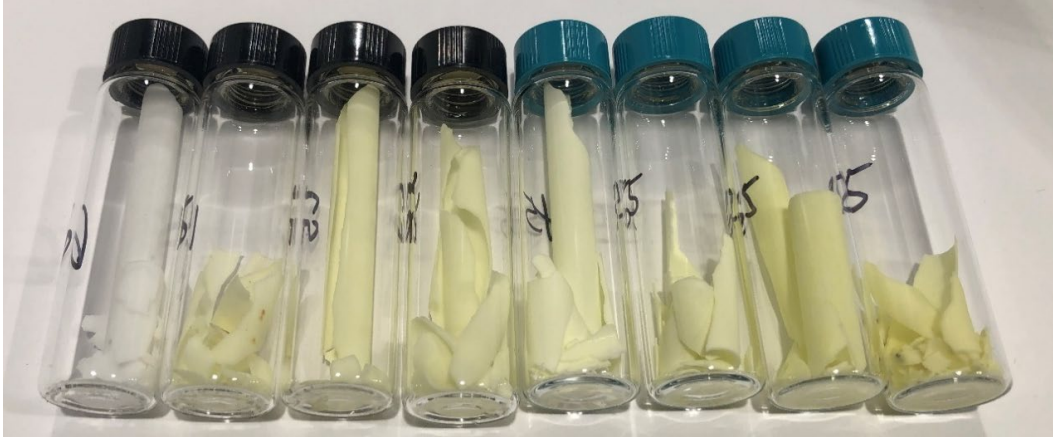
Figure 5.68: Solid nitrate salt samples taken from 620°C experiment from left to right: after initial bakeout, 500hr, 1000hr, 1000hr fresh salt bakeout, 2000hr, 3000hr, 4000hr, and 5000hr.

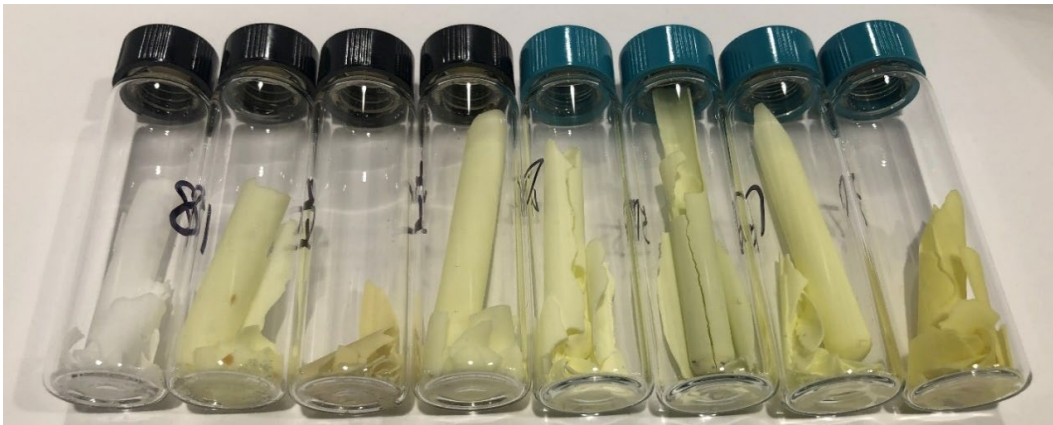
Figure 5.69: Solid nitrate salt samples taken from 630°C experiment from left to right: after initial bakeout, 500hr, 1000hr, 1000hr fresh salt bakeout, 2000hr, 3000hr, 4000hr, and 5000hr.

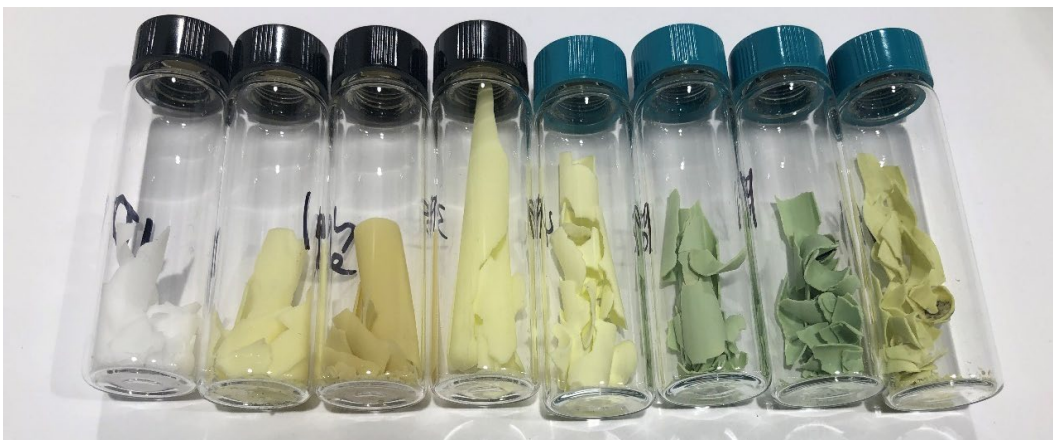
Figure 5.70: Solid nitrate salt samples taken from 650°C experiment from left to right: after initial bakeout, 500hr, 1000hr, 1000hr fresh salt bakeout, 2000hr, 3000hr, 4000hr, and 5000hr.

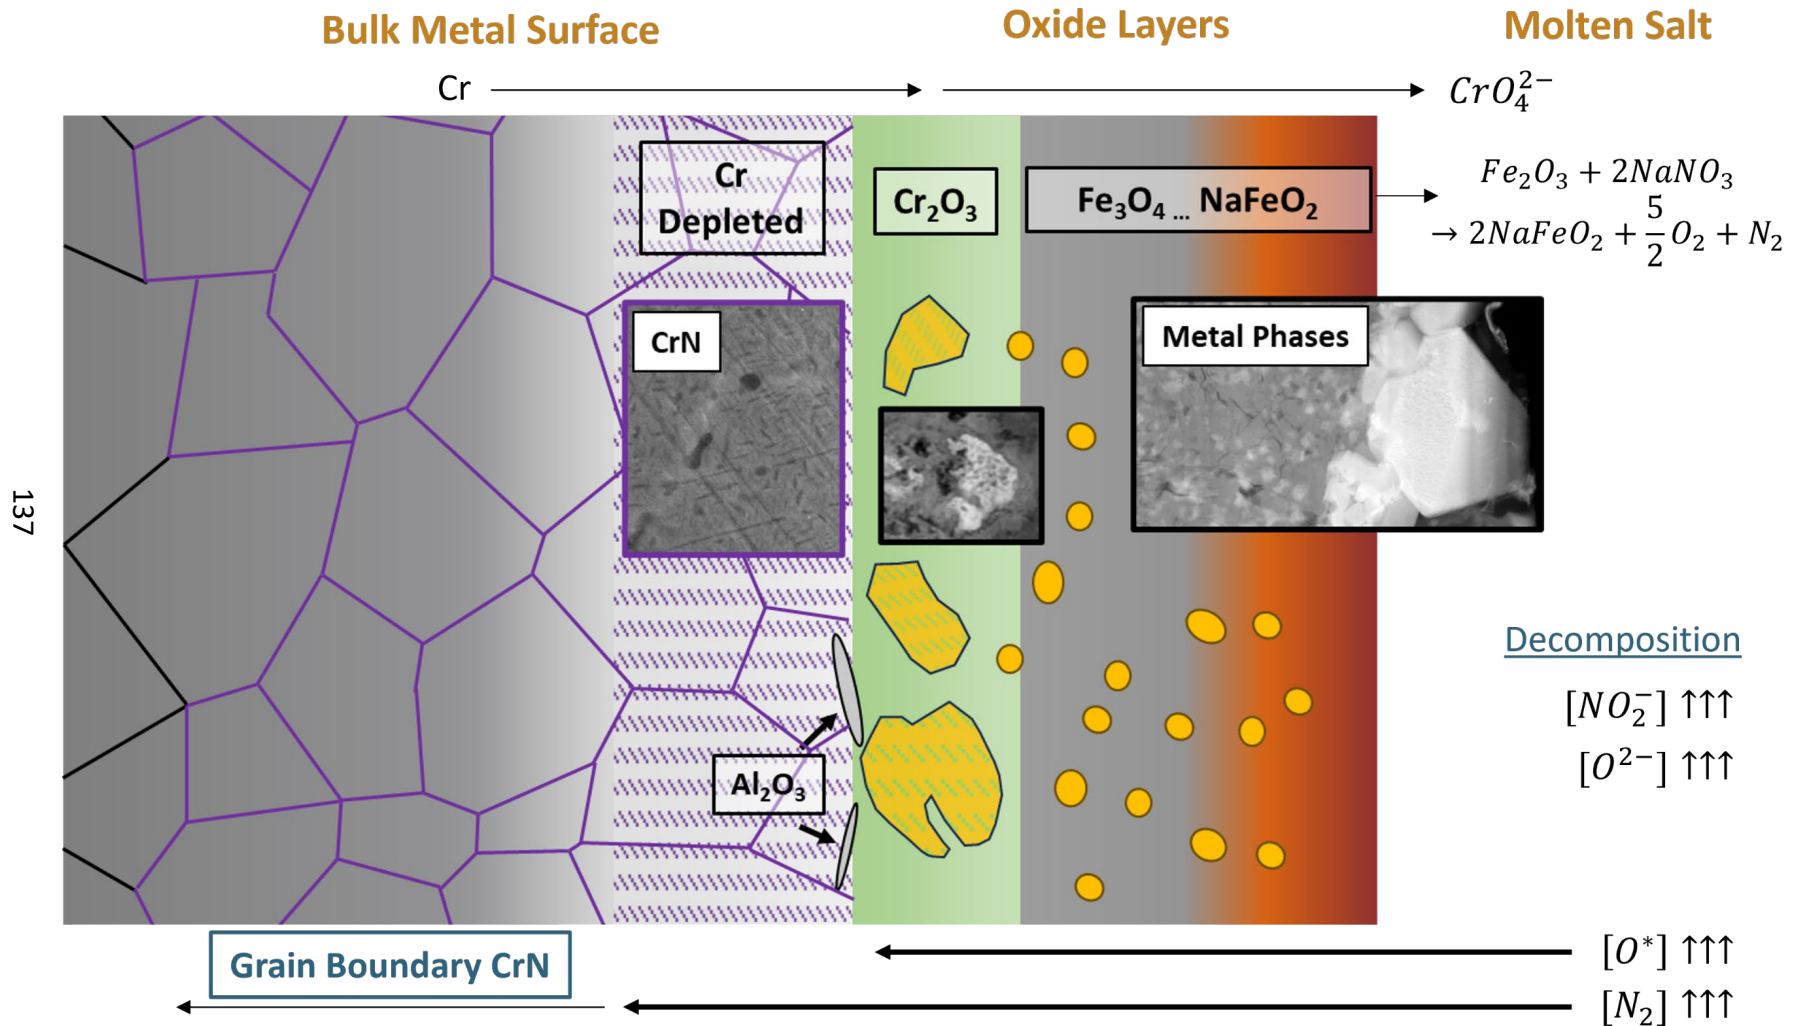
Figure 5.83: Schematic of the corrosion mechanism of 601 in elevated temperature Solar Salt.
