CAL/APT Goal LLPRS--Rigid Phase III: Concrete Test Section 516CT Report

**CAL/APT Goal LLPRS – Rigid Phase III:  
Concrete Test Section 516CT Report**

April 1999  
Pavement Research Center  
Institute of Transportation Studies  
University of California at Berkeley

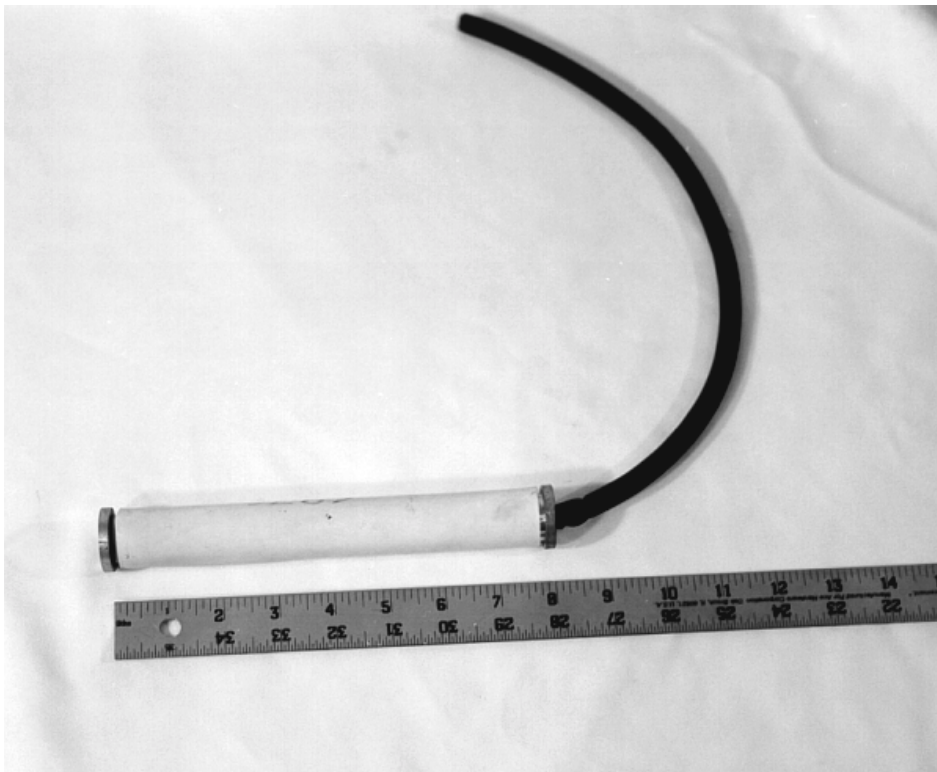
**Figure 17. Carlson A-8 strain meter.**

The Carlson A-8 strain meters, manufactured by RST Instruments, Inc., were the third type of strain gage embedded in the concrete. The gage was tubular and contained two coils of highly elastic steel wire. One coil increases in length and electrical resistance when strained, while the other decreases in length when unloaded or compressed. A picture of this gage is shown in Figure 17. This type of gage responds to changes in dimension of the concrete due to load stress, creep, shrinkage, temperature change, and moisture change. Completion resistors were required for the Carlson A-8 strain meters. Campbell Scientific supplied the bridge completion modules for the A-8 strain meters. One Carlson A-8 strain meter was installed 38 mm from the top of the concrete and the other 38 mm from the bottom of the concrete as shown in Figure 14. The Carlson A-8 strain meters were online sensors and were connected to the Campbell Scientific CR10X datalogger.

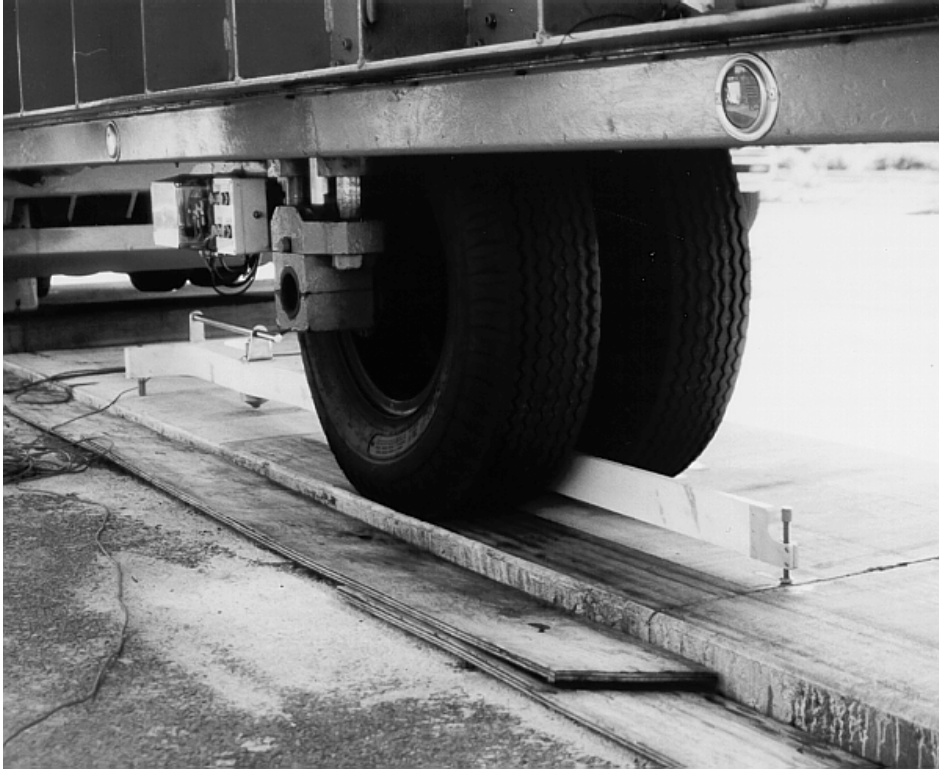
**Figure 19. Road Surface Deflectometer.**

RSD measurements were initially taken at five points, with the length of the RSD in the direction of wheel traffic. However, plots of the results varied too much because of the effect of slab movement on the RSD reference feet. Later data collection involved moving the RSD perpendicular to the direction of wheel traffic. This method allowed the

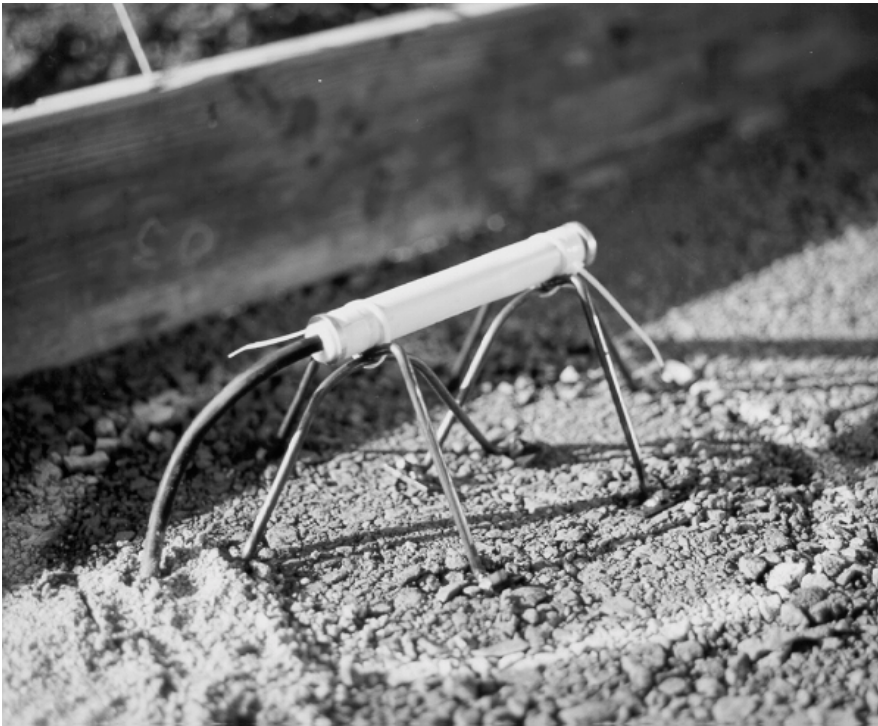
**Figure 21a. Carlson A-8 strain meter on its cradle to maintain gage height and**

**orientation during concrete placement.**

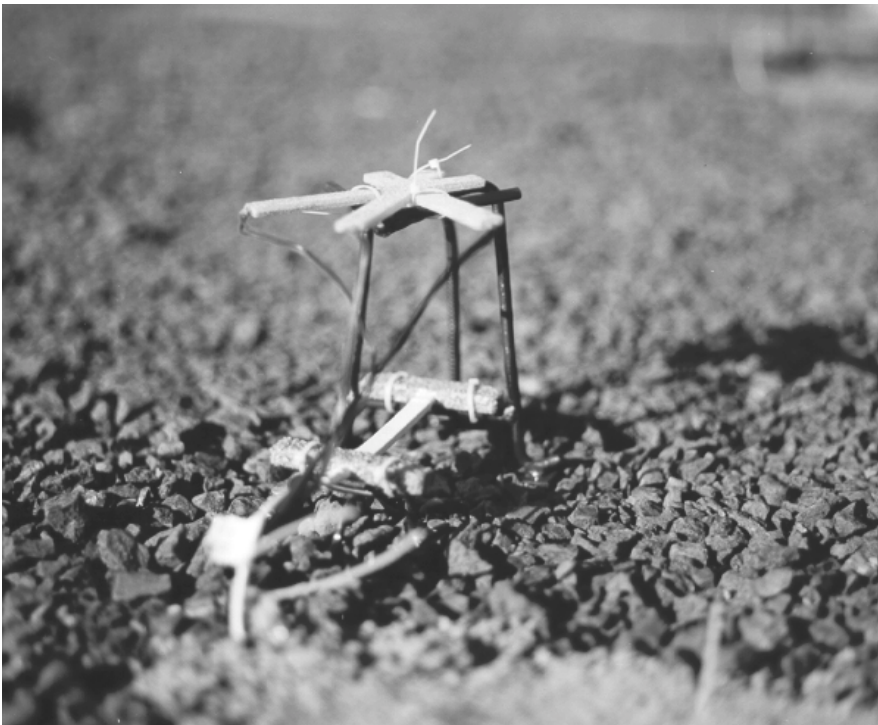
**Figure 21b. Tokyo Sokki PMR-60-6L (top) and Dynatest PAST-2PCC (bottom) on cradle to maintain gage height and orientation during concrete placement.**

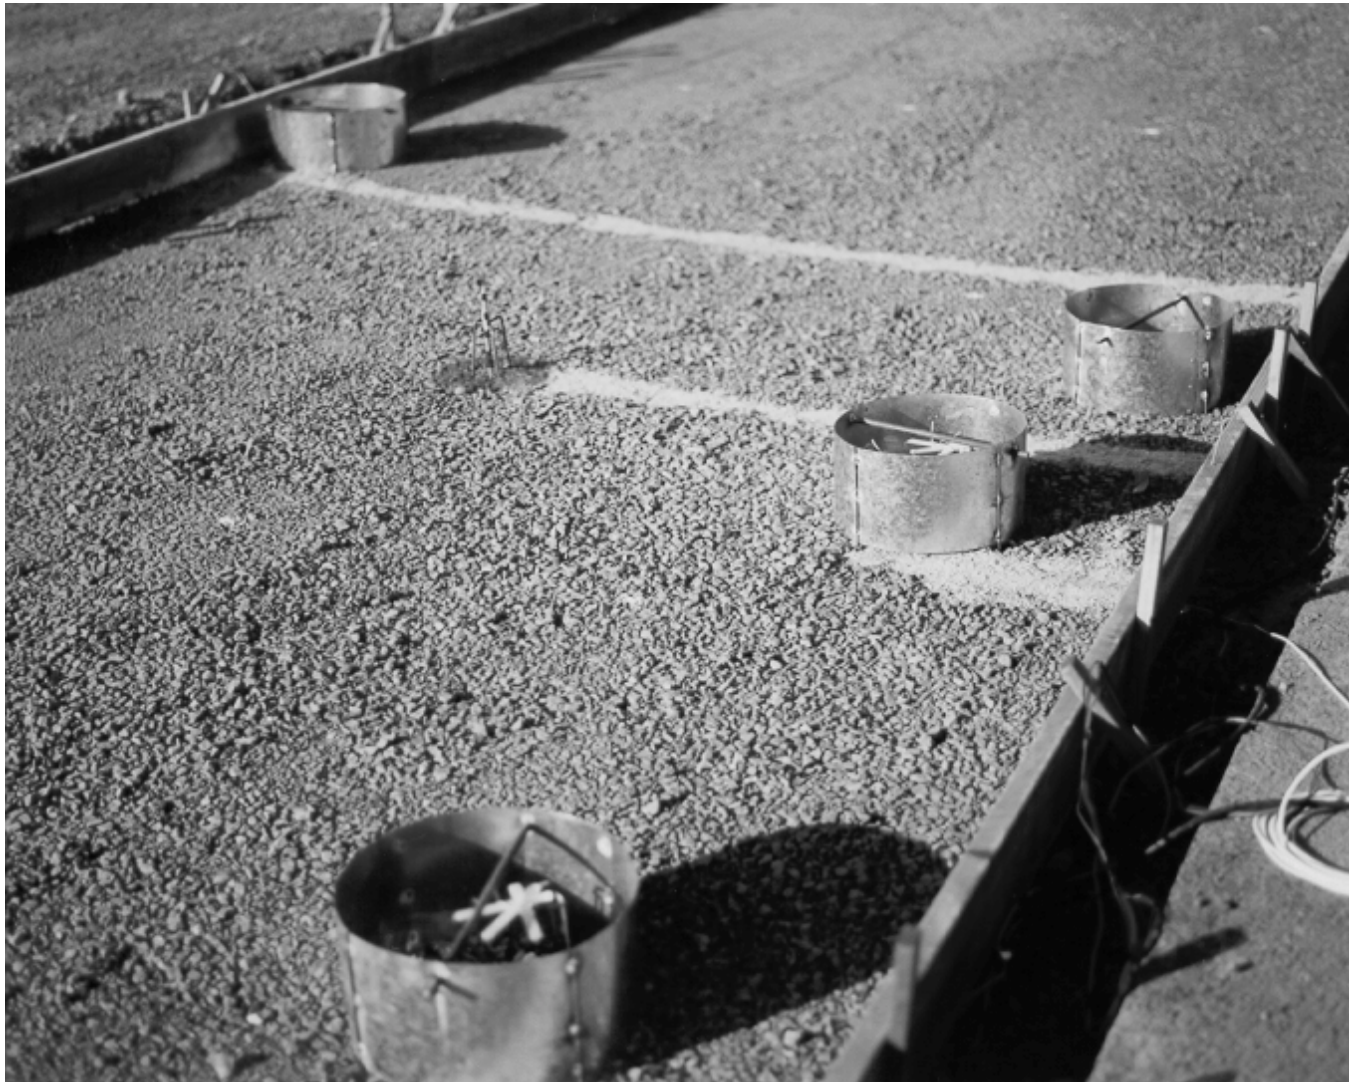
**Figure 22.** Sheet metal boxes are used to protect strain gages from flow of fresh concrete.

surface. However, the first load of concrete soon began to lose its workability, and the second mixer truck did not arrive immediately after the first truck. There was concern that the concrete would harden to the point where the sheet metal boxes could not be pulled out, so the boxes were removed prematurely.

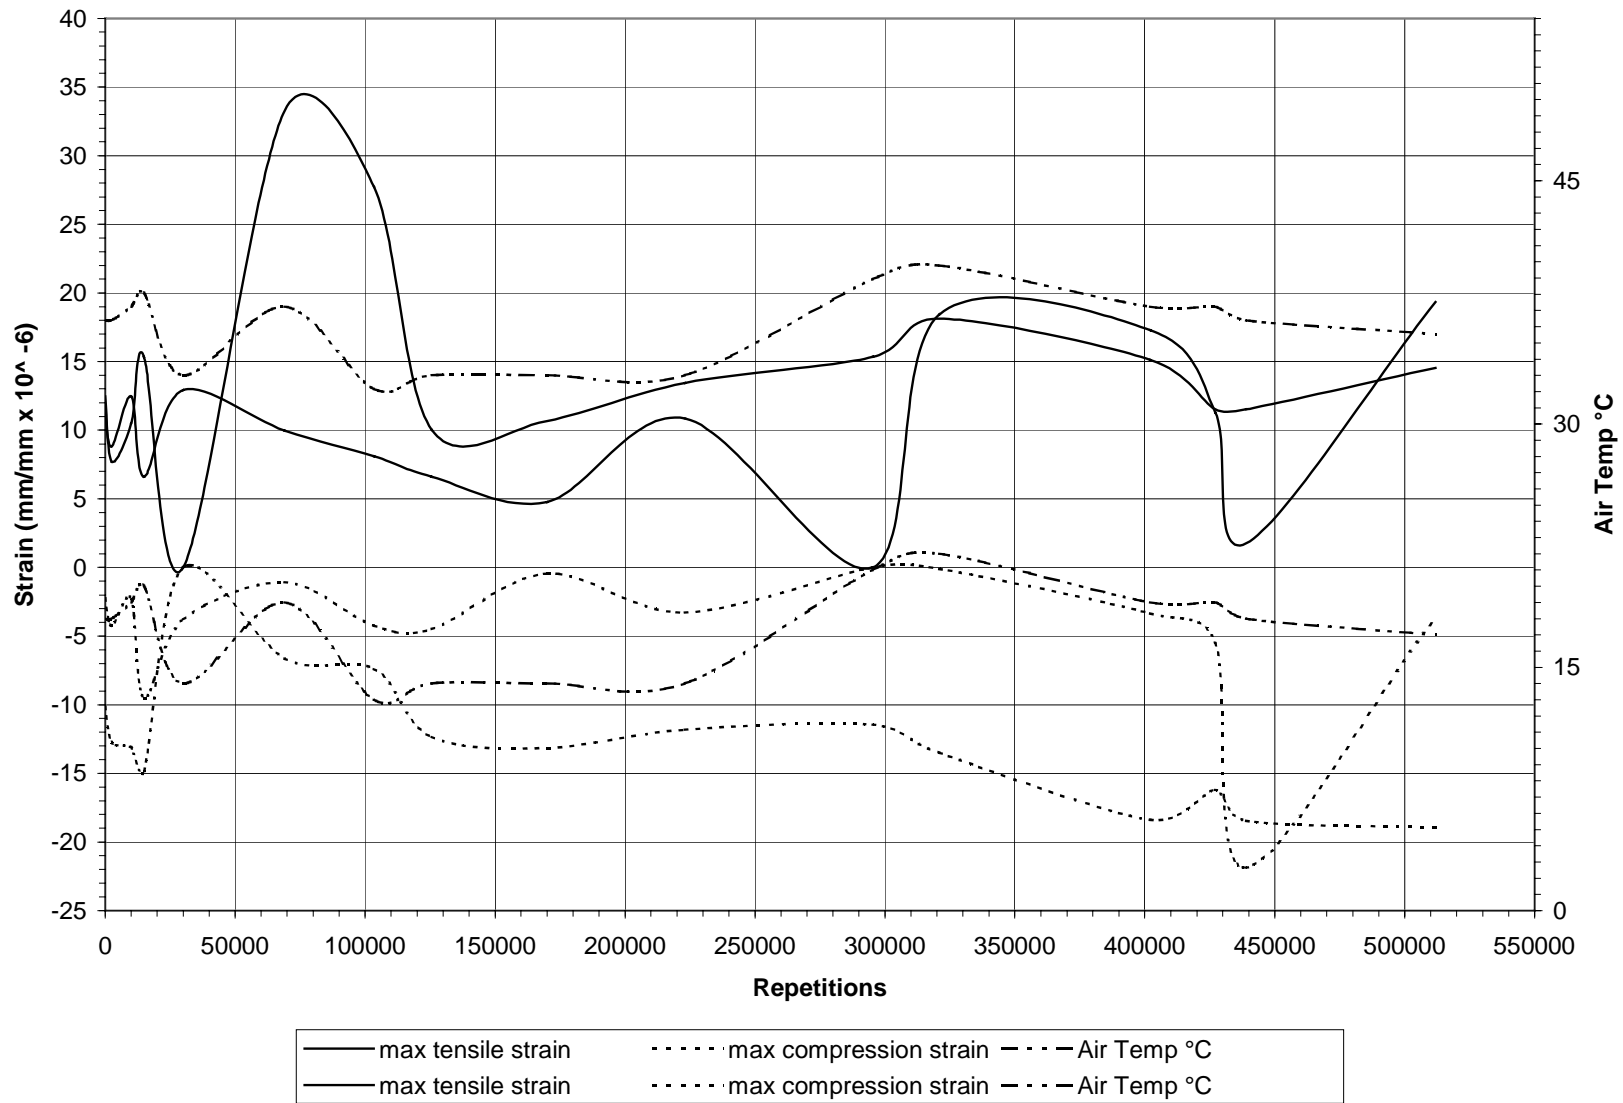
**Figure 30. Dynamic strain data from Section 516CT under 60kN load. Strain gage located near the surface of the pavement, near the middle slab edge, oriented at +45-degree angle to slab edge.**

At approximately 440,000 repetitions, the maximum compressive strain began to decrease, as shown in Figure 30. At this time, a corner crack began forming near the

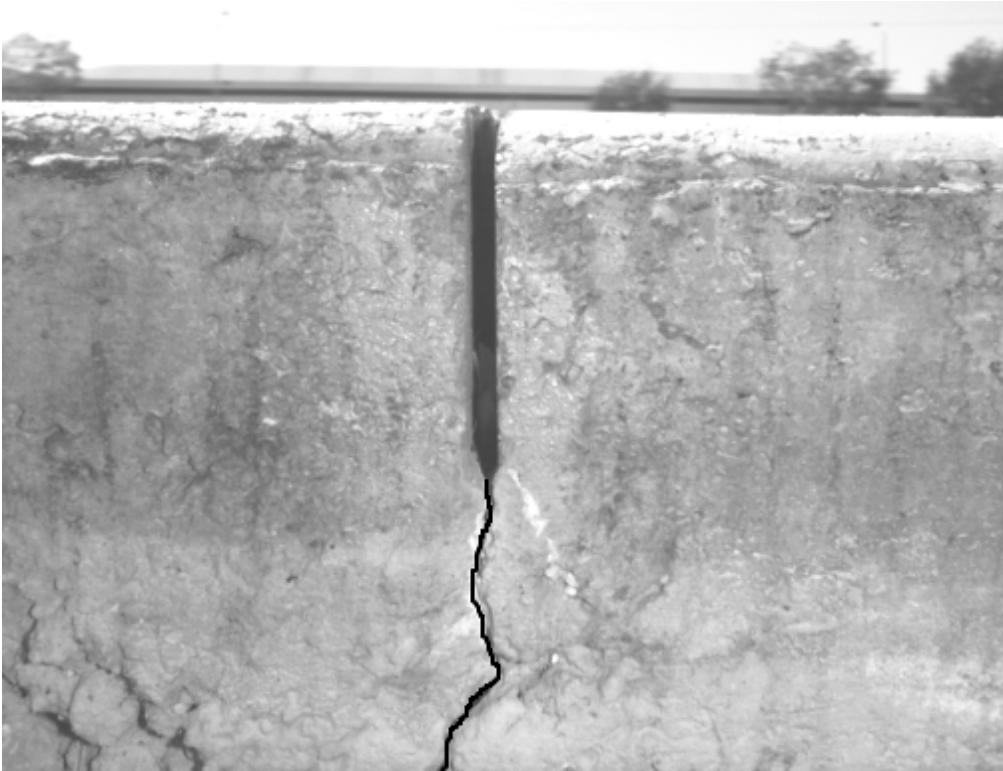
**Figure 47a: Photo of Joint 1. Joint crack is enhanced for easier viewing.**

crack lightly skewed towards Slab 3. The joint crack at Joint 2 was skewed towards Slab 4.

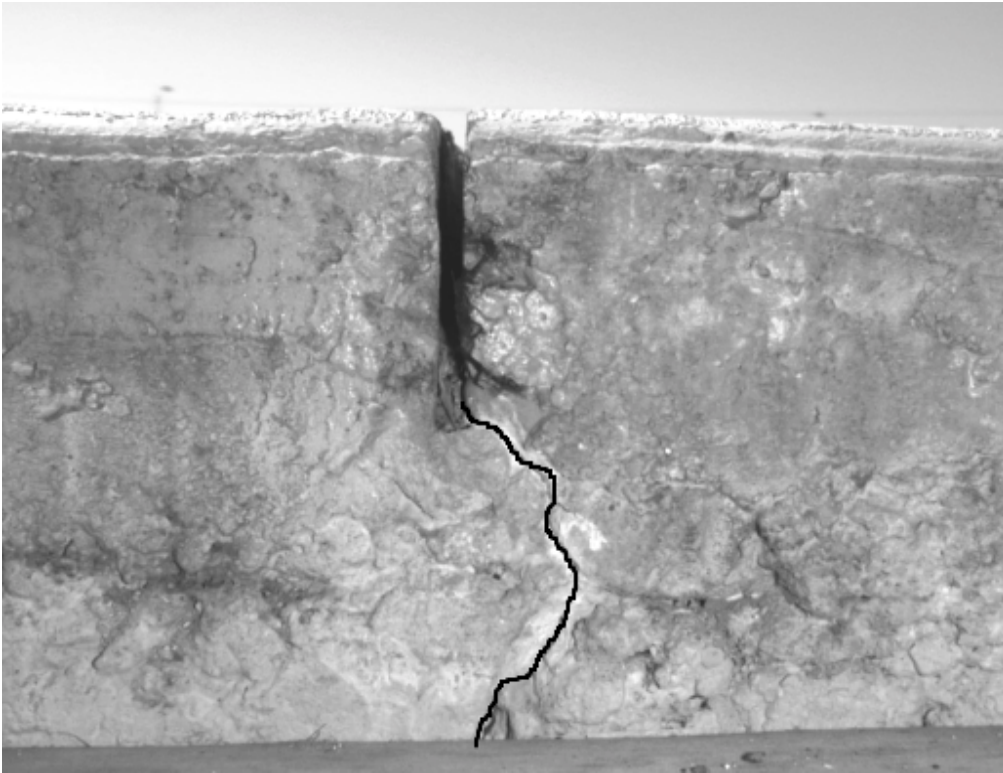
**Figure 47b: Photo of Joint 2. Joint crack is enhanced for easier viewing.**

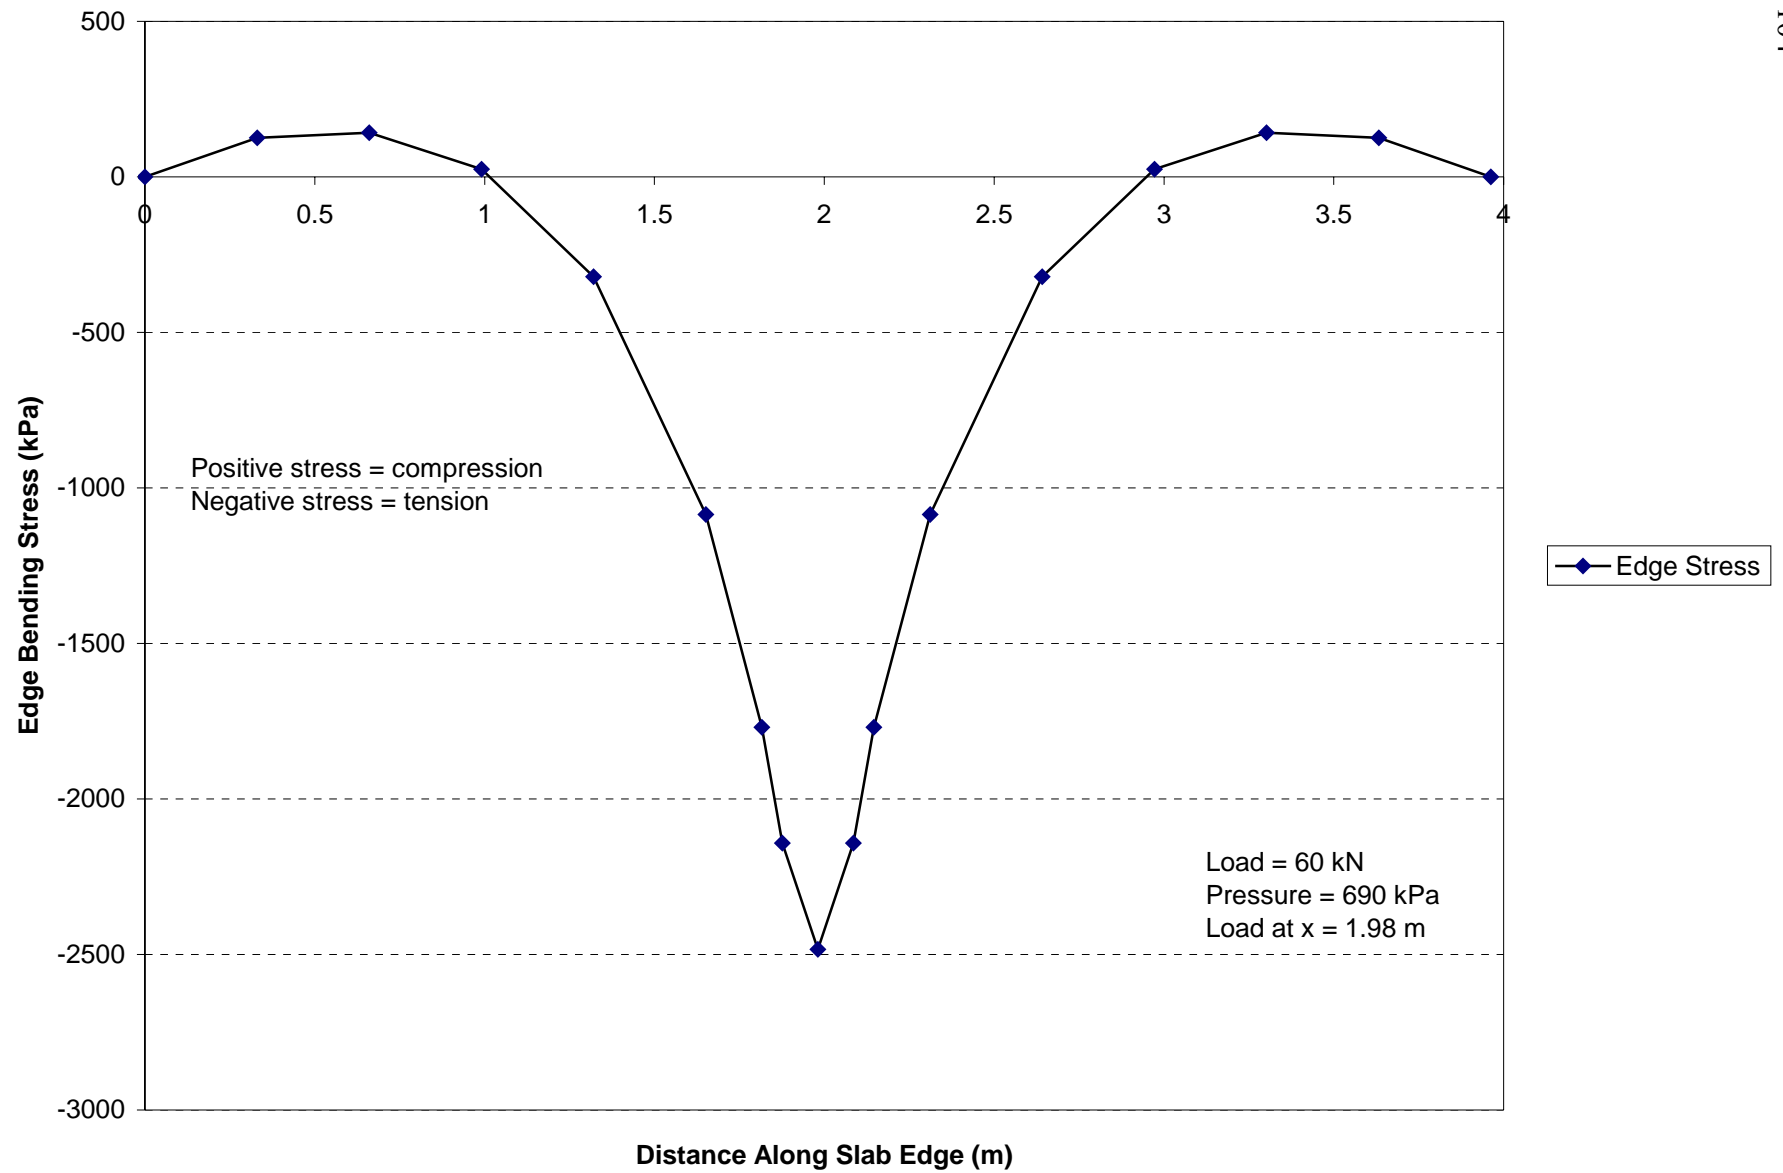
Figure 49. Critical bending stress along middle slab edge.

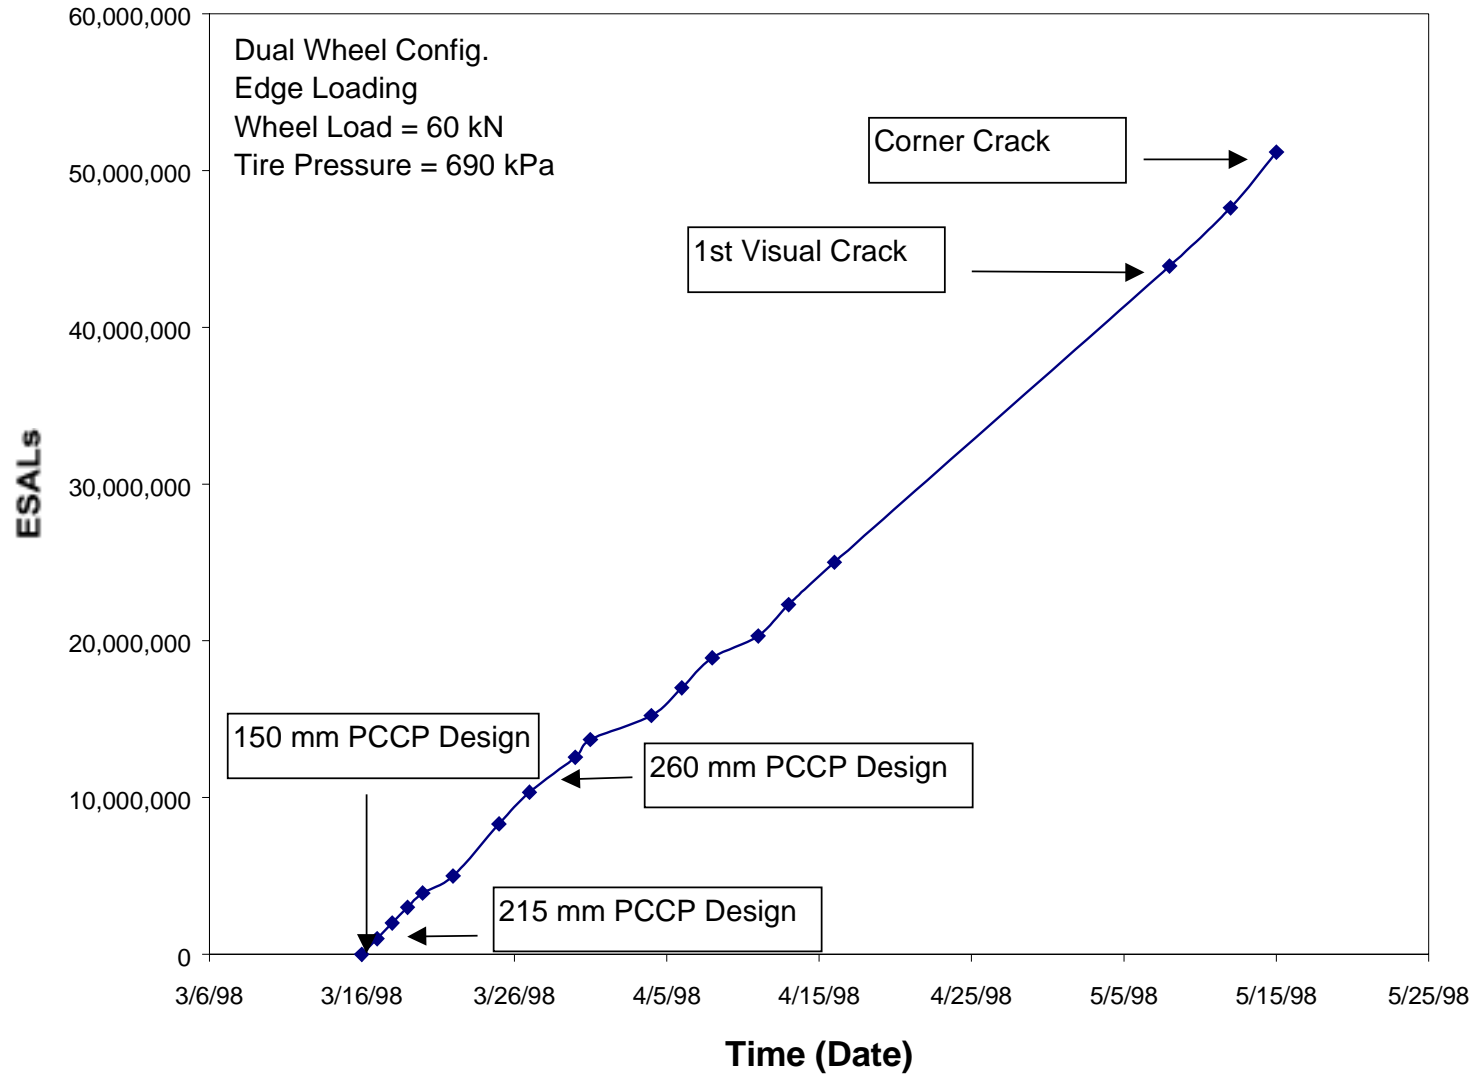
Figure 54. Richmond Field Station concrete test Section 516CT ESALs versus time.
