Field Evaluation of Recycled Water for Avocado Irrigation

UNIVERSITY OF CALIFORNIA
RIVERSIDE

Masters of Science

Environmental Sciences

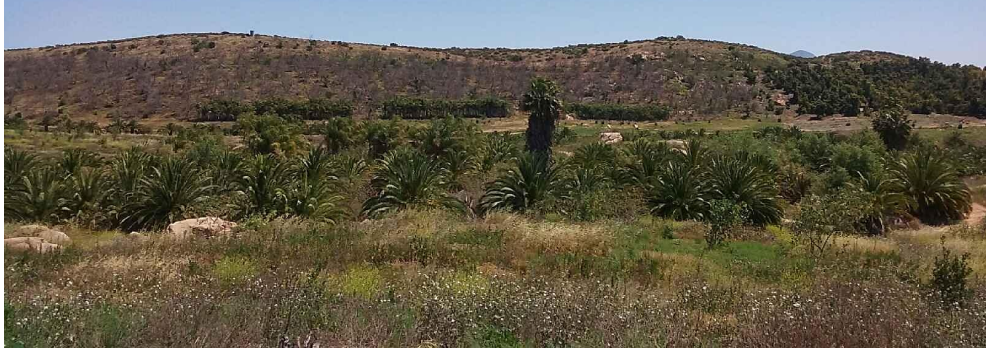
Figure 1. Riparian zone planted with palm trees to reduce irrigation runoff.

In the background, the trees on the left side of the hill recently died in a wildfire.

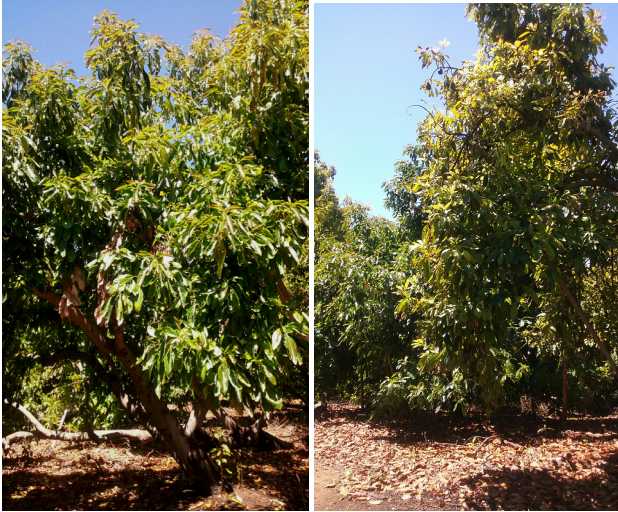
Figure 2. 30-year old trees at Witman Ranch doing well under irrigation with recycled water.

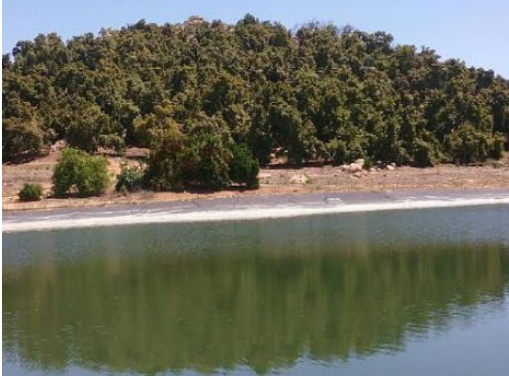
Figure 3. View of the healthy avocado orchard near the water reservoir.

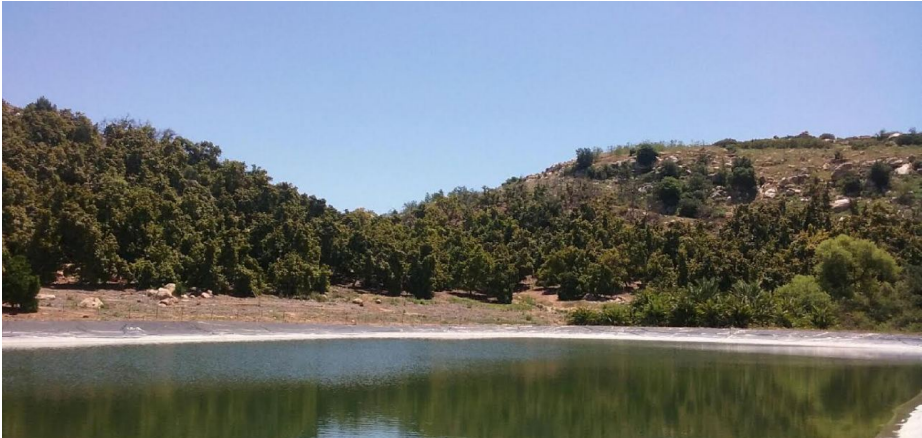
Figure 4. Another view of the Witman Ranch avocado orchard near the water reservoir.

All photos of Witman Ranch were taken on April 20, 2016.

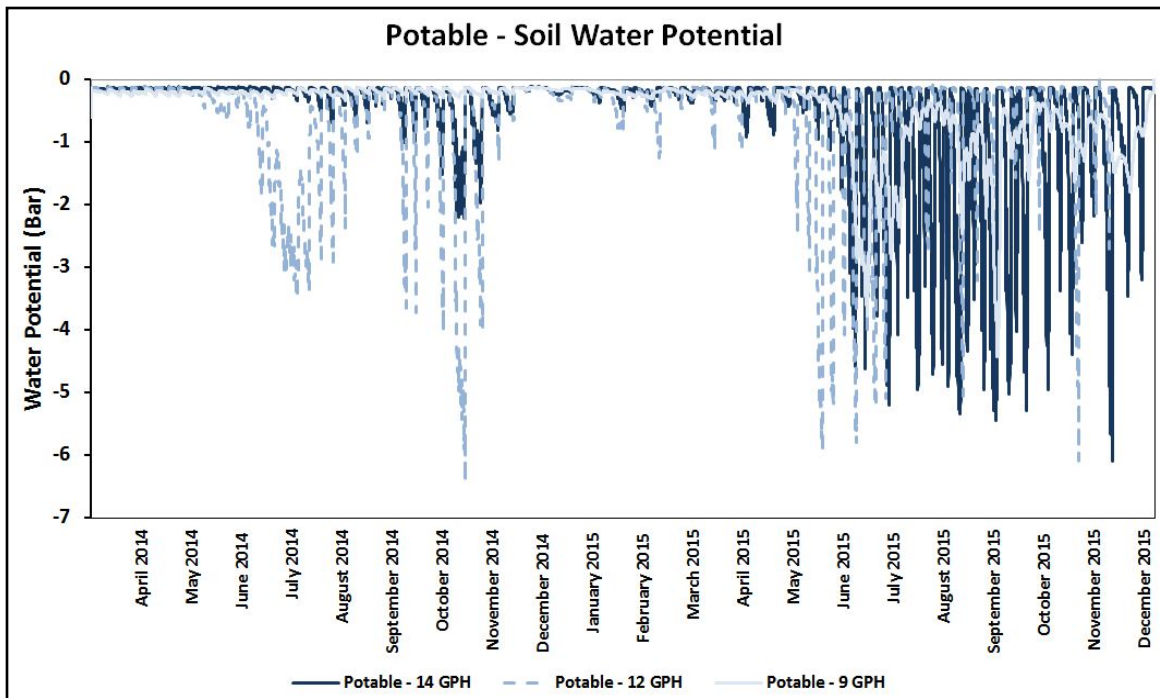
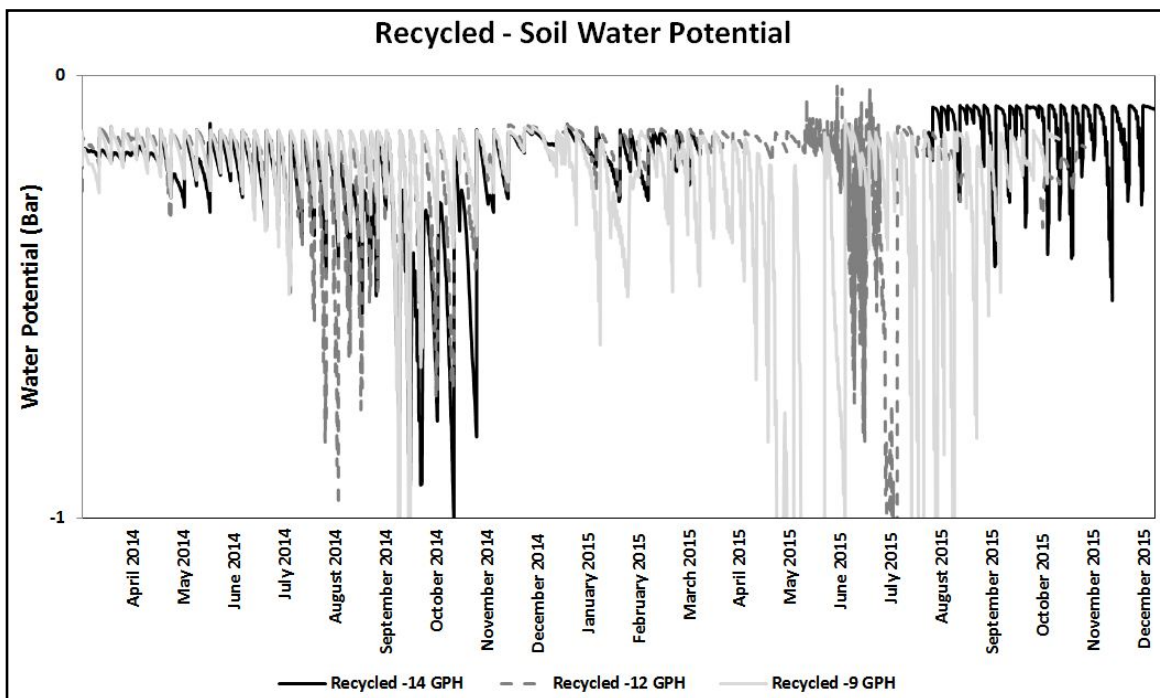
Figure 6. Soil water potential. Plant water availability as determined by measurements of soil water potential for the field experiment examining use of recycled water for avocado irrigation. Note differences in scales for the y axis (water potential) in top and bottom figures.

The soil moisture profiles from the Decagon soil monitoring equipment illustrate that the target water levels were achieved to provide a distinct contrast between the treatments with regard to the leaching fraction. During the first year, trees irrigated with potable water at 9 GPH were routinely water stressed, with the soil drying to -400 cb. Trees watered at 12 and 14 GPH were mostly maintained at less than -100 cb (Figure 6). This changed during the second year as the trees grew much larger and had increased water requirements. Thus greater water stress was experienced for trees in the potable water treatment, indicating that the soil was not as effectively leached and that the irrigation duration and/or frequency may need to be increased.

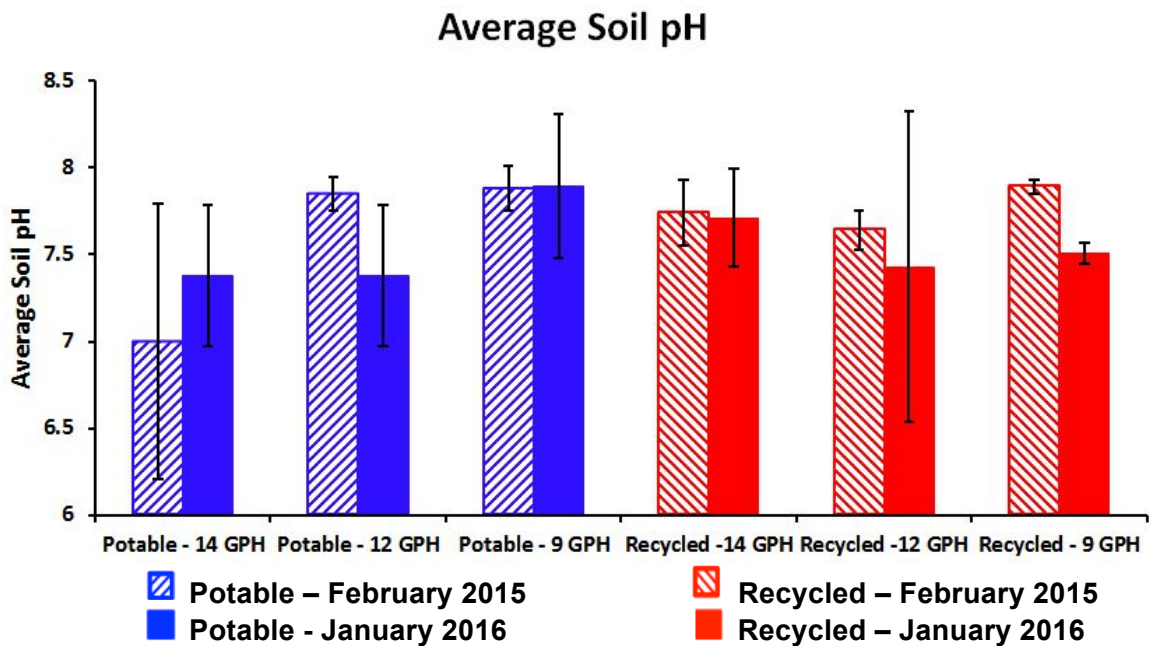
Figure 9. Average Soil pH. Measurements were made on soil taken from 6” below soil surface, 50 cm away from trunk of tree. Note the scale on the y-axis only runs from pH 6 to pH 8.5 for higher resolution. Error bars indicate standard error values. November 2015 soil pH data shown in table below, but not represented in above graph.

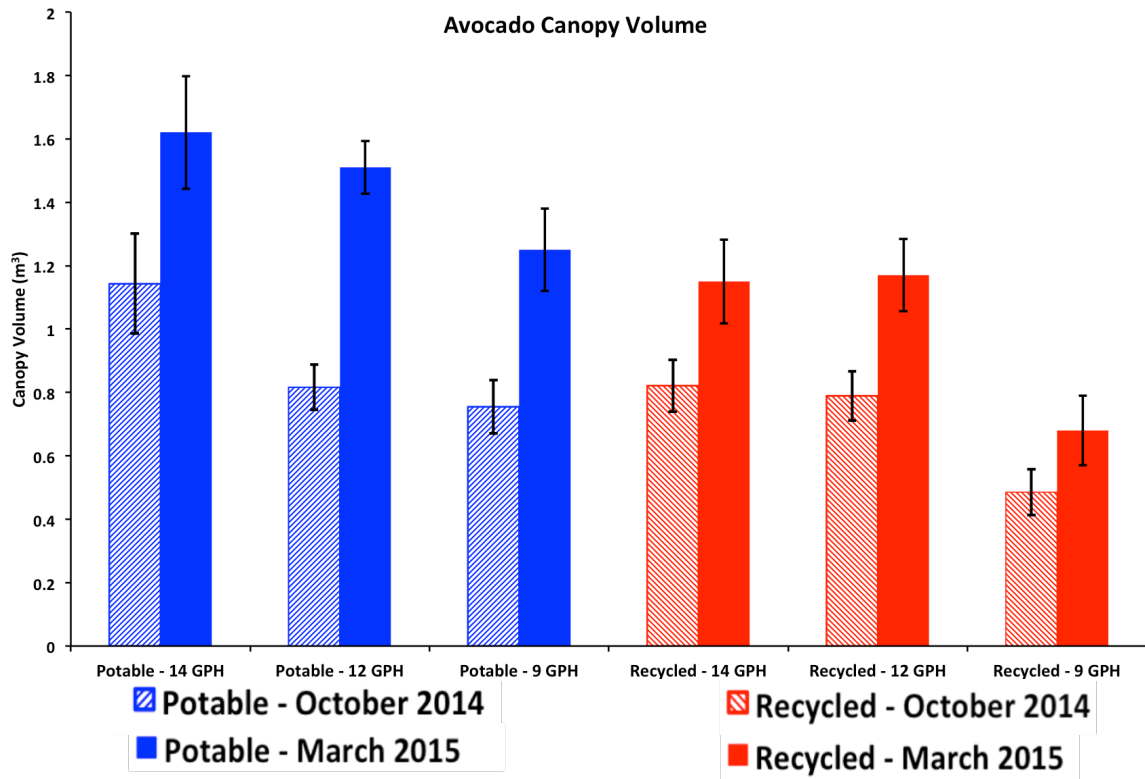
Figure 10. Tree canopy volume. Vertical error bars indicate standard error values. Average values are shown in the table below. $P < 0.05$

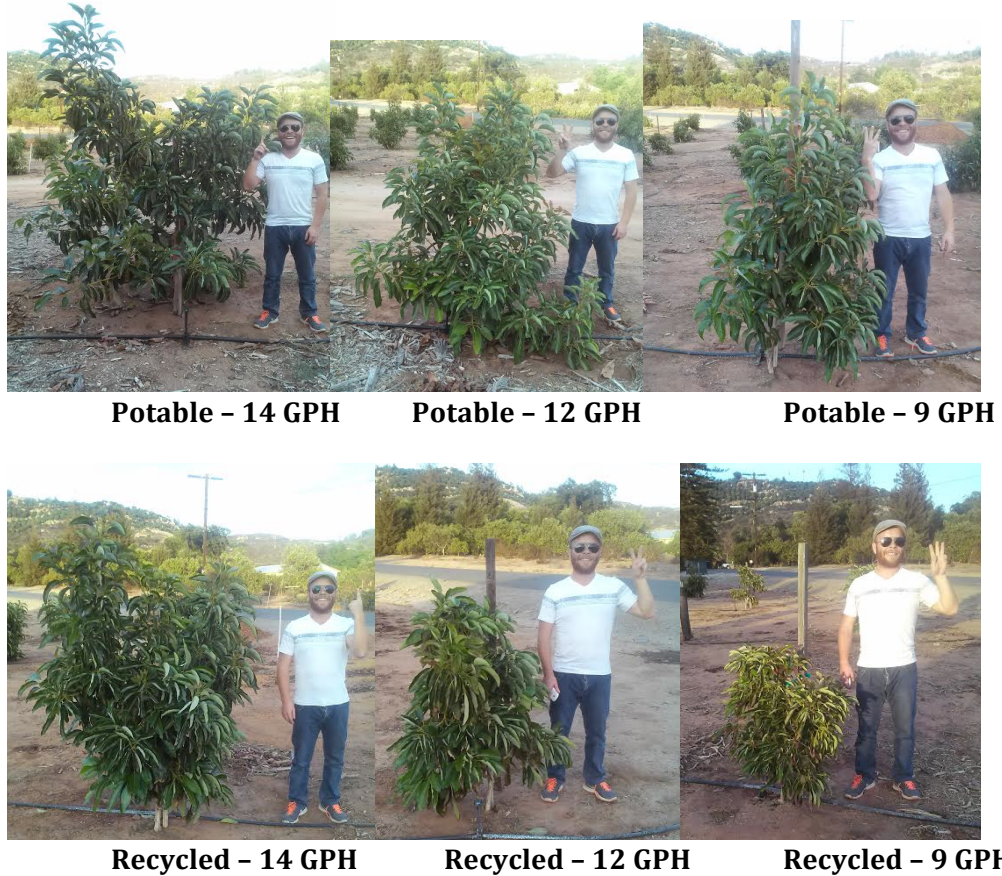
Canopy Volume - October 2014

Figure 11. Avocado tree canopy volume by irrigation treatment. Photographs were taken of trees that represented average tree canopy volume, with Patricio as a scale reference (Patricio is 5'3", 160 cm in height). Above photos were taken October 16, 2014.

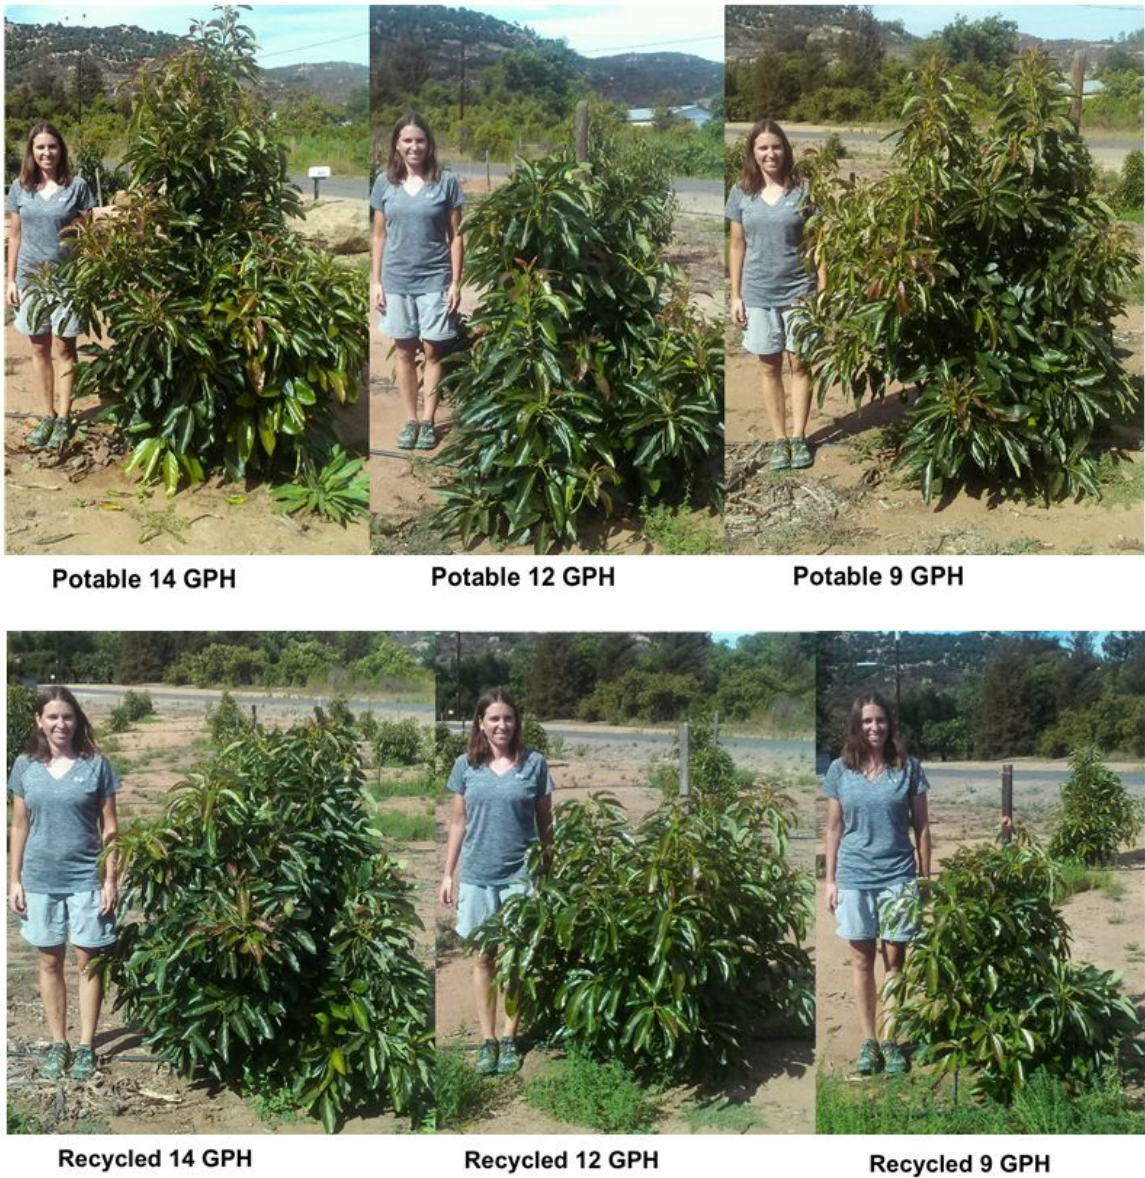
Canopy Volume July 2015

Figure 12. Avocado tree canopy volume by irrigation treatment. Photographs were taken of trees that are representative of the average tree canopy volume, with Jenessa as a scale reference (Jenessa is 5'7", 170 cm in height). Above photographs were taken July 11, 2015.

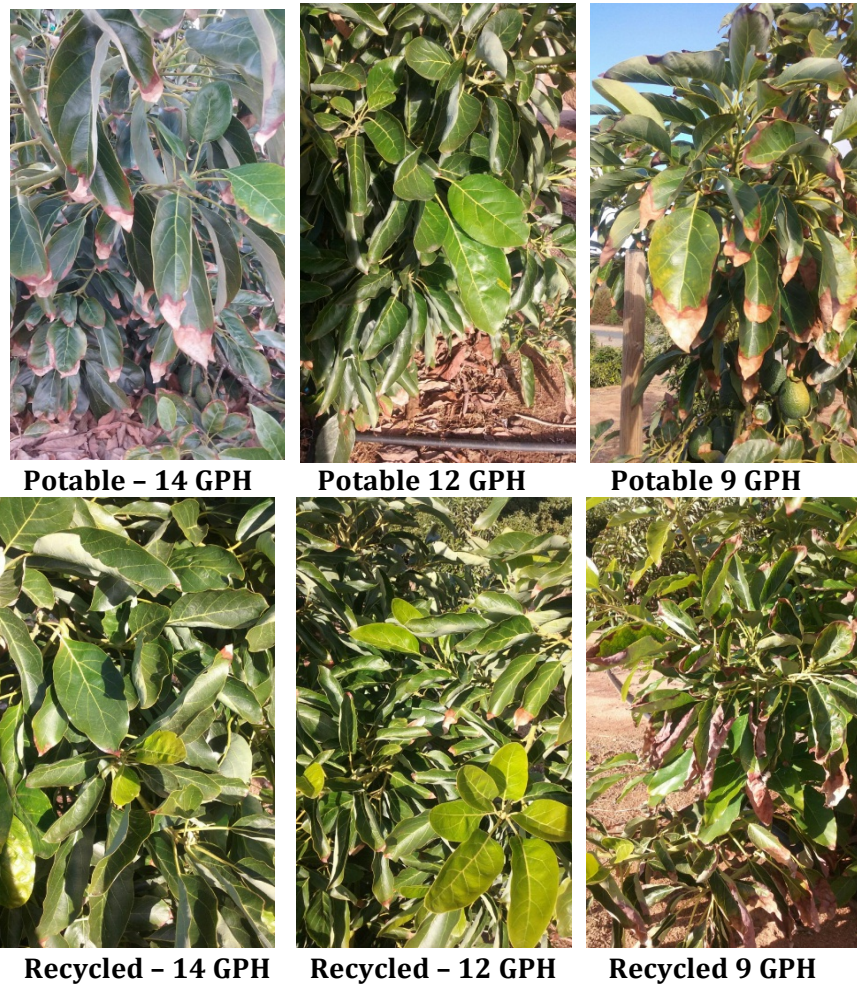
Figure 15. Leaf salt-burn damage. Pictures shown were taken of trees representative of the average appearance in regards to leaf salt burn damage. Photographs were taken on December 13, 2015.

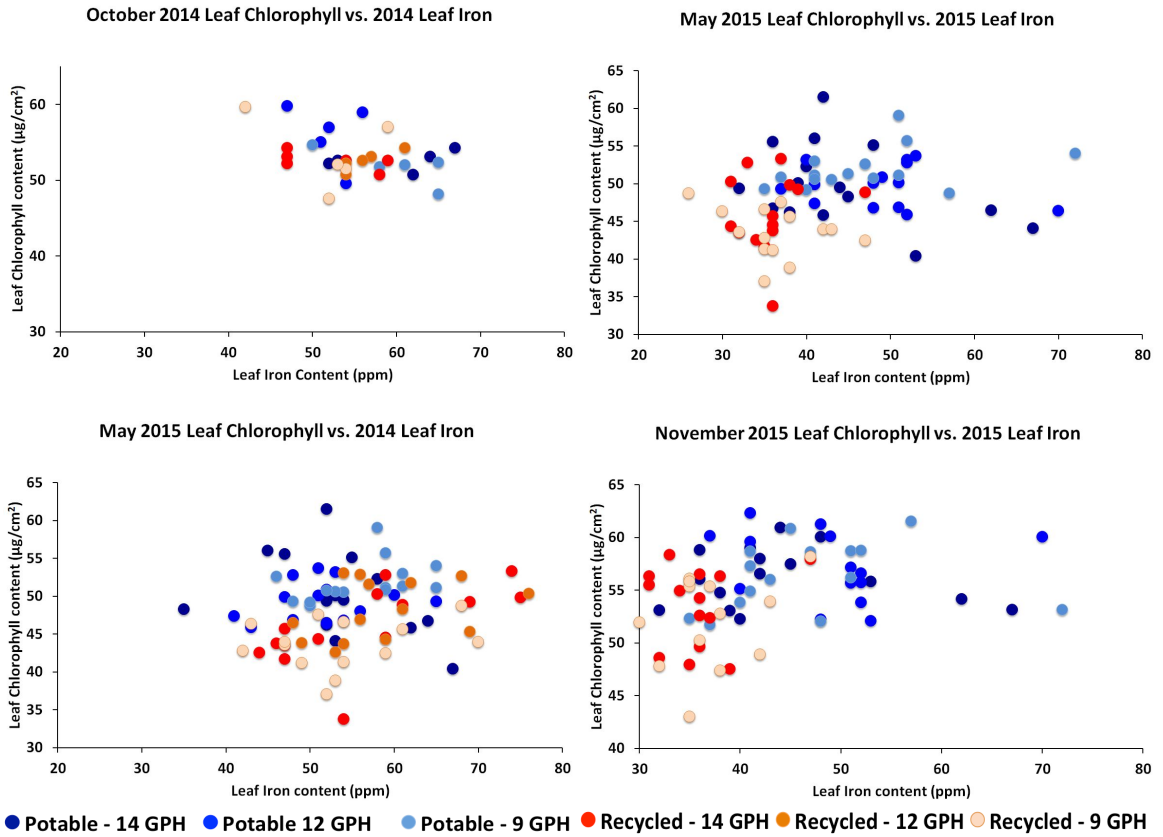
Figure 18. Leaf chlorophyll concentration vs. leaf iron concentration. Top left: October 2014 leaf chlorophyll vs. October 2014 leaf iron content. **Bottom left:** May 2015 leaf chlorophyll content vs. 2014 leaf iron content. **Top right:** May 2015 leaf chlorophyll content vs. 2015 leaf iron content. **Bottom right:** November 2015 leaf chlorophyll content vs. 2015 leaf iron content.

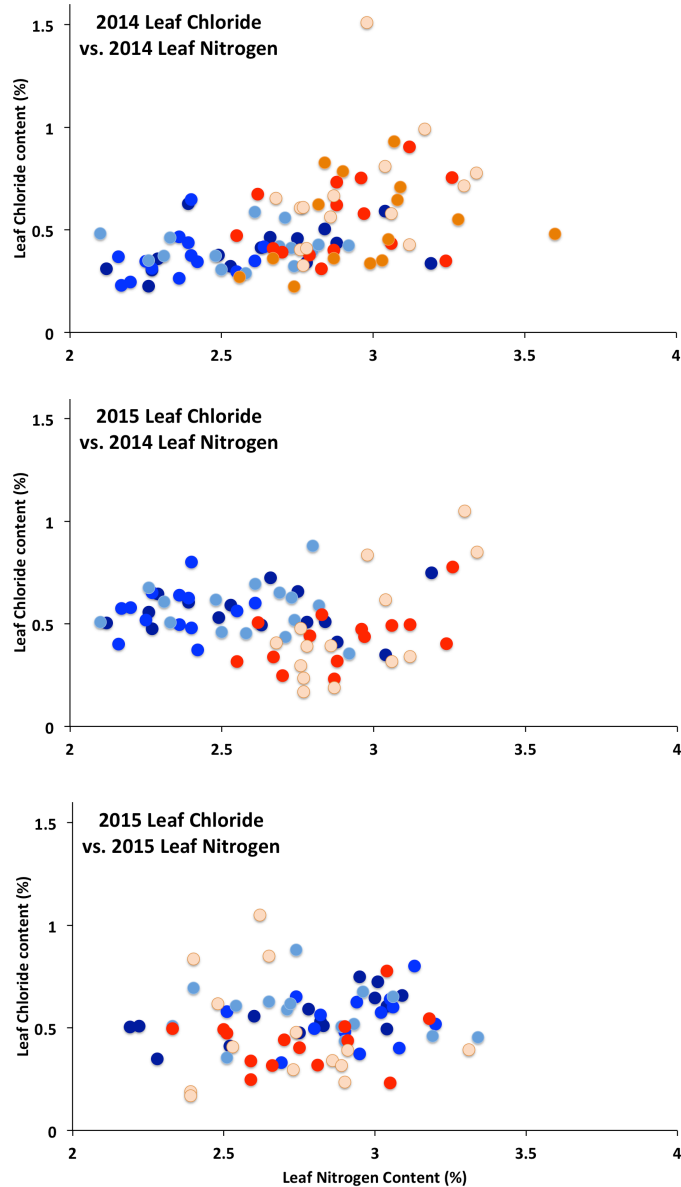
● Potable - 14 GPH ● Potable 12 GPH ● Potable - 9 GPH ● Recycled - 14 GPH ● Recycled - 12 GPH ● Recycled - 9 GPH
Figure 21. Leaf chloride contents of individual avocado trees. Top: 2014 leaf chloride vs. 2014 leaf nitrogen. **Middle:** 2015 leaf chloride content in relation to 2014 leaf nitrogen content. **Bottom:** 2015 leaf chloride content vs. 2015 leaf nitrogen. Leaf chloride concentrations below 0.25% is considered ideal, above 0.5% is considered excessive.

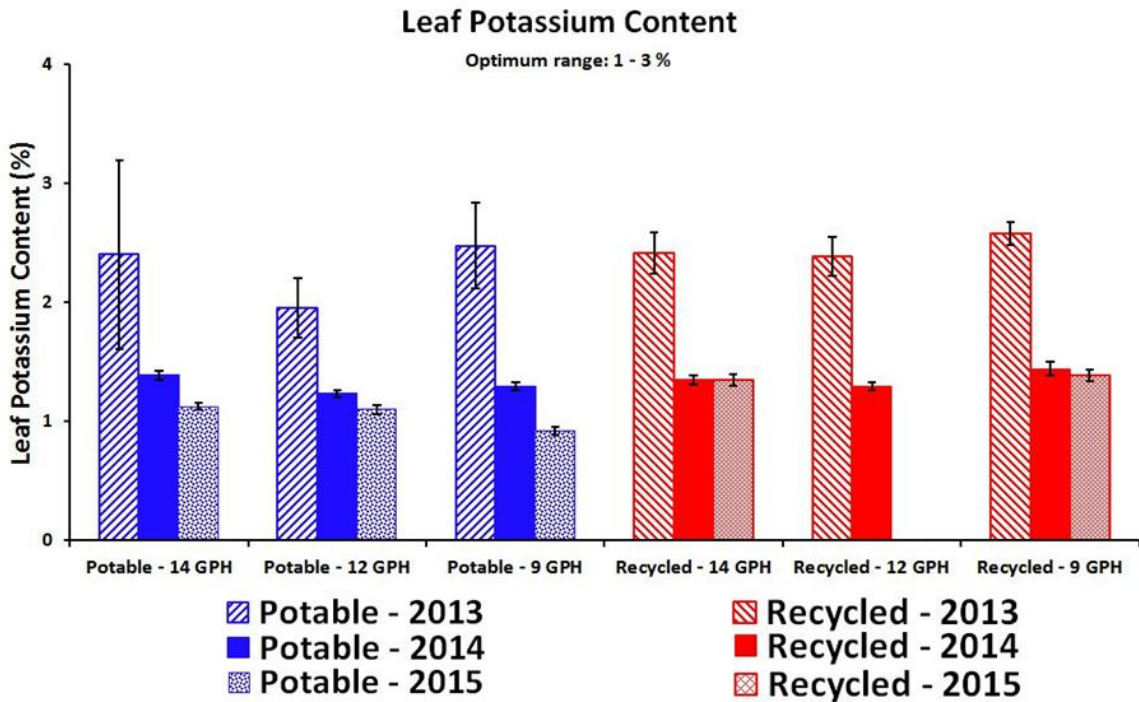
Figure 34. Leaf Potassium content. 2015 Data not available for Recycled – 12 GPH. Error bars indicate standard error values.

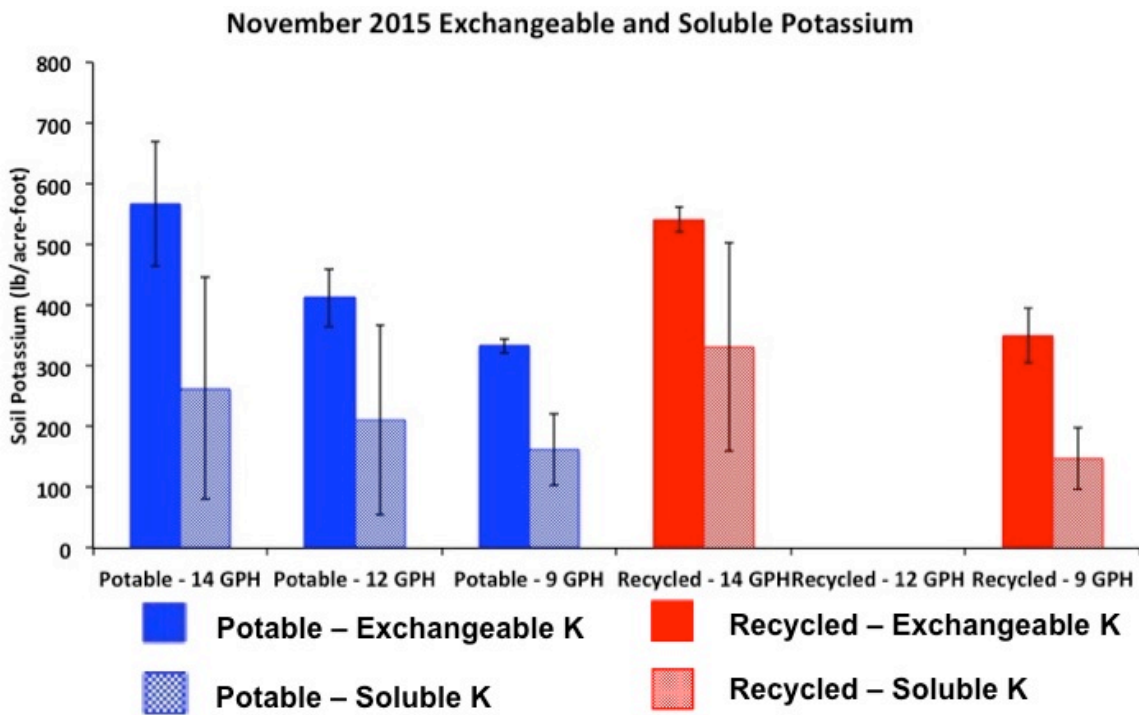
Figure 35. November 2015 exchangeable and soluble potassium in the soil. Error bars indicate standard error. Data not available for Recycled – 12 GPH.

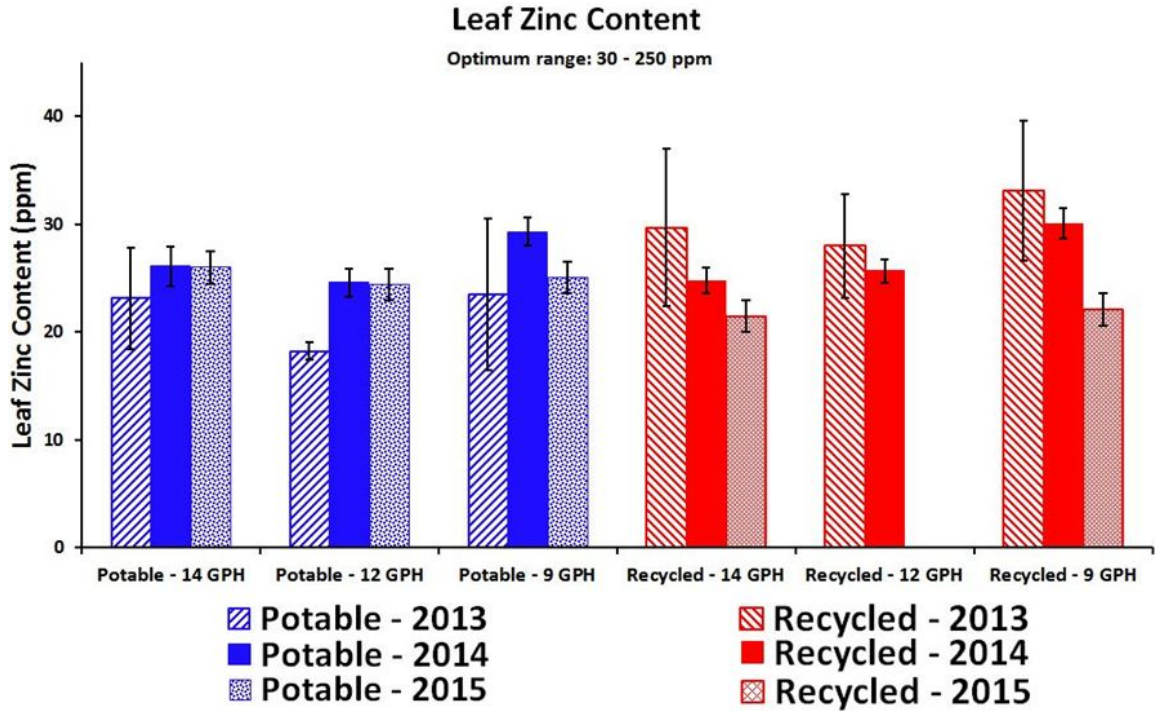
Figure 36. Leaf zinc content. 2015 data is not available for Recycled – 12 GPH. Vertical error bars indicate standard error values.

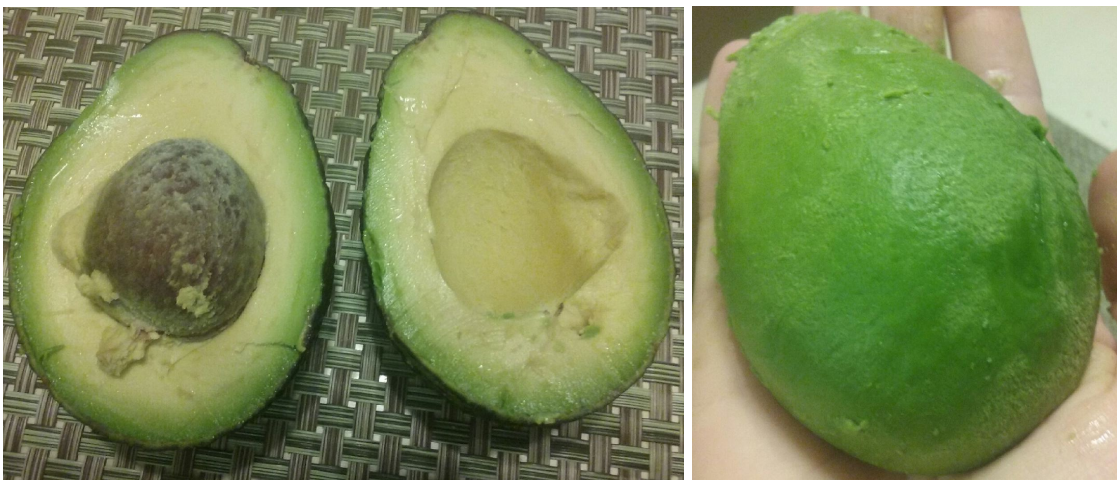
Figure 51. Potable – 9 GPH – Tree 4. High-quality fruit, representative of fruit with an appearance rating of 4.5-5.

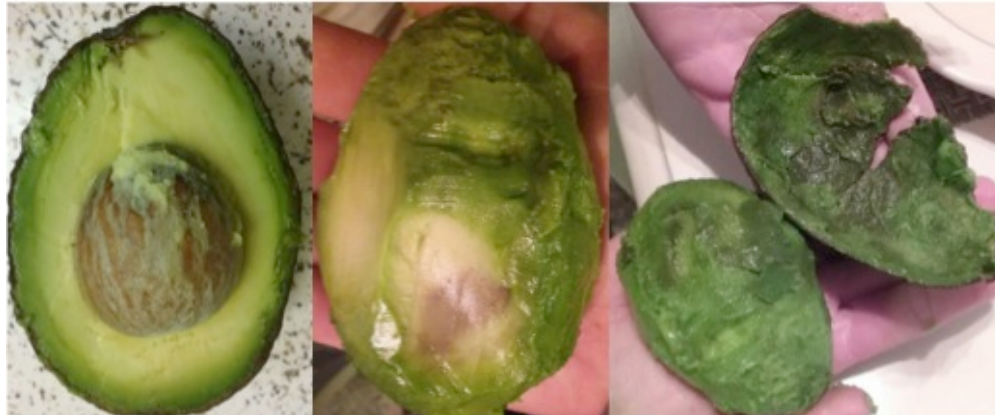
Figure 52. Potable - 14 GPH- Tree 8. This fruit received a rating of 2.85 due to rotten spots on the pulp and a slimy coating on the pulp just inside the peel. The right image shows circular rotten spots on the peel, a characteristic anthracnose symptom.

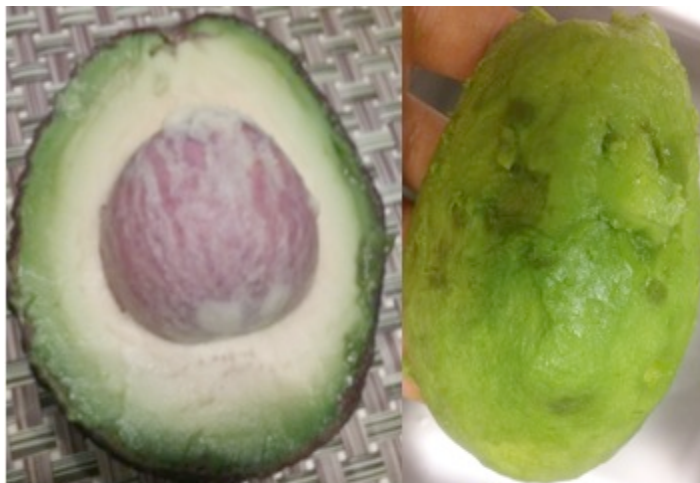
Figure 53. Potable - 9 GPH - Tree 5. This fruit received a 4 rating. Overall it looked good, but had some brown slime on the pulp just inside the peel.

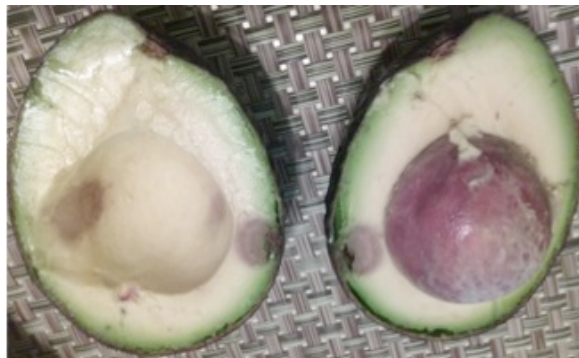
Figure 54. Potable - 12 GPH - Tree 10. characteristic anthracnose symptoms with circular brown rot.

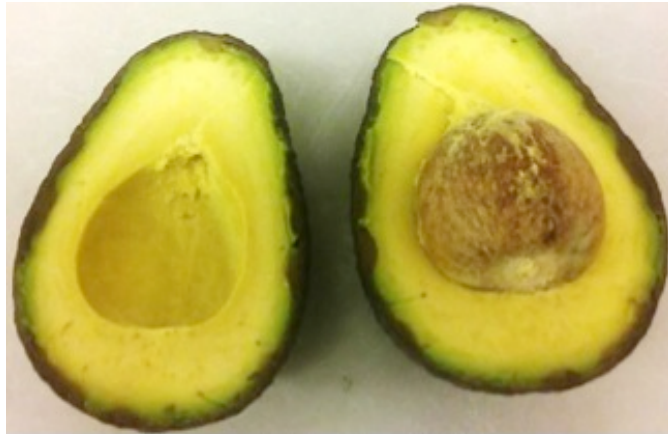
Figure 55. Recycled – 12 GPH – Tree 7. This fruit received a 1 rating. This picture does not capture the severity of the rot, or the associated foul odor. The fruit pulp was almost entirely coated in a thick dark brown slime inside the peel.

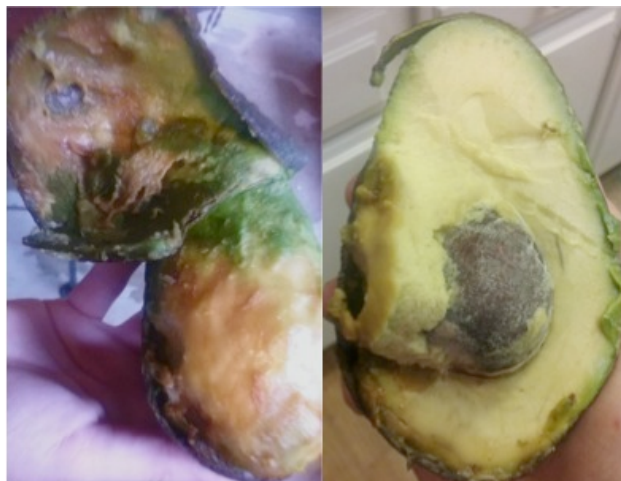
Figure 56. Recycled – 9 GPH – Tree 12. This fruit also received a rating of 1 due to extreme rot. However, the upper green part of the fruit had good flavor, texture and aftertaste.

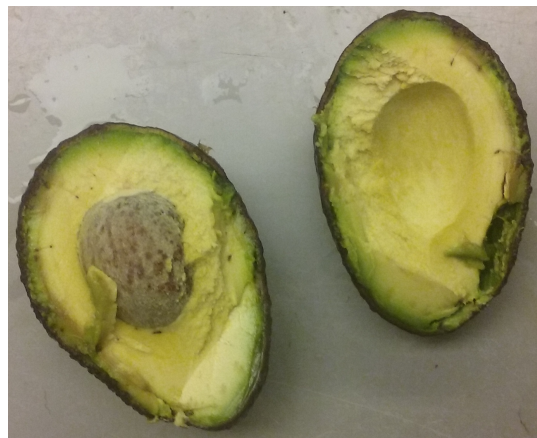
Figure 57. Potable – 12 GPH – Tree 13. This fruit had moderate rot on the peel and was rated a 2.

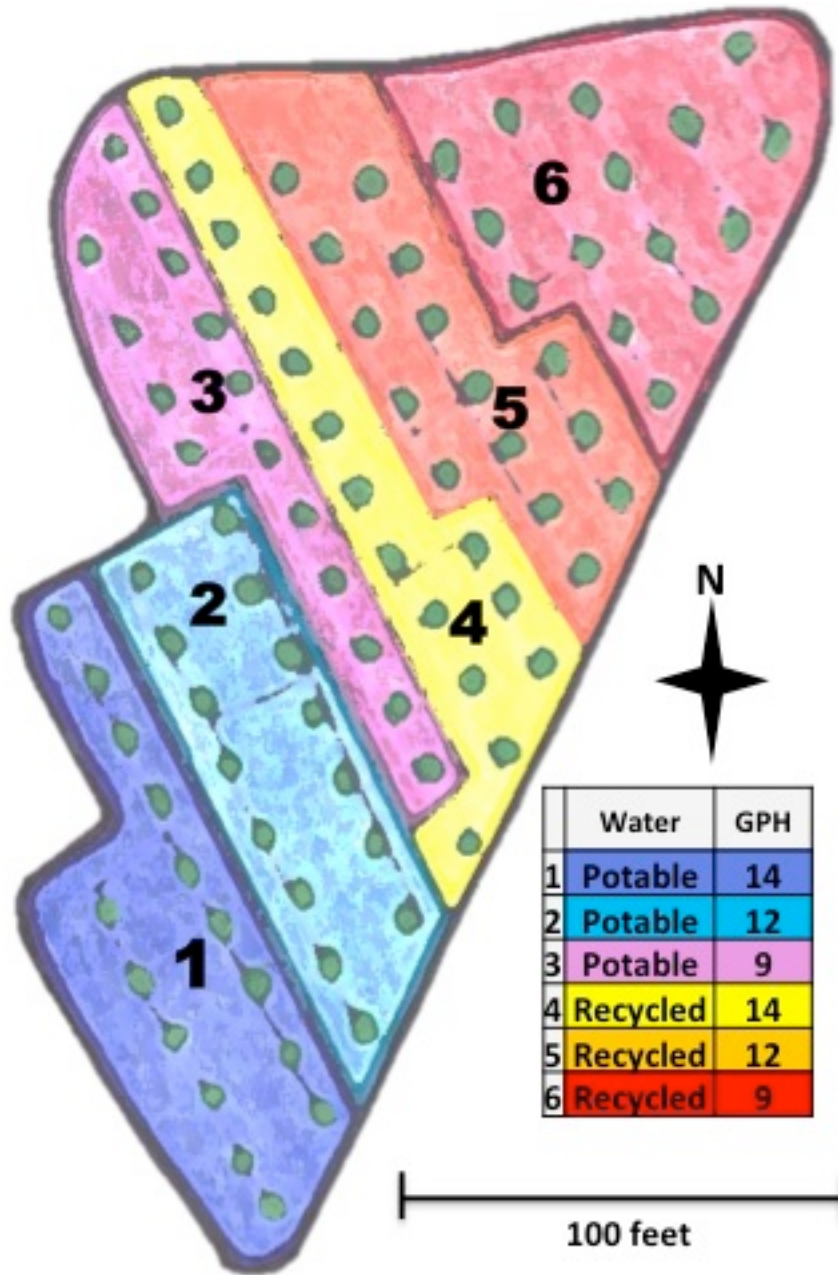
Trial Plot Map

AP Figure 3. Trial plot map showing irrigation treatments. Dark blue, light blue and pink represent trees irrigated with potable water. Yellow, orange and red colors represent trees irrigated with recycled water. Dark blue and yellow are irrigated with 14 GPH of their respective water sources, light blue and orange are irrigated with 12 GPH, and pink and red are irrigated with 9 GPH.
