29 **Keywords:** pile group foundation; bridge scour; soil-pile interaction; seismic damage; post-earthquake residual
30 strength; ductility capacity; pushdown test.

82 This study represents the first experimental investigation of the post-earthquake vertical load-carrying capacity of
83 scoured RC pile group foundations using quasi-static tests. The experimental data presented in this paper are
84 extremely valuable for modeling calibration and validation for future numerical investigations of soil-pile interaction
85 and post-earthquake load-carrying capacity evaluation of pile group foundations. This research represents a key step
86 toward the development of a rapid post-earthquake assessment approach for bridges with pile group foundations.

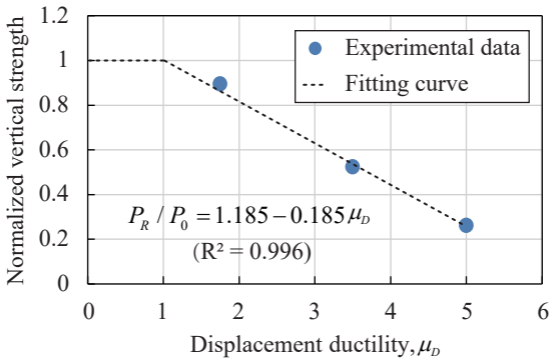
453 The test results demonstrated that the pile damage after the cyclic loading phases affected significantly the
 454 residual vertical load-carrying capacity of the pile groups and their failure modes induced by vertical loads. Figure
 455 15 illustrates the experimentally-derived vertical load-carrying capacity degradation (expressed as vertical peak
 456 strength normalized by the estimated peak strength of the undamaged pile group) as a function of the peak
 457 displacement ductility of the pile groups. The data points obtained from the pushdown tests were fitted by using a
 458 piecewise linear function given by:

459 where P_R and P_0 denote the residual and initial vertical load-carrying capacity of the pile group, respectively. This
 460 proposed equation is based on two assumptions: (1) no losses in the vertical load-carrying capacity of the pile groups
 461 are suffered if the displacement ductility is less than or equal to 1.0; and (2) the degradation of the vertical load-

462 carrying capacity is assumed linear in the range $1.0 \leq \mu_D \leq 5.0$. The high value of the coefficient of determination
463 $R^2 = 0.996$ suggests that the linear model proposed in this study is appropriate. It is noteworthy that Equation 4 is
464 valid only for the specific conditions representing the experimental tests reported in this paper. However, the proposed
465 vertical load-carrying capacity degradation curve could represent a starting point to develop more general curves to
466 predict the residual vertical load-carrying capacity of damaged scoured pile groups, e.g., for bridge rating and post-
467 earthquake rapid assessment applications. However, in order to develop such curves, additional experimental results
468 are needed considering, at a minimum: different pile configurations, sizes, and numbers; different material properties;
469 different scour depths; and different soil profiles and conditions.
