Longevity of Duct Tape in Residential Air Distribution Systems: 1-D, 2-D, and 3-D Joints

ERNEST ORLANDO LAWRENCE BERKELEY NATIONAL LABORATORY

**Environmental Energy
Technologies Division**

December 2002

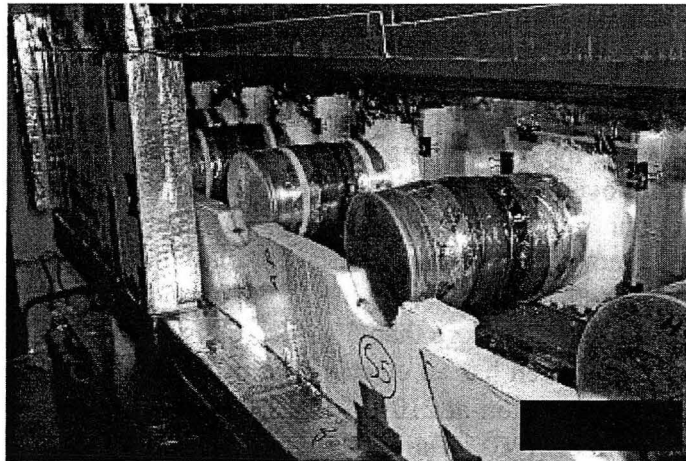
Figure 1 shows samples mounted on the aging test apparatus. Heated air is continuously circulated through the test apparatus to both heat and pressurize the leakage sites. The apparatus is divided into an upper and lower chamber that each contains nine (eight?) samples. The inside of the test samples are exposed to high pressure heated air and the outside (shown in Figure 1) is in an insulated chamber that also becomes heated during the experiments by conduction through the test samples. This means that there is little temperature gradient across the samples. The hot air temperature is controlled using electric resistance heaters mounted directly in the air stream. The surface temperatures of each sample, the air temperature and the pressure across the leaks are continuously monitored using a computer based data acquisition system. The actual leakage measurements are conducted periodically (typically on a monthly or weekly basis) by removing the samples from the test machine. They are then allowed to cool to room temperature before being placed in a separate testing device that pressurizes the samples to 25 Pa and measures the air flow rate required to maintaining this 25 Pa pressure difference. This 25 Pa air flow is the leakage of the sample that is then recorded and compared to initial 25 Pa air flow measurements of the connections before and after initial sealing.

Figure 1. One chamber of the high temperature aging test apparatus.

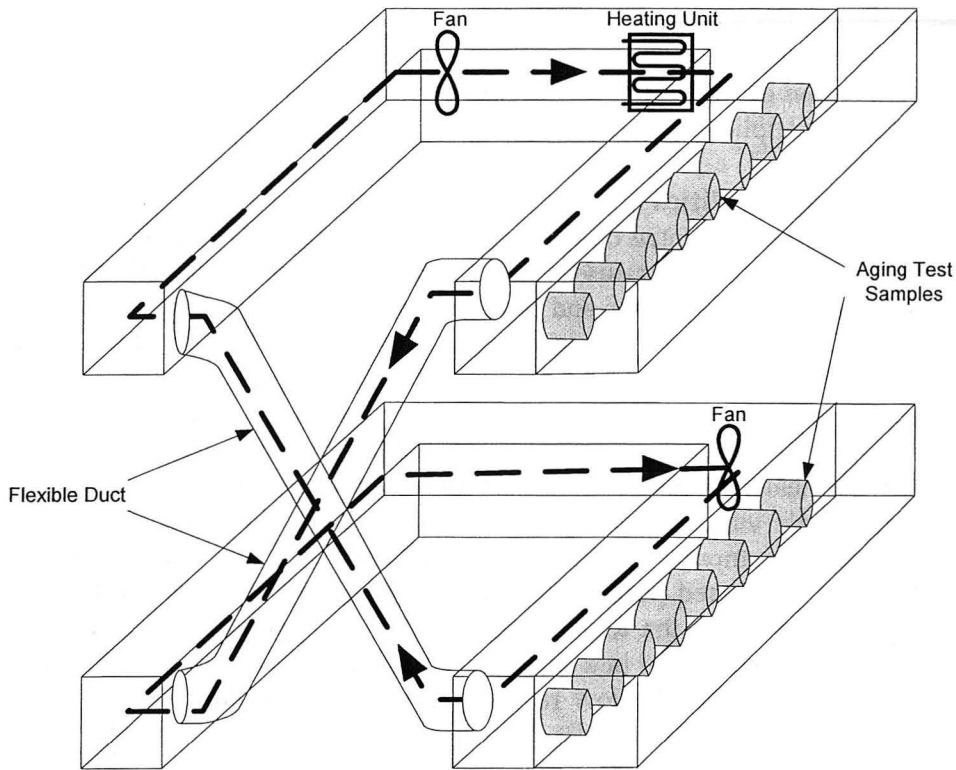
Figure 2 shows a schematic of the hot air circulation path in the aging test apparatus. The upper and lower test chambers are connected by insulated ducting so that the same air flows through both chambers and only one heater is required. In the previous phase of

testing, the lower chamber had cold air circulating through it. This apparatus conforms to proposed ASTM test requirements in order to develop an industry standard test method.

Figure 2. The hot air circulation in the modified aging test apparatus.

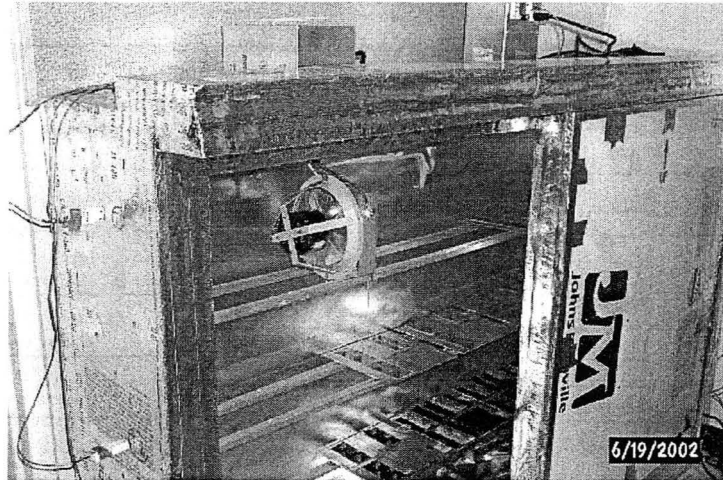
Figure 3 shows the baking test oven that provides constant circulating air temperature of 212°F (100°C) for the baking specimens following the UL 181B “temperature test” protocol. All walls of the oven are made with 4” (100 mm) thick foil-faced foam sheathing. The bottom of the oven, sitting on the floor, is made thicker (6” (150 mm)) for added insulation. The oven is 44” (112 cm) high, 72” (183 cm) wide, and 10” (25 cm) deep. It contains four racks made of two strips of aluminum that hold the testing specimens. Six temperature sensors equidistantly placed on both sides of the oven provide readings of the temperature profile inside the oven. Measured results show that the temperatures do not vary by more than 5°F (2.5°C) from the average temperature of 212±5°F (100±3°C). The oven has an electric heating unit controlled by a relay box to turn off at 214°F (101°C) and on at 210°F (99°C), and also protected by a safety snap thermostat rated at 250°F (121°C). The temperature values are recorded at a one-minute interval. The air circulation inside the oven is insured by a thermally-protected ball-bearing 115 volts.

Figure 3. The high temperature baking apparatus.

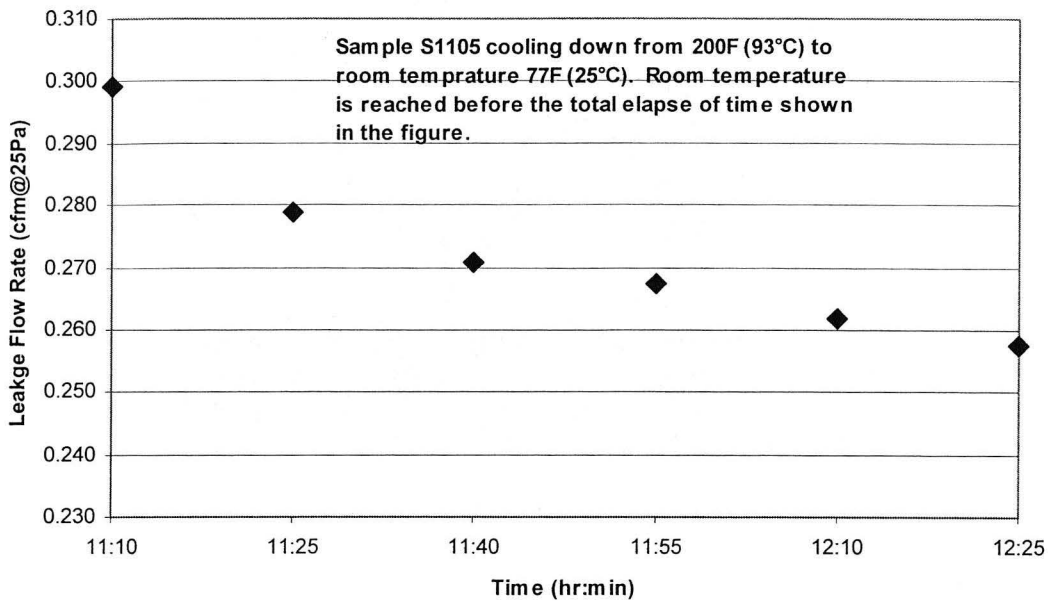
Because the aging test involves heating the specimens continuously at 200°F (93°C), it takes some time for the specimens to return to room temperature. Therefore the elapsed time between removal from the test chamber and measurement of leakage could have an effect on the results. To examine this effect, a specimen was tested six times at 15-minute intervals, with the first measurement taken at its highest temperature (200°F (93°C)). The experiment took place in the laboratory where room temperature is 77°F (25°C). Figure 4 shows the decay in the leakage flow as a function of cool-off time. The leakage flow at the highest temperature is 16% higher than the last value taken 1 hour and 15 minutes later. The difference in leakage is attributed to the “re-sealing” of the joint as it shrinks and hardens at lower temperatures. For consistent results the samples need to cool to room temperature before being leakage tested. However, for some of these results discussed here we did not wait a uniform time, which resulted in additional uncertainty in measured sample leakage.

Figure 4. Decay in the measured leakage as the specimen cools down from 200F (93°C) to room temperature.

stabilization and tested the samples at some intermediate temperature, thus leading to higher measured leakage. The magnitude of the changes in leakage with time and therefore sample temperature shown in Figure 4 indicate that the negative leakage shown in Figures 13a and b is of a similar magnitude to this effect. In addition, a general observation of the core-to-collar joints undergoing an aging test is that the shrinkage of the duct tape can have a positive effect as it tightens up around the joint, unlike the case of a collar-to-plenum joint where the shrinkage of the duct tape makes it peel off and pull away from the surface it is applied to, thus exposing the leaks.

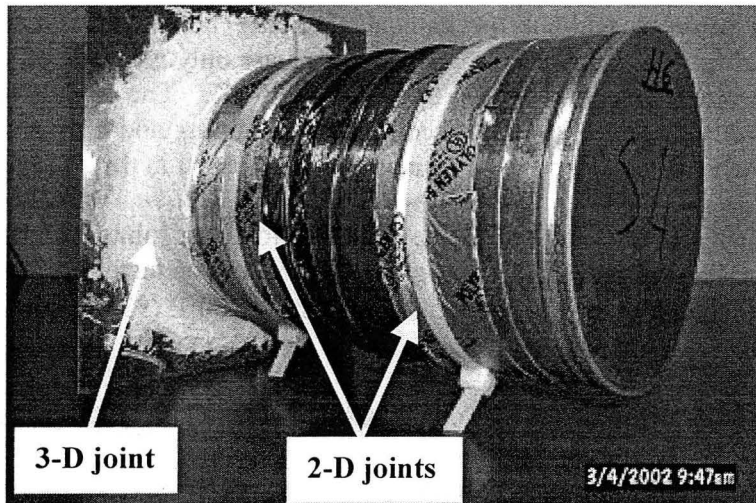
Flexible ducts consist of three layers: inner membrane called "core", a layer of insulation and an outer layer acting as a moisture barrier called a "jacket". The test samples were sealed with two layers (one continuous piece) of duct tape applied to the core of the duct with the insulation and outer moisture barrier removed. The taped joint is reinforced with a mechanical plastic clamp installed over the tape as required for UL 181 B-FX installations. Figure 5 shows a laboratory construction of the 6" (150 mm) flexible core-to-collar joint aging test specimens, which contains two core-to-collar joints (the joint being tested) and one collar-to-plenum joint (not tested and sealed with mastic). The white irregular ring of material at the back (left) is mastic that has been applied over the collar-to-plenum joint. The end of the duct is capped with a metal cap that is sealed before testing. Figure 6 shows a schematic of the flexible duct core-to-collar joint as it fits on the aging test apparatus. Figure 6 shows how the whole specimen is enclosed in insulation that forms a test chamber.

Figure 5. Example of test sample showing the two taped connections and the mechanical clamps.

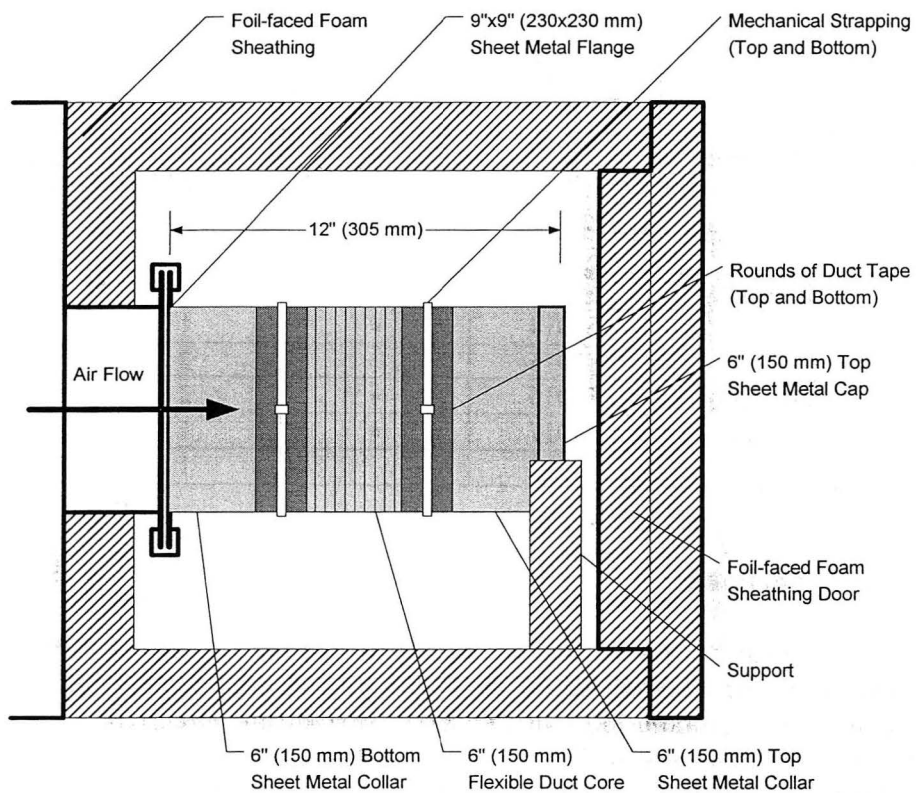
Figure 6. A side-view schematic of a flexible duct core to sheet metal collar joint specimen positioned on the aging test apparatus.

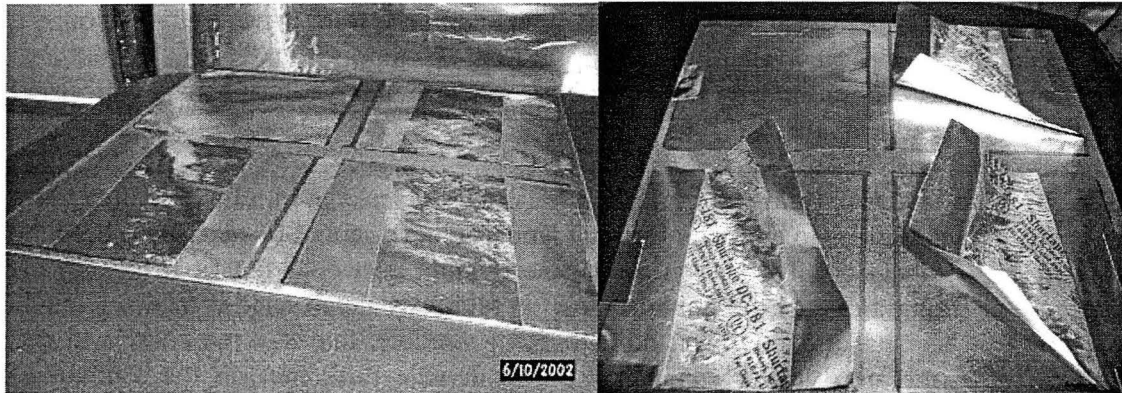
For each duct tape (Tape 1, Tape 2, Tape 3, and Tape 4), twelve specimens were made by applying a strip of tape to three 4 by 4 inch (100 by 100 mm) samples of each of the following materials: aluminum foil, polyethylene, polyethylene terephthalate (PET), and sheet metal (steel). Another 4 by 4 inch (100 by 100 mm) control sample of each of the substrate materials is included in the specimen without applying the tape to it. The control sample serves as a means to quantify the deterioration attributed to the substrate in isolation from the duct tape. A specimen set in the baking test, therefore consists of three similar samples and one control sample, all carried by a sheet metal tray in the oven (Figure 7). Since the substrates used in this test are very thin and light weight, they are

attached from two sides to the sheet metal tray so that the fan can not blow them away from their locations.

Figure 7. A baking specimen following the UL 181B temperature test protocol consisting of three samples of tape (Tape 3) and one control sample of the substrate (Aluminum Foil) before testing and after four weeks of testing.

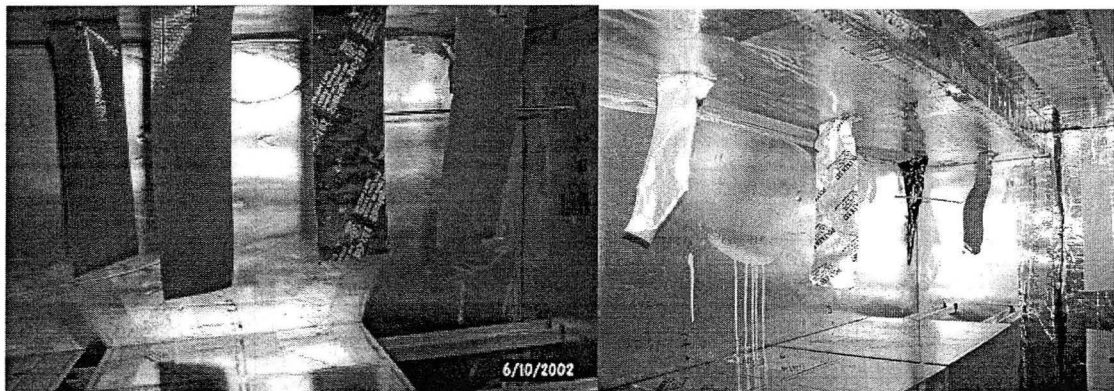
In addition to the specimens following the UL 181B temperature test protocol, we included “hanging specimens” (Figure 8) of all four tapes in the oven to examine their deterioration in isolation from the substrate they are applied to.

Figure 8. Hanging specimens of Tapes 1 to 4 in the high temperature baking apparatus before testing and after three weeks of testing.

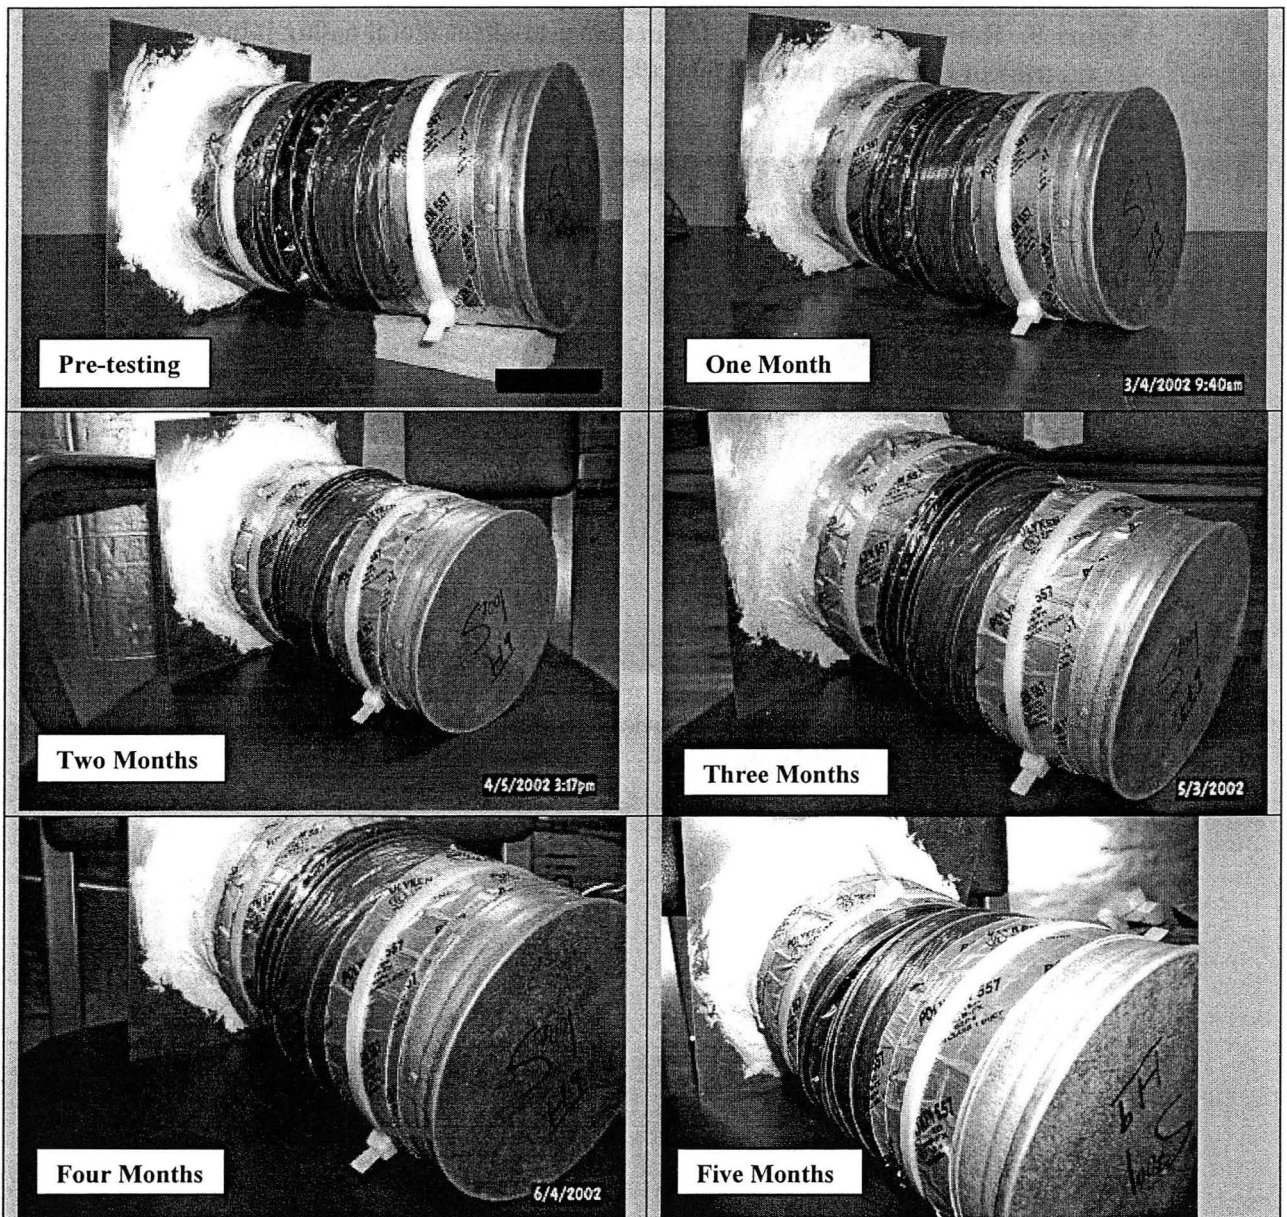
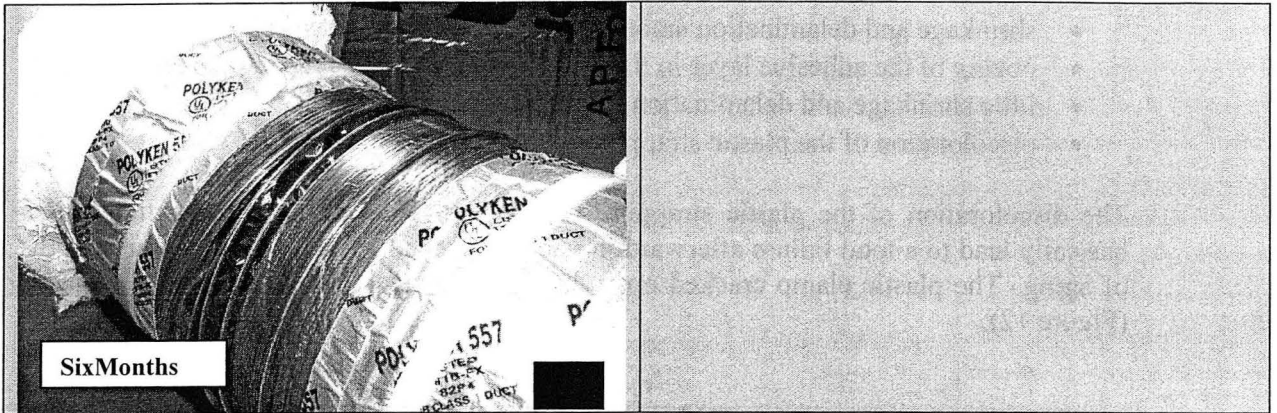
In order to systematically record the visual deterioration of the samples, monthly pictures of all 18 specimens were taken. Typical minor deteriorations were observed as discoloration, wrinkling, and oozing, and major deteriorations were shrinking, peeling, delamination, and cracking. Figure 9 shows the deterioration of one of the specimens with clamping, and 2 continuous wraps of duct tape.

Figure 9. Deterioration of flexible duct core-to-sheet metal collar joint during the six months of the aging test at 200 F (93°C) temperature.

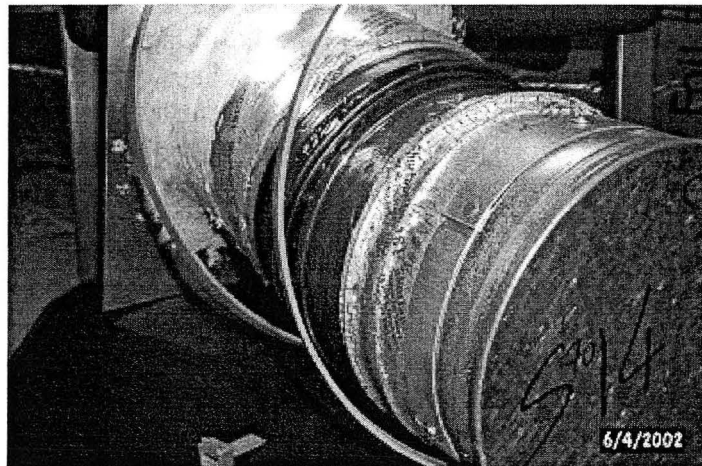
The discoloration of the plastic strapping was an indication of its deterioration which basically lead to a total failure afterward in one case (specimen S7014) after four months of aging. The plastic clamp cracked open due to the increased brittleness of the plastic (Figure 12).

Figure 12. The failed plastic strapping on one of the flexible core to sheet metal collar specimens after four months of aging.

Lastly, we found that plastic straps became discolored and brittle during the tests, and a couple of straps broke completely. Therefore, we recommend that clamping the duct-taped flexible core-to-collar joints should be done with metallic adjustable straps.

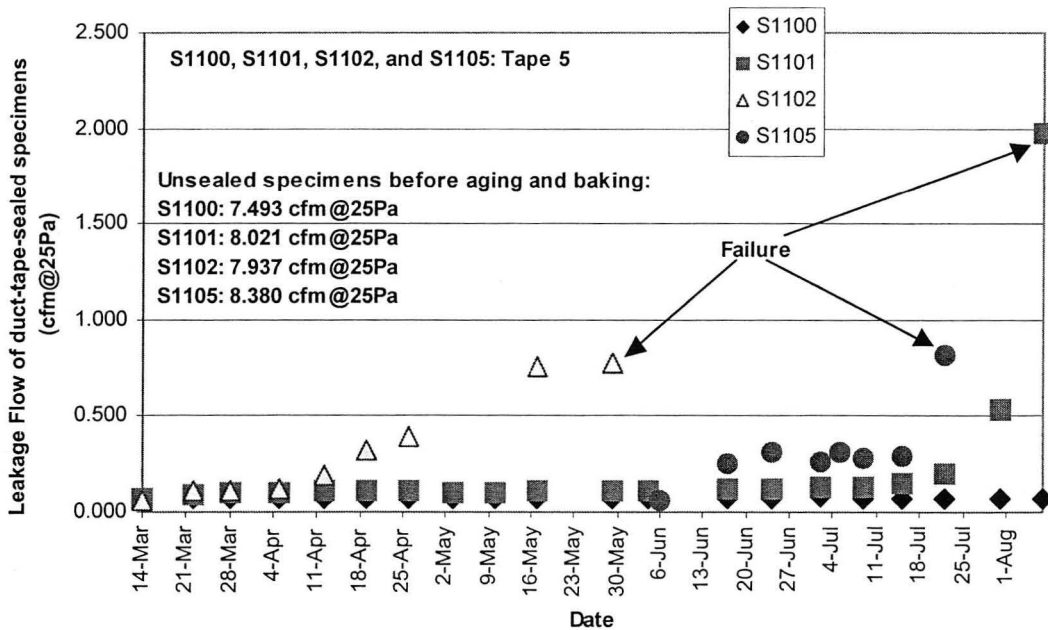
Collar-to-plenum joints aging test. In addition to the aging tests of the flexible duct, core-to-collar joints, we also repeated the tests of the collar-to-plenum joints aging tests that were conducted in previous studies. These tests were performed for a new duct tape product that has been developed to have improved high temperature performance (Tape 5) as well a sample of Tape 1. The tape new failed in 9 days (using the >10% of unsealed leakage criteria), showing shrinkage and pulling away from the sheet metal plenum. Figures 14 and 15 show the results of these tests. Because they were mounted in a different location on the test apparatus, these collar-to-plenum were exposed to different temperatures than the core to collar samples. These samples were placed between the left and right chambers (shown in Figure 2) where in previous phases of longevity testing the samples experienced cycling temperatures. Table 4 shows the temperatures the specimens were exposed to during the test, and the corresponding elapsed time before failure. Specimen S1102 failed after 2.5 months, and was replaced with specimen S1105. Specimen S1105 appeared to leak at a faster rate at the beginning, then leveled off, then showed a catastrophic (sudden) failure, contrary to the gradual failure of S1002). It took specimen S1105 only one month and three weeks to fail.

Figure 14. The measured leakage of the collar-to-plenum joint Tape-5 specimens.

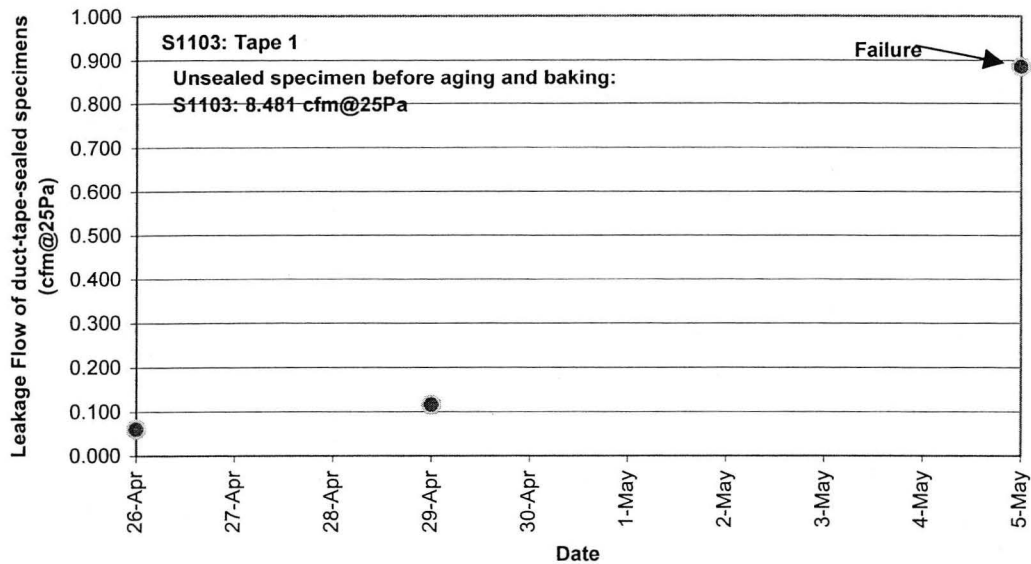
Figure 15. The measured leakage of the collar-to-plenum joint Tape-1 specimen.

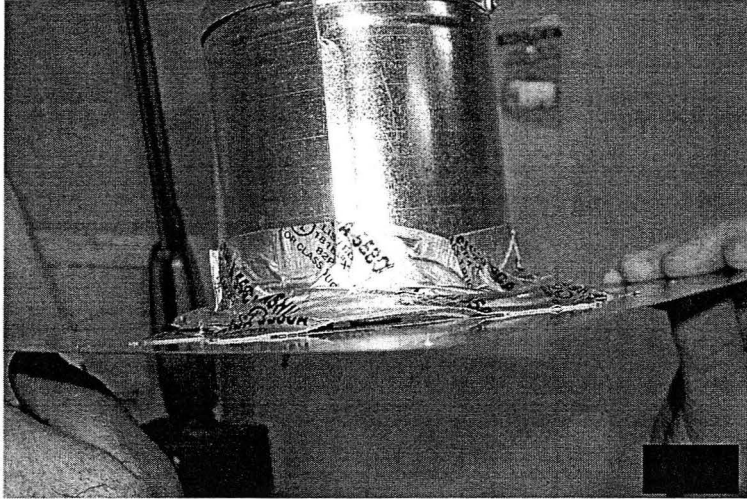
Figure 16 shows the failure of the 3-D joint as the duct tape tends to pull away from the sheet metal, thus uncovering the series of overlapping fin-joints.

Figure 16. A typical failure of the 3-D collar-to-plenum joint.
