Man with Total Knee Arthroplasty Now Unable to Extend the Joint

Clinical Practice and Cases in Emergency Medicine, 2(2)

Barden, Matthias
Kasarjian, Julie K. A.

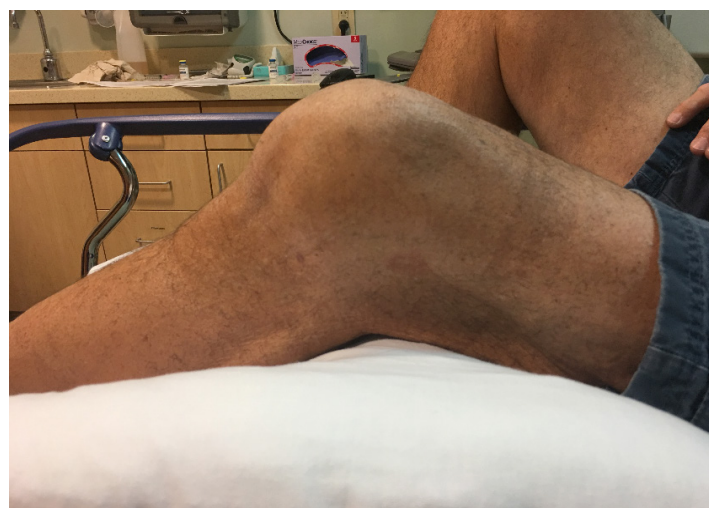
Image 1. Photo of knee showing the position of locked flexion during a cam-jump dislocation of prosthetic knee.

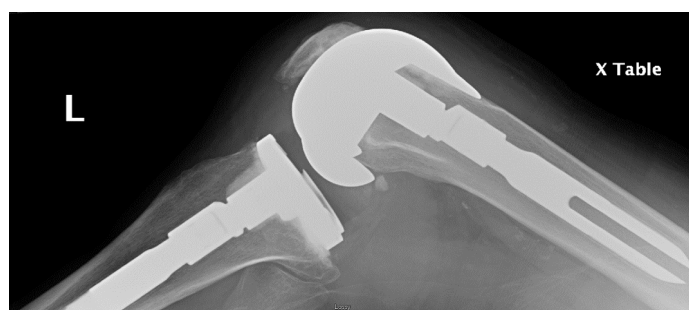
Image 2. Initial lateral radiograph of cam-jump dislocation of prosthetic knee joint. The femoral component is subtly displaced anteriorly versus the tibial component of the prosthesis.

A 70-year-old man presented to the emergency department (ED) complaining of inability to extend his left knee. He had been kneeling on the ground pushing a heavy box when he felt a “pop” in the knee. Prior history included remote total knee arthroplasty complicated by instability requiring multiple revisions. On physical exam, the leg was distally neurovascularly intact and his knee was flexed at about 45° with limited range of motion (Image 1). Radiographs were performed; however, imaging was somewhat limited by his decreased mobility and pain (Image 2).

rare and represents the most severe degree of instability.¹ The patient stated that he had “jumped the cam,” which was the term his orthopedist used when he had a similar episode two years previously. With this type of dislocation, hyperflexion of the joint causes the femoral component (“cam”) of the prosthesis to be rotationally translated anteriorly relative to the tibial component (“post”).² The posterior aspect of the femoral component becomes locked in articulation with the tibial component and the patient is unable to extend the joint back into a normal position.

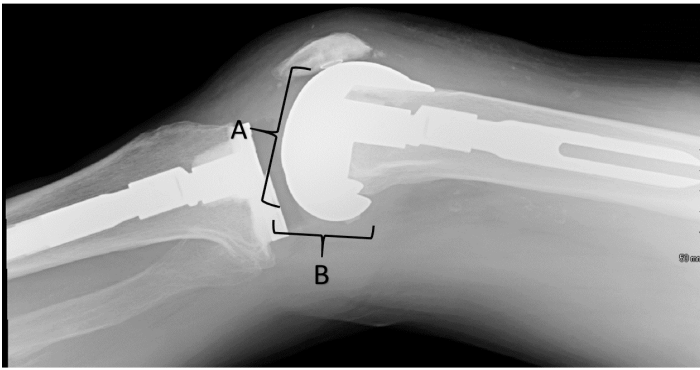
Image 3. Post-reduction radiograph showing proper articulation of the prosthetic components. Prior to the reduction, the posterior aspect of the femoral component (B) articulated with the tibial component. After reduction, the inferior aspect of the femoral component (A) now articulates with the femoral component.

After discussing the case with the orthopedic surgeon, the patient underwent procedural sedation and reduction in the ED. Reduction was accomplished with hyperflexion of the knee to exaggerate the deformity, followed by extension to re-establish the normal articulating position of the prosthetic.³ Post-reduction radiographs were obtained showing normal articulation of the prosthesis components (Image 3). After reduction the patient was able to ambulate without any pain and had full range of motion. The orthopedic surgeon did not recommend splinting or a knee immobilizer, but was very clear that the patient should be given instructions to never kneel again to avoid this rare and painful complication.
