NCOS News - October 2017

North Campus Open Space Restoration Project

HIGH QUALITY WATER FOR YOUR HOME, AND FOR BIRD HABITAT AT NCOS!

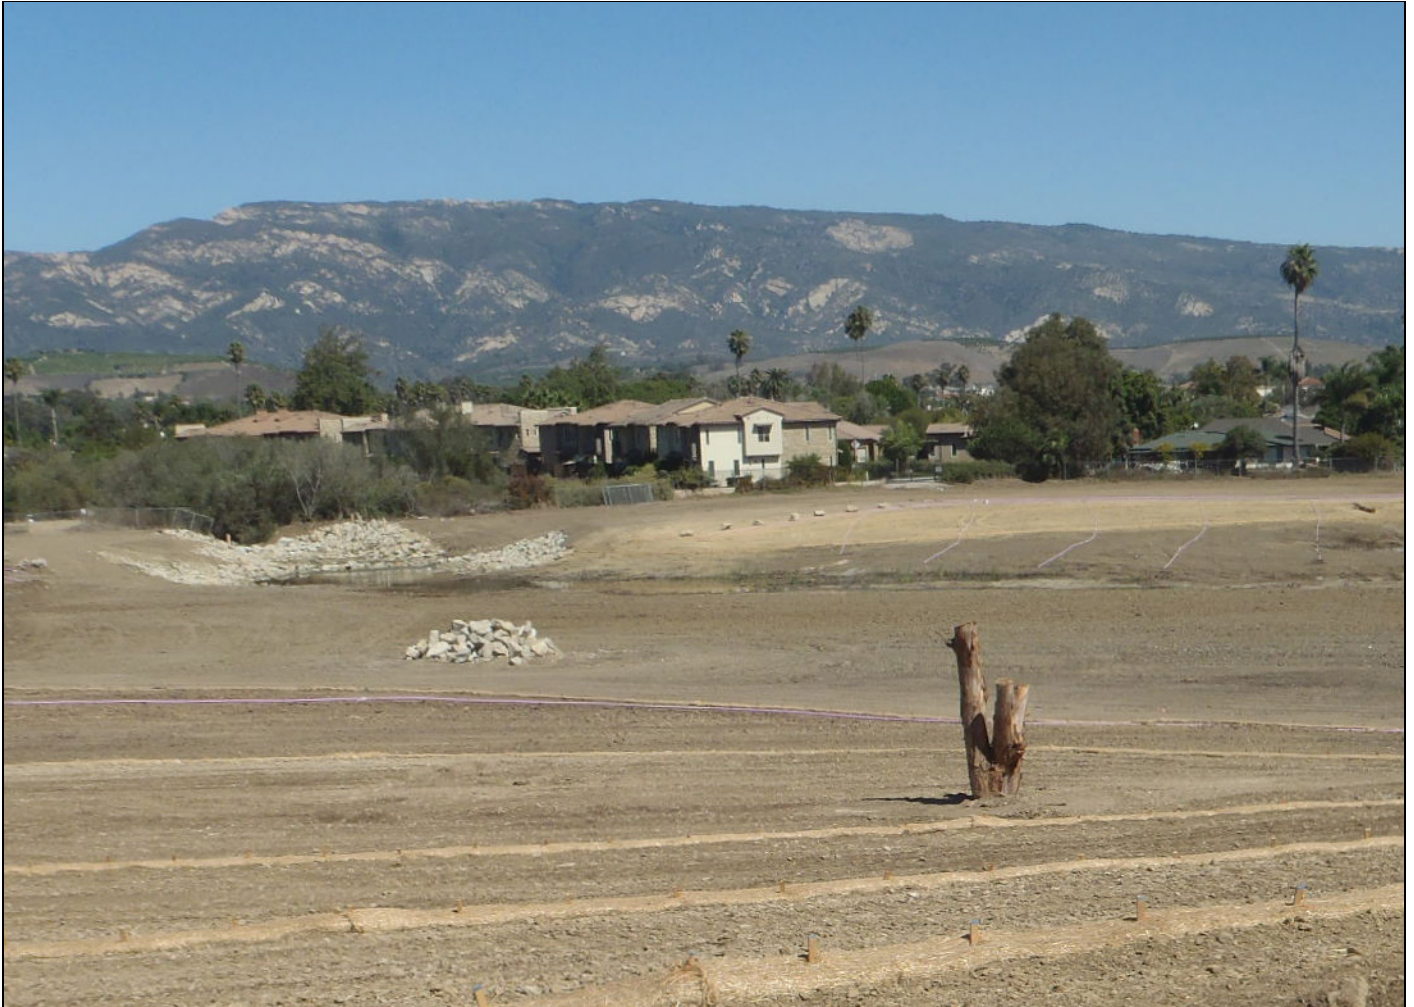
Photo of one of the habitat features, a snag, or standing trunk, installed on the newly graded hill slope of the NCOS restoration site.

- The installation of [habitat features](#) is nearly complete, and hydroseeding of the hillside is planned for mid-October.
- The irrigation we've been installing on site is temporary and will be removed after the first year or two, once native plants have become established.

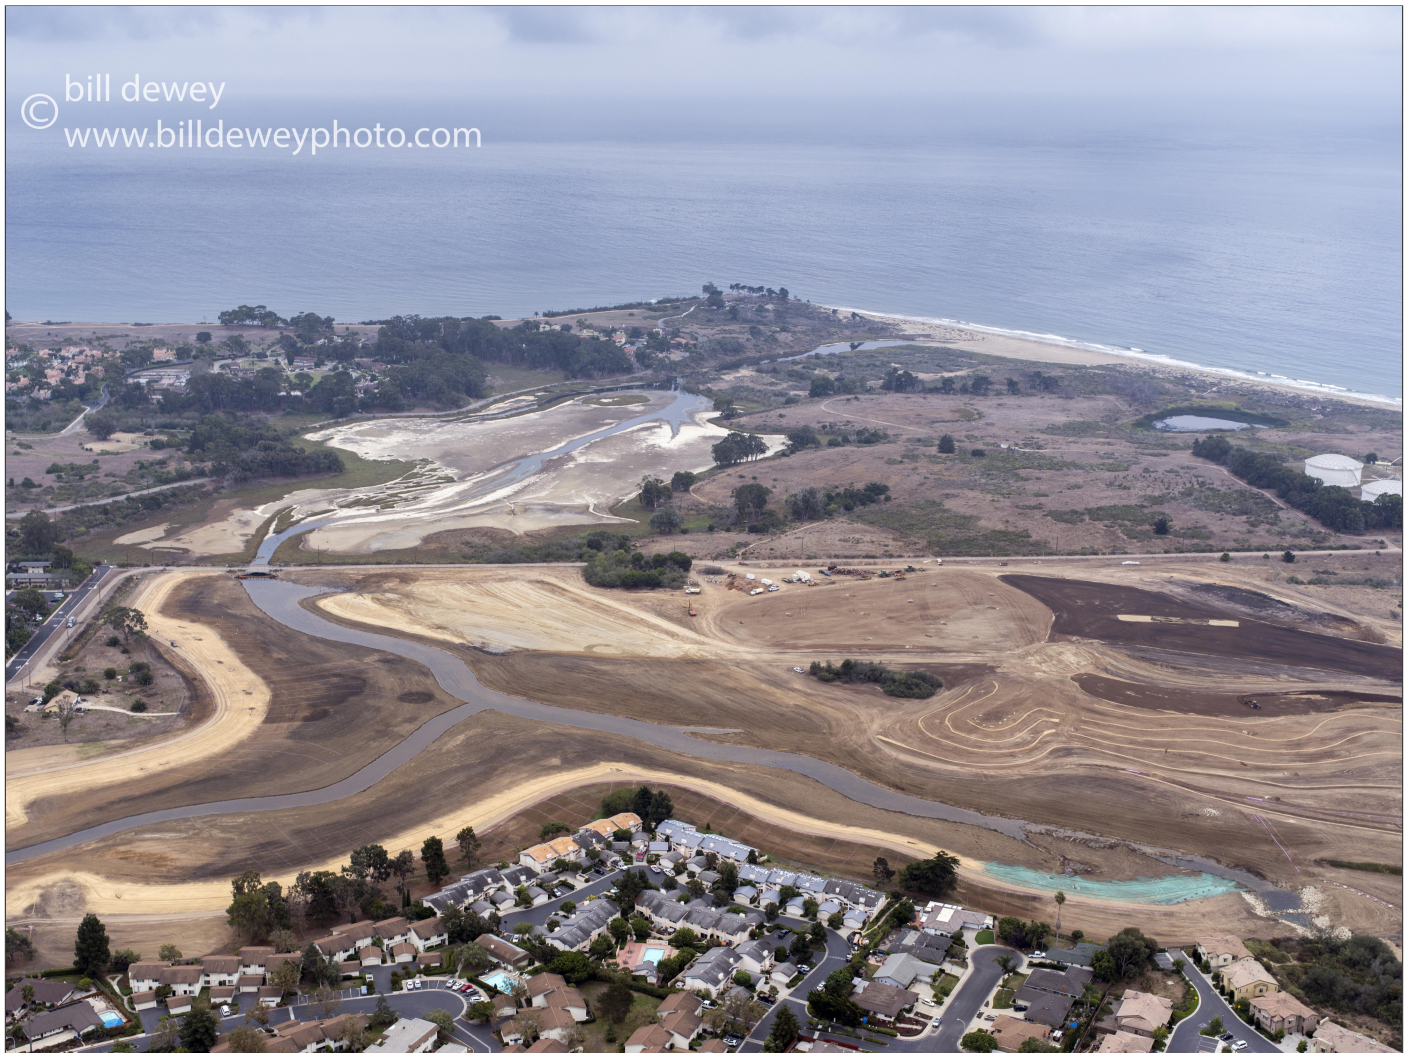
This aerial image, taken on September 19, shows the water in the east arm (lower-left) and main channel of the NCOS restoration site.

in late August, much more water appeared, enough to connect the main channel from Phelps Creek to Venoco Bridge, and fill the sub-tidal channel in the eastern arm. The source of this water turned out to be the result of maintenance on the Goleta Water District's (GWD) distribution system.

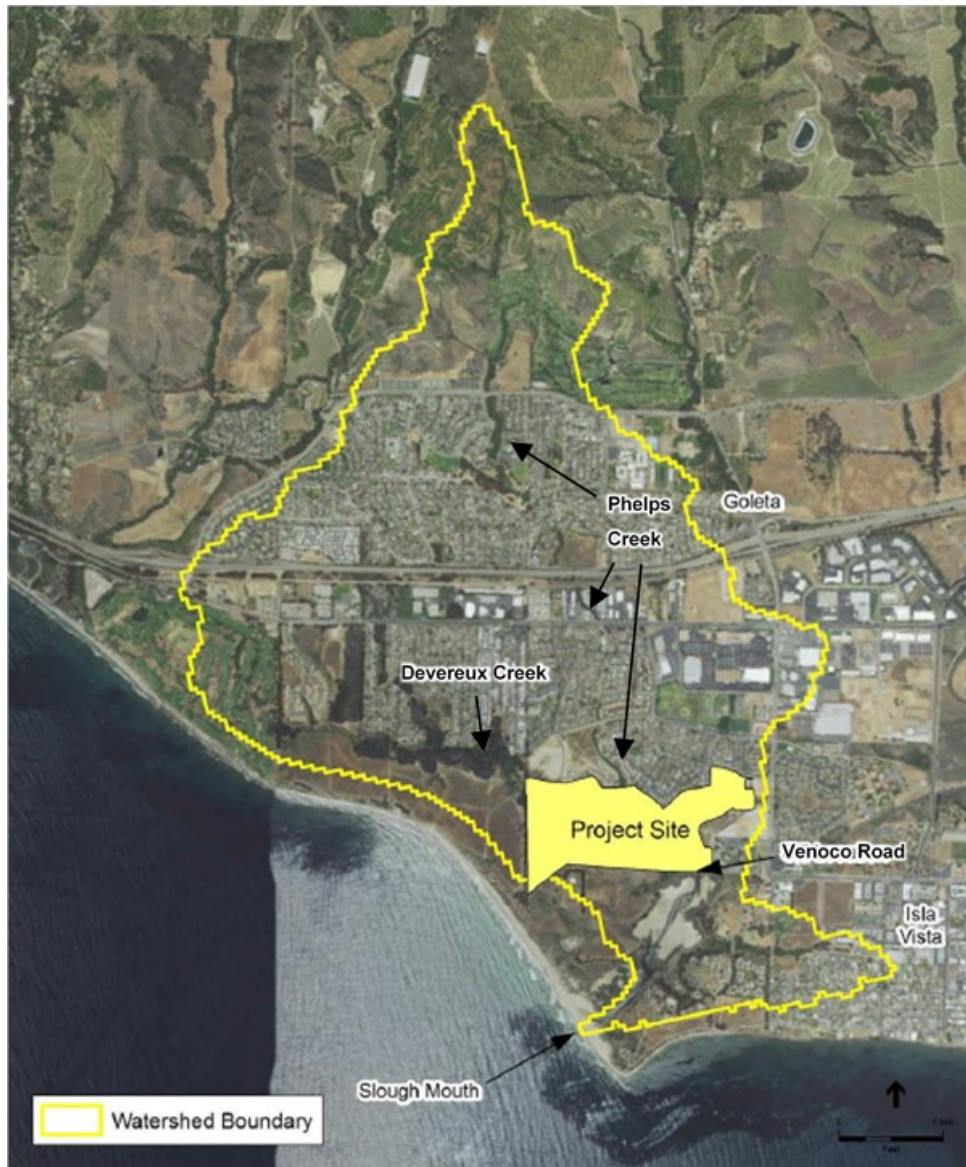
Figure 1. Map of the approximate boundary of the Devereux Slough watershed. The locations of Phelps and Devereux Creeks are indicated with arrows.

One of the main tributaries, and sources of surface water in NCOS and Devereux Slough is Phelps Creek, which enters NCOS from the north and converges with Devereux Creek from the west (see map in Figure 1 below). A temporary dam was installed in Phelps Creek while the boulder-lined pools were constructed in July (Figure 2). This dam was removed early August, and a small amount of water in Phelps creek trickled into NCOS. However,

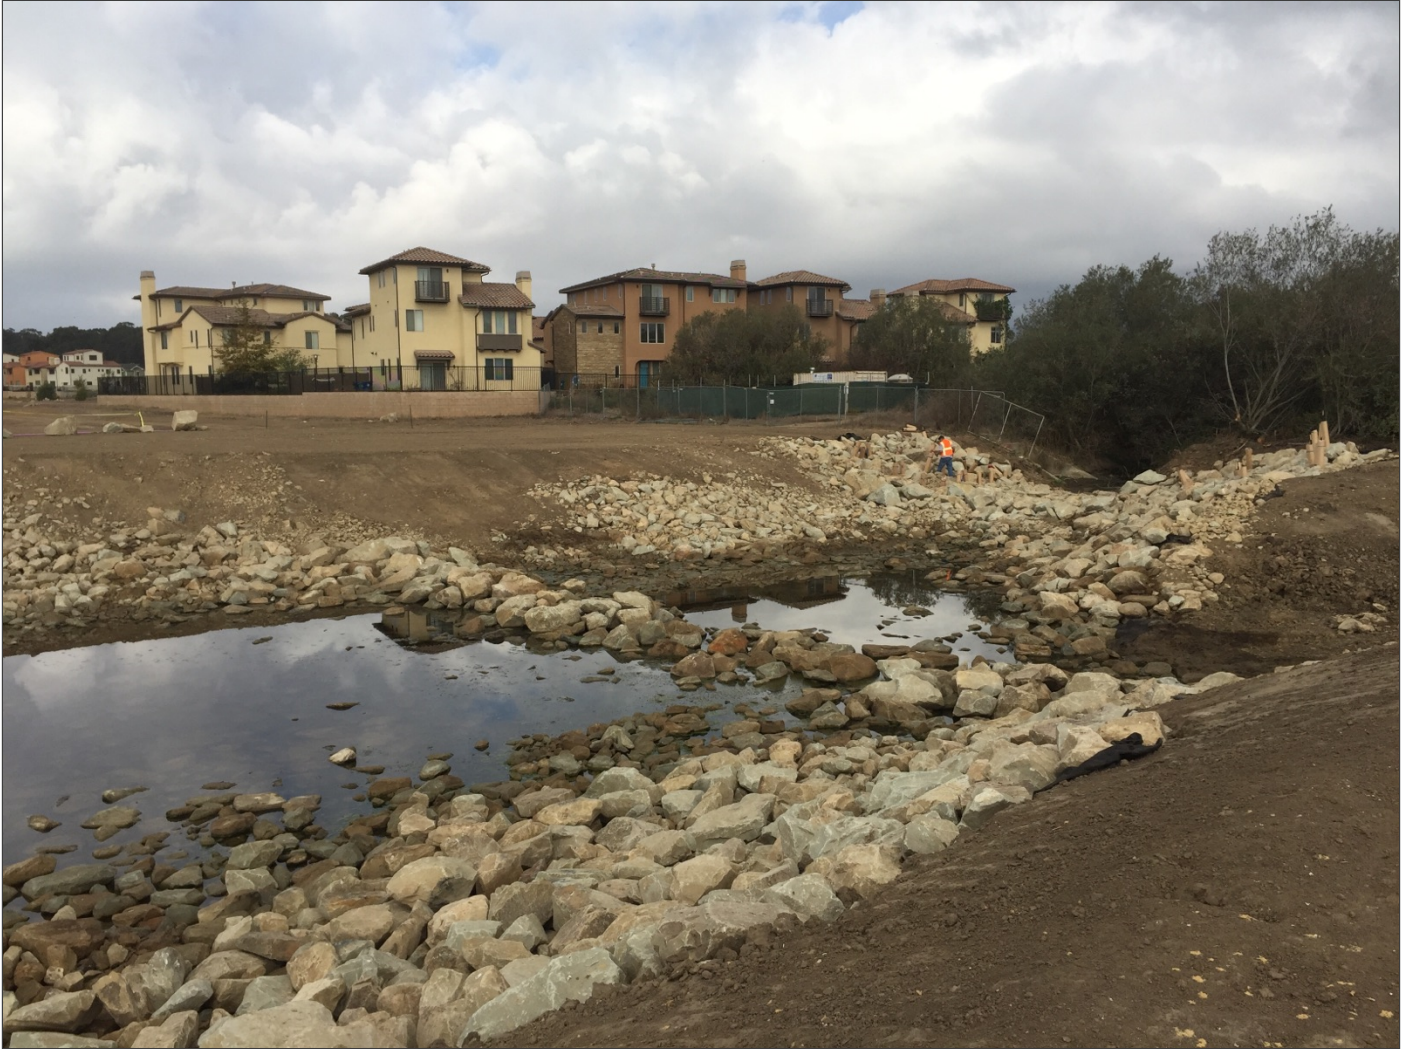
Figure 2. Picture of the boulder lined pools constructed where Phelps Creek enters the NCOS restoration project site.

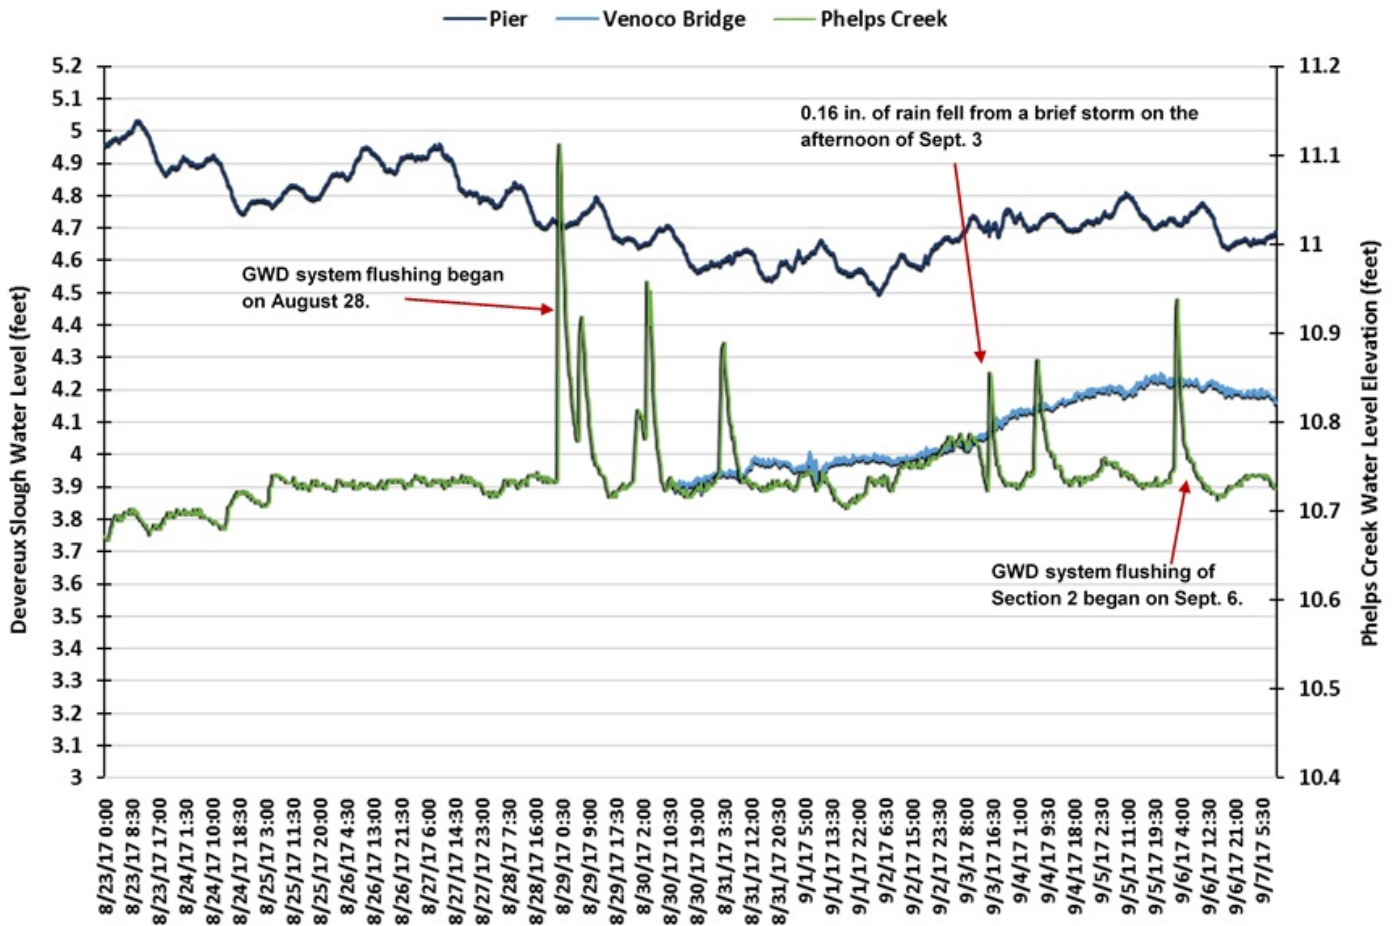
Devereux Slough & Phelps Creek Water Level: 8/23/2017 to 9/7/2017

Figure 3. Graph of water levels (in feet above sea level) in Phelps Creek (green line), and Devereux Slough at Venoco Bridge (light blue line) and Devereux Pier (dark blue line) between August 23 and September 7, 2017.

The water system flushing began in Winchester Canyon (Section 1) on August 28, and moved to the neighborhood just north of NCOS (Section 2) on September 6. Thanks to our hydrology monitoring equipment, we can see when the flushed, de-chlorinated water came through Phelps Creek. This was indicated by a half foot increase in the water level of Phelps Creek over a 12-hour period that began overnight on August 28. The chart below (Figure 3) shows the water level data recorded in Phelps Creek, and in two locations in Devereux Slough, between August 23rd and September 7th. The pulses of water that entered the system overnight from the GWD flushing program can be easily seen in the chart (green line), as well as the brief rise from a short burst of rain on the afternoon of September 3.

The total volume of water that entered NCOS was roughly estimated to be more than 300,000 cubic feet, and was calculated from flow rate curves measured in the Phelps Creek channel. The area of inundation in the project site is 3.7 acres of sub-tidal area, which is approximately 161,172 square feet (3.7 acres x 43,560 square feet per acre = 161,172). The site requires 161,172 cubic feet of water to inundate the sub-tidal channel up to a depth of 1 foot. Some portions of the site are inundated up to 1.5 feet, and some water carried on through the system and increased water levels in the downstream portion of Devereux Slough. This increase can be seen in the water level data from Devereux Pier, shown with a dark blue line on the graph, and from under Venoco Road bridge between the project site and Devereux Slough, shown by a pale blue line.
