Eleventh U.S. National Conference on Earthquake Engineering
Integrating Science, Engineering & Policy
June 25-29, 2018
Los Angeles, California

The 2016 Central Italy Earthquake Sequence: Observations of Incremental Building Damage

R. De Risi¹, A. Sextos², P. Zimmaro³, A. Simonelli⁴, and J. Stewart⁵

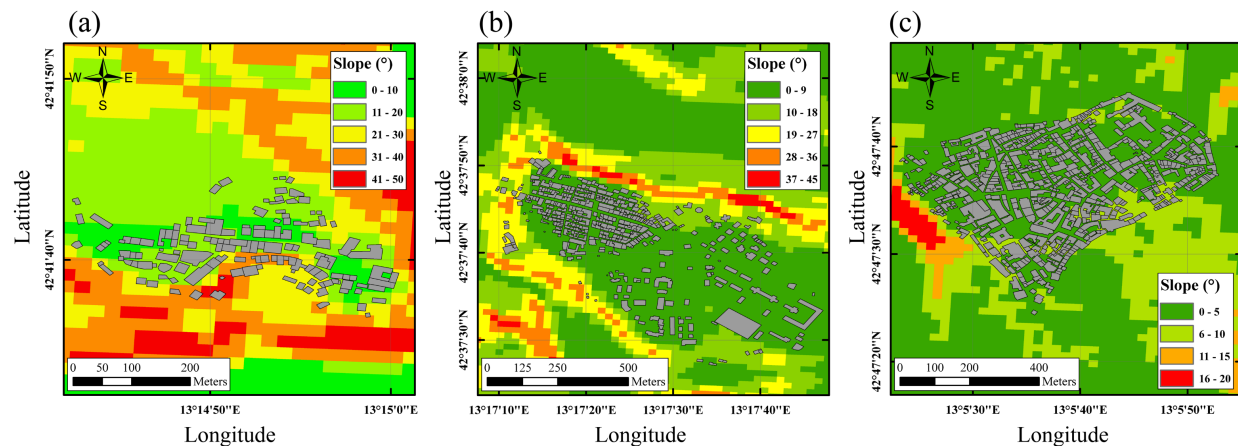
Data processing after the sequence of earthquake events has shown that the structural damage in various hamlets and villages is closely correlated with local site effects [14]. According to the 1:500,000 Italian geological map, the geological bedrock in Accumuli and Amatrice is made of sedimentary lithology units composed of sandstones and clay lithofacies of the late Miocene, while the geological bedrock in Norcia is composed by unconsolidated colluvial, terraced alluvial, fluvio-lacustrine and fluvio-glacial deposits of Pleistocene. Figure 3 illustrates the slope maps obtained on the basis of a 20m resolution digital elevation model for Accumuli, Amatrice and Norcia. It can be observed that due to the ridge-type local topography in Accumuli, topographic amplifications are likely to have occurred. Similarly, the slope map of the region of Amatrice indicates a sharp hill border which is also probable to have led to local site amplification to some extent. On the contrary, the slope map in the area of Norcia shows that the valley is flat and that topographic effects are not expected.

Figure 3. Slope maps for (a) Accumuli, (b) Amatrice, and (c) Norcia. The grey rectangles represent the surveyed buildings.

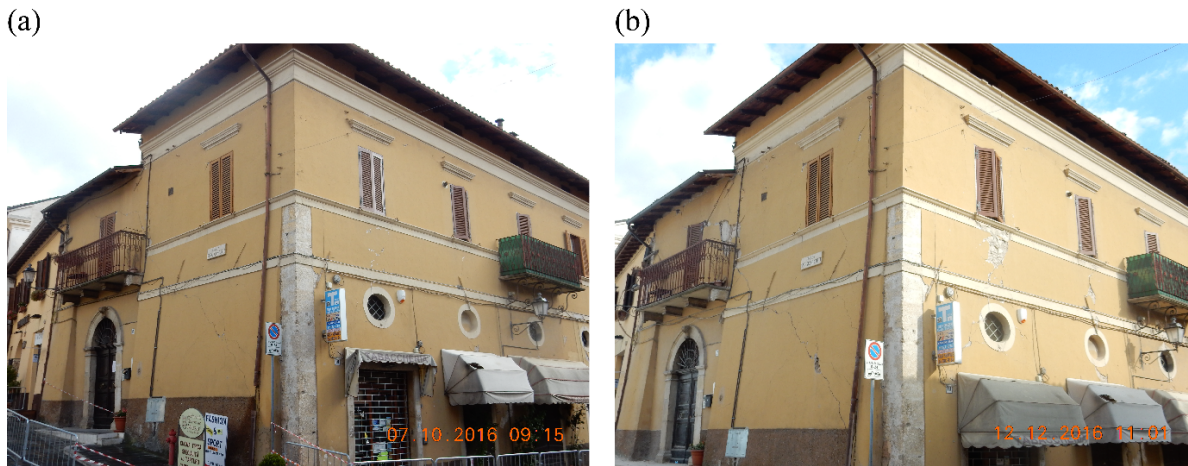
Figure 7. Masonry residential building (a) after the first earthquake and (c) after the entire sequence.

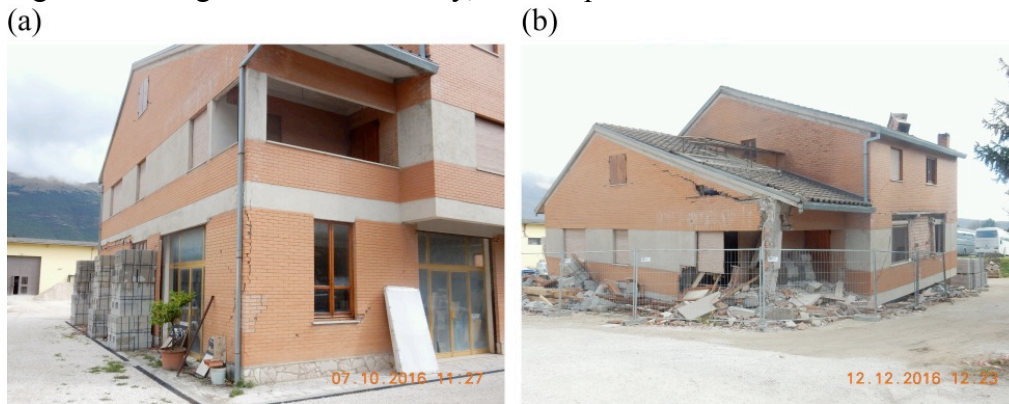
Reinforced concrete buildings, mainly suffered typical out-of-plane collapse of the infills, cracks in the beam-column joints and sporadic shear failures. Concrete spalling and buckling of longitudinal rebars was also observed. Even though the general trend was that damage in R/C buildings built up slower than in the case of masonry structures under multiple earthquake events, there were few cases where damage accumulation was abrupt. An example is the residential RC building in Norcia depicted in Figure 9 which only suffered shear failure in a single column after the first event, but experienced soft-story collapse during the third event. This was due to its high irregularity in both elevation and plan as well as its inadequate transverse reinforcement. Failure of such irregular buildings is common in Italy, as exemplified in the work of Verderame et al. [18].

Figure 9. Reinforced concrete residential building (a) after the first earthquake and (b) after the entire sequence.
