Experimental study of single-plate steel beam-to-girder connections

**REPORT NO.
UCB/SEMM-92/13**

**EXPERIMENTAL STUDY OF SINGLE-PLATE
STEEL BEAM-TO-GIRDER CONNECTIONS**

by
**ALISON L. SHAW
A. ASTANEH-ASL**

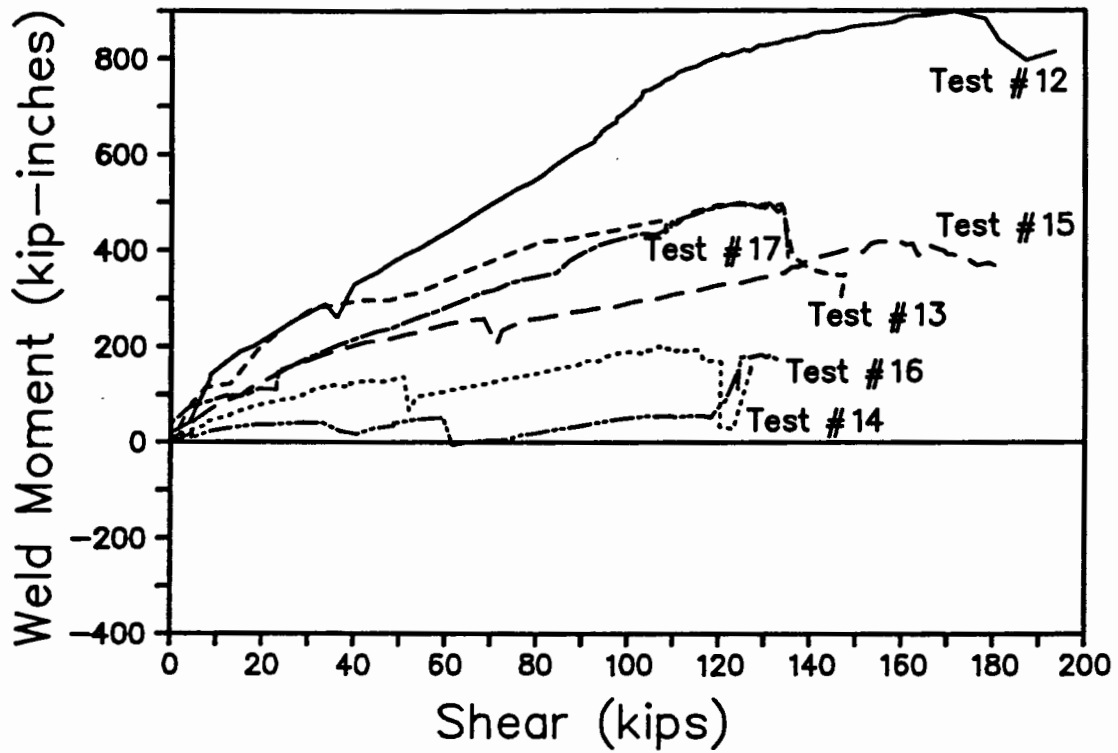
Summary - Weld Moment vs. Shear

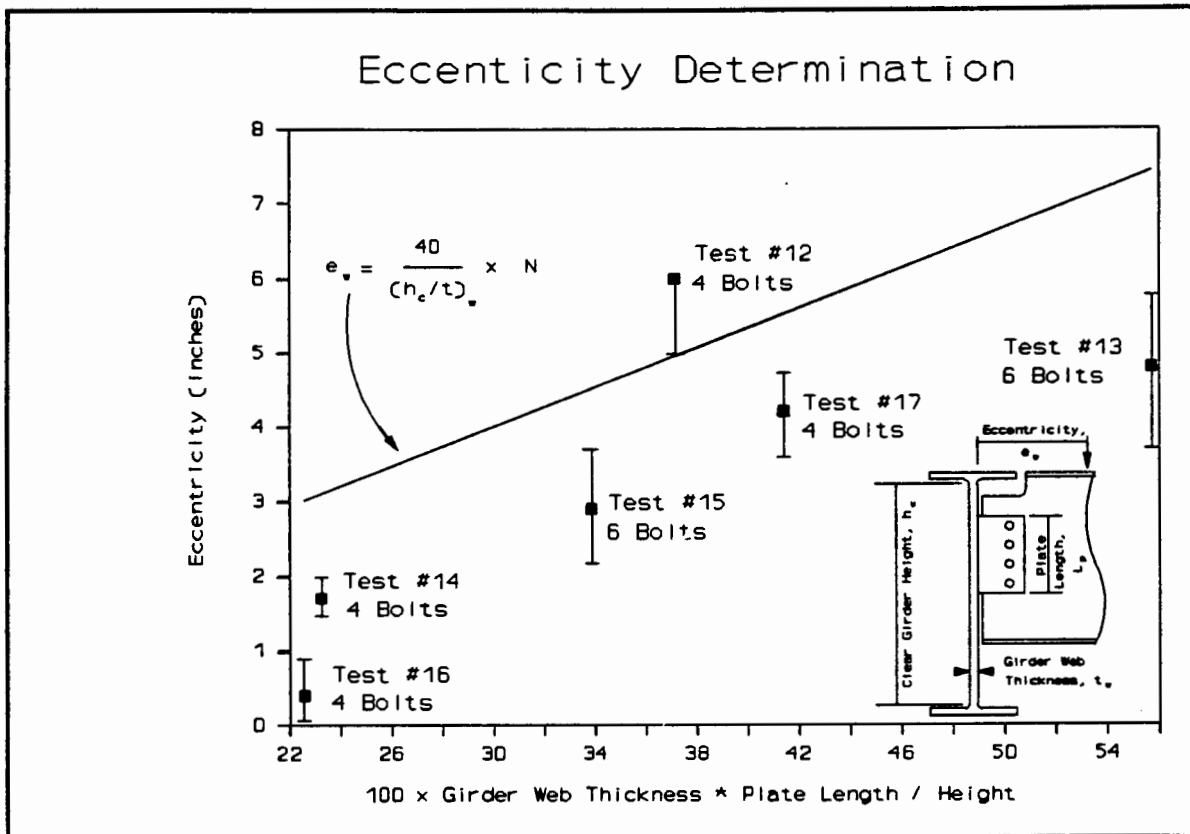
Figure 5.2 Eccentricity correlation

height and free span, and indirectly to girder web thickness and connection length. Several correlations were looked at with these four variables. It appeared that the most important variables in determining the eccentricity were shear plate length, girder web thickness, and girder clear web height. The test points, their uncertainties, and the chosen correlation are shown in Figure 5.2.

In all tests bolt spacing was chosen to be 3 inches. Plate length was then 3 times the number of bolts. Thus the two important variables in the correlation line are number of bolts and the AISC tabulated value $(h_c/t)_w$. Eccentricity can then be defined as:

$$e_w \approx \frac{40}{(h_c/t)_w} \times N \quad (\text{inches})$$
