CAN WILDLIFE VEHICLE COLLISION BE DECREASED BY INCREASING THE NUMBER OF WILDLIFE PASSAGES IN KOREA?

Abstract: The mitigation of fragmentation due to high density road network has been a hot topic among environmentalists and road construction engineers of South Korea. Over the last ten years 92 wildlife passages, 55 ecoducts and 37 wildlife underpasses, have been constructed on existing roads, and many more will be constructed in the future (Ministry of Environment of the Republic of Korea, 2006). We are at an early stage of data collection on wildlife vehicle collision and the role of traditionally non-wildlife-engineered passages, such as underpasses including bridges, culverts, and human underpasses, for wildlife passages.

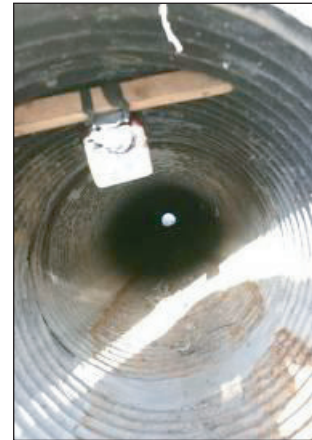
Figure 5. Installed camera in circular culvert

For the survey of underpass structures that could potentially be used as wildlife passage systems, circular culverts about 1m in diameter were monitored by installing infra-red-operated 35mm camera in the ceilings, 1~2m into the entrances. In the case of box culverts and passageway boxes, the cameras were installed in the walls or ceilings of their central sections, and where the ranges of the sensor and of the lens did not cover the entire passageway, two cameras were installed on each opposite wall. Cameras were installed in a total of 14 structures, and the types and characteristics of the structures in which cameras were installed are as shown in [table 1].

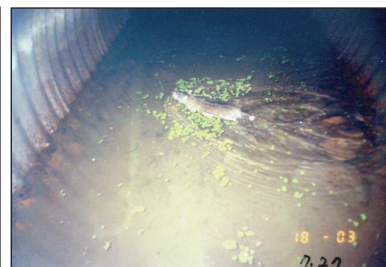
Figure 7. Inundated circular culvert.

The structures that served as circular culverts functioned as agricultural water channels between April and September, thus making animal movement physically impossible during those times. Therefore the counts between the usable number of crossing structures per month, and the number of roadkills occurring per month were compared to analyze the relationship between the seasonal fluctuations in the number of crossing structures and roadkill incidence.

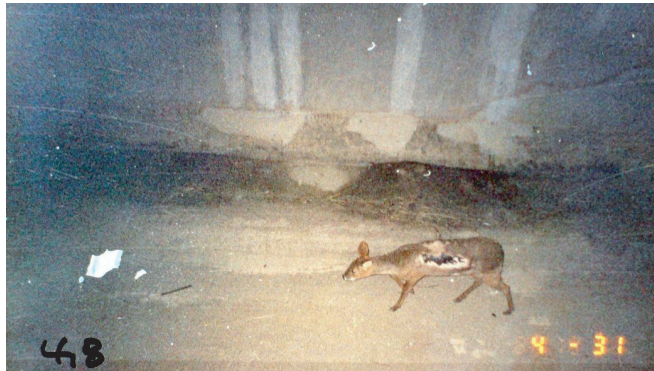
Figure 11. Water deer roadkill. Figure 12. Water deer in box passageway (Openness index 0.7).

Therefore given the unique conditions in Korea, if wildlife passages are created in agricultural region, water deer should be selected as a target species, and the optimal size for structures such that the deer will not be averse to using the passages must be considered. Additionally the home ranges and movement characteristics of water deer must be factored in when deciding upon optimal inter-structural distances. For species other than the water deer, wildlife fences that restrict access to roads and highways will be sufficient to guide wildlife to the existing passages, and that they will thereby have a huge positive impact in terms of reducing wildlife roadkills, without aggravating habitat fragmentation.

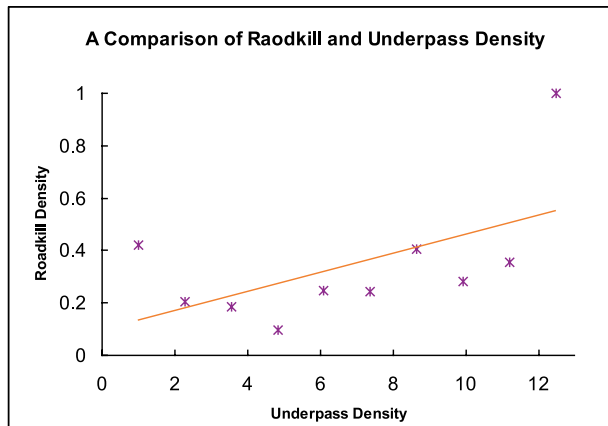
Figure 15. The more passages there were in an area, the higher the roadkill frequency, which differed from the general expectation that roadkill accidents would decrease in areas where crossing structures were concentrated ($r=0.559$, $p<0.093$). Refer to Fig. 16.

Furthermore, there appeared to be a very weak but positive correlation ($r=0.559$, $p<0.093$) such that the more passages there were in an area, the higher the roadkill frequency, which again differed from the general expectation that roadkill accidents would decrease in areas where crossing structures were concentrated (fig. 15, 16).
