## The Urban Gauntlet for Steelhead Trout: A Reconnaissance Study of Habitat in Upper Bollinger and Little Pine Creeks, Contra Costa County

UC Berkeley, Landscape Architecture 227: River Restoration

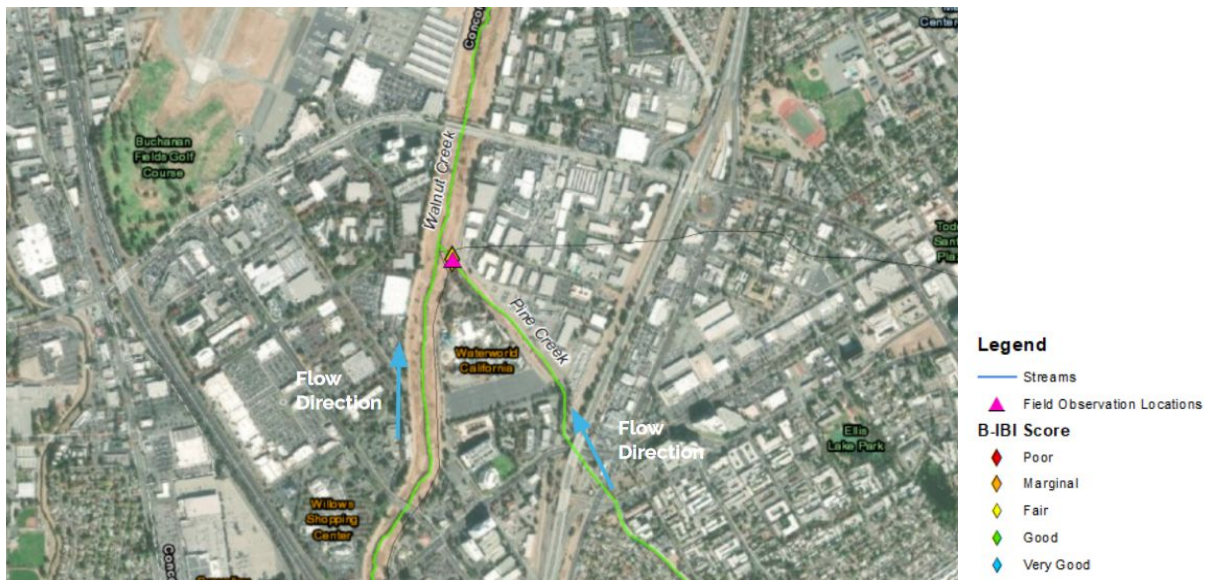
**Figure 8:** The confluence of Pine Creek with Walnut Creek.

Pine Creek, part of the Urban Gauntlet, had an engineered channel. Aerial observations and the 2020 Walnut Creek Watershed Opportunity Atlas' impervious cover data (Appendix C,

Map W-4. Current Watershed Conditions) indicated that this site is in a highly impervious drainage area with over 60% of surfaces being impervious. The Atlas' associated this level of impervious cover with urban drainage and poor water quality, consistent with the fair B-IBI score (Appendix D), shown in Figure 8 above.

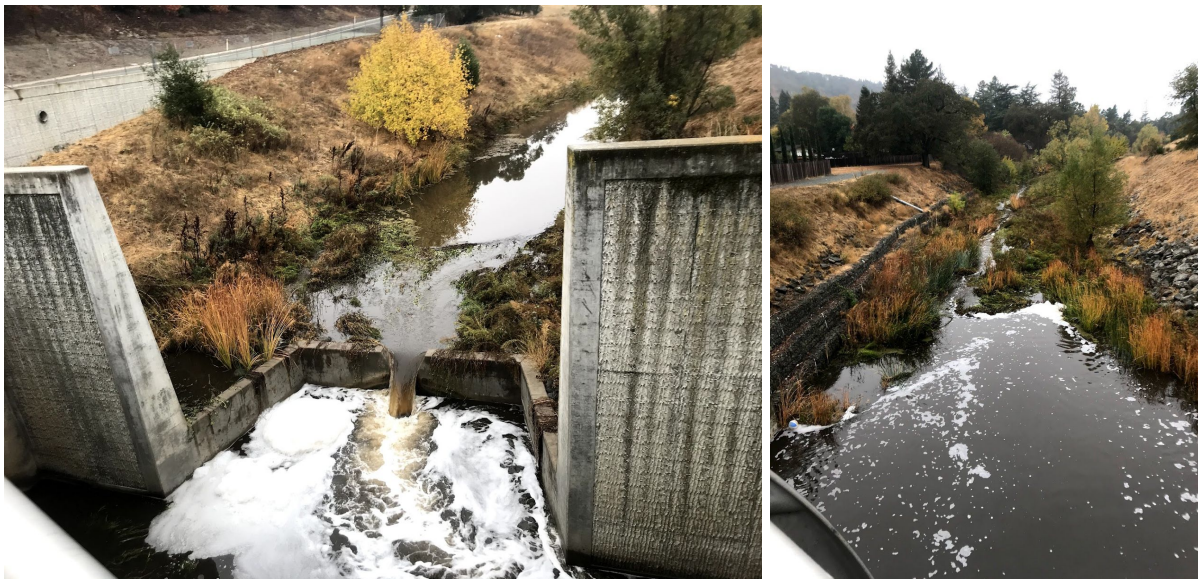
**Figure 9:** San Ramon Creek at Livorna Rd.  
(a) Left: Concrete drop structure. (b) Right: Downstream view.

San Ramon Creek was our second Urban Gauntlet observation site with “fair” B-IBI and “very likely altered” CSCI scores. Most notable was a drop structure and brown foamy water with moderate flow (Figure 9a). The engineered channel was earthen and trapezoidal in shape. Gabion structures and boulders lined the bank (Figure 9b). There was minimal canopy cover and channel access was blocked to further observe.

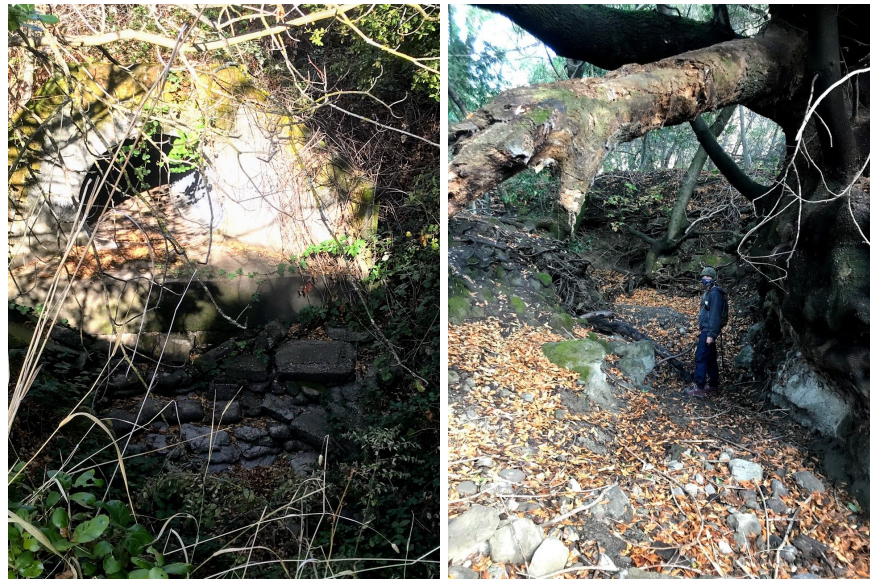
**Figure 11:** (a) Left: Facing upstream, corrugated metal pipe culvert pictured. (b) Right: Facing upstream.

A large culvert, 60-72-inch corrugated metal pipe, flowed underneath the parking lot entrance to the observation site (Figure 11a: outfall to channel bottom, approximately 10 feet (ft)). As seen in Figure 11b, downstream of the culvert, the channel was an earthen trapezoidal channel with a bottom width of approximately 8 ft, depth of approximately 13 ft, and steep

side-slopes. The channel appeared incised for approximately 100 ft, but downstream it became wider with overhanging banks for cover and space for step pools as the creek meandered around mature trees. Grain size decreased moving downstream of the culvert and spawning gravels were observed. Canopy cover remained at 90% along the channel.

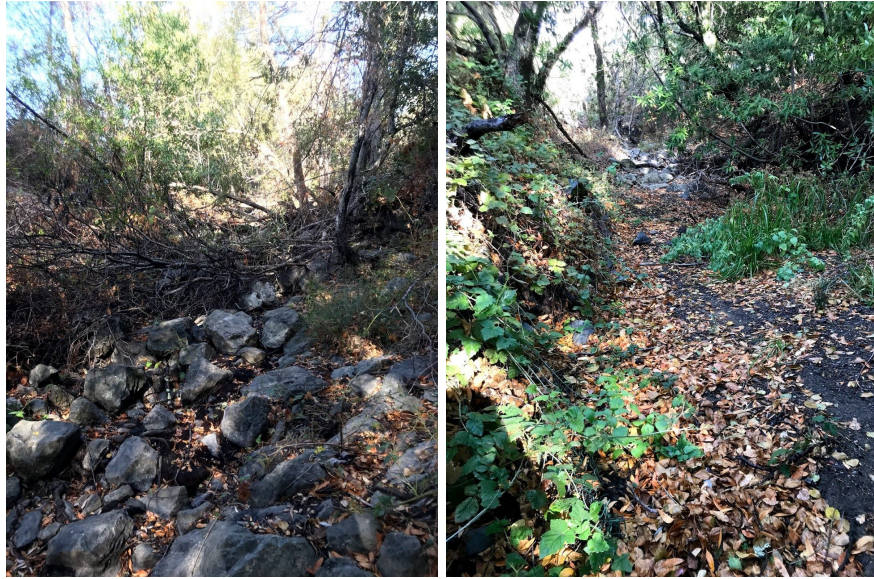
**Figure 12:** (a) Left: Facing upstream with step pools. (b) Right: Facing downstream.

The second Bollinger Creek observation was approximately 0.8 miles upstream of a B-IBI and a CSCI sampling location, scored at “very good” and “likely intact,” respectively. Clustered boulders formed space for step pools, large woody material added habitat cover, and spawning gravels were present (Figure 12). Canopy cover was approximately 80%. The bottom width of the trapezoidal earthen channel was 30 ft at its widest. Moving downstream, the channel started to narrow and bend.

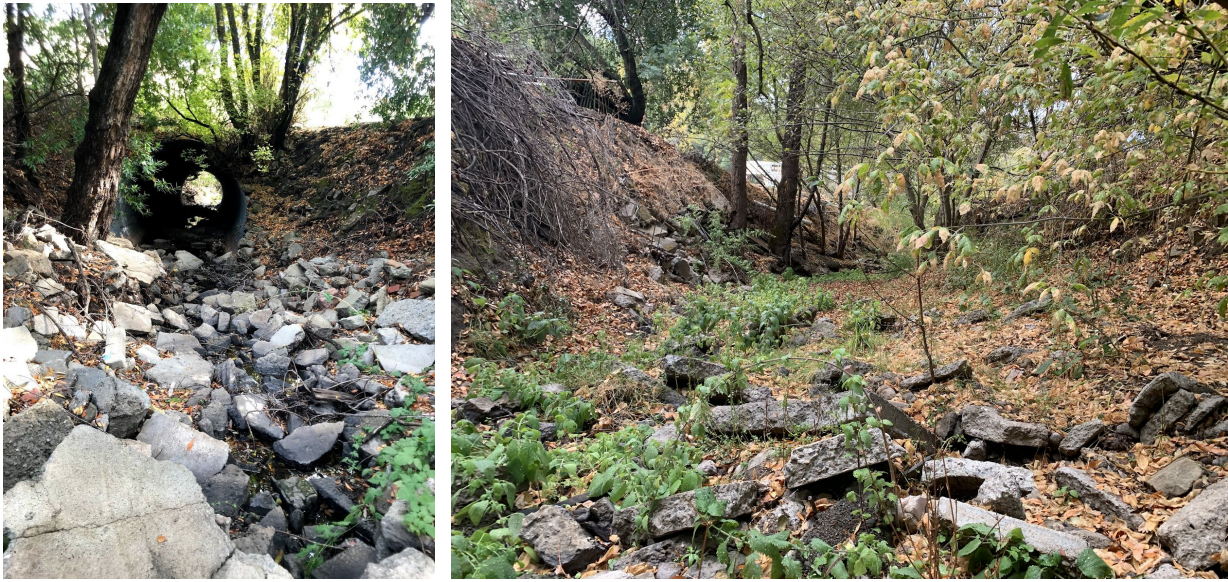
**Figure 13:** (a) Facing downstream, corrugated metal pipe culvert. (b) Facing upstream with riprap.

The furthest downstream location observed along Bollinger Creek cut between two private properties. This site had a “good” B-IBI score. The channel passed under Bollinger Canyon Road via a large, corrugated metal pipe approximately 120 inches in diameter (Figure 13a). The earthen trapezoidal channel had one bank significantly steeper and taller (10 ft) than the other. Channel bottom width was 15 ft and canopy cover was 60%. Habitat cover was high with ample large woody debris. Substrates consisted primarily of boulders and gravel suitable for spawning with some cobble, as seen in Figure 13. However, approximately 20% of the boulder sized rocks were riprap (Figure 13b).

Spawning habitat potential decreased downstream of Bollinger Canyon Creek, consistent with past B-IBI and CSCI Scores. The uppermost observed reach of Bollinger Canyon Creek had the greatest canopy cover, presence of large woody debris, overhanging banks, and gravel; all preferred steelhead spawning habitat attributes (CalFish 2020). Downstream at our second stop along the creek, there was also dense canopy cover (80%), large woody debris, and a mixture of boulders and gravel. Although steelhead trout would not spawn in areas with boulders, they could use those reaches as resting areas as the boulders created space for step pools. This reach had bank erosion at one location adjacent to a parking lot, likely caused by runoff from the impervious surface. The furthest downstream location observed along Bollinger Creek had the lowest amount of canopy cover (60%) and boulder-sized riprap throughout the channel. Thus,

although this part of the creek had high canopy cover, large riprap is not an ideal bed material as it can alter flow velocity. Downstream of the Bollinger Canyon Creek confluence with San Ramon Creek, the habitat quality degraded further. At Livorna Road, a drop structure was flagged as a potential migration barrier. Furthermore, brown foamy water suggested poor water quality, which was consistent with a CSCI score of “very likely altered” and a B-IBI of 24 or “fair.” Therefore, although there may be potential spawning habitat for steelhead trout in the uppermost reaches of Bollinger Canyon Creek, the drop structures and degraded water quality in San Ramon Creek, an Urban Gauntlet reach, may prohibit them from arriving at those sites.

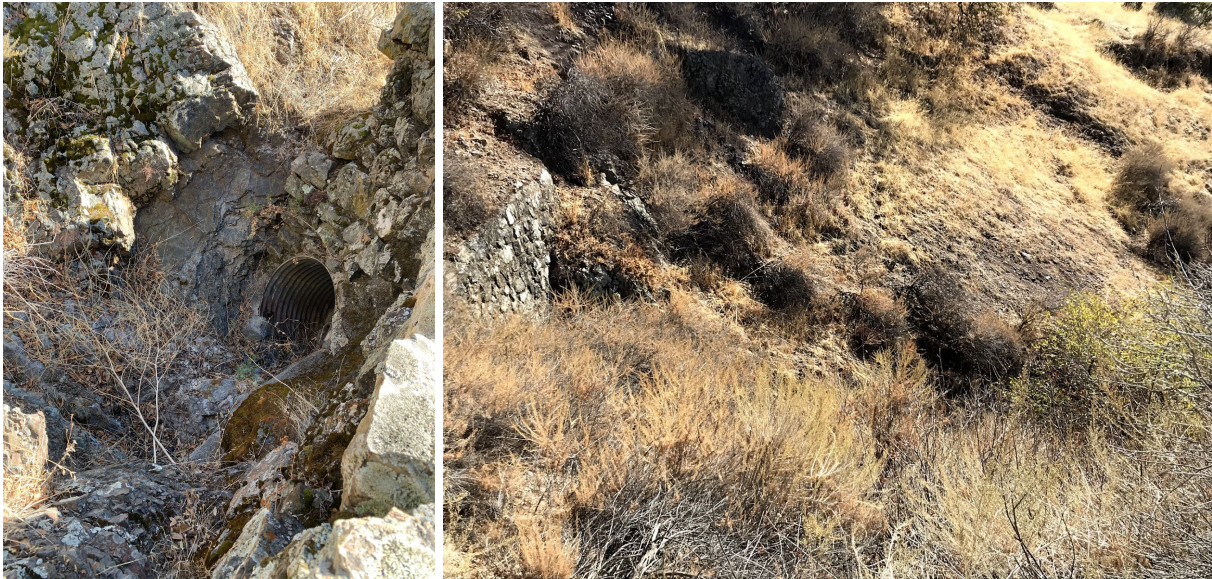
**Figure 15:** (a) Left: Upstream culvert with pipe (b) Right: Downstream of North Gate Road culvert.

The creek was a v-shaped channel with steep side-slopes primarily composed of bedrock. A reinforced concrete pipe culvert crossed under the road before traveling down a steep hillside (Figures 15a, 15b). The bottom width and top width measured 3 ft and 30 ft respectively and the steep side-slopes carried the channel depth to approximately 30 ft. There was little observed habitat cover, no spawning gravels, and minimal canopy cover of about 10%.

Little Pine Creek had different habitat characteristics than Bollinger Canyon Creek. At the most upstream observed reach, the bedrock v-shaped channel had no gravel and minimal canopy cover, suggesting inadequate spawning habitat conditions. Conversely, the second observation location downstream had 70% canopy cover and had a gravel-dominated bed. These improved habitat conditions were consistent with the “very good” B-IBI score. Although these conditions aligned with steelhead trout habitat preferences, there were two small drop structures observed, which could hinder them from reaching further upstream. The third reach along Little Pine Creek reverted to similar conditions as the uppermost reach, which 10% canopy cover but had primarily fine-grained bed material. Thus, this location was not an optimal spawning habitat, but could serve as a passageway to swim to the better habitat upstream. Lower in the Pine Creek subwatershed, satellite images revealed Pine Creek as a rectangular concrete channel, in addition to the myriad of drop structures, thus would not be an optimal spawning habitat for steelhead trout. Therefore, efforts would need to be made to allow steelhead trout to reach the second observation location along Little Pine Creek.

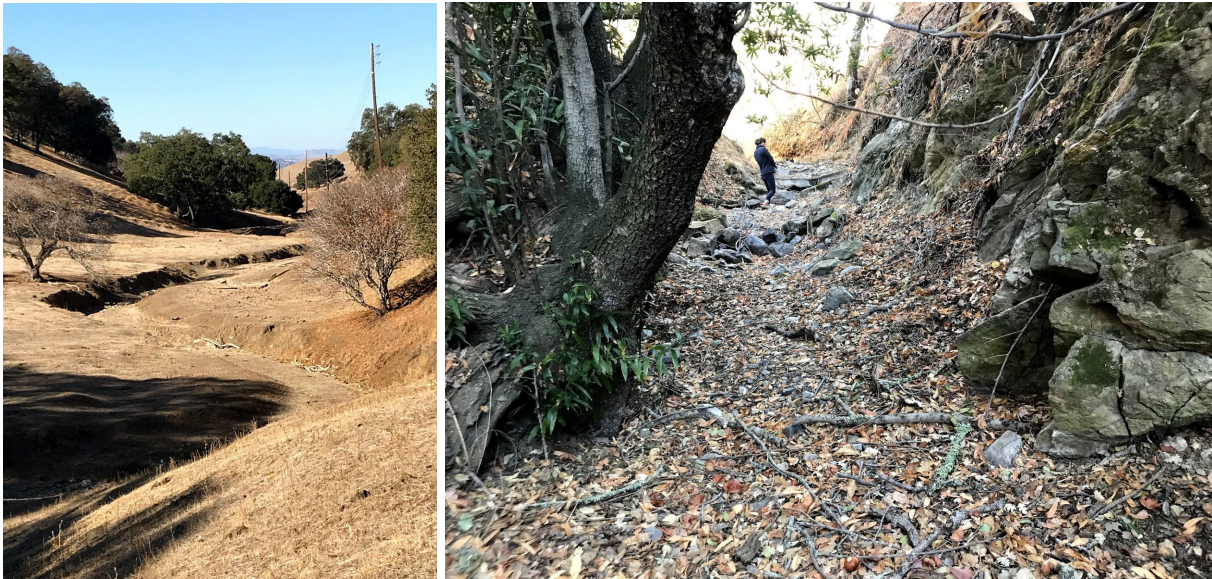
**Figure 16:** (a) Left: Downstream segment with sparse vegetation  
(b) Right: Drop structures

This segment started as a narrow, grassy, earthen channel. In contrast, just around a bend the earthen trapezoidal channel transitioned for approximately 400 ft to conditions containing spawning gravels, 70% canopy cover and habitat cover. Substrates were estimated at 20% Boulders, 30% Cobbles, 40% Gravels, and 10% Fines. However, two small drop structures (3ft high) were in this section, shown in Figure 16b. Downstream, the channel returned to a narrow grassy channel and was intersected by a cattle grazing fence (Figure 16a). The B-IBI score at this site was “very good.”

3. Invite fish passage experts in the field to assess whether steelhead trout can safely migrate up tributaries across drop structures on Little Pine and through observed culverts and long stretches without canopy cover. If not, ask the experts for recommendations on how to modify structures to permit fish passage.

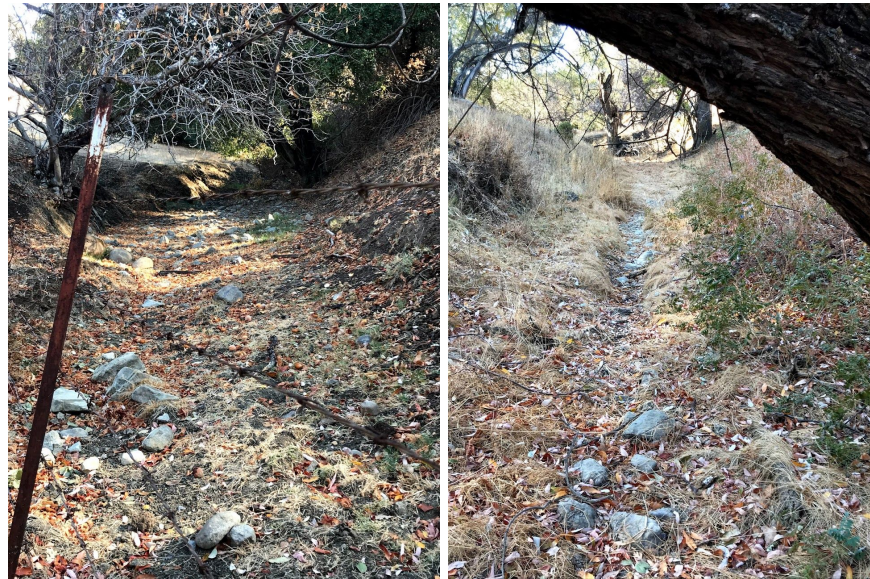
**Figure 17:** (a) Left: Facing upstream. Earthen trapezoidal shape. Bound by fence.  
(b) Right: Facing downstream. Channel becomes narrow and shallow.

This segment was a trapezoidal earthen channel noticeably shallower than previous Little Pine segments (Figure 17b). There was little habitat cover observed. Canopy cover was approximately 10% and ground cover was high consisting primarily of wild licorice. There was minimal substrate variety; scattered boulders and cobbles, but clay and fines dominated the channel. Notably, the area neighboring the site smelled of manure and a barbed wire fence ran adjacent and across the channel to contain grazing cattle (Figure 17a).

reduce costs. In discussing our observations with Jen Natali, Natali pointed out that the cattle grazing in the Little Pine Creek drainage area could contribute to sedimentation in the creek. Additionally, cattle grazing has the potential to reduce ground cover and soil roots, consequently altering flows. Therefore, research and preservation efforts may be more feasible for Little Pine Creek compared to Bollinger Canyon Creek, but the extent of cattle grazing should be further assessed.

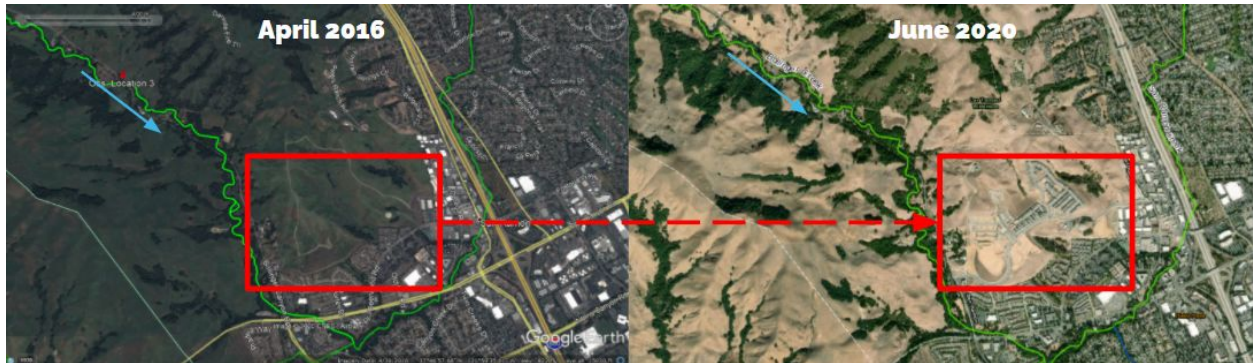
**Figure 18:** April 2016 near Bollinger Canyon Creek observation location 3, pre-development left, post development right. Approximately 135 acres.

Figure 18 below respectively show pre and post-development aerial images of the downstream Bollinger Creek section.

The 2020 Walnut Creek Watershed Opportunities report estimated that up to 70% of Walnut Creek's watershed remains unprotected from development. Relevant to our study, land use change near Bollinger Canyon Creek could be of concern, as seen by the new housing development at the bottom of the canyon adjacent to the creek and two newly constructed parking lots located at the top Bollinger Canyon Road. Such land use, development, and hydromodification contributes to erosion and sedimentation on spawning gravels, especially in sections of the creek lacking flow velocity high enough to remove excess sediment.

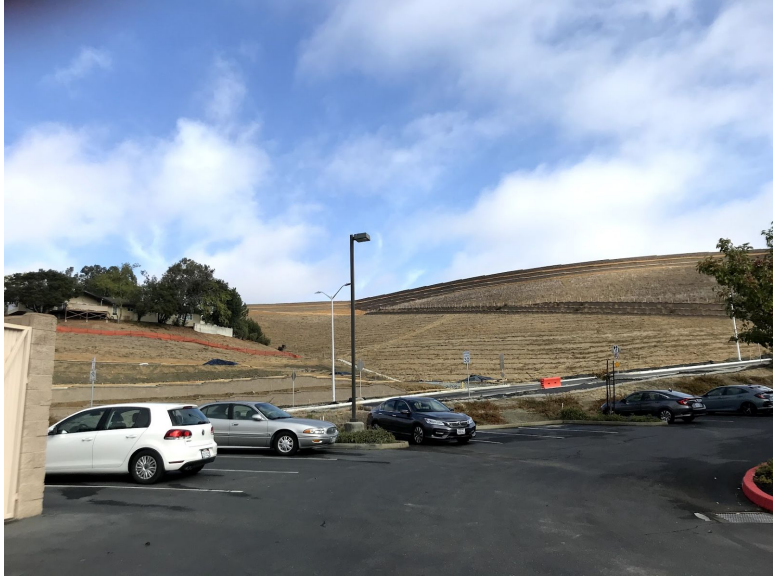
D. The bottom of Bollinger canyon hosts a new housing development adjacent to the creek.

<p>Land prepped for new housing development at the bottom of Bollinger Canyon Creek.</p>

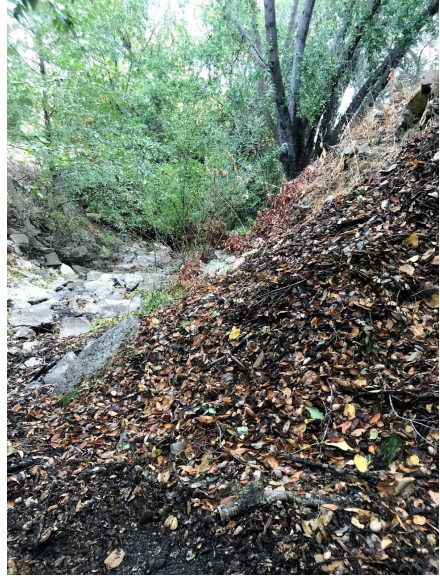
Leaf pile from adjacent property in Bollinger Canyon Creek, stop 2.

The observed trash, loose soil, and leaf litter deposited by residents along the creek could also degrade spawning habitat by introducing chemical pollutants, smothering eggs, and decreasing dissolved oxygen (United States Environmental Protection Agency 2020; Reiser and White 2011; Duan et al. 2014). It is worth monitoring these impacts to ensure Bollinger Canyon creek remains a potential steelhead trout spawning tributary.

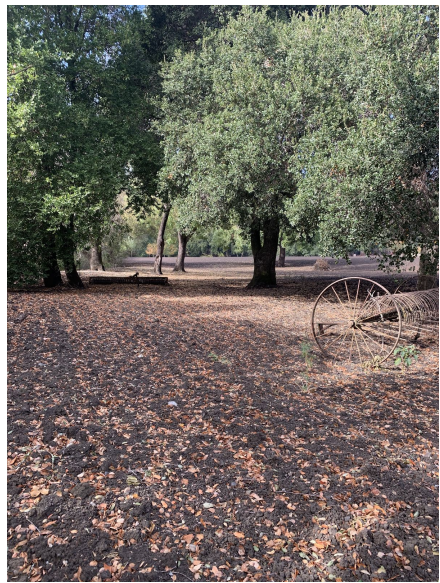
Tilled land created loose dirt right up to creek bank edge, Bollinger Canyon Creek, stop 3.
