A Study of Hydrogen Embrittlement in Lath Martensitic Steels

A STUDY OF HYDROGEN EMBRITTLEMENT IN LATH  
MARTENSITIC STEELS

Y.-H. Kim  
(Ph.D. Thesis)

June 1985

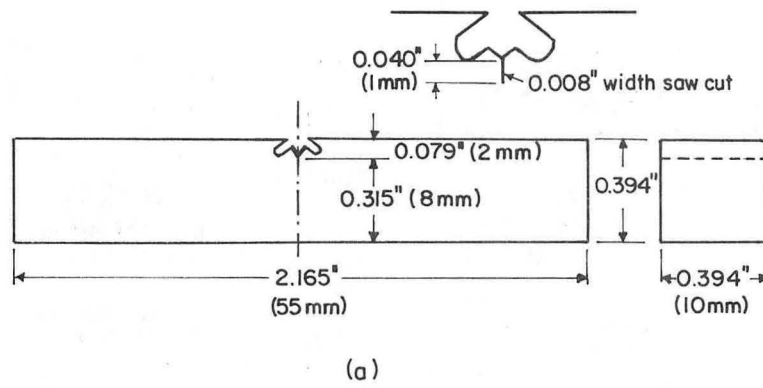
Fig. 3

Standard size Charpy specimens were modified to use in the three point bending test (Fig.3). Specimens were machined after heat treatment, fatigue precracked, and subjected to hydrogen charging. The notches were made perpendicular to the rolling direction of the plate. The crack tip area was protected with teflon tape, while the back side of the crack tip was exposed to the electrolyte for hydrogen absorption. The 1334 kN (300kips) MTS universal testing machine was used for this test.

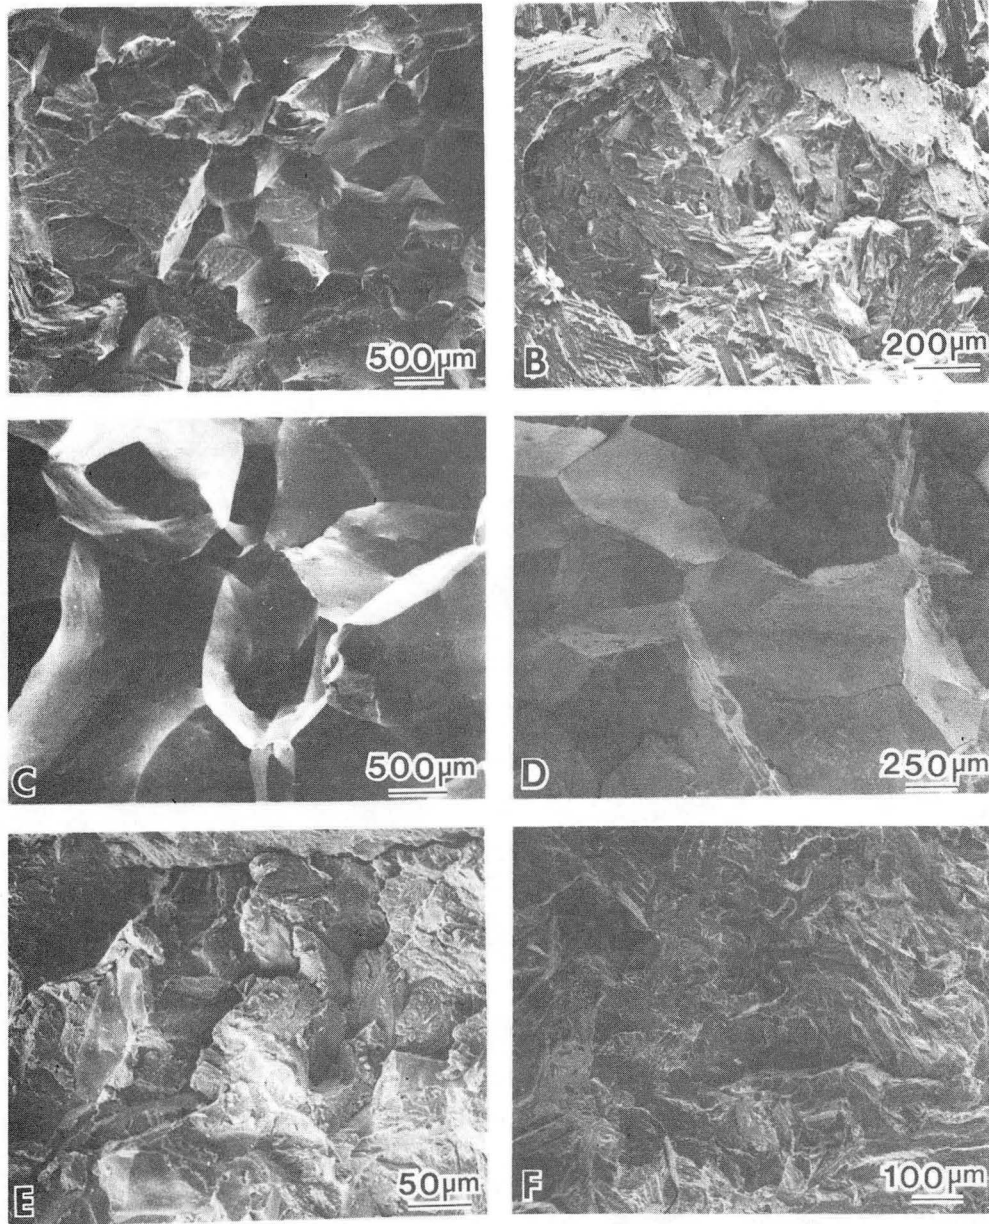
Fig. 5

The 5.5 Ni steel that had been homogenized at 1250°C fractured in an intergranular mode when broken after hydrogen charging (Fig. 5A). The same alloy fractured in a ductile mode when broken at room temperature before hydrogen charging. Intergranular cracking was not observed when the specimens were broken at liquid nitrogen temperature (Fig. 5B). As homogenizing temperature decreased, the portion of intergranular fracture decreased. The specimens homogenized below 1200°C and quenched to room temperature fractured in a mixed transgranular and dimple rupture mode even though hydrogen was charged.

Uncharged specimens were broken in a totally ductile manner at room temperature and in a quasicleavage mode at liquid nitrogen temperature (Fig. 5B). The charged specimen fractured at room temperature showed a mixture of intergranular and transgranular mode (Fig. 5A). The intergranular portion was about 70%.

Charged specimens fractured in a intergranular mode (Fig. 5C). The fracture surface was very smooth and there was no indication that some particles precipitated on the grain boundaries.

The specimens broken after hydrogen charging showed intergranular cracking (Fig. 5D). The intergranular facet size of this specimen was same as that found in Case 1 or 2. A careful examination of the fracture surfaces showed small microvoids on the grain boundaries.

Intergranular cracking was found in the charged specimen (Fig. 5E). Grain boundaries revealed by hydrogen were same size as those formed at 1250°C, but the intergranular facets were very small compared with Case 2. It is believed that these grain boundaries were formed during a heat treatment at 1000°C.

Charged specimen fractured in a mixture of transgranular and dimple rupture mode (Fig. 5F). No intergranular cracking was observed.

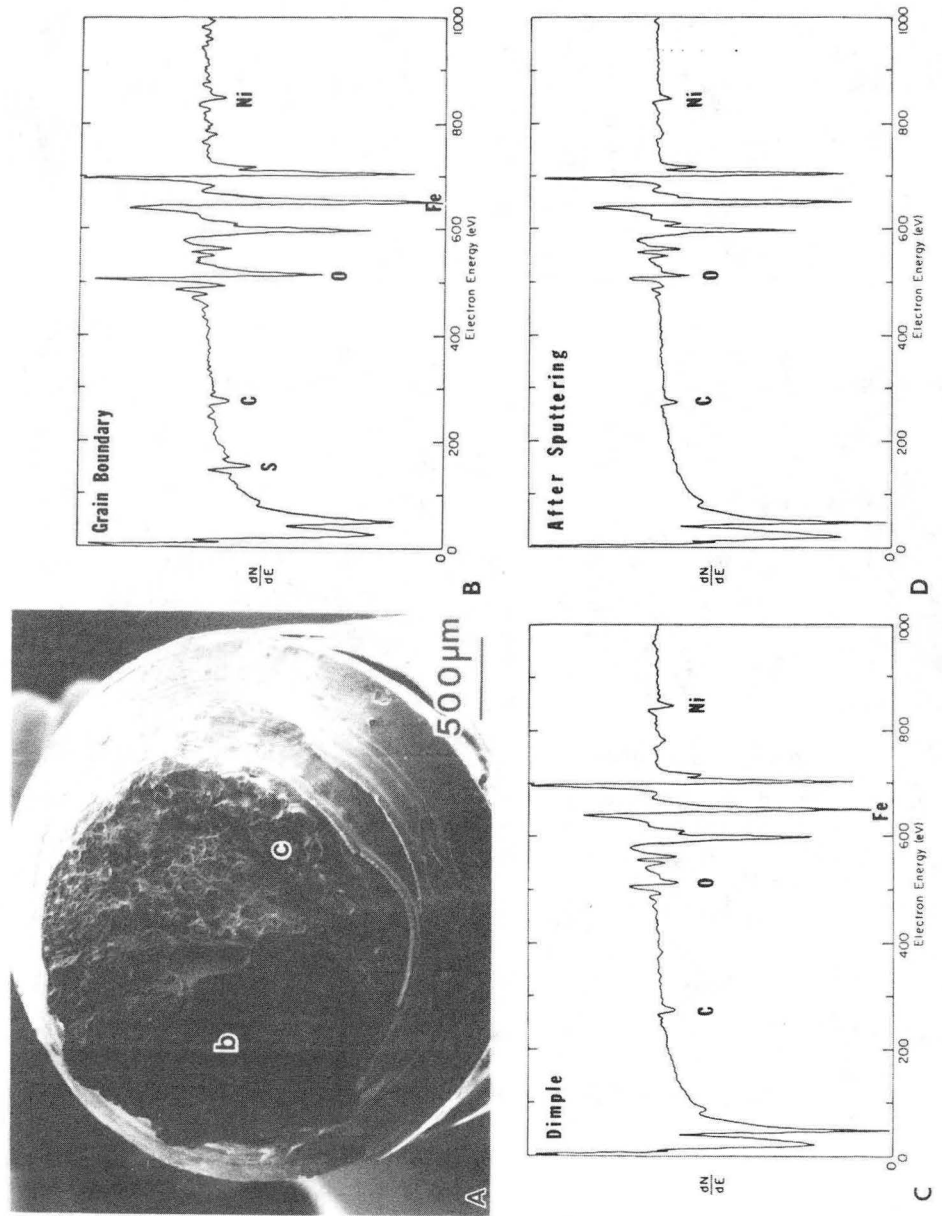
Fig. 6

As shown in Fig. 6, a sulfur peak was observed in the grain boundary. Carbon and oxygen were also detected on the whole fracture surface; however, their presence was attributed to adsorption from the environment. In order to reduce hydrogen outgassing from the Auger samples, the sample was loaded and fractured at the vacuum of about  $10^{-6}$  torr; therefore oxygen and carbon adsorption rates were sufficiently high to account for the observed coverages. It was also noticed that the vacuum suddenly dropped when specimen was loaded, which indicated that hydrogen diffused out easily from the stressed specimen.

Phosphorus and other impurities were not observed. After  $\text{Ar}^+$  ion sputtering on the prior austenite grain boundary, the sulfur peak disappeared from Auger spectrum (Fig. 6A and D).

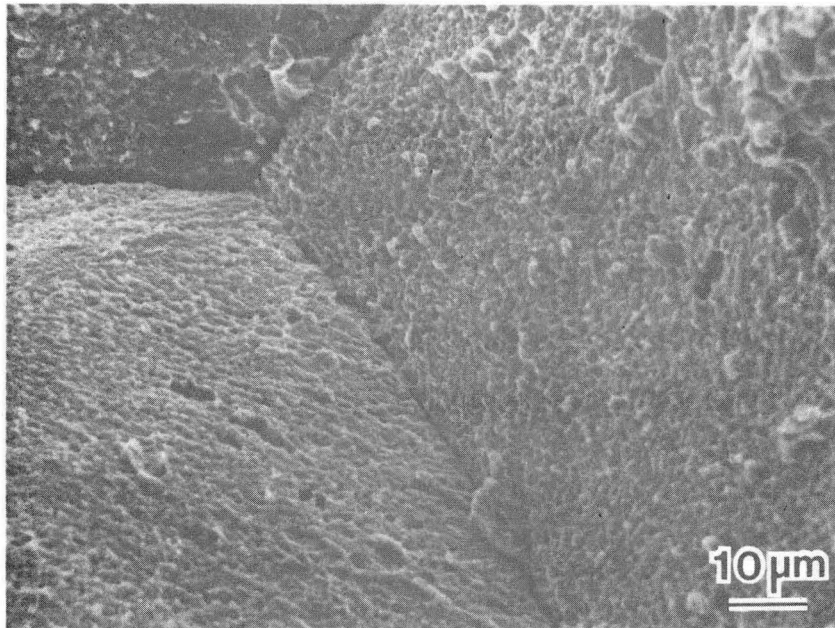
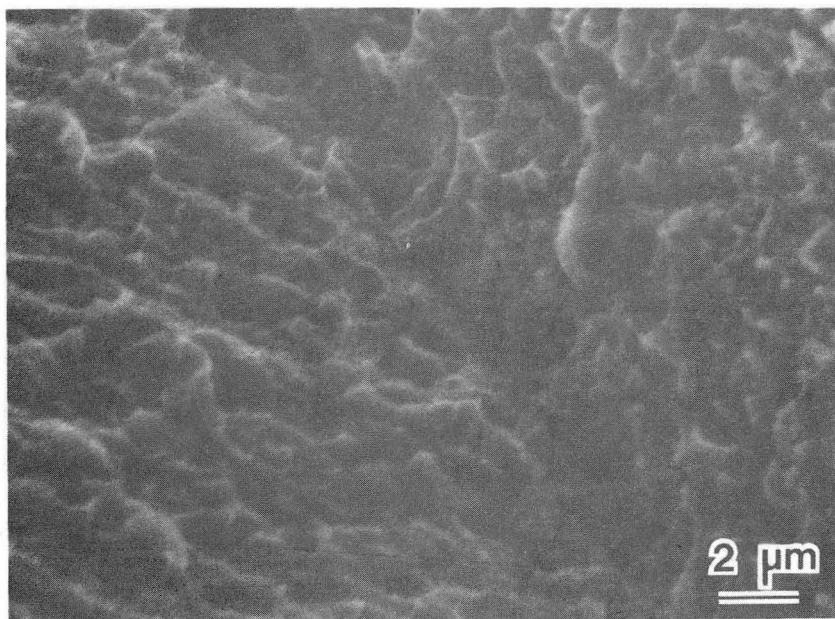
Fig. 9

The ALT specimen was hydrogen charged and fractured using a three point bending fixture at room temperature. The fractography of this specimen is shown in Fig. 9. The specimen showed intergranular cracking (Fig. 9A), but the fracture surfaces of this specimen were not so smooth as those in the homogenized specimen (Fig. 9B).

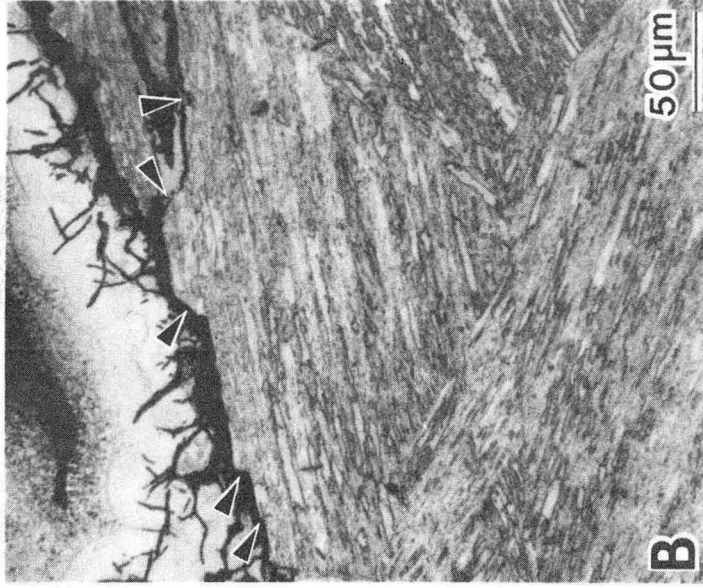
Fig. 28

- Fig. 28. Optical micrograph of the cross section of the fracture surface in the untempered 5.5Ni steel specimen embrittled by hydrogen. The fracture surface was protected by iron plating. (A) Low magnification picture showing profile surface. (B) High magnification view of the fracture surface showing in (A).

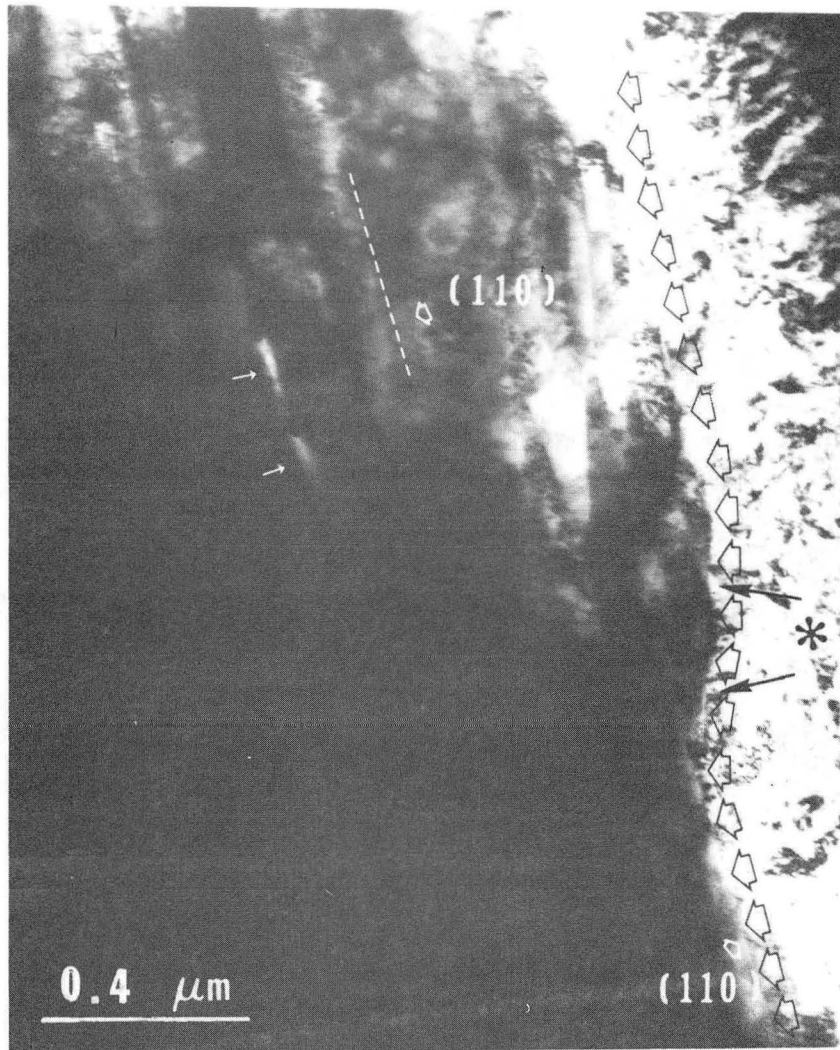
Fig. 34

- Fig. 34. Transmission electron fractograph showing the fracture surface (open arrows), apparent translath steps in the fracture surface (\*), and subsurface interlath microcracks (small arrows) (QT-treated 5.5Ni steel).

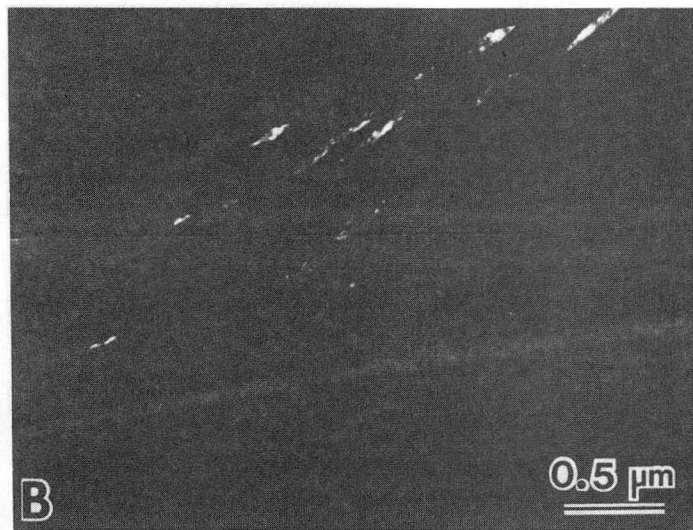
Fig. 47

- Fig. 47. Transmission electron micrographs showing precipitated austenite in QLT treated 5.5 Ni steel. Diffraction pattern shows the N-W relationship between austenite and martensite.

- $[\bar{1}00]$  martensite
- $[\bar{1}\bar{1}0]$  austenite

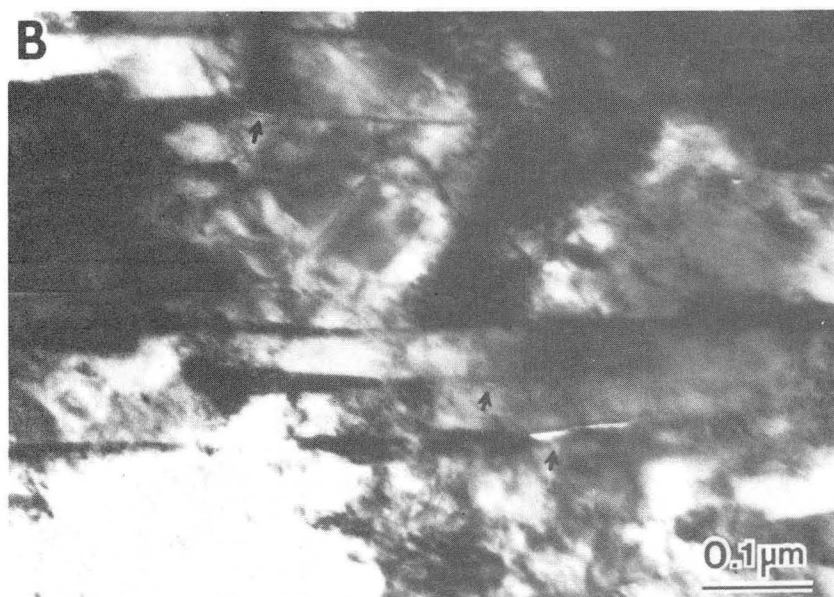
Fig. 50

- Fig. 50. Transmission electron fractographs of a hydrogen-charged 5.5 Ni QLT specimen. The fracture surface is marked by the open triangles in micrograph (A). The solid arrows point to interlath microcracks just beneath the fracture surface. Micrograph (B) is a high magnification of the region designated (B) in micrograph (A). The arrows point to interlath microcracks, which tend to lie at the periphery of fresh martensite islands, as evidenced by the cracks at the upper and lower arrows.

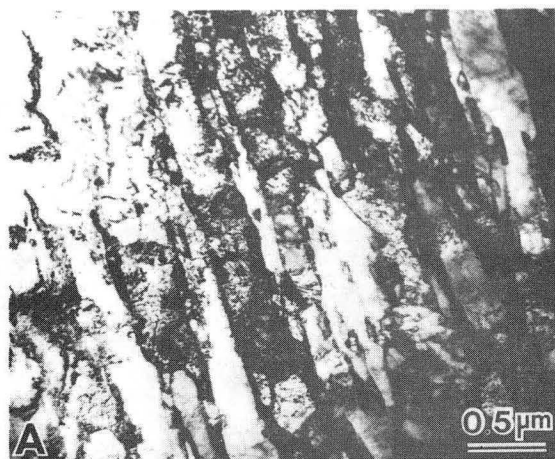
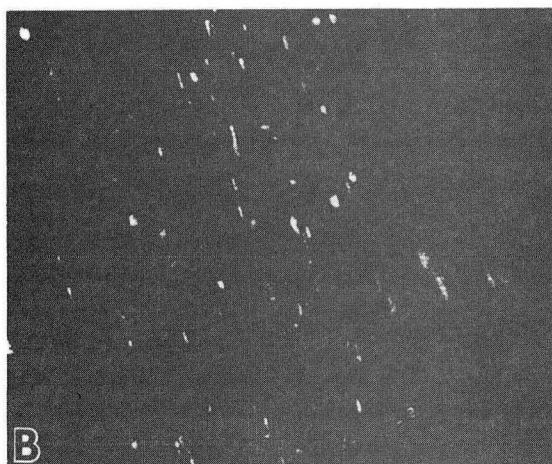
Fig. 56

- Fig. 55. Optical micrographs of a plane perpendicular to the quasicleavage fracture surface in an untempered 5.5Ni steel broken at 77 K.
- Fig. 56. Transmission electron micrograph showing the substructure below the ductile fracture surface in an as-received 5.5 Ni steel specimen. (A) bright field image (B) dark field image of the precipitated austenite which still remained (C) dark field image of mechanically transformed martensite.

- $[111]$  martensite
- $[\bar{1}00]$  martensite
- $[\bar{1}\bar{1}0]$  austenite
