Yuba River analysis aims to aid spring-run chinook salmon habitat rehabilitation

California Agriculture, 64(2)

by Gregory Pasternack, Aaron A. Fulton and Scott L. Morford

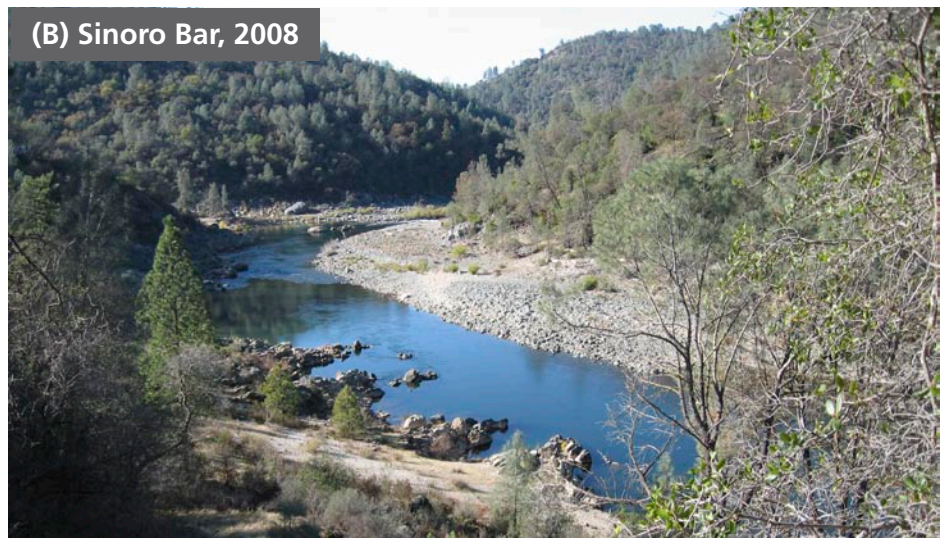
Fig. 3. (A) The 1909 image shows a sequence of mesohabitats. The upper riffle is located at the bedrock high point near the apex of the point bar, and the other riffle is adjacent to the mouth of Deer Creek. The bedrock high point does not appear to resemble any feature typical of alluvial meanders with tributary junctions, and instead appears to be related to the characteristics of the bedrock. The 1909 photo shows relatively little lateral and longitudinal elevation change in the channel — the entire area looks relatively flat. **(B)** The structure of physical habitat is different in 2008, with the upper riffle degraded to a chute composed of exposed bedrock and boulders with almost no gravel. The water looks slower and deeper upstream of the upper riffle. The surface of the point bar is still relatively flat, but the cross-channel relief is much greater, suggesting that the bar is less connected with the channel than in the past and that incision (a drop in elevation) of the riverbed due to erosion has occurred. Also, some vegetation is established on the point bar.

Earliest images. A direct comparison of the 1909 and 2008 ground-based photos of Sinoro Bar shows dramatic change (fig. 3). The Smartville gage discharge record shows that water rose on Jan. 2, 1909, peaked on Jan. 15 at about 111,000 cfs (3,143.1 m³/s), and did not drop below 4,000 cfs (113.3 m³/s) until June 27. Gilbert's photo (fig. 3A) appears to have been taken after flows receded. It shows a large point bar on river right composed of well-rounded gravel, cobble and sand likely from hydraulic mining.

The bright surface of the bar and lack of shrubs suggest that the surface sediment was freshly deposited, consistent with 1909 being a flood year. Also, there is a large amount of hydraulic mining debris in the mouth of Deer Creek in the photo. In contrast, the 2008 photo (fig. 3B), coupled with direct visual observations, reveals angular boulders and cobbles overlying a mixture of sand, gravel and cobble. The downstream riffle is composed of boulders and cobble and it has steepened into a rapid with standing waves
