Study of Impact Damage in PVA-ECC Beam under Low-Velocity Impact Loading Using Piezoceramic Transducers and PVDF Thin-Film Transducers

Sensors, 18(2)

2018

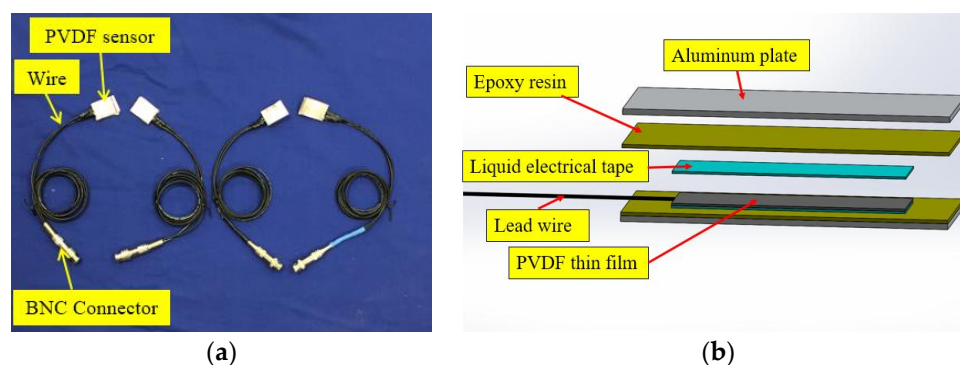
**Figure 1.** Embedded polyvinylidene fluoride (PVDF) thin-film sensor: (a) photo and (b) internal structure.

In this research, embeddable PVDF thin-film sensors were designed to detect the impact events, as shown in Figure 1. The PVDF thin-film sensors used in this experiment consists of two thickness of 2-mm aluminum plate and the middle PVDF film thickness is 0.05 mm. The PVDF thin-film sensor was connected by lead wires and isolated by liquid electrical tape. Subsequently, two aluminum plates house the sensor, and the entire module is stabilized with epoxy resin. The aluminum housing protects the PVDF thin-film from physical and chemical damage, as well as load imbalance when embedded within concrete structure. The detailed mechanical and material properties of PVDF and PZT transducers used in this research is given in Table 1.

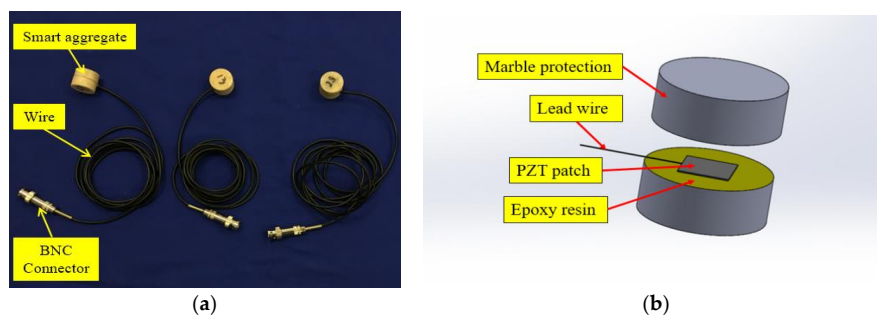
**Figure 2.** Smart aggregate (a) photo and (b) internal structure.

To evaluate the severity of damage of a concrete beam under discrete repeated impacts, the smart aggregate-based active sensing approach was employed in this research. Smart aggregate (SA) was designed by sandwiching a waterproofed PZT patch with two marble pieces, as shown in Figure 2. The Piezoelectric SA in this experiment is composed of two pieces of granite with 12 mm thickness, and a PZT sheet with a thickness of 0.3 mm in the middle of the smart aggregate. The cylindrical shaped smart aggregate has a radius of 25 mm and a height of 25 mm. In the active sensing approach, one SA was used as an actuator to generate guided waves, while the other SA was used as a sensor to detect the propagated wave response. When impact-induced cracks develop in concrete, the cracks function as stress relief which attenuates the wave propagation energy. The attenuation increases with the degree of failure, therefore the energy received by the SA sensor is an effective indicator to determine the degree of impact-induced cracks in concrete beams.

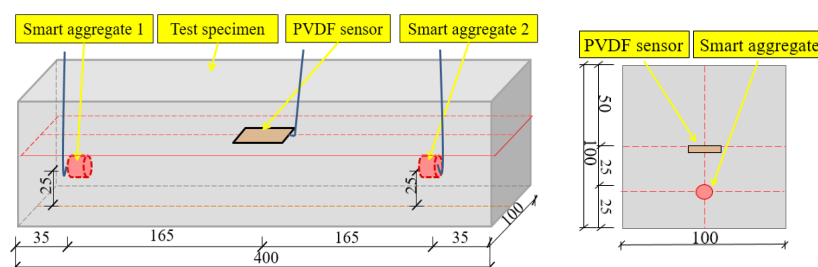
**Figure 3.** Detailed sensor location (unit: mm).

To investigate the impact loading behavior of PVA-ECC and mortar beams, a total of three PVA-ECC and three mortar beams were fabricated in the laboratory. The beams measured  $400 \times 100 \times 100$  mm, and the compositions of the beams are shown in Table 2. The detailed properties of PVA fibers are shown in Table 3. Within each beam, one PVDF thin-film sensor and two smart aggregates were positioned at predetermined locations with wooden sticks within the beam molds before casting, as shown in Figures 3 and 4. A PDVDF thin-film sensor was used for impact monitoring, and the PVDF film sensor was embedded in the location that is 1/2 thickness away from the surface of the beam to prevent the impact damage to the PVDF thin-film sensor. The crack of PVA-ECC beams is produced in the region of the maximum bending deformation under low-velocity impact loadings, and this region is near the center of the beam. To detect the crack of the PVA-ECC beams, a pair of SAs was embedded in the locations on both sides of the beams, so that to ensure the impact induced cracks occur between the SA pair. To minimize the effect of the sensor wires on the mechanical properties of the specimens, all the wires were placed in straight and come out from the top surface of the specimens. A mechanical vibrator was used during casting for concrete compaction, and the beams were subsequently cured for twenty-eight days.

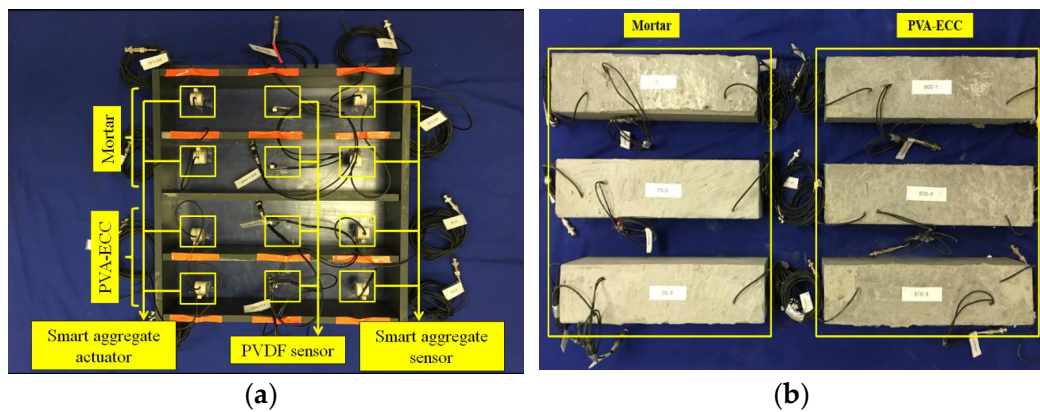
**Figure 4.** Specimen preparation. (a) molds with pre-installed PVDF sensors and smart aggregates (b) casted PVA-ECC and mortar beams.

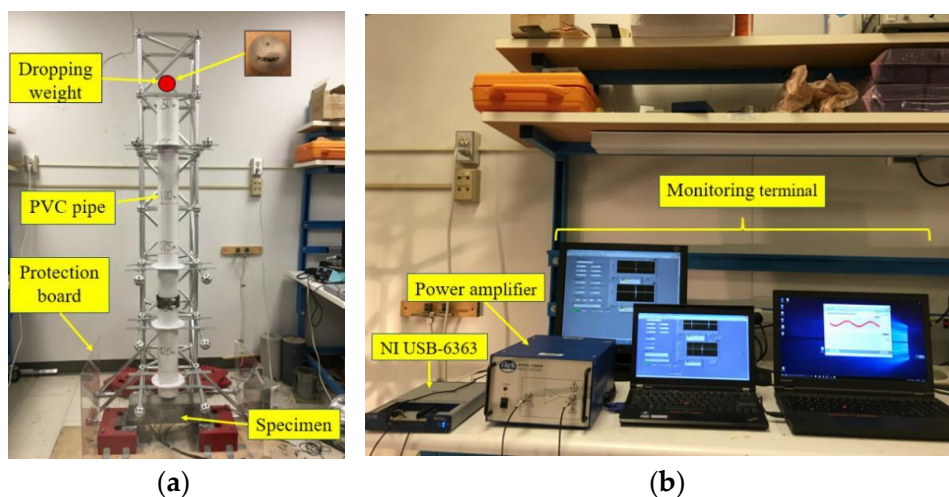
**Figure 5.** Low-velocity impact test setup (a) test setup; (b) data acquisition system.

The low-velocity impact test setup is shown in Figure 5. An aluminum frame was used to position PVC pipes which guided a dropping weight to impact on a desired location of the beam. The inner diameter of the pipe measured 10 cm, and three drop heights were used (0.5, 1, and 1.5 m). Two lead ball drop weights (2.724 kg and 8.172 kg) were used. The position of the impact was at the center of the beam. The test beam was fixed onto four L-shaped fixtures which prevented horizontal movement of the beam. The data acquisition system included an NI-6363 data acquisition board, a power amplifier, and corresponding monitoring terminals. During each impact test, the signal received by the PVDF sensor was first recorded, then, active sensing with the two smart aggregates was performed. The original propagated signal was a swept sine wave, with parameters provided in Table 4. The signal was amplified 50× by a power amplifier and propagated by the SA actuator. The data acquisition system subsequently recorded the propagated signal response from the SA sensor. The sampling rates of the data acquisition system for the PVDF sensor and SA are 1 kHz and 2 MHz, respectively. A high-resolution camera was used to image crack evolution after each impact test.

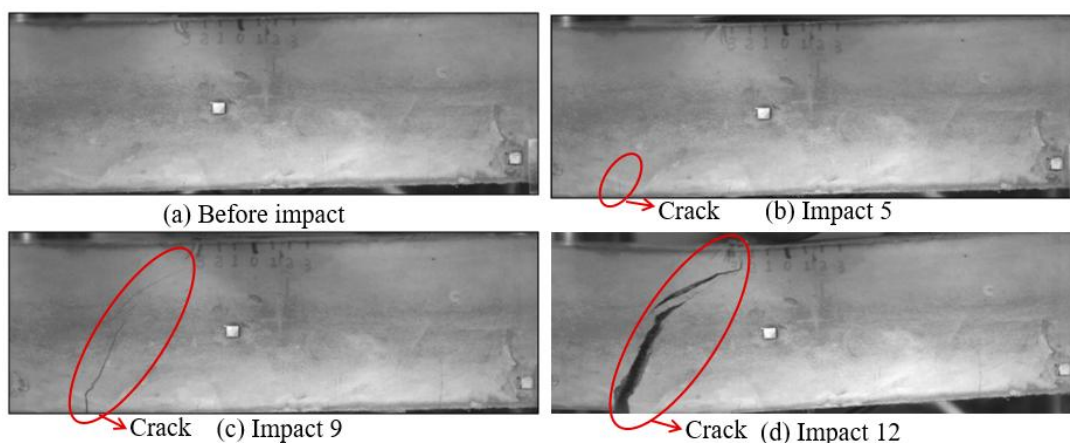
Figure 10. Results of crack detection in PVA-ECC-1 with high-speed video.

Low-velocity impact tests were repeated for each beam until the beam completely failed. For PVA-ECC-1 to 3, the impact counts were 12, 15, and 3, respectively. Figures 10–12 show the PVA-ECC-1 beam after impact tests, the time-domain signal received by the SA sensors, and the signal energy based on wavelet packet-based analysis. Due to space limitation, photos and time-domain signals are shown before impact, after impact 5, after impact 9, and after the last impact for each beam. Evolution of cracks for each beam can be observed. Figures 13–18 show the same measurements for PVA-ECC-2 and 3.

Between PVA-ECC-1 and 2, the drop height decreased from 1.5 to 1 m, which resulted in the impact test count increasing from 12 to 15. Since the crack acts as a stress relief, the propagated wave energy decreased which resulted in a decreased signal amplitude as received by the SA sensor. In both their time-domain signal response shown in Figures 6 and 7, it can be seen that the general amplitudes of the received signal decreased as the impact tests continued. In addition, wavelet packet-based signal energy plots provided a quantitative view to present the loss of the received signal energy. When the beam completely failed, the energy of the received signal approached 0 since the stress wave cannot propagate through a major crack. Compared with PVA-ECC-1, the drop weight of PVA-ECC-3 increased from 2.724 kg to 8.172 kg, which resulted in the impact test count decreasing from 12 to 3.

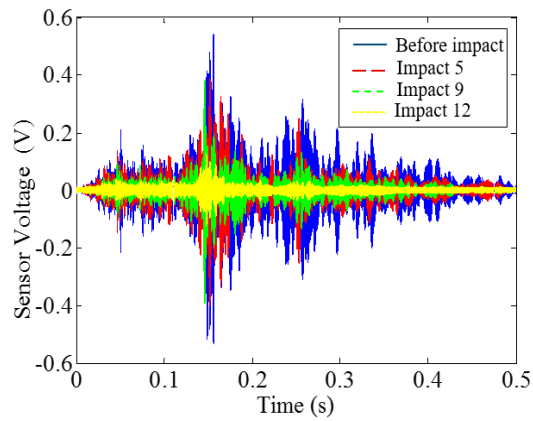
Figure 11. Time-domain signal received by smart aggregate (SA) sensor in PVA-ECC 1.

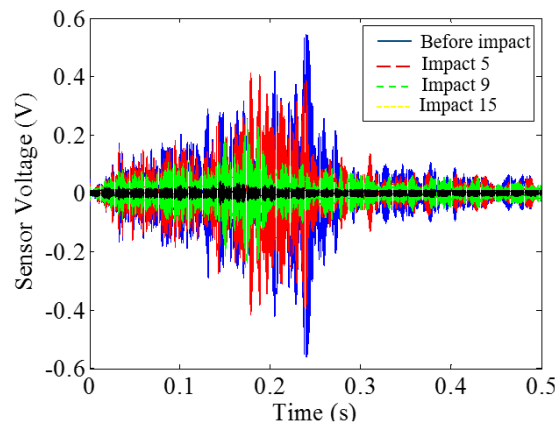
Figure 14. Time-domain signal received by SA sensor in PVA-ECC-2.

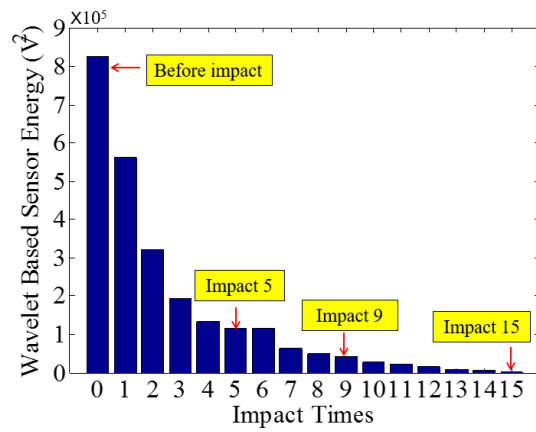
Figure 15. Wavelet packet-based energy plots of the received signal in PVA-ECC-2.

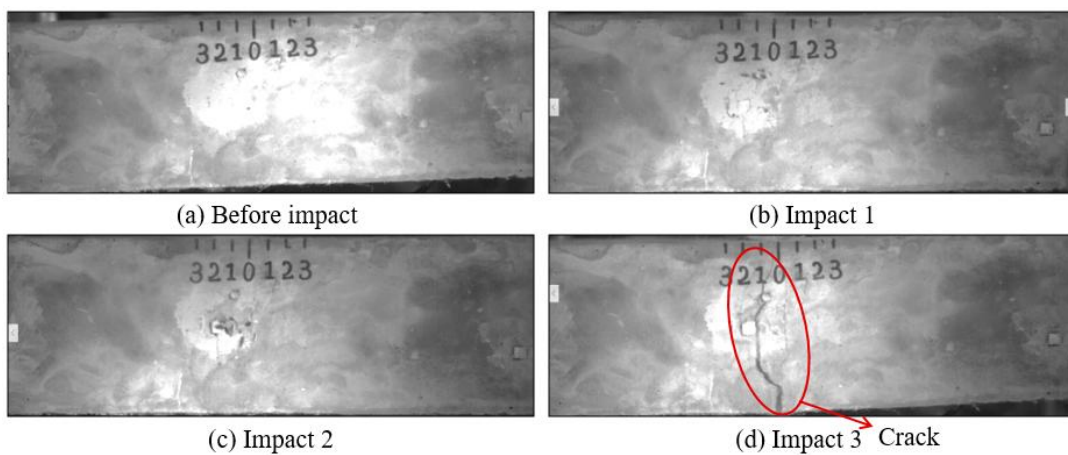
Figure 16. Results of crack detection in PVA-ECC-3 with high-speed video.

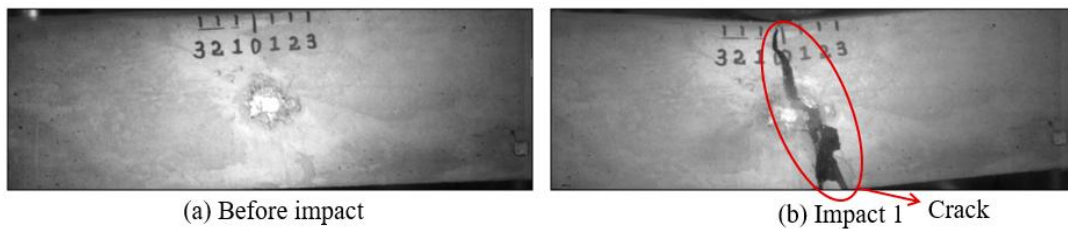
Figure 22. Results of crack detection of Mortar-2 with high-speed video.

Figures 19–27 show the Mortar-1, 2 and 3 beams respectively, after impact tests, the time-domain signal received by the SA sensors, and the signal energy based on wavelet packet-based analysis. Compared to PVA-ECC beams, the drop weight for all mortar beams was 2.724 kg. The only variable was the drop height which decreased from 1.5 to 0.5 m. It was seen that all mortar beams completely failed after the first impact, and no signal response was detected by the SA sensors. Similar results were verified by the wavelet packet-based energy plots. After the first impact test for each beam, the energy of the propagated signal rapidly zeros.

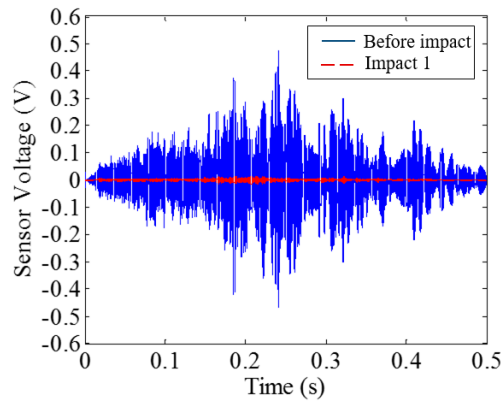
Figure 26. Time-domain signal received by SA sensor in Mortar-2.
