Construction and Preliminary HVS Tests of Pre-Cast Concrete Pavement Slabs

Research Report: UCPRC-RR-2006-10

Work Conducted as part of Partnered Pavement Research Center Strategic
Plan Element No. 4.17: HVS testing of pre-cast PCC panels in District 8

University of California
Pavement Research Center
UC Davis and Berkeley

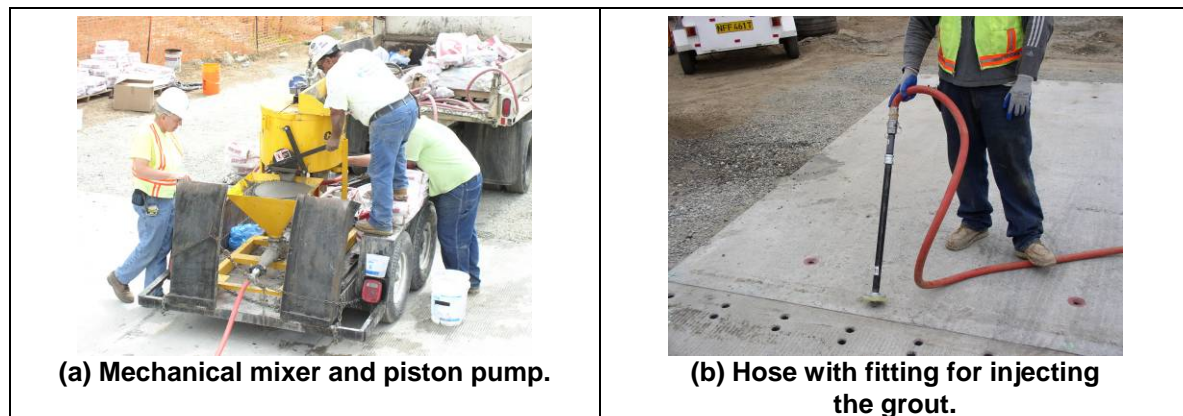
The fast-setting grout used in the grouting process required that the mix water be cooled before mixing. Ice blocks were placed in the mix water to cool it. The grouting system consisted of a mechanical mixer with a piston pump and hoses with customized fittings to inject the grout into the grout holes in the slabs as shown in Figure 12.

Figure 12. Basic components of the grouting equipment.

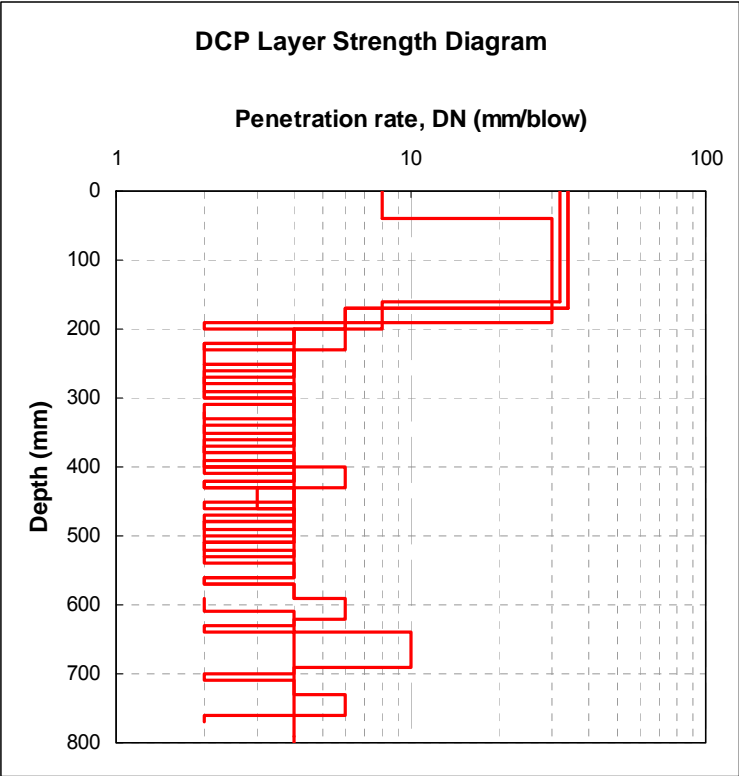
Figure 17 shows the DCP layer strength diagram (LSD) for the combined data of the DCP tests done on the northern side of the test site. Although the DCP did not always penetrate to the full depth of 800 mm the LSD clearly show that the top 200 mm (0.65 ft) of the subgrade generally had a relatively high penetration rate of approximately 30 mm/blow (0.1 ft/blow). Below 200 mm depth, the penetration rate decreased to between 2 and 4 mm/blow (0.0065 and 0.013 ft/blow) which is very low for a pavement subgrade. These low penetration rates, combined with the fact that the DCP did not always penetrate 800 mm, indicate a stony subgrade.

Figure 17. DCP layer strength diagram for the test locations on the northern side of the site.

Based on the results obtained by the DCP analysis it is concluded that the subgrade at the site where the Super-Slab® test section was constructed has sufficient bearing capacity to carry the expected loads. If well protected through the design of a proper upper structure, the subgrade at this testing area should not be the cause of any early unexpected failures under the influence of repetitive loading.

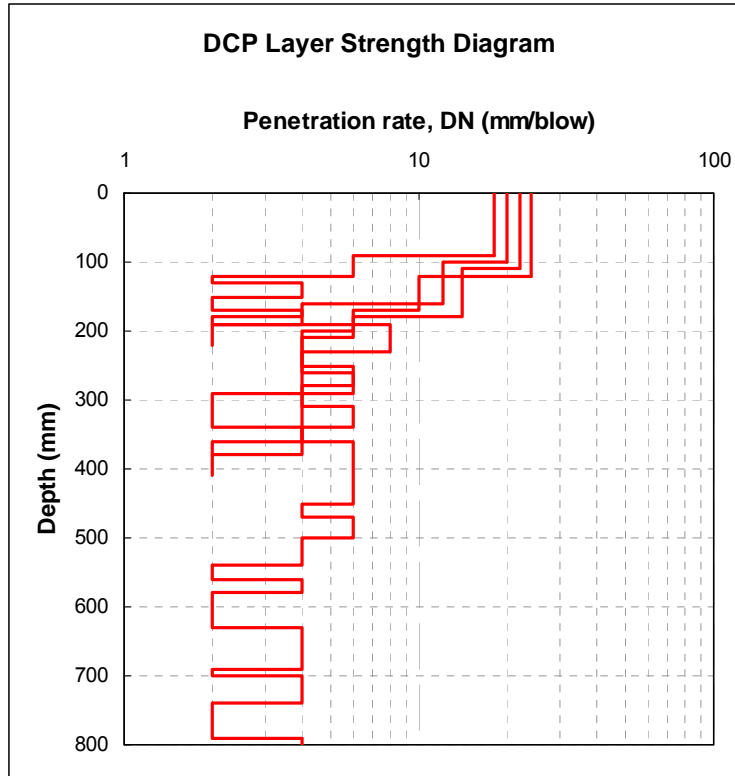
Figure 18 shows the LSD for the combined data of the DCP tests done on the southern side of the test site. Although the thickness of the top layer with the high penetration rate is only about half of the thickness of this layer on the northern side, the general trend in the data is very similar to the trend observed on the northern side of the site.

Figure 18. DCP layer strength diagram for the test locations on the southern side of the site.

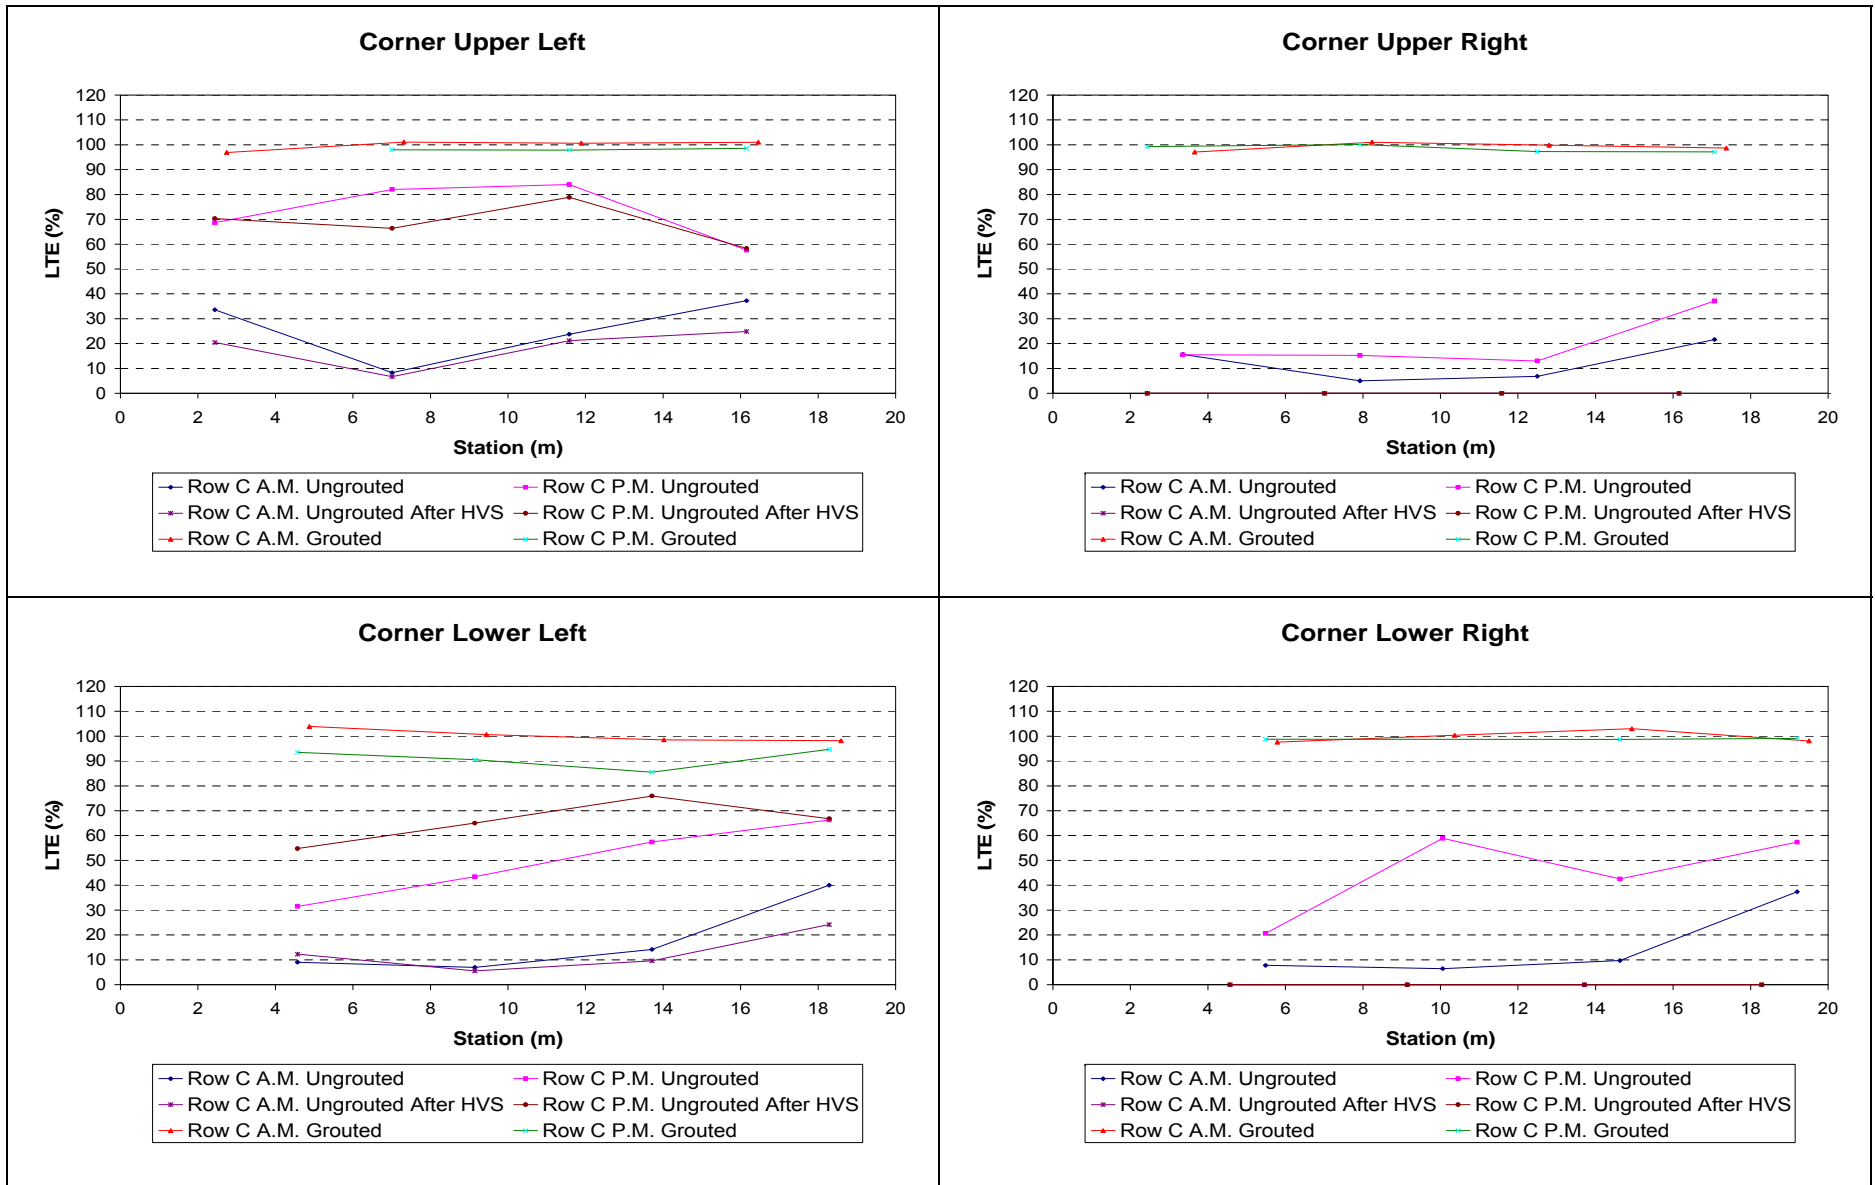
Figure 25. Transverse joint LTE data from the corners of the slabs: Row C.

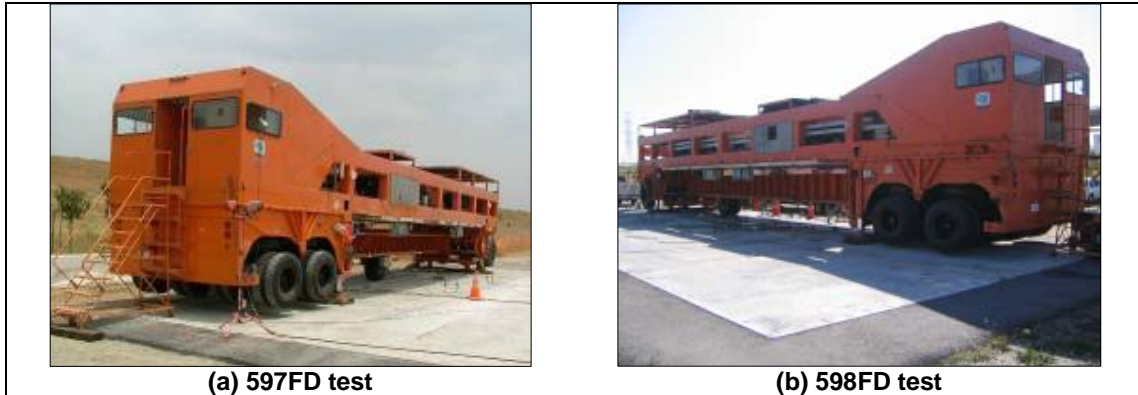
Figure 35. Photographs of HVS2 during Tests 597FD and 598FD.

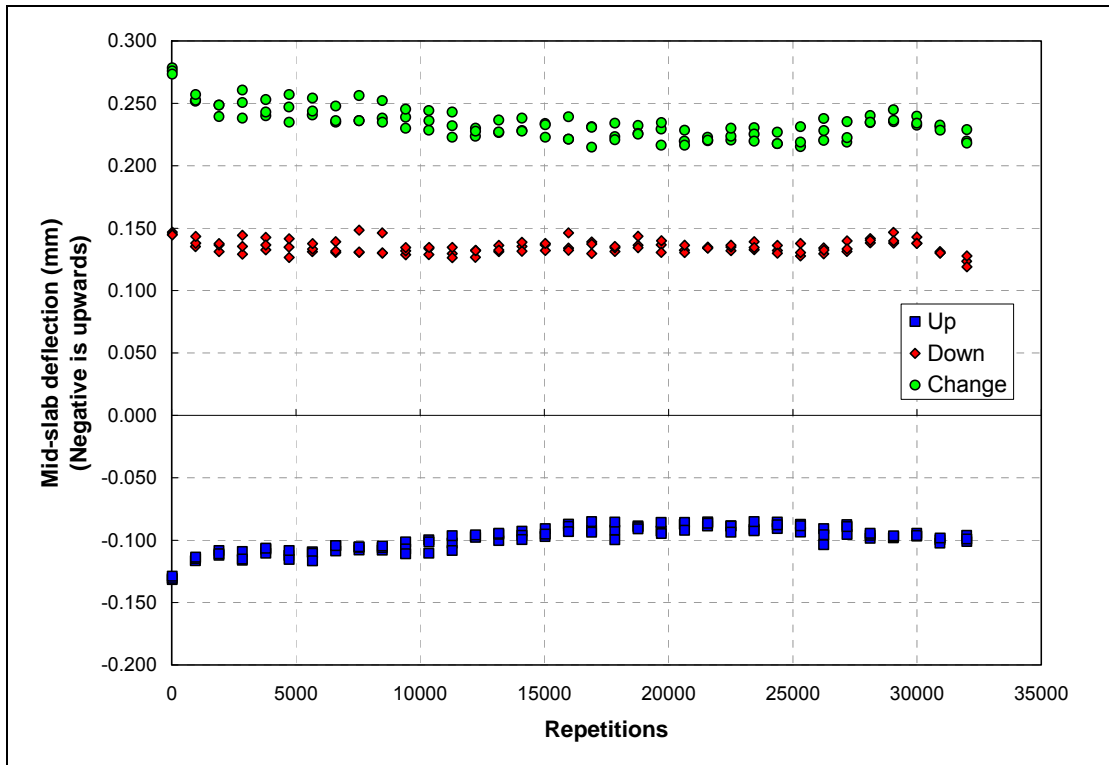
Figure 71. Mid-slab deflection for the ungrouted test, 597FDUG.

The peak resilient deflections plotted in Figure 68, Figure 70, and Figure 71 presented daily variations. The effects of the temperature and sunlight exposure conditions (shade projected on the pavement by the HVS versus exposed pavement) on the resilient deflections was therefore investigated. Figure 72 shows the resilient vertical deflection of the shaded corners plotted against the temperature gradient of the slab. The slab corner at JDMD 4 clearly had the lowest deflection but there is a correlation between the resilient vertical deflection and the temperature gradient of the slab for the other slab corners. Figure 73 shows the resilient vertical deflection of the exposed corners plotted against the temperature gradient of the slab. These slab corners were not directly trafficked but the rocking motion of the unrestrained slabs caused substantial deflection at these slab corners with the corner at JDMD 6 having deflections as high as 0.8 mm.

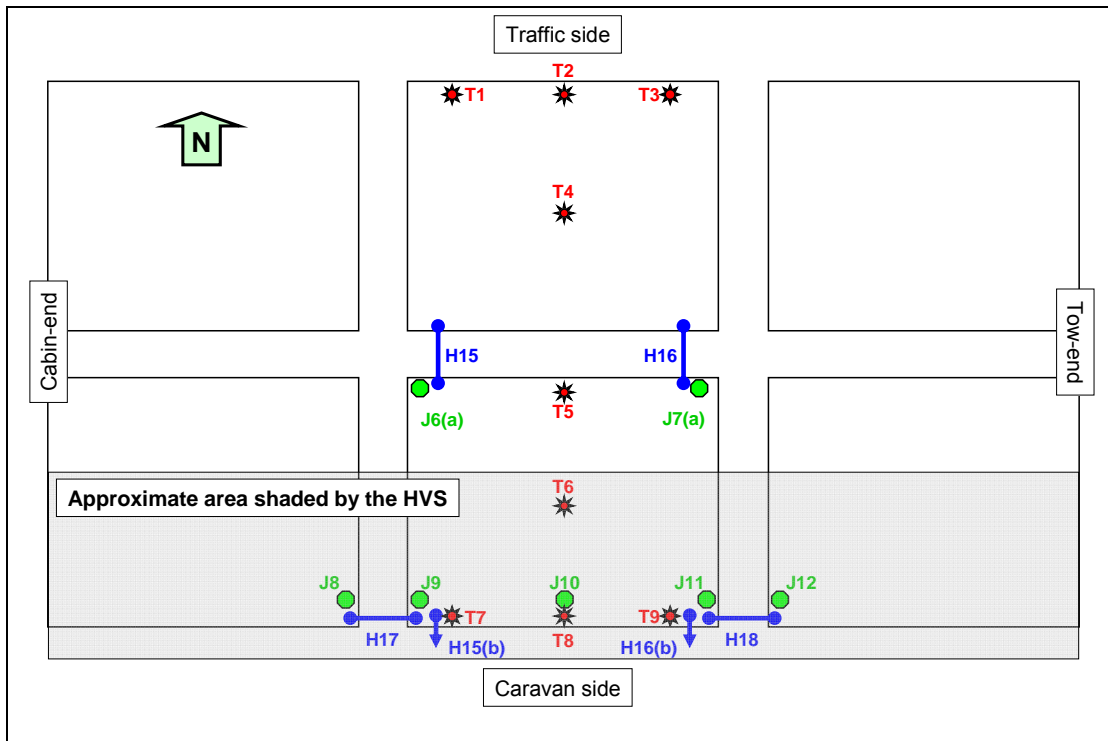
Figure 77. Thermocouples and JDMDs monitored during the second ungrouted test, 598FDUG.
