NCOS News - May 2017

North Campus Open Space Restoration Project

THE PAST, PRESENT, AND FUTURE HYDROLOGY OF DEVEREUX SLOUGH

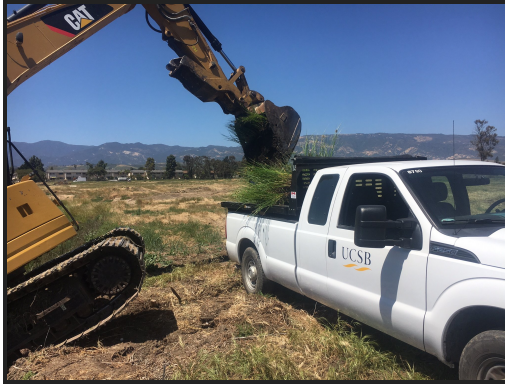
Figure 1.
Photos of

the native plant and special soil salvage efforts at the NCOS restoration project.

- In the last couple weeks, the NCOS grading contractors have been establishing environmental protection measures, salvaging special soil and plants (Figure 1 below), and removing the cement golf cart pathways and buried obsolete water and irrigation pipes in preparation for grading and movement of soil, which will begin the second week of May. Grading and soil movement will be done using low ground pressure equipment specially designed to work in and around wetlands (Figure 2 below).

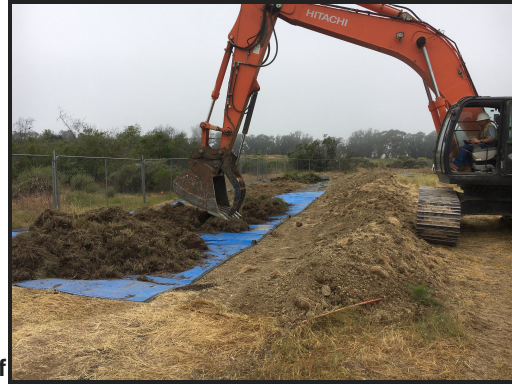
Figure 2. The specially designed graders that will be used for the grading and soil movement.

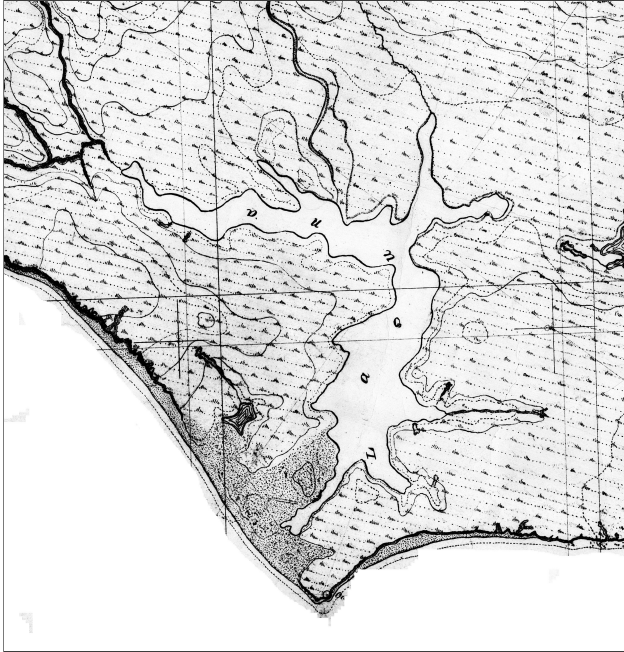
Figure 1. Portion of a U.S. Coastal Survey Map from 1871-73.

Devereux slough once extended throughout and beyond the boundaries of the former golf course (Figure 1). In the mid 1960s, the upper portion of the slough was filled in to create the golf course and housing sites, as can be seen in this 1967 aerial photo (Figure 2). The 3.2 square mile watershed reaches the slough through 4 tributaries that funnel their way through the former upper arms of the slough. From the west is Devereux Creek, from the north is Phelps Creek, from the northeast is the Whittier channel, and from the east is a small, unnamed tributary from the Storke Ranch housing area that once connected Devereux Slough to Goleta Slough (Figure 3). These channels merge together in the middle of the NCOS restoration project site, and the flow into Devereux Slough is controlled by a sheet-pile grade control structure that separates the creek system from the slough.

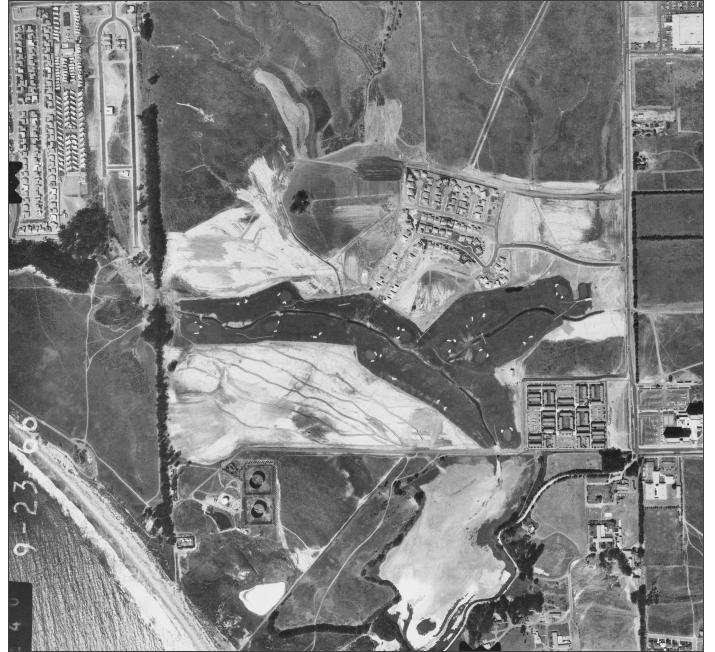
Figure 2. Aerial photograph from 1966.

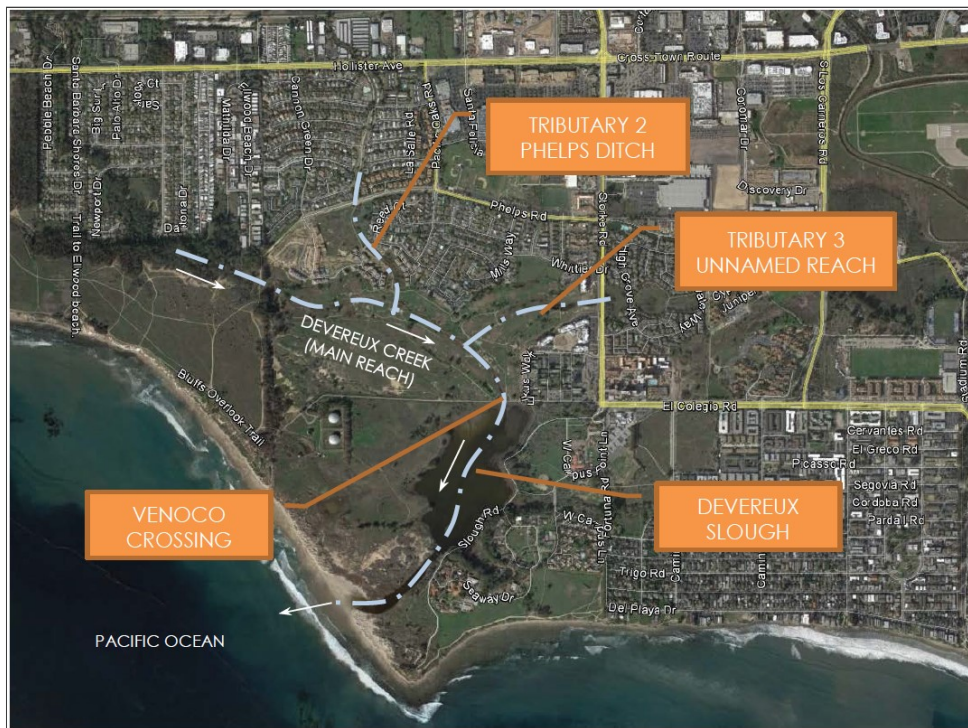
Figure 3. Map of the tributaries and flow of water through Devereux Creek and Slough.

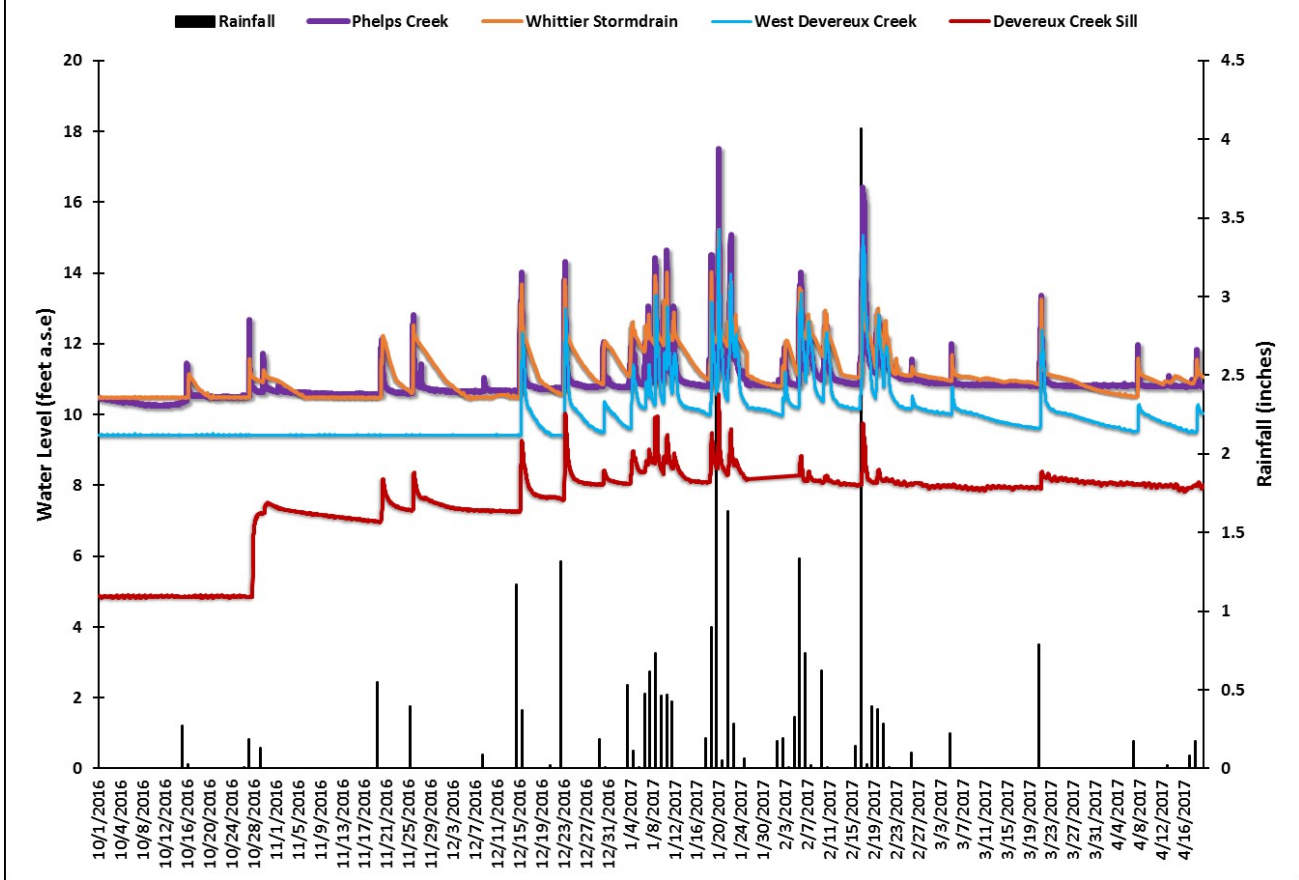
Water Level in NCOS Creeks - Oct 2016 to April 2017

CCBER maintains water level sensors in these tributaries and in the slough. The two graphs below show the changes in water levels in the creeks from October 2016 through April 2017, with a close-up of the January-February period when the heaviest rains fell. These figures show that water levels near the junction of Phelps creek and Devereux creek (purple line) had peak flows of 17.5 feet above sea level during a heavy rainfall event (more than 2 inches in a few hours) on January 20th, and 16 feet above sea level during the large storm (more than 4 inches of rain) on February 17th. The ground level elevation of the former golf course ranges from 10 to 15 feet and, therefore, stormwater easily rises over the edges of the channelized creeks and floods the site during relatively minor to moderate rain events of 2 inches or more.

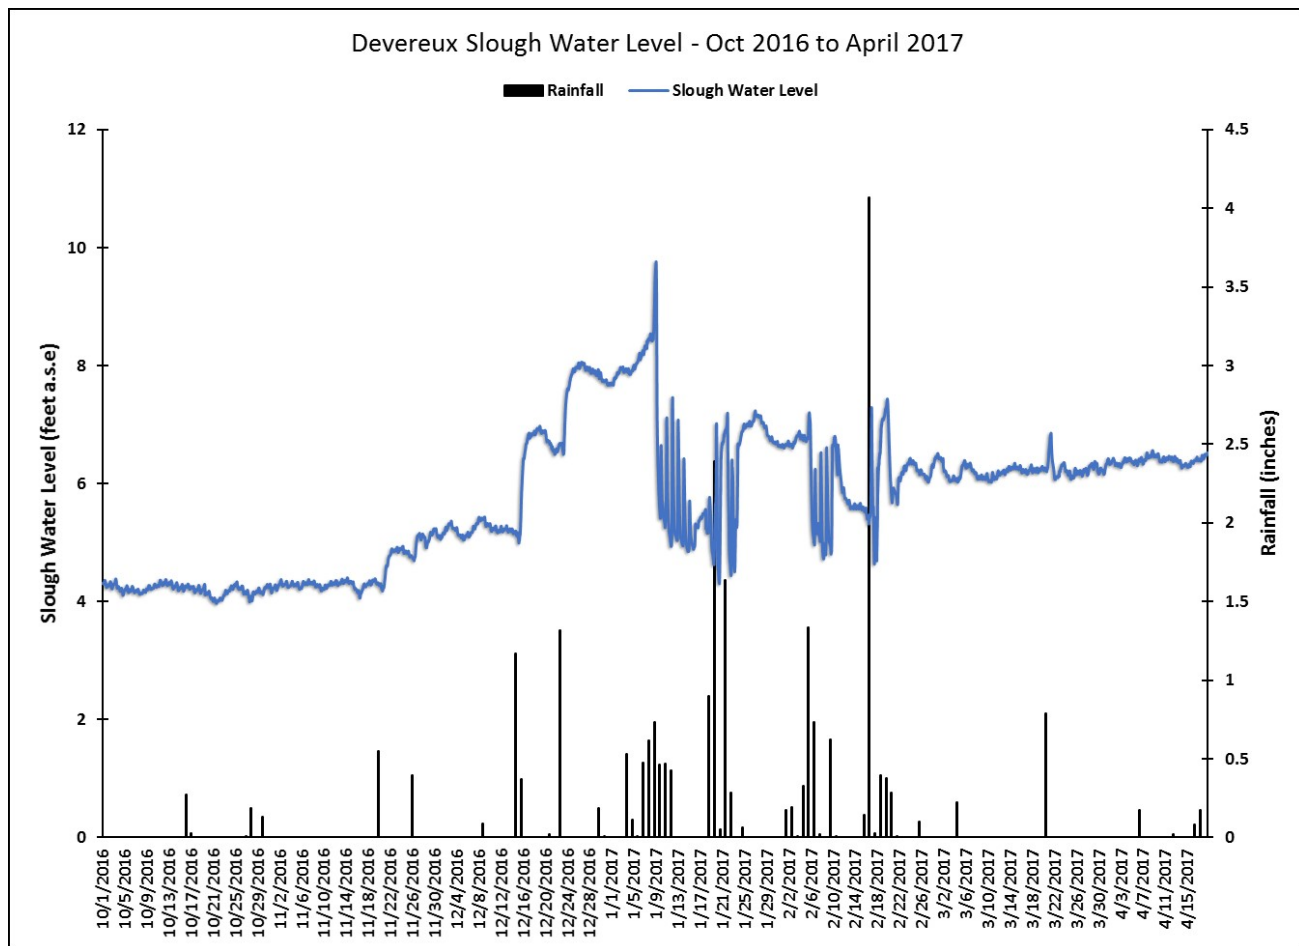
Devereux Slough is an intermittently tidal system, which means that there is a sand bar at the mouth where the slough meets the ocean. This sand bar changes height depending on the waves and is breached when water levels in the slough reach almost 10 feet, the average height of the berm. When the water in the slough breaches the berm, the system becomes tidal. This pattern is clearly seen in the data recorded by the level logger in the slough and displayed in the two charts below. The figures show that the height of water in the slough ranged from 4 to 5 feet in elevation during the fall, then began to rise as winter rains started to fall and fill the slough. On January 9, the water level peaked at almost 10 feet following consecutive storms, the sand berm was breached and the water level quickly dropped by more than 4 feet as the water in the slough emptied into the ocean. This breach event began a period of several weeks when water levels in the slough periodically fluctuated daily with the tides, until the mouth gradually filled with sand, replacing the berm and holding the water level near 6.5 feet in elevation through early spring.

During summer, the sun's energy will evaporate water from the slough surface at a rate of approximately 4 to 6 inches per month. Once the NCOS restoration project is complete, the whole system will be connected to the mouth and should follow patterns very similar to what is shown in the figures above. Rain events will fill up the system, and when water levels reach 8 to 10 feet, depending on waves and tides, the sand bar will be breached and the system will become tidal for 1 to 3 weeks until the mouth is slowly closed up again.
