Evaluating the effectiveness of calcium hydroxide nanoparticle dispersions for the consolidation of painted earthen architectural surfaces

A thesis submitted in partial satisfaction  
of the requirements for the degree Master of Arts  
in Conservation of Archaeological and Ethnographic  
Materials

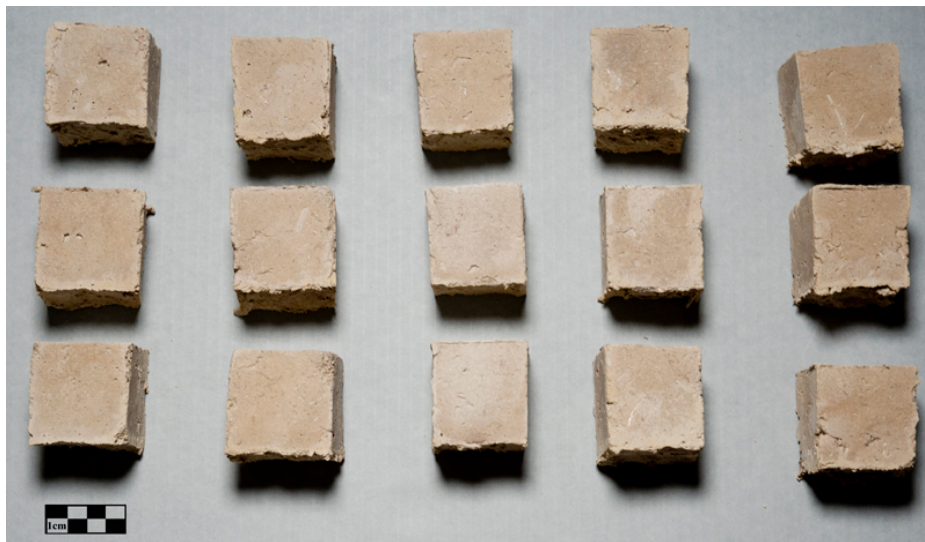
*Figure 1: Earthen architectural test blocks before plastering*

Blocks were made in batches of three, with a ratio of approximately 3: 5: 4: 3 kaolin: montmorillonite: sand: straw, by volume. Ingredients were measured by weight to ensure uniformity in block composition. 64.1g of kaolin (yellowish white kaolinite supplied by Kremer Pigments  $\text{Al}_2(\text{Si}_2\text{O}_7)\cdot x\text{H}_2\text{O}$ ), 271.8 g montmorillonite, 366.6g sand, and 13.2g straw was used per “batch” (see *Appendix 8* for suppliers) The clay and sand were thoroughly mixed before adding the straw. Straw was cut into pieces approximately 2.5-5cm in length. The straw was then incorporated with the dry components adding deionized water (approximately 150-200mL water) until a desirable consistency was reached. The mixture was poured into pre-fabricated wooden molds, which were open on the top and bottom to allow for easy removal and drying. Once the blocks were sufficiently hardened (after two or three days), they were removed from the molds and allowed to dry for an additional two weeks exposed to direct sunlight in a sunlit room.

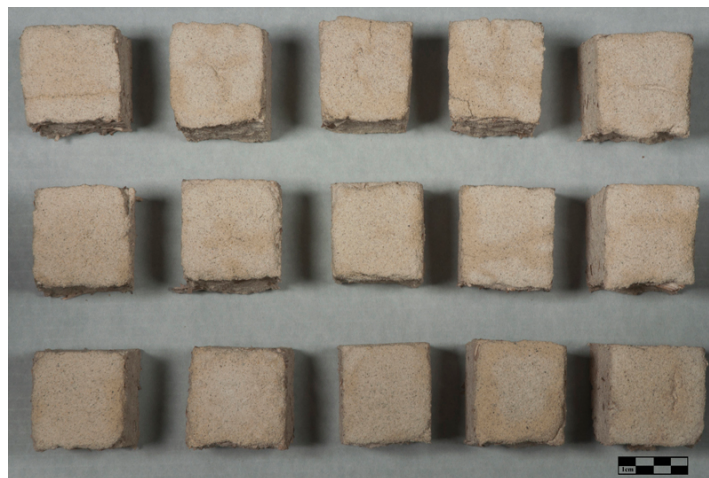
*Figure 2: Plastered test blocks before painting, after accelerated aging*

Once the adobe blocks had been allowed to dry, their surfaces were covered with a clay plaster layer, consisting of montmorillonite and kaolinite clays. In addition, sand, water and a gum-like extraction from soaked cactus mucilage were added to this mixture. This has traditionally been used as an additive in earthen constructions in many regions of South America (Beas 1991). The sulfuric acid esters in the vesicular cells of the parenchymatous structure of the cactus have conglomerating properties, which also prevent against bacterial growth (Hoyle 1990). After consulting the literature and attempting several different techniques, the chopped prickly pear cactus (from the *Opuntia* genus, likely *ficus-indica*) was soaked in deionized water for 24 hours, as described by Hoyle (1990). It was then used within 48 hours, as Hoyle warns that after this time the cells begin to decompose resulting in loss of viscosity. The overall composition of the plaster consisted of 2 parts (by volume) sand to 2 parts clay (1.5 parts montmorillonite and .5 parts kaolin), .25 parts cactus and .5 parts water, which was applied to the surfaces of the blocks in a layer approximately .5cm thick.

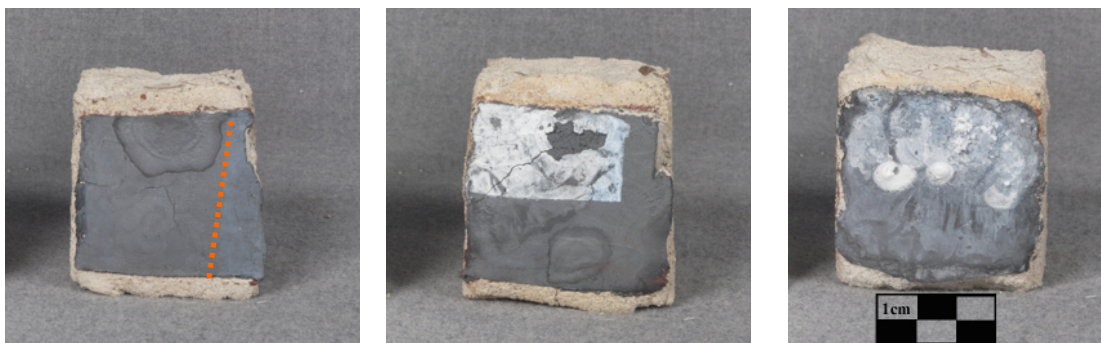
*Figure 3 (from left to right) Block 2 following spray application of pure CaLoSiL on the right (see light area, to the right of the red dotted line), and application of CaLoSiL diluted in ethanol (1:1) on the left; block 3 following test application of poultice (white area); and block 8 following brush application of CaLoSiL (visible on bottom of block), followed by the application of ammonium bicarbonate poultice (visible in upper portion) in an attempt to remove the white veil formed. Tidelines are the result of the “Surface Absorption Test” (see Section 5.5.1)*

In these preliminary trials, the use of poultices caused an unacceptable whitening of the surface that was very difficult to eliminate, brushing caused slight whitening and removal of loose particles (through the mechanical action of the brush), with spraying causing no discernible whitening nor other negative effects (*Figure 3*). To avoid over-saturation of the surface and to better control the application of the consolidant a diluted version of CaLoSiL was used with a ratio of 1:1 per volume ethanol to CaLoSiL. Based on this preliminary testing, it was therefore

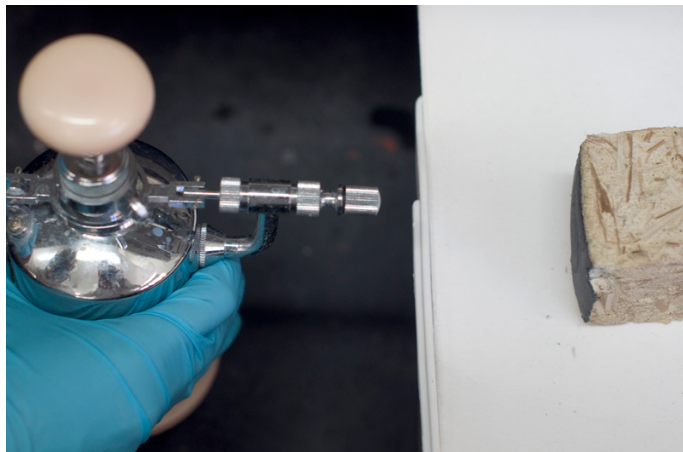
*Figure 4: Spray application of the CaLoSiL, on a painted test block, using an atomizer*

The blocks were sprayed from a distance of 10cm with the painted surfaces in a vertical orientation (*Figure 4*). The challenge with this method of application was in spraying the entire surface evenly without over-saturating the block. Owing to the small surface area of the block, acquiring consistent results, even with the controlled mist of the atomizer, proved incredibly difficult. As the T and RH can affect the penetration of the consolidant, these measurements were recorded. The RH was 50%, and the T 22°C during application.

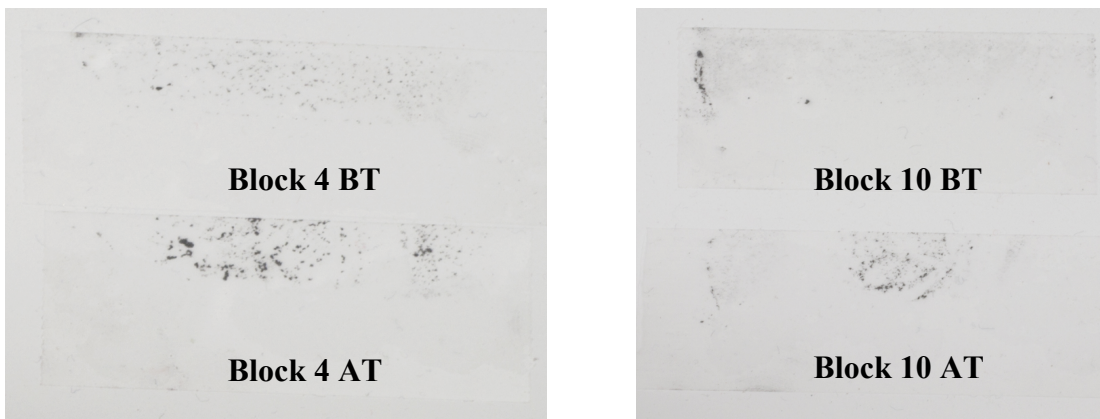
*Figure 6 details of the results of the Scotch Tape Tests for two of the blocks, before and after treatment (note: block 4 contains paint without a cactus mucilage binder, while block 10 contains a cactus mucilage binder)*

Scotch Tape Tests showed an improvement in the cohesion of the paint layer after consolidation, though the consolidation achieved seems to be superficial. While the Scotch Tape Test on the consolidated samples seems to have removed more material from the surface, there is a clear indication of pigment clustering suggesting strengthening of the bonds between the loose particles of the paint layer (*Figure 6 and Figure A3.1*).
