**Eddy Current Inspection of
Superconducting Cable
During Manufacturing***

D. A. Bein,¹ J. Zbasnik,¹ S. Graham,¹ and R. Scanlan²

Superconducting Super Collider Laboratory[†]
2550 Beckleymeade Ave.
Dallas, TX 75237

March 1992

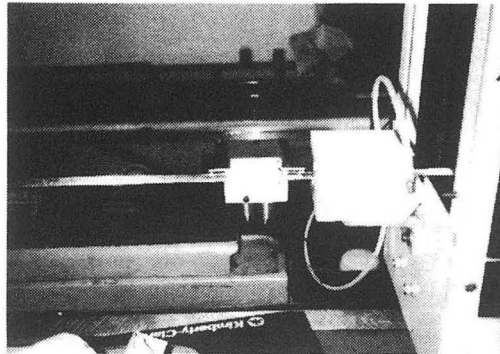
Figure 4. Probe arrangement between turk's head and caterpillar.

We then moved the transducer banks between the turks head and the caterpillar. The tension in this region was very constant, of the order of 200 pounds, which resulted in a very steady Eddy current background signal. The set-up, with staggered probe position, is shown in Figure 4.

The probes were initially arranged this way without the proper mechanical fixturing, but with the transducer holders "riding" on the oscillating cable they performed surprisingly well. The holders were not held by any rigid fixture, but only supported by the cable itself, and constrained to move with any oscillation of the cable. In this orientation we began to obtain a low - noise signal output, and it became evident that cold welds also could be detected.

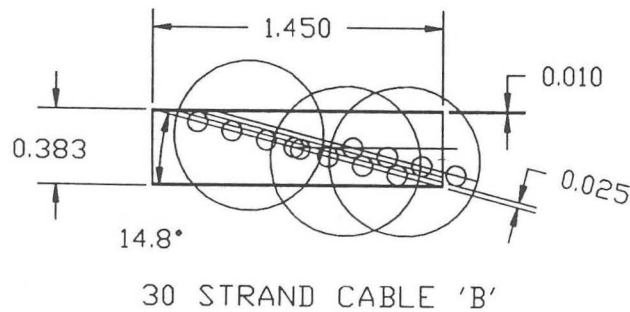
Figure 5. Orientation of Eddy current probes for inspection of 40mm cable

40mm Outer Cable Experiments. This cable run was for LBL quads, and it had no cold welds. The geometry of the orientation of the transducers is shown in Figure 5.

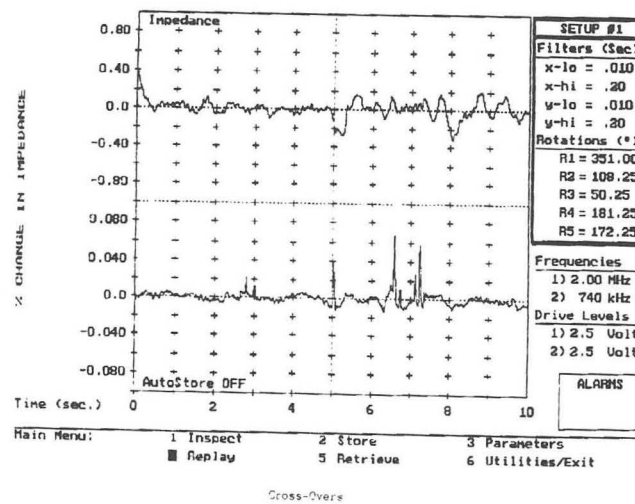
Figure 10. Trace indicating cross-over.

These were then inspected and clear indications were detected using the smart EDDY 3.0 system, and our specialized probes. The output signal traces associated with the cross-overs, and cold welds, shown in Figures 10, and 11, respectively.

The Eddy current system, and probes proved useful for inspection of the superconducting cable during manufacturing. The instrument, and probes clearly showed that the detection of cross-overs could be made with a signal to noise ratio of 4:1. While the cold weld indications occurred with a signal to noise ratio of the order of 2:1, we need to improve this signal to noise ratio for reproducibility, and reliability of cold weld detection. The results suggest that we can implement the cross-over detection because of both: the satisfactory signal to noise ratio for these defects, as well as, their cause of degradation of the mechanical integrity of the cable. Our future work will entail first optimization of the mechanical fixturing. Then working on better cold weld detection. And finally work on edge detection should be soon to follow.
