A FIELD EVALUATION OF DAYLIGHTING SYSTEM PERFORMANCE

To be presented at Advancing Building  
Technology, 10th CIB Congress, International  
Council for Building Research, Studies, and  
Documentation, Washington, DC,  
September 21-26, 1986; and to be published  
in the Proceedings

### A FIELD EVALUATION OF DAYLIGHTING SYSTEM PERFORMANCE

## A Field Evaluation of Daylighting System Performance

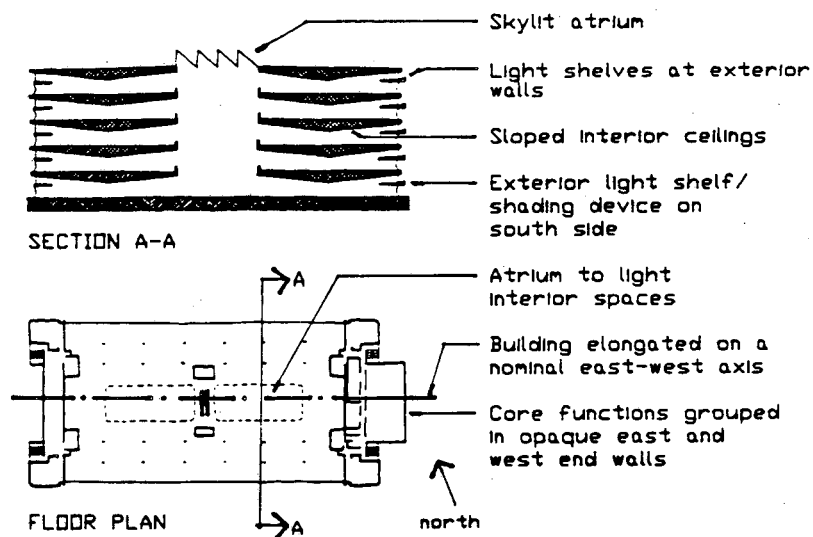
Figure 1. Diagram of building scheme.

This paper describes a post-occupancy study providing monitored performance data for an innovative daylighted office structure in the San Francisco Bay Area. The structure represents a major advancement in daylighting use by a large U.S. corporation that seeks reduced energy consumption, lower peak demand, and improved employee productivity. The 56,000-m<sup>2</sup> office is occupied by 3,000 technical personnel in open-plan offices. The building, diagrammed in Figure 1, is a design strongly driven by daylighting. The building plan is elongated on an east-west axis producing major fenestration surfaces facing roughly north and south (the building is actually turned approximately 25 degrees west of south). Building functions lacking a strong relationship to daylighting (computer facilities, conference rooms, rest rooms, copy rooms, etc.) are gathered into opaque core groups placed on the east and west ends of the building. A central atrium was introduced to provide light, visual relief, circulation, and drama to the building's large interior zones. The building has a high floor-to-floor dimension (5.5 meters) to increase the depth of daylight penetration from exterior and atrium openings, with a sloped ceiling to intercept and reflect illuminance from the light shelves. Large light shelves are located along both north and south exterior walls. The horizontal interior light shelves are about 2.3 meters above the floor and extend inward 3.75 meters from the exterior glazing. The south side of the building has an additional exterior light shelf with a reflective white upper surface. To further reduce glare and winter solar gain, the glazing below the light shelf has a relatively low transmittance (17% on the south side and 41% on the north). Ambient illumination for circulation and casual tasks is provided by daylighting whenever possible and supplemented by indirect fluorescent ceiling fixtures. A photosensor provides the signal to control each circuit's continuous-dimming system. A separate computer-based control system turns the lights off at scheduled periods of low occupancy. Task lighting is provided by individually controlled fixtures built into each workstation.

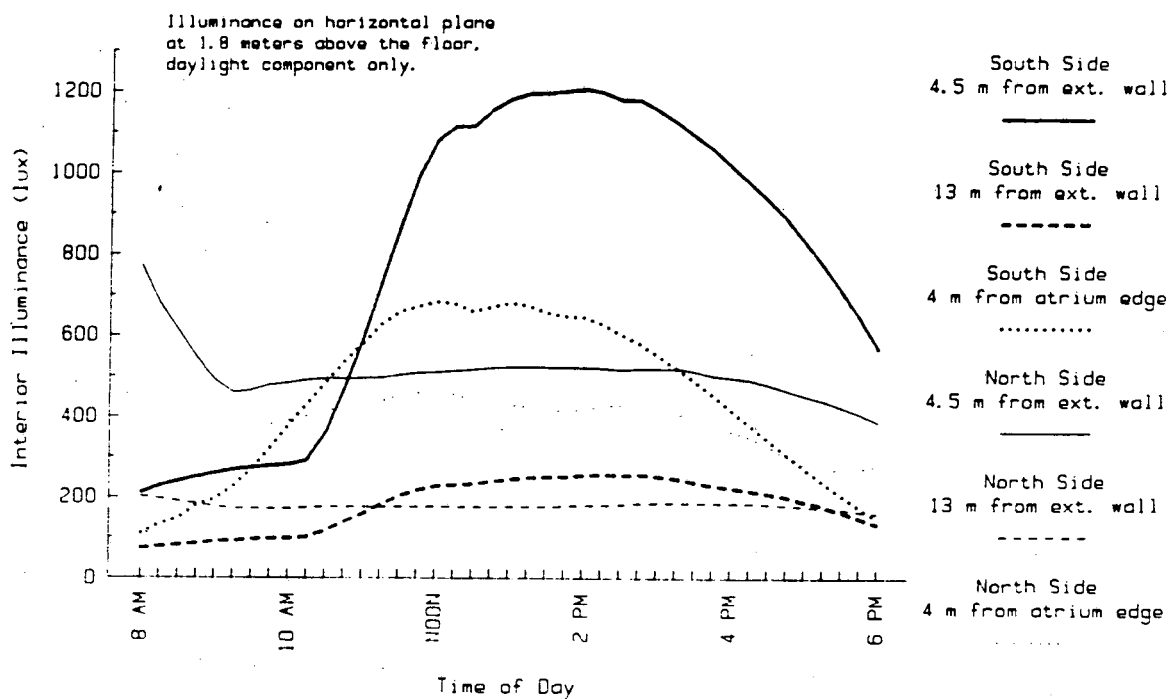
Figure 2. Interior illuminance values for a typical clear summer day.

Monitored performance data indicate a number of interesting trends in the daylighting patterns of the building. Typical data for interior illuminance under summer clear sky conditions are shown in Figure 2. The south side of the structure, with exterior light shelves and low-transmittance glass, is strongly influenced by beam sunlight. Interior illuminance is low during the morning hours but rises quickly as direct sunlight strikes the exterior light shelf. Peak interior readings 4 meters from the exterior wall exceed 1200 lux, almost 4 times the target of 350 lux. In order to prevent glare in the immediate vicinity of the window, a combination of low-transmission glazing and shading from the exterior light shelf was used, so the area immediately below the light shelf does not receive enough natural light to exceed 350 lux. Thus there are lower levels of natural light in the zone closest to the window than in the interior zones. Illuminance levels 13 meters from the exterior wall peak at approximately 250 lux. Though this does not provide 100% of ambient illuminance, it does reduce the electric lighting load significantly.

The north side of the building has an entirely different daylighting character. The north sky provides diffuse light to this zone, which has higher-transmittance glass and no exterior reflector. Interior illuminance here does not reach the high levels of the south side, peaking at 600 lux. The interior light levels, however, consistently exceed the 350-lux target and therefore provides substantial dimming potential. The area immediately beneath the light shelf has higher daylight levels than its south-side counterpart because of the higher transmittance of the view glazing. Like the south side, the

Illuminance levels near the atrium edge on both sides are quite high and fall rapidly nearer the building's interior. A 6000-lux reading at the atrium edge becomes 700 lux at 3.5 meters from the edge and 400 lux at 5.5 meters.

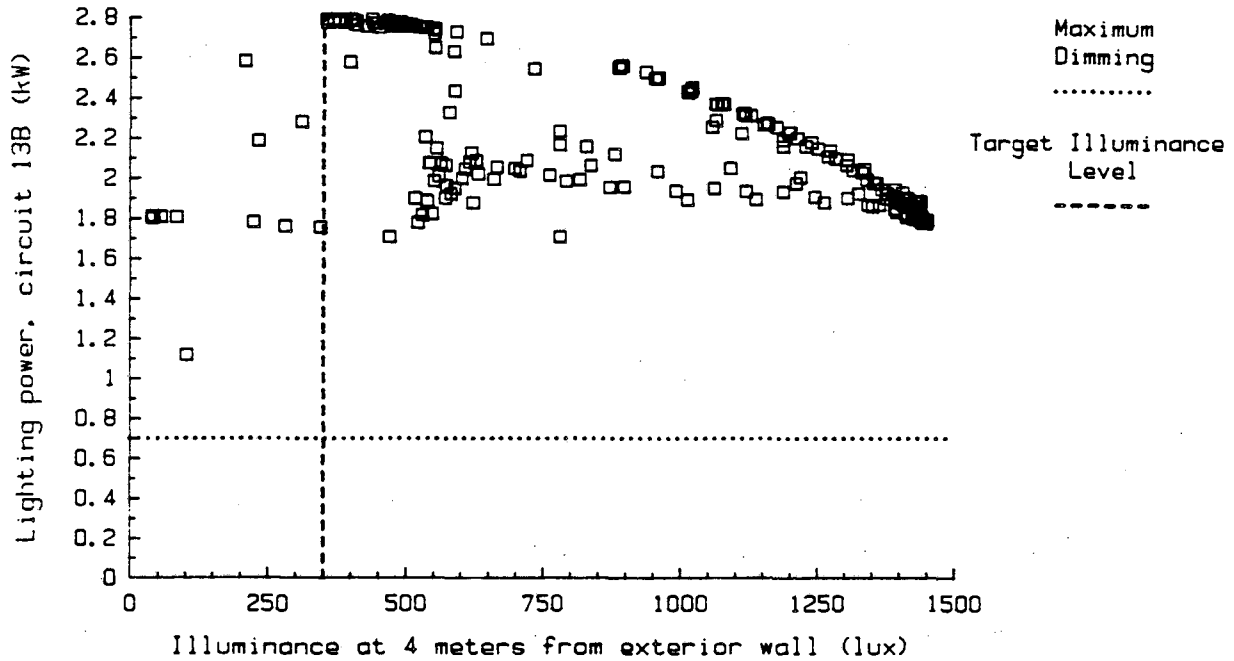
Figure 3. Electric lighting power vs. interior illuminance for a representative location in the south exterior zone (summer conditions).

Observations and manual testing of the fluorescent ballast dimming system at night indicated that it was operating within manufacturer's specifications, but was not reaching its full dimming potential. The system can dim continuously from full output to a minimum of 25% of full power. A careful examination of correlation between interior illuminance and electric lighting power consumption in 14 locations across the third floor reveals that dimming to low electric light levels occurred on only four circuits. The other circuits exhibit either some dimming at higher daylight levels, or no dimming at all. Figure 3 gives a typical example, where the scatter plot of lighting power versus illuminance is clearly not consistent with design objectives. Ideal system performance would show a reduction in electric power consumption while illuminance remains relatively constant at the 350-lux target. The illuminance level should increase only when the electric lighting system is fully dimmed. Though the architectural elements and dimming ballasts perform well, the lighting-control system responds poorly to available daylight. Fortunately, of the three components, the control system is the easiest to correct.

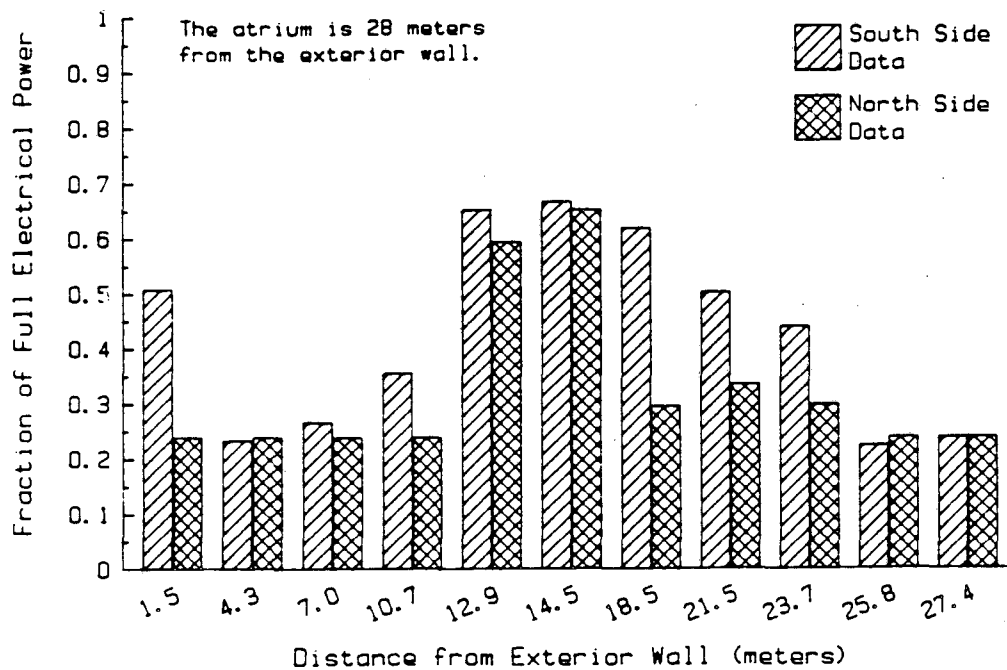
Figure 4. Dimming potential for the third floor shown as the fraction of full electrical lighting power required to achieve the target illuminance level (350 lux) for daytime occupied periods.

The dimming potential calculated by this process is summarized in Figure 4 for each illuminance sensor location across the third floor. The calculations indicate that the potential for dimming during summer occupied periods on the third-floor south side is 44% of full power, but actual measured consumption is 75%. On the third-floor north side the potential for dimming during occupied periods is 30% of full power while the actual average power consumption during occupied periods is 50%.
